This document is the consolidated Expert Report of Prof. Asif Sohail Usmani and Prof. Jiang Liming (incorporating the Expert Report dated 15 June 2026 and Corrigendum dated 24 June 2026)

**Independent Committee in relation to  
the fire at Wang Fuk Court in Tai Po**

**Expert Report**

**Prof Asif Sohail Usmani  
Prof Jiang Liming**

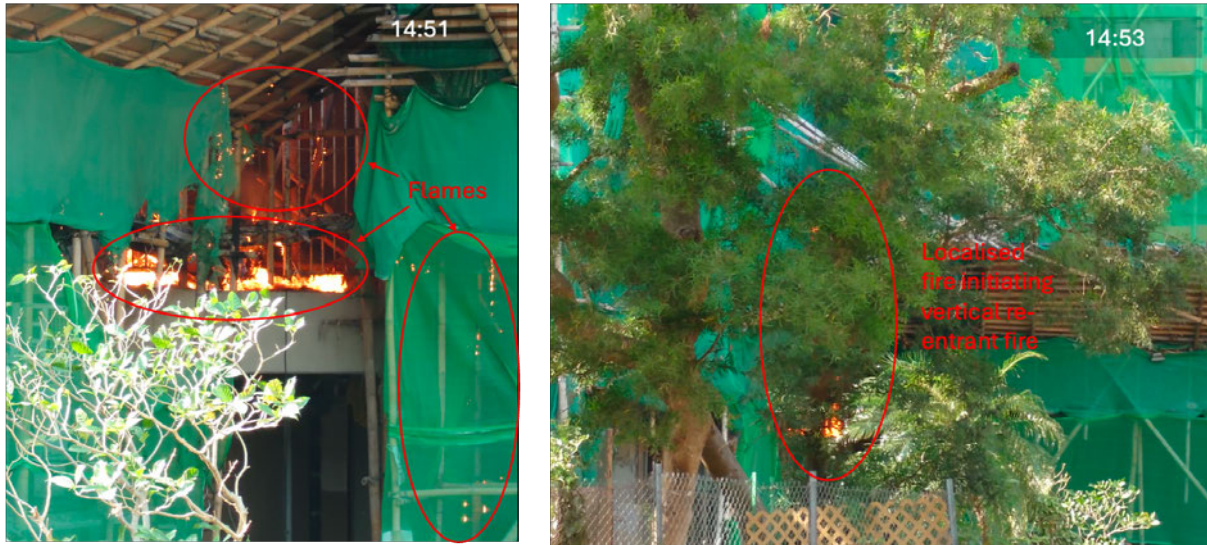
- 3.2.1. The initial fire at Wang Fuk Court was reported at 14:51, 26 November 2025 (referring to Section 5.1.1 of IFITF Final Report). Witness reports suggested that the earliest found products of fire (e.g., smoke) might be around 14:30, but it cannot be verified by clear evidence. However, the first available video footage showing the initial fire at re-entrant flat roof indeed showed that the fire had already developed for a short period. The video was captured at 14:50:43 according to the time stamp of video, and there existed flames at various locations, including the floor of re-entrant roof (1<sup>st</sup> floor, between Unit 104 and Unit 105) and safety net pieces attached to bamboo sticks. At 14:53 (Fig. 3-1), the fire had developed to a localised fire of certain height, which was then able to initiate the massive fire in the re-entrant region. Here the growing size of localised fire is likely due to the stacked fuel on re-entrant flat roof forming a fuel base of the fire.

Figure 3-1. Initial fire development at re-entrant of Block F

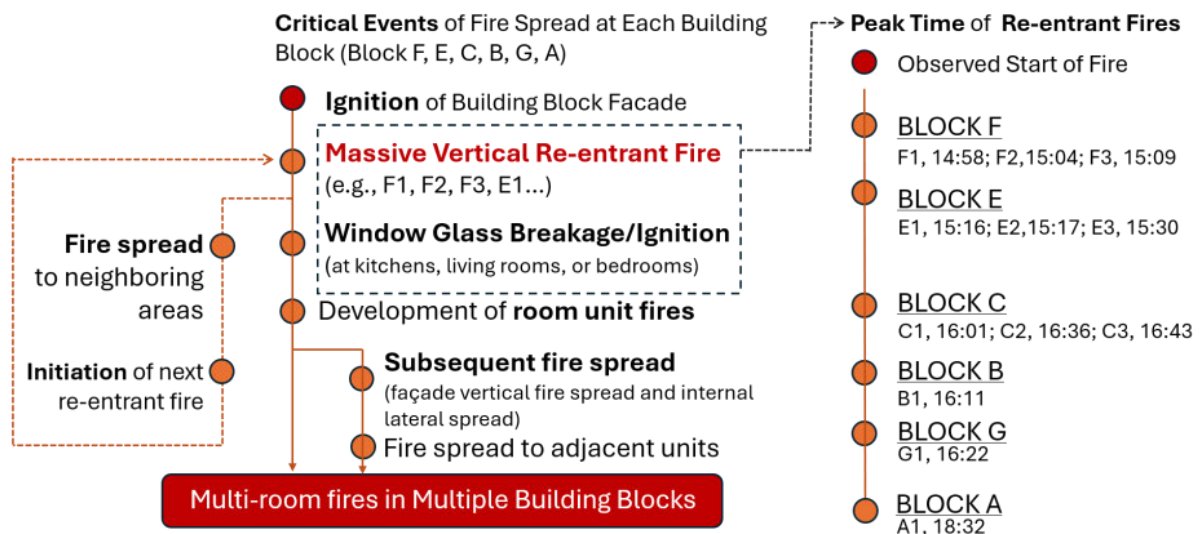
3.2.2. The first massive vertical-spreading fire along the re-entrant region occurred after the initially observed fire at re-entrant flat roof of Wang Cheong House (Block F) between Unit 104 and Unit 105. The subsequent fire spreading follows similar patterns among various buildings. If taking a vertical re-entrant fire as the most critical event, it would always be initiated by a localised fire of certain size, which was likely to have resulted from the ignition of building block façade. Window glass breakage at various locations such as kitchens, bathrooms, and living rooms (depending on room unit types) occurred immediately during the massive vertical re-entrant fire. The correlation of glass breakage and room unit fires is discussed in Section 3.4 below.

Figure 3-2. Critical events of fire spread among building blocks

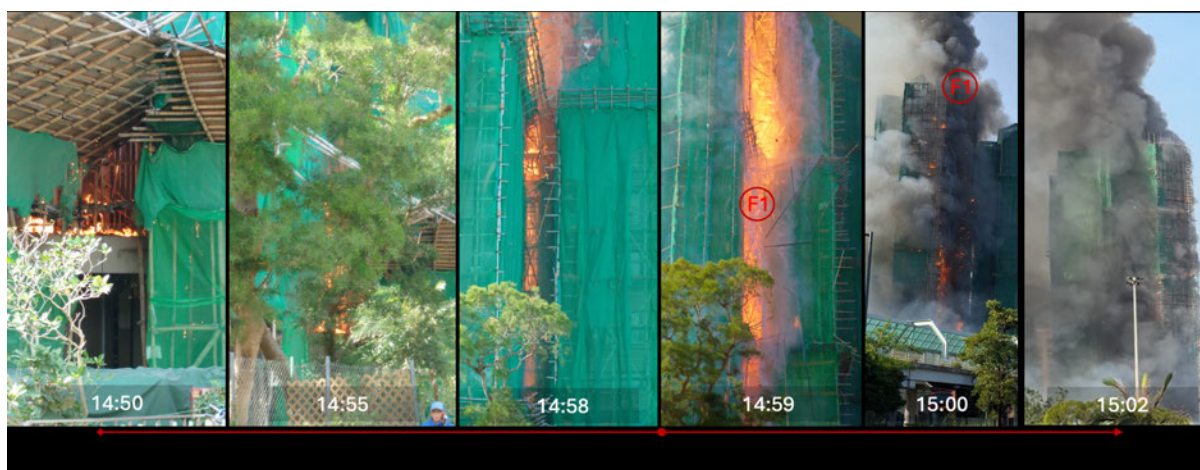
- 3.3.2. The first vertical fire spread at Wang Cheong House (Block F) re-entrant “F1” was first captured at 14:50 on 26 November 2025. The full development stage of “F1” was around 14:59, and the decay stage was observed at 15:02. At the decay stage, the building was engulfed by a huge amount of smoke as the photographic evidence shows.

**Figure 3-4. Initiation and development of F1 re-entrant vertical fire**

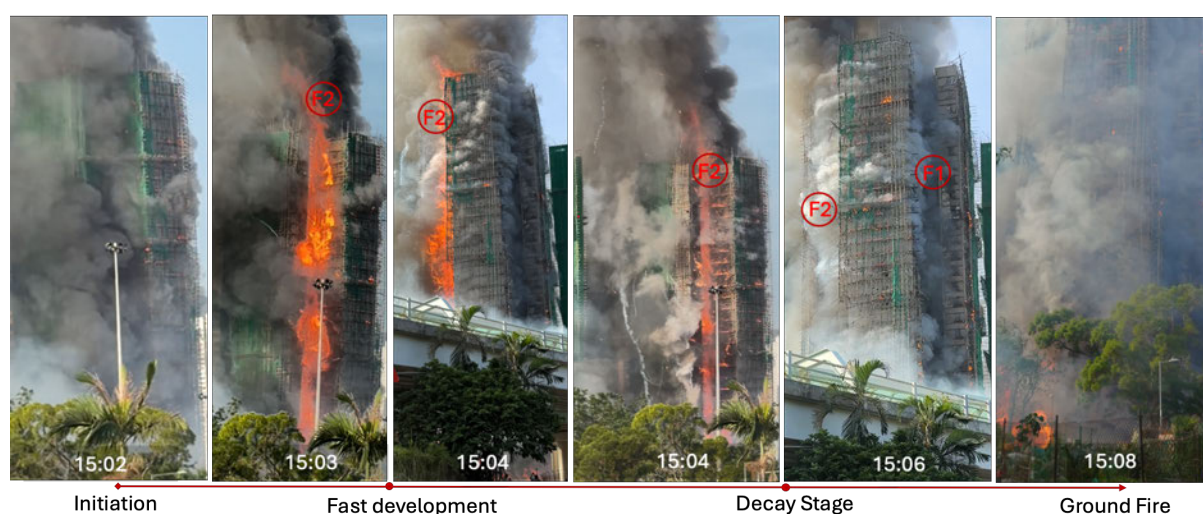
3.3.3. The second vertical fire spread along the re-entrant region between Units 6 and Unit 7 (F2) was initiated at 15:02, which underwent fast development at 15:03-15:04. According to visual evidence, the vertical fire entered its decay stage at 15:06. It indicated that the intense heating period due to vertical fire spread along re-entrant region was very short, only lasting for 2-4 minutes.

**Figure 3-5. Initiation and development of F2 re-entrant vertical fire**

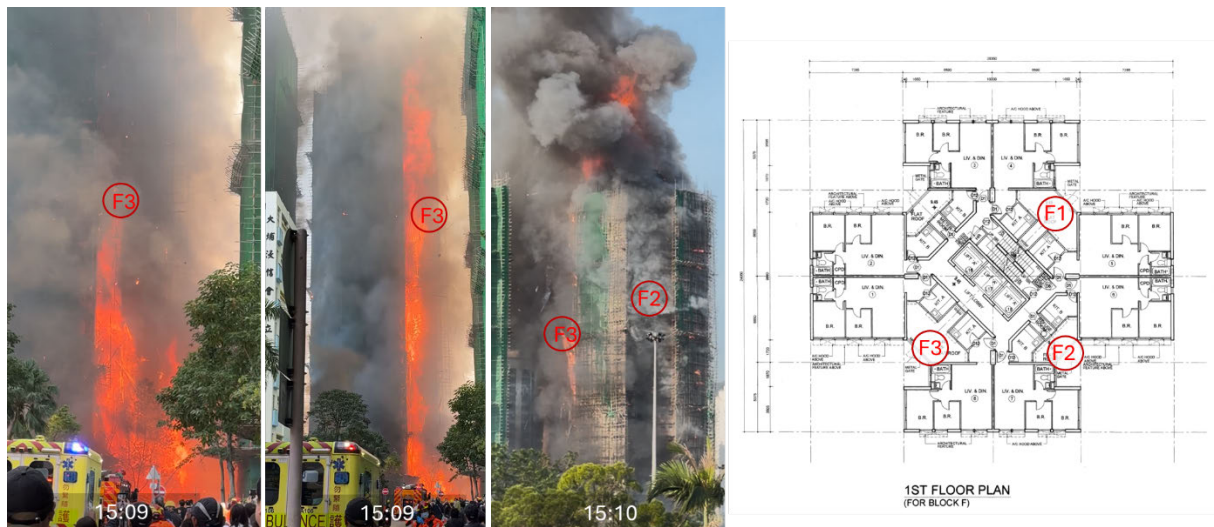
3.3.4. The third vertical fire spread along the re-entrant region between Units 1 and Unit 8 (F3) of Wang Cheong House was observed at 15:09, undergoing fast development at 15:09-15:10.

**Figure 3-6. Initiation and development of F3 re-entrant vertical fire**

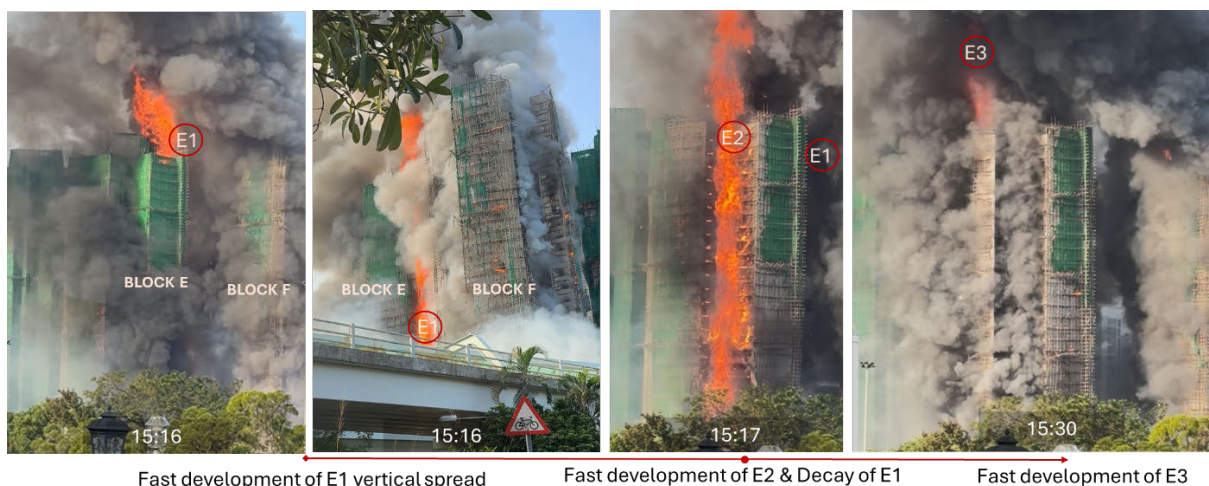
3.3.5. Wang Tai House (Block E) had the peak stage of its first vertical re-entrant fire spread (E1) around 15:16 and soon the second vertical fire spread of E2 occurred at 15:17. In the meantime, E1 already entered its decay stage as the flames became invisible at the facade. Similarly, a large amount of smoke engulfed the building at the decay stage of re-entrant fire. At 15:30, the third re-entrant vertical fire of Wang Tai House was observed. Note that the order of E1 to E3 is identical to the order of F1 to F3.

**Figure 3-7. Initiation and development of E1, E2, and E3 re-entrant vertical fire**

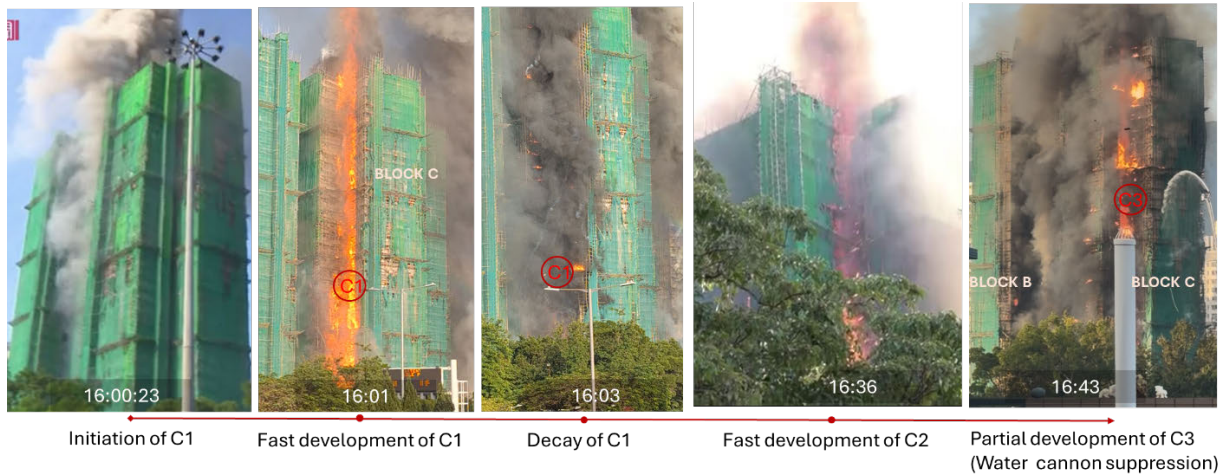
3.3.6. While Wang Kin House (Block D) did not have any re-entrant fires that were developed, the first vertical fire spread of Wang Sun House (Block C) (C1) was initiated at 16:00, which underwent fast development at 16:01. The second vertical fire of a Block C re-entrant was observed at 16:36. The third vertical fire spread along the re-entrant of Block C was captured at 16:43.

**Figure 3-8. Initiation and development of C1, C2, and C3 re-entrant vertical fires**

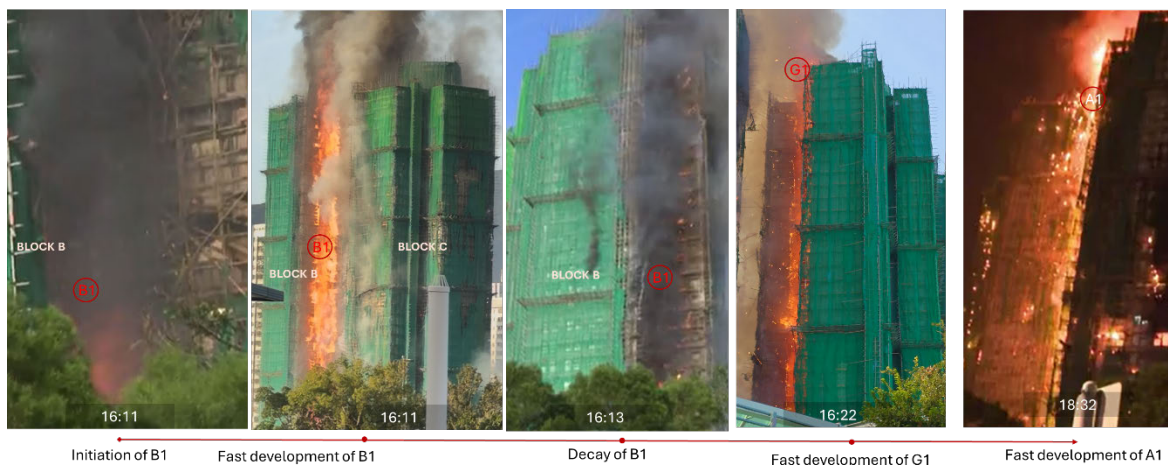
3.3.7. For Wang Tao House (Block B), Wang Shing House (Block G) and Wang Yan House (Block A), there was only 1 re-entrant region for each building which underwent vertical fire spread according to the available video footage. The development of B1 was clearly captured in the live coverage of “Cable News”, which exhibited the initiation starting at 16:10-16:11 with visible flames near the ground. It very quickly developed to an intensive re-entrant fire at 16:11 and entered its decay stage at 16:13. The peak of the first and only re-entrant fire of Wang Shing House (Block G) was seen at 16:22, whereas a re-entrant fire of Wang Yan House (Block A) (A1) was seen in the evening at 18:32.

**Figure 3-9. Development of B1, G1, and A1 re-entrant vertical fires**

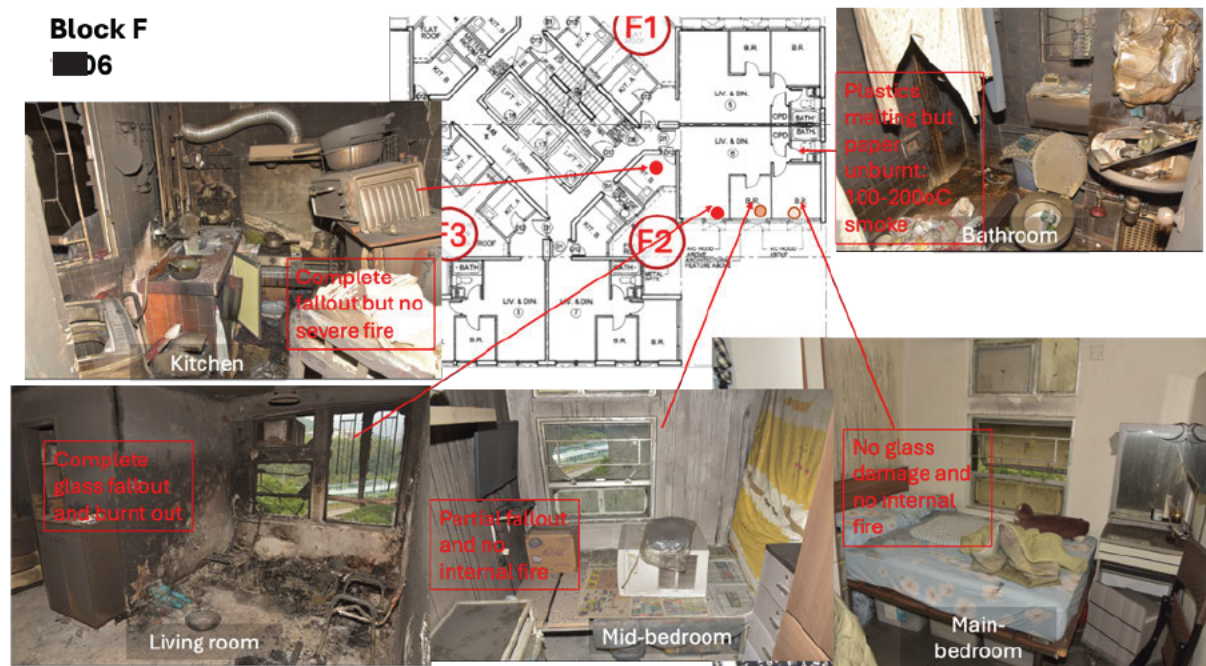
- 3.4.5. The relatively large living room windows were broken during the short-period of re-entrant fires, which thereafter ignited any combustible items in living rooms. Moderate fire burning was observed in some room units as there was no or there was limited fuel near the living room.

**Figure 3-10. Typical unit (Block F 06) with living room windows exposed to re-entrant fire**

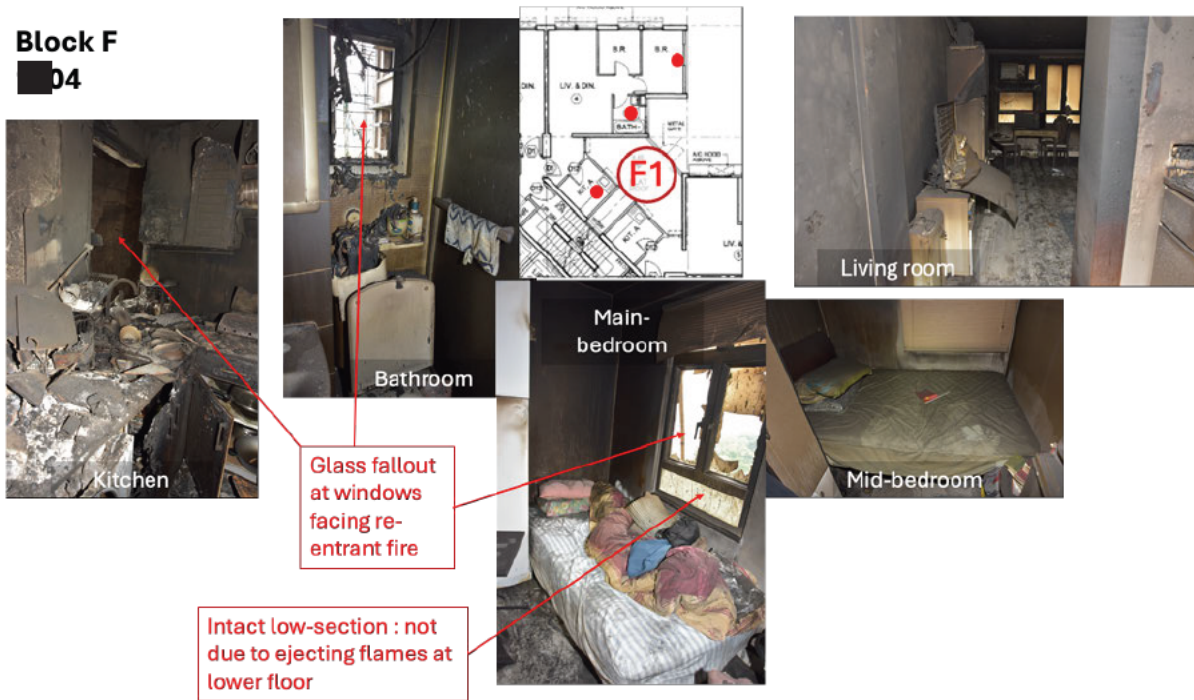
**Block F**  
**04**

- 3.4.6. These room units only have kitchen windows, bathroom windows and side windows of bedrooms facing the extended re-entrant fire. After analysing the photos of post-fire room units, it is clearly seen that glass breakage at kitchens and bathrooms did not introduce fire spreading into room units, except in some rare cases. This is because limited combustible items existed near the windows of kitchens and bathrooms. The side windows of main bedroom are relatively far from the re-entrant area, which caused limited fire impact on the glass windows.

**Figure 3-11. Typical unit (Block F 04) with bedroom windows exposed to re-entrant fire**

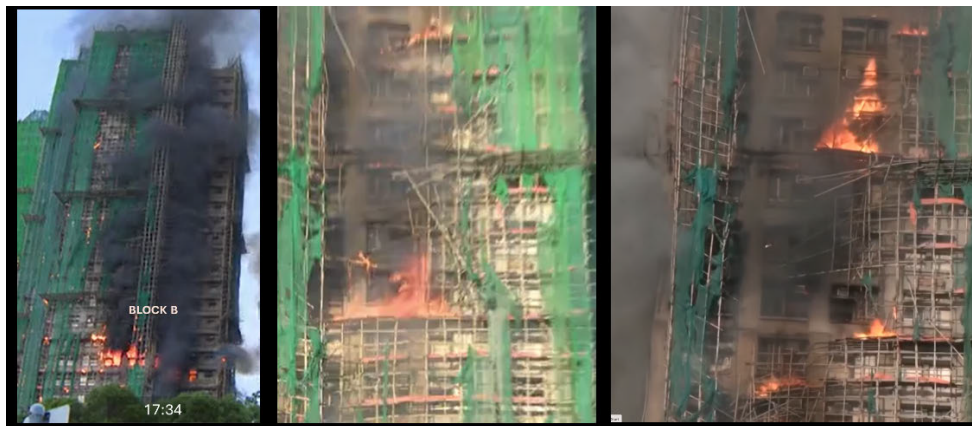
- 3.5.1. As stated above, the fast-developed vertical re-entrant fire quickly caused glass breakage of some room units, especially those room units of living room windows facing the vertical fire. In other words, each building would have multiple rooms being ignited after its 2-4 minute re-entrant fire. Subsequently, these room unit fires continue to develop to flashover (intense burning at each ignited unit), with ejecting flames out of nearly all the windows of the unit.

**Figure 3-14. Remaining scaffolding to fuel the subsequent fire spread**

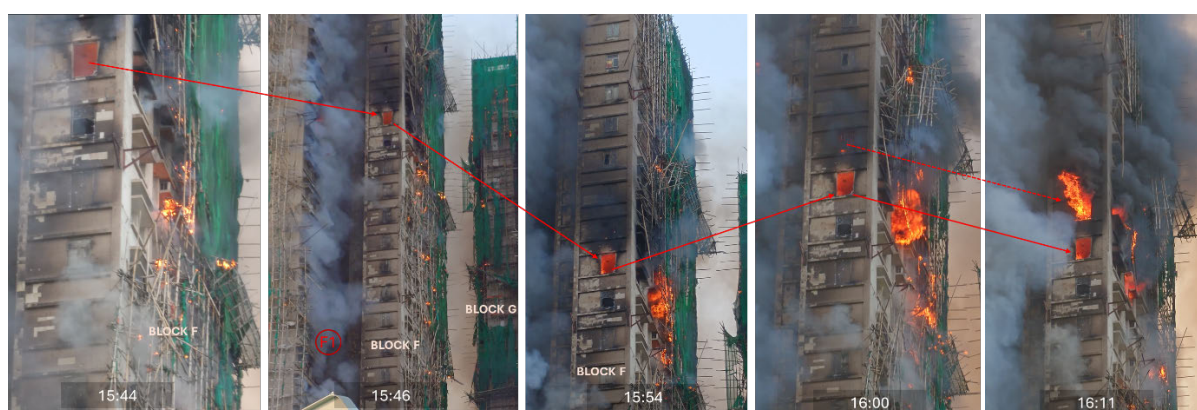
- 3.5.2. During the re-entrant vertical fire, only the combustible items of bamboo scaffolding in the re-entrant and near the re-entrant were burnt. The bamboo scaffolding on other sides of the façade remained attached, and remaining bamboo scaffolding including safety nets, wood planks, bamboo tubes, and other combustible materials could be ignited by the ejecting flames of post-flashover room fires to enable subsequent fire spread from lower floors to upper floors as shown in Fig. 3-15. Therefore, after the series of fast-developed re-entrant fires, many rooms of the six buildings (Block F, Block E, Block C, Block B, Block G, Block A) were ignited at different time points. The whole progression of room unit fires lasted from the evening of 26 November to 27 November 2025.

**Figure 3-15. Subsequent fire spread from lower floor to upper floor**

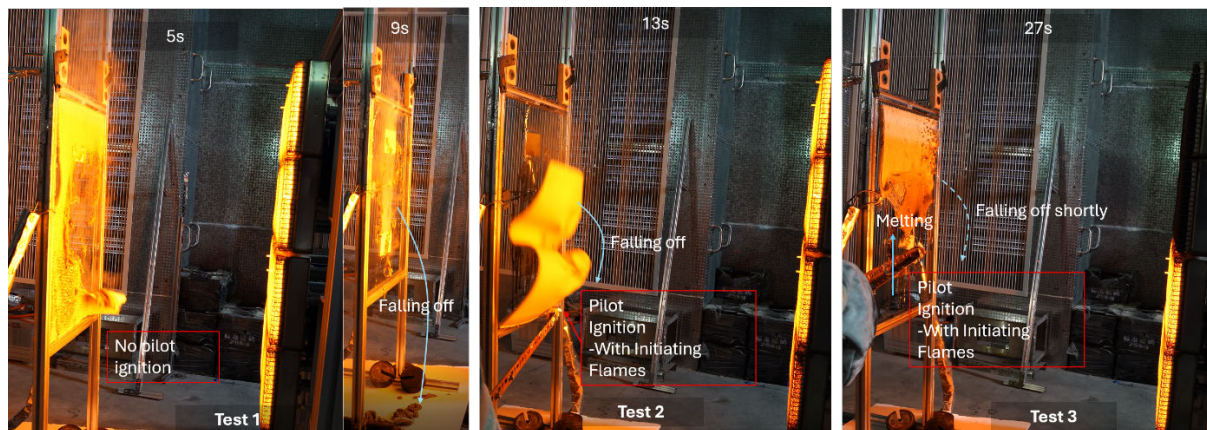
**Figure 3-16. Radiant panel heating tests on polystyrene boards on glass panels (Tests A1-A3)**

3.6.2. Test A1 to Test A3 showed that the polystyrene foam boards would quickly melt and drop off from the glass panels when subjected to heating. The rates of melting and timing of drop-off of the foam boards depended on the heating conditions.

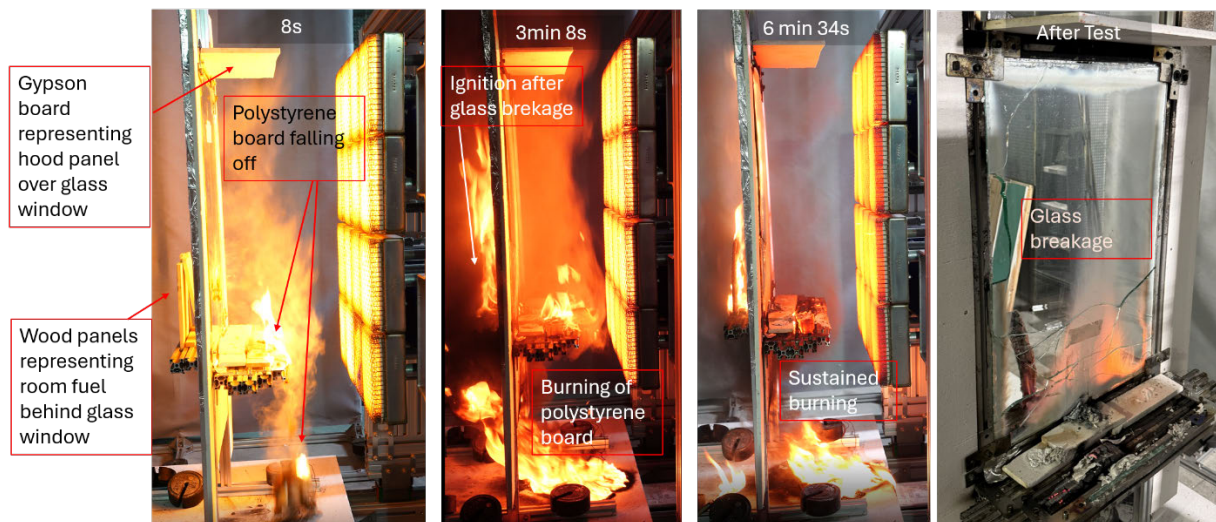
**Figure 3-17. Radiant panel heating tests on polystyrene boards on glass panel (Test A4)**

- 3.6.3. As to Test A4, the polystyrene board panel quickly fell off, leading to sustained flames at the lower board and the wood sticks in front of glass window. At 3 minutes 8 seconds, the glass panel cracked and the wooden board behind glass window was ignited, exhibiting flames (representing the ignition of in-room fuel). At 6 minutes 34 seconds, the melted polystyrene board remains burning. After radiant panel heating, glass breakage and fallout can be seen.

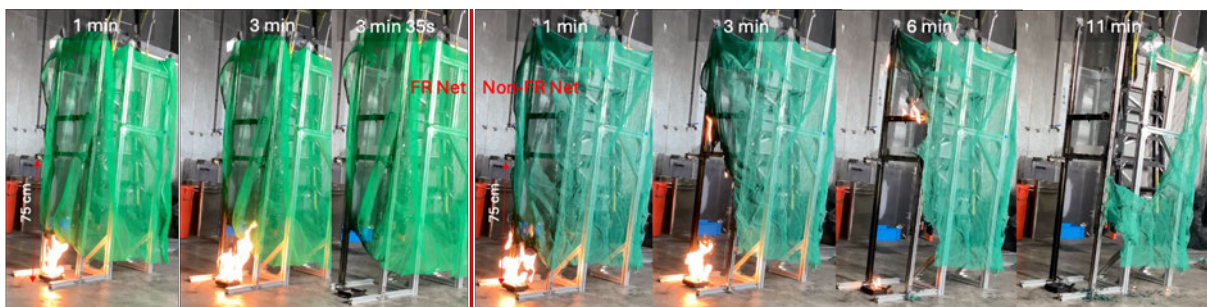
- (b) The non-FR safety net sample (Test B2) quickly melted and the propagation of ignition was much faster as compared with the FR safety net at 3 minutes after pool fire heating.
- (c) After the pool fire exhausted and extinguished, flames sustained on the non-FR safety net in Test B2. After 11 minutes, the burning front still moved forward and flames were seen on the net.
- (d) Dripping flames were seen during the burning of non-FR safety net in Test B2, and the flames of net dripping on the floor can sustain for a few minutes.

**Figure 3-18. Burning tests on FR and non-FR safety net samples (Tests B1 and B2)**

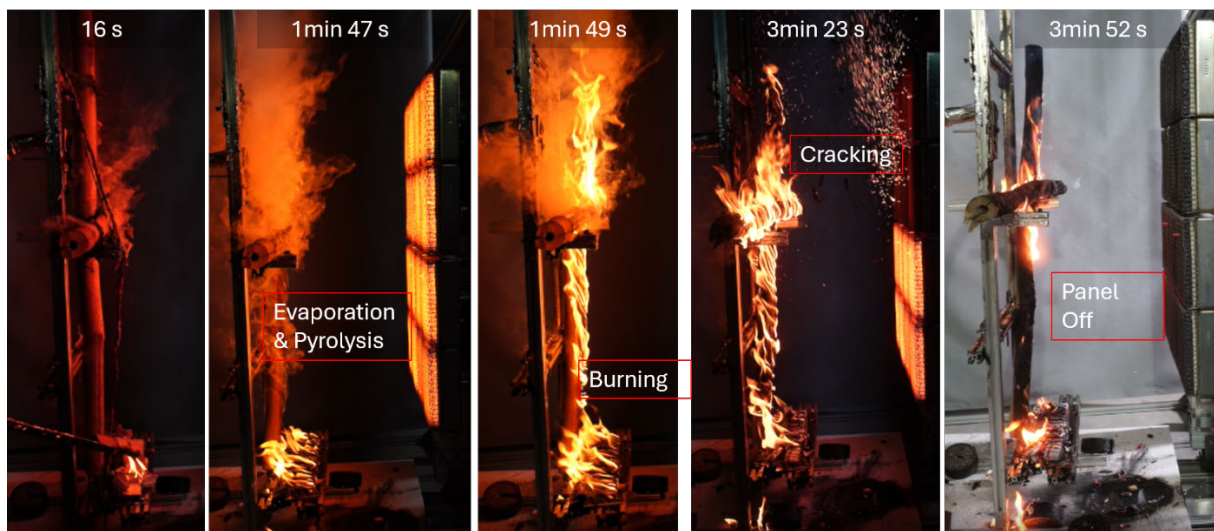
3.6.12. The combustible behaviour of bamboo sticks is similar to timber or wood products. Small heating energy cannot ignite it, whereas fast pyrolysis and burning can occur when subjected to relatively high heating conditions (such as 50 kW/m<sup>2</sup> of radiant heat flux in this test).

**Figure 3-19. Burning tests on bamboo samples (Test C1)**

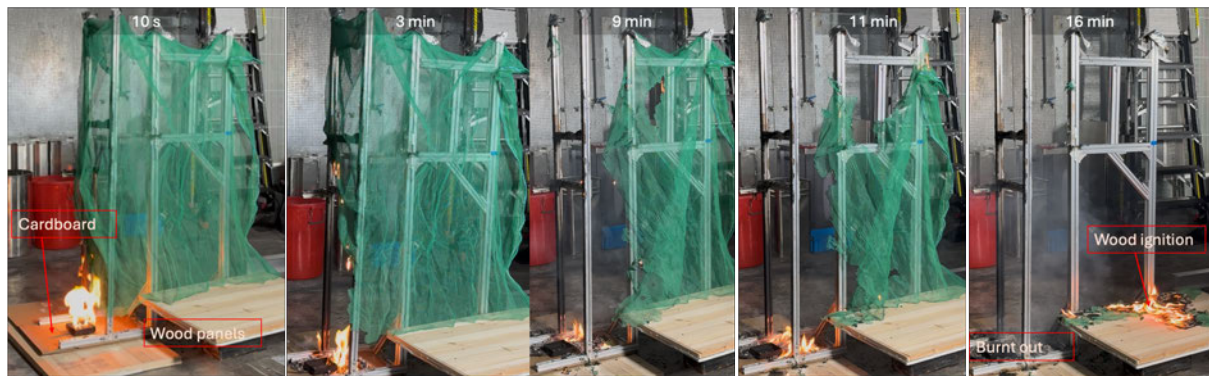
3.6.18. We note the dripping flames of non-FR safety net seen in Test B2, as stated above. The ignition of cardboard due to the dripping flames from the non-FR safety nets is clearly shown in Test D1 at 3 minutes. At 9 minutes, the flames have propagated to the right-hand side of safety net, and an area of the wood panel was ignited by the dripping flames as shown in the test photo at 16 minutes and Fig. 3-21. After the fire extinguished, the cardboard had been burnt out and the charring of wood panel had propagated to deeper section.

**Figure 3-20. Joint burning test on non-FR safety net and cardboard, and wood panels (Test D1)**

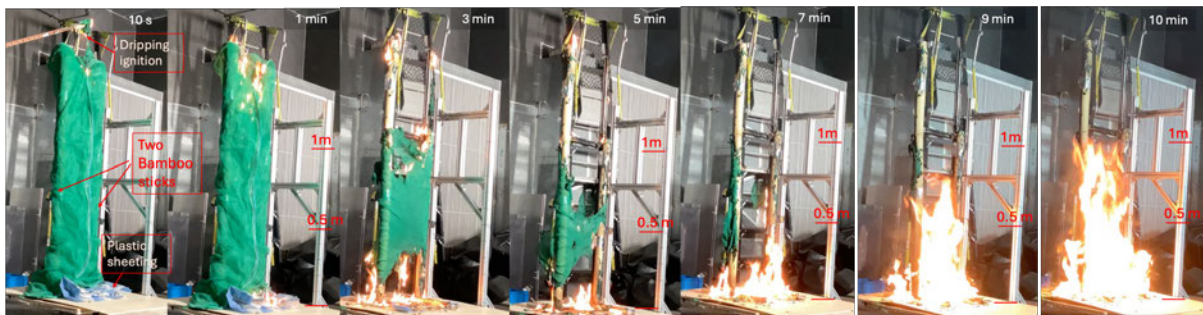
- (a) At 1 minute after the ignition, the visible flames at the top area moved fast, and half of the net melted and fell to ground wood panel at 3 minutes, which led to ground distributed flames.
- (b) Later on, as shown in Fig. 3-22, the flame height increased at 5 minutes, 7 minutes, 9 minutes, and 10 minutes, which reached nearly 1 meter.
- (c) This joint burning test may explain the initial fire growth at the flat roof of re-entrants leading to the massive re-entrant fire.

**Figure 3-22. Joint burning test on non-FR safety net and cardboard, and wood panels (Test D2)**

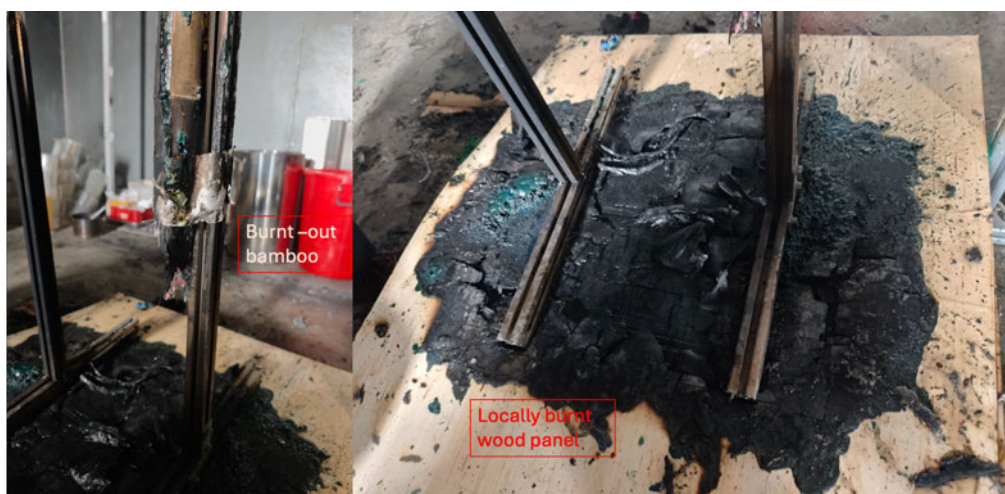
3.6.21. From 7 minutes to 10 minutes, it was observed that the bamboo stick had joined the localised fire, and the fire was further intensified along the charring and pyrolysis of bamboo. As shown in Fig. 3-23, the bamboo stick was burnt out and a large area of the wood panel was ignited. Since the bamboo stick was ignited after a sufficiently large fire through the dripping flames igniting cardboard and wood panels on the ground, this demonstrates the likely role played by the dripping effect of non-FR safety nets and the burning of combustible items at flat roofs in initiating the re-entrant fire.

**Figure 3-23. Burning behaviour of cardboard, and wood panels subjected to dripping fires in Test D2**

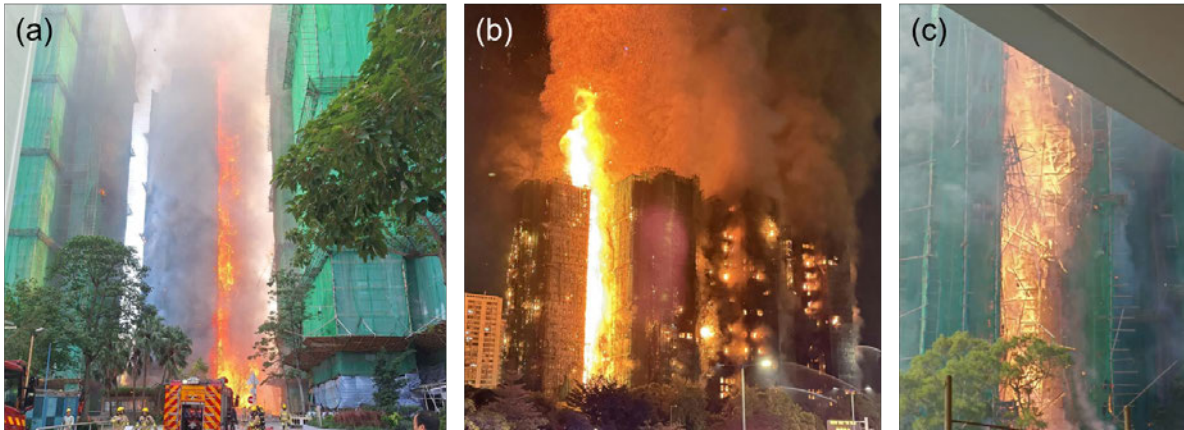
**Figure 3-38. Chimney effect observed at (a) Wang Cheong House west re-entrant and (b) Wang Yan House south re-entrant, and (c) combustible scaffolding burning along the re-entrant**

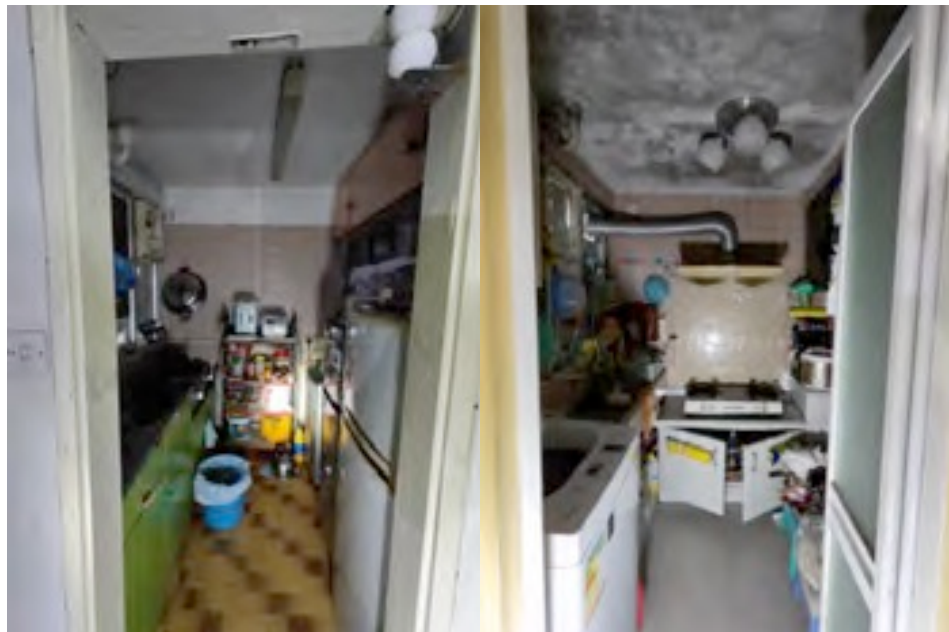
**Figure 4.2. Self-closing kitchen doors replaced by non-fire rated doors**

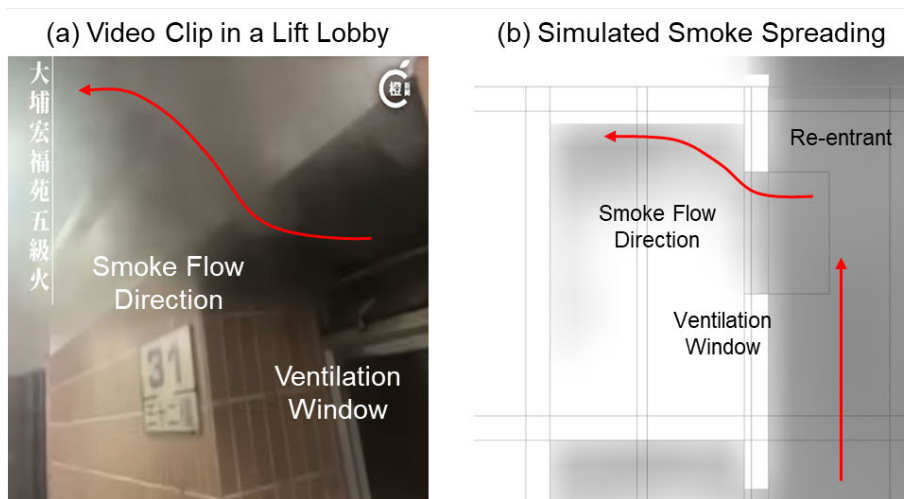
**Figure 4.10. Smoke spreading conditions in the lift lobby: (a) video, and (b) simulation result**

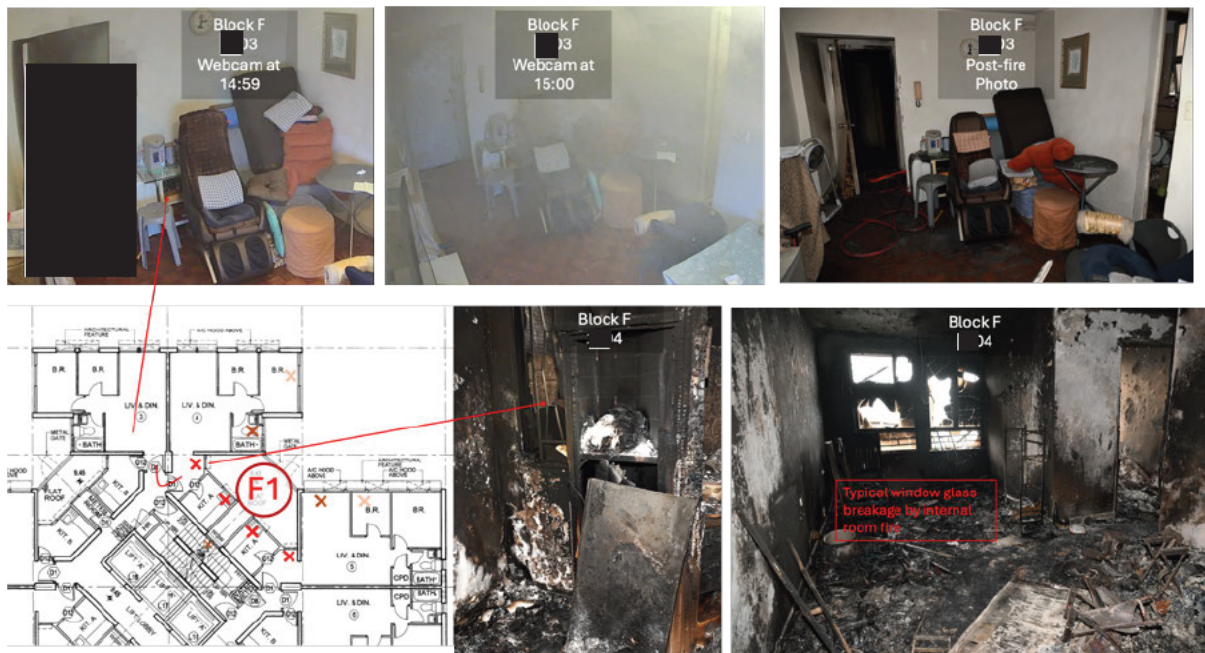
**Figure 4.11. Conditions in Unit 03 of Wang Cheong House**
