# Final Investigation Report No.5 Alarm Fire at Wang Fuk Court on 26 November 2025

Inter-Departmental Fire Investigation Task Force

May 2026

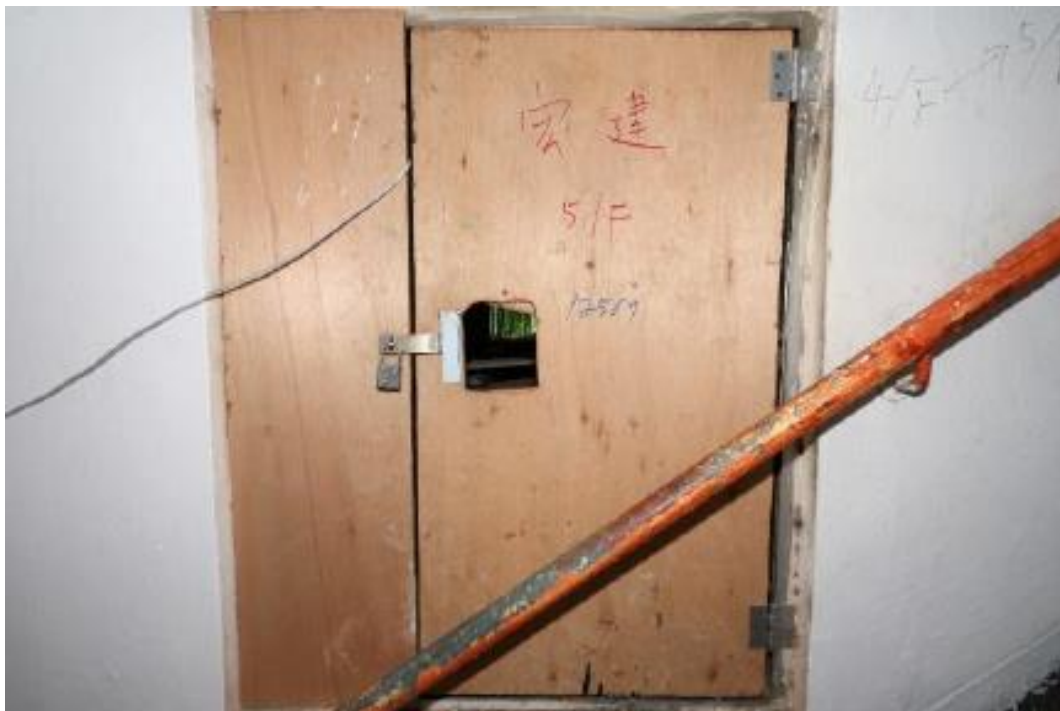
- 4.5.5.4 For all blocks of Wang Fuk Court, all the existing staircase windows, the upper parts of which were openable, were proposed to be replaced with fire-rated windows<sup>24</sup> as part of the renovation works of Wang Fuk Court. As explained in paragraph 4.5.4.3 above, such proposed works were not a prescribed repair item under the MBIS regime; but given that it was categorized as a type of minor works under the MWCS<sup>25</sup>, as shown in **Photo 4-3 (b)**, relevant minor works submissions were submitted to the ICU under MWCS. While it was indicated in the relevant minor works submissions that all windows at staircases would be replaced with fire-rated windows, it was only revealed after the fire that some windows at the staircases had been replaced with movable boards, most of them believed to be wooden<sup>26</sup>, to provide convenient access for workers to the scaffoldings, as shown in **Photos 4-9 (a) to (c)**, at the following locations:

<sup>26</sup> The post-fire investigation revealed two types of movable boards present at the site: (i) boards entirely made of wood and (ii) boards constructed with wood on one side and aluminium composite panels on the other. In both cases, gaps and holes were observed in the boards, allowing smoke and heat to infiltrate into the staircase, even when the boards were in a closed position.

Photos 4-9 (a) to (c): Replacement of Windows With Movable Board

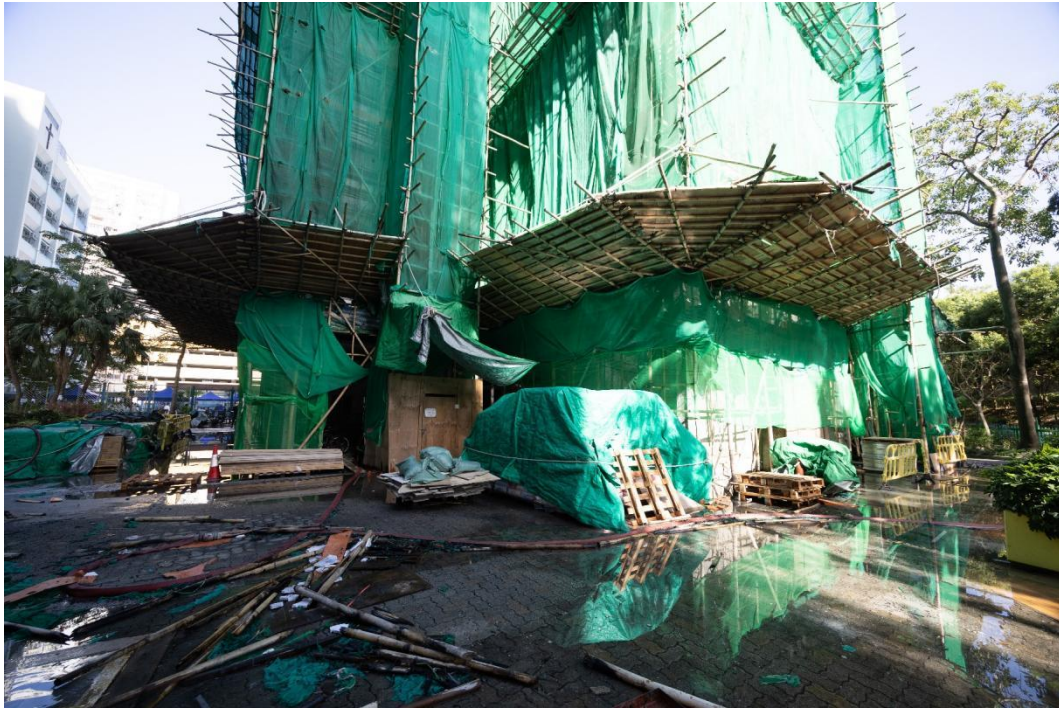
- 4.5.6.1 At the open ground surrounding Wang Chi House, a significant quantity of construction materials was found, including safety nets, wooden planks, bamboo and other covered construction materials, as shown in **Photo 4-10**.

*Photo 4-10: Construction Materials Scattered at  
Ground Level Around Wang Chi House*

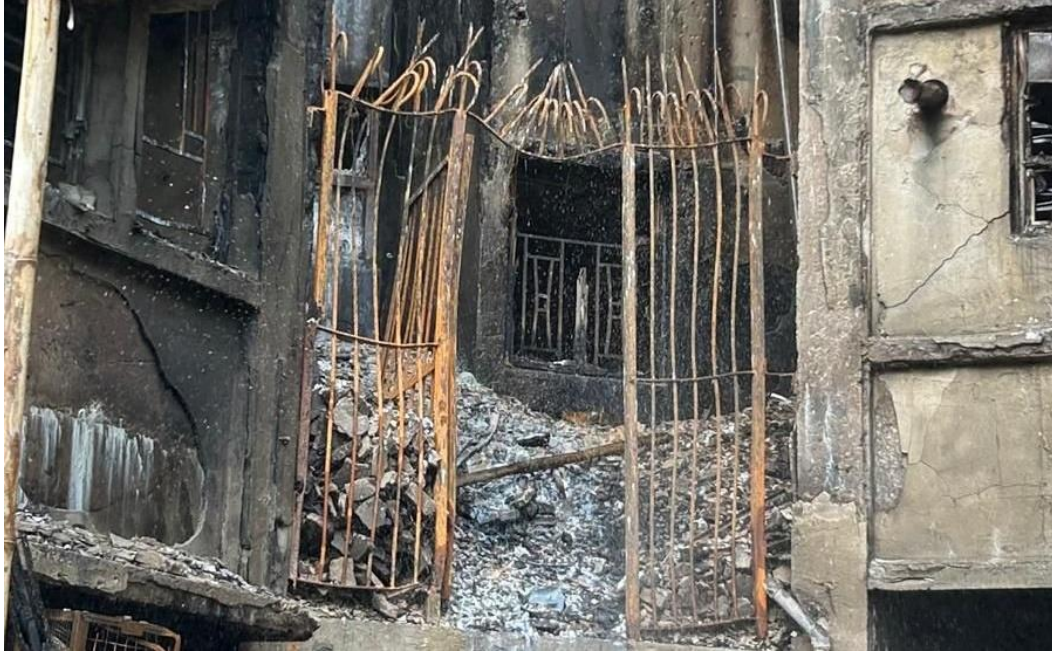
- 6.1.10 No other sources of ignition could be identified at the suspected point of origin. As such, with no contradictory evidence suggesting otherwise, the IFITF was satisfied that the fire was most likely accidental in nature. Most probably: A glowing source, such as a lit cigarette end, ignited combustible materials, such as carton paper boxes, at the scene.

Photo 6-1: Debris Piled up on the Flat Roof Outside Flats 104 and 105 of Wang Cheong House

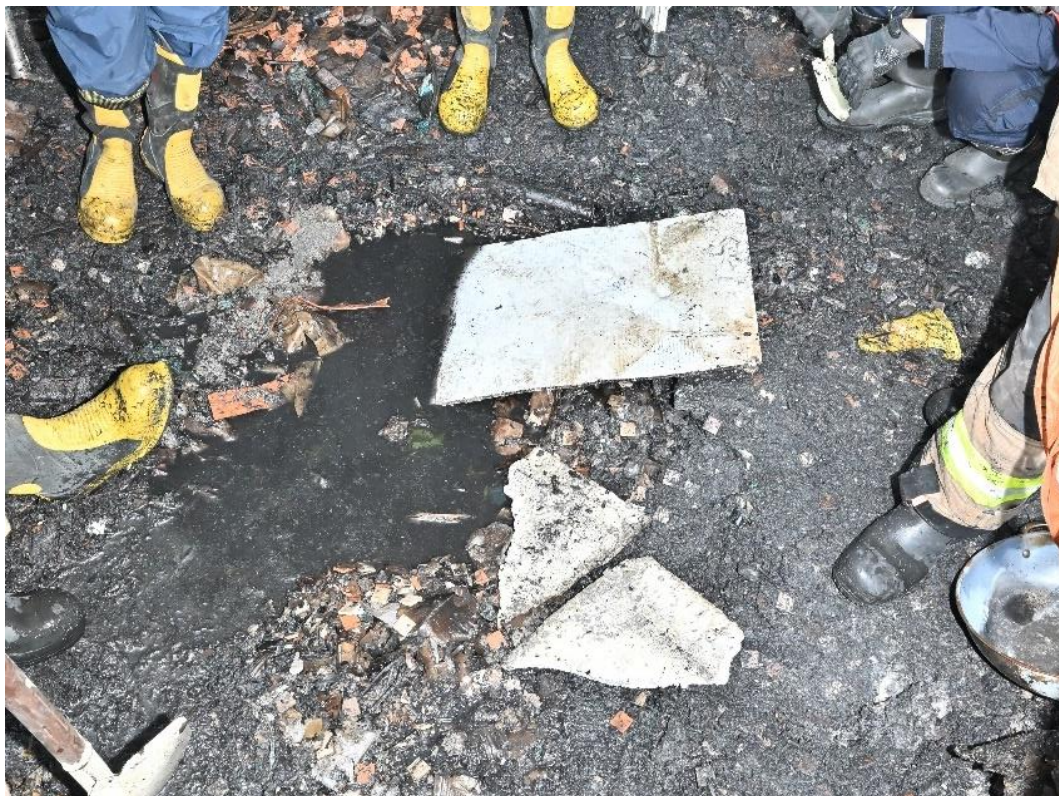
Photo 6-2: Polystyrene Window Covers Found at the Suspected Fire Origin

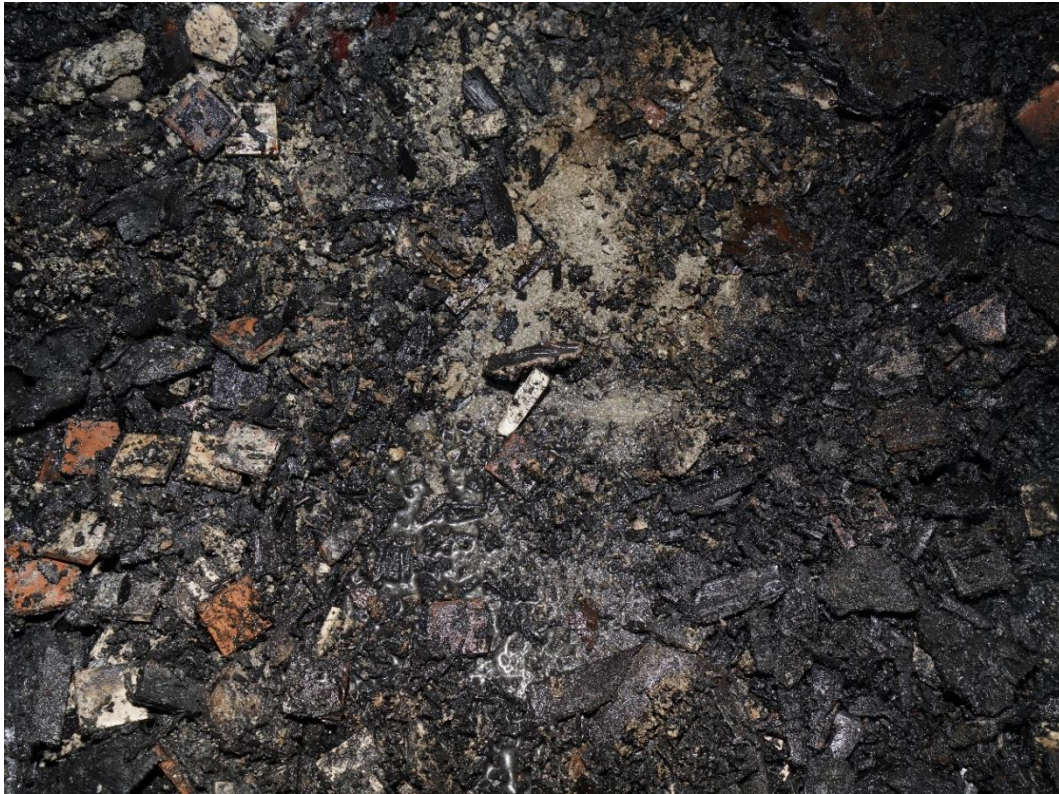
Photo 6-3: One of the Cigarette Ends Found at the Subject Flat Roof

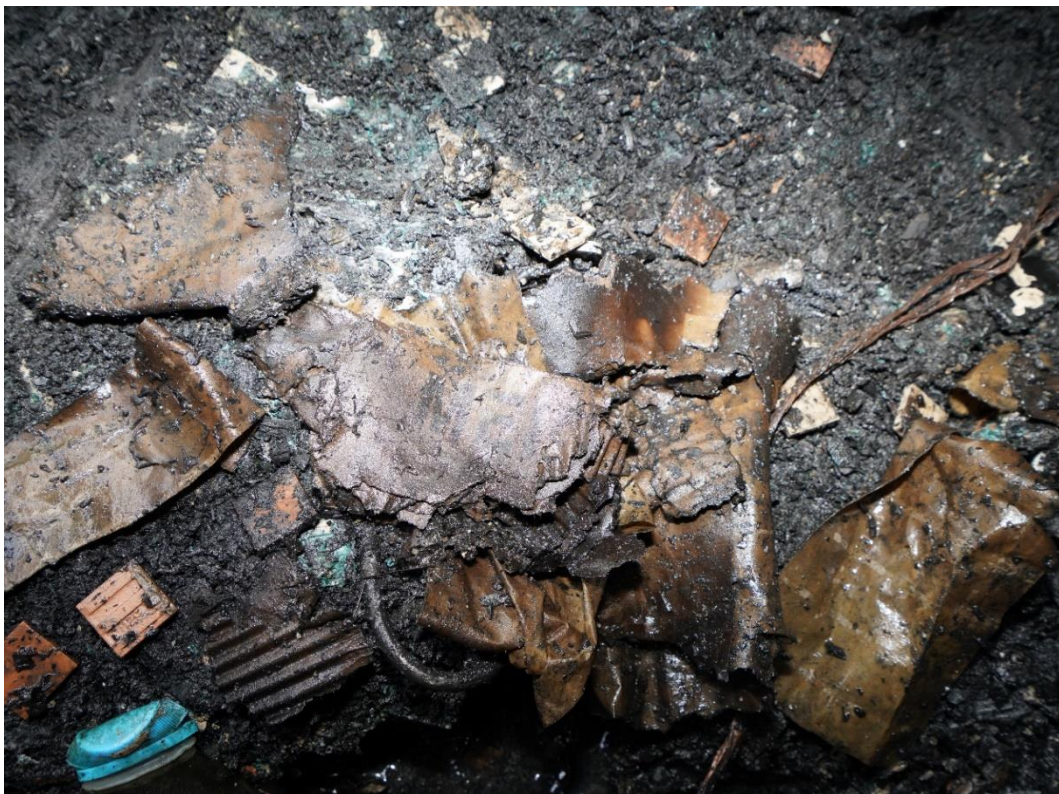
Photo 6-4: Burnt Remnants of Carton Paper Boxes

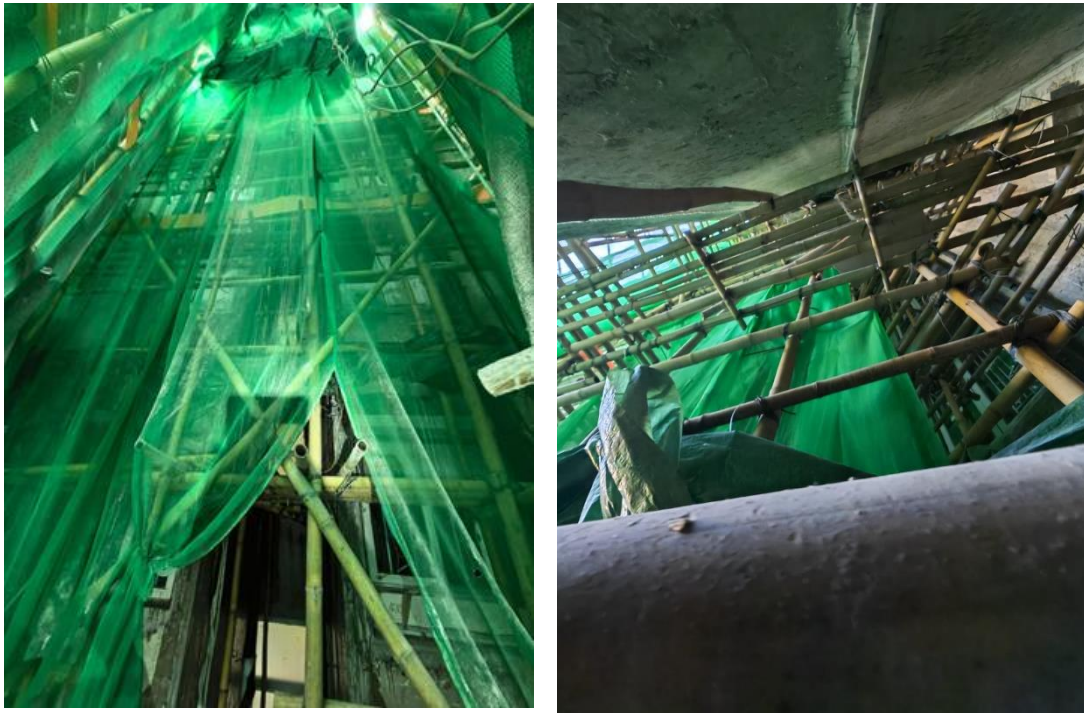
Photos 6-6 (a) & (b): Continuous Fuel Source in the Re-Entrant

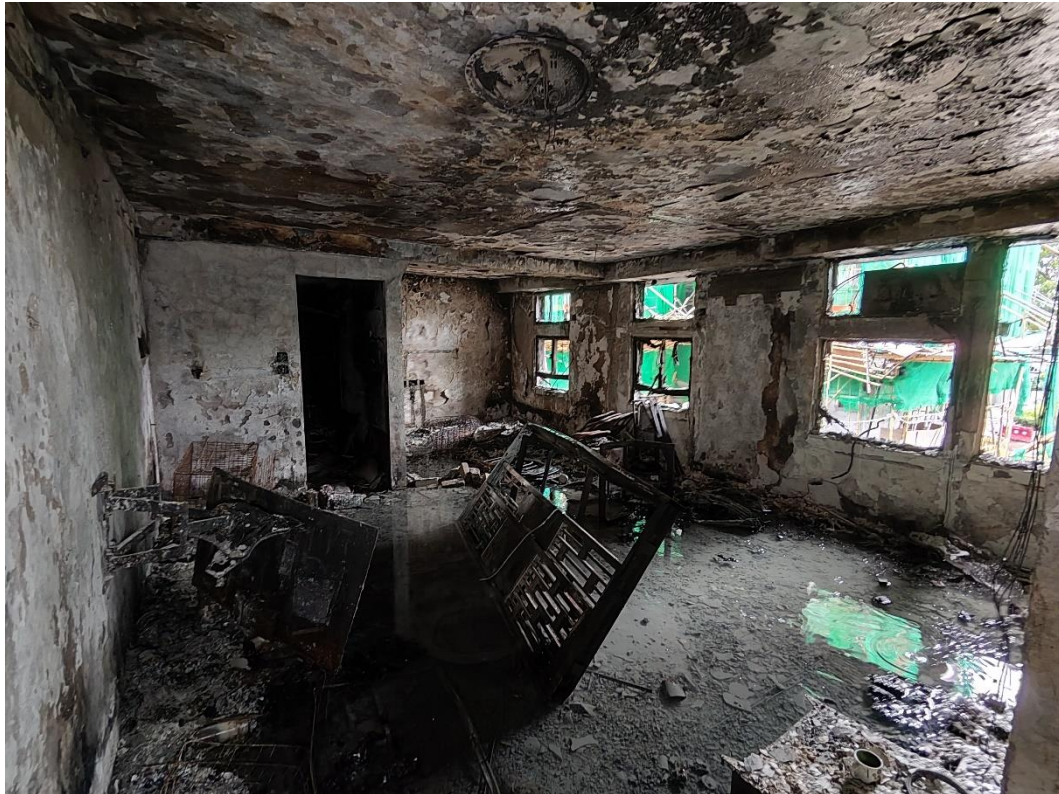
Photo 8-3 (a): Unit Sustained Extremely Severe Damage – Flat 02,  
Wang Yan House

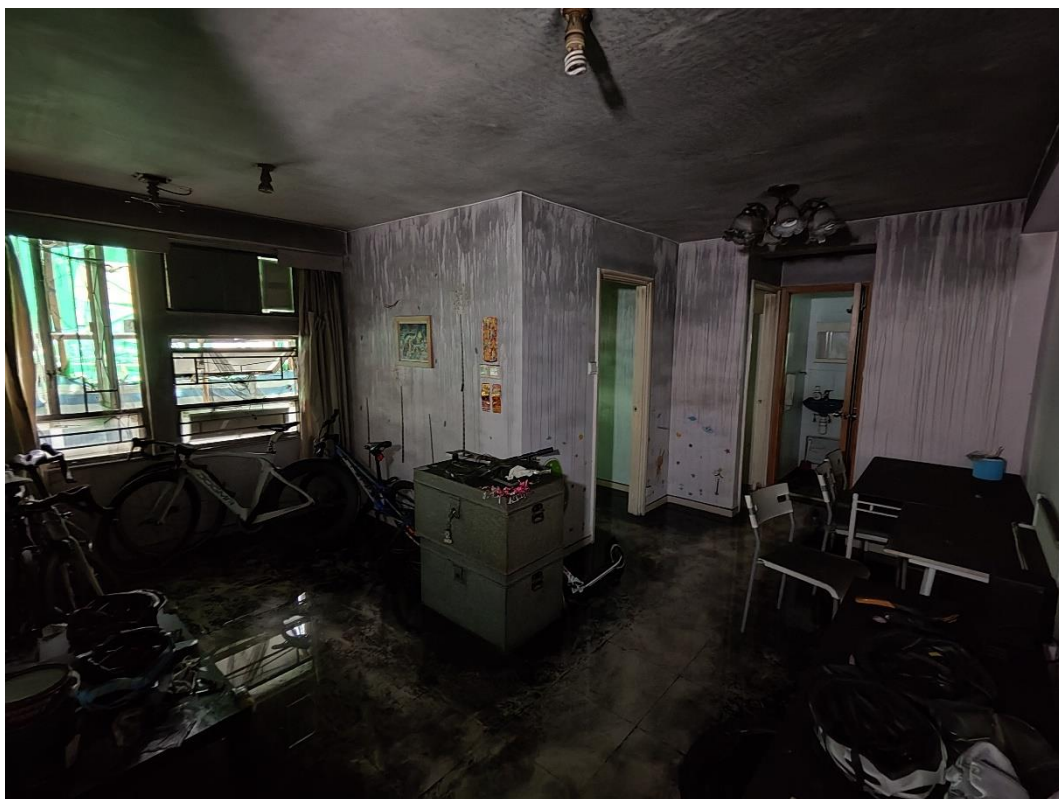
Photo 8-3 (b): Unit Sustained Severe Damage – Flat 01, Wang Yan House

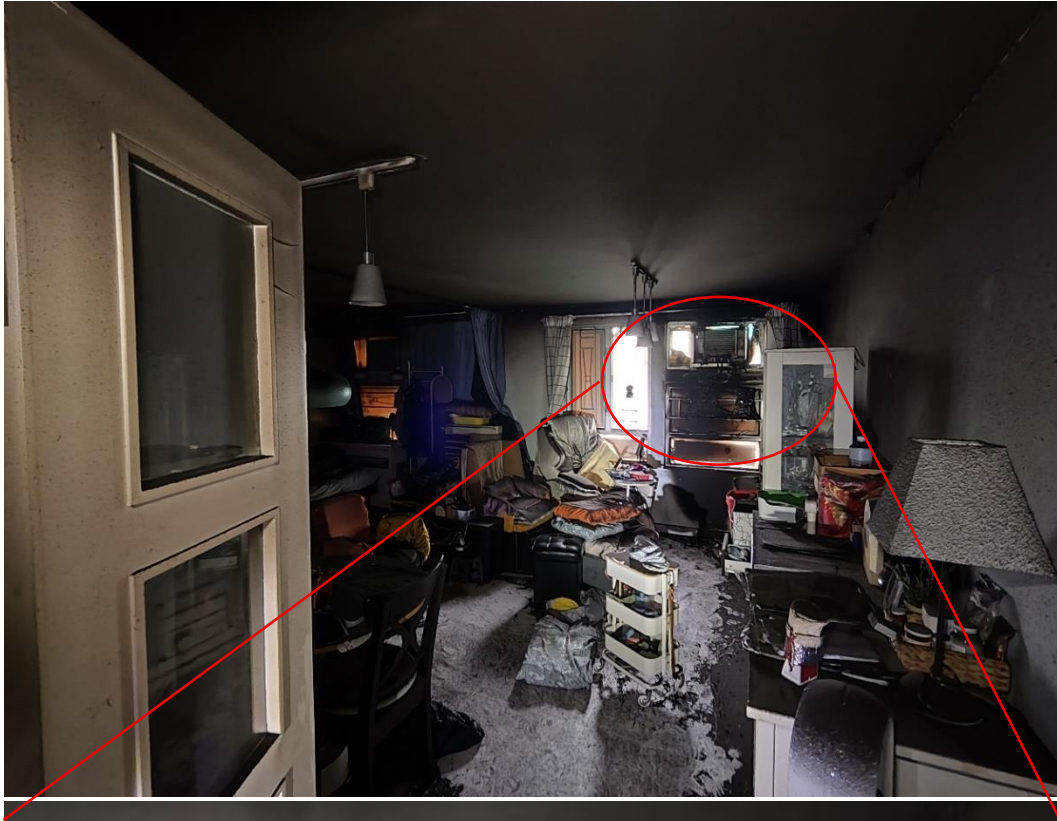
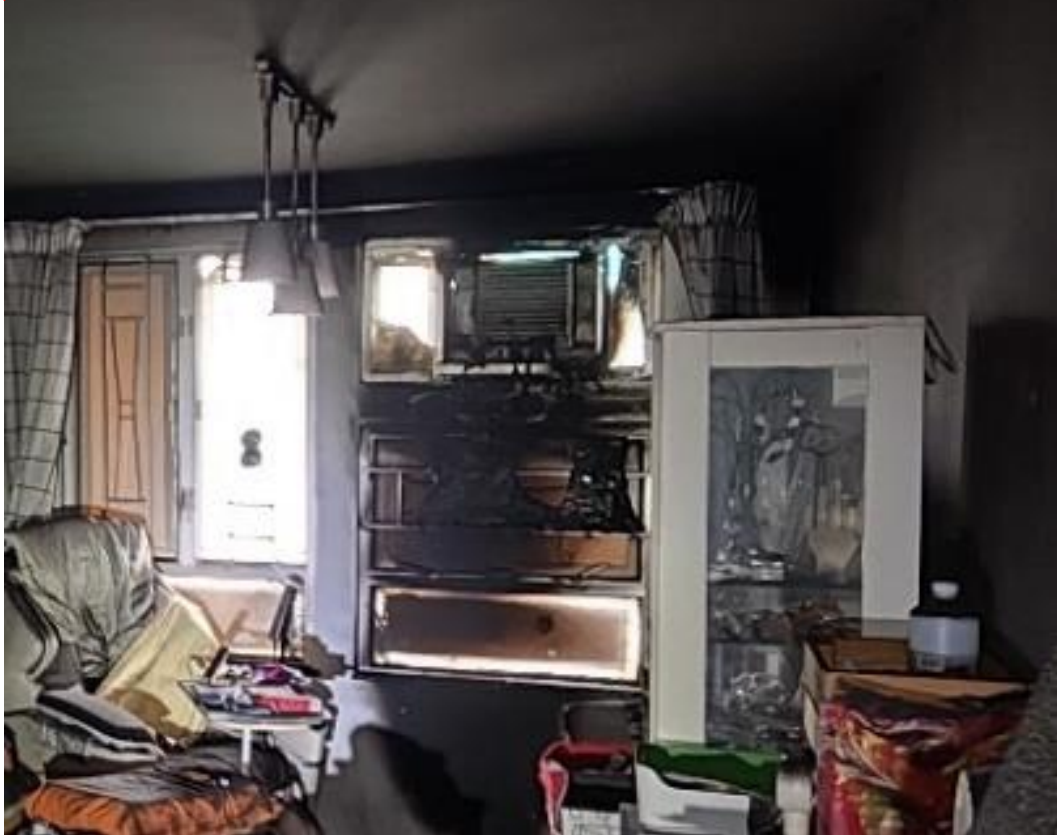
Photos 8-7 (a) & (b): Fire Spread Into Flat 08 via the Air-conditioner

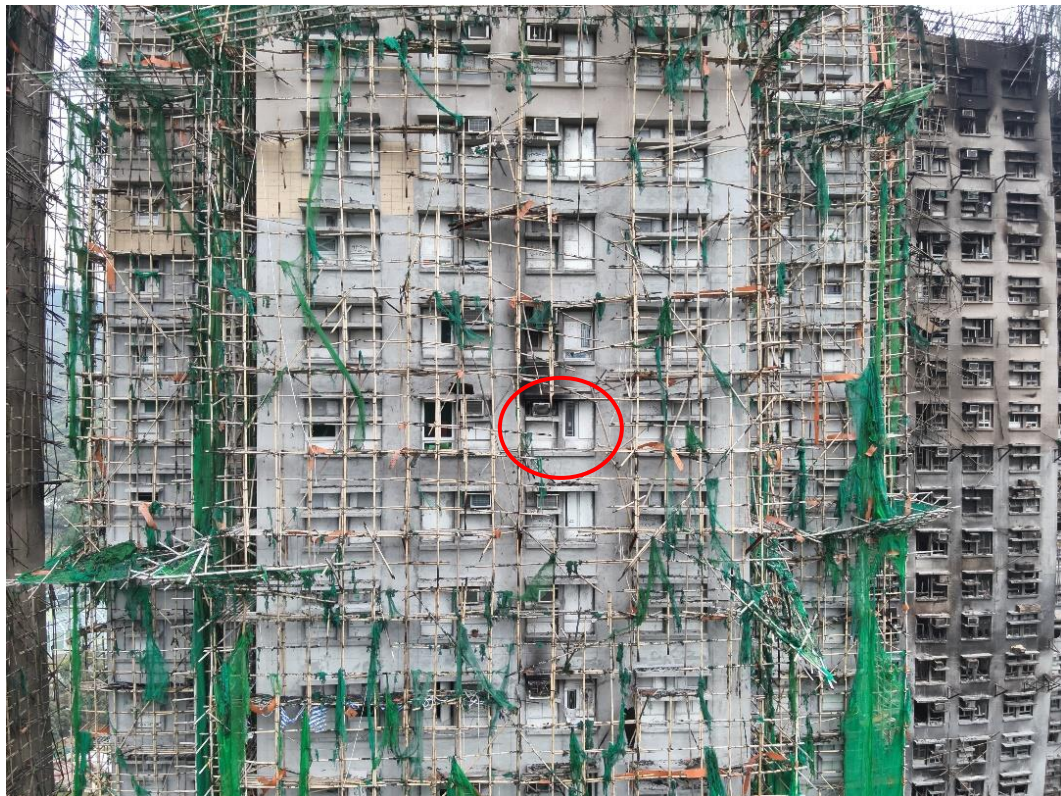
Photo 8-7 (d): External Post-Fire Condition of Flat 2308

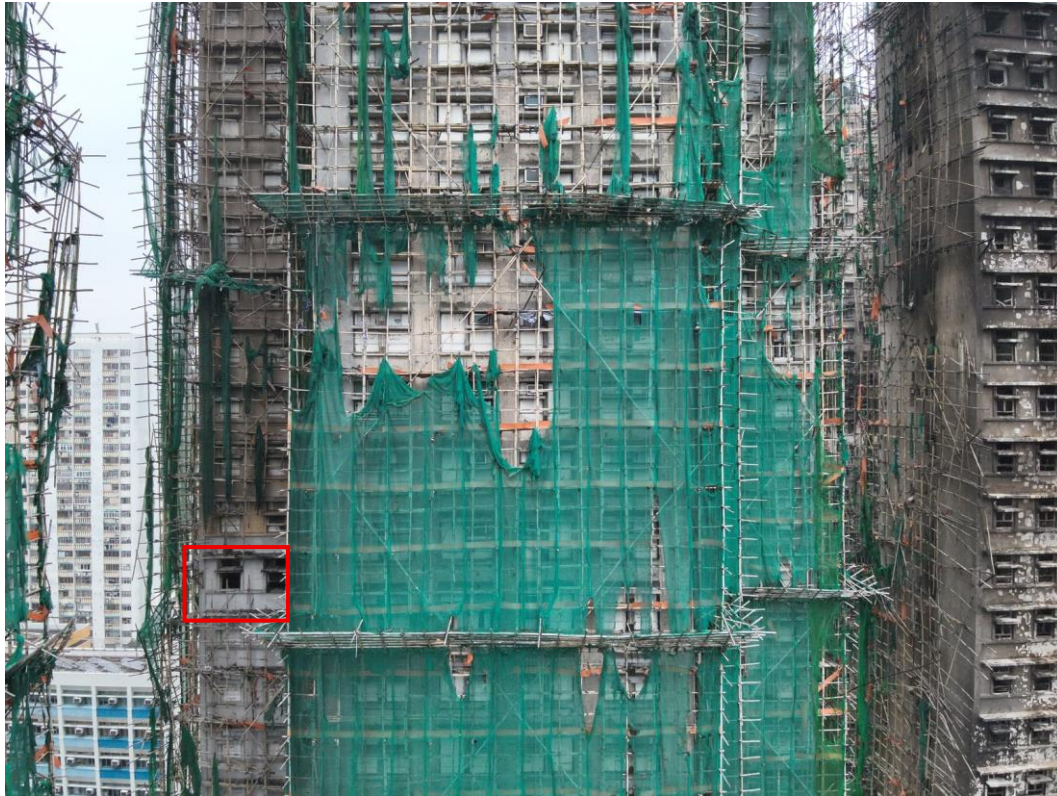
- 8.3.5.3 Flat ■02 of Wang Kin House sustained extremely severe damage, as shown in **Figure 8-3** and **Photos 8-8 (a) to (g)**. Upon inspection, the toilet and kitchen windows were found to be intact. However, most of the windows in the bedrooms and living room were broken, with these areas experiencing extensive fire damage, as shown in **Photos 8-8 (d) to (f)**. This damage is believed to have resulted from the fire spreading into the unit from the exterior.

*Photo 8-8 (g): External Post-Fire Condition of Flat ■ 02*

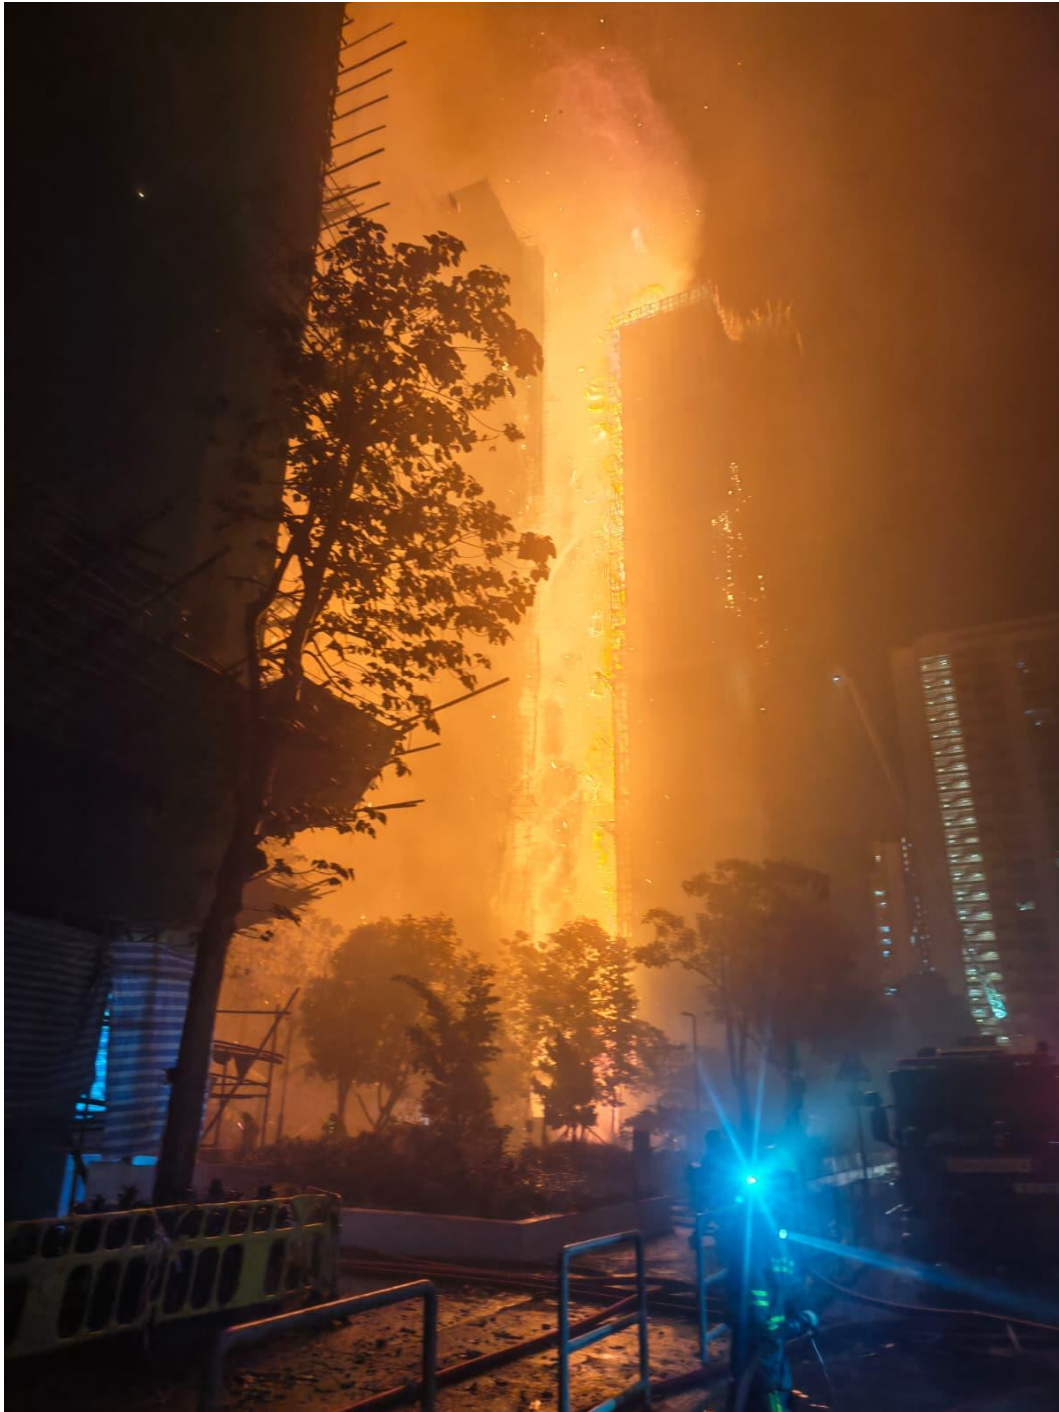
Photo 8-9: Rapid Fire Spread Observed at the Re-Entrant Between  
Flats 02 and 03 of Wang Yan House

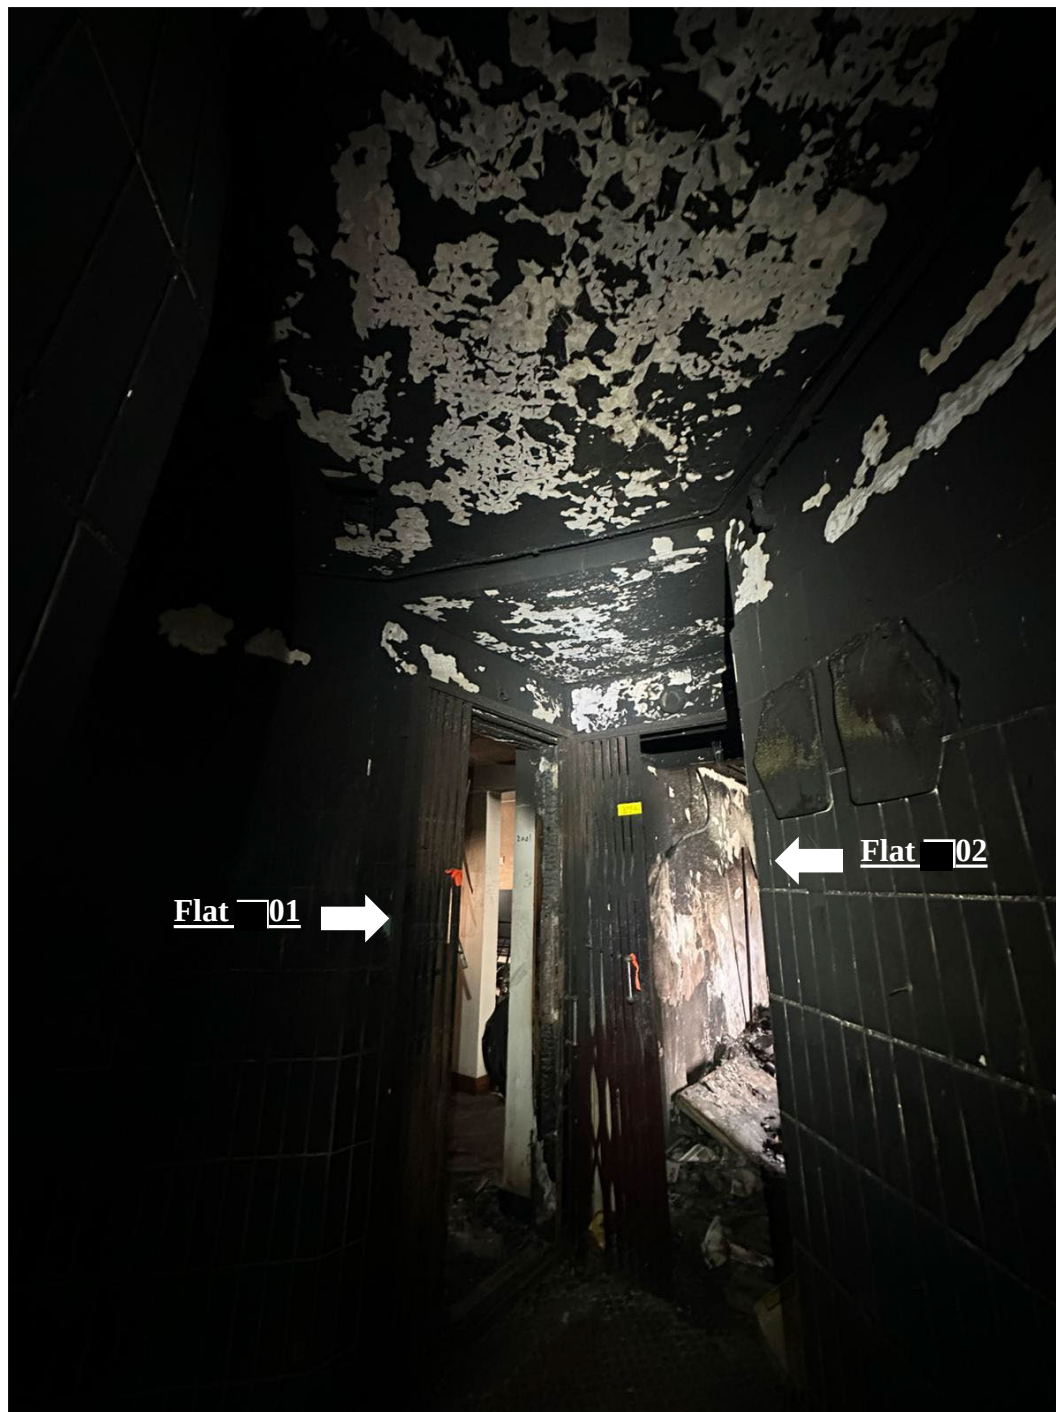
*Photo 8-12 (b): Post-Fire Condition in the Common Corridor<sup>113</sup> Connecting Flats 01 and 02, Wang Yan House*

<sup>113</sup> The common corridor connecting Flats 01 and 02 sustained extremely severe damage, with the unit entrance door completely consumed by fire.

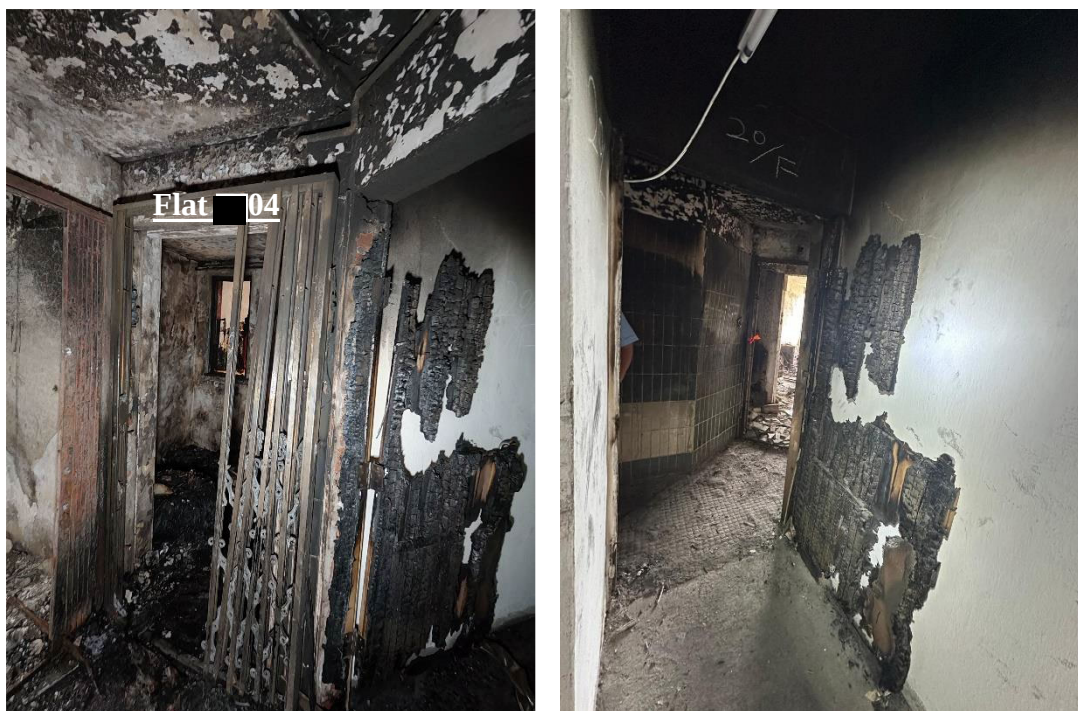
*Photos 8-13 (e) & (f): Damaged Smoke Stop Door on [REDACTED]/F of Wang Yan House*

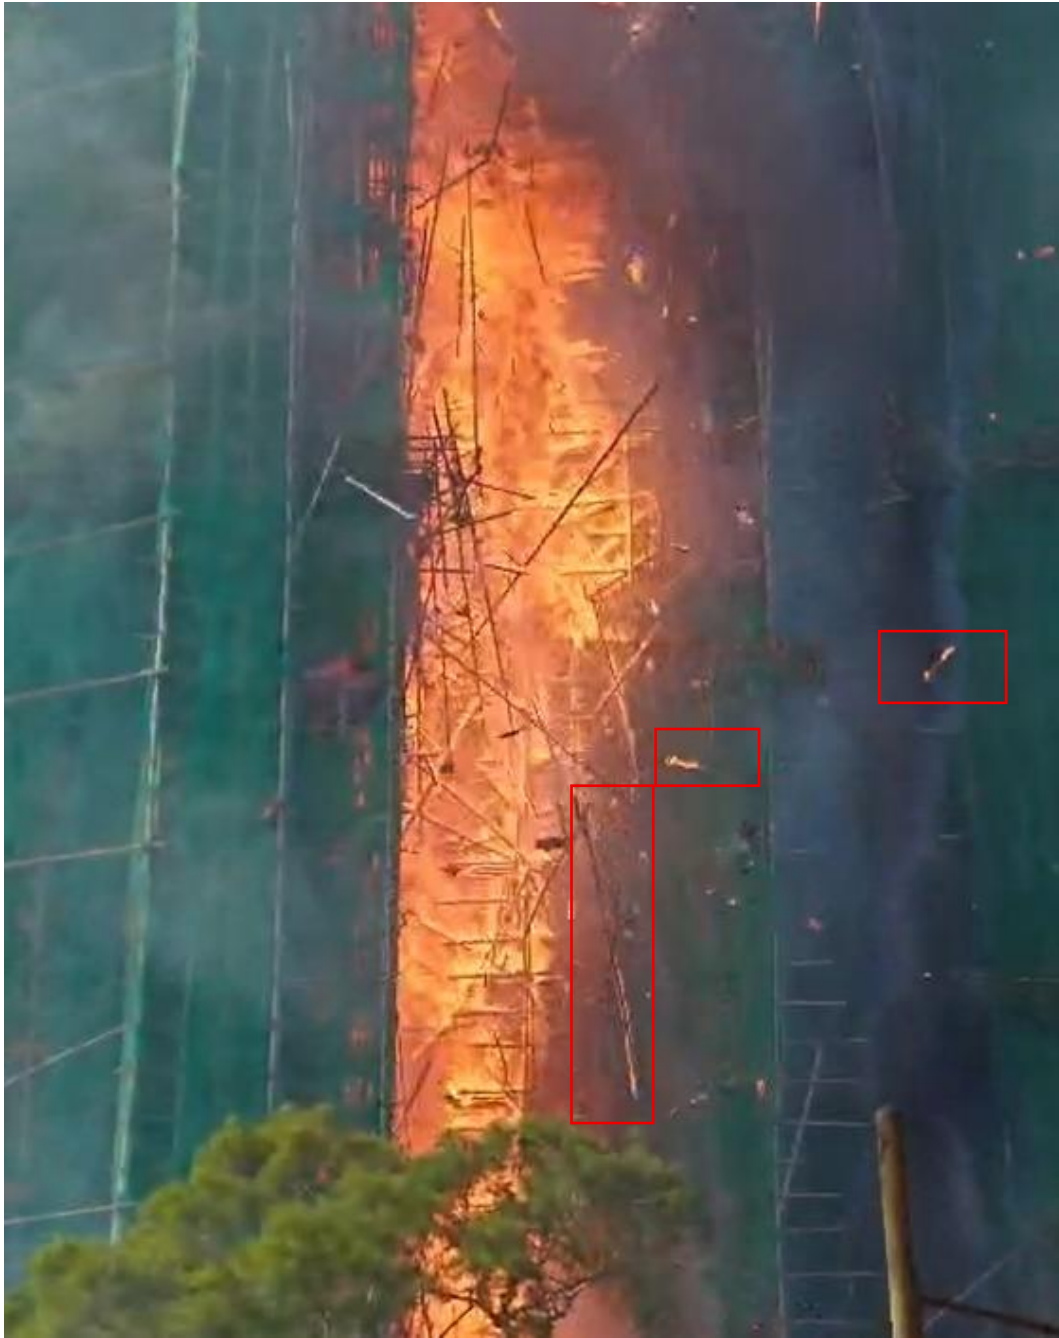
Photo 8-17: Collapsed Burning Debris From the Damaged Bamboo Scaffolding

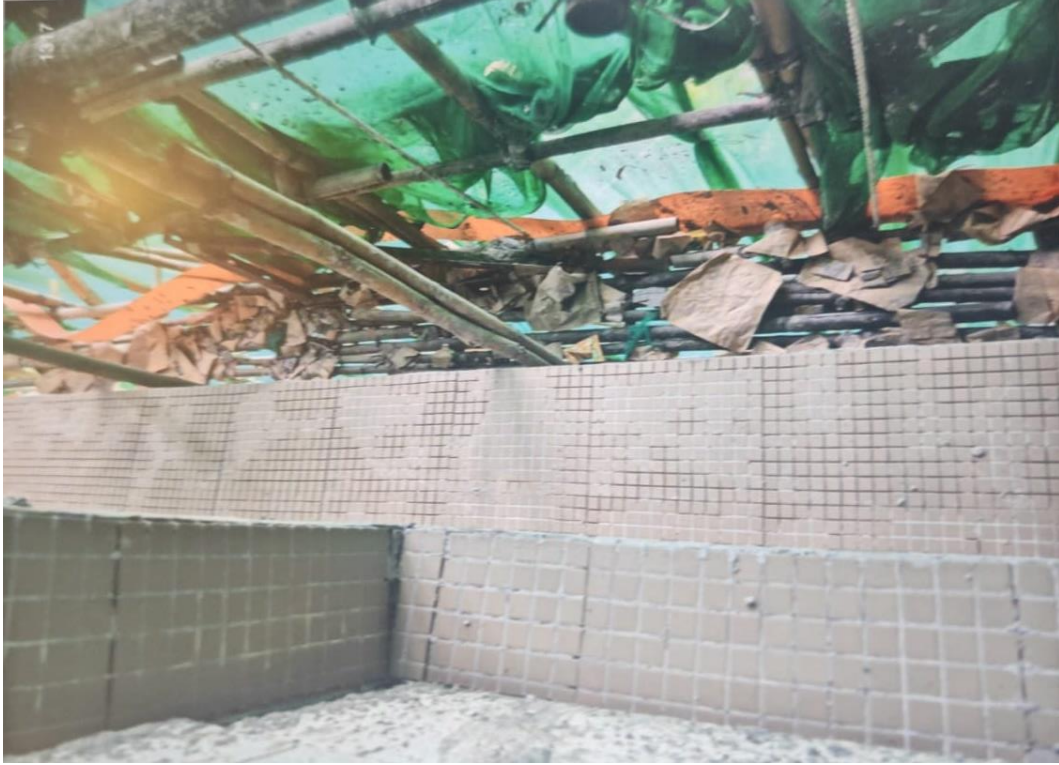
- 8.4.6.5 Various combustibles were identified on the external scaffolding, including bamboo, toe-boards, wooden planks, safety nets, canvas, nylon strips and miscellaneous waste from the works, as shown in **Photo 8-19 (c)**, all of which contributed significant fuel to the façades of all eight buildings in Wang Fuk Court, **Photos 8-19 (d) to (f)**.

Photo 8-19 (c): Combustible Waste on the External Scaffolding

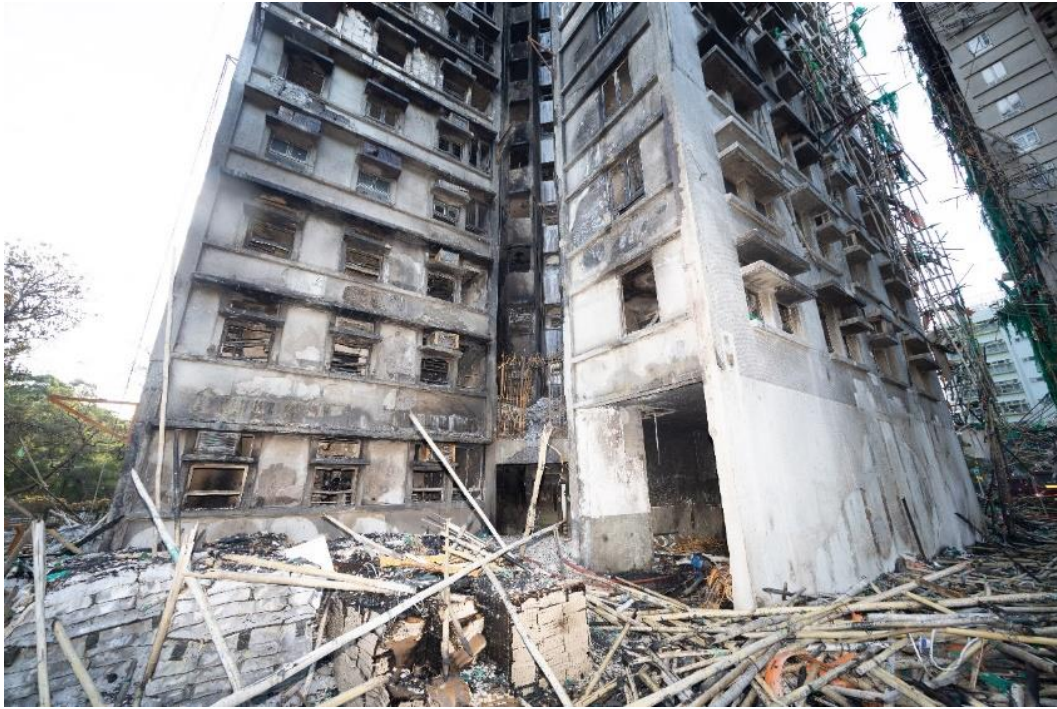
*Photo 8-21 (a): Post-Fire Condition Outside the East Re-Entrant of Wang Cheong House*

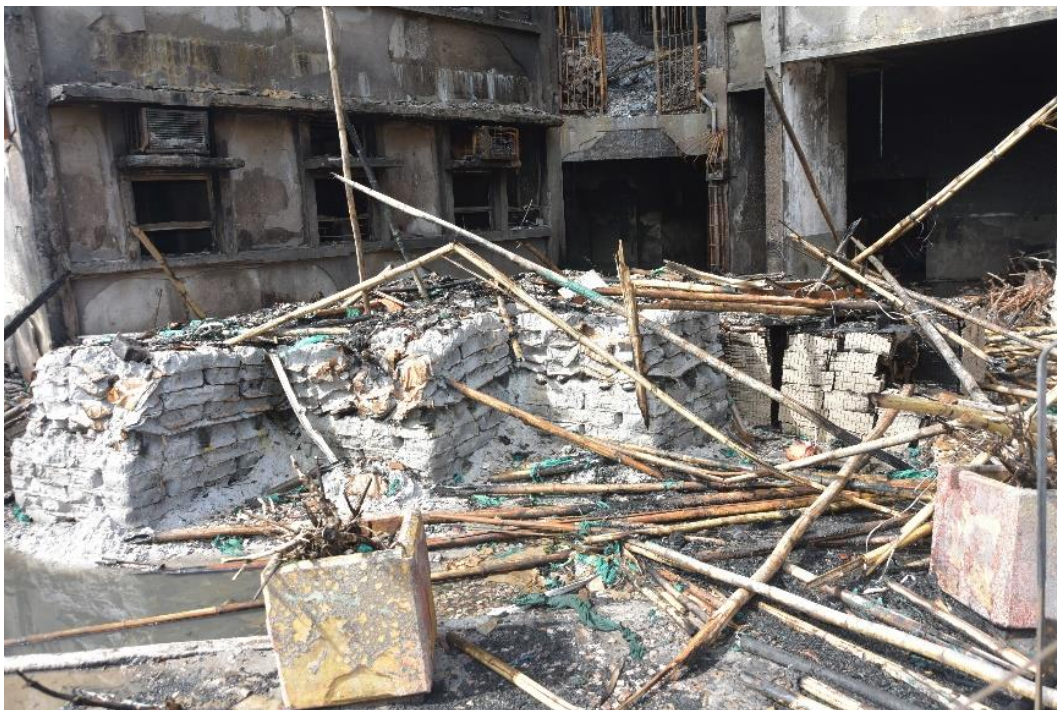
*Photo 8-21 (b): Post-Fire Condition Outside the East Re-Entrant of Wang Cheong House*

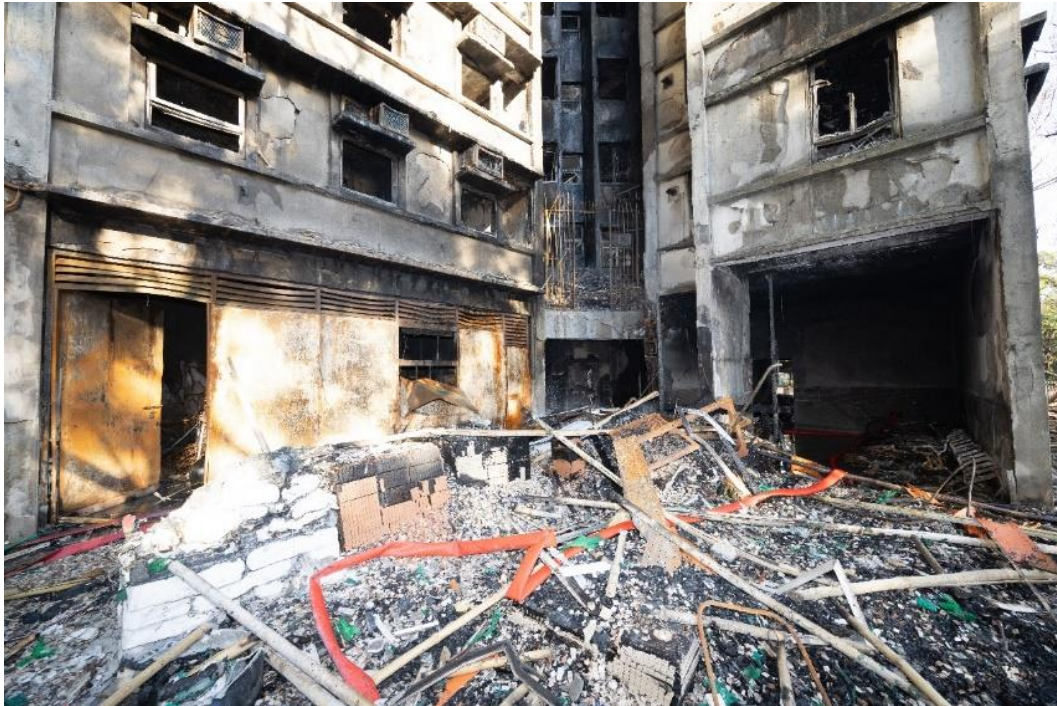
Photo 8-21 (g): Post-Fire Condition Outside the West Re-Entrant of  
Wang Tai House Facing Wang Kin House

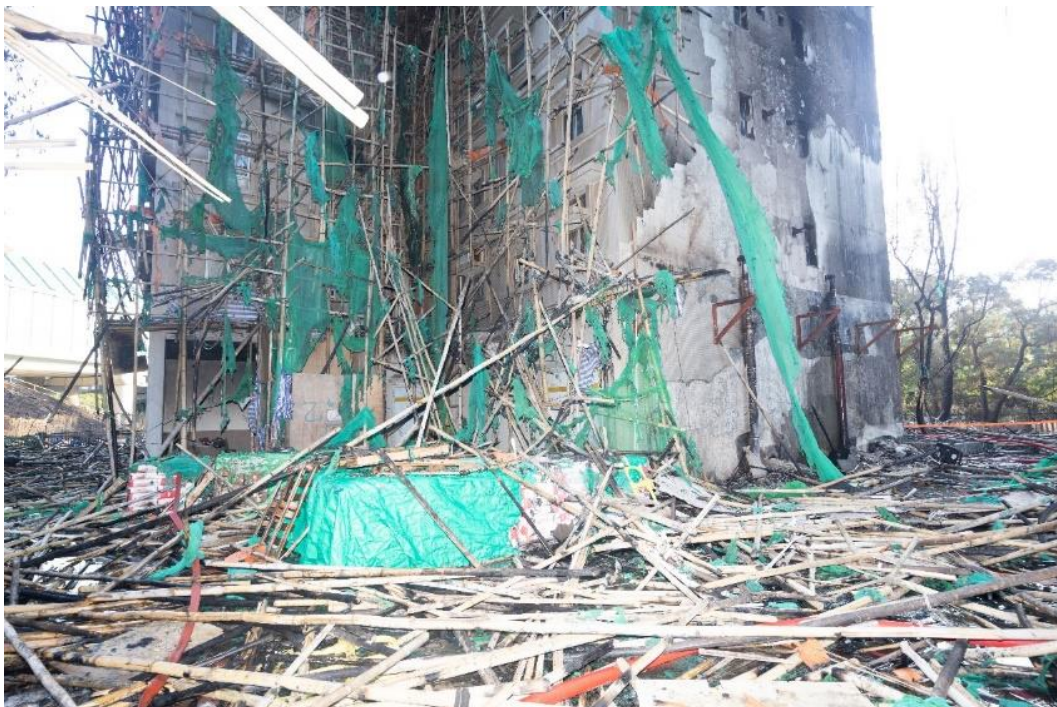
Photo 8-21 (h): Post-Fire Condition Outside the North Re-Entrant of  
Wang Cheong House
