# Final Investigation Report No.5 Alarm Fire at Wang Fuk Court on 26 November 2025

Inter-Departmental Fire Investigation Task Force

May 2026

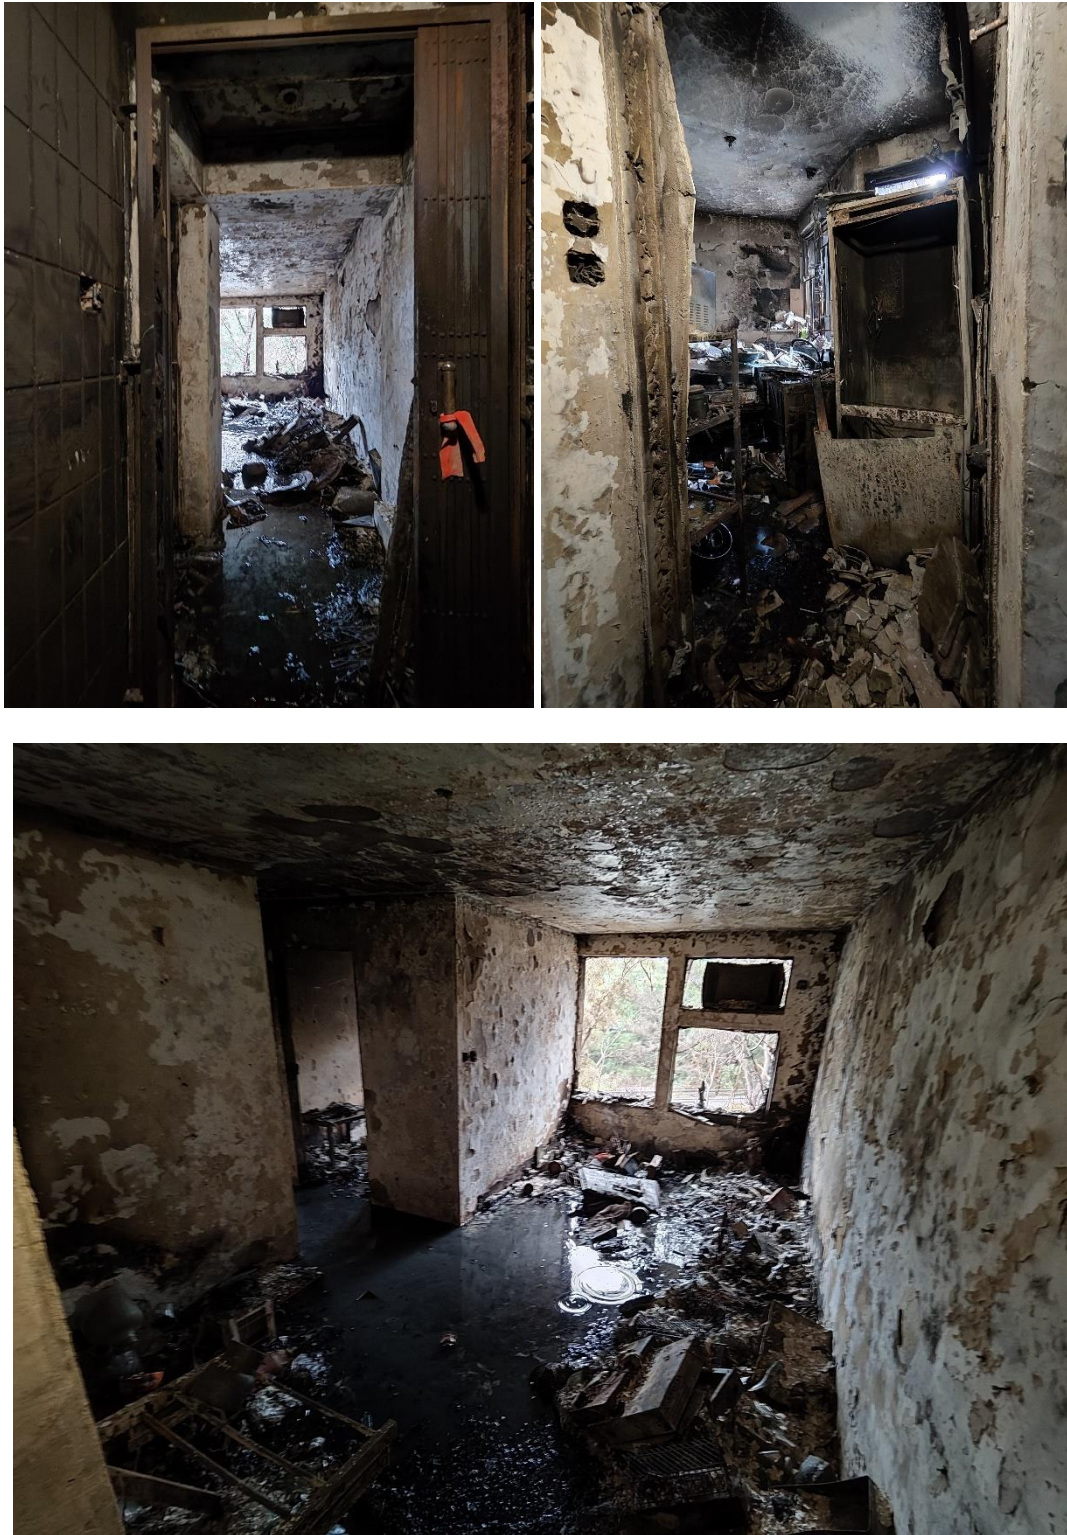
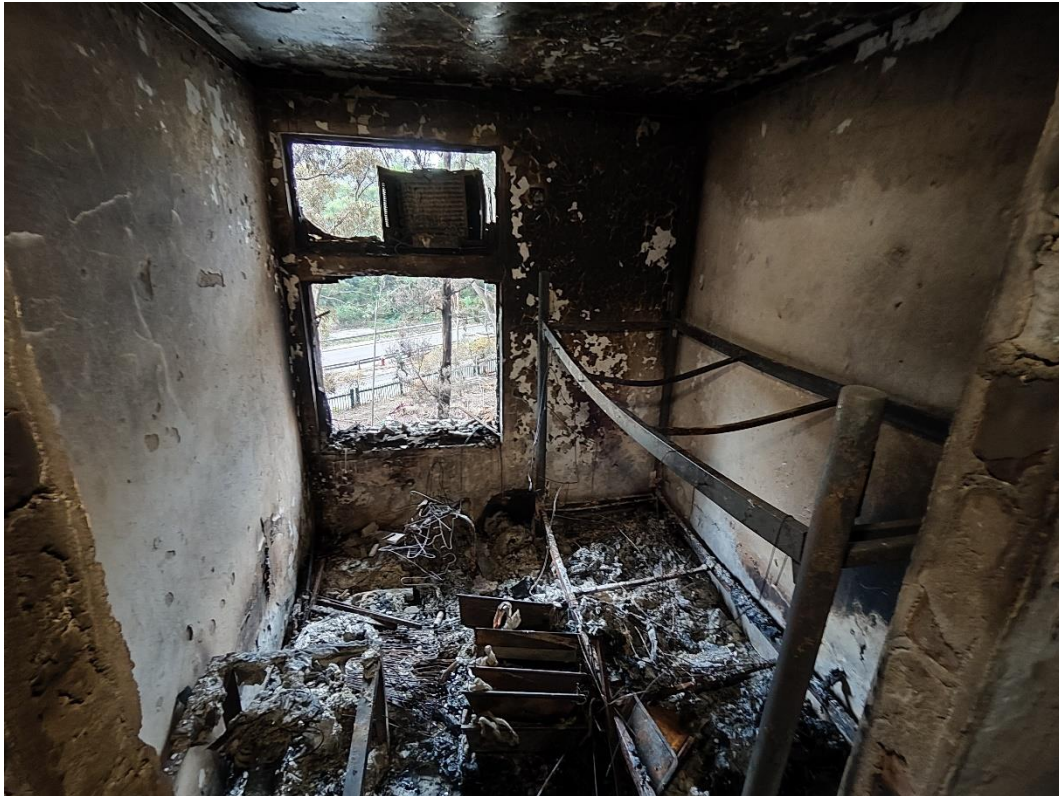
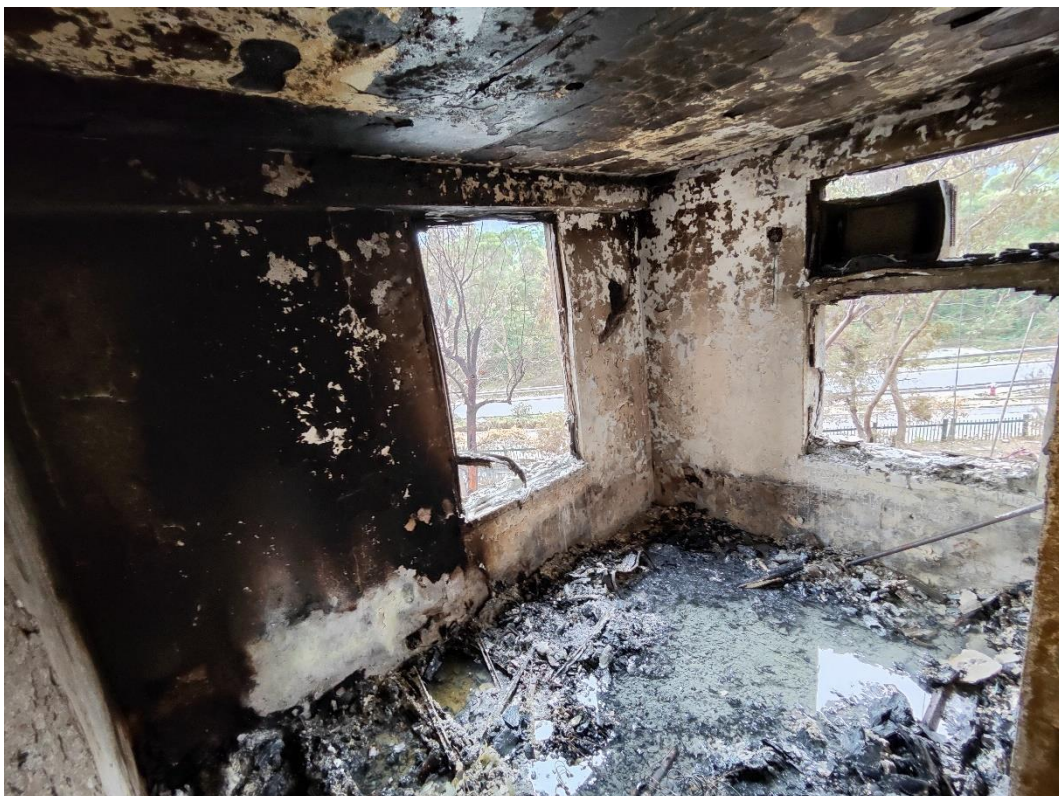
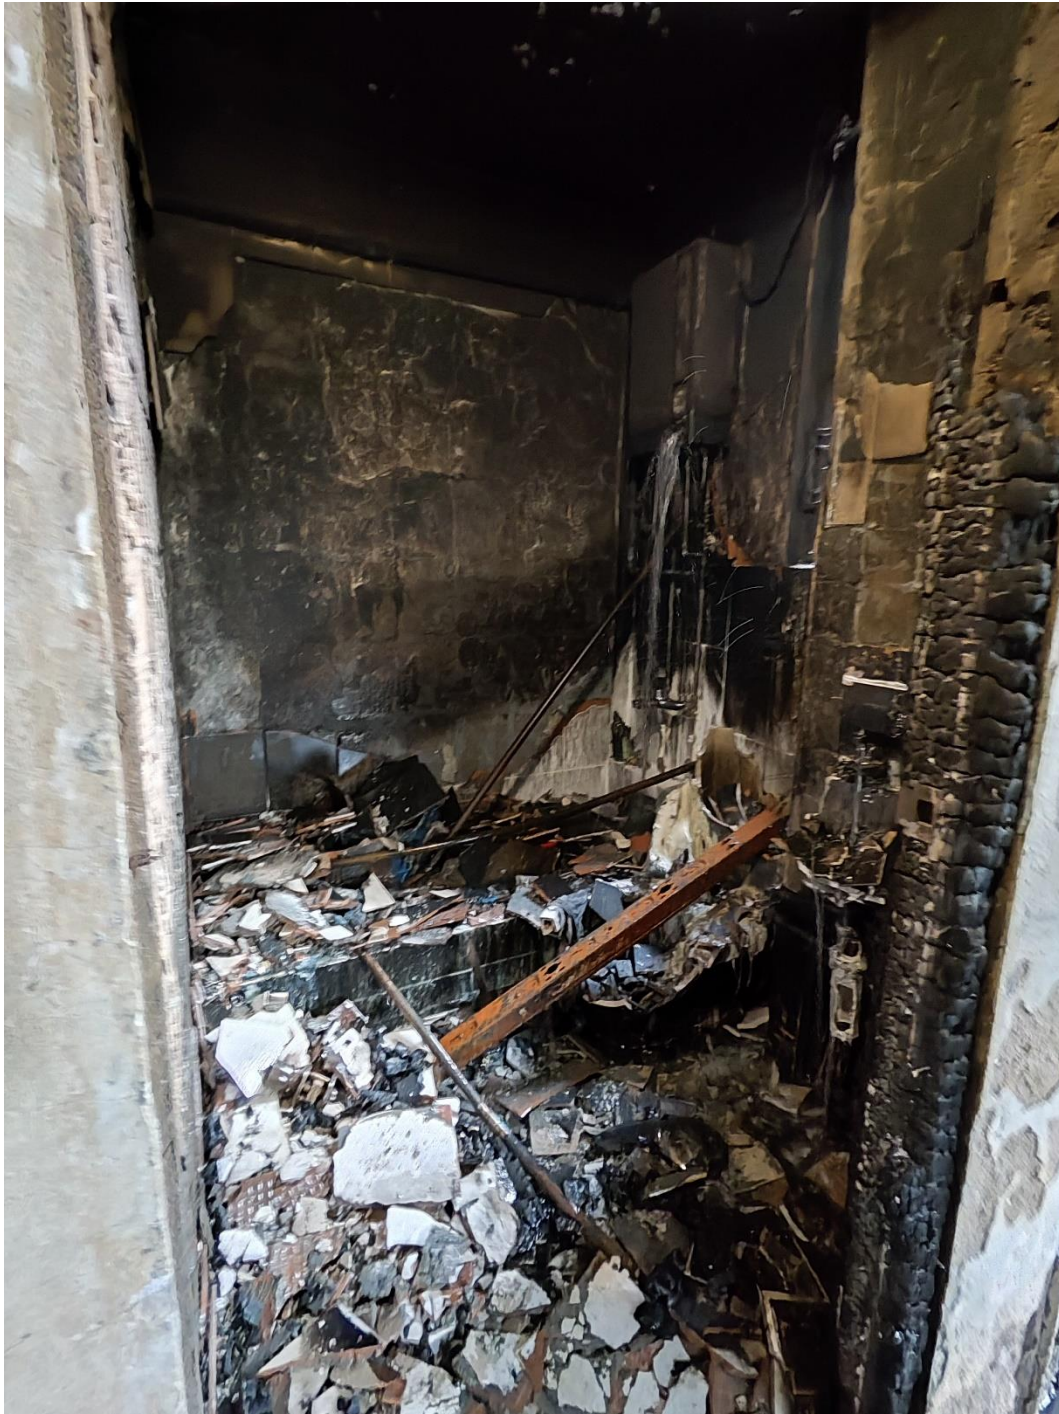
Photos 10-5 (a) to (f): Post-Fire Condition of Flat 2█, Wang Cheong House

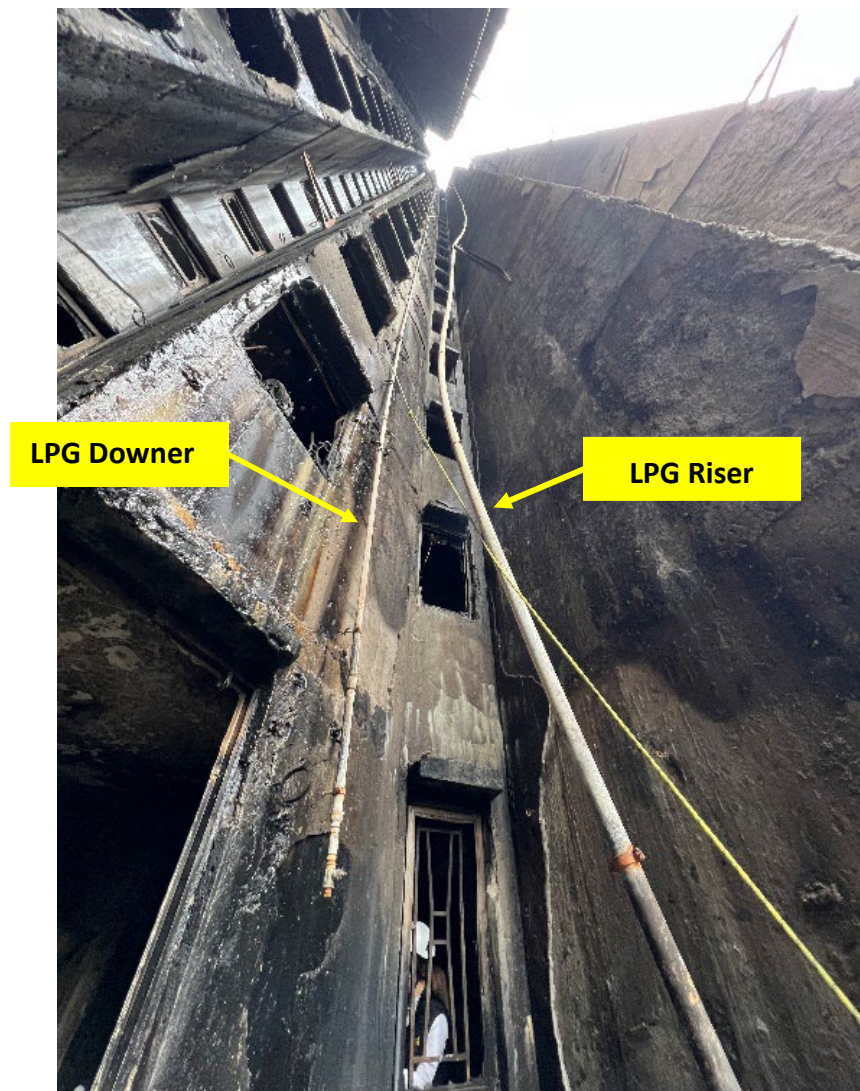
Photo 5 - Deformed LPG riser and downer at Wang Cheong House with no sign of rupture

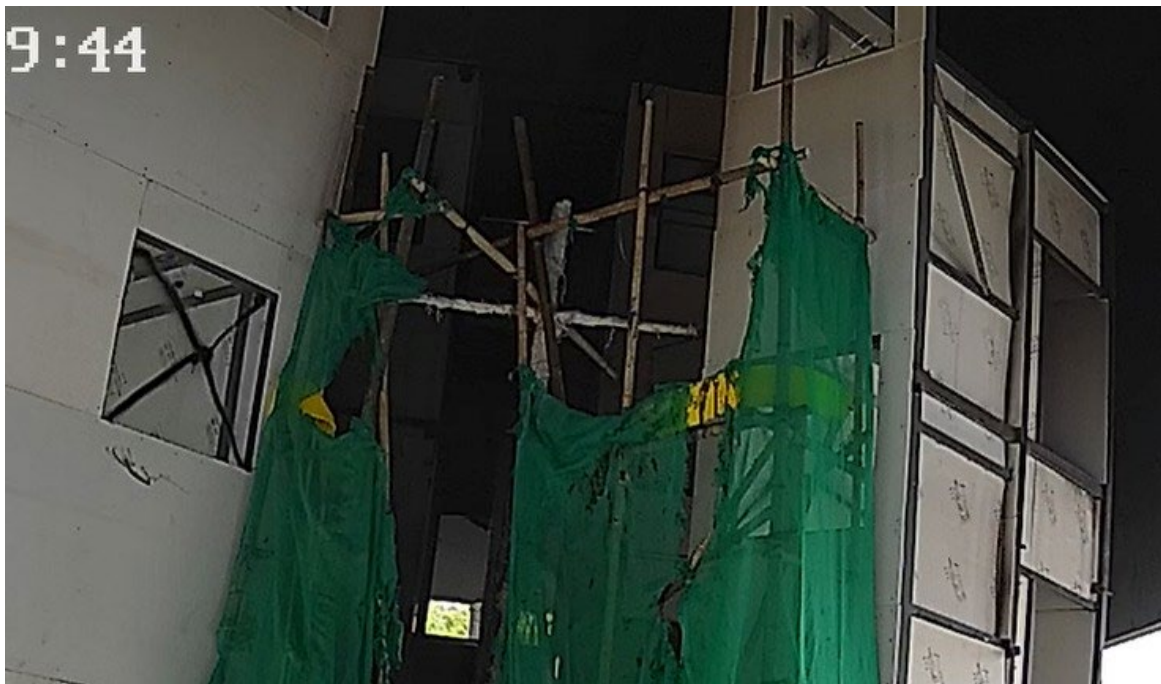
Photo 2-12 (g): Seriously Damaged Safety Nets in Test 8

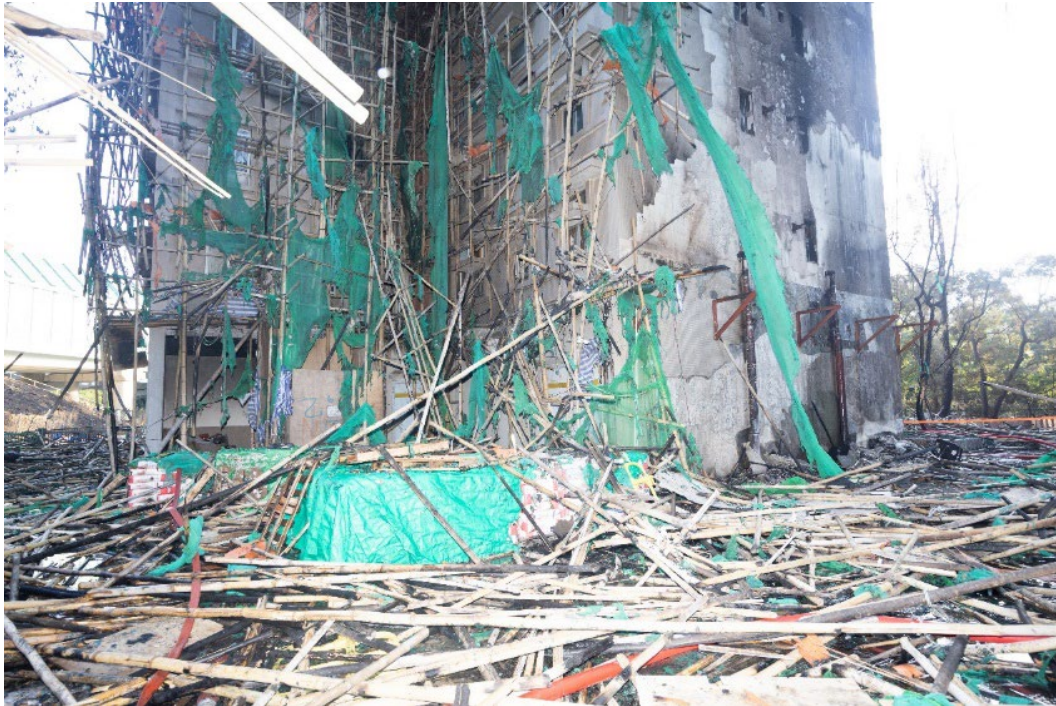
Photo 4-9 (h): Post-Fire Condition outside the North Re-entrant of Wang Cheong House
