# Interim Investigation Report No.5 Alarm Fire at Wang Fuk Court on 26 November 2025

Inter-Departmental Fire Investigation Task Force

February 2026

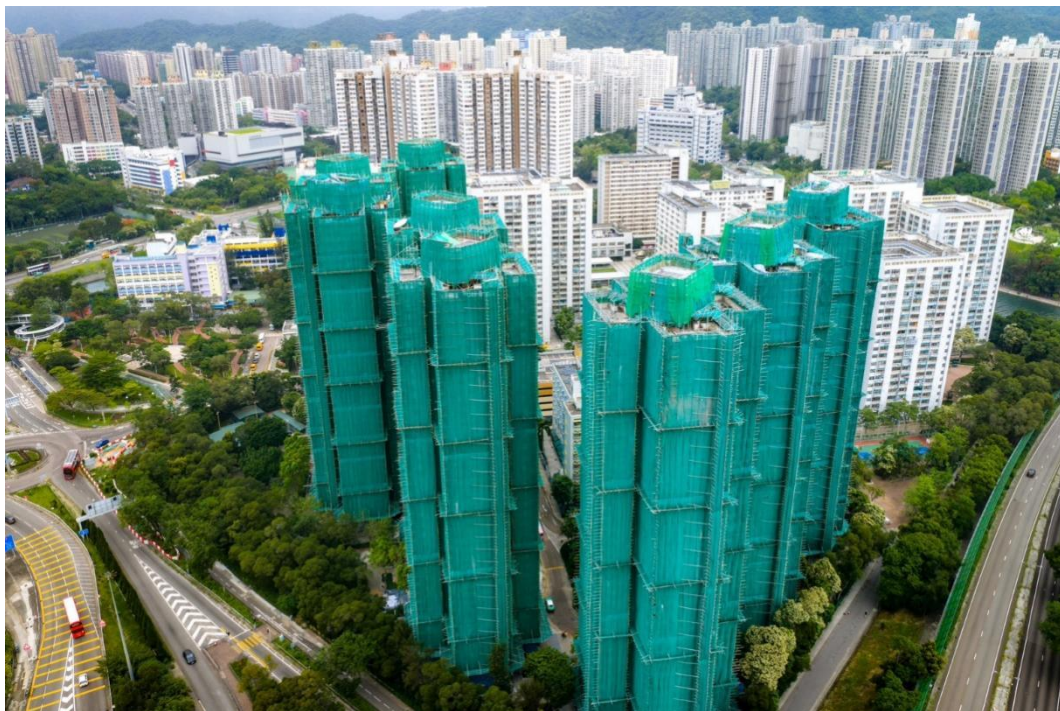
- 4.5.4.5 The external wall repair work was included as part of the renovation work. For this purpose, scaffolding works commenced outside the external walls of all blocks of Wang Fuk Court since July 2024, according to the record provided by the PMC. These scaffoldings<sup>16</sup> (comprising bamboos, wooden planks, toe-boards, safety nets, canvas<sup>17</sup> and nylon strips<sup>18</sup>) enveloped all blocks entirely from G/F to R/F (as shown in **Photo 4-4** and **Photo 4-5**).

Photo 4-4: Renovation of Wang Fuk Court in 2024

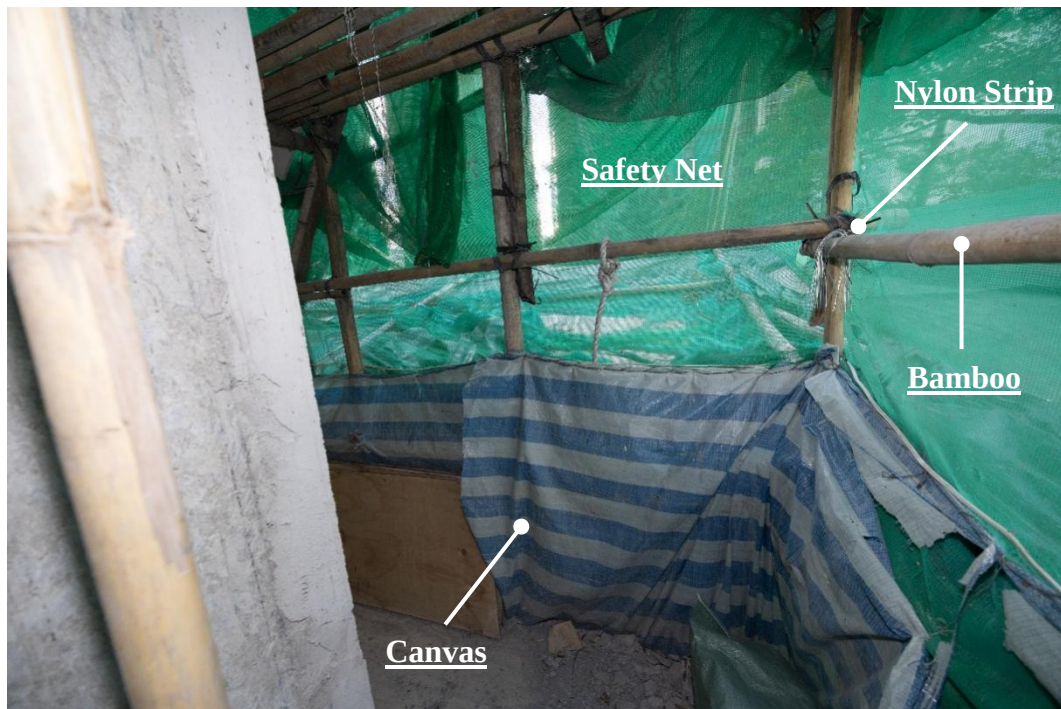
*Photo 4-5: Photo Showing Different Combustibles in the Scaffolding  
(Bamboos, Safety nets, Canvas and Nylon strips)*

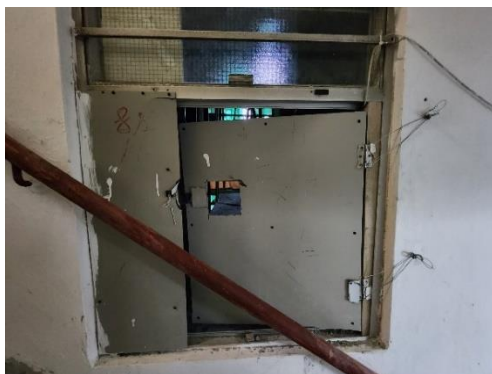
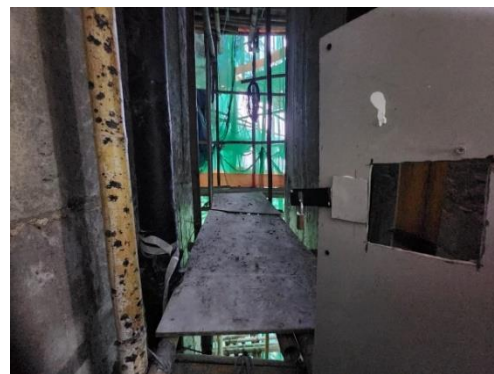
- 4.5.5.4 For all blocks of Wang Fuk Court, all the existing staircase windows, of which the upper part was openable, were proposed to be replaced with fire-rated windows<sup>22</sup> as part of the renovation works of Wang Fuk Court. As explained in paragraph 4.5.4.3 above, such proposed works were not a prescribed repair item under the MBIS regime; but given that it was categorised as a type of minor works under the MWCS<sup>23</sup> (as shown in **Photo 4-3(b)**), relevant minor works submissions were submitted to ICU under MWCS. While it was indicated in the relevant minor works submissions that all windows at staircases would be replaced with fire-rated windows, it was only revealed after the fire that some windows at the staircases were replaced with movable boards, most of them believed to be wooden, to provide convenient access for workers to the scaffoldings (as shown in **Photos 4-9 (a) & (b)**) at the following locations:

*Photos 4-9 (a) & (b): Replacement of Windows with Movable Boards*

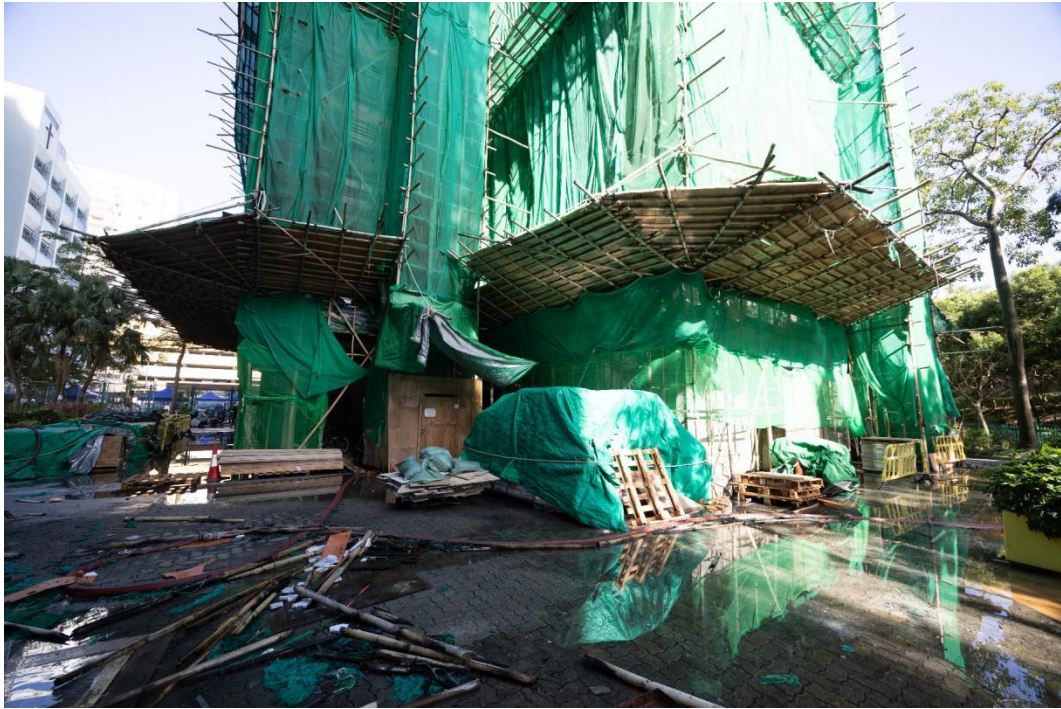
- 4.5.6.1 At the open ground surrounding Wang Chi House, a significant quantity of construction materials was found including safety nets, wooden planks, bamboos and other covered construction materials (as shown in **Photo 4-10**).

*Photo 4-10: Combustible Materials Scattered at  
Ground Level around Wang Chi House*

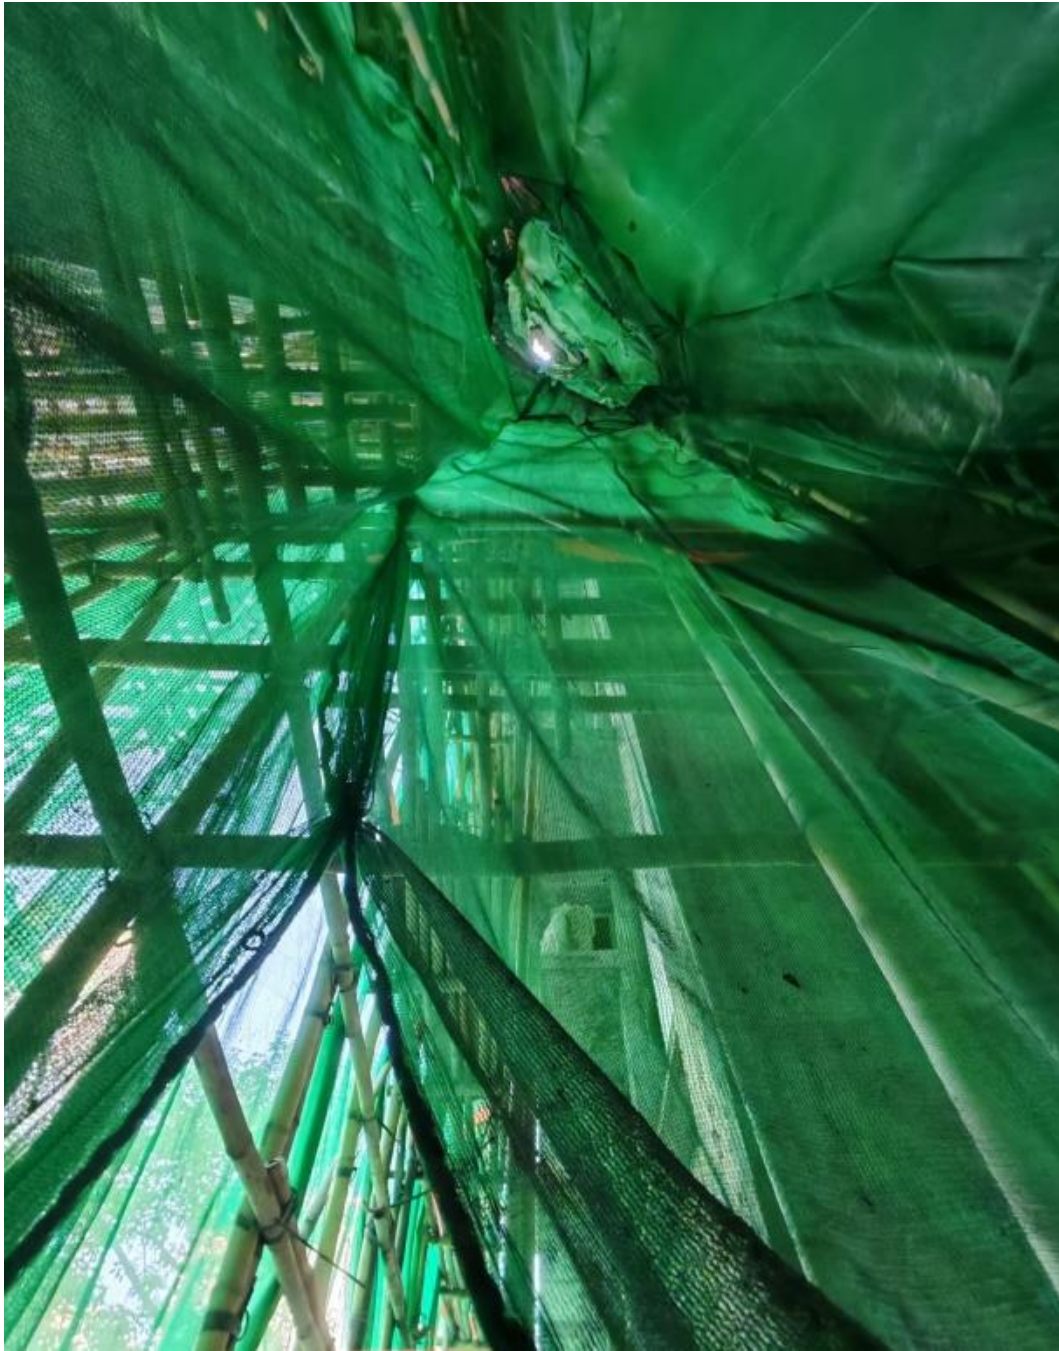
- 4.5.6.3 A considerable amount of combustibles, including bamboos, wooden planks, safety nets, nylon strips and canvas, was located at the re-entrants (as shown in **Photos 4-12 (a) to (d)**). Especially at the re-entrants with windows immediately outside the lift lobby and staircases, where a triangular channel extending from the flat roof to the roof level was observed (as shown in **Photo 4-13**).

Photo 4-13: Triangular Channel Leading from Flat Roof to R/F at the Re-entrant

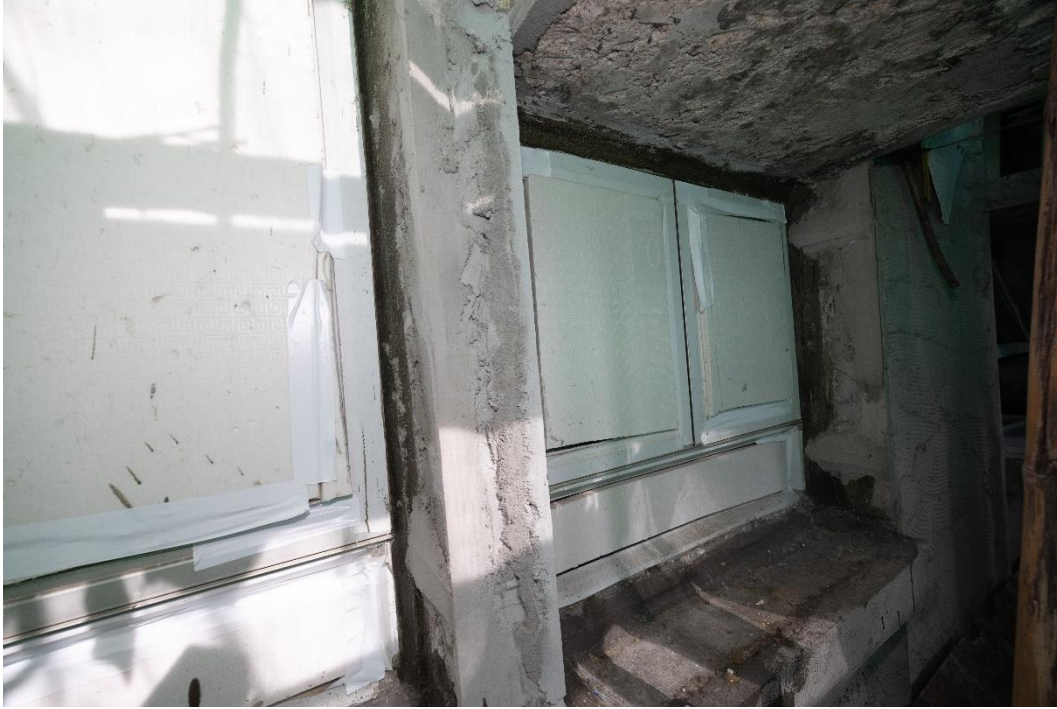
- 4.5.6.4 Polystyrene window covers<sup>24</sup> were found covering the windows of most flats, lift lobbies and staircases to protect window glass from accidental impacts (as shown in **Photos 4-14 (a) to (c)**).

Photos 4-14 (a) to (c): Polystyrene Window Covers

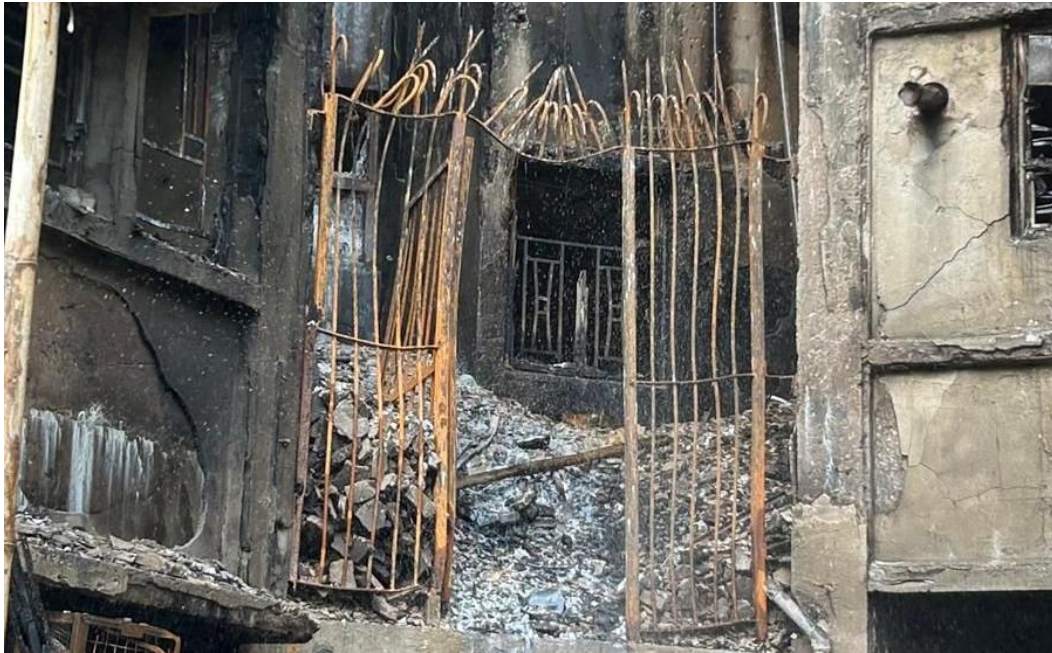
Photo 6-1: Debris Piled up on the Flat Roof outside Flats 104 and 105

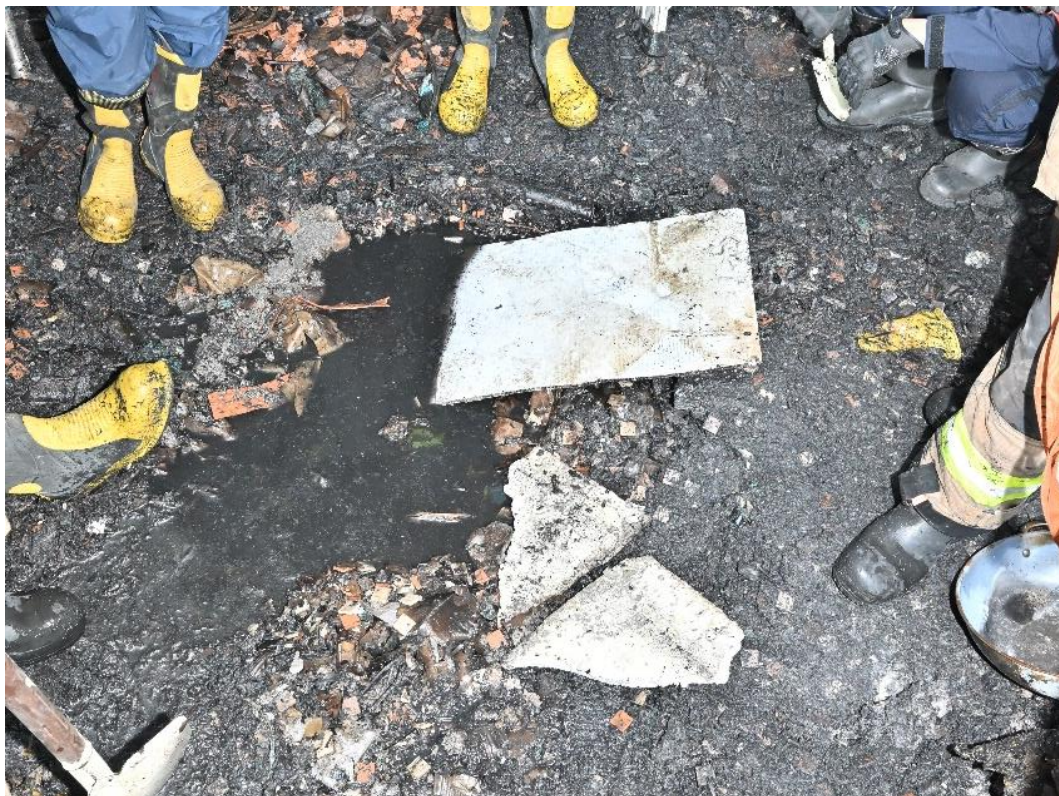
Photo 6-2: Polystyrene Window Covers Found at the Suspected Fire Origin

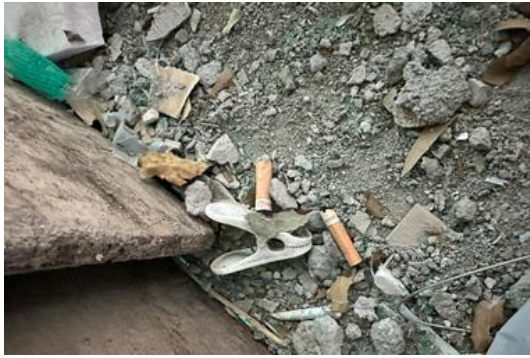
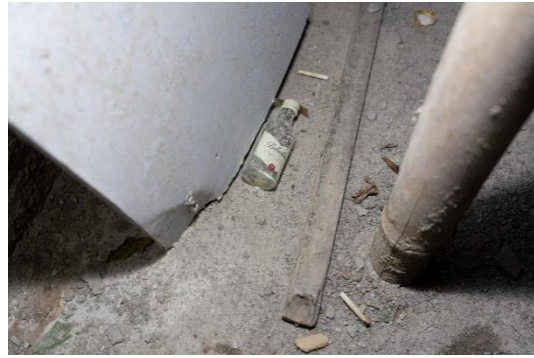
Photos 6-5 (a) & (b): Cigarette Ends Found on the  
First Level Scaffolding at Wang Chi House

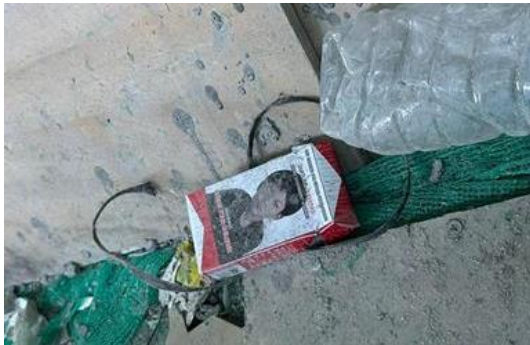
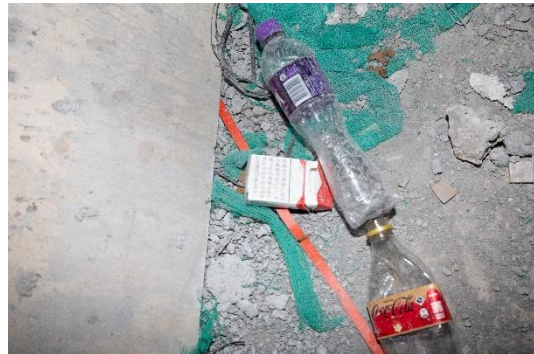
Photos 6-5 (c) & (d): Cigarette Boxes Found on the  
First Level Scaffolding at Wang Chi House

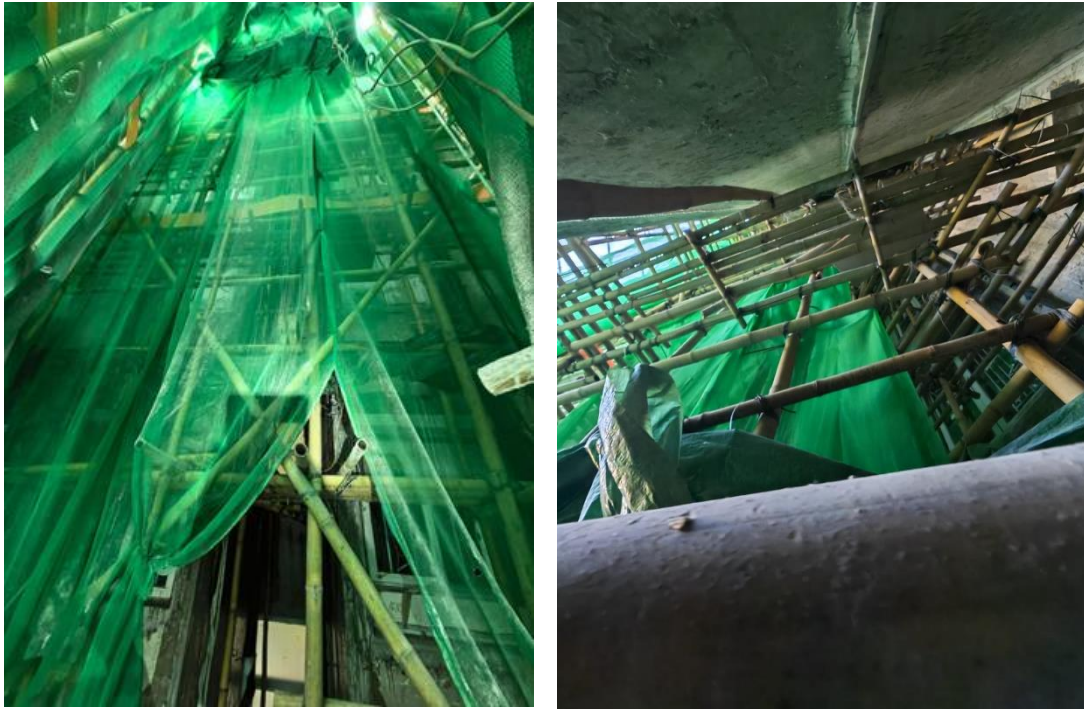
Photos 6-6 (a) & (b): Continuous Fuel Source in the Re-entrant

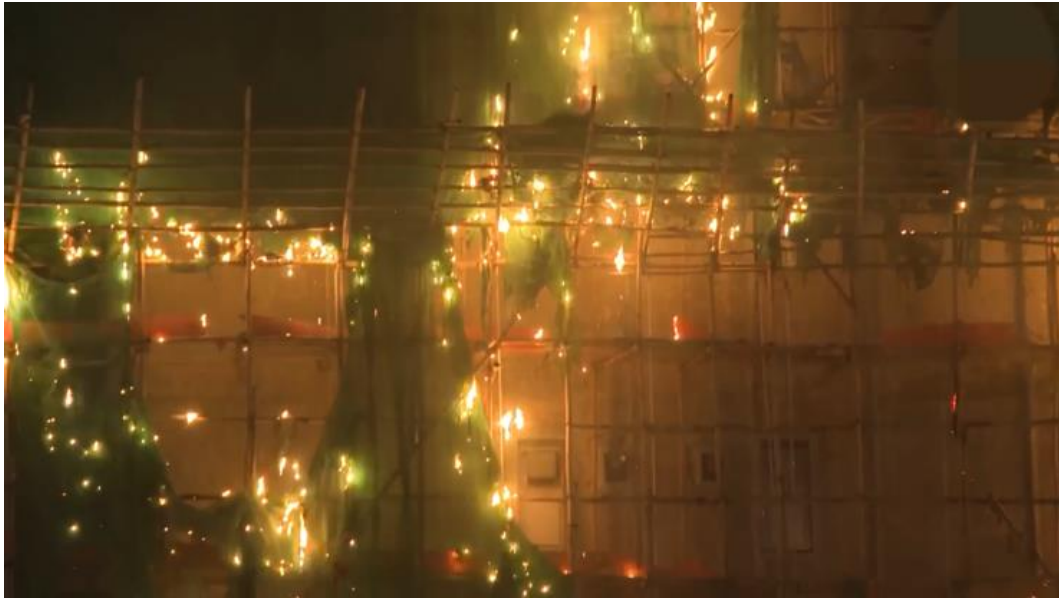
Photo 6-10: Falling Fragments of Burning Safety Nets

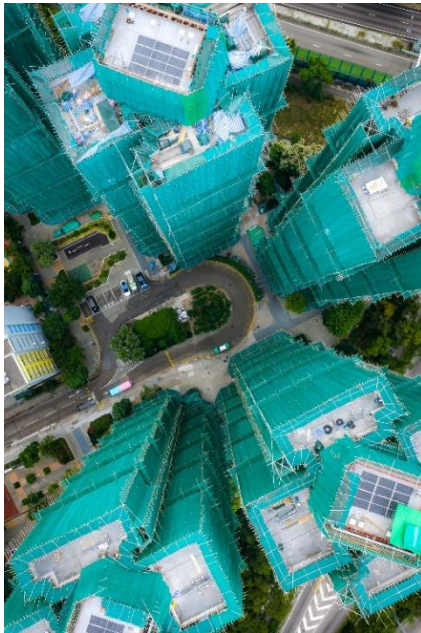
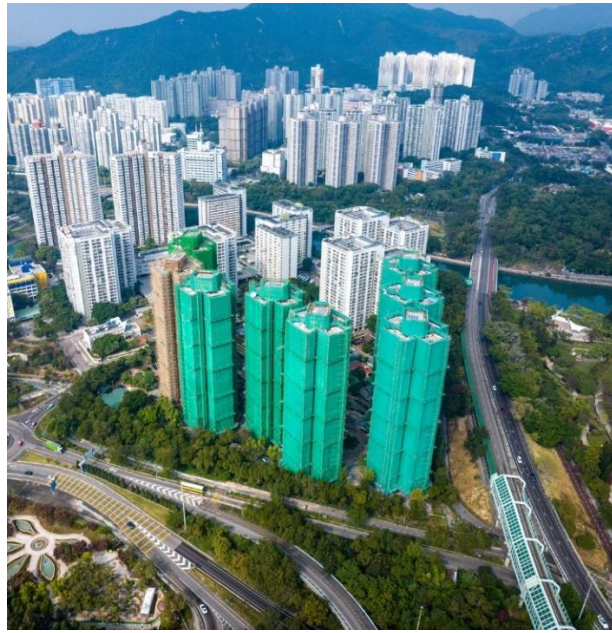
Photos 6-11 (a) & (b): Buildings in Wang Fuk Court Enveloped by Safety Nets

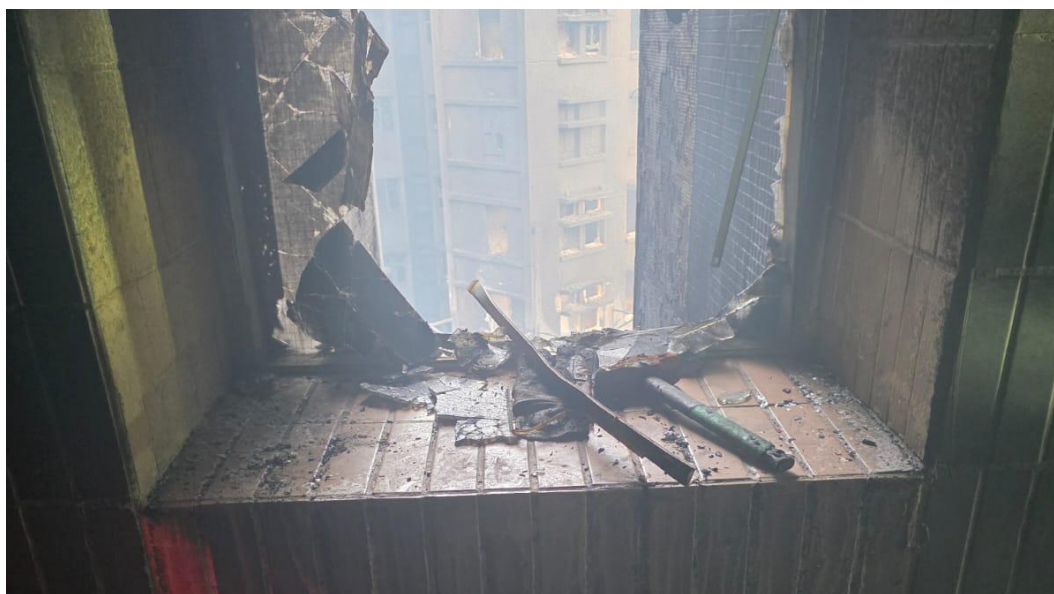
7.2.6.3 Additionally, Fn HO's left hand glove and a hammer were found on the window sill of the lift lobby on the 31/F, near the broken window (as shown in **Photo 7-10**). The boots belonged to Fn HO were recovered separately at G/F outside Wang Tai House (as shown in **Figure 7-2**) by Acting ADO TSE Kwong-for and PFn [REDACTED] TANG Cheuk-yin respectively.

*Photo 7-10: Photo Showing the Window Sill on the 31/F*

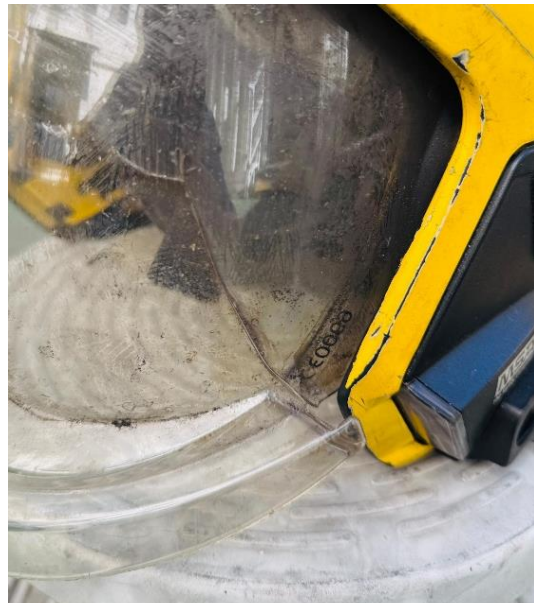
7.2.6.4 The post-fire visual inspection revealed that Fn HO might have been in prolonged contact with hot or burning objects, resulting in severe fire damage to his Station T-shirt, No. 3 trousers, PBI Matrix tunic and trousers anti-flash hood and his helmet (as shown in **Photos 7-11 to 7-16**).

Photo 7-16 (b): Crack on Visor

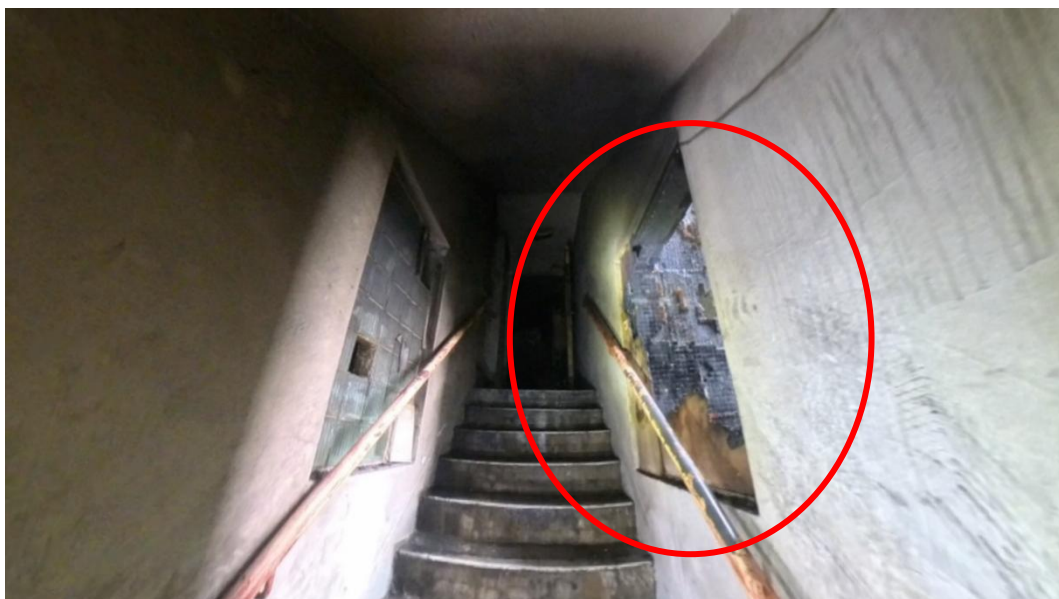
Photo 8-2: Windows Replaced by Movable Boards (Damaged by Fire) at Escape Staircase of 10-11/F of Wang Tai House

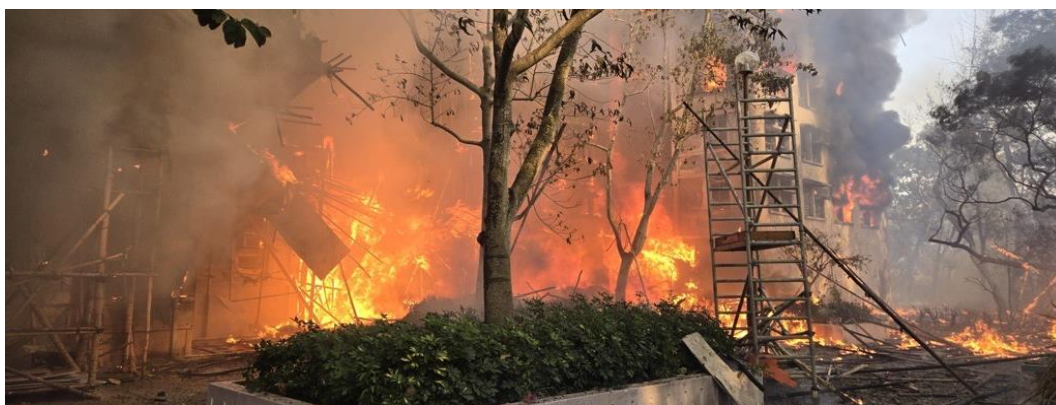
*Photo 8-3: The Burning Debris and Bamboo Scaffolding Blocking Exits*
