**GOVERNMENT LABORATORY**  
Forensic Science Division

Fire Investigation  
No. 5 Alarm Fire at Wang Fuk Court

- 1 Cause of Fire
- 2 Examination of Temporary Protective Materials found at the Scene  
(comparison of burning behavior of different materials upon exposure of a small flame source)

# Cause of Fire

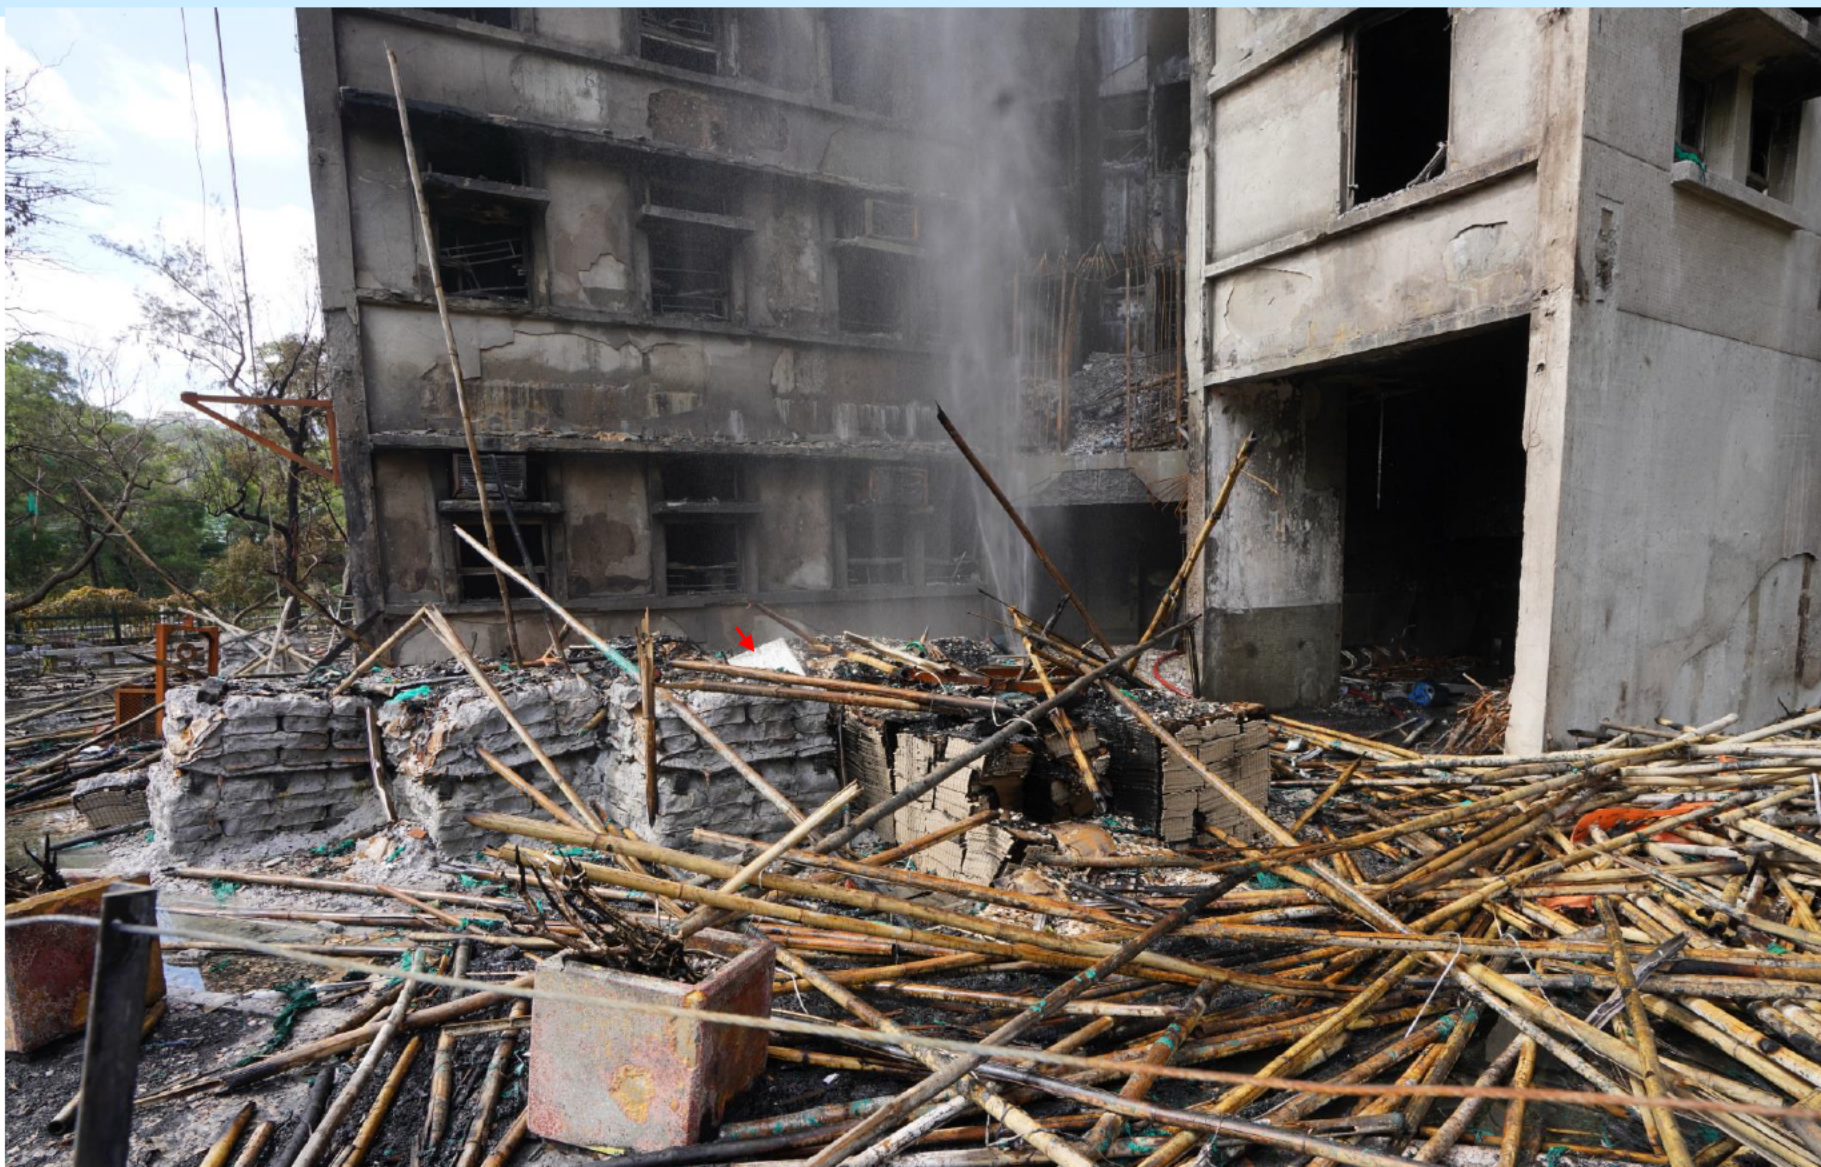
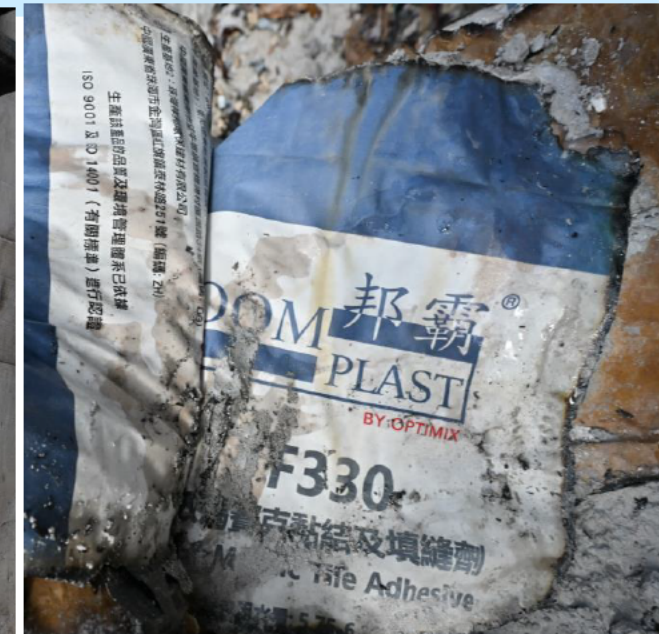
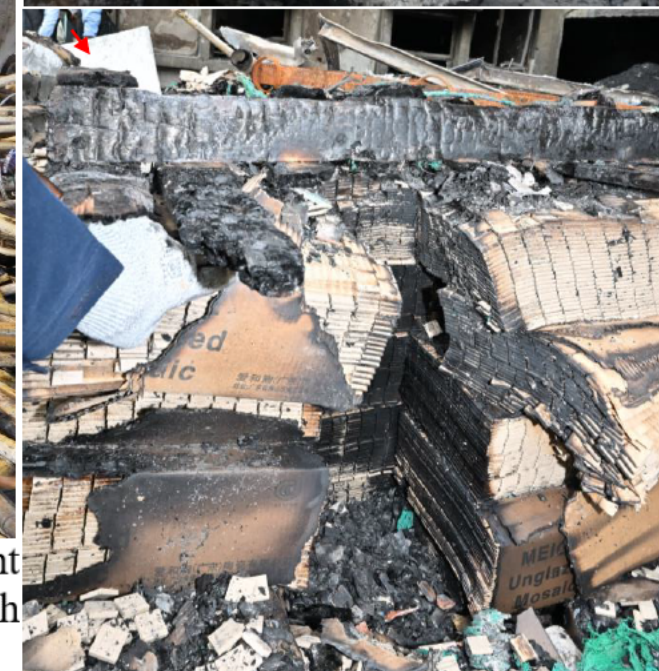
**Photo 12:** Outside the ground floor of side 4-5 of Wang Cheong House (collapsed scaffolds, such as burnt bamboo remains, remnants of safety nets and foam boards [\(↑\)](#), with bags of plastering materials (with close-up at **Photo 12a** below) and carton paper boxes of mosaic tiles (with close-up at **Photo 12b** below) .

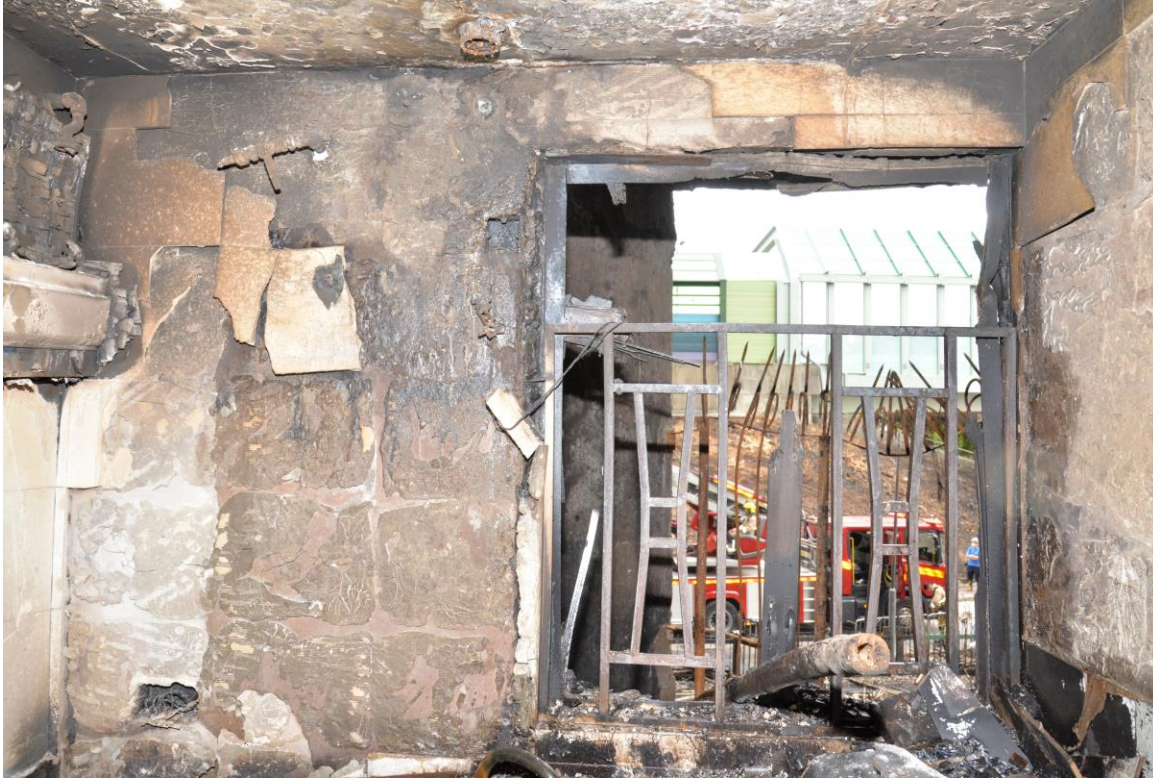
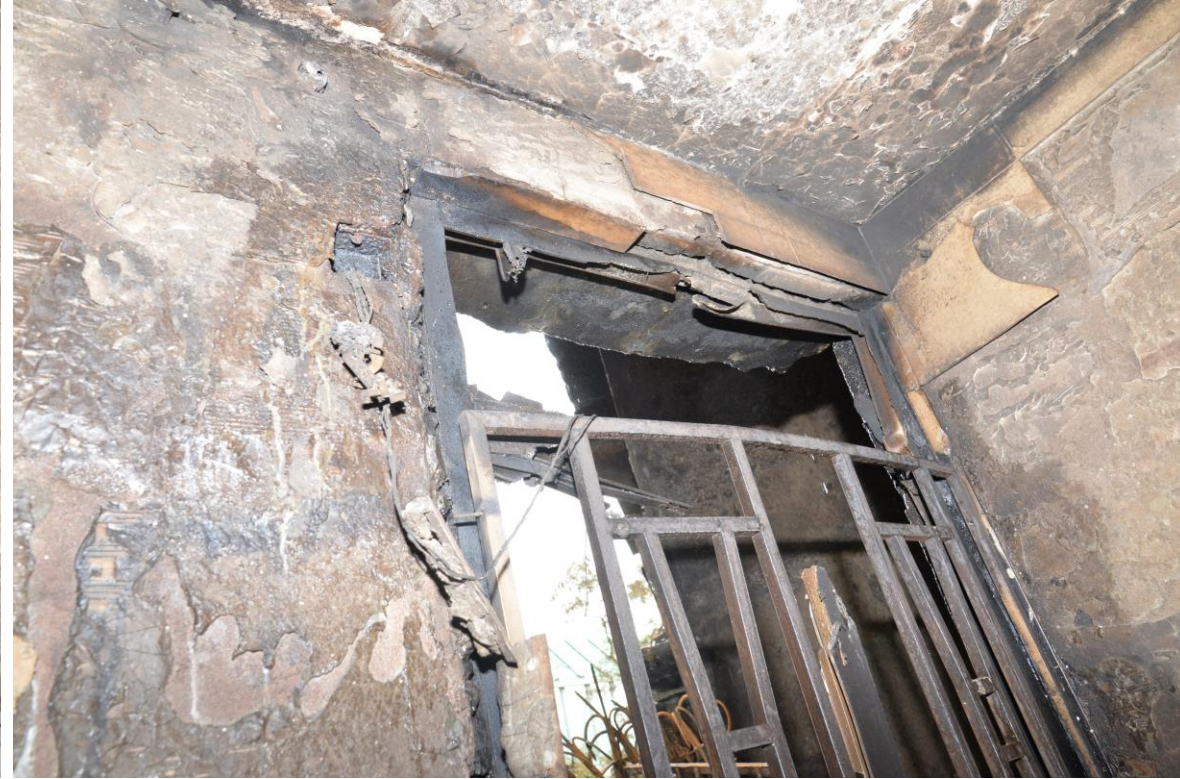
Close-up of kitchen window (intense spalling of concrete window overhang outside with irregular outline, whereas the inner wall above the window sustained comparatively less fire damage with tiles remained on the wall at the top right corner above the window.)

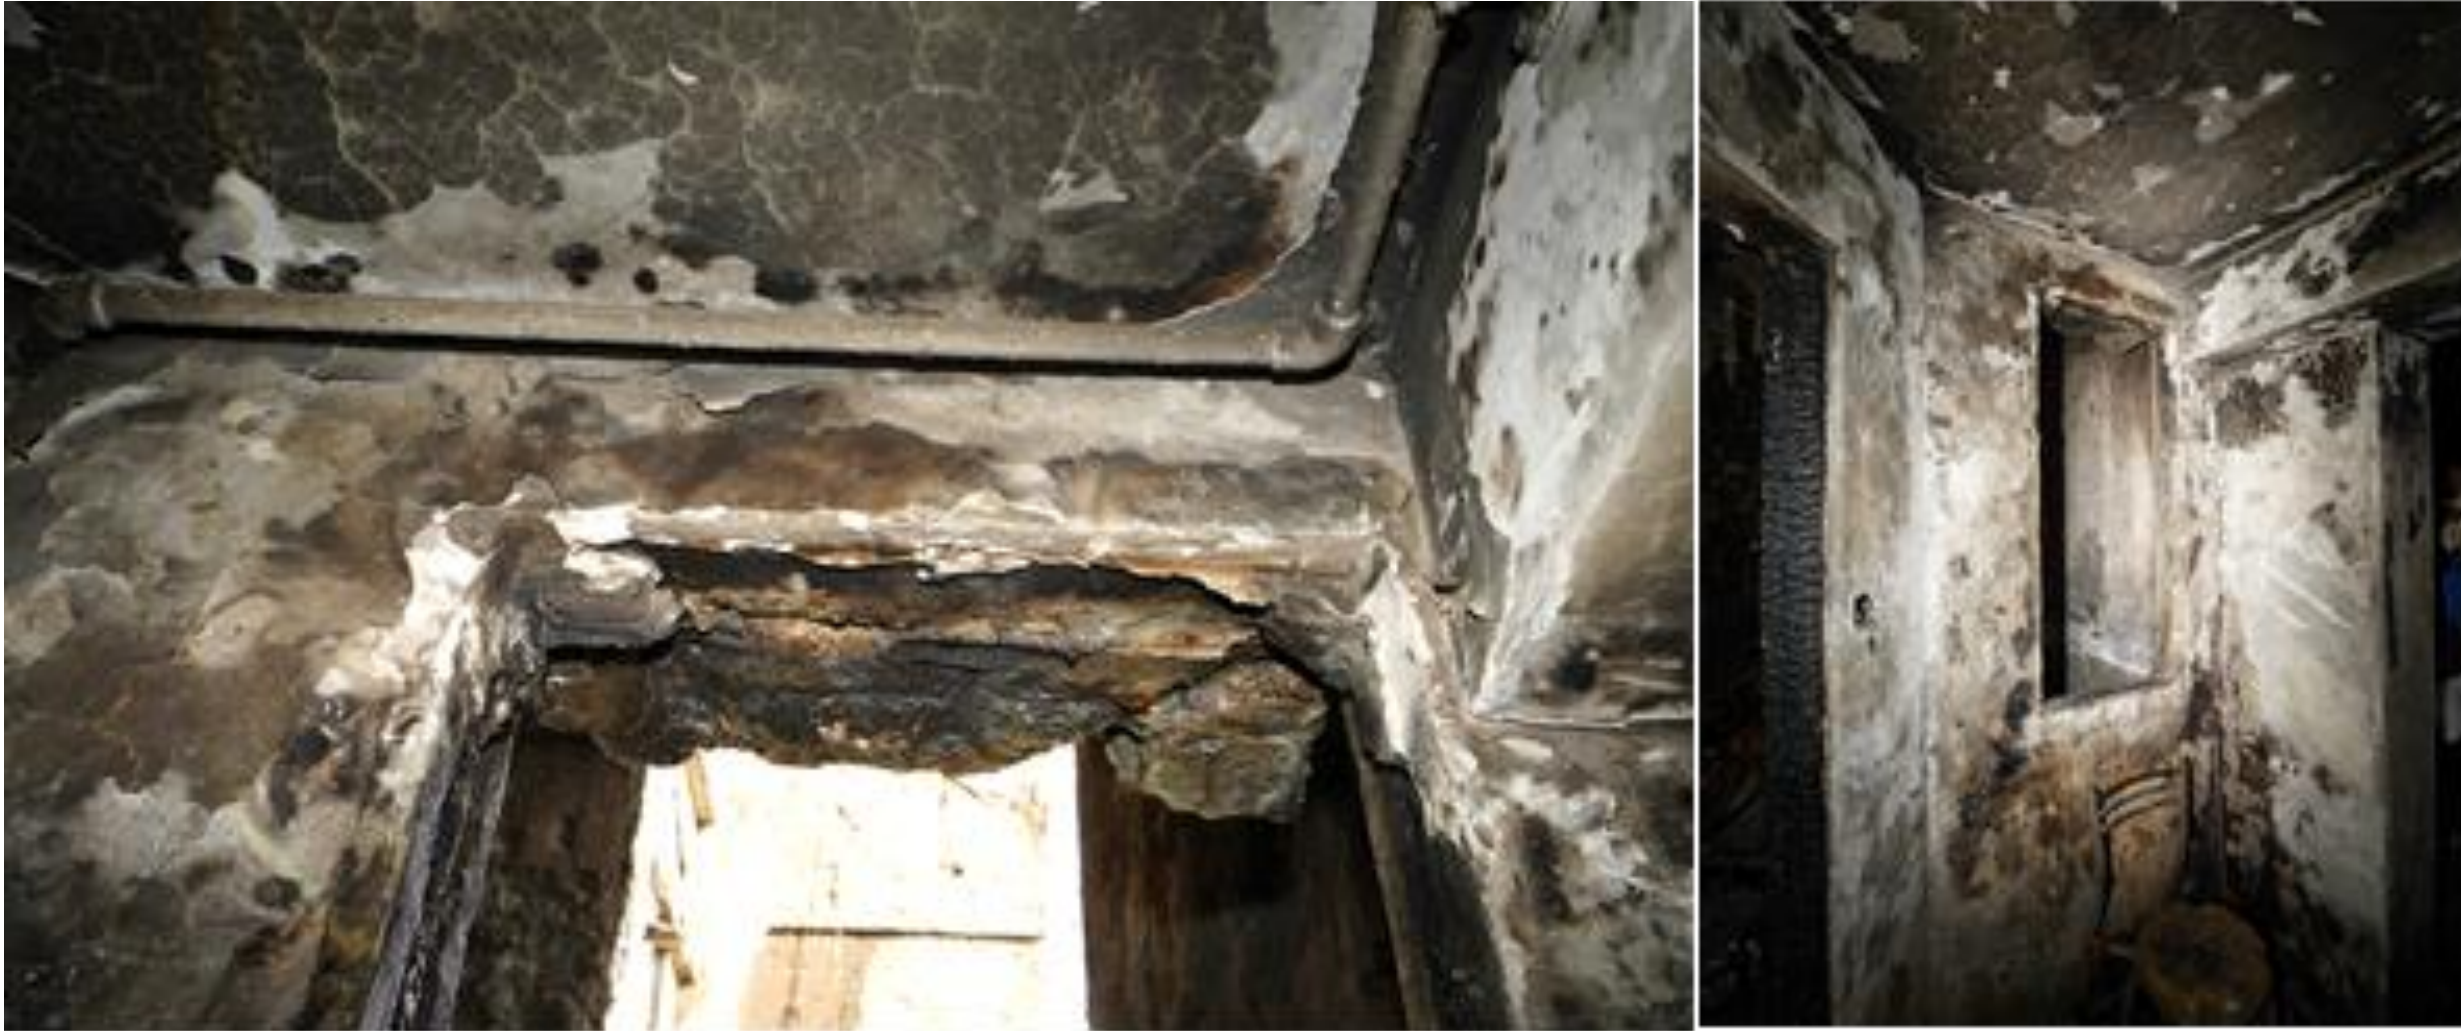
View of entryway window (more severe spalling on the concrete window overhang than the inner wall)

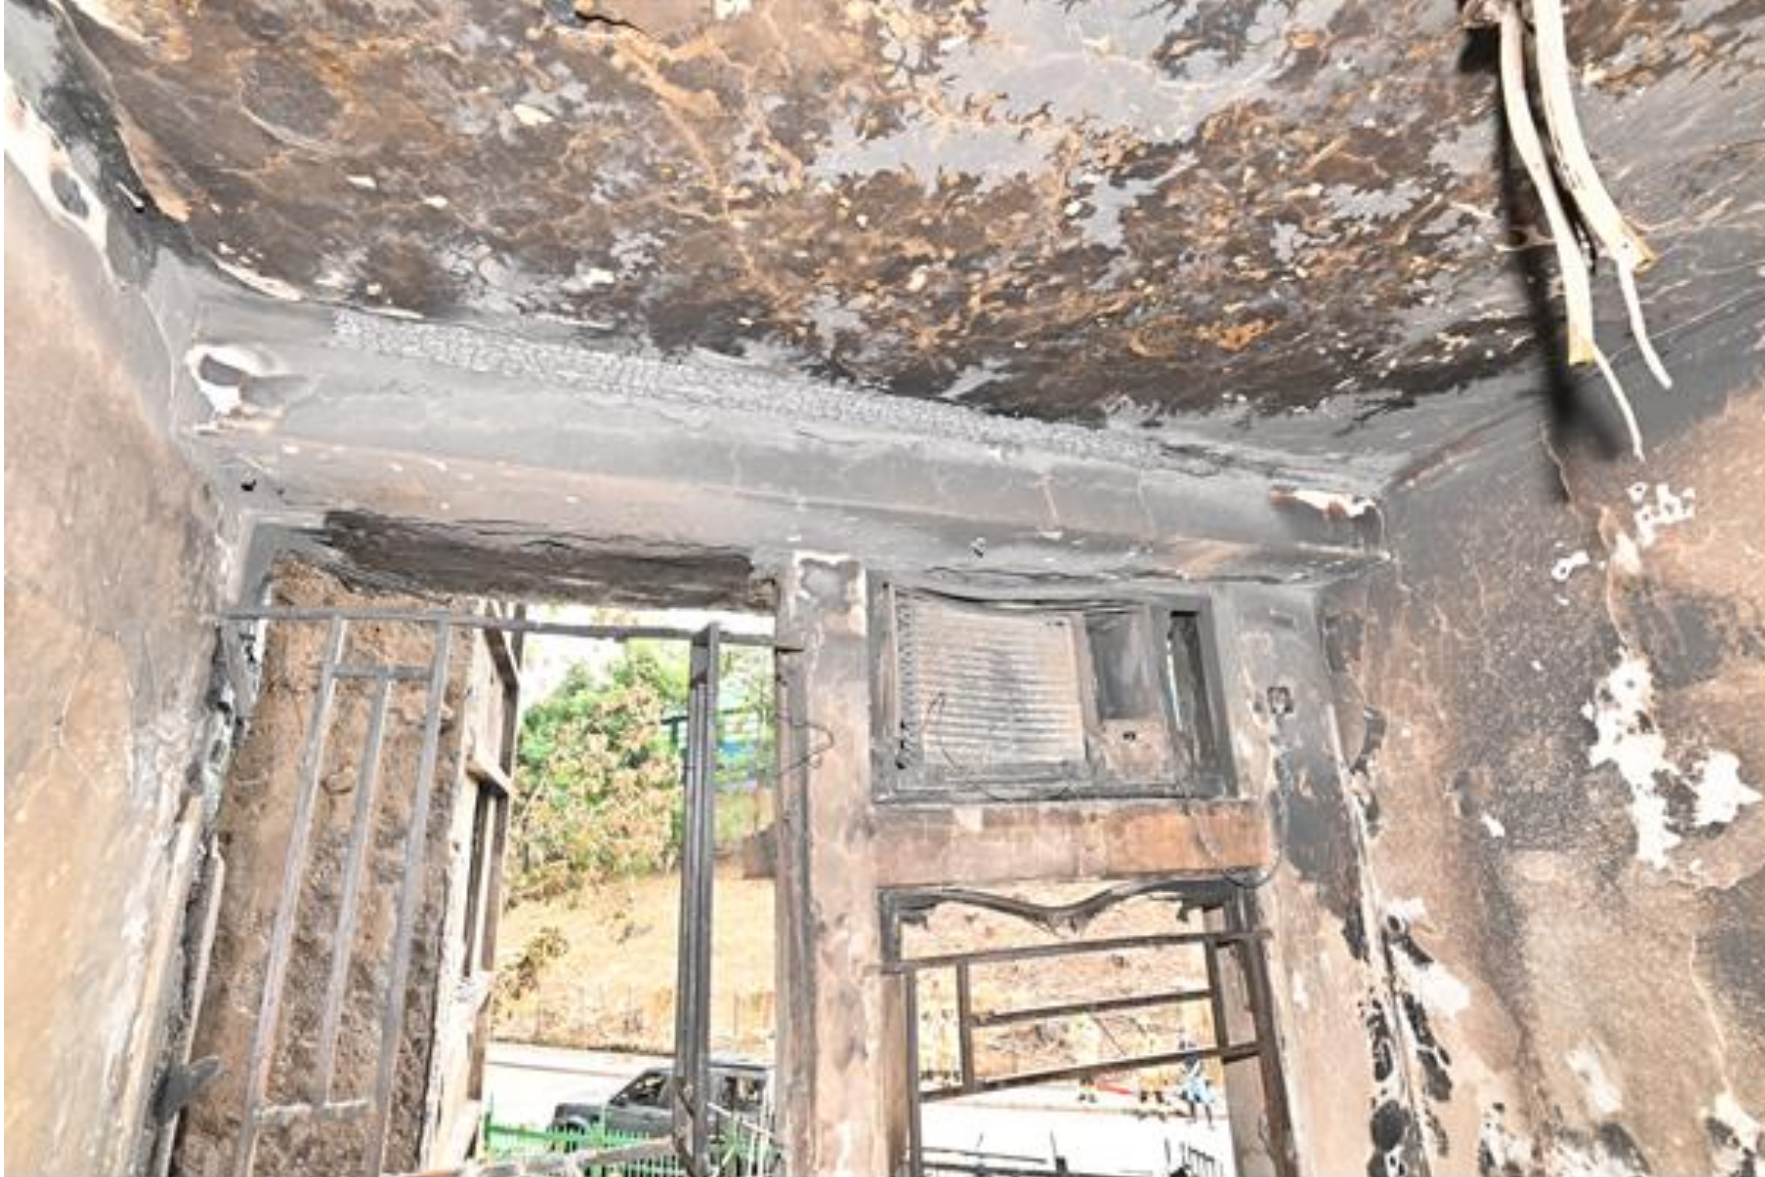
View of living room window (more severe spalling on the concrete window overhang outside rendering it an irregular surface)

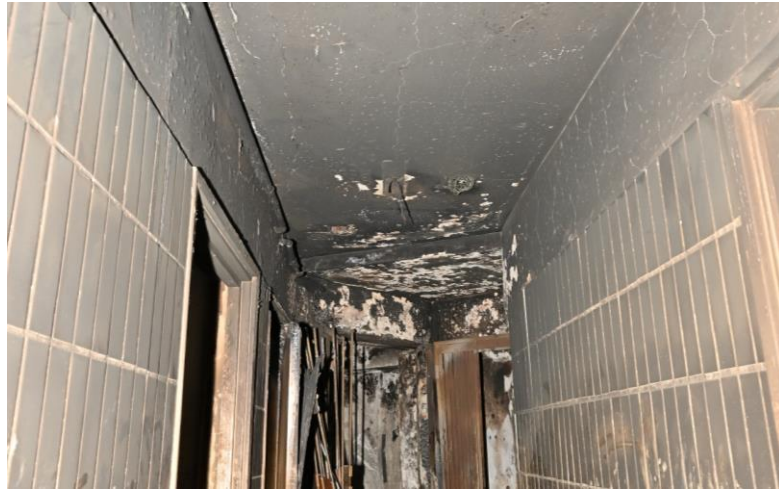
A: View of entrance Flat 105-106

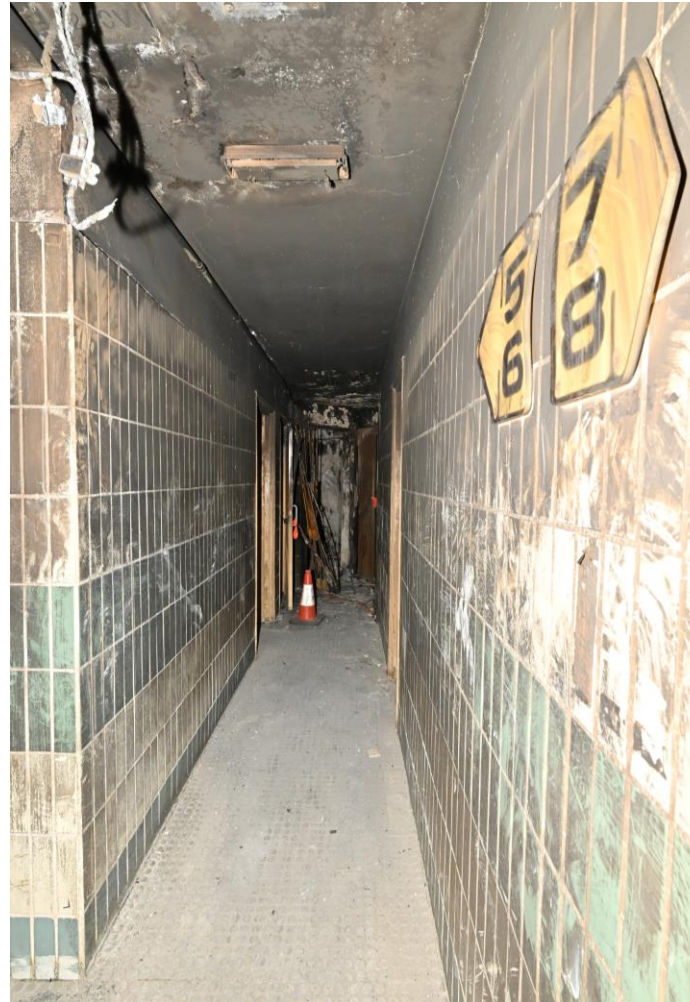
View of corridor from Flat 107-108 towards Flat 105-106, with close-up view at **Photo A** (more severe heat damage at the end of Flat 105-106)

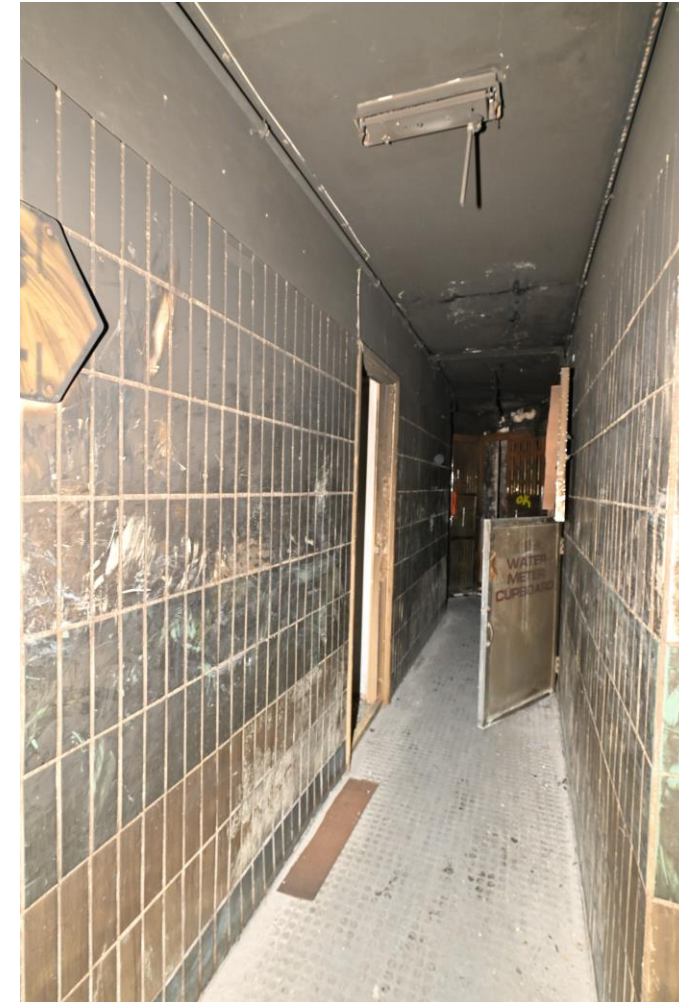
View of corridor from Flat 101-102 towards Flat 103-104, with close-up view of the end of Flat 103-104 at **Photo 2B**

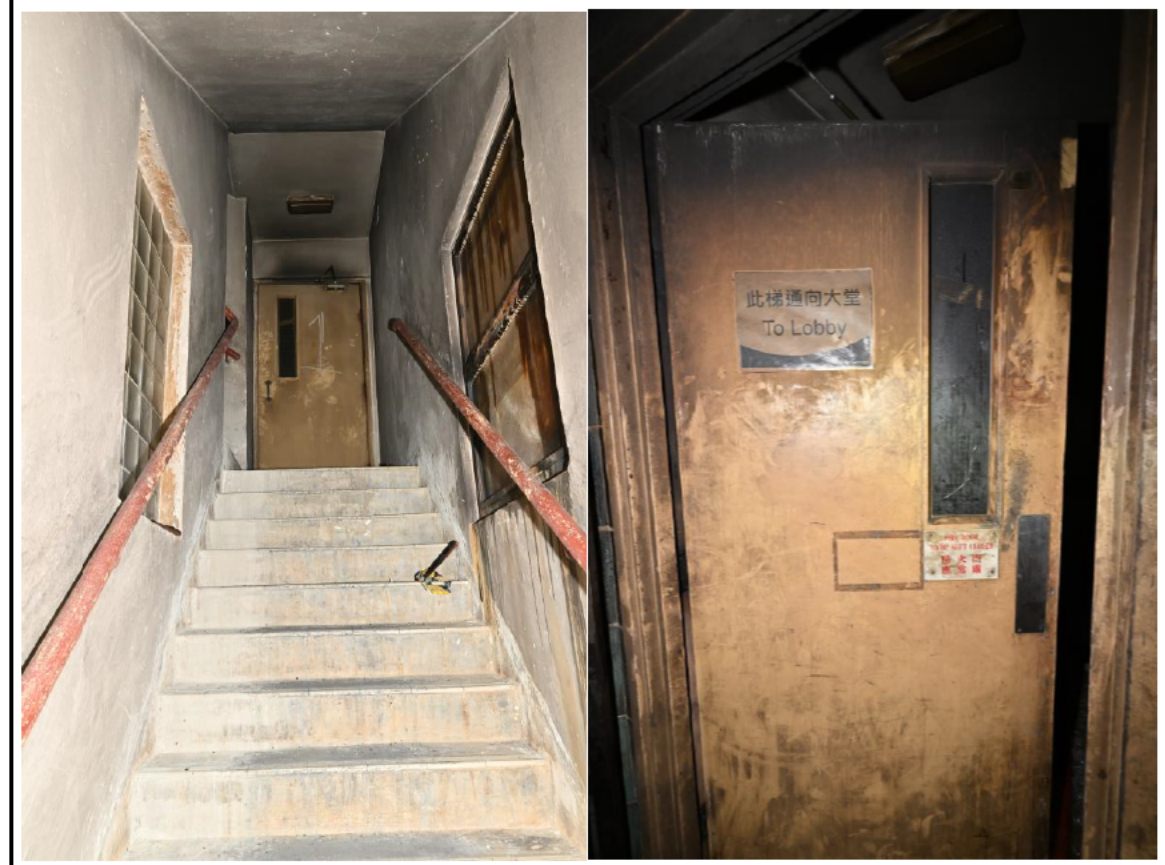
| <p>Wang Cheong House, Front staircase to 1/F, near Flat 104<br/>The heat damage and soot deposit record indicated that the door was closed during the fire</p> | <p>Wang Cheong House, Rear staircase to 1/F, near Flat 105<br/>Contrast of heat damage on both side of the fire door indicated that the door was closed during the fire</p> |

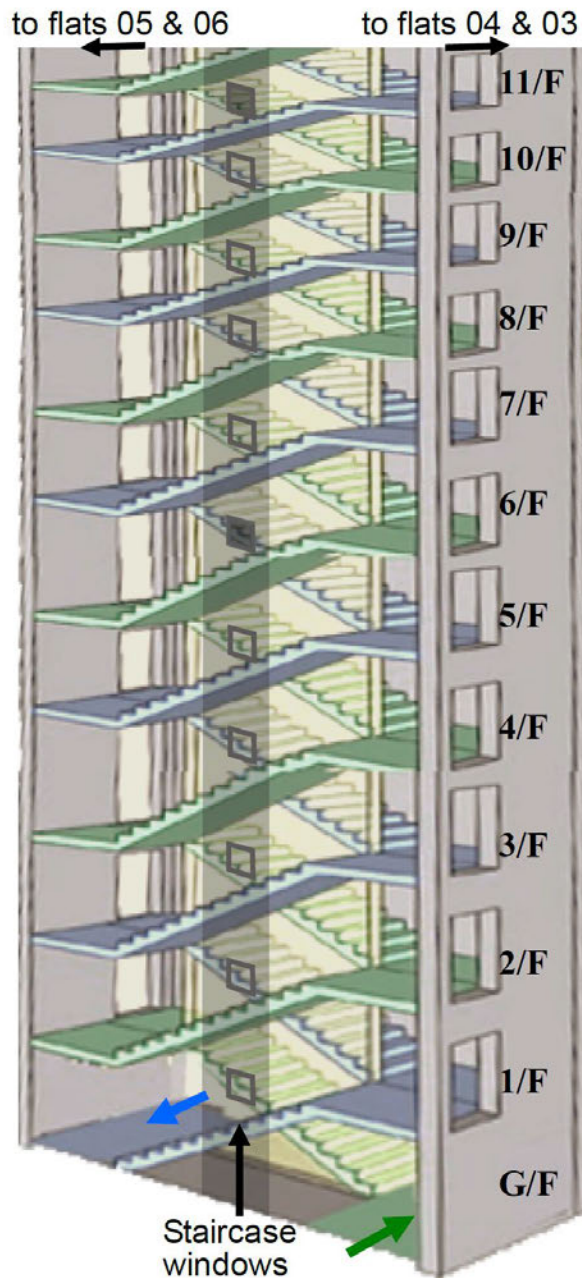
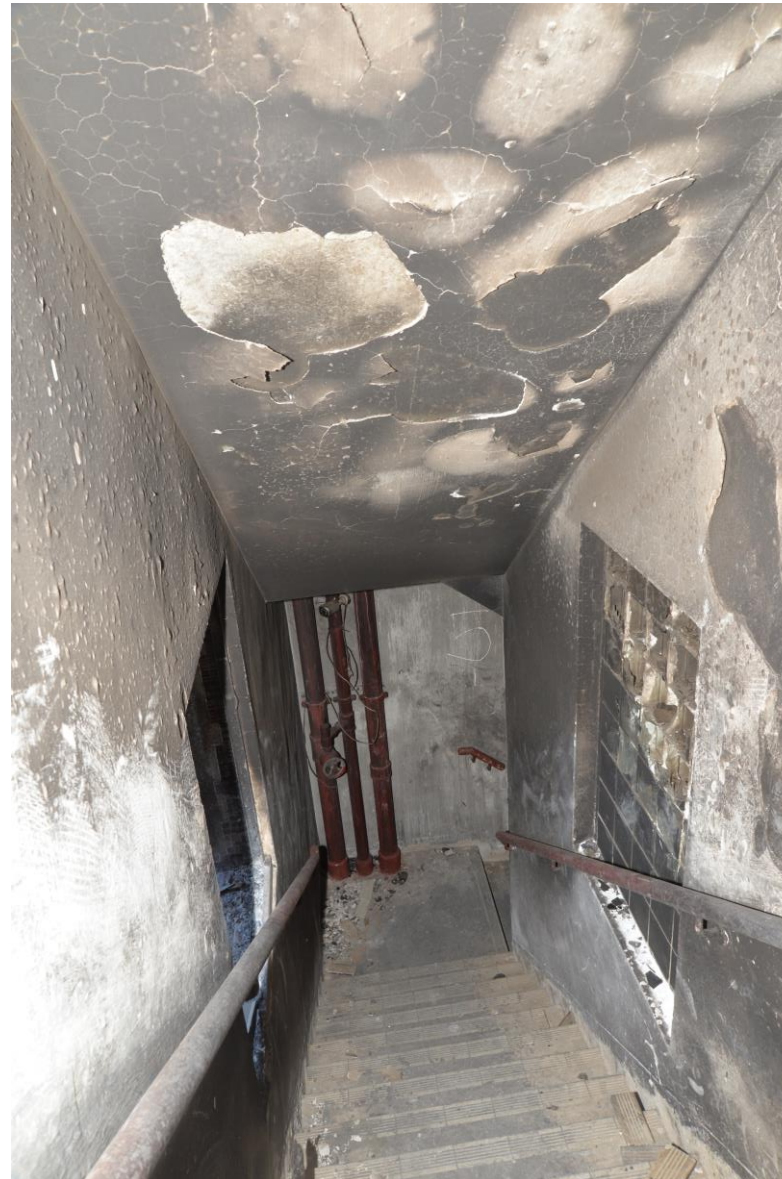
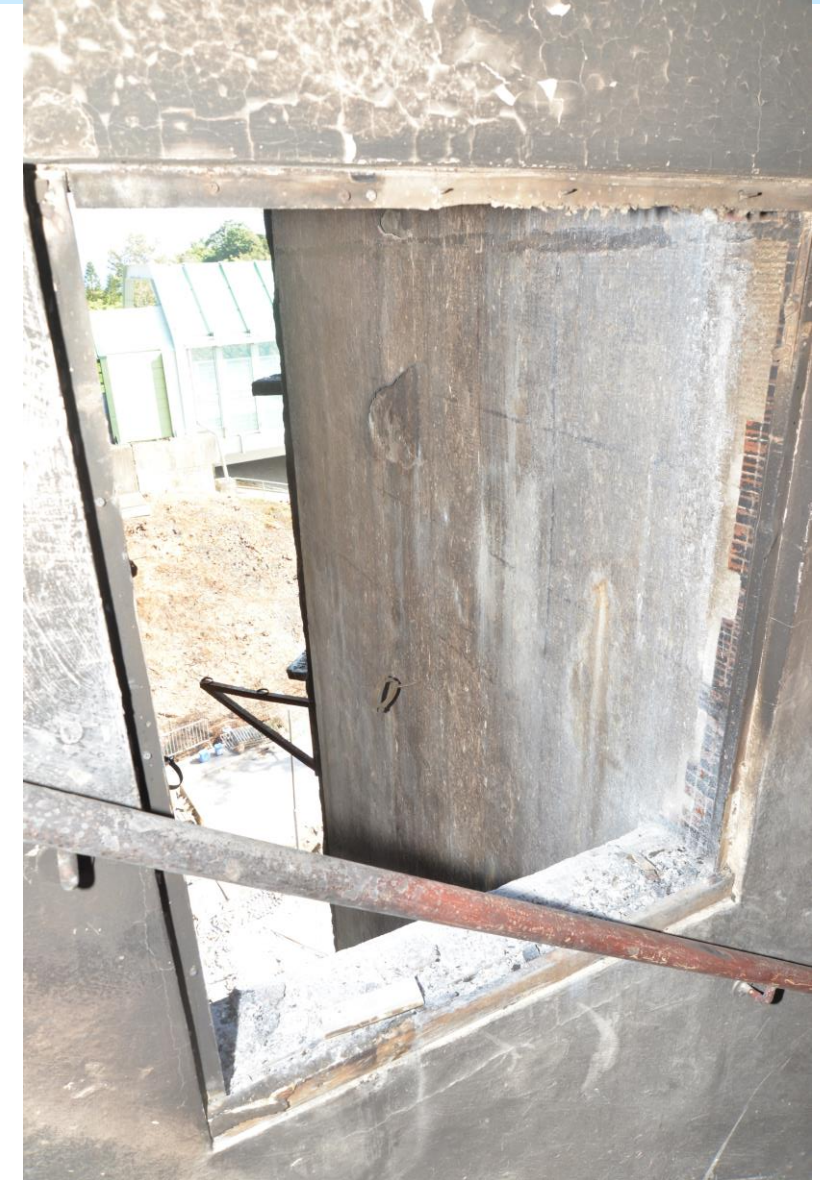
View of rear staircase from 5/F to 6/F, the window towards Light Well 4-5 had been removed leaving an intact wooden slat at the base of the opening. Severe heat damage above the opening

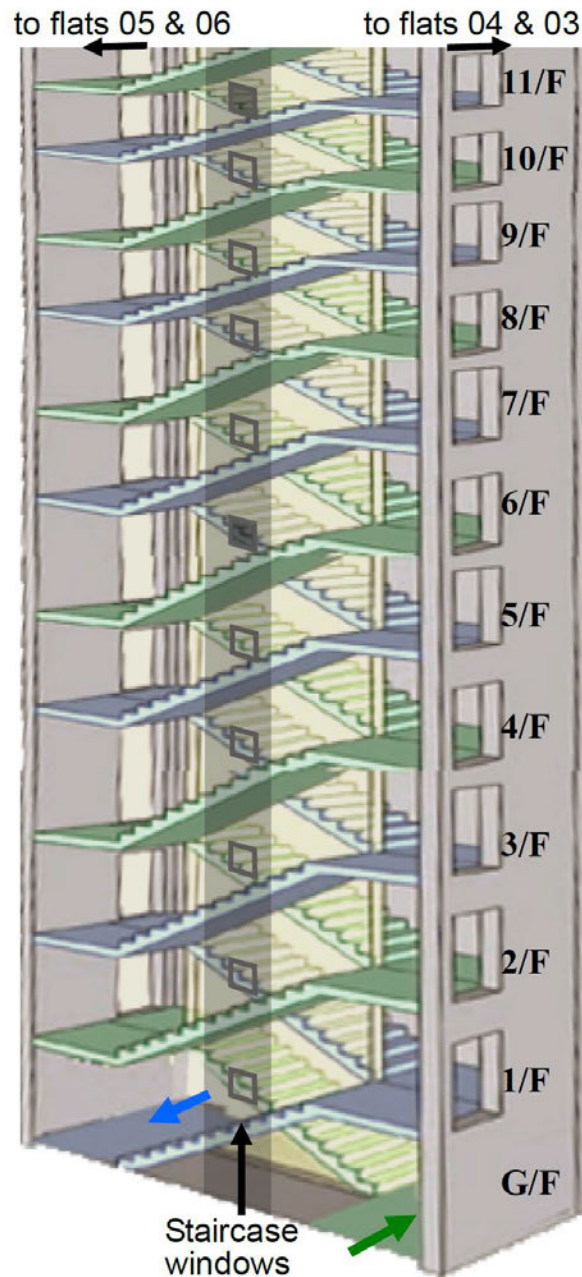
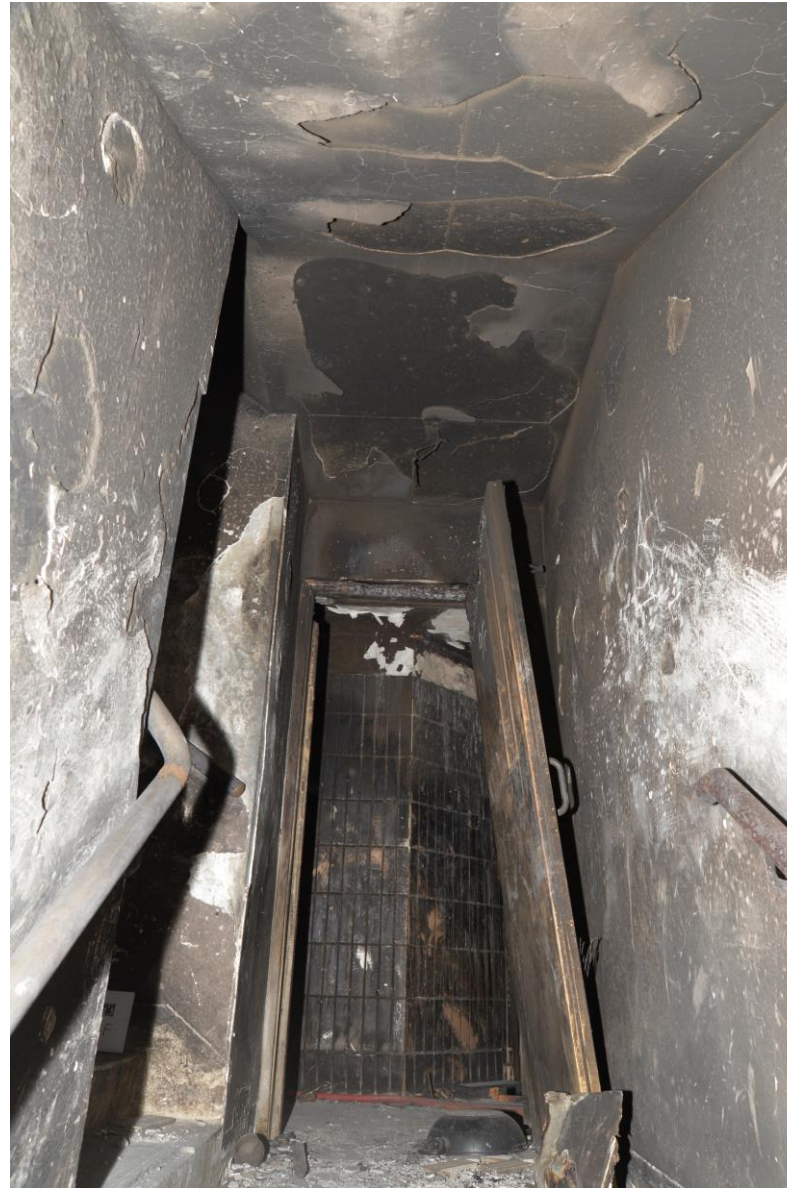
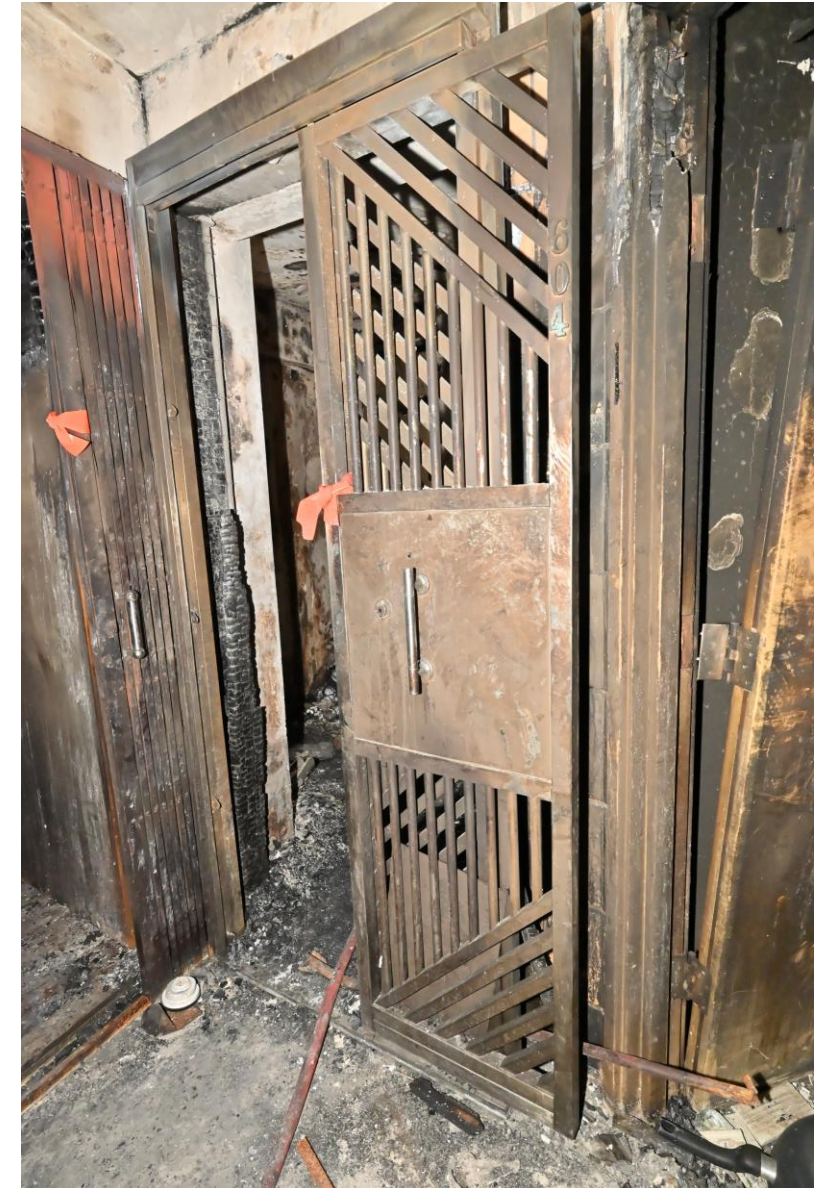
Fire door at 6/F from rear staircase to room 604, the soot deposit pattern suggested that the fire door was closed during the fire

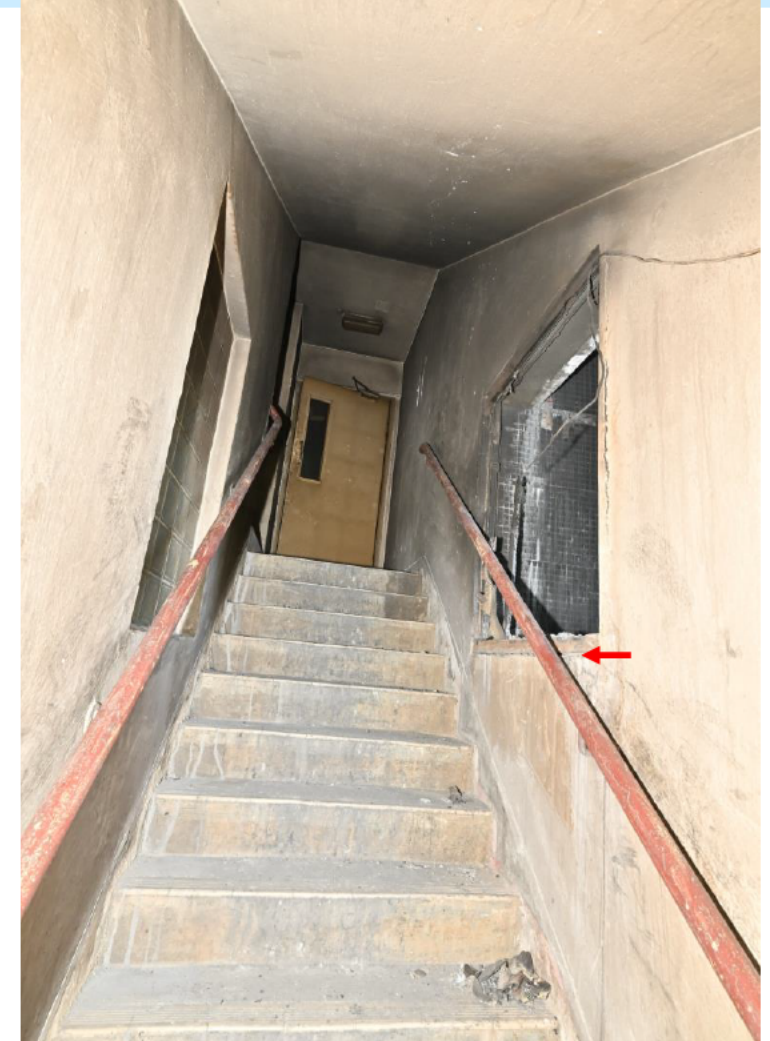
View of front staircase from 10/F to 11/F

**Photo 14d:** View of front staircase from 10/F to 11/F, the window towards Light Well 4-5 had been removed leaving an intact wooden slat at the base of the window opening together with a burnt remnant of vertical wooden slat (marked by red arrow).

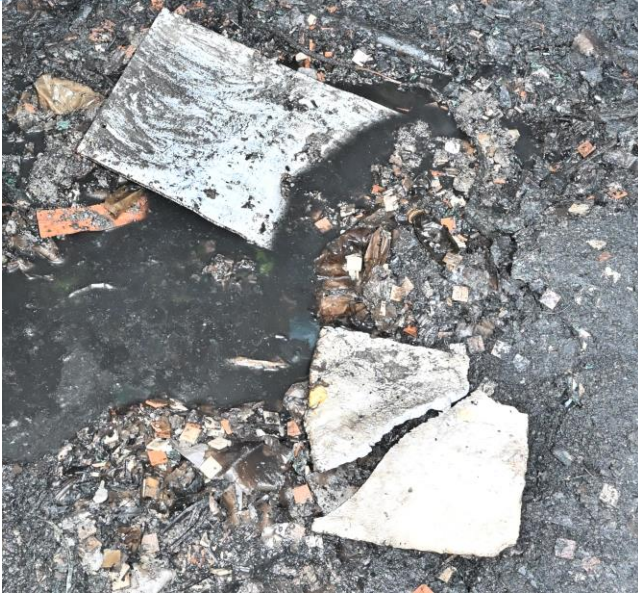
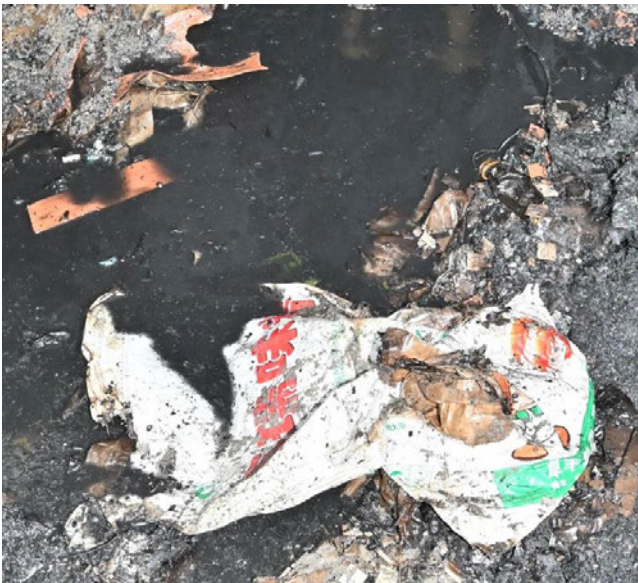
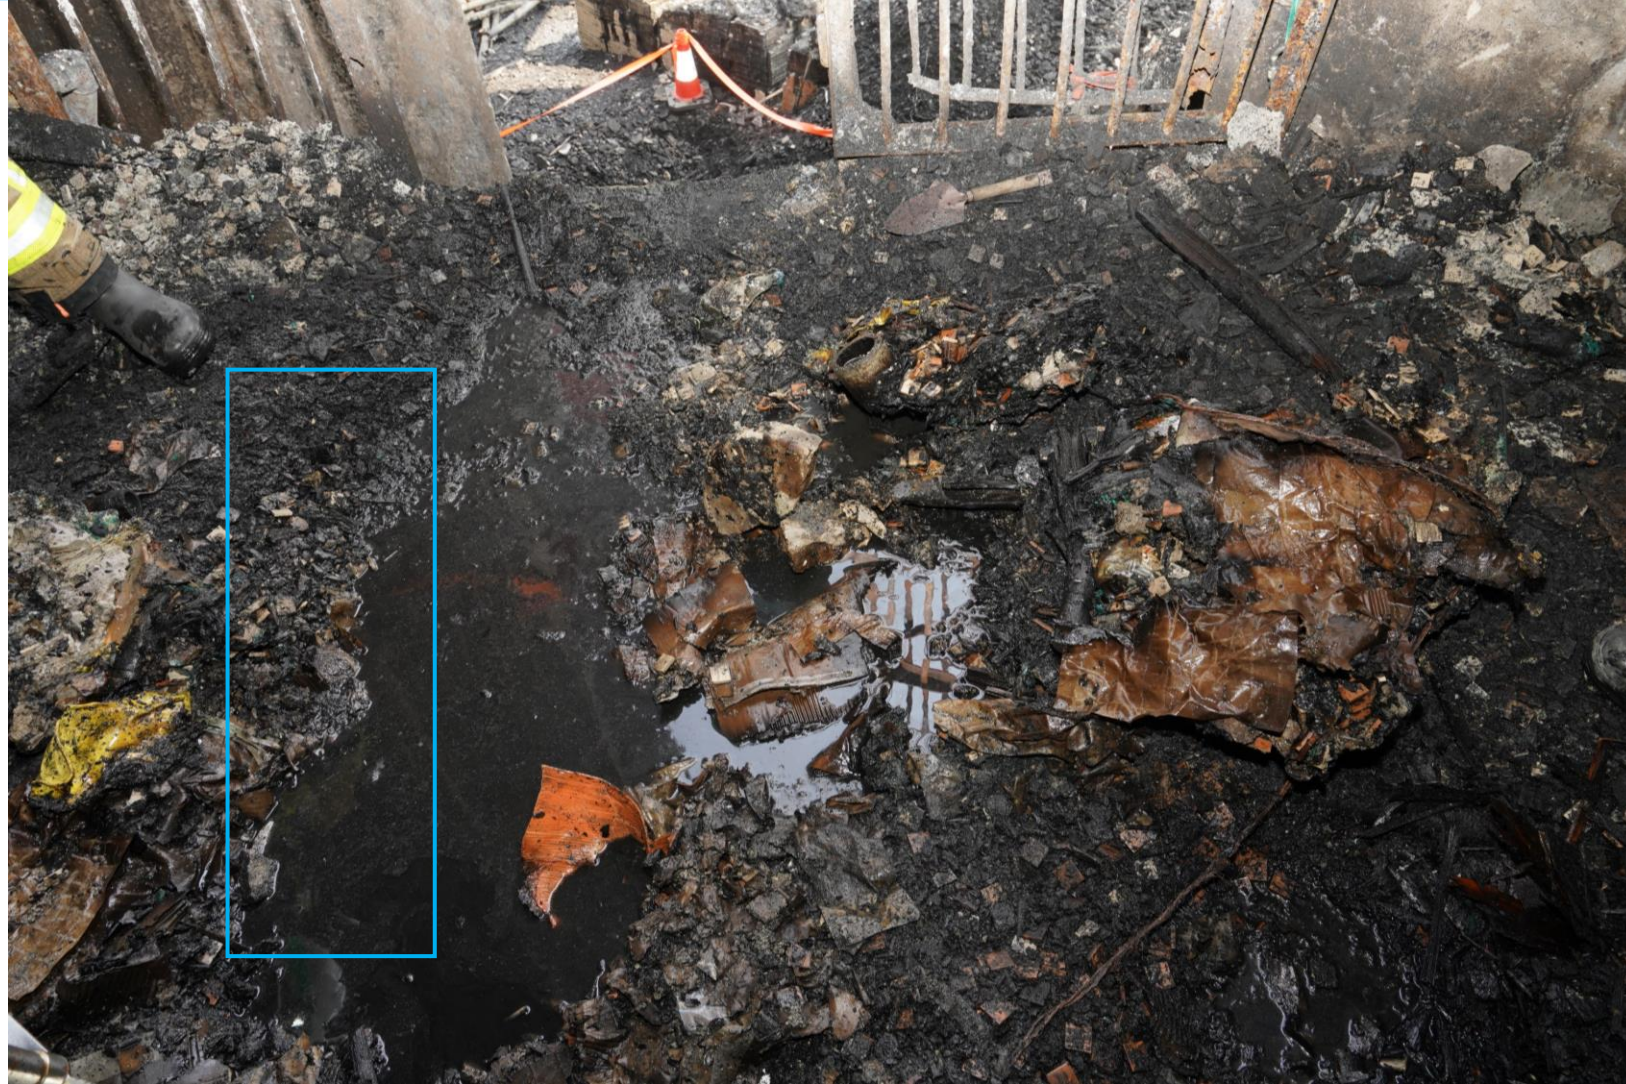
**Photo 26:** View of seat of fire toward the metal gate (substantial amount of burnt remnants of carton paper boxes, found in the area next to the metal fence near Flat 105). Foam board fragments and a corrugated plastic board (**A**) and a woven plastic bag of backing papers (**B**) were recovered in the middle area as marked in the blue rectangle

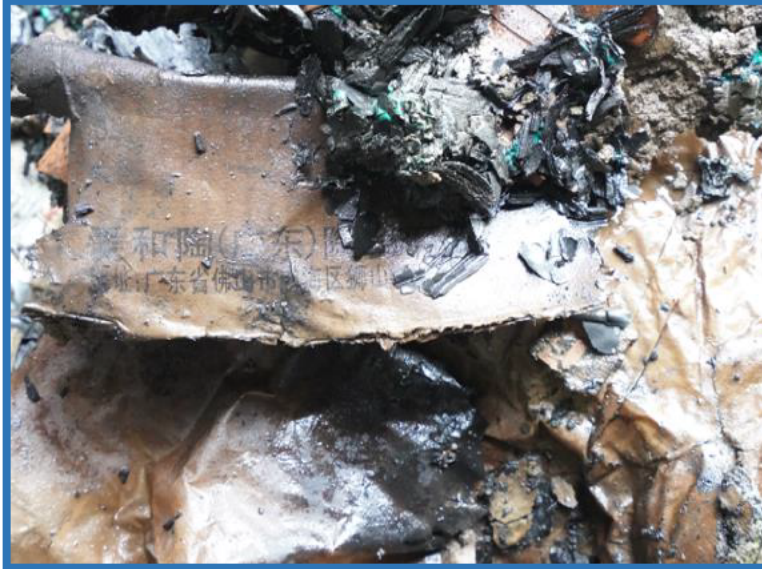
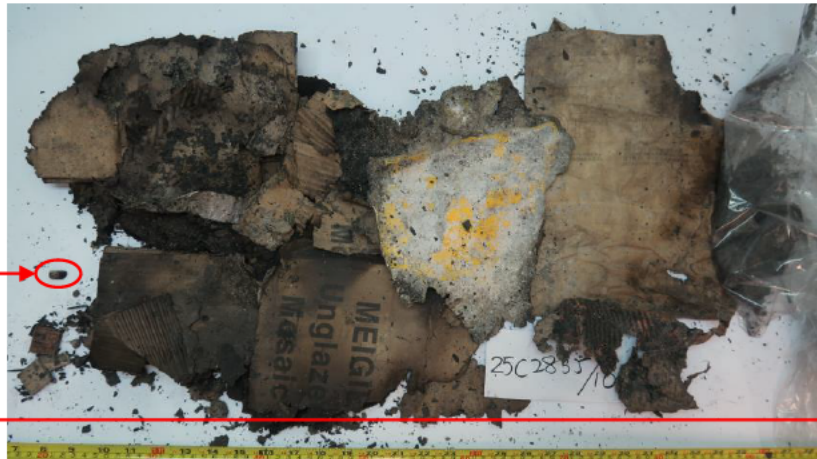
burnt remnant of cigarette end
