**GOVERNMENT LABORATORY**  
Forensic Science Division

Fire Investigation  
No. 5 Alarm Fire at Wang Fuk Court

- 1 Cause of Fire
- 2 Examination of Temporary Protective Materials found at the Scene  
(comparison of burning behavior of different materials upon exposure of a small flame source)

# Cause of Fire

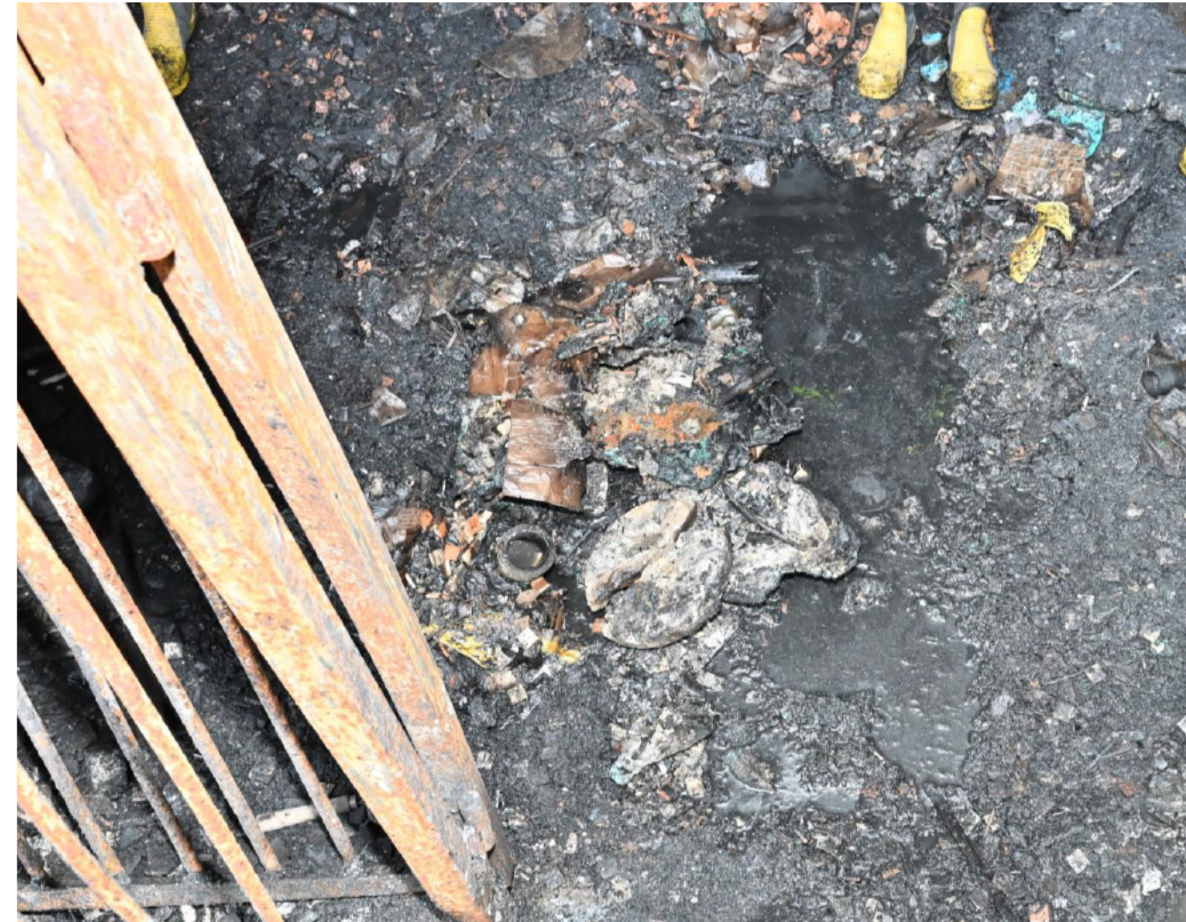
View of seat of fire from the metal gate

Nothing of significance was found with respect to recovery of ignitable liquid residues from all debris samples seized from the seat of fire

Item 25C2835/10 (WC5) was found comprised mainly burnt remnants of carton papers of the mosaic tiles boxes with a few pieces of backing papers. A piece of plastic board remnant fused with carton papers, burnt remnant of suspected orange toe-board and a burnt remnant of cigarette end were also found mingled with these carton papers.

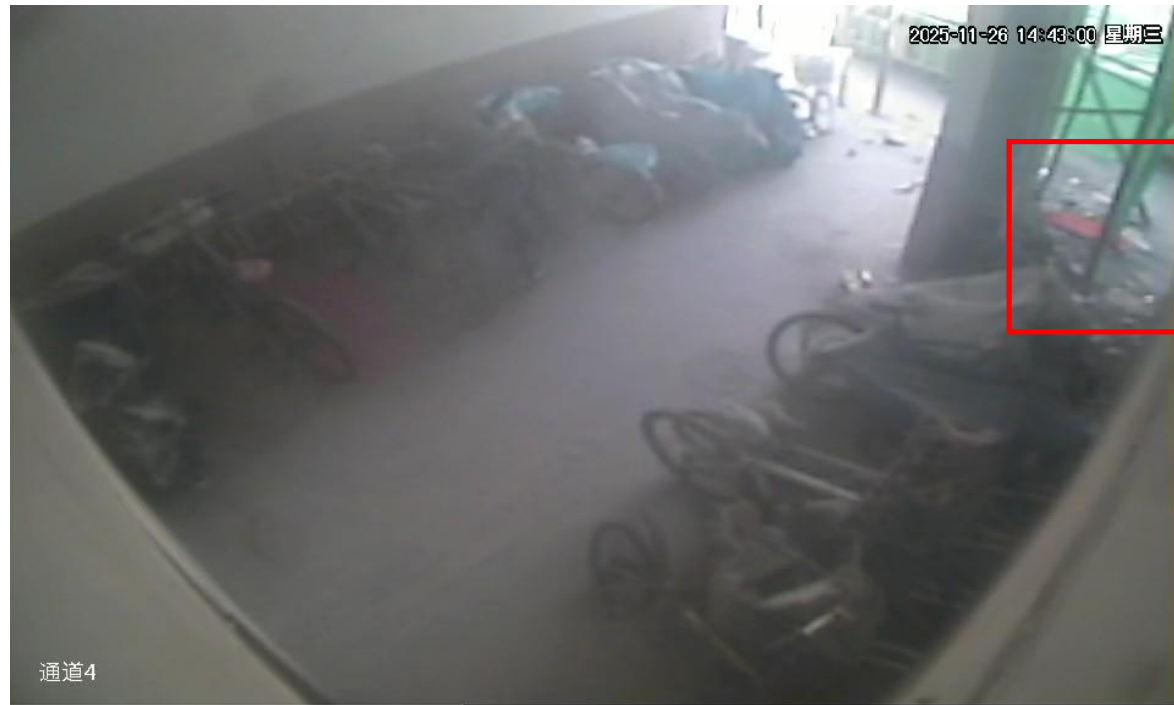
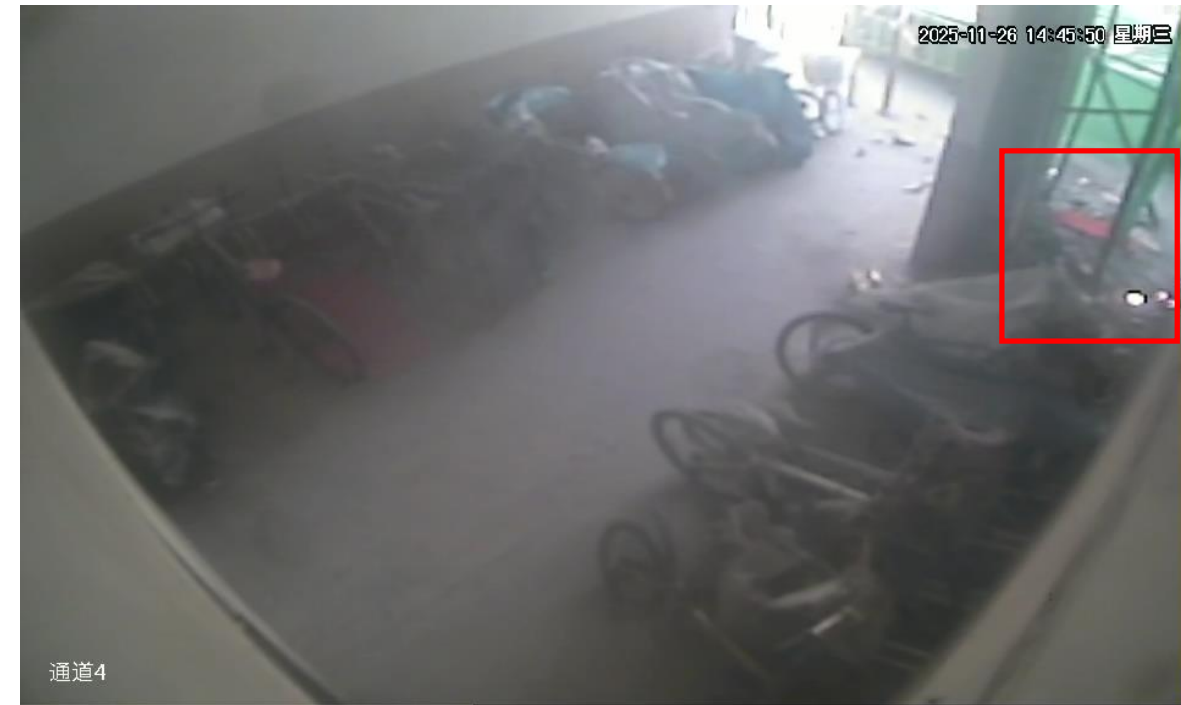
**View V1a to V1b:** small light-tone objects, resembling lighted materials, were continuously dripping from the top of the view onto the floor as highlighted in the red box in the period

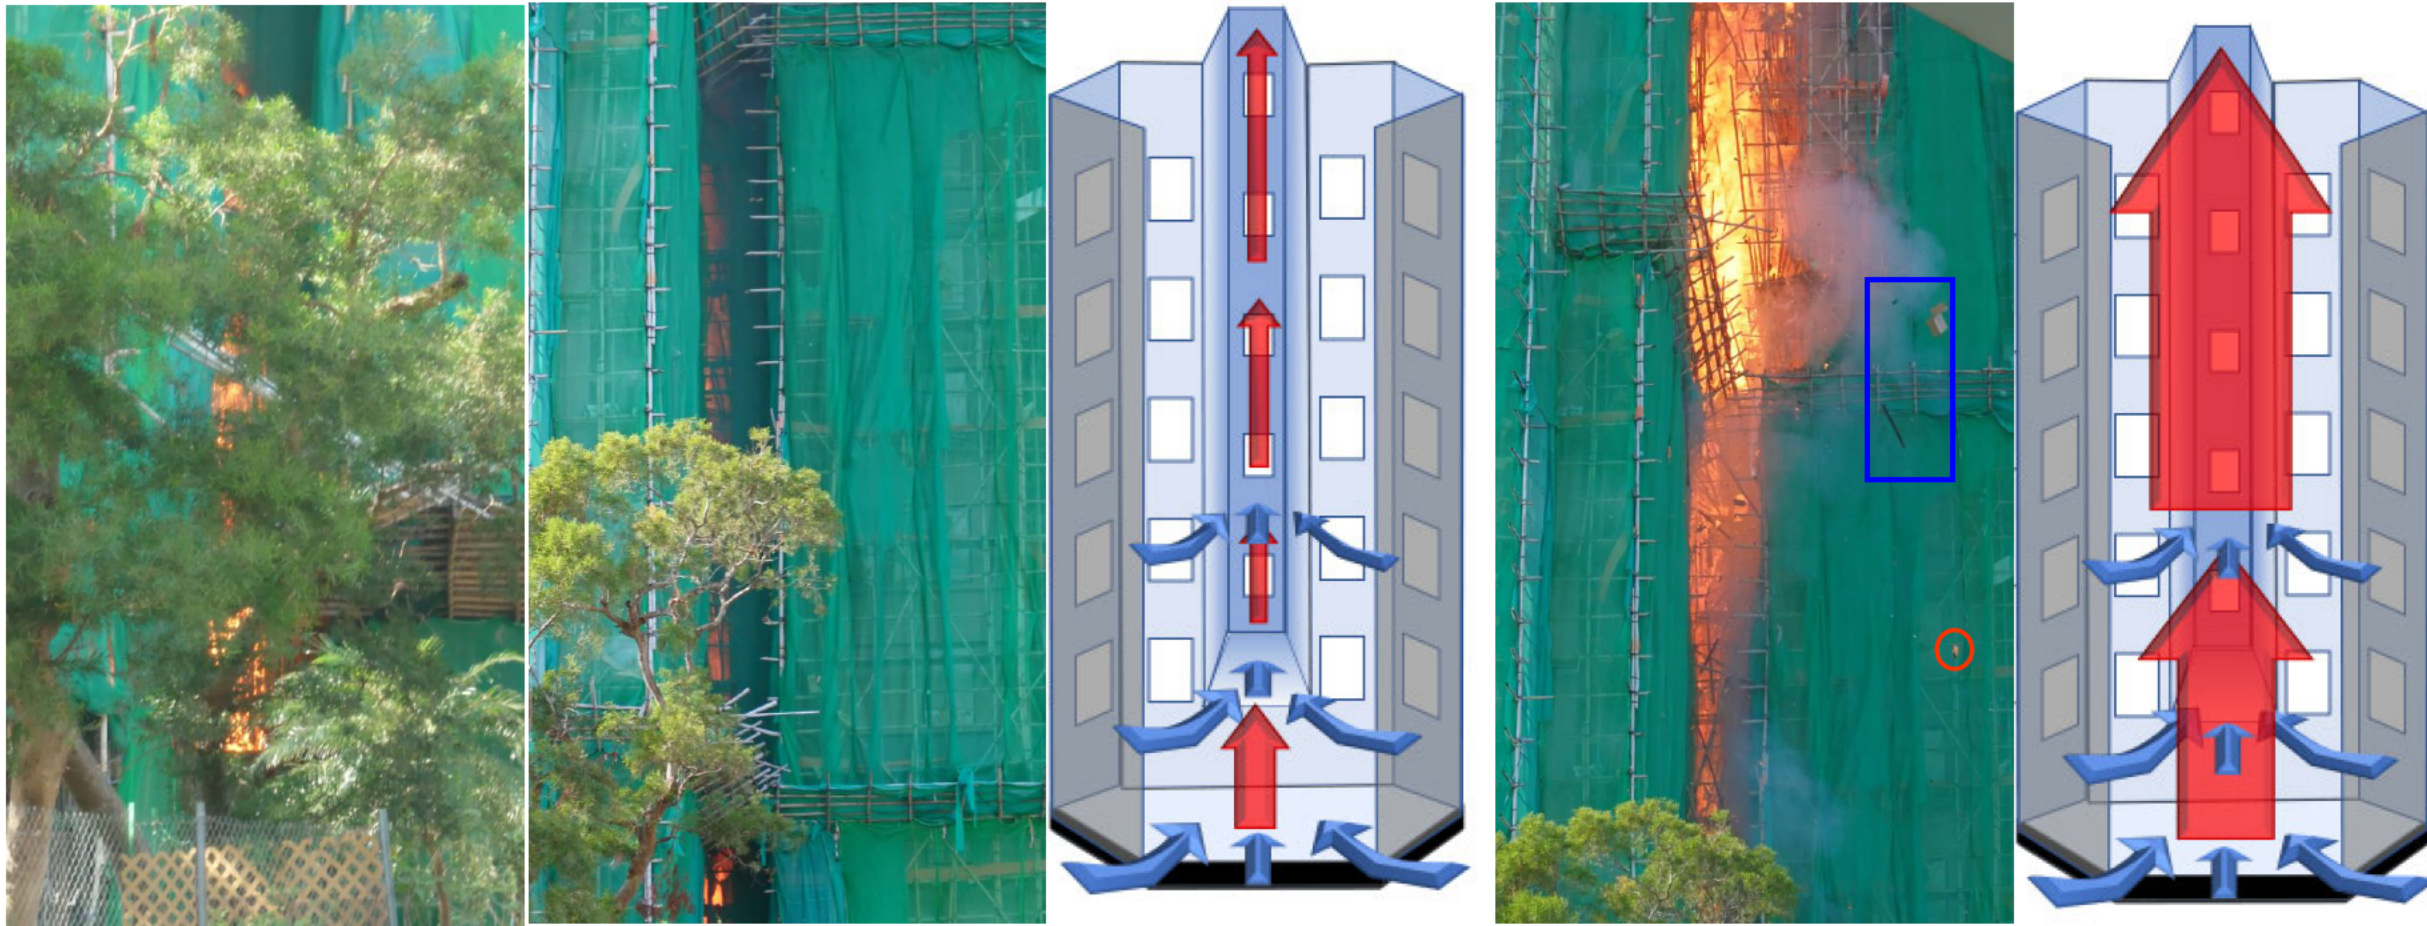
**View V4a-V4c:** The fire propagated upward abruptly inside the narrow vertical gap between the kitchens of flats 04 and flats 05. At the later stage of the video, the fire burnt fiercely in the light well, and objects appeared to be bamboo member dropped from height and a paper box dropped comparatively slower (as marked in blue square), whereas suspected burning object (as marked in red circle) was lifted by the upward draught of the fire from the area near light well and then descending gradually.

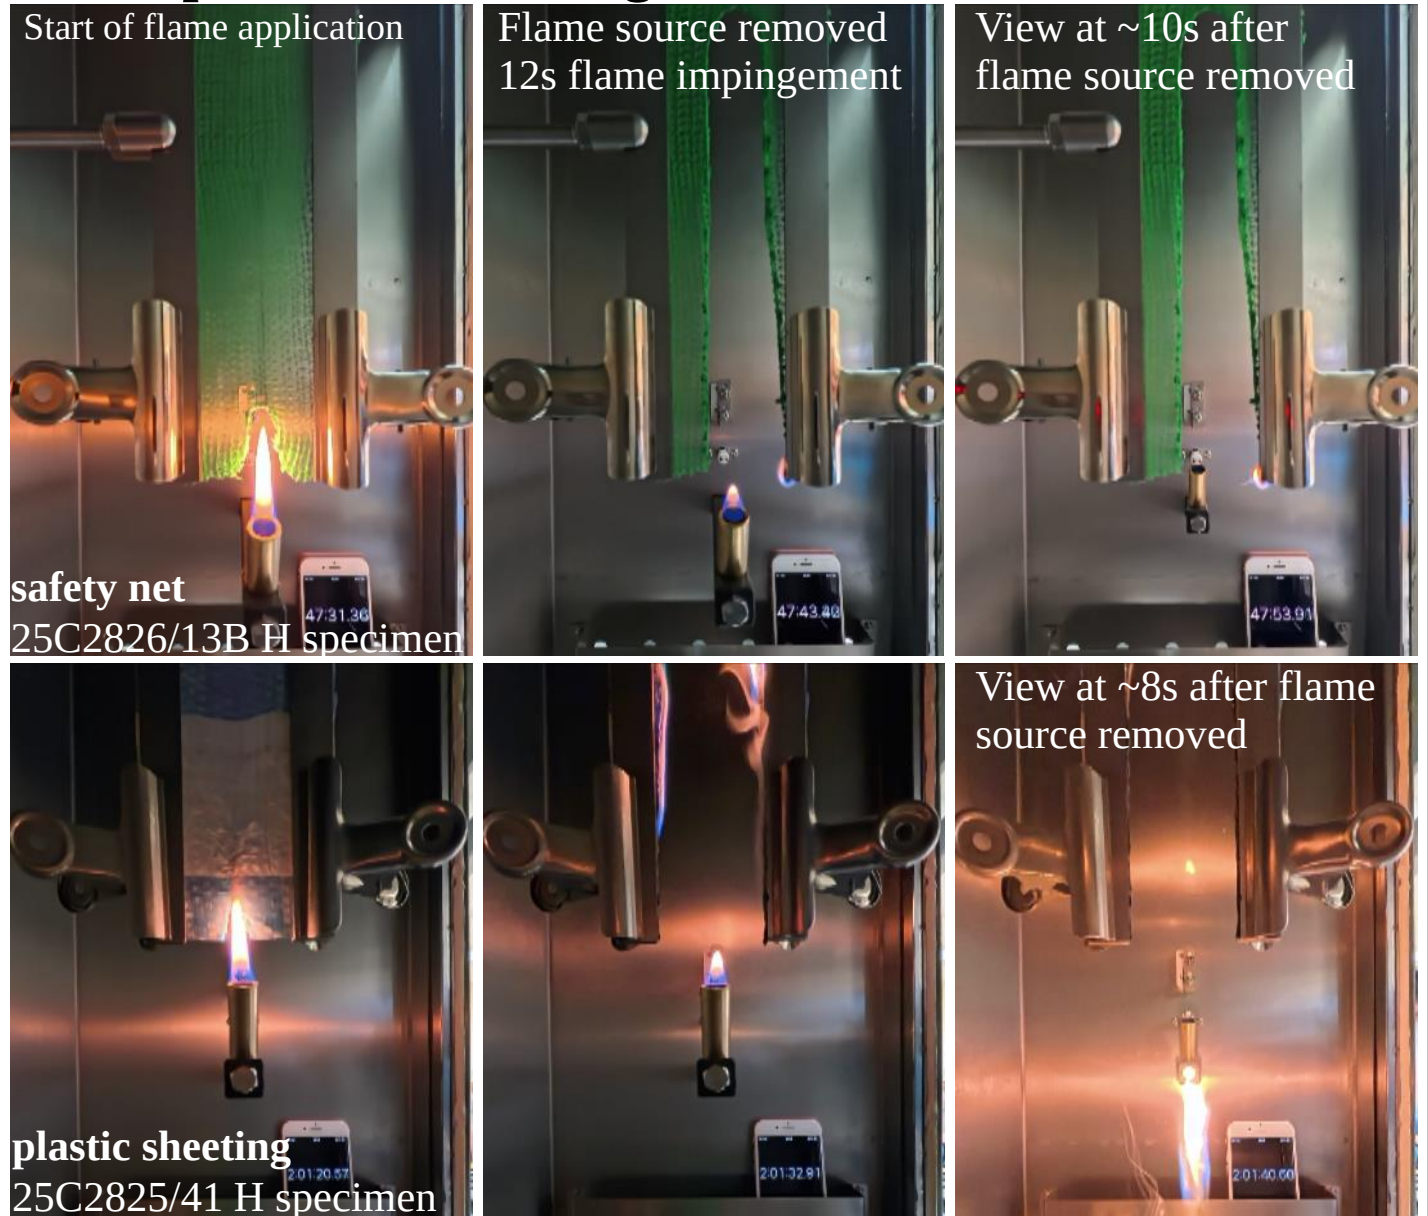
PS seized from the scene is more susceptible to sustained burning upon impingement of a flame as compared with the safety nets

All are combustibles

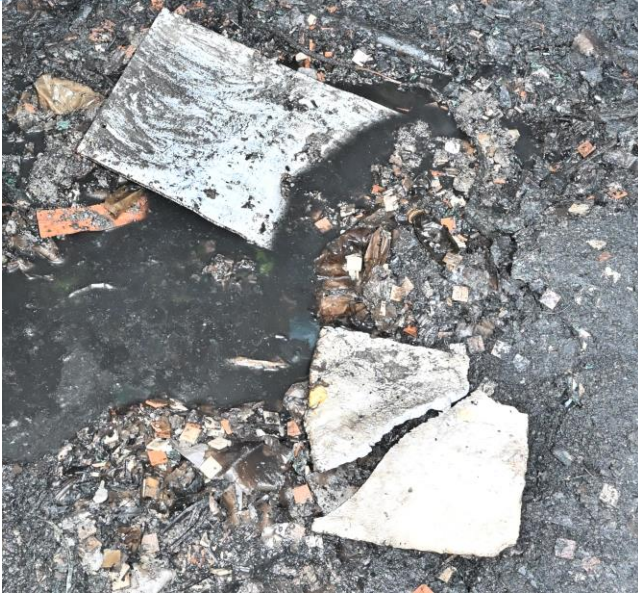
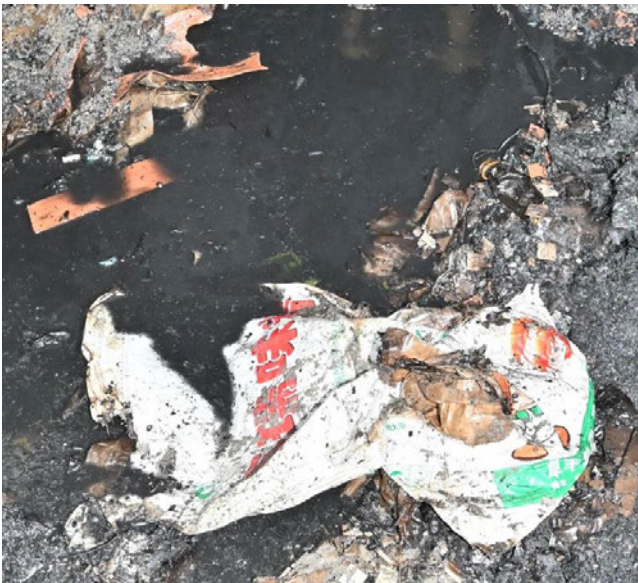
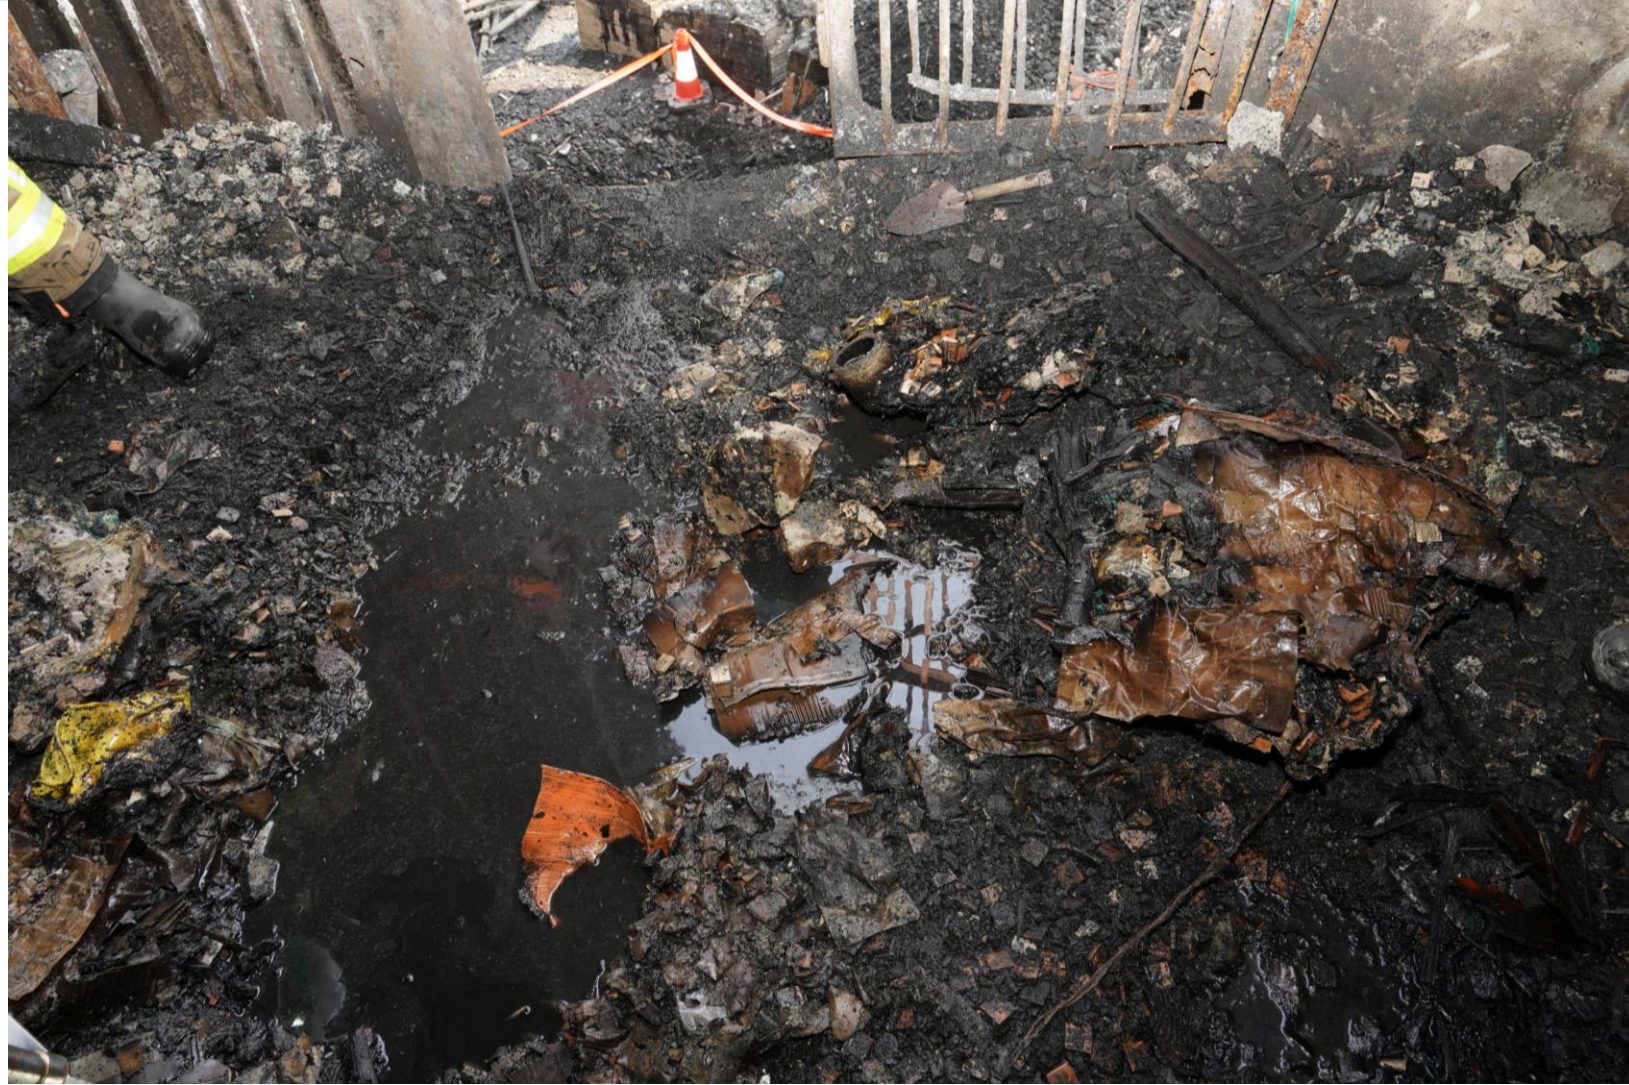
**Photo 26:** View of seat of fire toward the metal gate (substantial amount of burnt remnants of carton paper boxes, found in the area next to the metal fence near Flat 105). Foam board fragments and a corrugated plastic board (A) and a woven plastic bag of backing papers (B) were recovered in the middle area as marked in the blue rectangle
