# **Independent Committee in relation to the fire at Wang Fuk Court in Tai Po**

## **Experts' Presentation**

**(Fire Engineering Experts for the Independent Committee)**

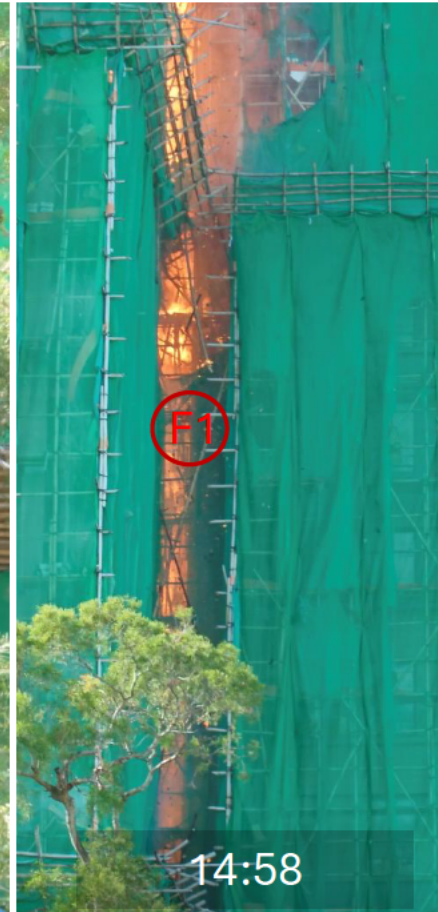
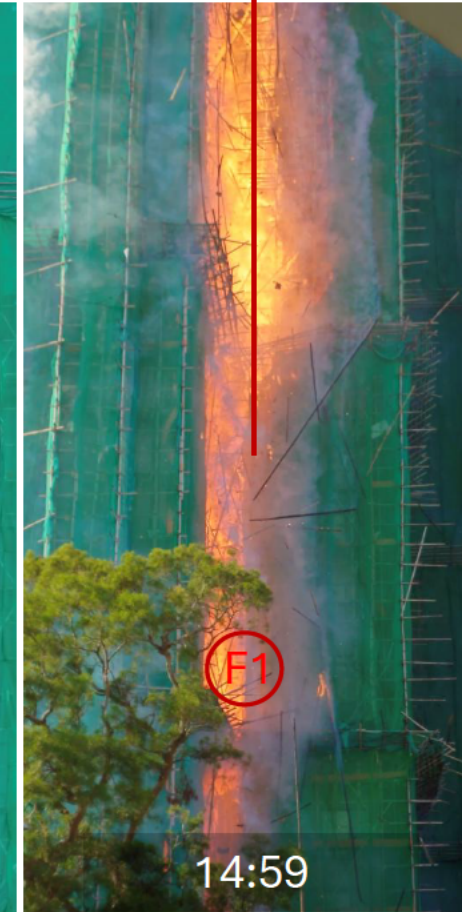
1<sup>st</sup> fast-spreading re-entrant  
fire of Block F

Observed Origin of fire

Fast Development of re-entrant fire F1

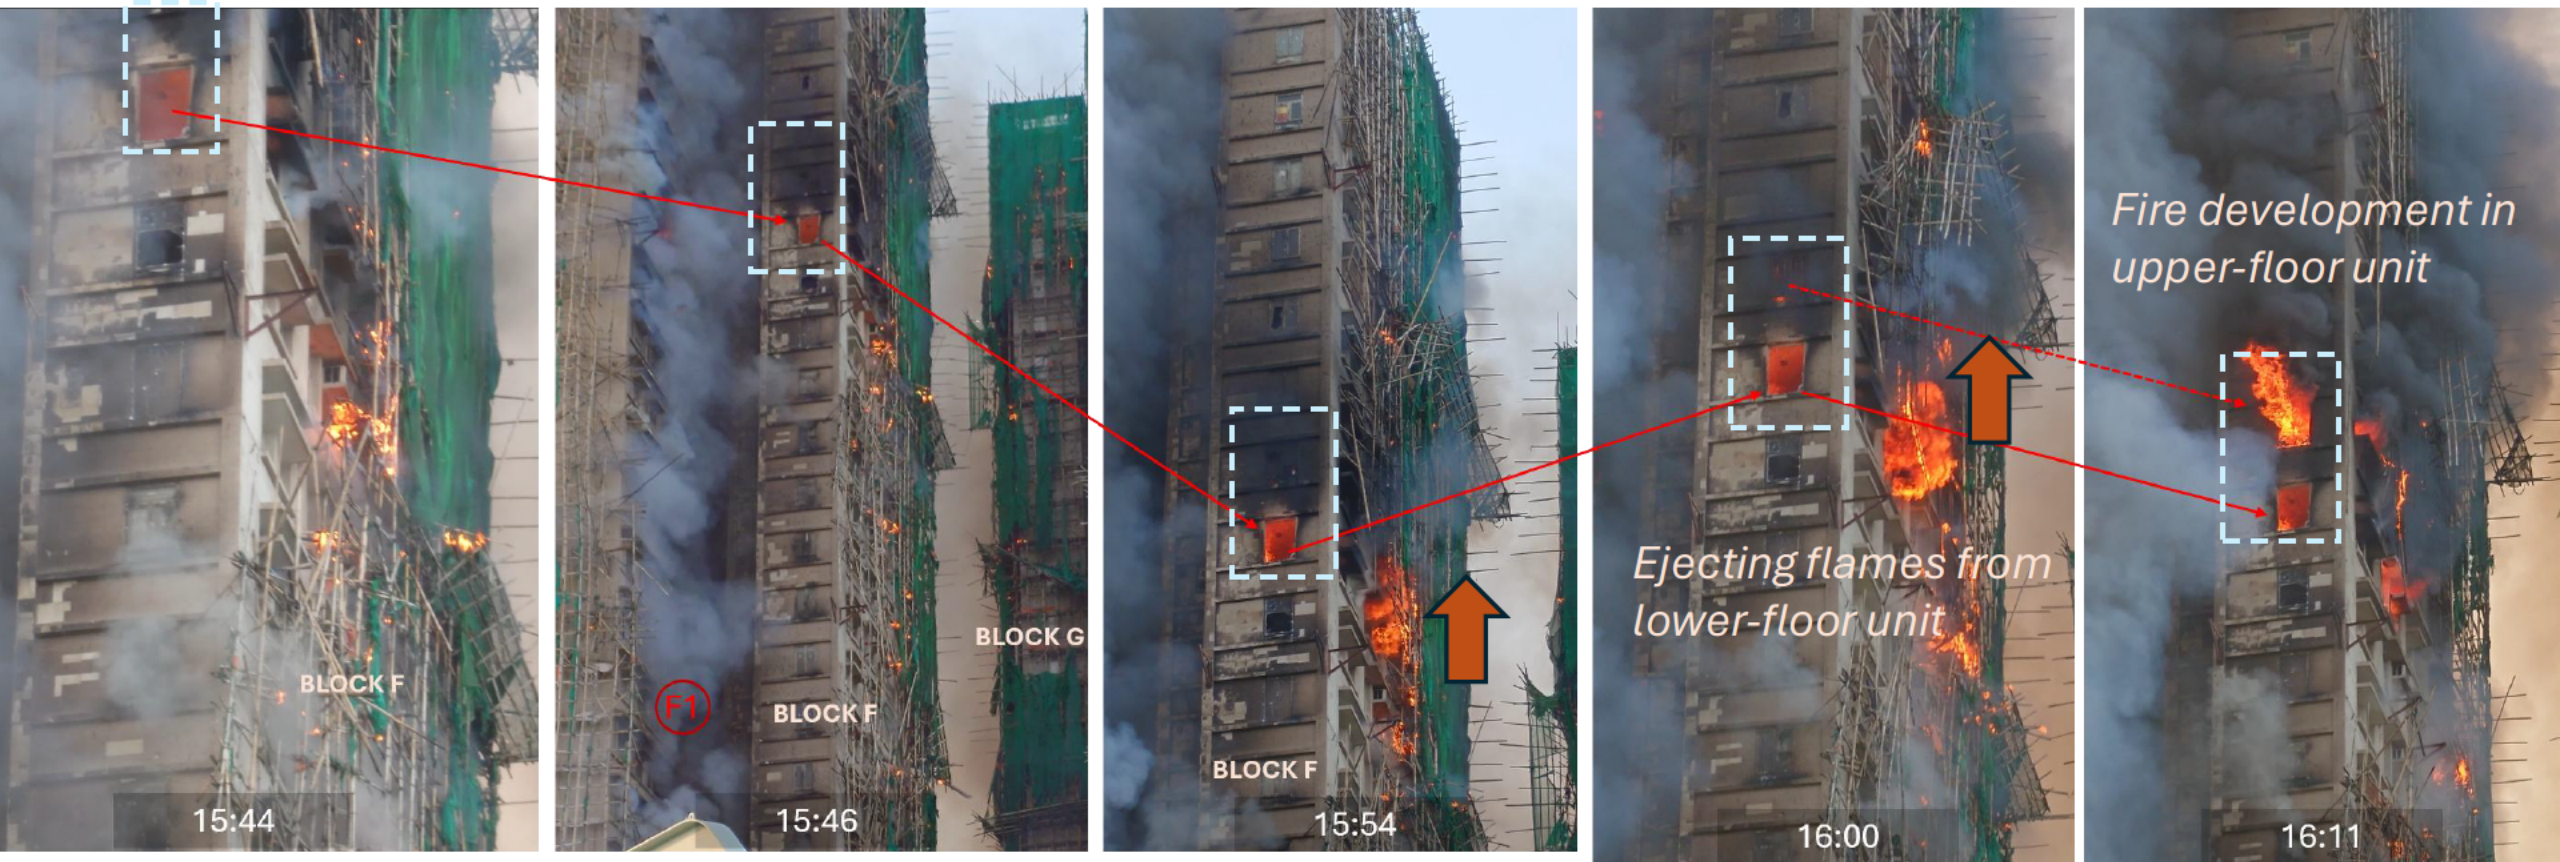
**Vertical Spread: Burning of remaining façade scaffoldings leading to vertical fire spread**

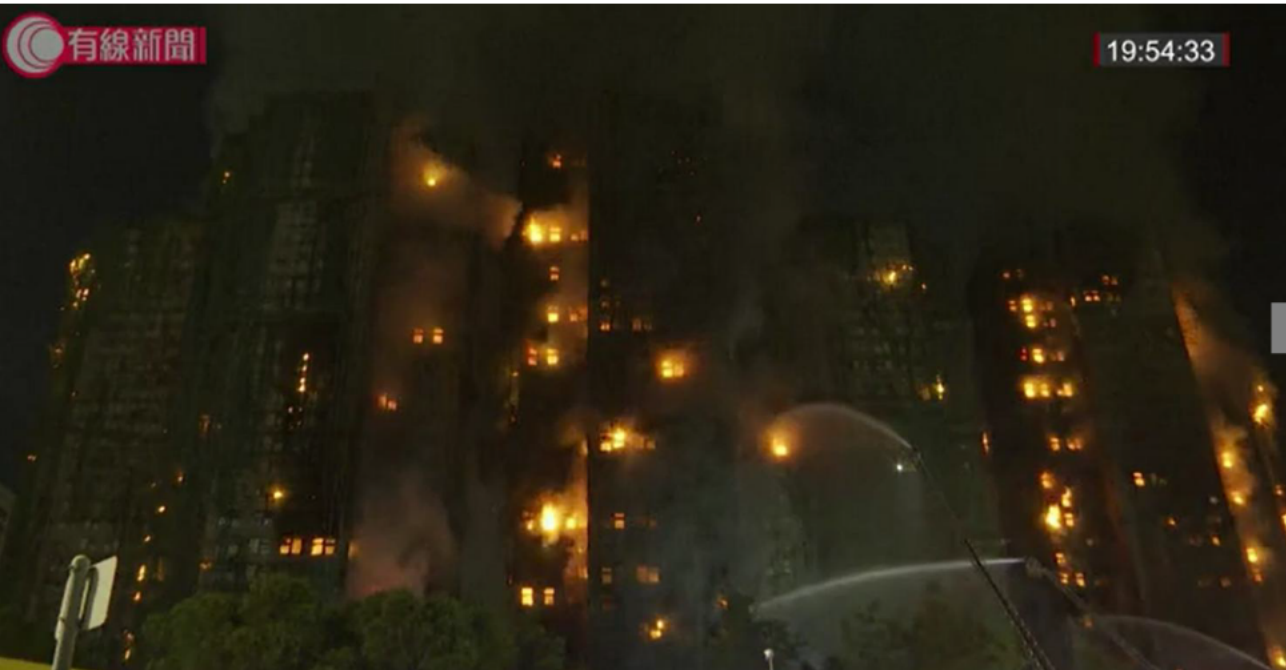
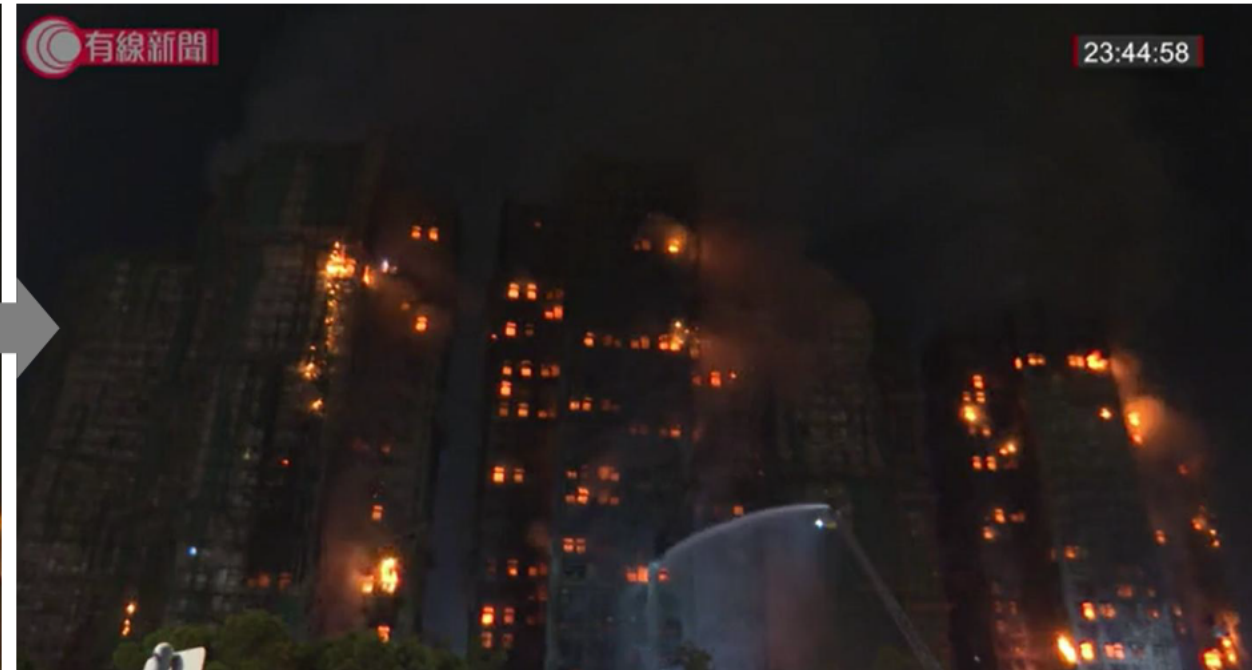
- Multi-point ignition of room units through broken windows
- Subsequent façade fire spread to non-ignited units
- Subsequent internal fire spread through front doors
- Continuous fire development and internal & external spread from units to units
- Buildings with multi-point room fires prevent effective firefighting operation

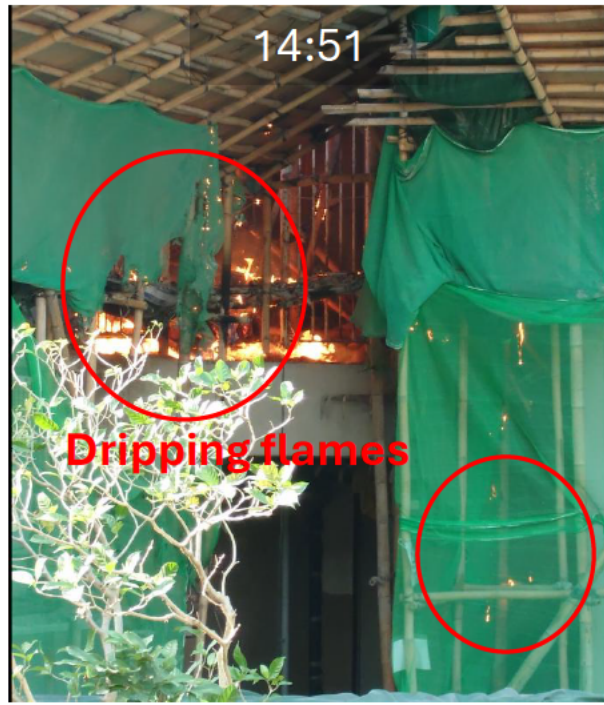
- Flames at building façade are likely the burning of safety net
- The burning of safety net was caused by unknown fire source at the flat roof area of F1
- The burning of safety net of other buildings could be caused by flying ember, flaming debris

Initiation of fire at flat roof

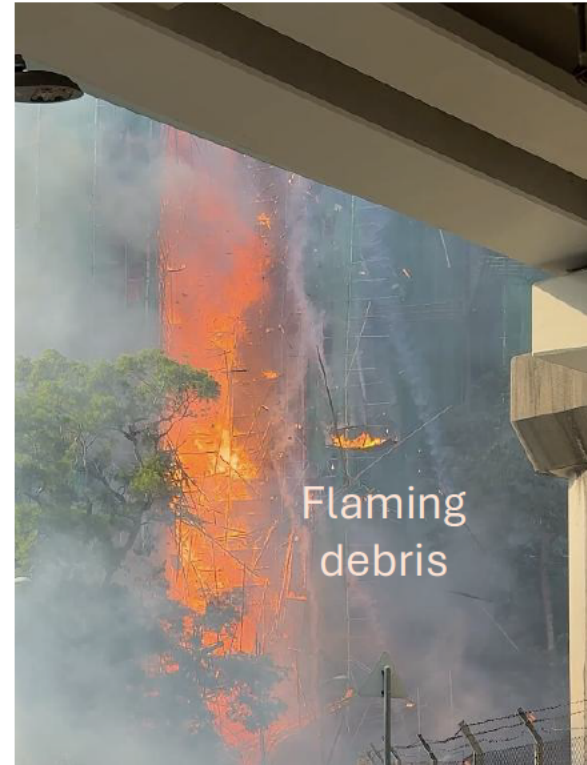
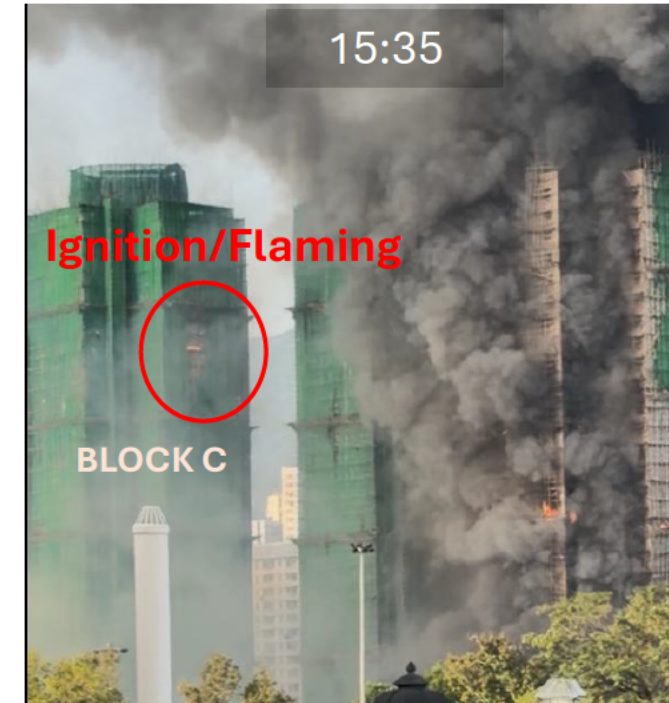
A large localised fire  
To trigger re-entrant  
fire

Ignition of adjacent building  
scaffolding

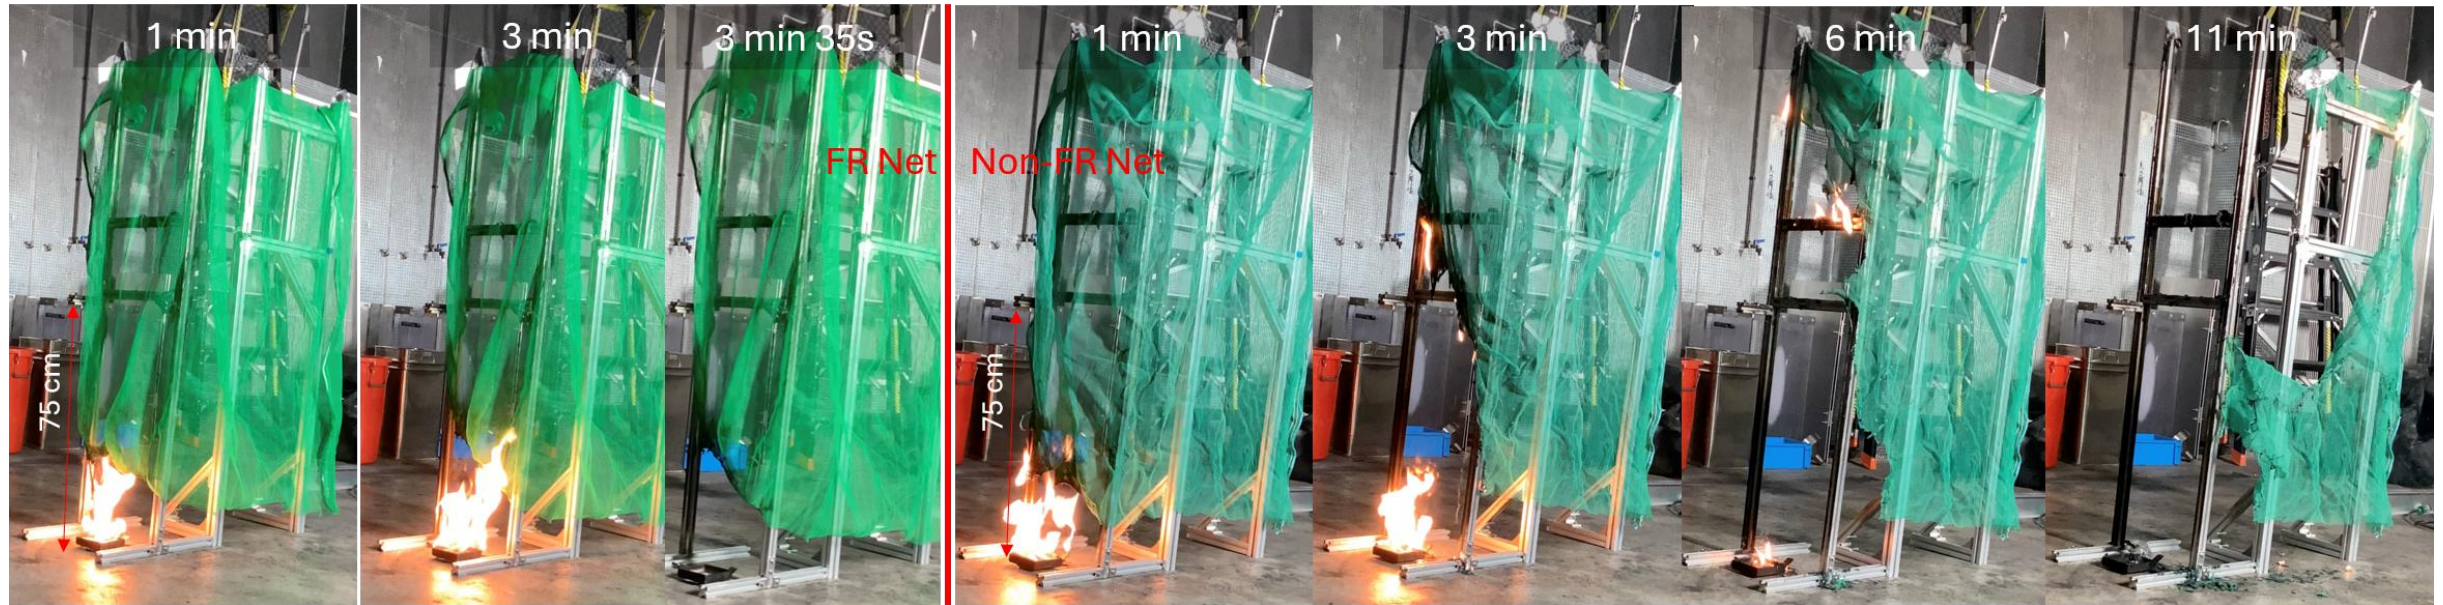
- Both samples in Test B1 and Test B2 were burnt using a 90 kw propane pool fire
- Safety net sample in **Test B1**: Collected from Block D(ground level); Safety net in **Test B2**: Collected from Block H
- FR behaviour shown in **Test B1**: Melting and shrinking when being heated; no flames sustained after the exhausting of pool fire.
- Non-FR behaviour shown in **Test B2**: Fast melting and shrinking; flames sustained and propagated'

Test B1 on safety net sample of fire-retardant (FR) behaviour

Test B2 on safety net sample of non-FR behaviour

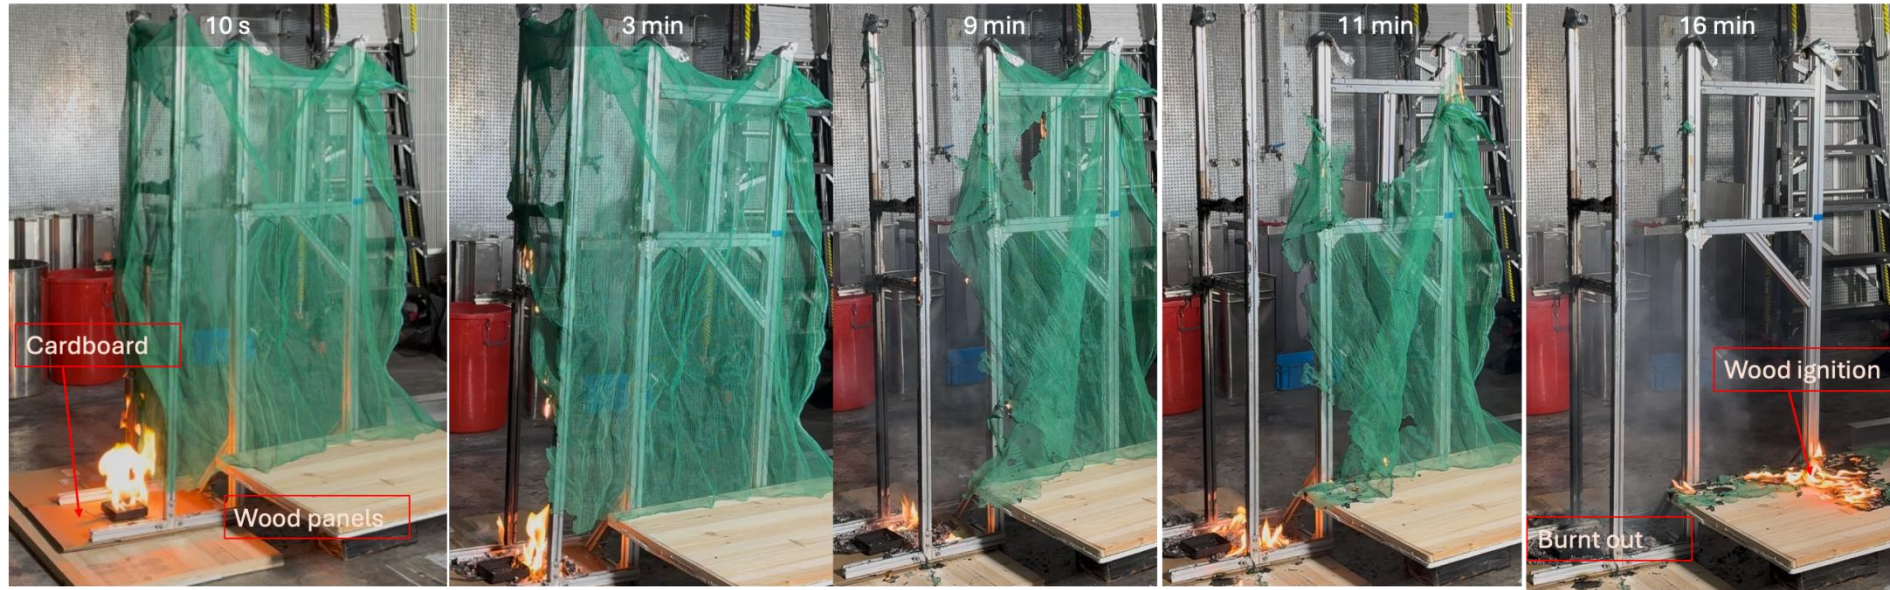
**Test D1** on safety net sample with cardboard and wood panel at

**Test D1:** cardboard and wood panels are ignited by dripping safety net, causing sustained flames for 16 minutes until being manually extinguished

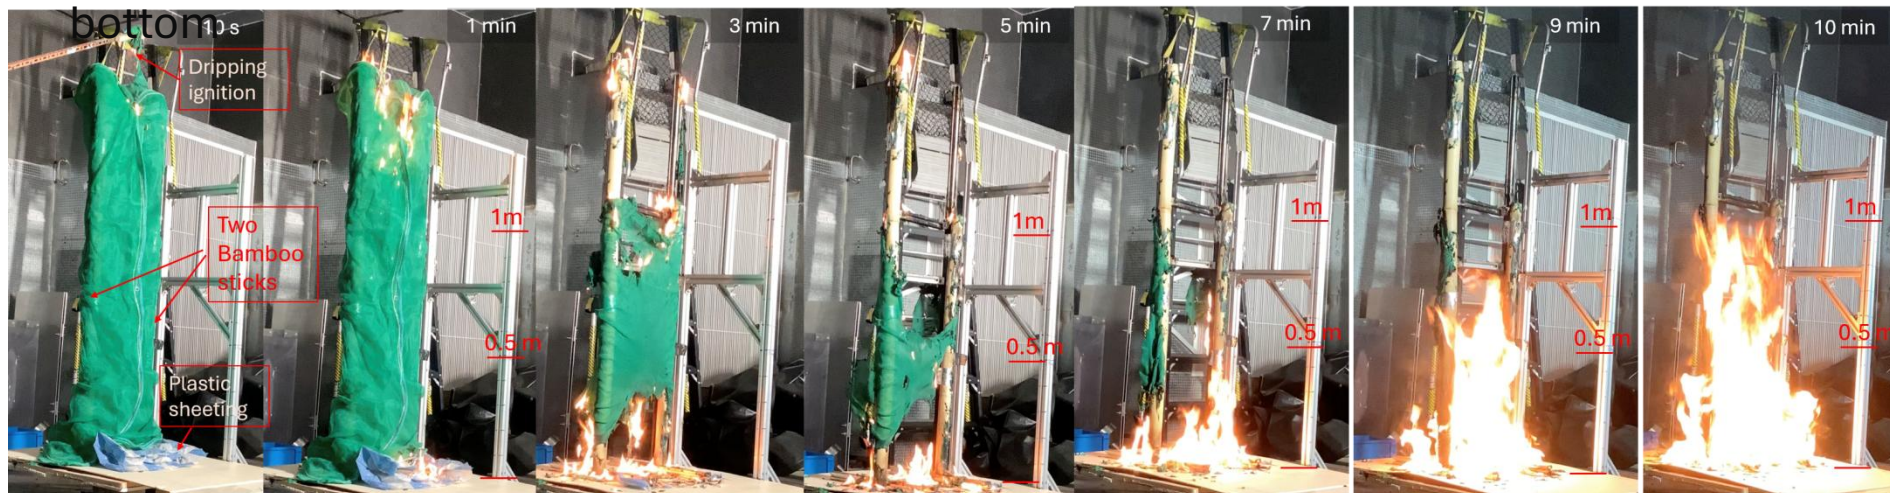
**Test D2** considering increased safety net and joint burning

**Test D2:** Continuous dripping of safety net caused the burning of canvas, bamboo, and wood board.

**A localised fire** of 1m flame height is formed.

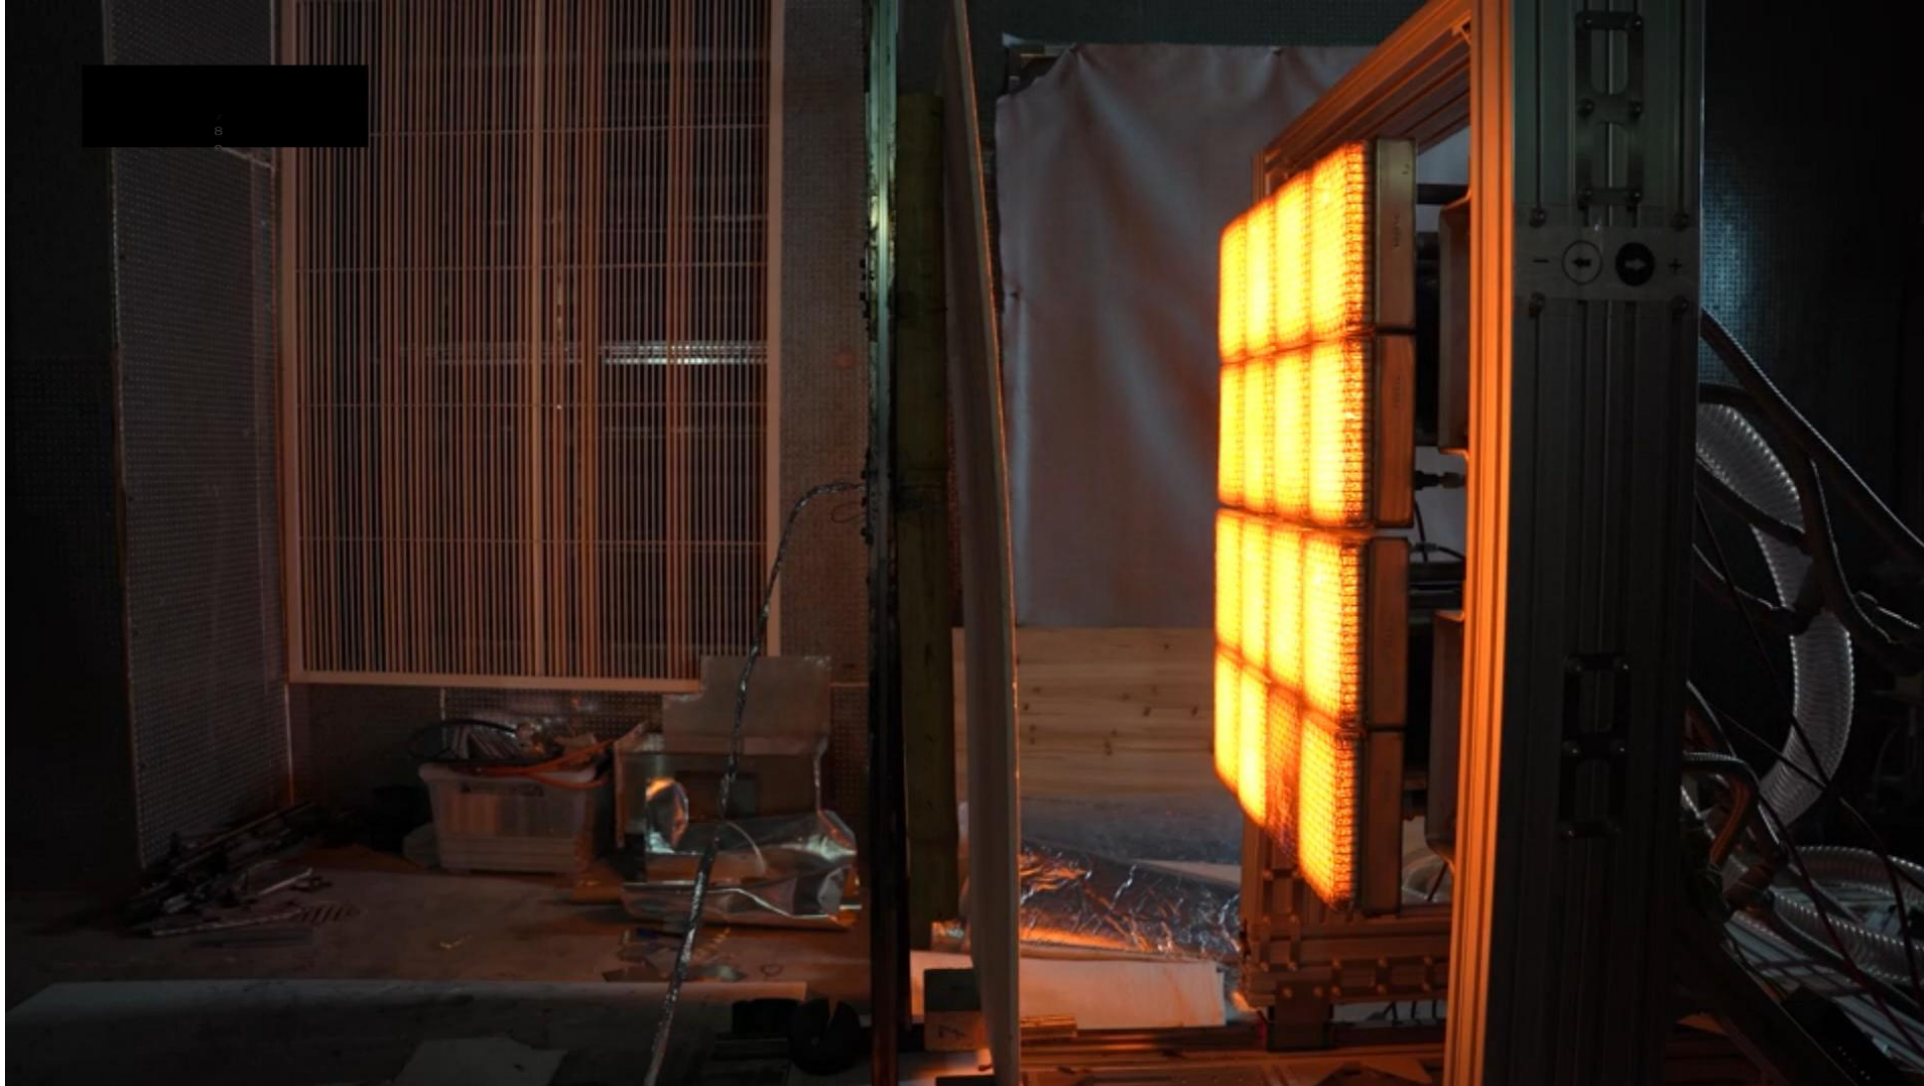
## Demonstration Test E1

- **Rapid Pyrolysis and burning** of bamboo in heating conditions approximating re-entrant fire
- Using high-intensity radiant panel testing system at PolyU
- Surrounding temperature: approx. 1000°C

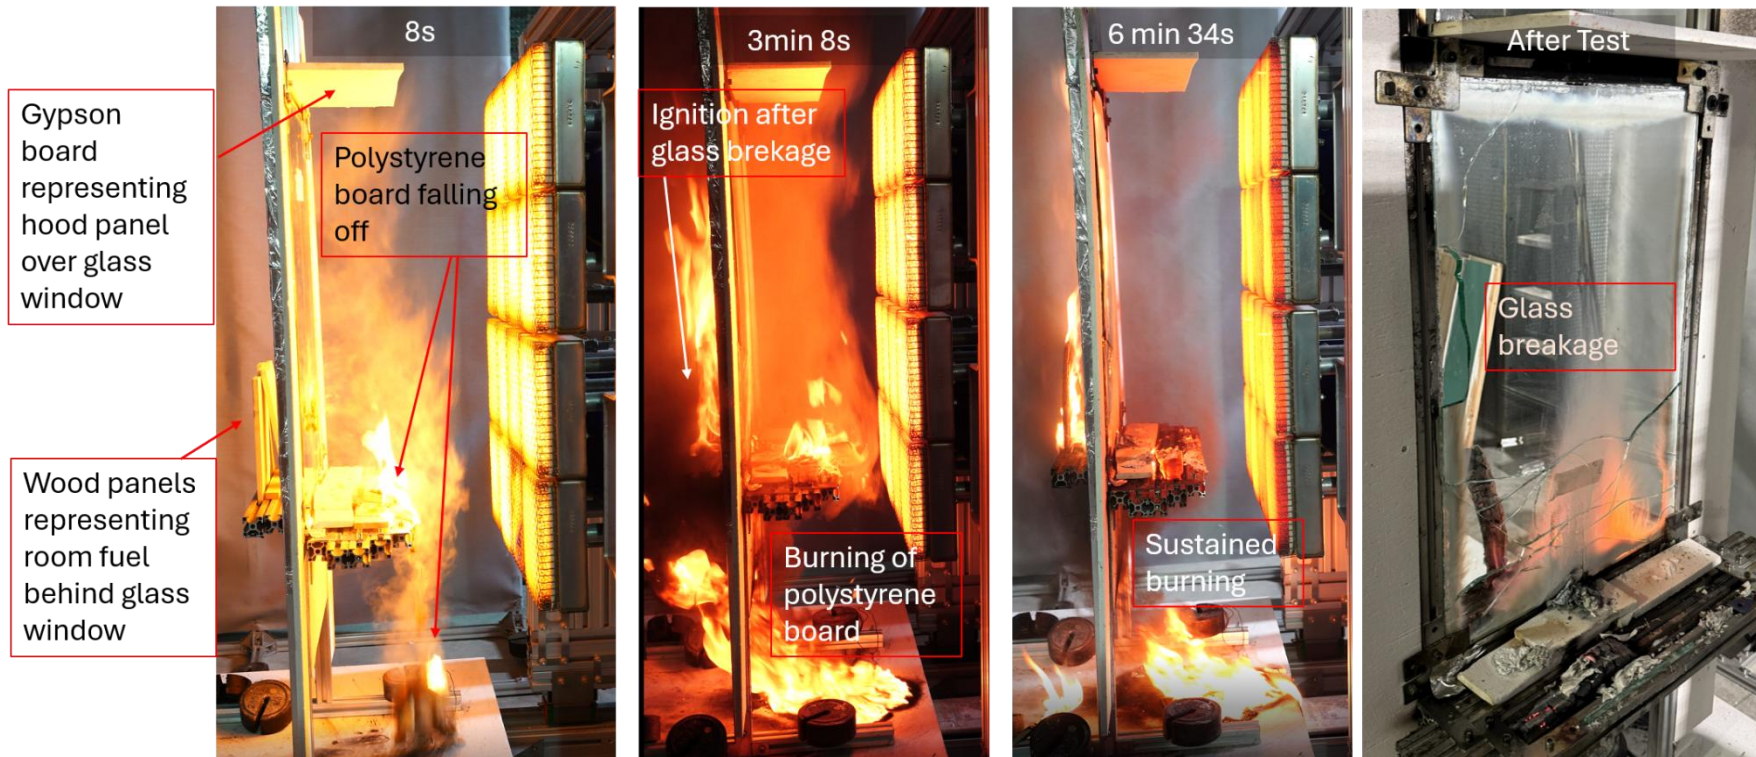
- Falling polystyrene foam boards can maintain a fire for several minutes if being ignited
- Glass breakage occurred and the small wood panel behind window (representing in-room item) was ignited.

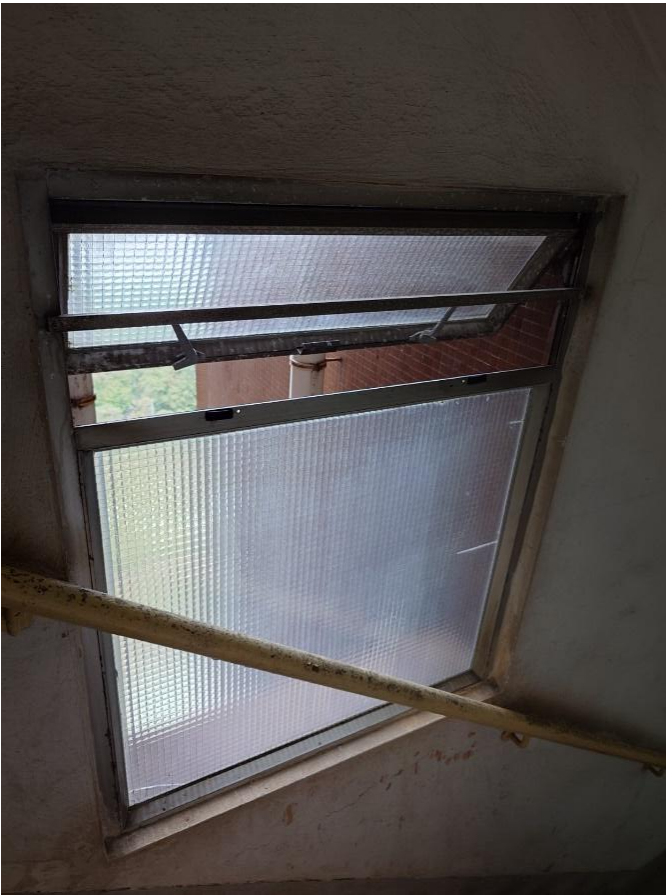
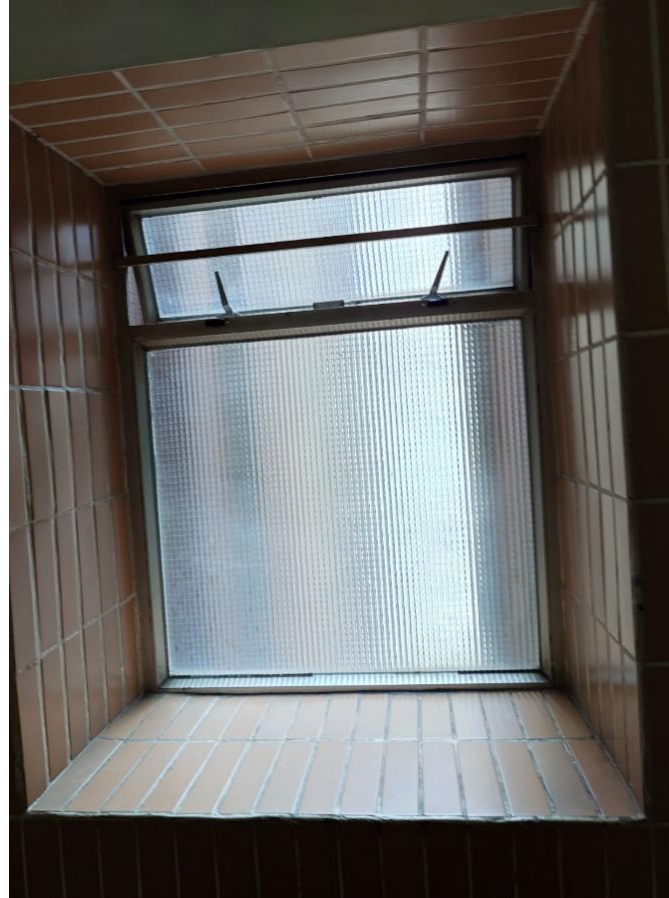
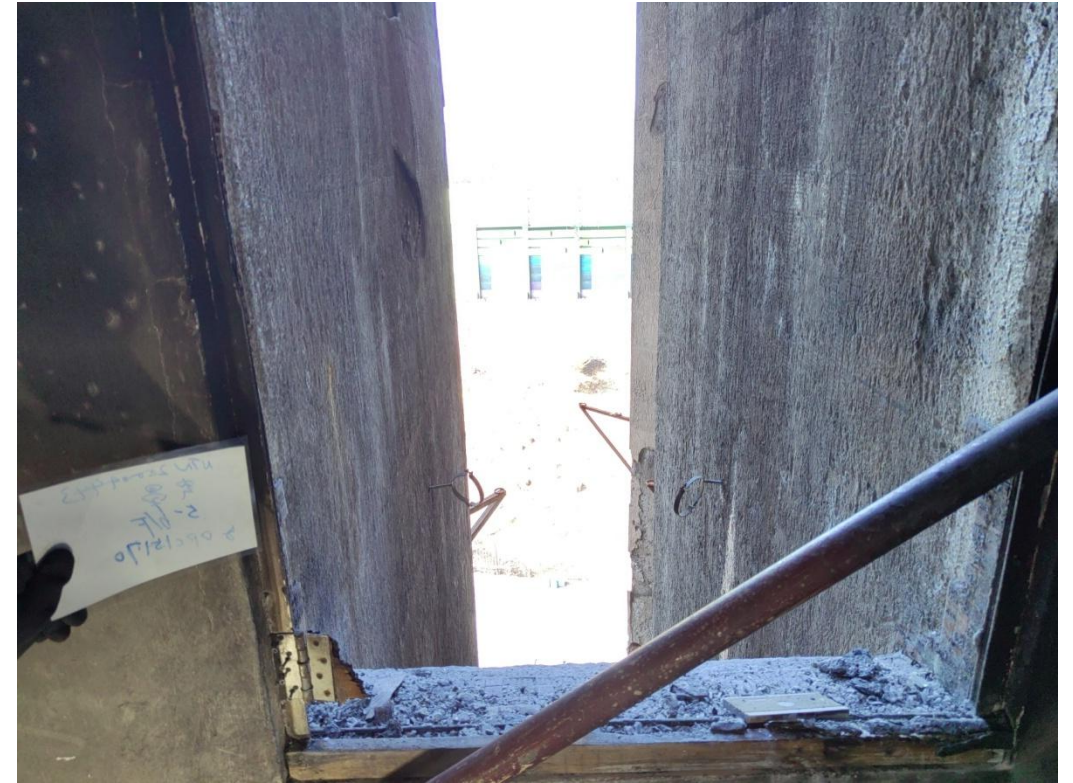
Figure 4.7. Wired glass window (WG) in (a) staircase; (b) lift lobby

Replaced temporary wooden door burnt out

- Video footage showed fire spread from the bottom to the top within 10 seconds.
- The upper part of WGWs is left open for ventilation.
- Some WGWs were replaced by wooden doors. The wooden doors have gaps or left open or burnt through during the fire.
- The CFD simulation results indicate a very rapid vertical spread of fire gases in the re-entrant, with smoke entering the staircases and lift hall on all floors.

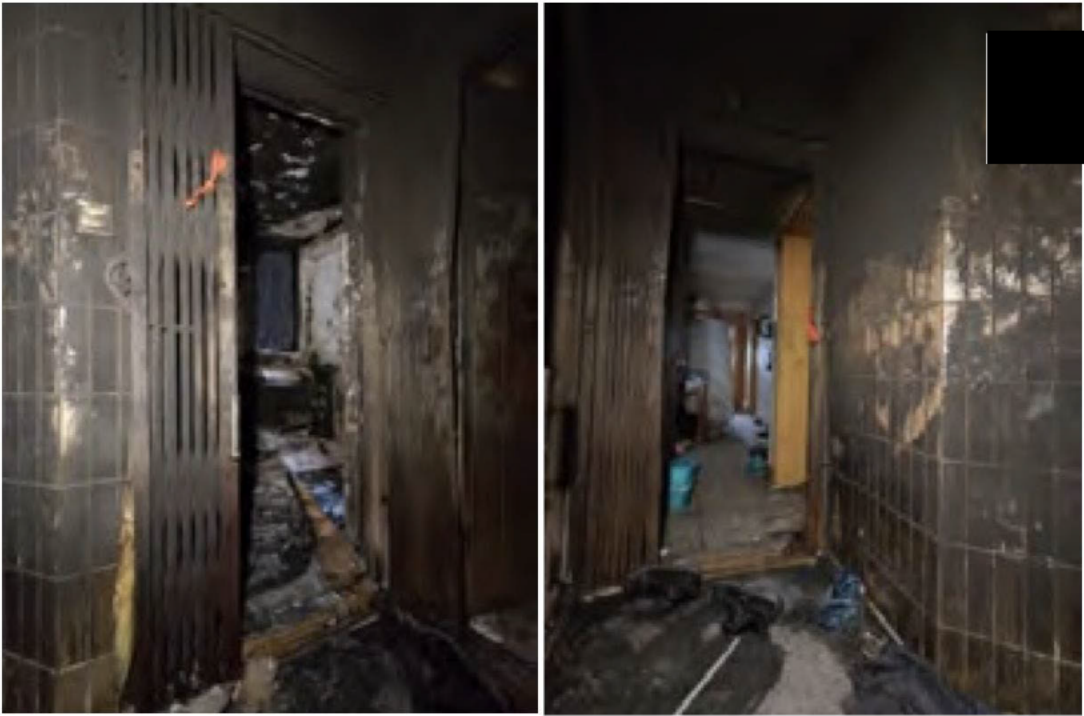
Figure 4.12. Entrance door of (a) Unit 01 and (b) Unit 02, Wang Cheong House

Unit 01 was totally consumed; the entrance door is immediately adjacent to the entrance door of Unit 02, and was burnt through.

Hot smoke penetrated into Unit 02 through the door gaps while other units on the same floor were burning for an extended period.

The post-fire photograph of the Unit 02 entrance door shows significant charring on the upper portion of the leaf and heavy soot deposition on the ceiling of the entrance foyer inside of Unit 02.
