**Independent Committee in relation to the  
Fire at Wang Fuk Court in Tai Po**

**Witness Statement of YIU Men-yeung**

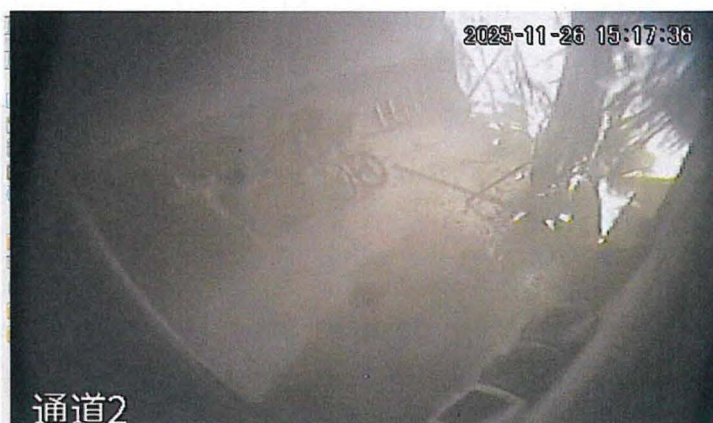
10. In the Wang Fuk Court Fire, it was observed that plastic strips used to secure the scaffolding were burnt in the fire, causing bamboos to detach from the scaffolding at upper levels. The said detachment accelerated both downward and lateral fire propagation, which in turn led to burning debris accumulating at building entrances and obstructing ground-level exits. Severe hazards were thereby created for both evacuees and firefighters seeking access.
11. Evidence also indicates that burning bamboo sticks had fallen to the ground level during the early stage of fire. According to the CCTV footage of Wang Tai House (recorded at approximately 1517 hours), large quantities of flaming bamboo sticks had fallen to the ground near the building entrance.

CCTV footage of Openground outside Wang Tai House<sup>1</sup>

12. Undoubtedly, bamboo's combustibility contributes to the fire load on building exteriors. Moreover, the structural stability of bamboo scaffolding under fire conditions raises serious safety concerns. If bamboo and other combustible materials on the scaffolding catch fire, their detachment may ignite other nearby materials and in turn lead to the acceleration of fire propagation and pose additional dangers to people on the ground level.
13. Yet, the difference between bamboo and other materials used as scaffolding is a complex scientific issue that requires systematic investigation and experimentation. To the best my knowledge, there is at present no conclusive research on this matter in Hong Kong or elsewhere. Hence, a comprehensive study is required to assess and eventually determine the replacement of traditional bamboo scaffolding with other alternatives.
