**Independent Committee in relation to the  
Fire at Wang Fuk Court in Tai Po**

**4<sup>th</sup> Witness Statement of YIU Men-yeung**

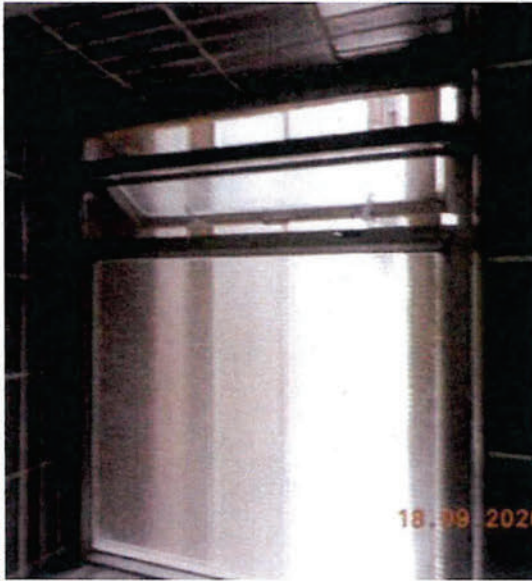
13. The lift lobbies, corridors, and staircases were originally designed as protected escape routes. As mentioned in paragraph 4.1.5 of the Interim Report, one of the re-entrants is located immediately outside the lift lobby window, whereas another re-entrant is located immediately outside the staircase window.

Photo 1 (a):  
Lift Lobby Window  
(Before renovation works)

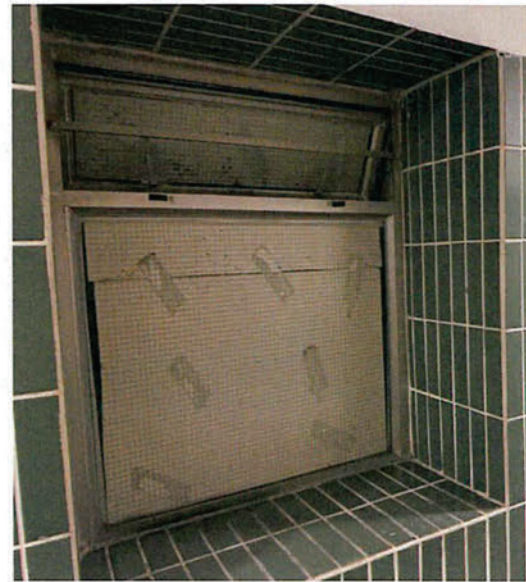
Photo 1(b):  
Lift Lobby Window  
(Photo taken after the fire)

26. The west re-entrant of Wang Cheong House was connected to the lift lobbies via windows on each floor, as shown in Photos 1(a) and 1(b), with the upper part of the windows being openable. The rapid fire spread along the west re-entrant was observed at 1511 hours. Intense smoke and heat generated by the rapid fire spread would have penetrated into the lift lobbies through the openable section of the windows, significantly hindering evacuation efforts.

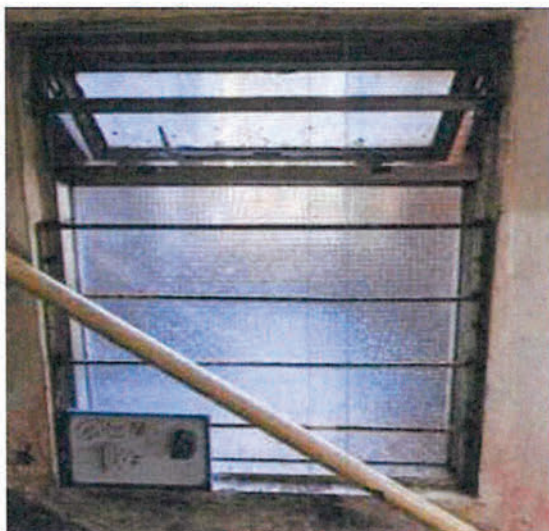
Photo 1(c):  
Staircase Window  
(Before renovation works)

Remarks: For all blocks of Wang Fuk Court, all the existing staircase windows, of which the upper part was openable, were proposed to be replaced with fire-rated windows as part of the renovation works of Wang Fuk Court.

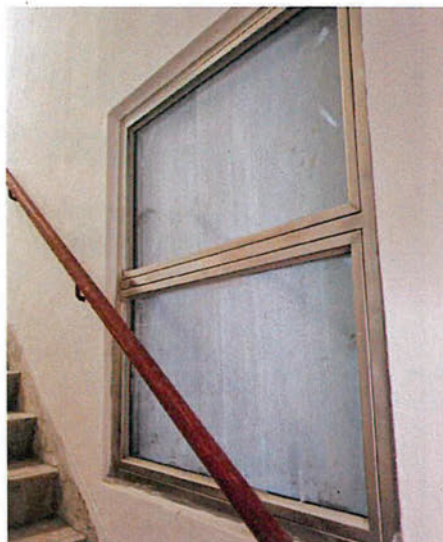
Photo 1(d):  
Staircase Window  
(Photo taken after the fire)

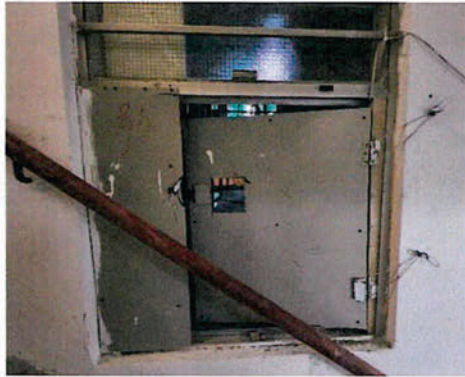
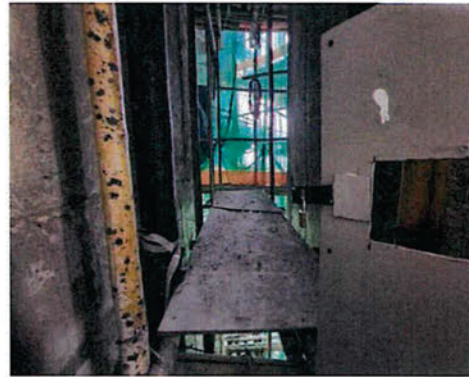
14. It was only revealed after the fire that some windows at the staircases were replaced with movable boards, most of which were believed to be wooden and the rest of them were made of other materials, to provide convenient access for workers to the scaffold.

Photos 2 (a) & (b): Replacement of Windows with Movable Boards

15. The upper openable portion of the lift lobby windows, along with the unprotected openings fitted with movable boards at the staircases, created a direct connection between the formerly protected means of escape and the re-entrants. During renovation,

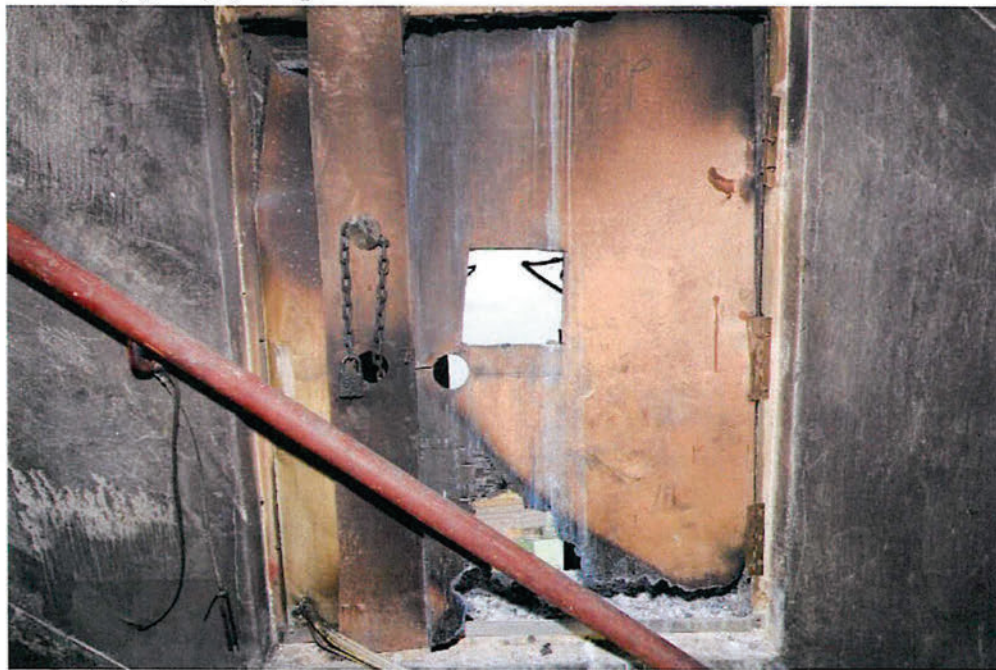
Photo 2 (c): Replacement of Windows with Movable Boards (Wooden)

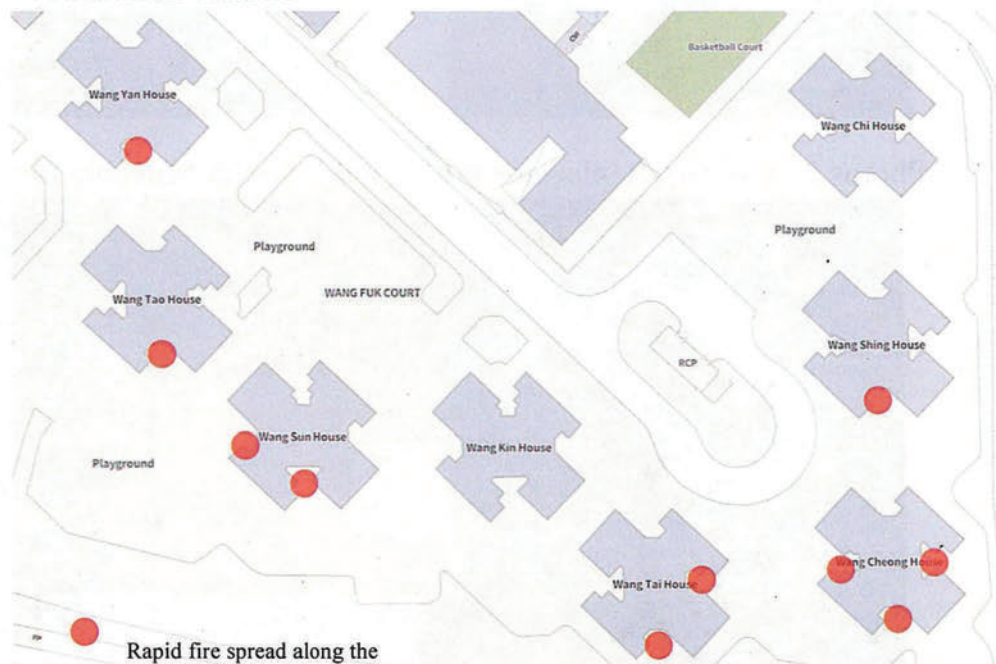
these re-entrants were filled with combustibles and featured a triangular channel extending from the flat roof to the roof level, where extremely vigorous fire spread was observed in certain buildings. This configuration allowed heat, smoke, and potentially flames to penetrate those escape routes that were designed to remain safe for evacuation. As a result, the safety of these escape routes was significantly compromised, and as the fire progressed, conditions in these areas rapidly deteriorated, severely impeding evacuation efforts.

Figure 2: Rapid Fire Spread along the Re-entrants

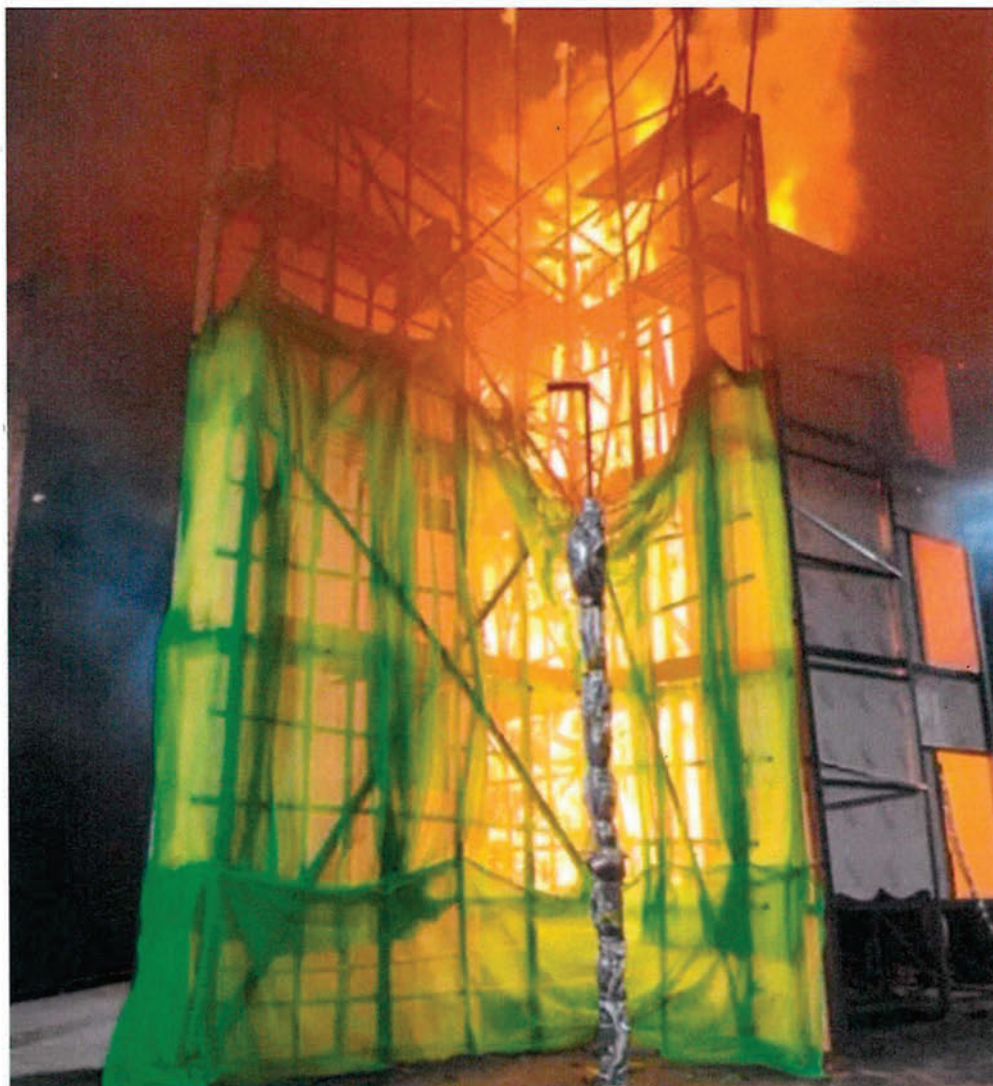
Photo 3(a): Severe Fire Development in the Re-entrant  
Observed during the Trial Test

18. As observed during the trial test, the fire spread rapidly and severely along the re-entrant. The temperature on 1/F, 2/F and 3/F rose to 60°C after 30m 34s (1834s), 27m 13s (1633s), and 27m 4s (1624s) respectively.<sup>2</sup> The wooden board on 2/F was ignited by the intense fire in the re-entrant, which in turn spread through the opening on 2/F into the staircase void, with the peak temperature recorded immediately outside the wooden board reaching approximately 1,000°C eventually. This extreme heat, combined with the vigorous fire spread, likely caused conditions in the lift lobbies, corridors and staircases connecting to the re-entrant to deteriorate rapidly in the actual fire incident, thereby severely impeding evacuation efforts during the fire at Wang Fuk Court. Therefore, it is reasonable to assume that the lift lobbies, corridors and staircases at Wang Fuk Court became untenable as the rapid fire spread along the re-entrant was observed.

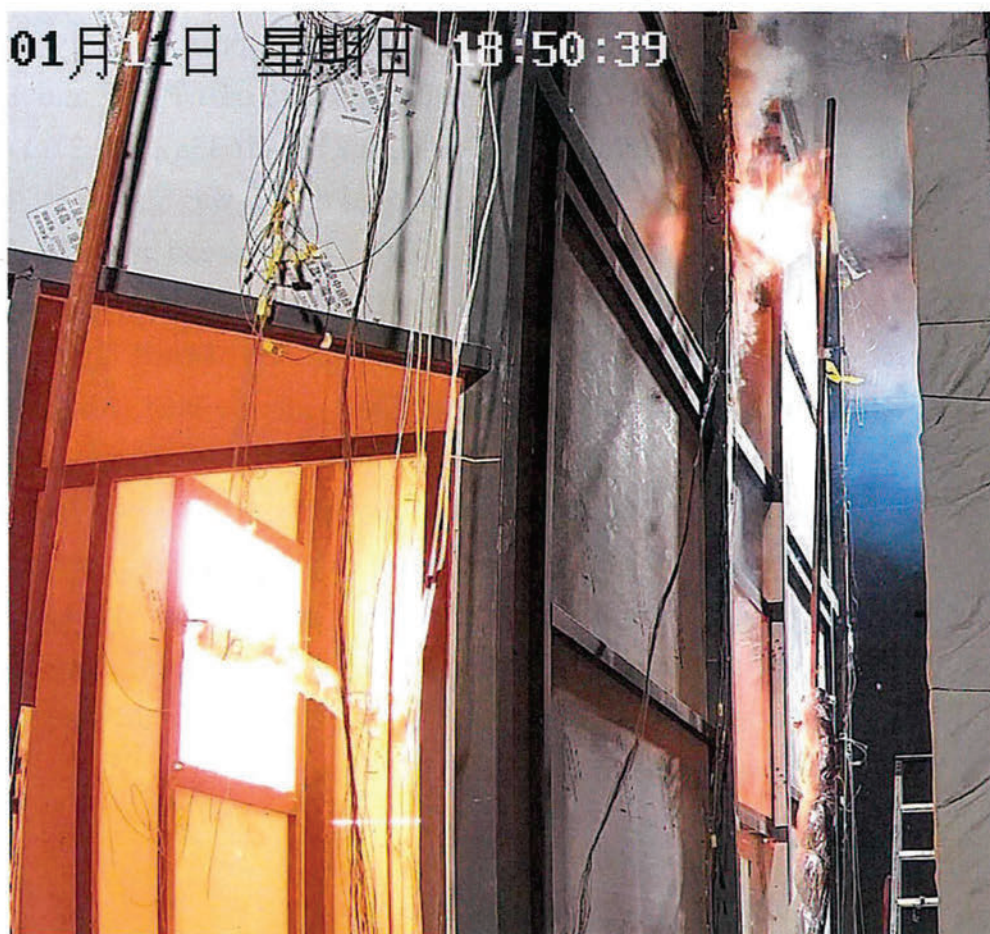
Photo 3(b): The Wooden Board on 2/F Ignited

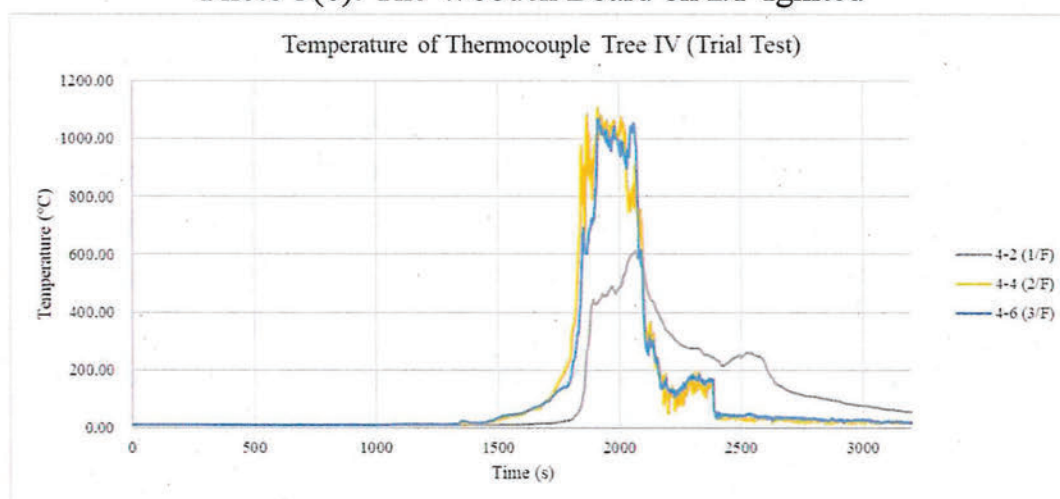
Figure 3(d): Temperature against Time Graph in the Trial Test

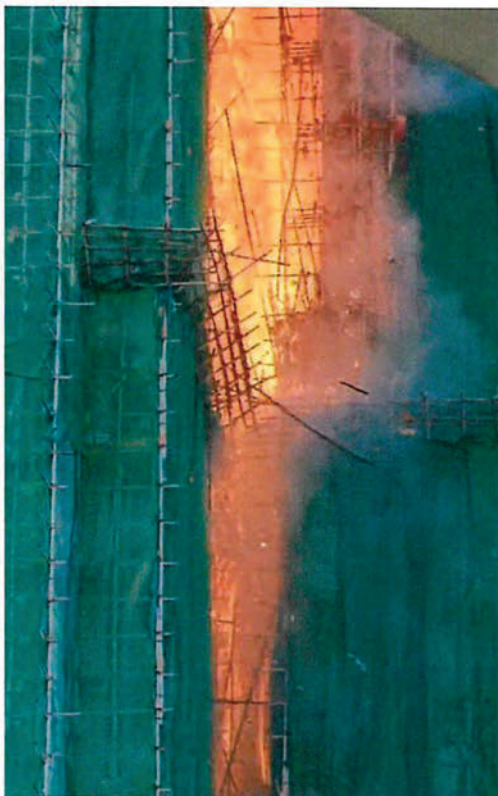
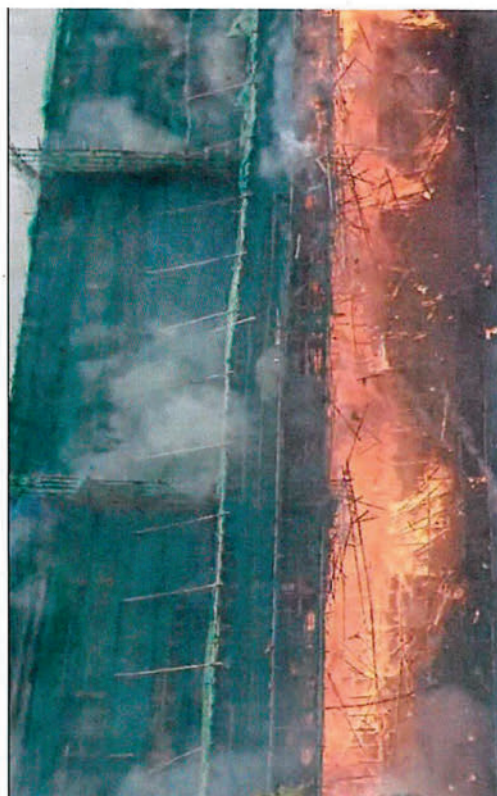
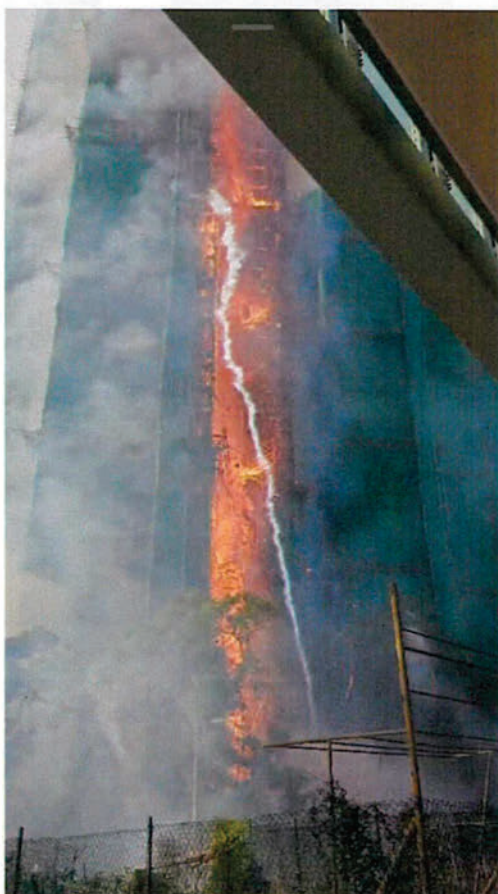
20. The fire was observed to have started on the flat roof outside Flats 104 and 105 at about 1451 hours and it engulfed the entire east re-entrant at 1458 hours after about 7 minutes.

Photos 4 (a) to (c):  
Fire Intensified and Engulfed the  
Entire East Re-entrant of Wang  
Cheong House with Falling Debris  
at 1458 hours

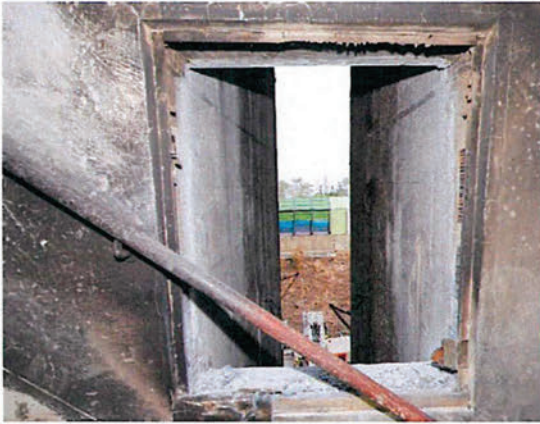
Rear Staircase between 5/F & 6/F

24. As shown in Photos 5(a) to (e), the movable boards of the rear staircase between 5/F and 6/F, the front staircase between 10/F and 11/F, and the front staircase between 20/F and 21/F were heavily damaged by fire. Correlating this damage with experimental observations shown in Photo 3(b) suggests that these movable boards might have ignited, with flaming subsequently blocking both escape staircases. Even if those movable boards had not yet been burnt, smoke and heat could still have penetrated into the staircase through the openings of the movable boards at the rear staircase between 15/F and 16/F, as well as between 25/F and 26/F.

Photos 5 (a) to (e):  
Fire Damage of the Movable Boards

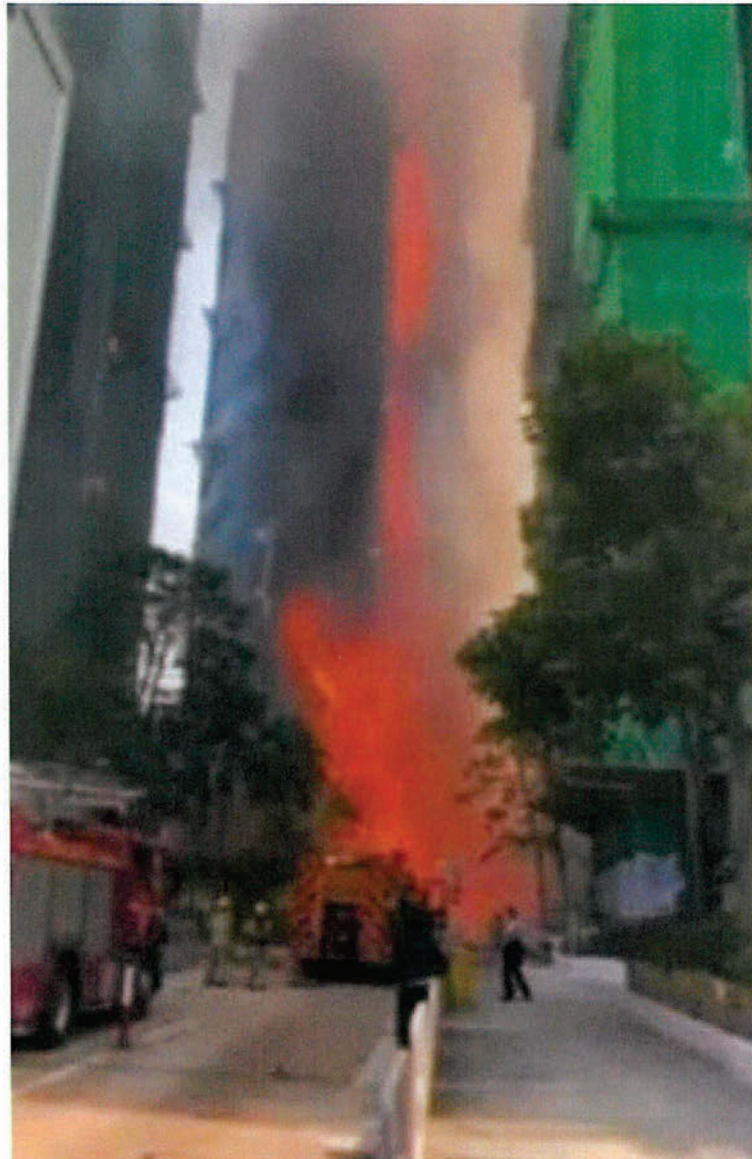
Photo 6: Fire Spreading along the West Re-entrant at 1511 hours

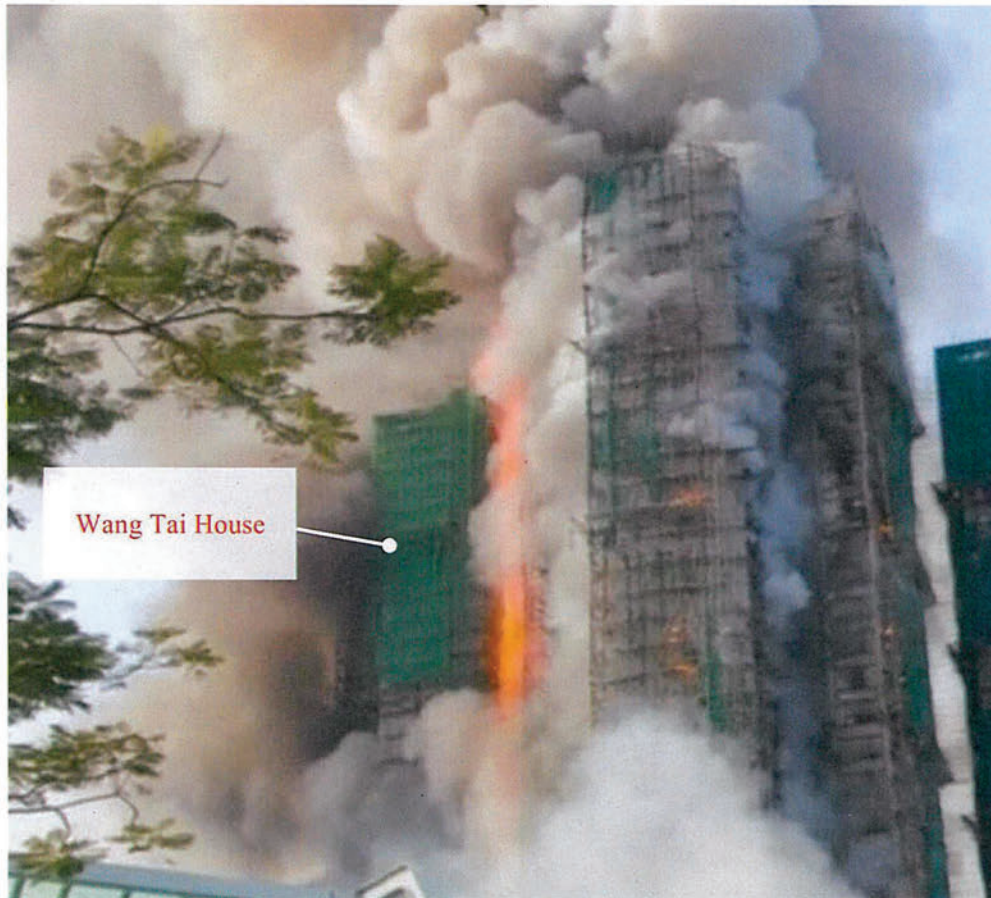
27. For Wang Tai House, vertical fire spread along the east re-entrant was observed at 1516 hours about 16 minutes after fire was first observed at the building at 1500 hours. The re-entrant is connected to the window at the lift lobby.

Photo 7: Rapid Vertical Fire Spread along the East Re-entrant of Wang Tai House at 1516 hours

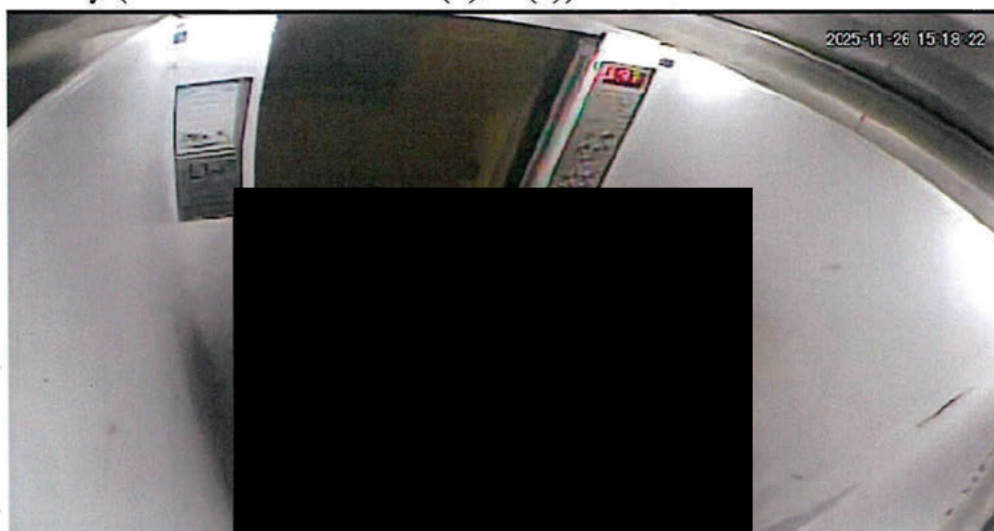
29. CCTV footage of Wang Tai House showed [REDACTED] entering lift L14 of Wang Tai House on 31/F at about 1520 hours<sup>3</sup> (as shown in Photo 8 (a)). Another video from an online source showed that [REDACTED] encountered heavy and dense smoke entering through the upper openable part of the window in the lift lobby (as shown in Photos 8 (b) & (c)).

Photo 8(a): CCTV Screenshot Showing [REDACTED]  
Entering Lift L14 on 31/F of Wang Tai House

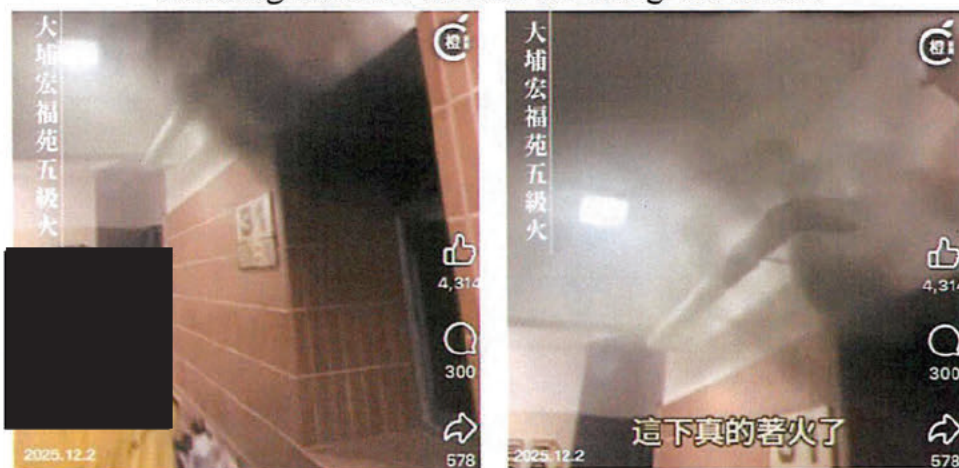
Photos 8 (b) & (c): Video from Online Source Showing Internal Condition  
of Lift Lobby on 31/F of Wang Tai House

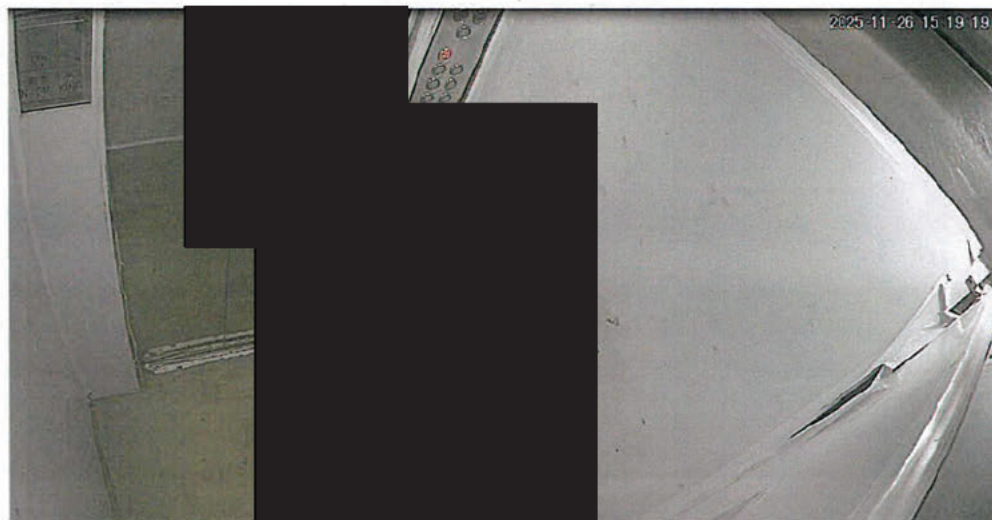
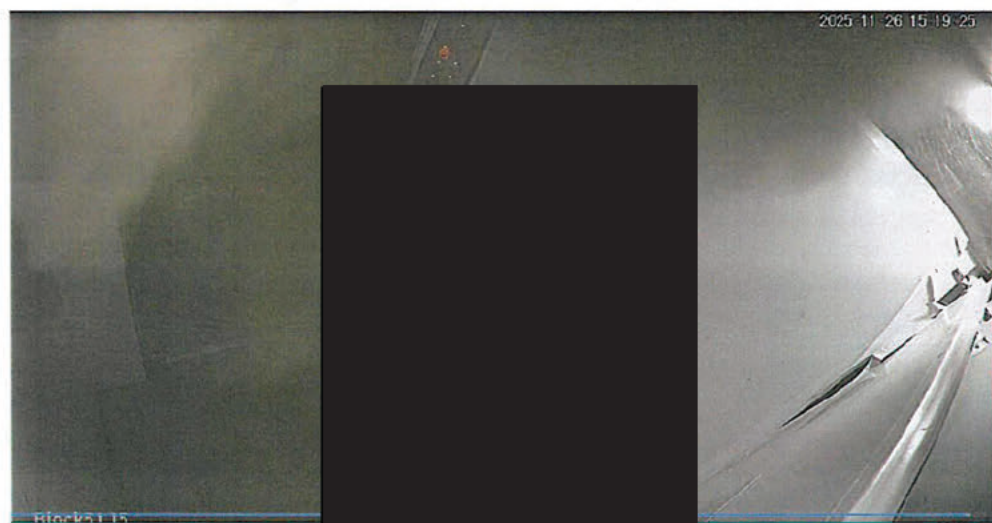
30. CCTV footage showed a [REDACTED] believed to be [REDACTED], inside lift L15 of Wang Tai House at about 1521 hours<sup>4</sup>. When the lift doors opened on 23/F, heavy and dense black smoke were captured to be infiltrating into the lift (as shown in Photos 9 (a) to (c)).

Photos 9 (a) to (c): CCTV Screenshots Showing Internal Condition of Lift L15 on 23/F

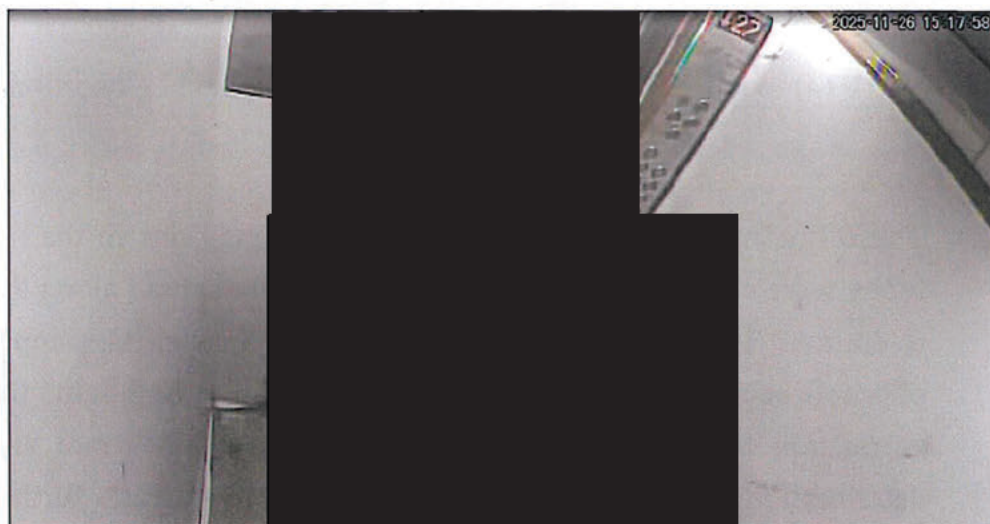
31. Another CCTV footage showed a [REDACTED] believed to be [REDACTED] inside lift L13 of Wang Tai House at about 1521 hours<sup>5</sup>. When the lift doors opened on 24/F, heavy and dense black smoke were also captured to be pouring intensely into the lift (as shown in Photos 10 (a) to (c)).

Photos 10 (a) to (c): CCTV Screenshots Showing Internal Condition of Lift L13 on 24/F

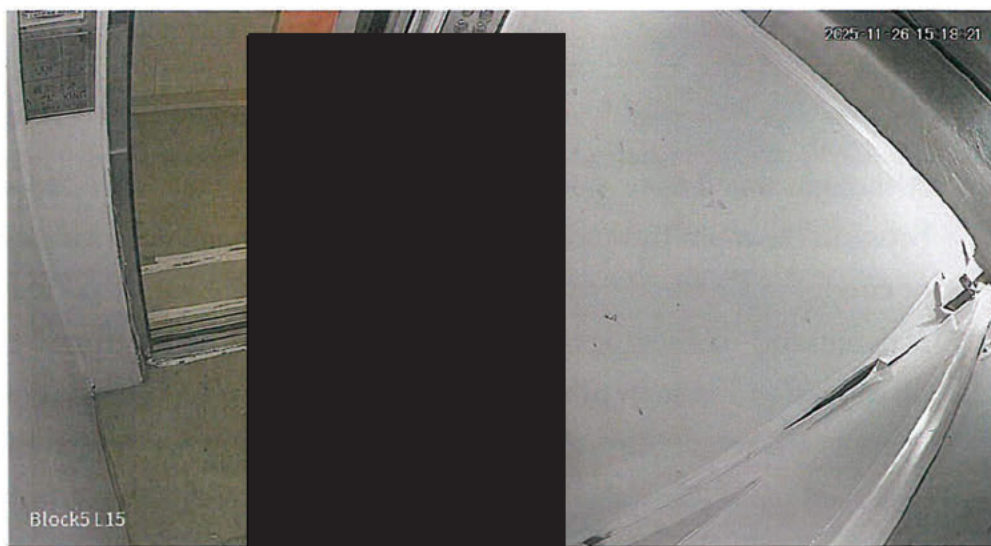
- ii. Similarly, [REDACTED], who arrived at G/F at about 1520 hours using lift L15, failed to exit the lift at G/F due to blockage of the exit by burning bamboo scaffoldings. [REDACTED] peeked out from the lift but was too afraid to escape through the fire, as shown in Photo 12. [REDACTED] chose to retreat into the lift and went upwards. Unfortunately, the tenability of the lift lobbies on upper floors deteriorated so quickly, as mentioned in paragraph 30, resulting in the loss of [REDACTED] life.

Photo 12: Blockage of Exit at G/F of Wang Tai House at about 1520 hours<sup>7</sup>

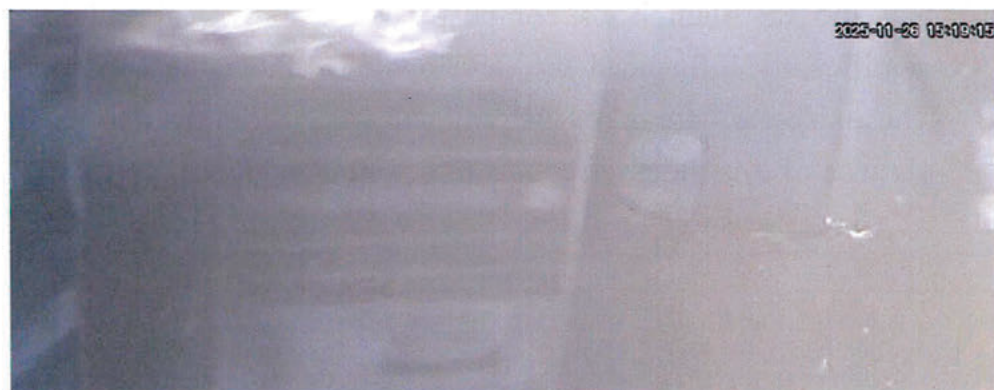
36. According to the CCTV footage as shown in Photo 13, flame was also observed at the entrance of Wang Tai House at about 1521 hours. Under these circumstances, even if [REDACTED] managed to reach the ground floor, [REDACTED] still unable to access a place of safety, further complicating evacuation efforts.

Photo 13:  
Flame Observed at the Entrance of Wang Tai House at about 1521 hours<sup>8</sup>
