**Independent Committee in relation to the  
Fire at Wang Fuk Court in Tai Po**

**Witness Statement of Ir Dr. TO Chi-wing**

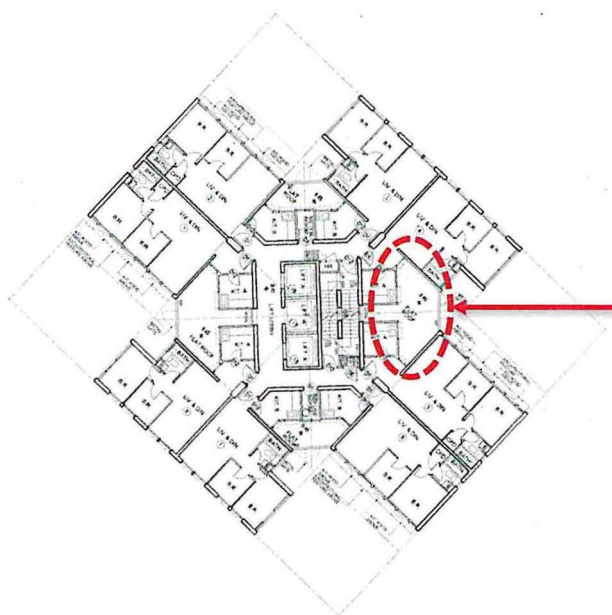
[FSD/D(I)/5]

8. Based on information and video provided by witnesses, the fire is believed to have originated from the flat roof outside Rooms 104 and 105 of Wang Cheong House. This finding is supported by subsequent on-site inspections by IFITF and the assessment of circumstantial evidence.

Layout showing the believed fire origin

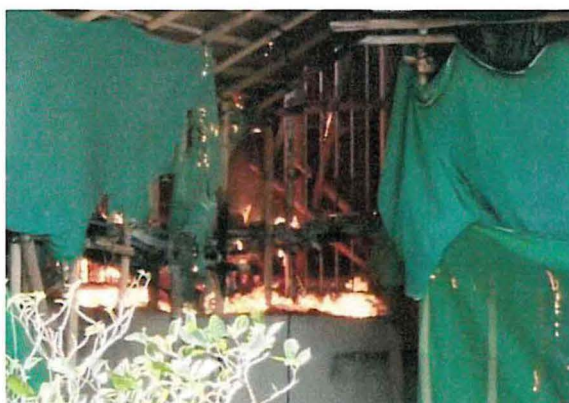
Incipient stage of the fire on the flat roof outside  
Rooms 104 and 105 of Wang Cheong House

- 13.2. Based on the above analysis, the incident was most likely accidental in nature, initiated by a glowing source (such as a lit cigarette end) igniting combustible materials (like carton paper boxes). A detailed analysis could also be found in the Statement from Dr. LEE Wing-man of Government Laboratory on 29.12.2025. [FSD/C(II)/1]

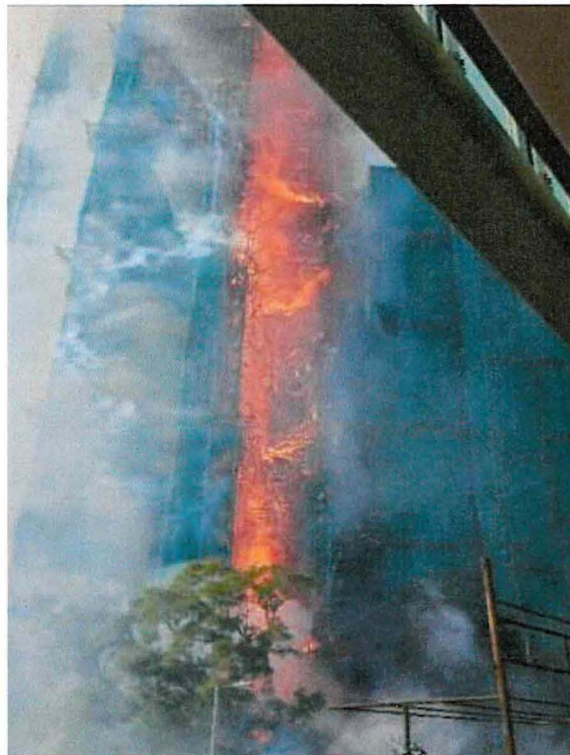
[FSD/D(I)/4]]

Rapid vertical fire spread observed at Wang Cheong House

- 19.4. It was observed that the re-entrant, acting like a “chimney,” facilitated the rapid upward fire spread, engulfing multiple floors in a very short time.
- 19.5. Cable TV footages provided a clear view of the fire spreading through the re-entrant of Wang Tao House, showing evidence that the rapid vertical fire spread was likely caused by the ignition of pyrolyzed gases<sup>8</sup>, generated from the pyrolysis of combustible

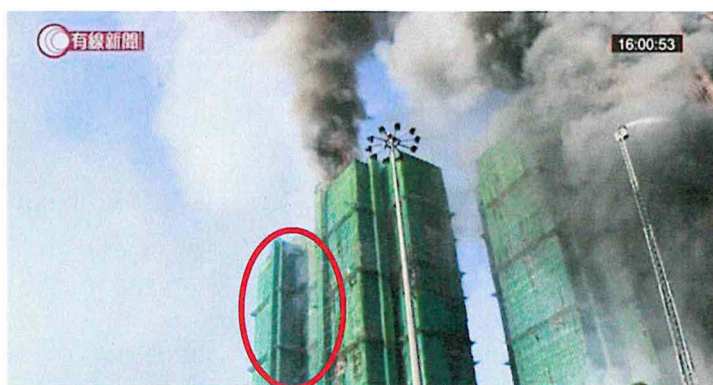
[FSD/D(I)/6]

The re-entrant of Wang Tao House remain unaffected in 16:00<sup>9</sup>

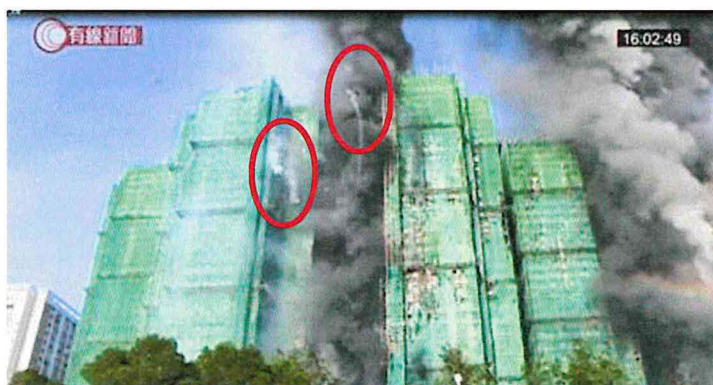
[FSD/D(I)/6]

Flying Embers was spreading from Wang Sun House<sup>10</sup>

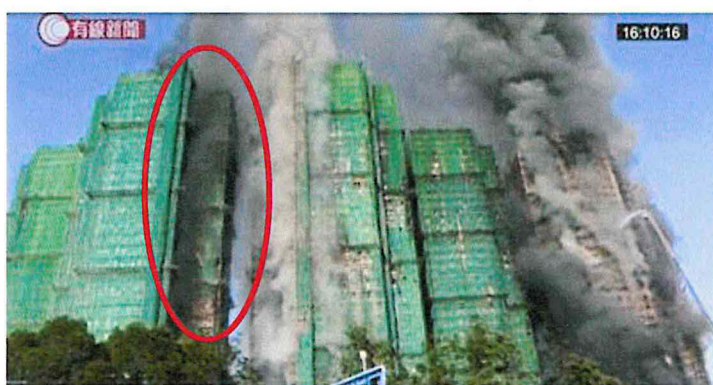
[FSD/D(I)/6]

materials (such as bamboo scaffolding, safety nets, and polystyrene window covers as mentioned in para. 19.2), which had accumulated within the re-entrant.

Pyrolyzed gases from combustibles accumulated in the re-entrant<sup>11</sup>

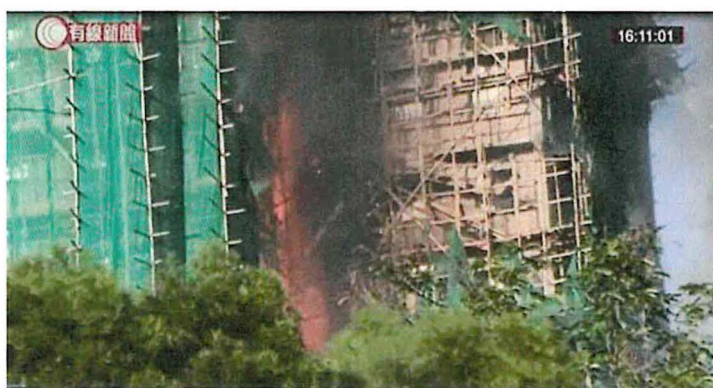
[FSD/D(I)/6]

Flaming fire observed in the lower portion<sup>12</sup>

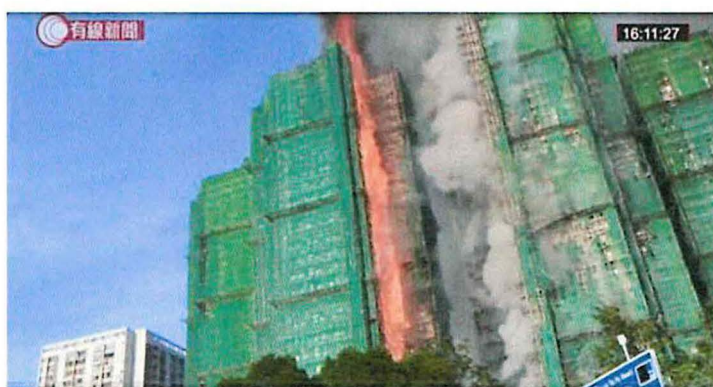
[FSD/D(I)/6]

Fire spread vertically throughout the building<sup>13</sup>

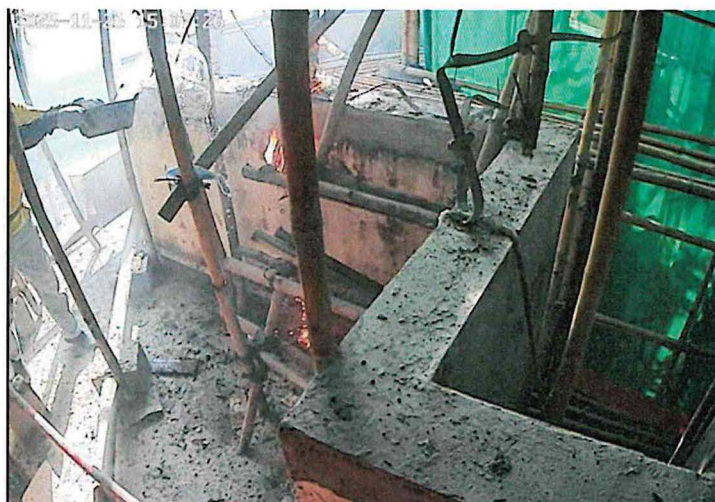
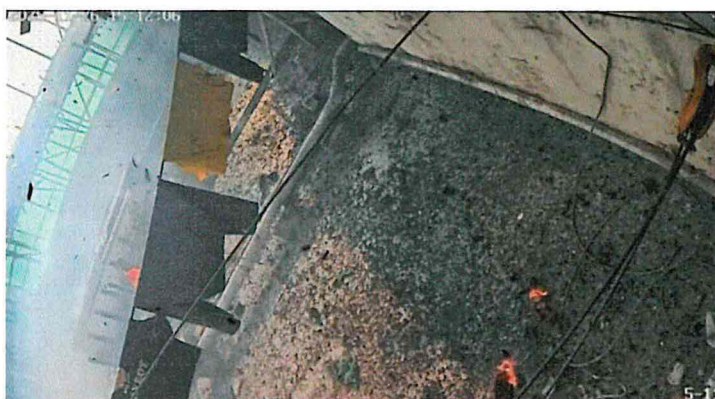
[FSD/D(I)/2]

- 20.1. Winds carried embers—small, burning fragments of combustibles—to nearby structures, where they ignited safety nets, construction debris, and other combustible materials. These embers were particularly dangerous because they could travel a significant distance and land on exposed surfaces far away from the original fire and in turn starting new fires.

Flying embers suspected spreading from Wang Cheong House to Wang Tai House<sup>14</sup>

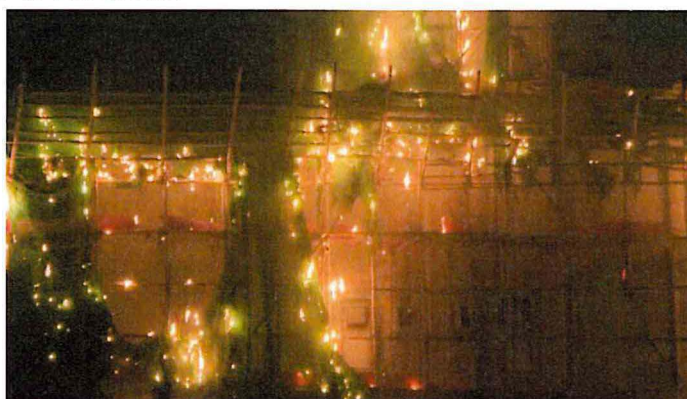
[FSD/D(I)/8]

- 20.2. In addition to wind-transported embers, burning safety nets melted and dripped as fire droplets onto lower floors, potentially serving as an ignition source for other combustible materials. Besides, falling debris also contributed to the fire spread by igniting lower floors and ground-level areas.

Falling fragments of burning scaffolding nets contributing to fire spread

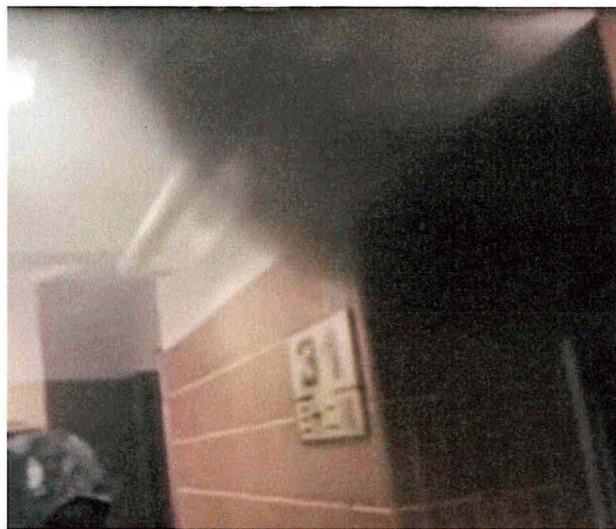
[FSD/D(I)/7]

- 27.1. During the fire, the openable windows in the common corridors on each floor, as well as in the staircases on some floors, when opened, allowed smoke from the burning of combustible materials on the external scaffolding to enter the corridors and hinder evacuation.

Video footage showing smoke entering corridors through openable windows

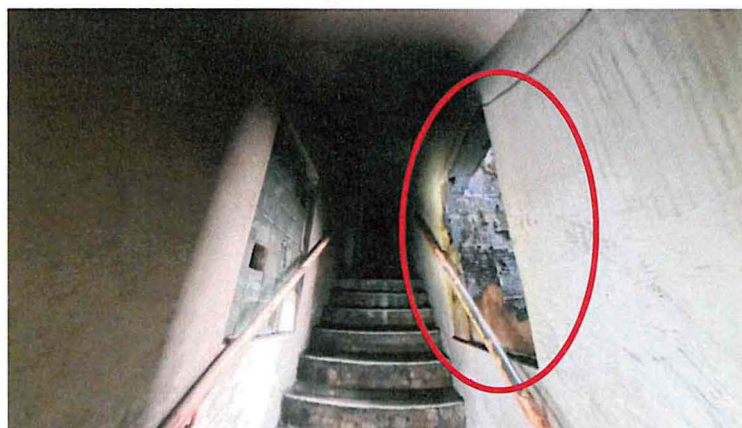
[FSD/D(II)/5]

- 28.1. Some of the windows at the escape staircases were replaced with wooden doors to allow workers' access to the exterior.

Windows replaced by wooden door (damaged by fire) at escape staircase of 10-11/F on Wang Tai House

- 28.2. During the fire, these wooden doors allowed smoke and heat to infiltrate the staircases. The above photo showed that there was severe blackening of the ceiling above the door, likely caused by heavy smoke poured into the staircase.
- 28.3. As a result, the escape staircases, meant to be protected routes for evacuation, were filled with smoke, leaving residents without a safe pathway to escape. This not only endangered the lives of residents but also posed additional challenges to firefighting efforts, as the compromised staircases restricted access for firefighters, delayed our operations and reduced the effectiveness of firefighting efforts.
