# Wang Fuk Court Fire Investigation Report

Inter-departmental  
Fire Investigation Task Force **(IFITF)**

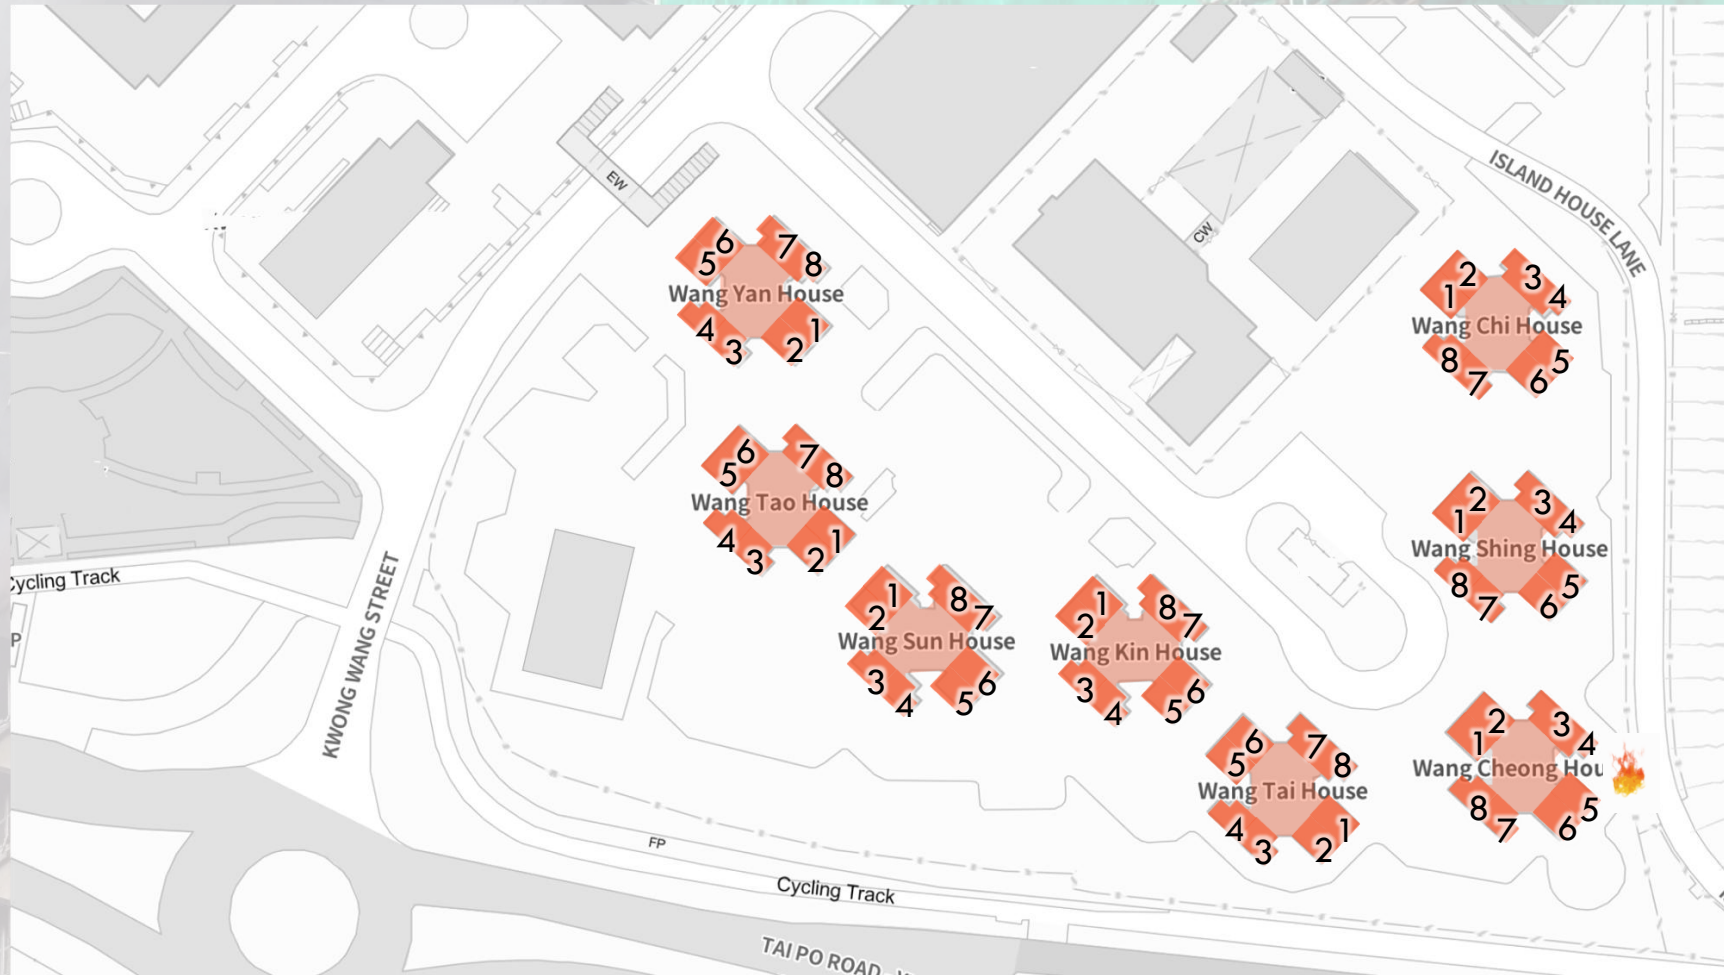
# Layout Plan of Wang Fuk Court

- 8 units per Floor
- U-shaped Corridor
- 2 Scissor Staircases  
(only 1 staircase can access to roof floor)
- 3 Lifts  
(each stop at every 3 floors)
- 4 Re-entrants  
(1 connects to staircase  
1 connects to corridor)

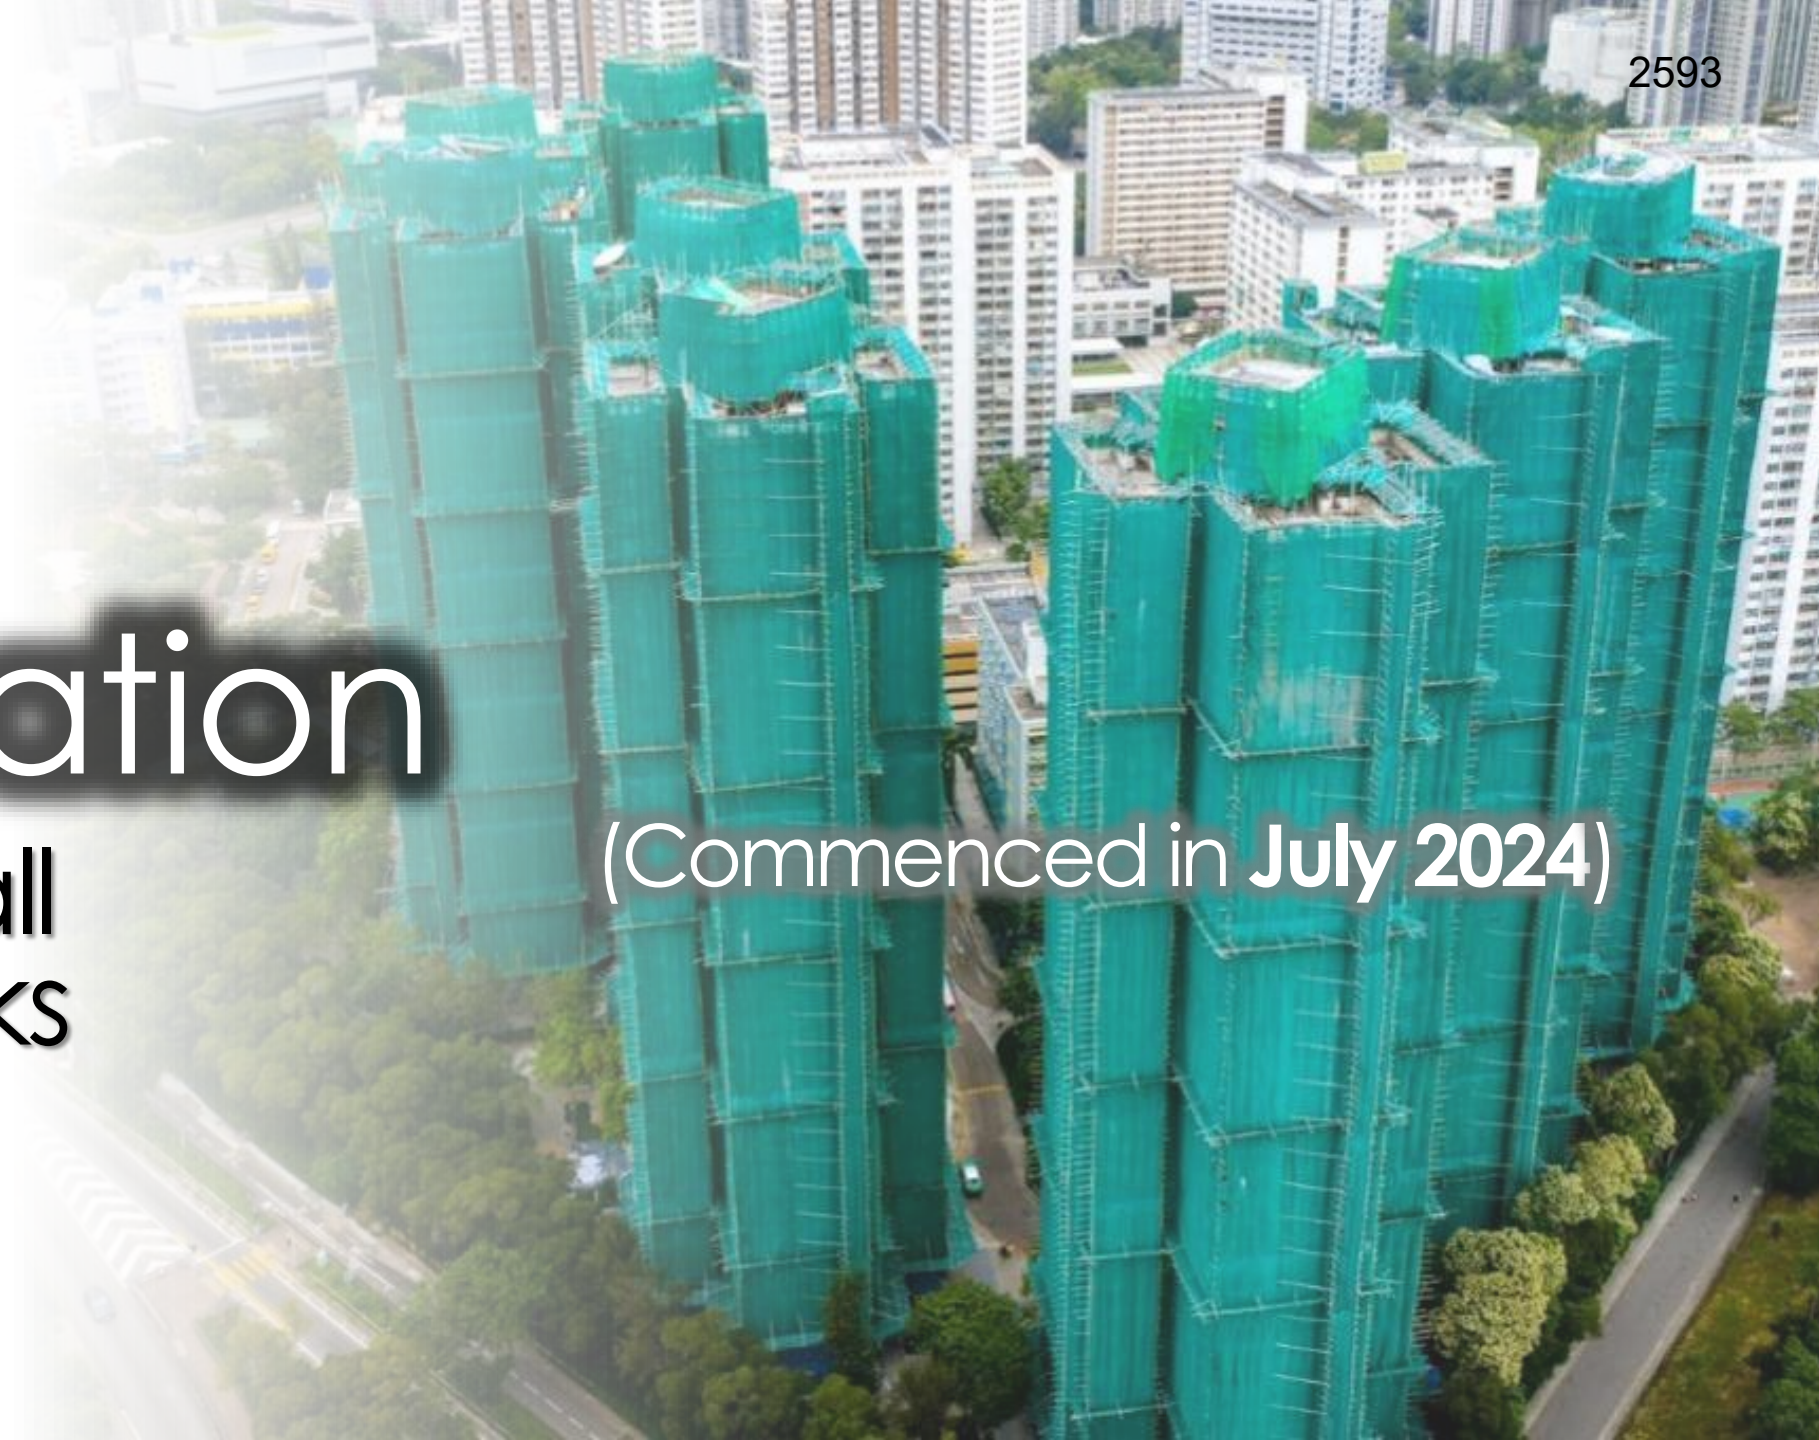
External Wall  
Repair Works

(Commenced in **July 2024**)

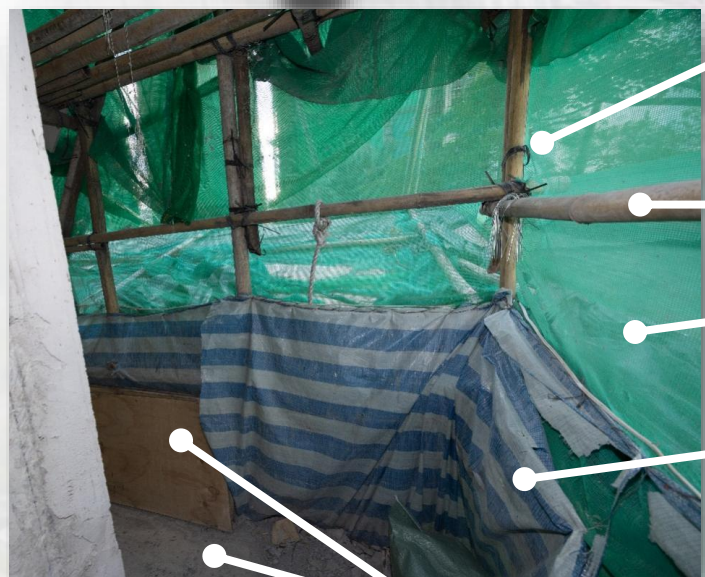
Nylon Strips

Bamboo

Safety Nets

Canvas

Wooden Planks

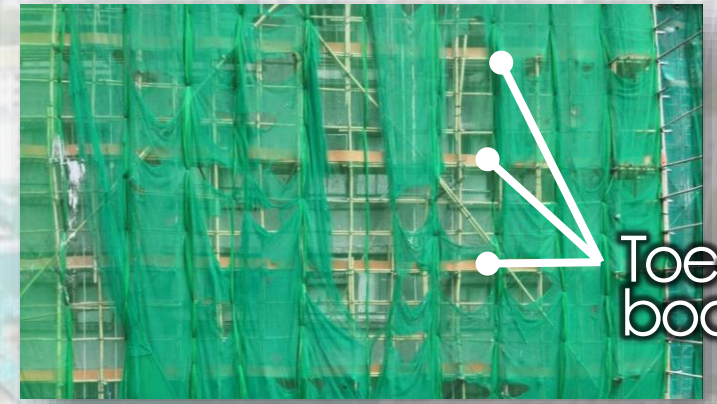
Toe-boards

Covered Walkway

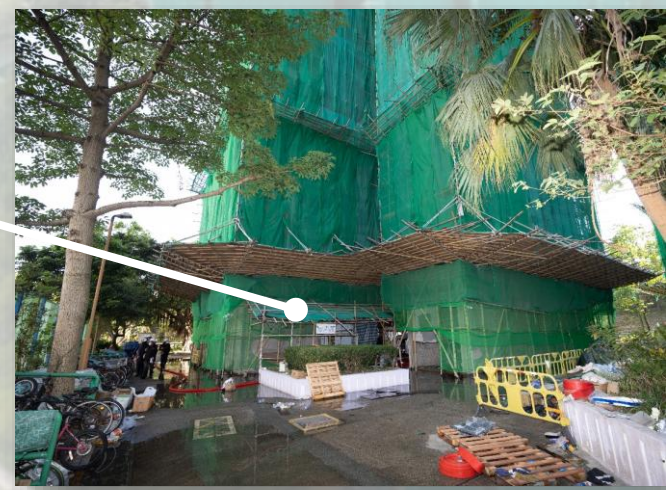
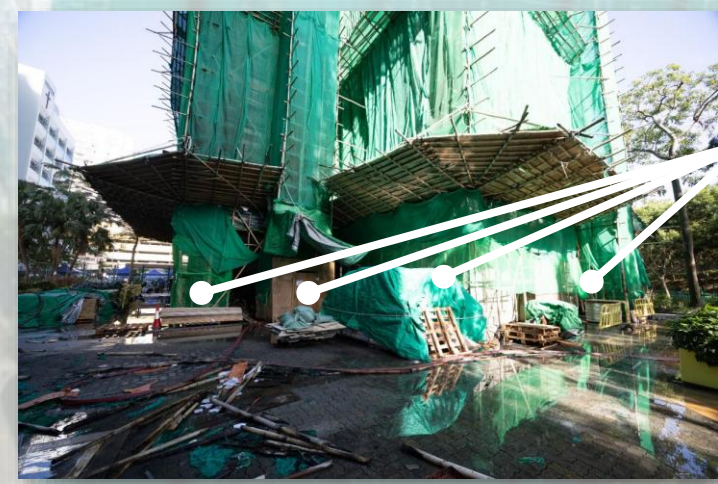
Construction Materials Scattered at Ground Level, Scaffoldings and Re-entrants

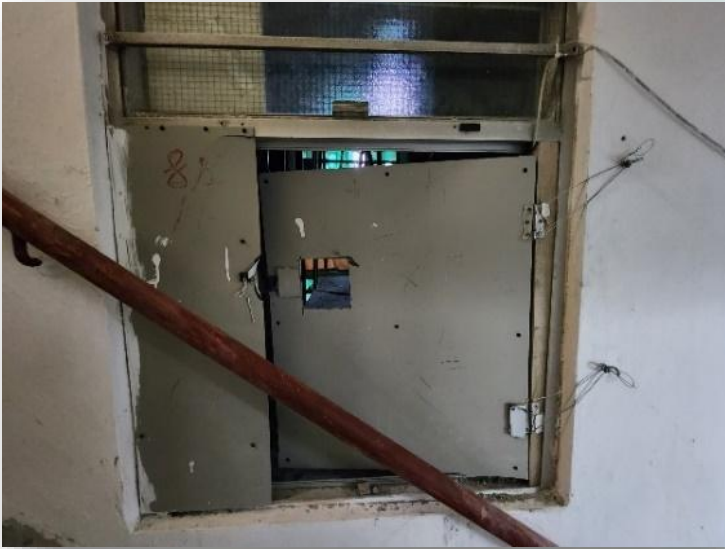
Replace staircase windows with movable boards on **every 5 floors** (at front and rear s/c)

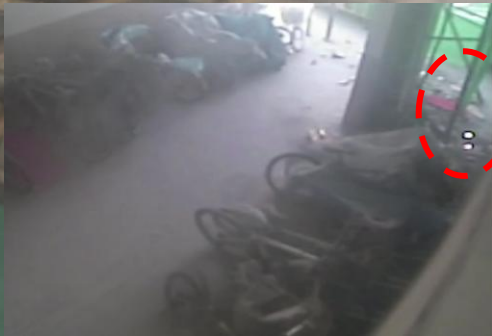
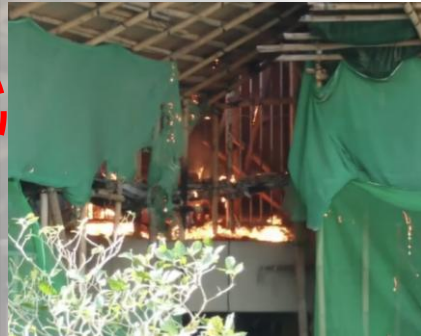
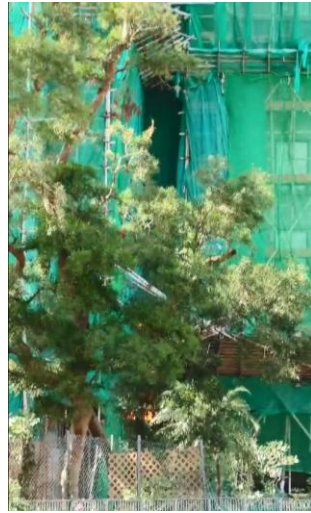
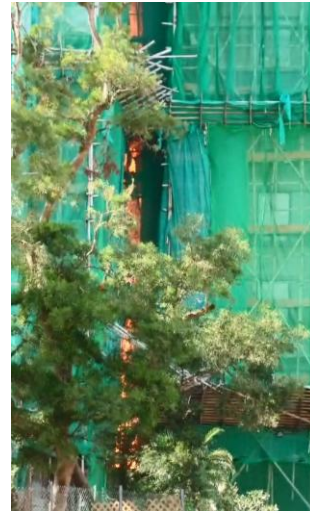
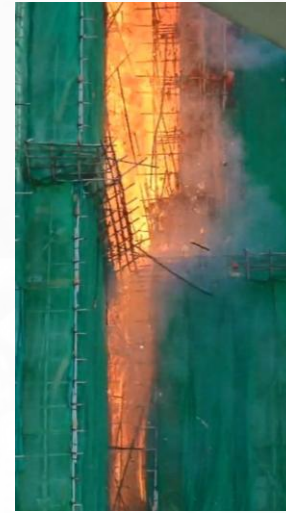
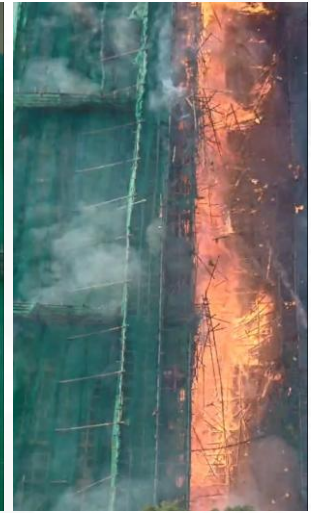
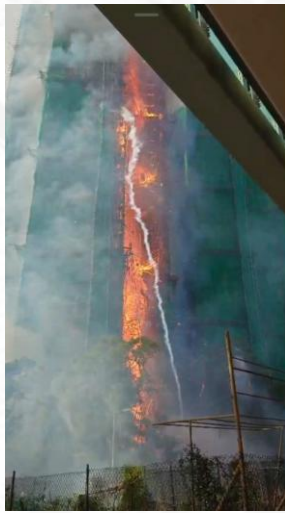
## CCTV footage

According to witness statements, fire was noted at **as early as 1430 hours**

Fire ember noted  
at **bicycle parking**  
lot on G/F of  
**Wang Cheong**  
House

Screenshot  
From the  
Informant's  
Video  
(Time of Call)

Fire  
Spread  
to About  
**4/F**

Fire  
Spread  
to About  
**8/F**

Fire Intensified and  
Engulfed the Entire  
East Re-Entrant of  
**Wang Cheong House**  
With Falling Debris
