This document is the consolidated Expert Report of Prof. Asif Sohail Usmani and Prof. Jiang Liming (incorporating the Expert Report dated 15 June 2026 and Corrigendum dated 24 June 2026)

**Independent Committee in relation to  
the fire at Wang Fuk Court in Tai Po**

**Expert Report**

**Prof Asif Sohail Usmani  
Prof Jiang Liming**

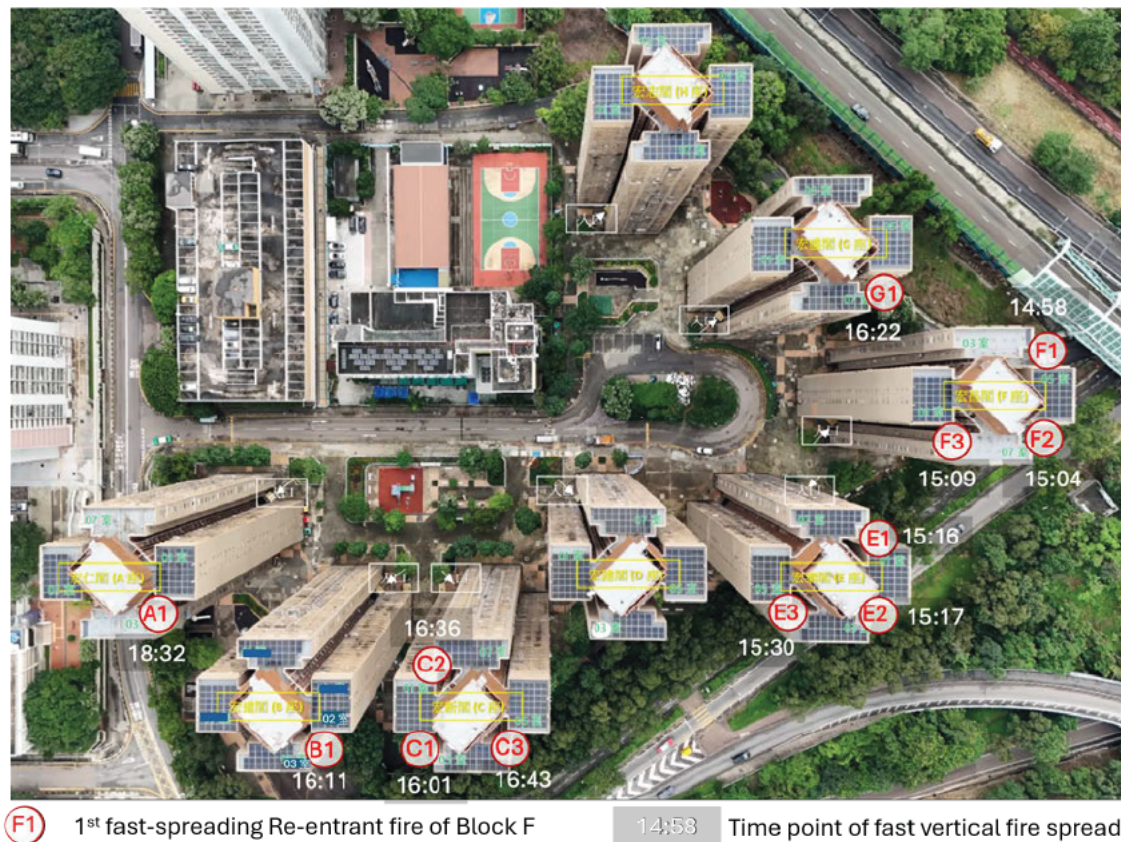
**Figure 3-3. Timeline of fast spreading vertical fires at re-entrant regions**

- 3.3.1. The severe fire impact to each building was always initiated by the extremely fast vertical fire spread at re-entrant region. The first vertical re-entrant fire spread followed the visible fire at re-entrant flat roof between Units 104 and 105 of Wang Cheong House (Block F), which is marked as “F1” in the following figure showing the timeline of vertical fire spread at different buildings. Here “F” represents the building block, while “1” represents the 1<sup>st</sup> re-entrant region experiencing rapid vertical fire.

- 3.3.2. The first vertical fire spread at Wang Cheong House (Block F) re-entrant “F1” was first captured at 14:50 on 26 November 2025. The full development stage of “F1” was around 14:59, and the decay stage was observed at 15:02. At the decay stage, the building was engulfed by a huge amount of smoke as the photographic evidence shows.

3.3.3. The second vertical fire spread along the re-entrant region between Units 6 and Unit 7 (F2) was initiated at 15:02, which underwent fast development at 15:03-15:04. According to visual evidence, the vertical fire entered its decay stage at 15:06. It indicated that the intense heating period due to vertical fire spread along re-entrant region was very short, only lasting for 2-4 minutes.

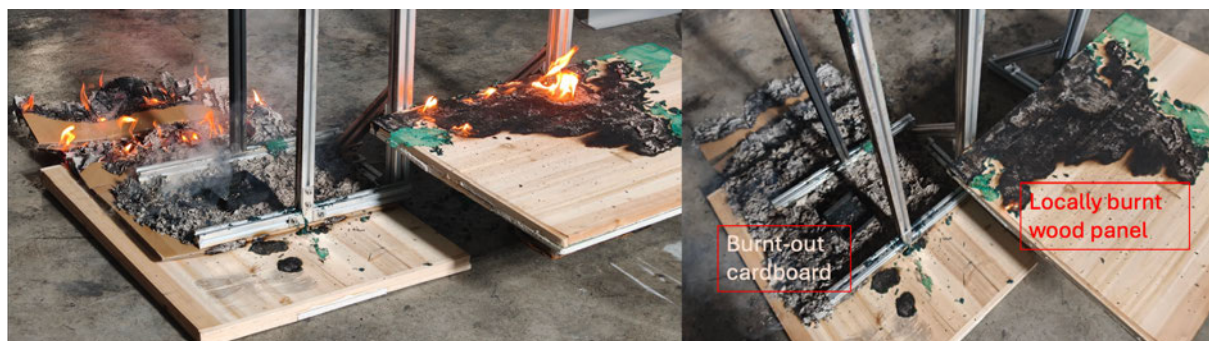
**Figure 3-21. Burning behaviour of cardboard, and wood panels subjected to dripping fires in Test D1**

3.6.18. We note the dripping flames of non-FR safety net seen in Test B2, as stated above. The ignition of cardboard due to the dripping flames from the non-FR safety nets is clearly shown in Test D1 at 3 minutes. At 9 minutes, the flames have propagated to the right-hand side of safety net, and an area of the wood panel was ignited by the dripping flames as shown in the test photo at 16 minutes and Fig. 3-21. After the fire extinguished, the cardboard had been burnt out and the charring of wood panel had propagated to deeper section.

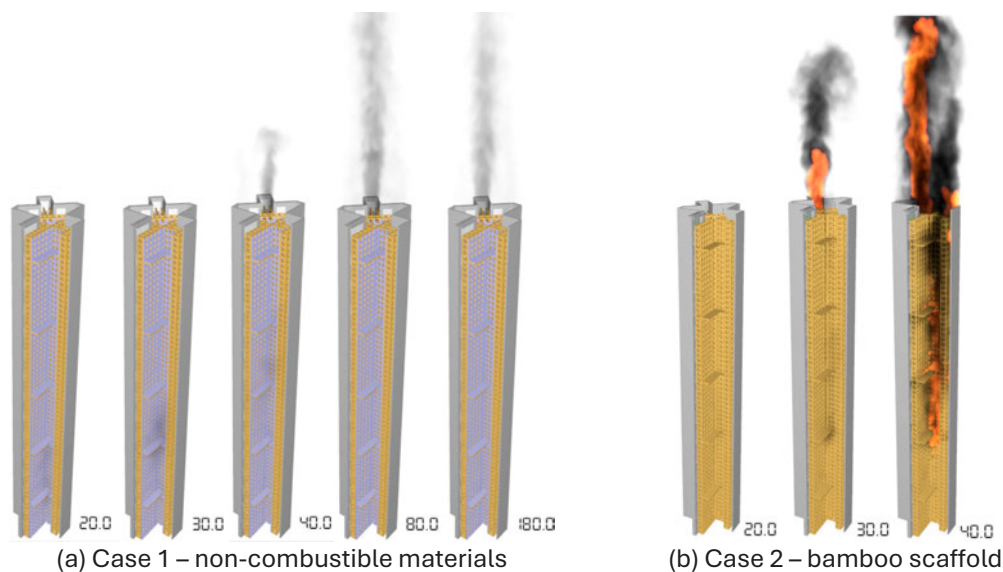
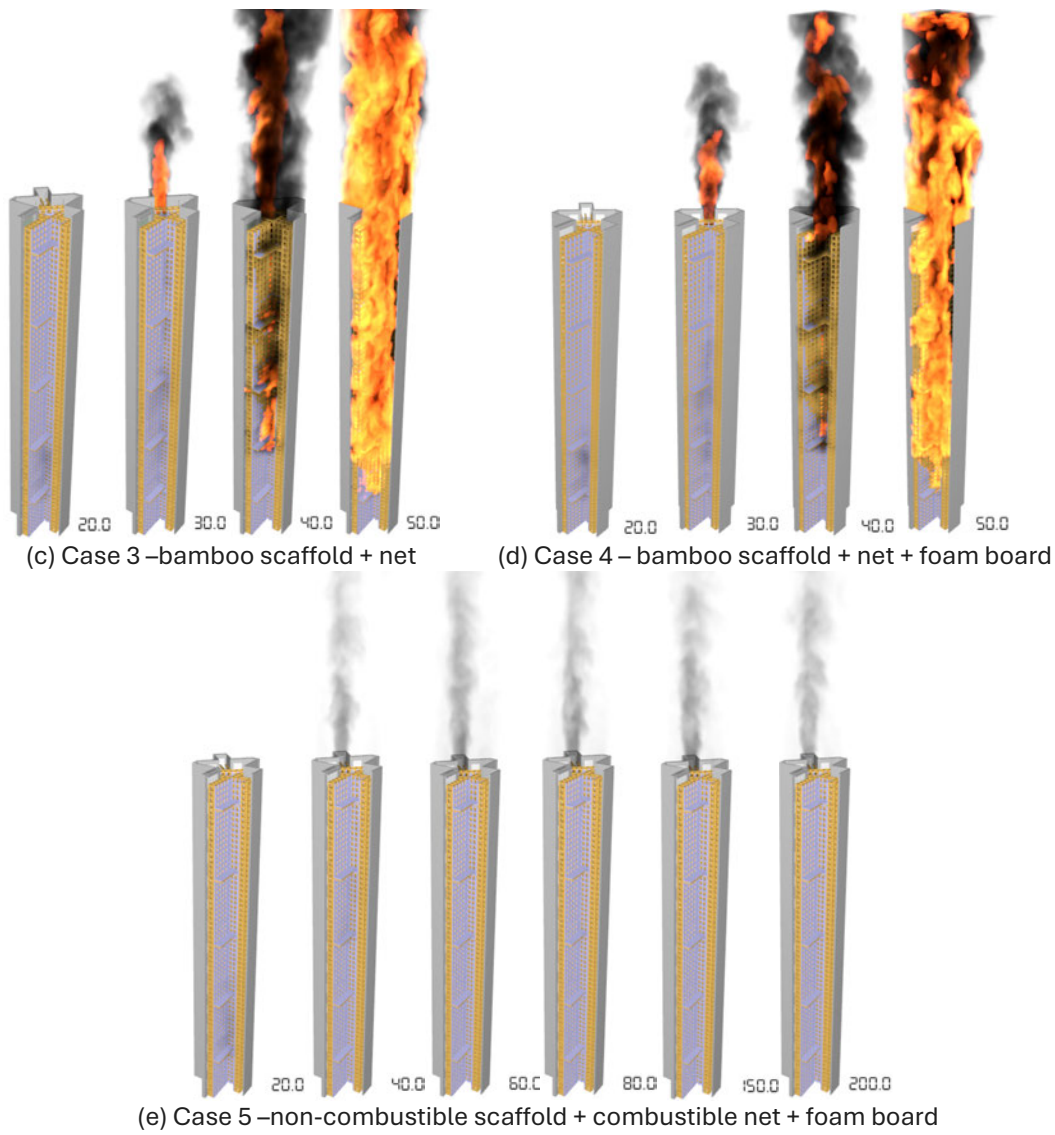
**Figure 3-25. Fire spread**

3.7.10. Fig. 3-25 compares the fire spread process in the re-entrant for Cases 1-5 at selected times, while Fig. 3-26 further compares the fire development of all cases at the same time of 40 seconds.

- 3.7.15. By contrast, in Case 5, where the scaffold geometry was retained but treated as non-combustible, the fire did not develop into large-scale vertical flame spread even with the presence of safety netting and foam boards. Consistent with the experimental tests, the combustibility of non-FR safety nets and foam boards primarily affect the ignition and propagation of the fire in smaller fires, such as during the earlier stages of a fire or in relation to secondary ignition, i.e. they determine whether a small fire escalates into one large enough to involve the bamboo scaffolding and trigger full re-entrant spread.

- 3.7.16. These comparisons indicate that the chimney effect can enhance upward smoke and heat transport, but rapid vertical fire spread is mainly governed by the availability of continuous combustibile materials. Among these components, the netting enhances flame continuity, the foam boards further intensify local façade and window exposure, and where the fire is sufficiently large, bamboo scaffold will also provide a vertical fuel path.

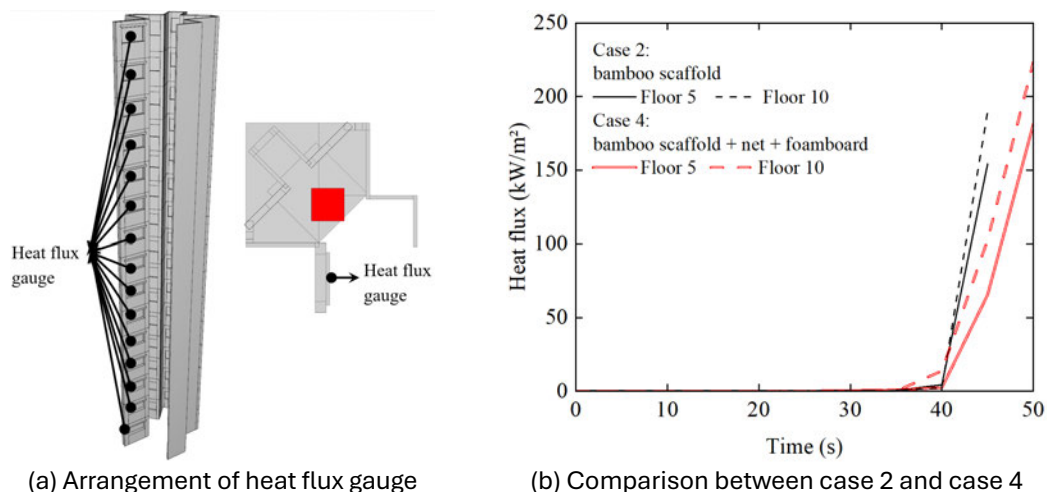
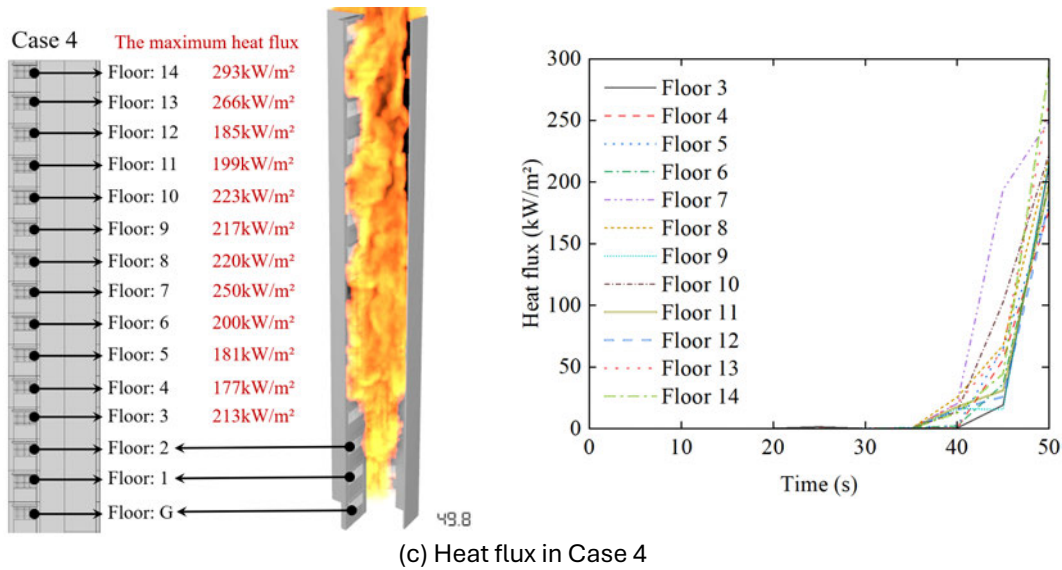
**Figure 3-27. Heat flux gauge**

- 3.7.17. Fig. 3-27 compares the heat flux received by windows under different façade fire configurations. In Case 2, where only the bamboo scaffold is considered, the window is directly exposed to the external flame and hot plume. As a result, the heat flux increases earlier and reaches a high level within a short period.

- 3.7.18. In Case 4, the addition of safety nets and foam boards provides temporary shielding to the window, leading to a slight delay in the heat flux rise. However, once the foam boards ignite, melt, or are consumed, this protective effect rapidly disappears, and the accumulated burning of the scaffold, safety nets and foam boards produces an even more severe thermal exposure.

- 3.7.19. Consequently, the heat flux in Case 4 rises more sharply and reaches a higher level than that in Case 2.
- 3.7.20. Although glass breakage depends on glazing type, size, edge restraint, and exposure duration, previous studies have shown that ordinary float glass may crack at approximately  $4\text{--}6\text{ kW/m}^2$ , while significant fallout can occur at around  $9\text{--}20\text{ kW/m}^2$ ; even tempered glass generally has a critical fallout heat flux of only about  $40\text{--}60\text{ kW/m}^2$ . Therefore, the heat flux levels predicted in Cases 2, 3, and 4, which exceed  $150\text{ kW/m}^2$ , are far above the reported critical ranges for window glass failure. This indicates a high probability of glass cracking and fallout, allowing flames and hot gases to penetrate into the interior and promoting fire spread from the exterior façade to indoor spaces.

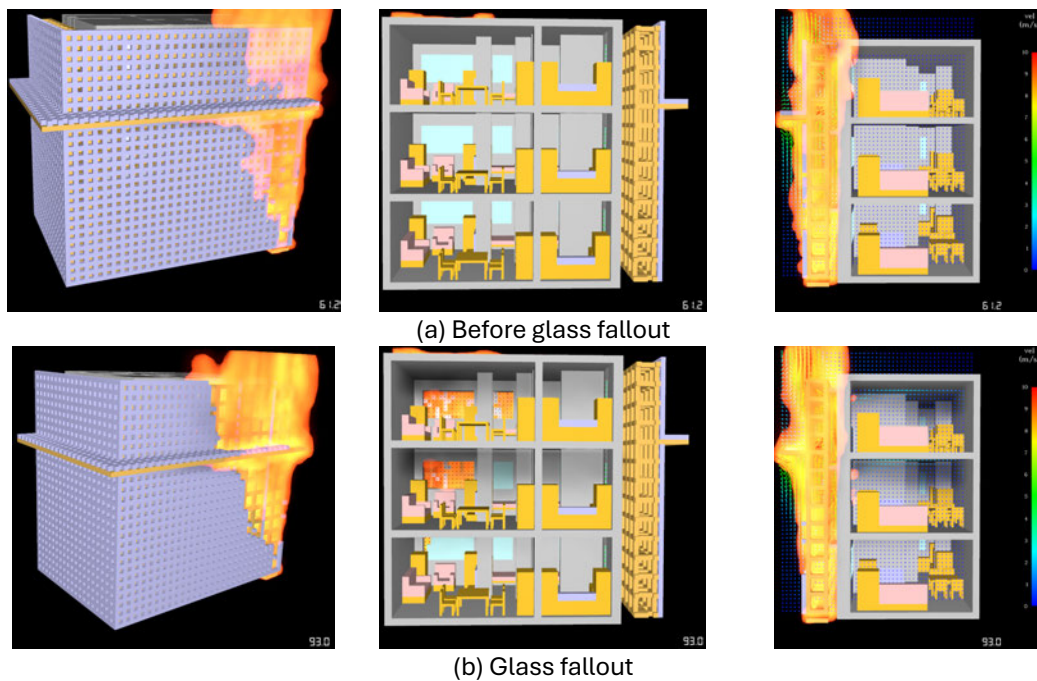
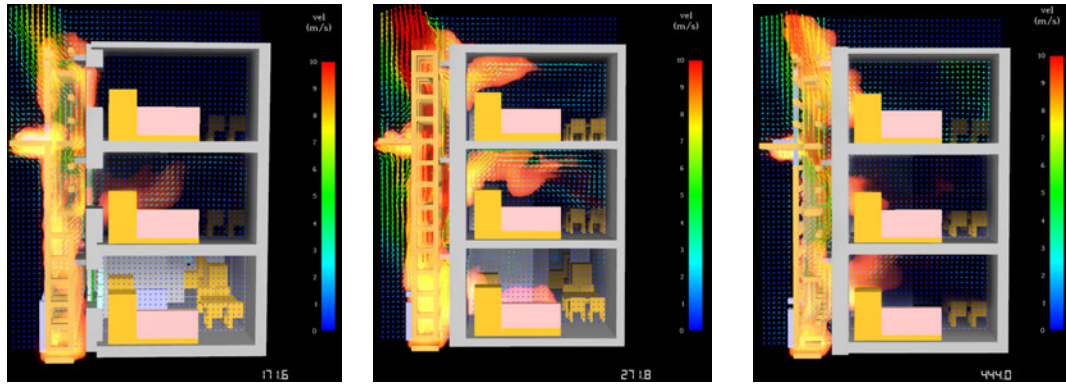
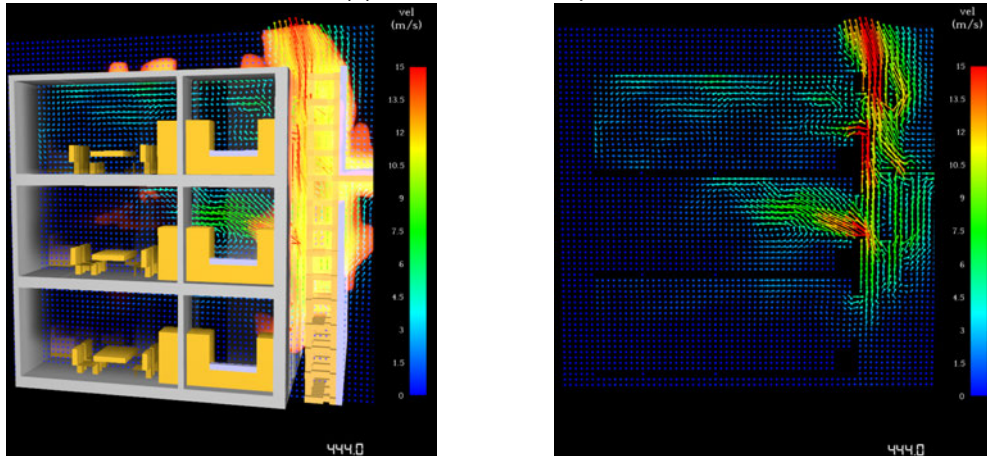
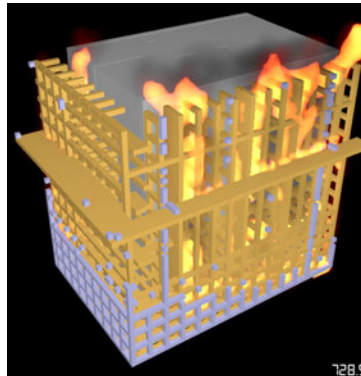
### Figure 3-29. Simulation results

- (a) Before glass fallout, the fire mainly develops along the exterior bamboo scaffold, as shown in Fig. 3-29(a).
- (b) After the window glass falls out, flames and hot gases penetrate into the adjacent rooms, causing ignition of indoor furniture and rapid fire development, as shown in Fig. 3-29(b) and (c). The failed windows become important exchange paths for flame, hot gases, and entrained air between the external scaffold region and the indoor compartments.

- (c) As the indoor fire develops further, flashover occurs in the compartment. The resulting high-temperature gases and flames then break through the windows on the opposite side, where the glass has not been directly exposed to the initial external scaffold fire. As shown in Fig. 3-29(d), the flame ejection from these newly failed windows impinges on the nearby side bamboo scaffold and causes its ignition.

- (d) At the later stage, the compartment fire continues to eject flames outward, sustaining the combustion of the bamboo scaffold and promoting further vertical and lateral fire spread, as shown in Fig. 3-29(e).

- (e) These results indicate that the subsequent fire spread is strongly governed by the coupled interaction among external scaffold combustion, glass fallout, indoor fire development, flashover-induced flame ejection, and secondary ignition of scaffold materials. These results also corroborate the visual evidence of the development of the Wang Fuk Court fire, as analysed in Section 3.4 and 3.5 above.

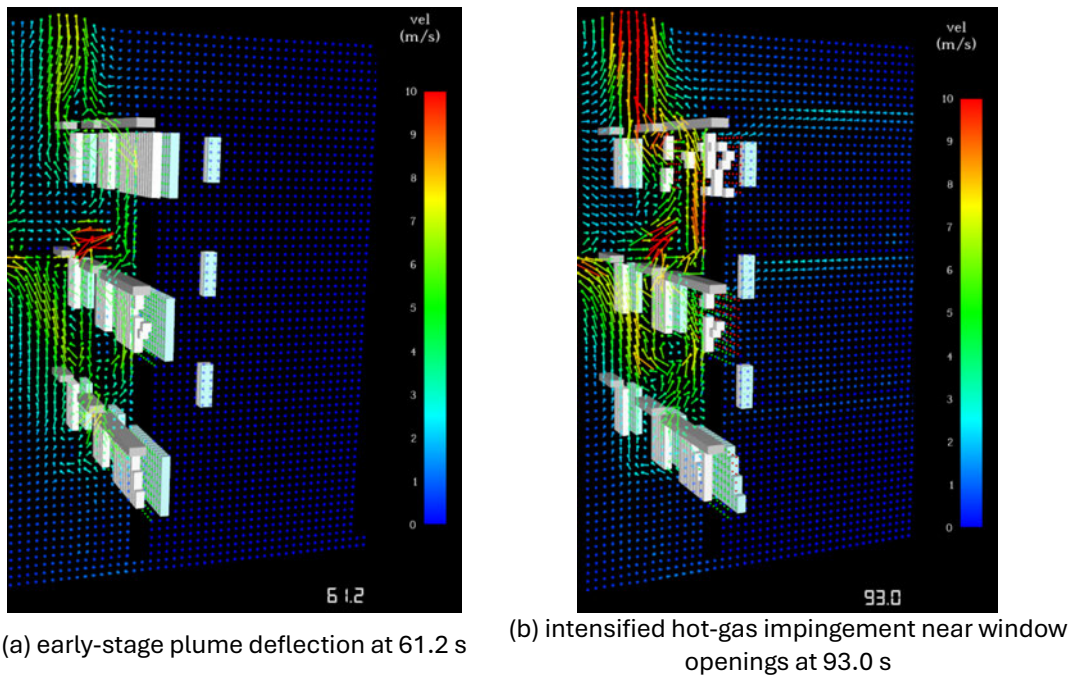
**Figure 3-30. Effect of façade hoods on the local velocity field near foam-board-covered glass windows**

3.7.24. Fig. 3-30 shows the velocity field near the foam-board-covered glass windows. The concrete hoods above the windows significantly disturb the upward movement of the external hot plume. Instead of allowing the hot gases to rise smoothly along the façade, the hoods partially block the vertical flow and redirect the plume toward the window region. As a result, high-temperature gases repeatedly impinge on the foam boards and glass windows beneath the hoods. This local flow obstruction increases the residence time of hot gases near the window surface and enhances convective heating, while the surrounding flames also intensify radiative exposure. With the development of

the external scaffold fire, this impingement effect becomes more pronounced, especially at the upper edges of the window openings. Therefore, the concrete hoods can unintentionally promote the thermal degradation of foam boards and accelerate glass cracking or fallout by concentrating hot gases and flame exposure around the window area. This indicates that the façade hoods do not simply act as passive barriers; instead, they can modify the local fire-induced flow field and increase the likelihood of window failure.

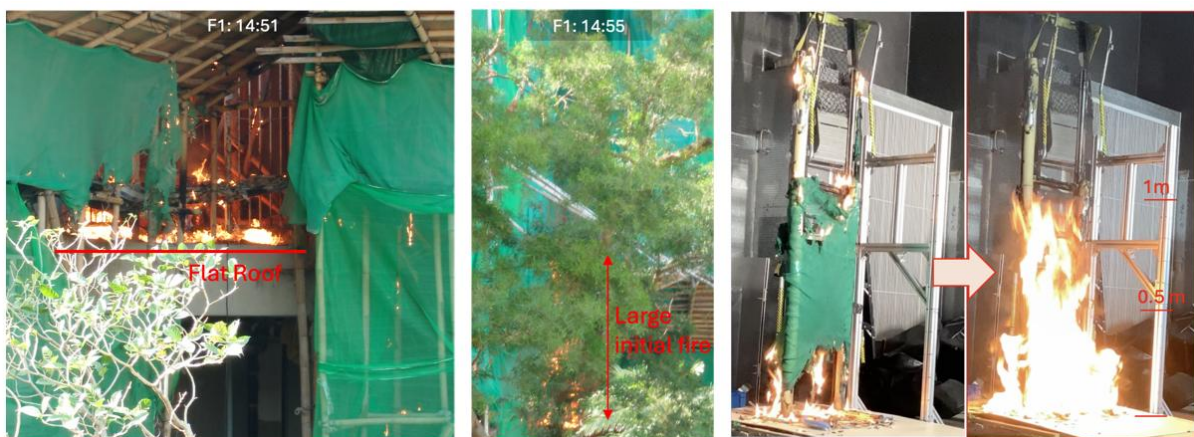
**Figure 3-31. Visual evidence of fire initiation VS fire test observations**

3.8.2. From our analysis of the evidence, this localised fire was formed at the flat roof of re-entrant of Wang Cheong House (F1). By comparing the videos and photos from 14:50 to 14:59 on 26 Nov 2025 and the experimental observations reported in Section 3.6 above, the following findings are suggested:

- (a) The scattered flames on safety nets at 14:51 suggests the ignition of non-FR safety nets at re-entrant F1 of Wang Cheong House (Block F).
- (b) The accumulated dripping and burning of these non-FR safety net over the flat roof could cause a large localised fire as there exists many cardboards and wood panels (reproduced by the test).
- (c) Bamboo sticks joined the combustion when the localised fire is large enough (flame height reaching 1 m), which further enhanced the localised fire and eventually leading to the re-entrant fire due to chimney effect.

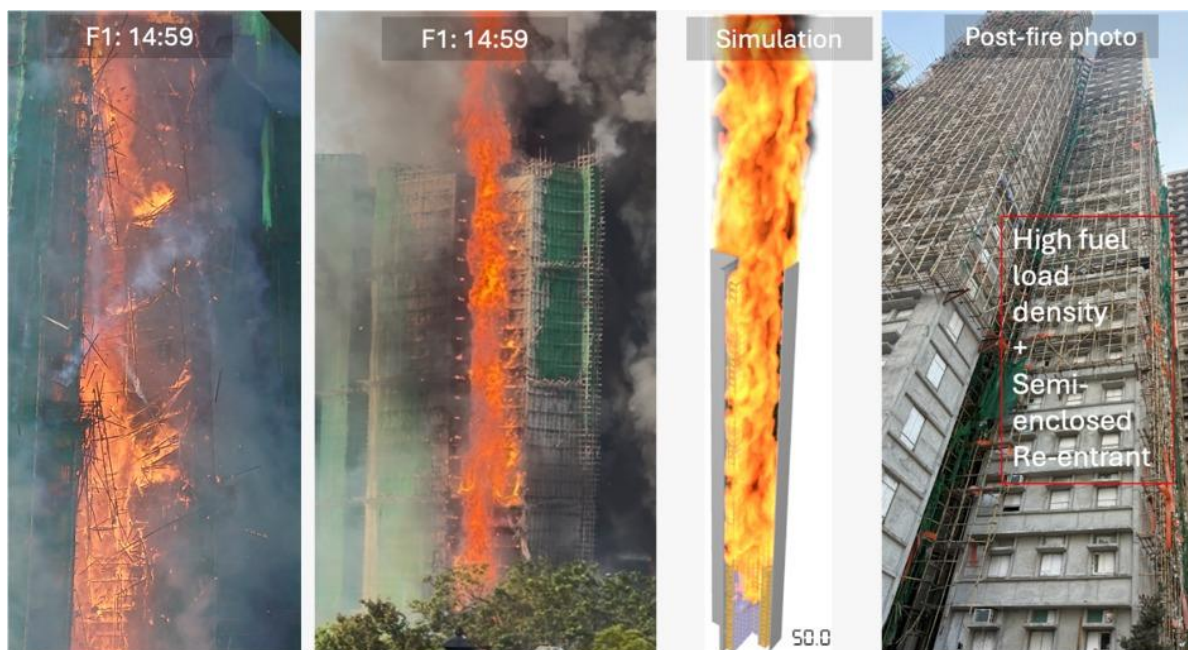
**Figure 3-32. Typical re-entrant fire**

3.8.5. The localised fire at flat roof (bottom of re-entrant region) would heat these combustible items and a huge amount of pyrolysis gas would have been generated from bamboo and wood, while the burning of pyrolysis gas would in turn further intensify the fire. Moreover, due to the semi-confined space, significant energy conservation occurred and the burning efficiency is extremely high. This is a possible reason for the fact that the vertical re-entrant fire of a massive size only maintained for 2-4 minutes.

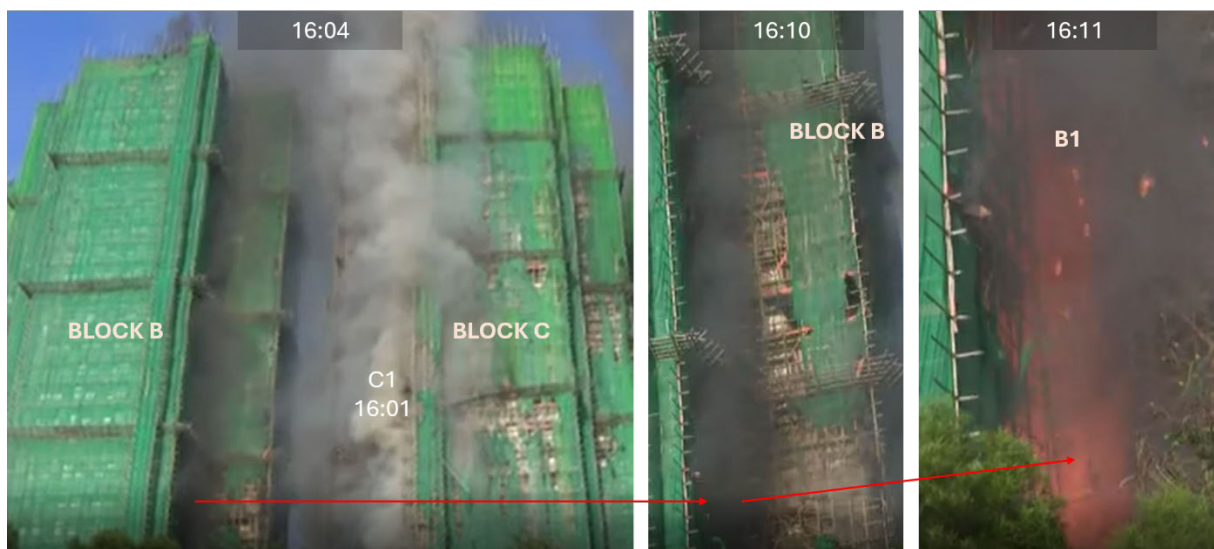
**Figure 3-33. Visual evidence of re-entrant fire initiation of B1**

- 3.8.7. If the safety net of a neighbouring building is not fire retardant, it is possible to catch small fires at the building façade, which may lead to a re-entrant fire depending on the location where the neighbouring building's safety nets caught fire (e.g. Wang Kin House (Block D)). The ignition of façade materials would generally have to form a localised fire at the flat roof, so as to be able to initiate a re-entrant fire.
- 3.8.8. It should be also noted that the progression of re-entrant fires at Wang Cheong House (Block F) and Wang Tai House (Block E) was extremely fast, which may be more likely due to the ignition of stacked renovation materials at ground floor.

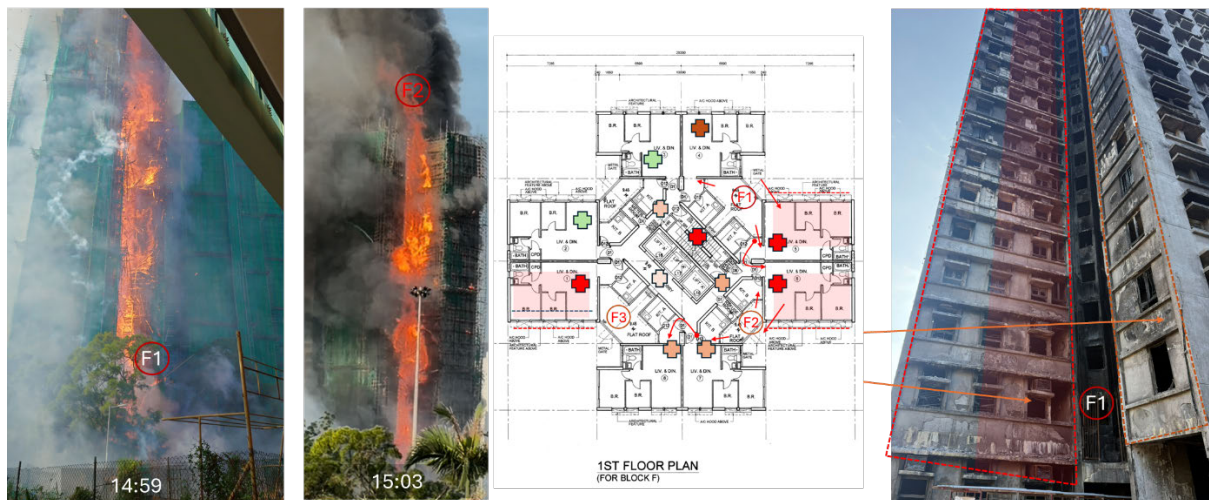
**Figure 3-35. Room units with living room windows facing to extended re-entrant fire**

- 3.9.3. The fast developing vertical fire created high-intensity heating impact over the façade walls in the vicinity of each re-entrant. Meanwhile, the extended flames of vertical fire impinged on the façade walls, including the side walls. Due to the high-intensity heating, the glass windows of kitchens would fail first, causing severe damage at kitchens facing the re-entrant fire. However, this might be not a devastating factor leading to the widespread room unit fires, as the kitchens were isolated from living rooms by fire-rated doors in most units (it is noted that some units had their kitchen doors changed to non-fire rated doors).

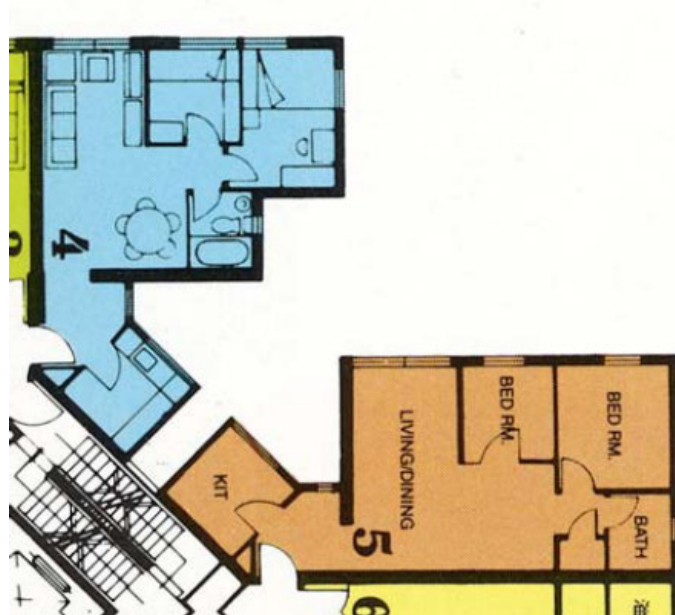
**Figure 3-36. Typical re-entrant of building blocks of Wang Fuk Court**

- 3.10.3. In Wang Fuk Court, the geometric configuration of the re-entrant corners, together with additional combustible materials within it, significantly enhances all three elements of the fire triangle and accelerates vertical fire spread in this semi-open space. Fig. 3-36 shows the trapezoid-shaped space located between Flat 4 and Flat 5 in a typical block of the estate. A slot between the kitchens of these two flats connects this trapezoid-shaped space to the external wall of the staircase and the staircase wired-glass window (**WGW**), forming the plan layout of the re-entrant. This space extends continuously from the first-floor roof up to the building roof level.

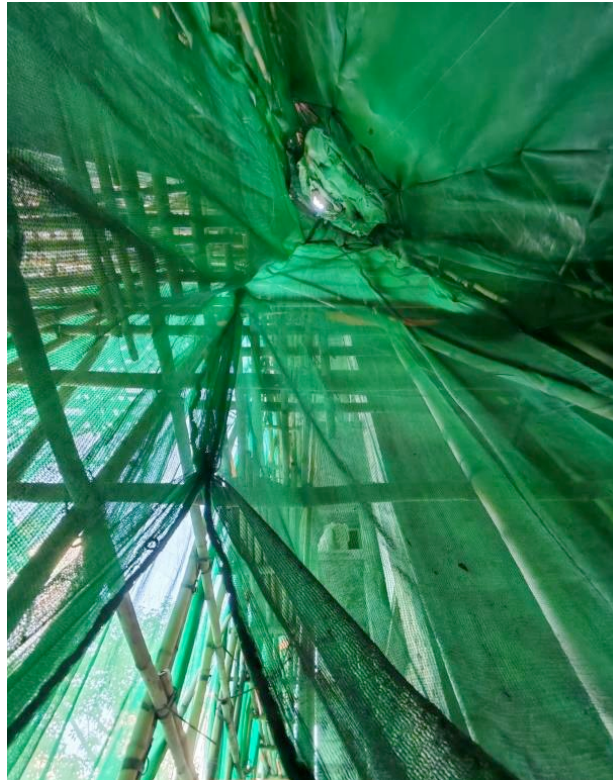
**Figure 3-37. Fuel load in re-entrant**

- 3.10.4. When a fire starts in the re-entrant, the surrounding walls reflect thermal radiation back onto the fuel, establishing a thermal feedback loop, greatly accelerating its pyrolysis (hence more heat is released).
- 3.10.5. Fig. 3-37 shows a photo of the re-entrant during renovation. A large amount of combustible material is present in this space, including bamboo scaffolding and safety nets. Because of the peculiar geometry of this space, the fuel density per unit volume is significantly higher than it would be on a planar façade (so more fuel is available).
- 3.10.6. The fire plume inside the re-entrant entrains as much fresh air as required from the open side of the trapezoid for more pyrolysis of the fuel vapours, accelerating the combustion process. The combination of all these three enhanced elements leads to rapid fire development and vertical spread within the re-entrant.

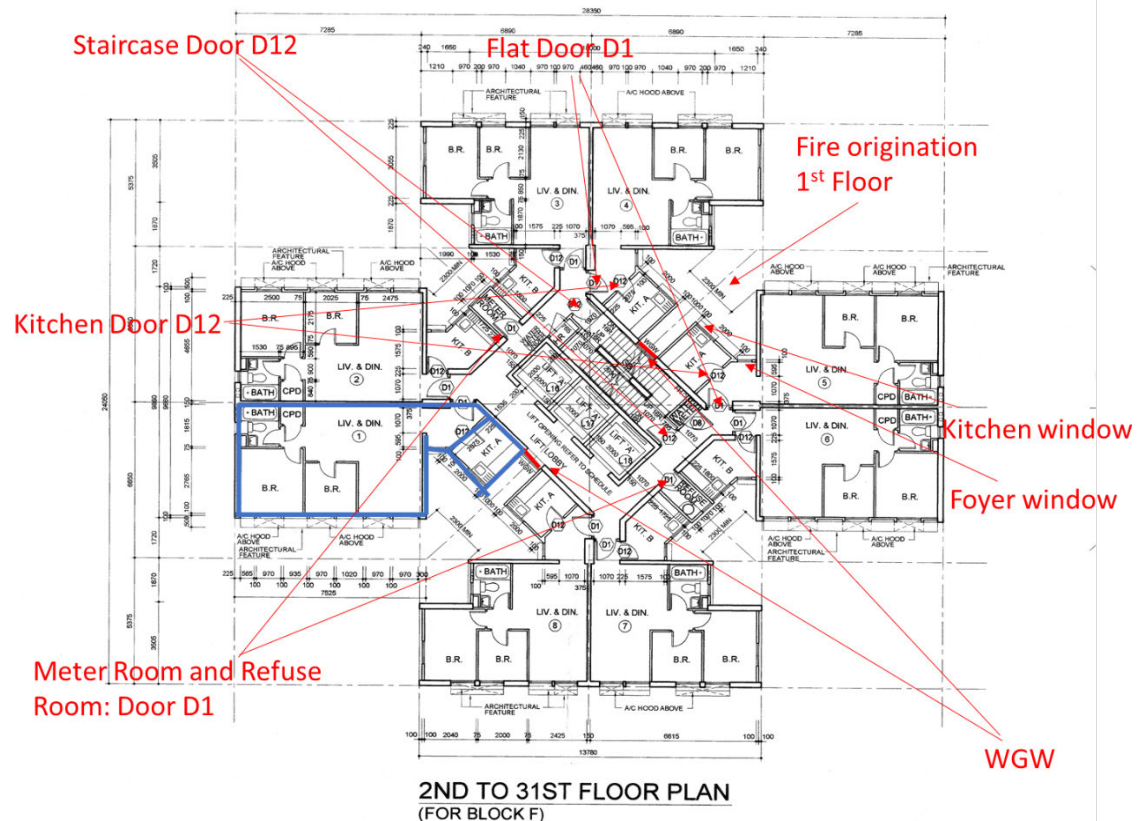
**Figure 4.1. Wang Cheong House Floor Plan, as-built drawing**

- 4.1.4. Fig. 4.1 shows as-built drawing of Wang Cheong House (Block F) with marked information of fire separation. The main entrance door to each flat is required to be a fire-rated assembly. On the submitted building plan (as-built drawing), it is identified as "D1" and specified as a "Single Leaf 50 mm Thick Solid Core Flush Door (Self Closing)." This description aligns with a standard fire-rated door; a 50 mm solid core timber door of this type typically provides a Fire Resistance Rating (i.e. FRR) > 1.0 hour. The applicable Code of Practice before 1980s requires an FRR of the flat entrance door not less than ½ hours.

- 4.1.6. CoP 1976 requires a lobby with FRR door to access the staircase from internal corridor. The lobby does not exist in the design as shown in Fig. 4.1.

- 4.1.8. The kitchen door is also identified as “D12” and is specified to provide a ½-hour fire resistance rating (i.e. FRR). CoP 1976 did not specify an FRR requirement for kitchen doors. However, Clause 11 (1) states “Every flat or tenement floor which is provided with a single exit door shall be so arranged that the entrance to the kitchen is not adjacent to the exit route, within the flat or tenement, to such exit door. Provided that the kitchen door may be adjacent to the exit route if: (a) such door is self-closing, and (b) the capacity of the flat or tenement floor does not exceed ten persons”. Therefore, the kitchen door specification shown in Fig. 4.1 exceeds the requirements of the CoP 1976 or at least complies the code requirements.

- 4.1.13. Based on a review of the as-built drawings (Fig. 4.1), four potential paths for lateral fire spread from the façade to the flats have been identified in the Wang Fuk Court fire:

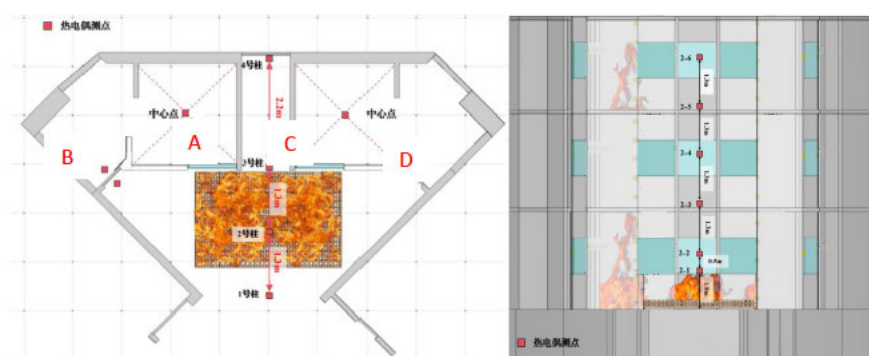
**Figure 4.3. Location of thermocouple trees (from the Yuen Interim Report)**

4.1.19. To evaluate this assertion in the Yuen Interim Report, the temperature measurements from the full-scale fire tests in the Yuen Interim Report were examined. The primary measurement locations of interest (Location A) are inside the kitchen, as shown in Fig. 4.3 (reproduced from Fig. 2.9 of the Yuen Initial Report at Appendix A-27(A) of the IFITF Final Report).

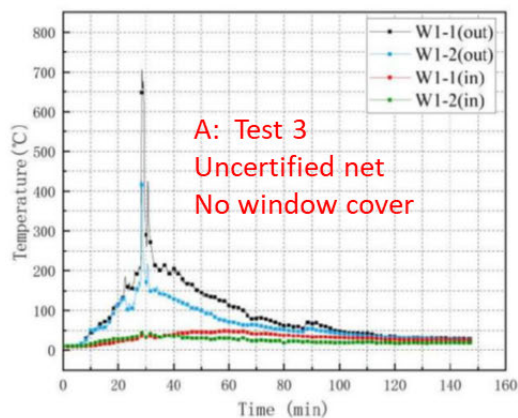
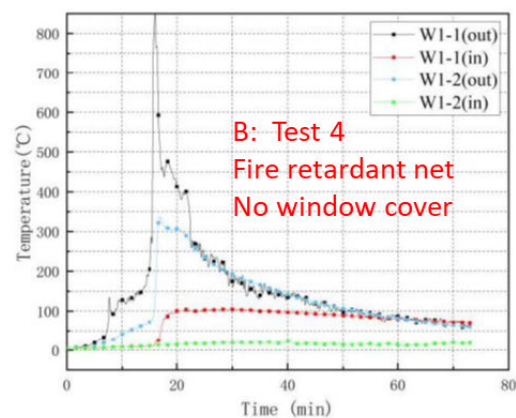
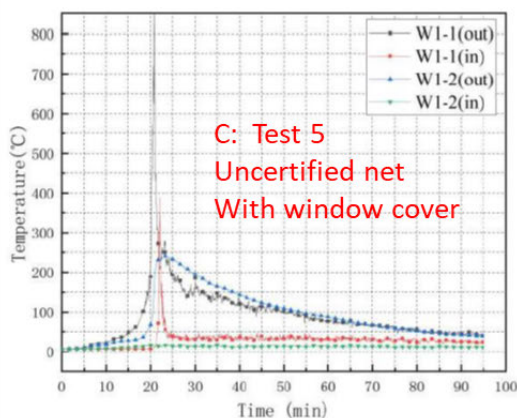
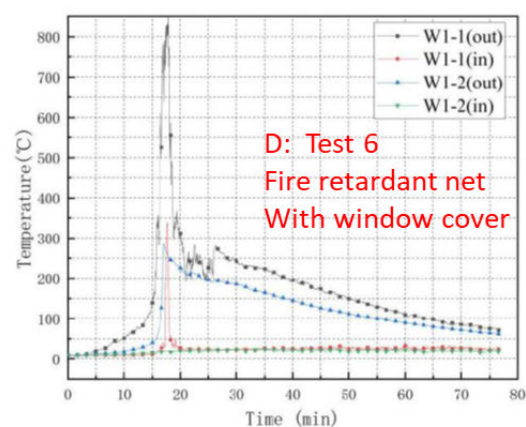
**Figure 4.4. Measured temperatures at Window A (outside and inside the kitchen window, reproduced from the Yuen Interim Report)**

4.1.21. Table 4.2 compiles the maximum temperature readings recorded at Window A. The label "W1-1 in" refers to the thermocouple located inside the kitchen, as illustrated in Fig. 4.3. These maximum values and the times to reach them were extracted from the temperature-time curves in the Yuen Interim Report (e.g., the 50°C reading for Test 3 was extracted from "Fig. 2.36 Temperature at A of Floor I and II"). The temperature-time curves of 4 tests are reproduced in Fig. 4.4.

4.1.23. Direct comparison of these tests reveals that the presence of the polystyrene foam board covers directly caused—or accelerated—the thermal shock and

subsequent breakage of the window glass. This failure mechanism enabled lateral fire and smoke spread into the building's interior.

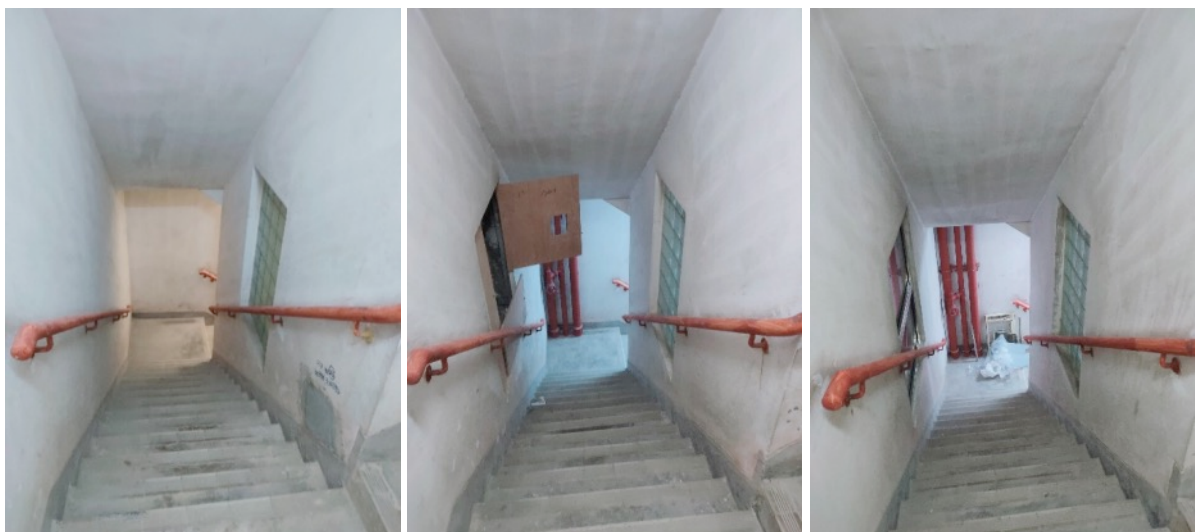
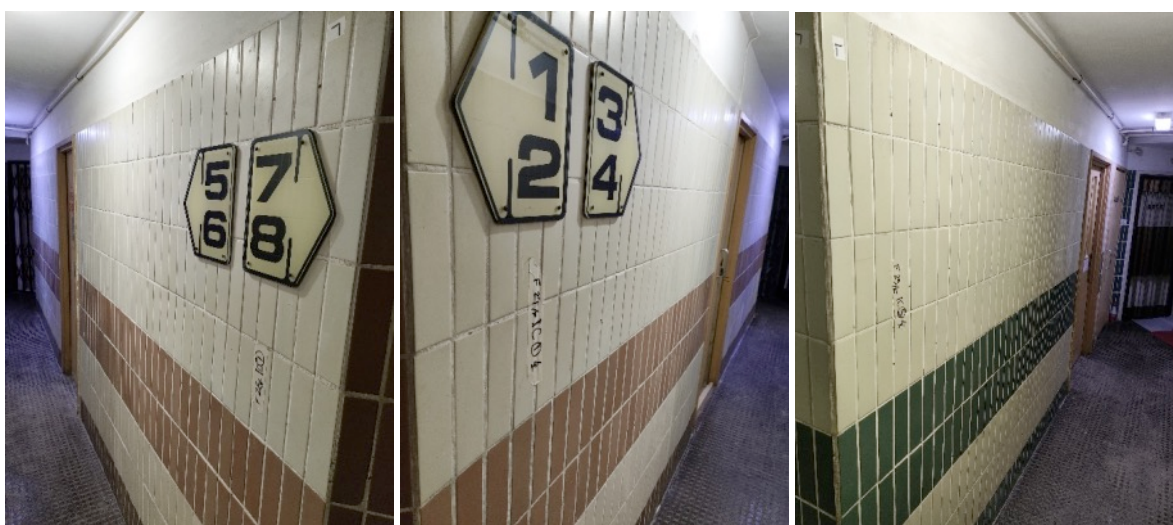
- 4.3.2. Fig. 4.5 and 4.6 show that the staircases and common corridors were clear and free of combustible materials prior to the fire incident. It is therefore reasonable to conclude that no localized fires developed in these areas, including the lift lobbies. Fig. 4.7 shows the wired glass windows (i.e. WGW) in the staircase and the lift lobby. The upper part of each WGW was open. This configuration was code-compliant and intended to provide natural lighting and ventilation. As illustrated in Fig. 4.7, both windows were located within the re-entrant, where smoke from a re-entrant fire could readily enter the staircase and lift lobby (common corridor). Smoke inhalation was therefore likely the major contributor to the fatalities that occurred in these areas.

**Figure 4.5. Conditions of staircases before fire**

**Figure 4.6. Conditions of common corridors before fire**

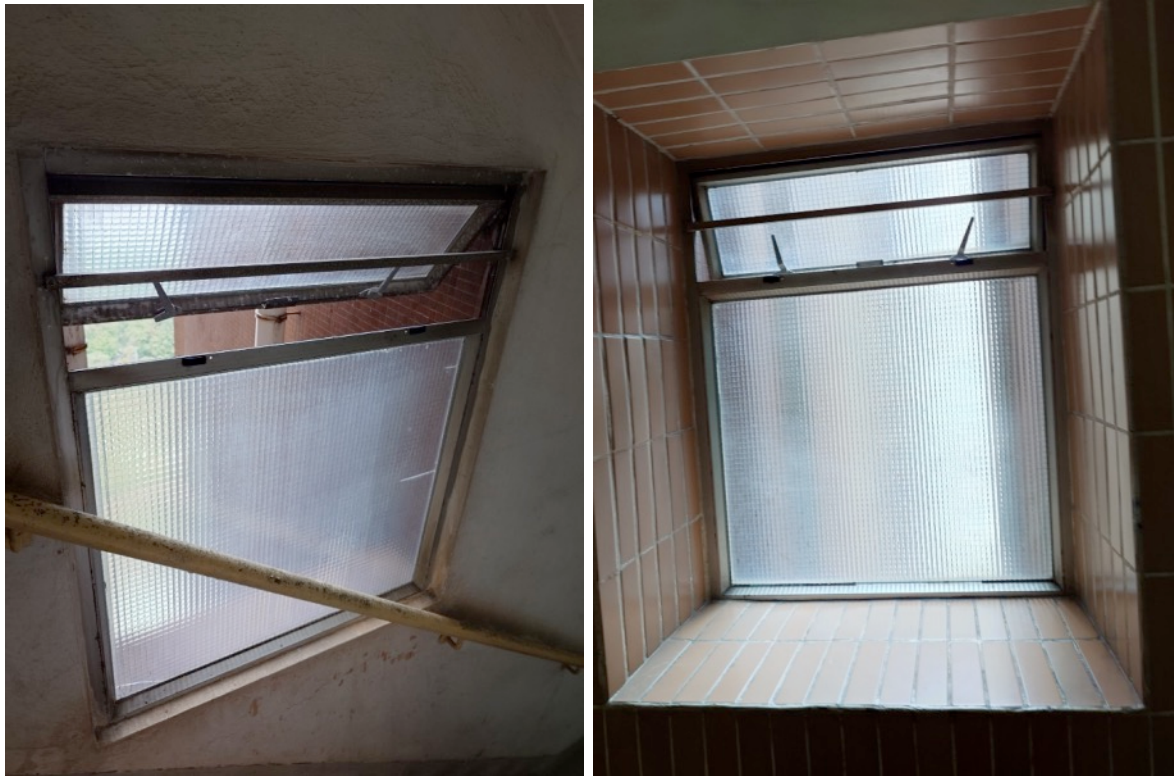
- 4.1.12. The fire at Wang Fuk Court was a rapidly developing fire within the re-entrant. Under this condition, these WGWs would have been likely to fail at some point. Further exacerbating this situation is the fact that some of the WGWs had already been removed and left open with access openings for workers to access the external scaffolding. This would allow smoke to quickly fill the scissor staircases and common corridors, compromising the only means of escape and preventing occupants on the upper floors from evacuating.

**Figure 4.7. Wired glass window (WGW) in (a) staircase; (b) lift lobby**

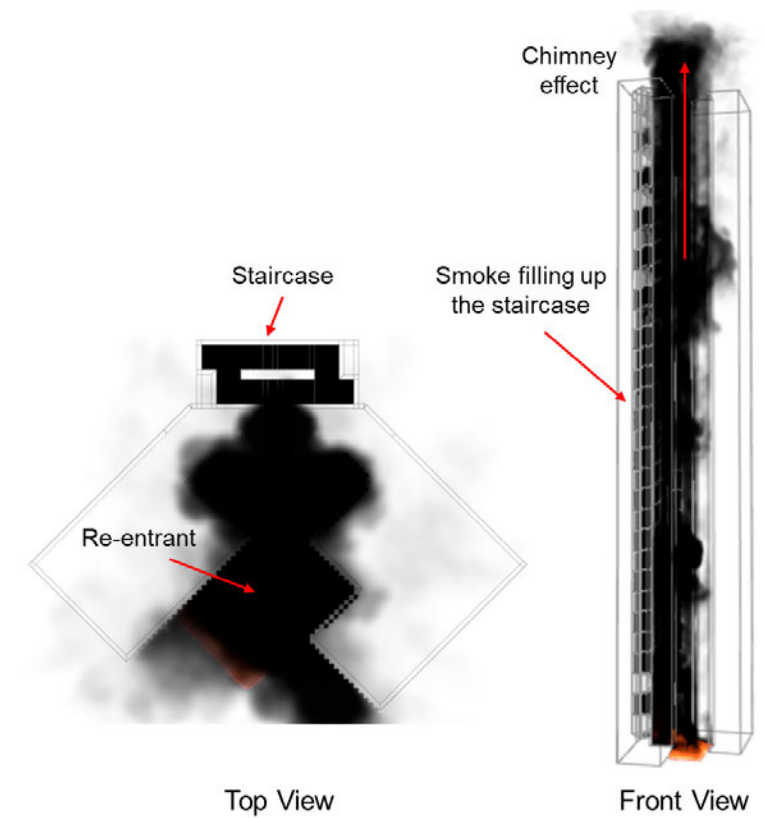
**Figure 4.8. Simulation results of smoke spread from the re-entrant into the staircase**

- 4.3.4. The simulation assumed that fire initiated at ground level at the bottom of the re-entrant. Due to the chimney effect, flames and smoke rapidly entered the re-entrant. The open windows/doors every five floors created a pressure differential, drawing smoke from the re-entrant into the staircase. Smoke gradually filled the staircase from the lower to the upper levels, eventually compromising the entire staircase from the ground floor to the roof.

- 4.3.5. The simulation results indicate a very rapid vertical spread of fire gases in the re-entrant, with smoke entering the staircases and lift lobbies on all floors. Fig. 4.8 shows the simulation results of smoke spread from the re-entrant into the staircase.

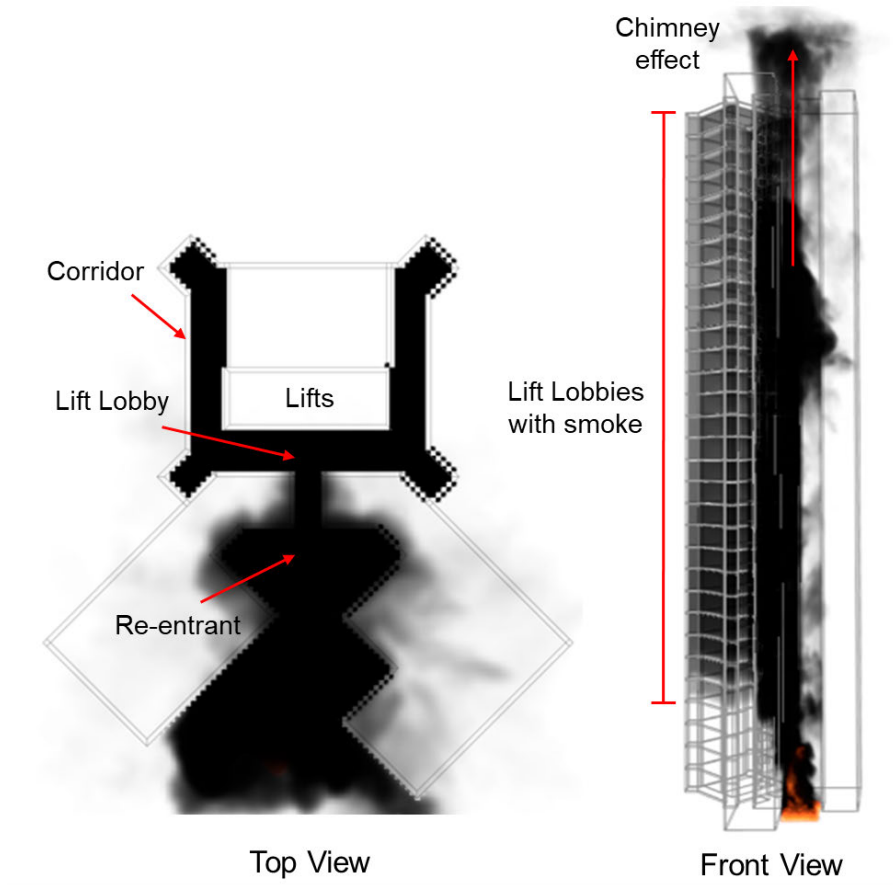
**Figure 4.9. Simulation results of smoke spread from the re-entrant into lift lobbies.**

- 4.3.6. As shown in Fig. 4.9, smoke spread rapidly upward through the re-entrant due to the chimney effect. Because the internal pressure in the lift lobbies was lower than in the re-entrant, smoke flowed inward through the open ventilation windows, gradually filling the lift lobbies and adjacent corridors with smoke and toxic gases (Fig. 4.10).

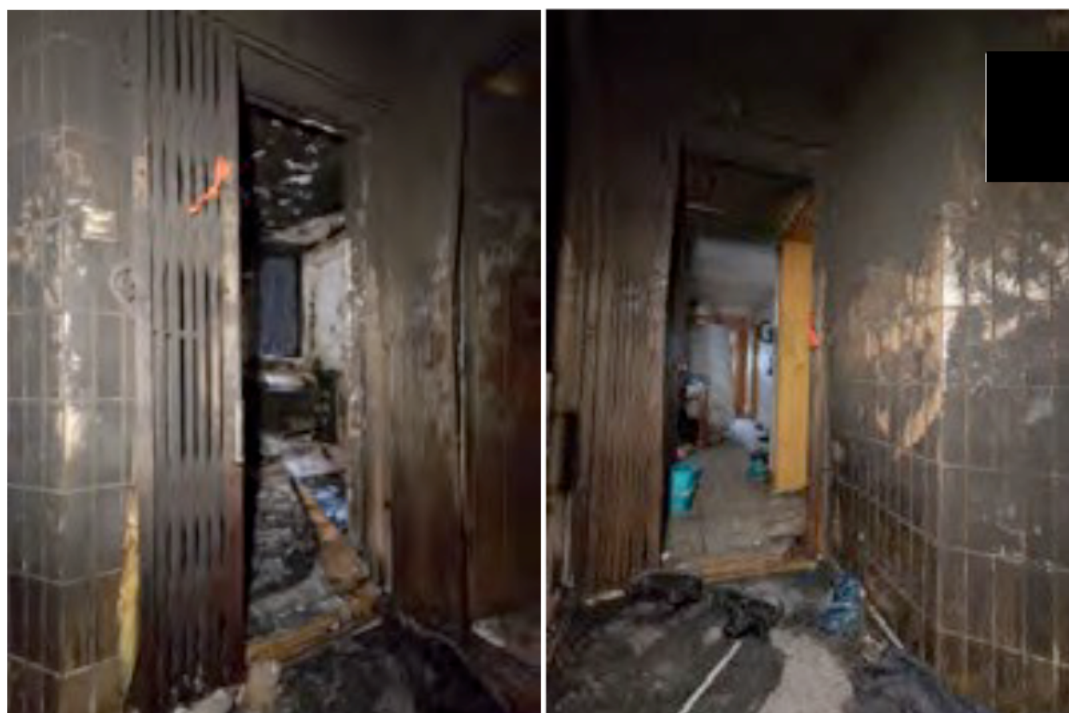
**Figure 4.12. Entrance door of (a) Unit 01 and (b) Unit 02, Wang Cheong House**

4.3.12. Unit 01 was totally consumed, and its entrance door was burnt through (Fig. 4.12a). The entrance door of Unit 01 is immediately adjacent to the entrance door of Unit 02. The post-fire photograph of the Unit 02 entrance door (Fig. 4.12b) shows significant charring on the upper portion of the leaf and heavy soot deposition on the ceiling of the entrance foyer inside of Unit 02. This

indicates that hot smoke penetrated into Unit 02 through the door gaps while other flats on the same floor were burning for an extended period.

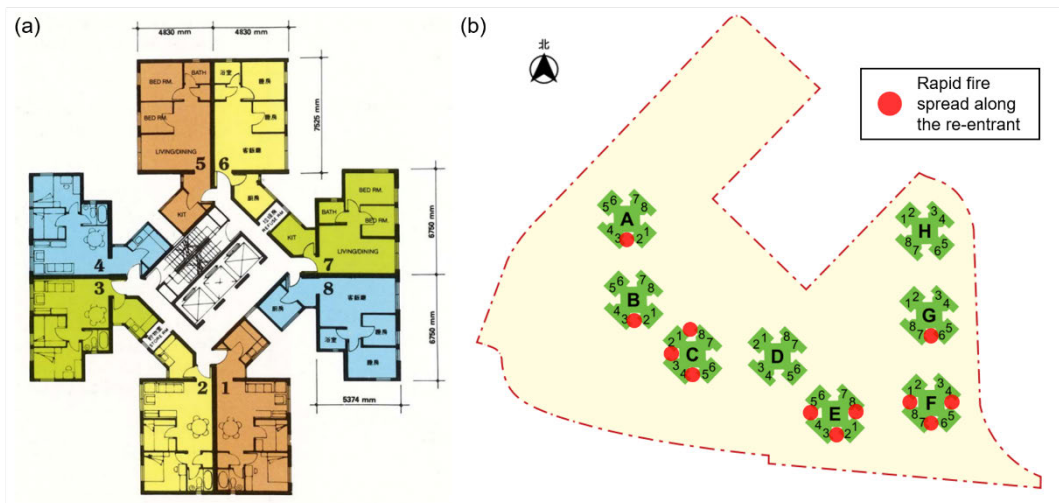
**Figure 1. (a) Typical floor plan (Wang Cheong House) of Wang Fuk Court buildings, and (b) re-entrant fire locations where the chimney effect occurred.**

- 1.1.1. High-rise residential buildings at Wang Fuk Court in Tai Po incorporate re-entrant spaces, also known as re-entrance bays or light wells (Figure 1). These semi-enclosed vertical shafts, formed by adjacent apartments, are designed to provide natural ventilation and daylight under normal operations.
