This document is the consolidated Expert Report of Prof. Asif Sohail Usmani and Prof. Jiang Liming (incorporating the Expert Report dated 15 June 2026 and Corrigendum dated 24 June 2026)

**Independent Committee in relation to  
the fire at Wang Fuk Court in Tai Po**

**Expert Report**

**Prof Asif Sohail Usmani  
Prof Jiang Liming**

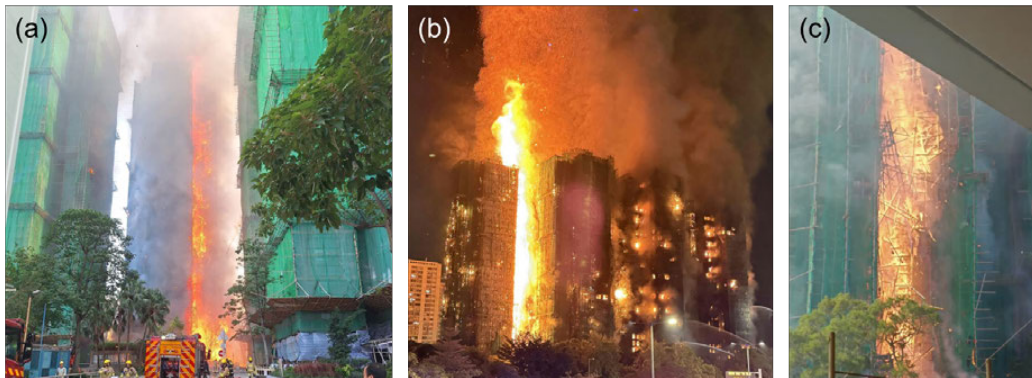
**Figure 2. Chimney effect observed at (a) Wang Cheong House west re-entrant and (b) Wang Yan House south re-entrant, and (c) combustible scaffolding burning along the re-entrant (credit to RTHK and HK01).**

- 1.2.3. In the Wang Fuk Court incident, renovation materials (e.g. bamboo, non-fire-retardant safety nets) added substantial fuel load (Figure 2c), which intensified the fire size and temperature, and thereby strengthened the chimney effect.

- 1.5.4. In Wang Fuk Court fire, the open-face area was further reduced by scaffolding, plastic mesh netting, and renovation materials, likely lowering the critical HRR even more. Restricted openings concentrate inflow and trap radiant heat, intensifying the draft. Even with the initial fire source outside, induced negative pressure pulled flames inward. Additionally, the fuel loads (i.e. bamboo and combustible renovation materials) were built along the re-entrant and façade, which allow continuous ignition and rapid upward climb. Notably, a relatively small initial fire at the Wang Cheong House east re-entrant reached the roof within minutes, while bamboo members fell and accumulated on the ground, which contributed a large HRR (Figure 2a).

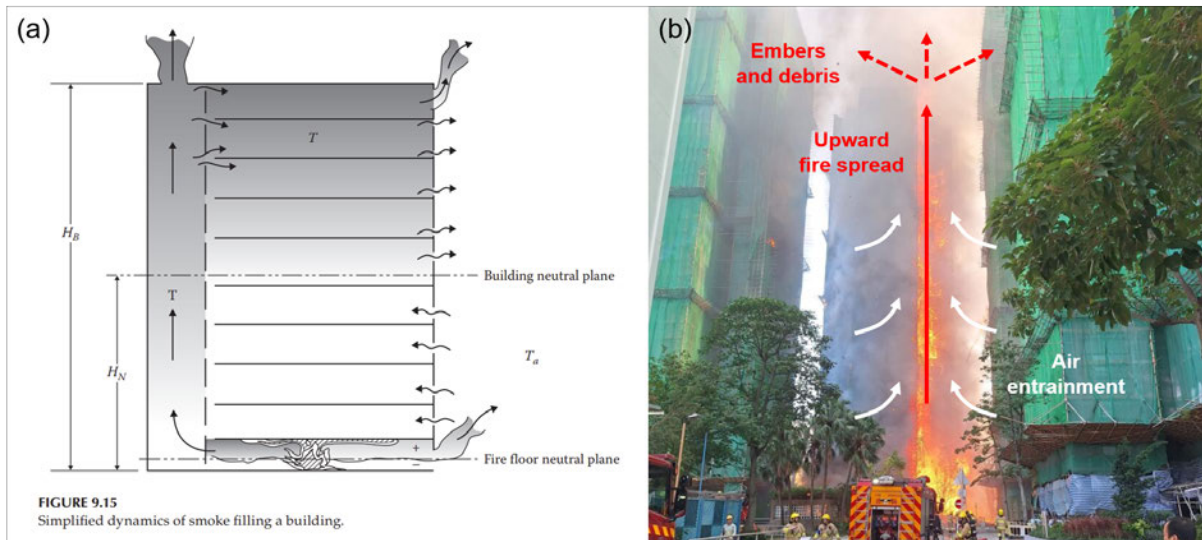
**Figure 3. (a) Fire spread mechanics driven by chimney effect <sup>[5]</sup> and (b) chimney effect at Wang Cheong House west re-entrant.**

- 1.2.2. In re-entrant spaces, the geometry acts as a partial chimney, which allows rapid vertical propagation of flames and smoke. The enclosed walls restrict lateral entrainment, while the open face allows air entrainment (Figure 3). The pressure differential  $\Delta P$  is quantified by the stack effect equation:

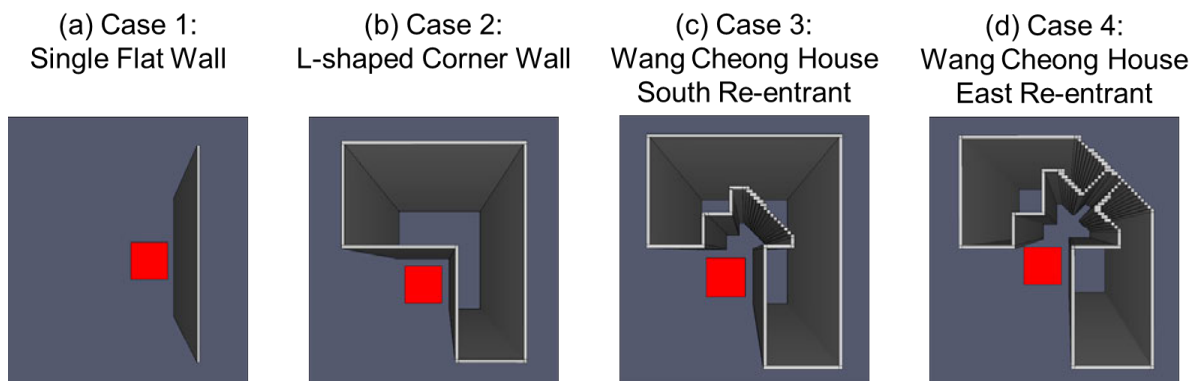
**Figure 4. Re-entrant models of (a) Case 1: single flat wall, (b) Case 2: L-shaped corner wall, (c) Case 3: Wang Cheong House south re-entrant, and (d) Case 4: Wang Cheong House east re-entrant.**

- 1.3.1. A CFD model was developed using Fire Dynamics Simulator (**FDS**) to simulate the Wang Fuk Court re-entrant configuration. The building geometry was simplified, with focus on the re-entrants. The model represented a 31-storey re-entrant bay approximately 100 m in height, based on Wang Cheong House. Vertical scaffolding fuel load and wind effect were not considered in the model. Four re-entrant shapes were simulated to represent increasing levels of lateral confinement, including single flat wall (Case 1), L-shaped corner wall (Case 2), semi-enclosed Wang Cheong House south re-entrant (Case 3), and semi-enclosed Wang Cheong House east re-entrant (Case 4), as shown in [Figure 4](#). The detailed simulation parameters are shown in [Table 1](#).

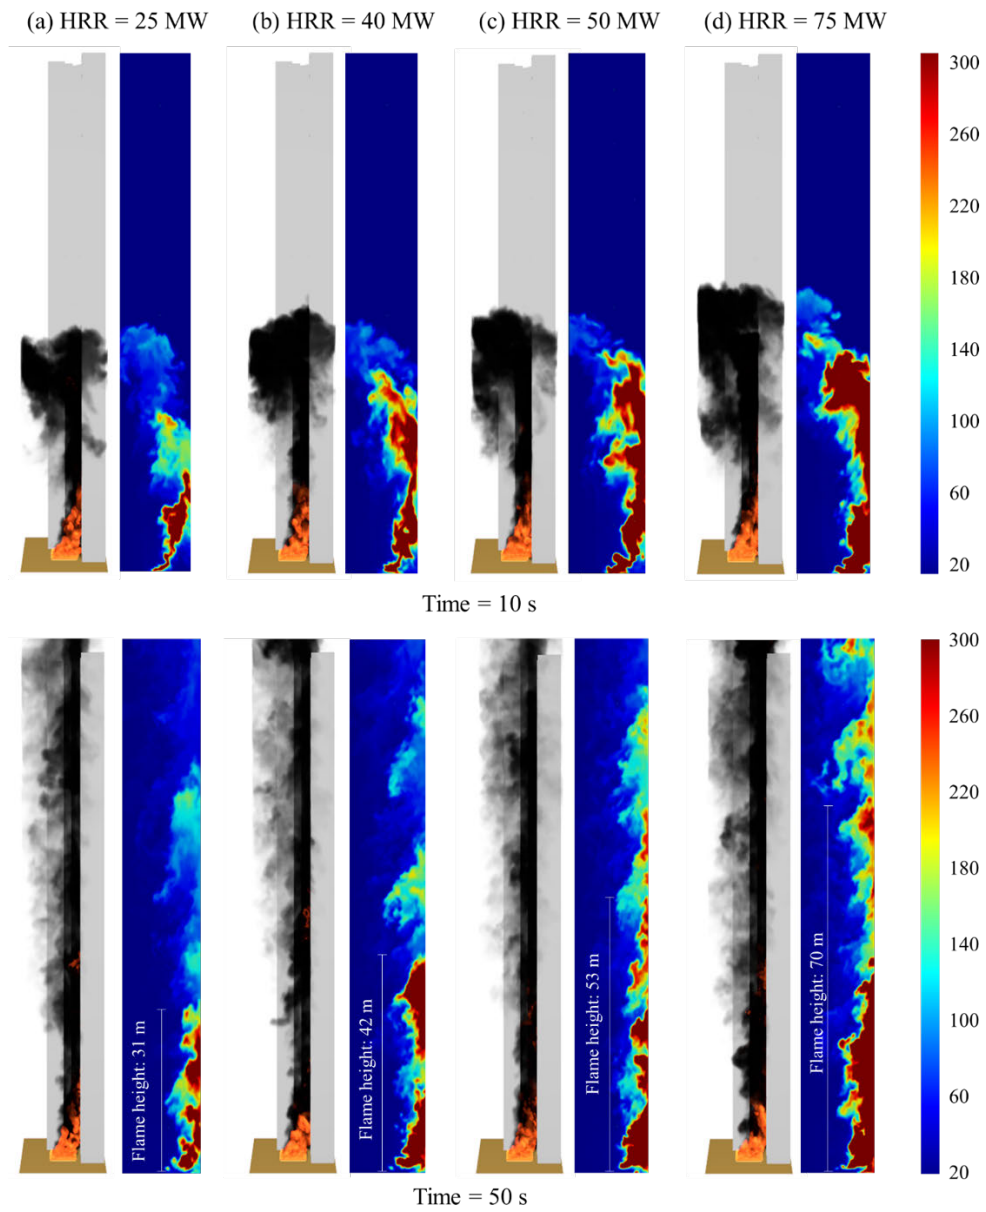
**Figure 7. Visualization of flame height and temperature contours in Case 3 (Wang Cheong House south re-entrant) for HRRs of (a) 25 MW, (b) 40 MW, (c) 50 MW, and (d) 75 MW.**

- 1.5.2. Numerical simulations also focused on identifying the critical HRR for the Wang Cheong House south re-entrant (Case 3). Results indicate that a 50 MW fire is capable of producing a flame height continuously reaching 50 m height in this configuration (Figure 7c-d). The narrow geometry enhances radiation feedback and restricts lateral entrainment, raising gas temperatures and strengthening the chimney effect. This allows flames to reach roof level at a relatively lower HRR compared with more open designs.

- 1.5.3. Below the critical HRR, flames remain intermittent and confined to the lower 30 to 40 m (Figure 7a-b). Once the critical HRR is exceeded, flame height increases, with continuous external flaming at the roof. As shown in Figure 8a, sustained gas temperatures above approximately 200°C at upper levels could provide sufficient radiant and convective heating, making the materials in the upper floors easier to ignite. Figure 8b further shows that a larger HRR leads to higher gas velocities at elevated floors, which may enhance upward flame spread and accelerate the transport of hot gases and firebrands, thereby increasing the fire risk in upper floors.

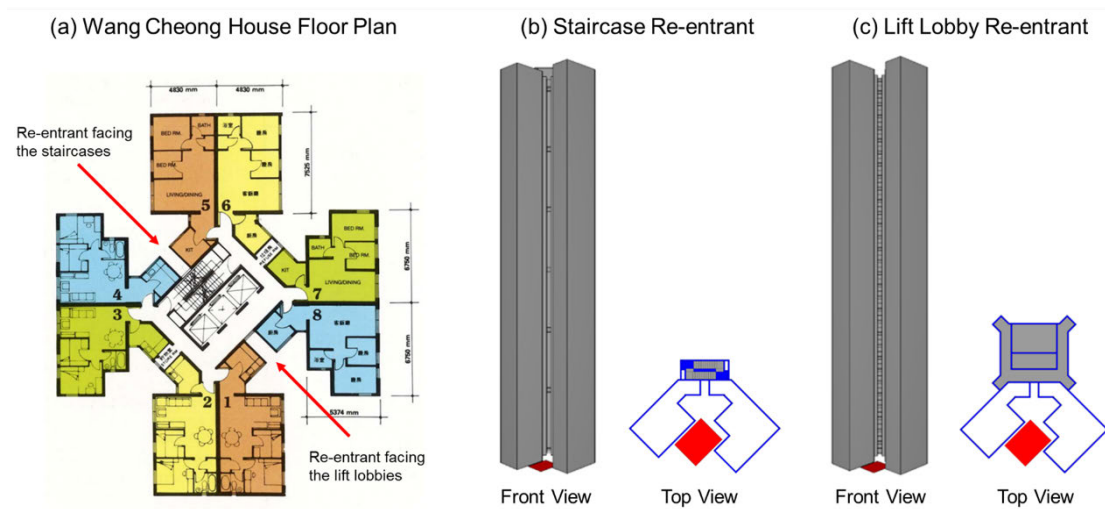
- 2.1.1. Same as Section 1, Computational Fluid Dynamics (i.e. CFD) simulations were performed by using Fire Dynamics Simulator (i.e. FDS) to investigate vertical fire spread from the re-entrant into the staircases and lift lobbies of Wang Cheong House ([Figure 9a](#)). The building geometry was simplified, focusing on one re-entrant. The model represented a 31-storey building with 83.7 m in height, based on the Wang Cheong House floor plan. Each floor height was assumed as 2.7 m (including floor slab thickness).
- 2.1.2. Two scenarios were simulated: re-entrant connected to staircase windows ([Figure 9b](#)), and re-entrant connected to lift lobby ventilation windows ([Figure](#)

9c). Vertical scaffolding fuel loads (e.g. bamboo, plastic net, and renovation materials) and wind effects were not considered in the models. The detailed simulation parameters are listed in Table 2.

**Figure 9. (a) Re-entrant locations in Wang Cheong House and re-entrant models: (b) connected to staircase windows, and (c) connected to the lift lobby windows.**

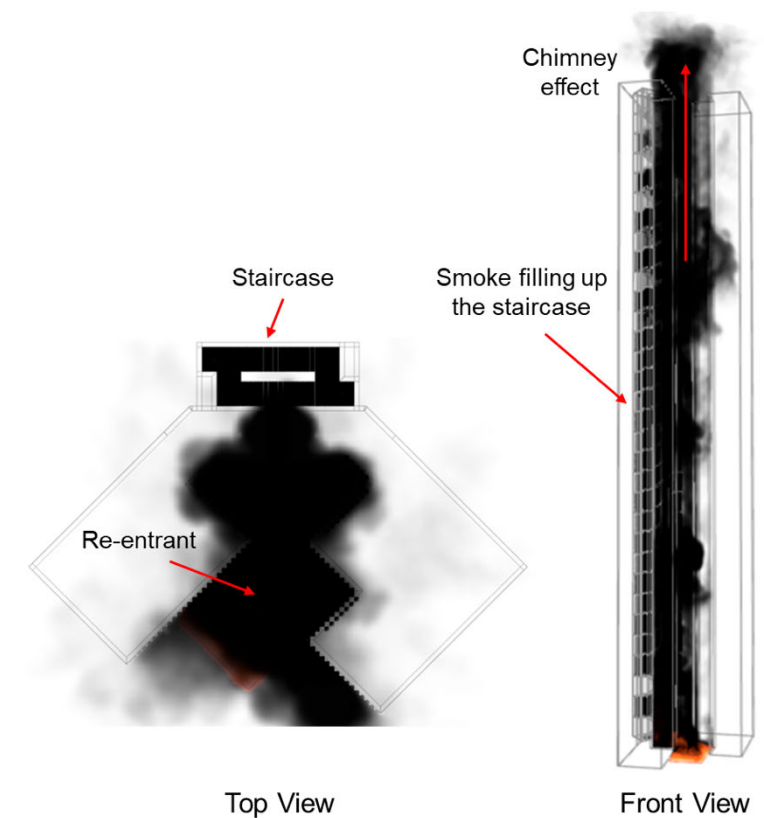
- 2.2.1. During the renovation of Wang Fuk Court, original staircase windows were removed and replaced with wooden access doors at approximately every 5 floors to allow worker access to the external scaffolding. These doors provided a direct pathway for smoke spreading once an external fire occurred.

- 2.2.2. In the simulation, staircase windows (or access doors) on every 5 floors were assumed fully open, consistent with observations that some wooden doors were burnt through during the incident. The fire initiated at ground level outside the re-entrant. Due to the chimney effect, flames and smoke rapidly entered the re-entrant. The open windows every five floors created a pressure differential, drawing smoke from the re-entrant into the staircase. Smoke gradually filled the staircase from lower to upper levels, eventually filling the entire staircase from ground floor to roof (Figure 10).

**Figure 10.** Simulation results of smoke spread from the re-entrant into the staircase.

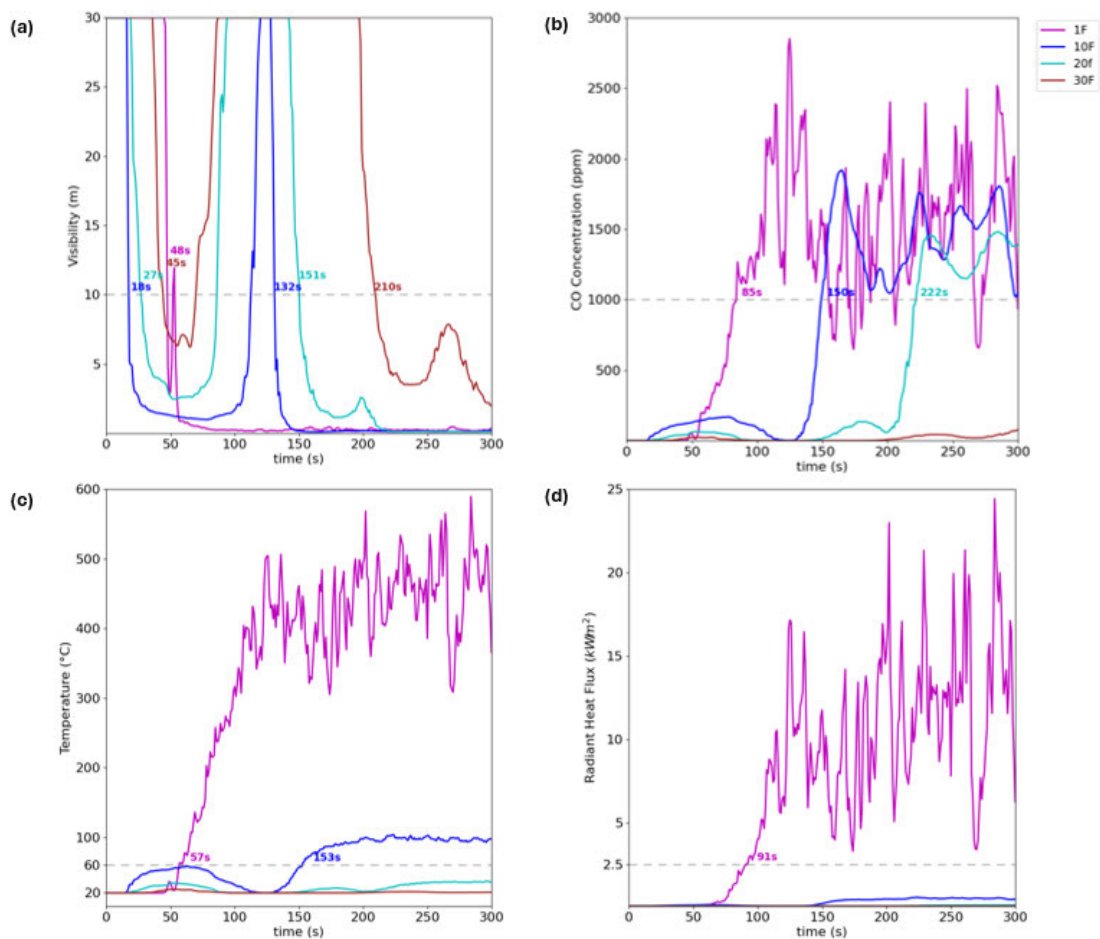
- 2.2.3. As smoke accumulated in the staircase, visibility decreased rapidly, followed by increasing CO concentration, temperature, and radiant heat flux (Figure 11). Visibility was the first tenability criterion to be exceeded on all floors. CO

concentrations in the staircase reached over 1,000 ppm across multiple floors, with a maximum of approximately 2,500 ppm on the lower floors (Figure 11b). At 1,000 ppm, CO exposure typically causes physical symptoms (e.g., headache, dizziness, nausea) within about 20 minutes and can become fatal within 1 hour. Residents who delayed evacuation were exposed to low visibility, toxic gases, and hot smoke. These could lead to disorientation, prolonged exposure to toxic gases, and even death. This explains the high number of fatalities found in the staircases, despite staircases being designated as protected means of escape.

**Figure 11. Tenability profiles in the staircases: (a) Visibility, (b) CO concentration, (c) temperature, and (d) radiant heat flux.**

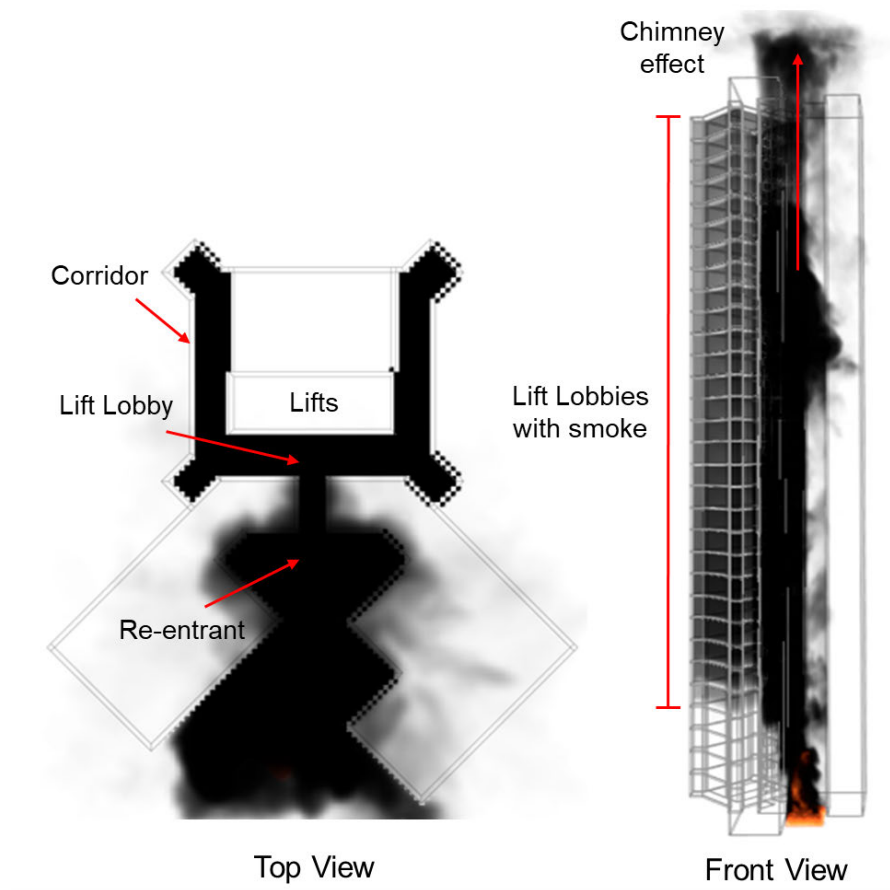
- 2.3.1. Fatalities also occurred in lift lobbies. Some of the ventilation windows in the lift lobbies were opened, allowing smoke ingress. Another simulation was performed to investigate how the smoke spread from the re-entrant into the lift lobbies. Assume that all lift lobby ventilation windows were open.
- 2.3.2. As shown in [Figure 12](#), smoke spread rapidly upwards through the re-entrant due to the chimney effect. As the internal pressure in the lift lobbies was lower than in the re-entrant, smoke flowed inward through the open ventilation windows, gradually filling the lift lobbies and adjacent corridors with smoke and toxic gases ([Figure 13](#)).

**Figure 12. Simulation results of smoke spread from the re-entrant into lift lobbies.**

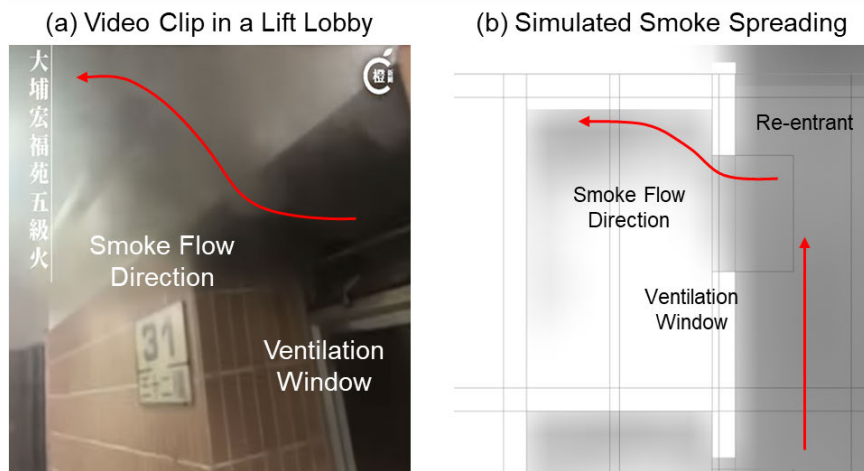
**Figure 13. Smoke spreading conditions in the lift lobby: (a) video, and (b) simulation result.**

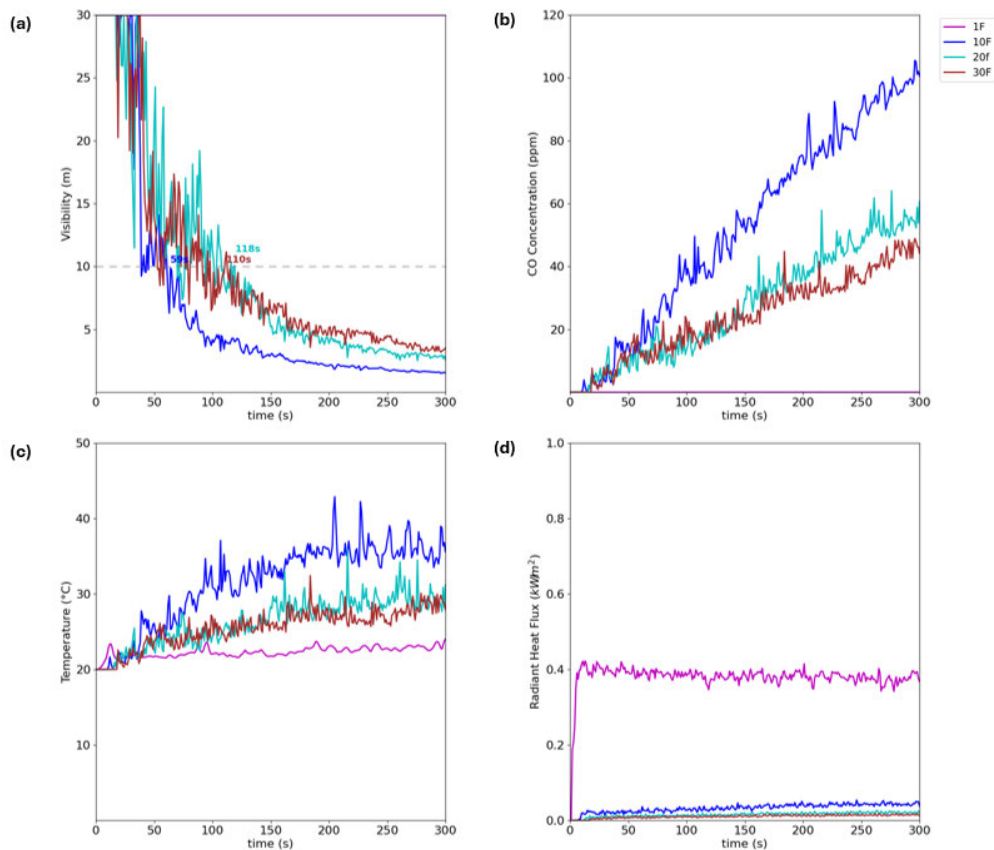
2.3.3. Although tenability limits were not exceeded immediately, CO and smoke concentrations increased over time (Figure 14). The deactivated fire alarm system likely delayed occupant awareness and evacuation. Some residents who found the staircases filled with smoke might have attempted to use the lifts, by which time toxic gas levels had become hazardous.

**Figure 14. Tenability profiles in the lift lobby on different floors: (a) Visibility, (b) CO concentration, (c) temperature, and (d) radiant heat flux.**
