# Final Investigation Report No.5 Alarm Fire at Wang Fuk Court on 26 November 2025

Inter-Departmental Fire Investigation Task Force

May 2026

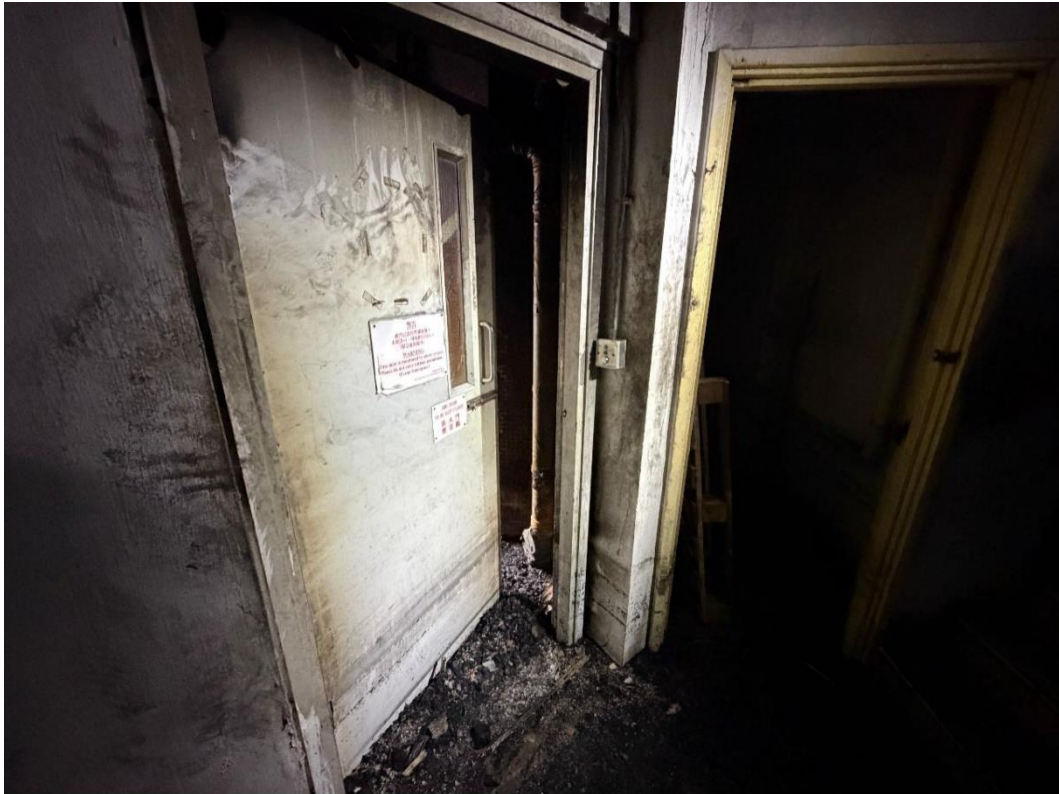
<sup>5</sup> On the ground floor, one staircase provides access to the lift lobby and the main building entrance, while another staircase leads to the rear exit. The rear exit features a smoke-stop door fitted with a horizontal bolt, as shown in **Photo 4-1 (b)**. A door sensor, which is not equipped with a locking mechanism, is also installed at this exit. When the door is opened, it triggers an audible buzzer and/or transmits a signal to the security office. It is important to note that this door sensor is not connected to, nor does it form part of, any fire service installations. It is installed exclusively for security and property management purposes.

Photo 4-1 (b): Rear Exit at Wang Cheong House

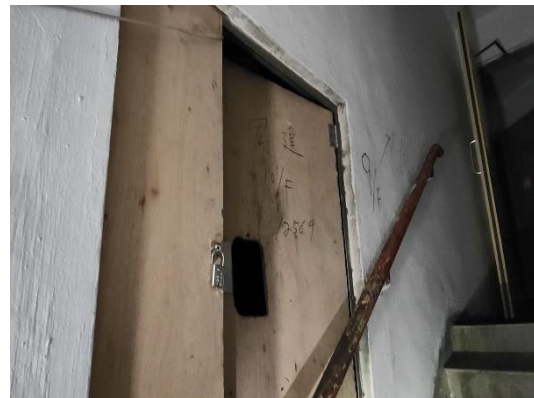
<sup>6</sup> No floor-level signage was observed at the staircase landings after the fire, as shown in **Photo 4-1(d)**.

Photo 4-1 (d):  
Staircase Landing of 10/F, Wang Kin  
House (Photo Taken After the Fire)

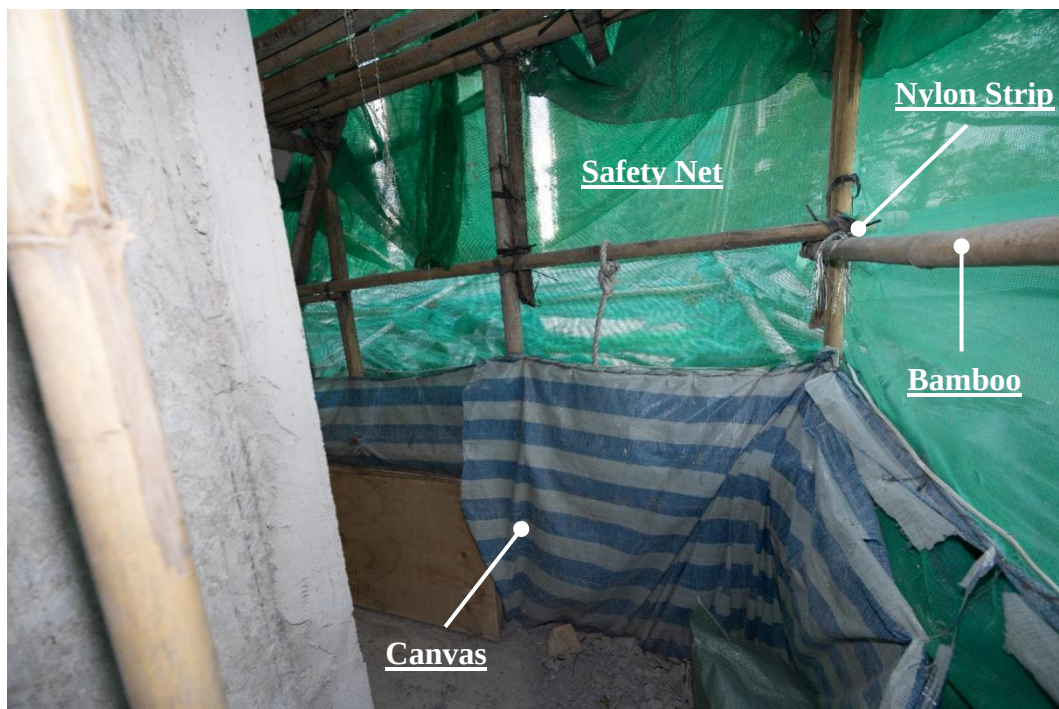
- 4.5.4.5 The external wall repair work was included as part of the renovation work. For this purpose, scaffolding works commenced outside the external walls of all blocks of Wang Fuk Court since July 2024, according to the record provided by the PMC. These scaffoldings<sup>18</sup> (comprising bamboos, wooden planks, toe-boards, safety nets, canvas<sup>19</sup> and nylon strips<sup>20</sup>) enveloped all blocks entirely from the G/F to the R/F, as shown in **Photo 4-4** and **Photo 4-5**.

*Photo 4-5: Photo Showing Different Combustibles in the Scaffolding  
(Bamboo, Safety Nets, Canvas and Nylon Strips)*

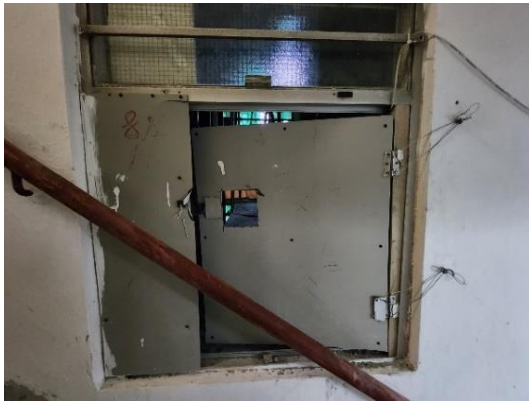
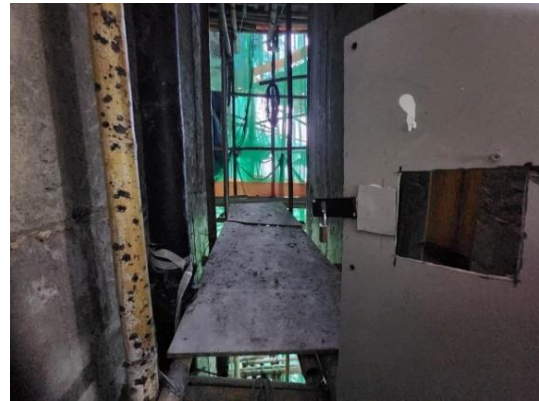
- 4.5.5.4 For all blocks of Wang Fuk Court, all the existing staircase windows, the upper parts of which were openable, were proposed to be replaced with fire-rated windows<sup>24</sup> as part of the renovation works of Wang Fuk Court. As explained in paragraph 4.5.4.3 above, such proposed works were not a prescribed repair item under the MBIS regime; but given that it was categorized as a type of minor works under the MWCS<sup>25</sup>, as shown in **Photo 4-3 (b)**, relevant minor works submissions were submitted to the ICU under MWCS. While it was indicated in the relevant minor works submissions that all windows at staircases would be replaced with fire-rated windows, it was only revealed after the fire that some windows at the staircases had been replaced with movable boards, most of them believed to be wooden<sup>26</sup>, to provide convenient access for workers to the scaffoldings, as shown in **Photos 4-9 (a) to (c)**, at the following locations:

Photos 4-9 (a) to (c): Replacement of Windows With Movable Board

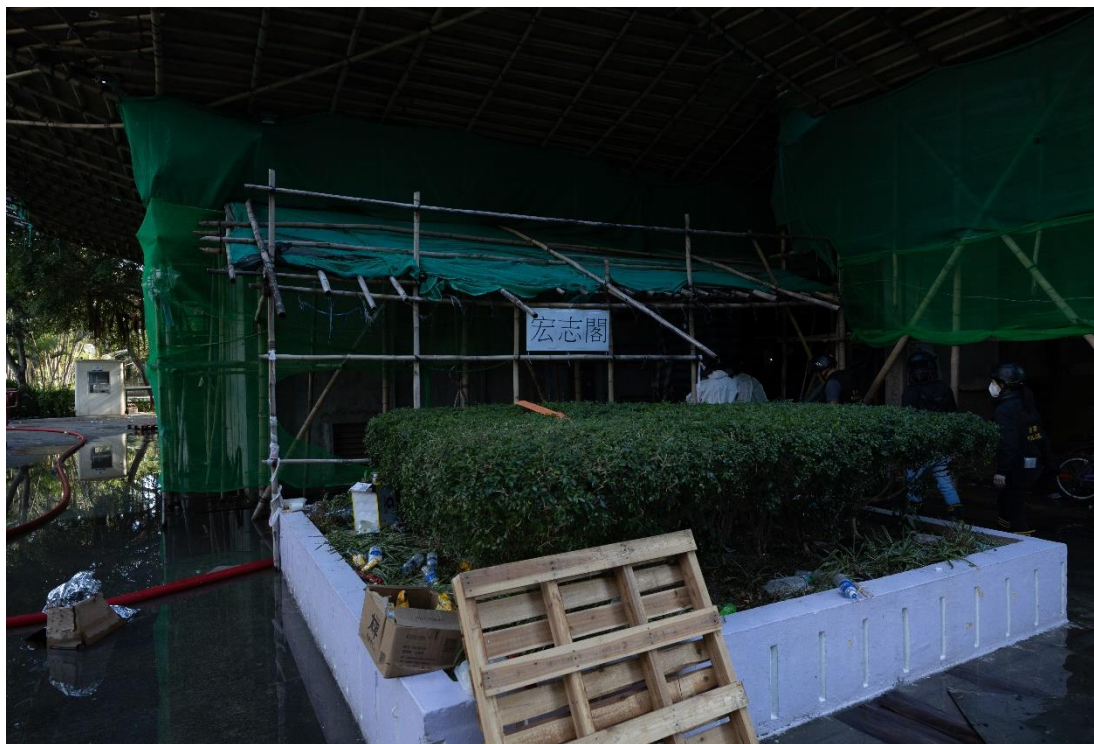
- 4.5.6.3 During the renovation, the scaffolding erected blocked the building name. As a remedial measure, the building name was printed on paper, laminated and taped outside each block, as shown in **Photo 4-11 (c)**. Meanwhile, no signage indicating the floor level was observed at the staircase landings, including at Wang Chi House.

*Photo 4-11 (c): Printed Building Signage at Wang Chi House*

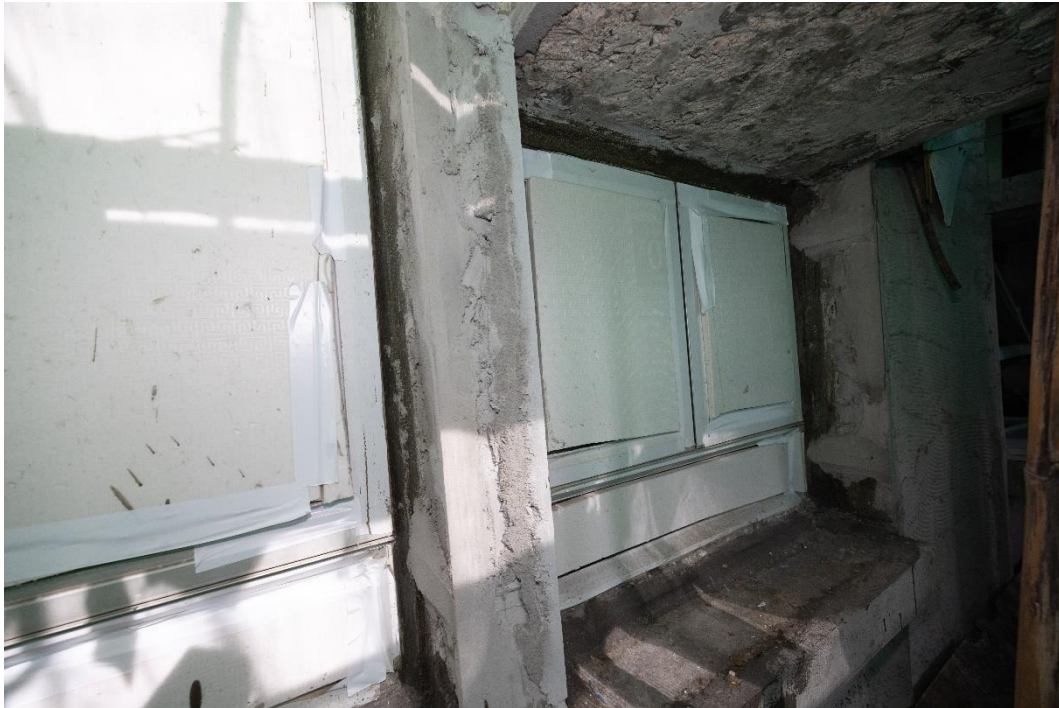
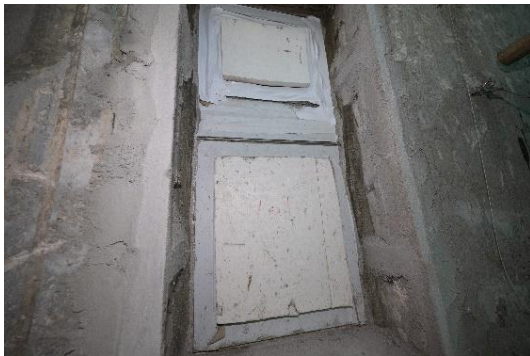
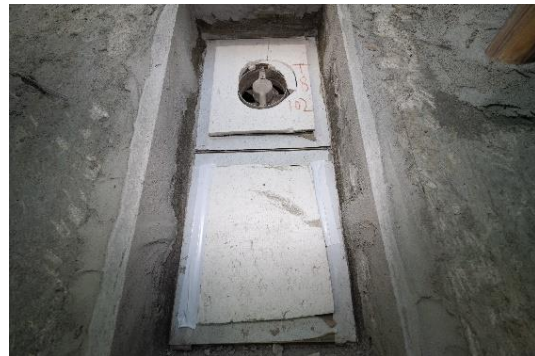
- 4.5.6.5 Polystyrene window covers<sup>27</sup> were found covering the windows of most flats, lift lobbies and staircases to protect window glass from accidental impacts, as shown in **Photos 4-14 (a) to (c)**.

Photos 4-14 (a) to (c): Polystyrene Window Covers

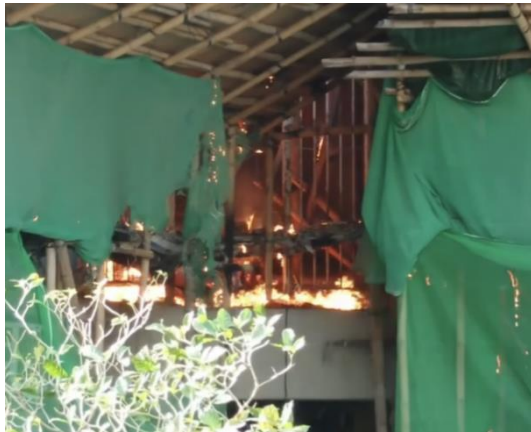
5.1.1 At 1451 hours, the informant, Mr. YIP [REDACTED]<sup>28</sup>, who was at the cycling path near Wang Cheong House, discovered a fire at Wang Fuk Court and immediately called 999 to report the fire (Location Map at **Figure 5-1**). According to the video provided by Mr. YIP, the fire was observed to have started on the flat roof outside Flats 104 and 105 of Wang Cheong House (Screenshot shown in **Photo 5-1** and layout plan at **Figure 5-2**).

*Photo 5-1:  
Screenshot From the Informant's Video  
at About 1451 Hours (Discovery)*

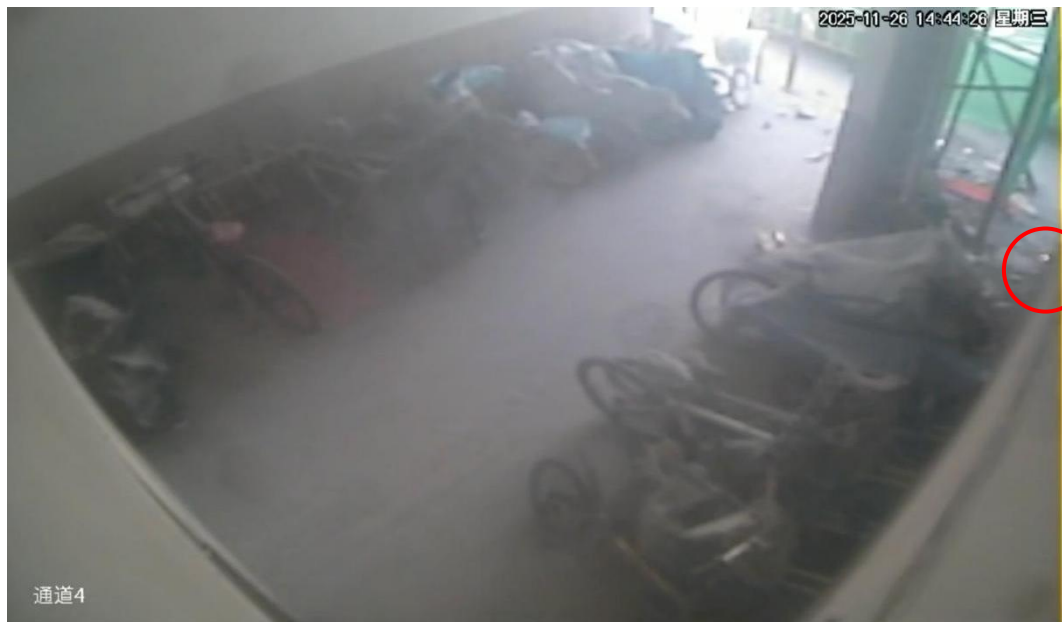
5.1.2 However, the investigation revealed that the fire might have started prior to Mr. YIP's report. According to CCTV footage, embers were observed falling onto the bicycle parking area of Wang Cheong House at approximately 1443 hours<sup>29</sup> (Screenshot shown in **Photo 5-2**).

*Photo 5-2: Embers Falling Onto Bicycle Parking Area*

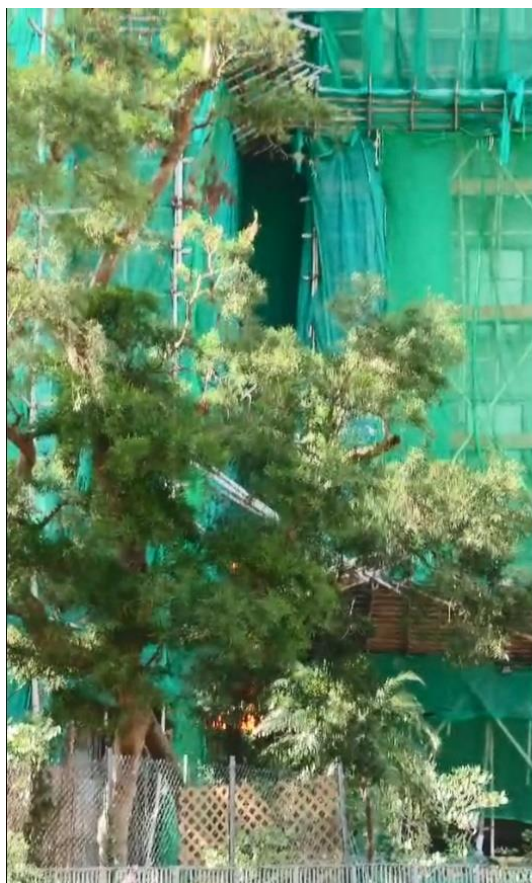
- 5.2.2.1 The video provided by the informant clearly showed the fire spreading through the **east re-entrant** of Wang Cheong House. **Photo 5-3** illustrates the fire spreading to about the 4/F at about 1455 hours; while **Photo 5-4** shows the fire spreading to about the 8/F at about 1457 hours<sup>36</sup>, shortly after the FS arrival at 1456 hours.

Photo 5-3:  
Fire Spread to About 4/F  
at About 1455 Hours

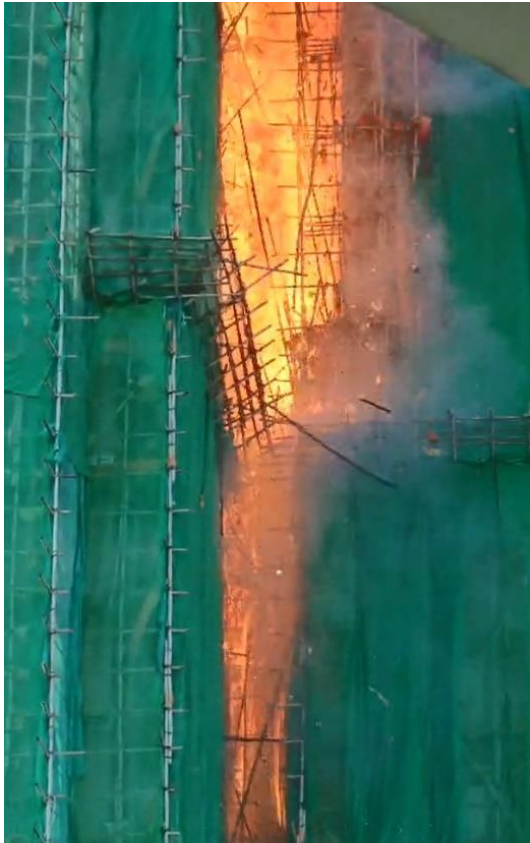
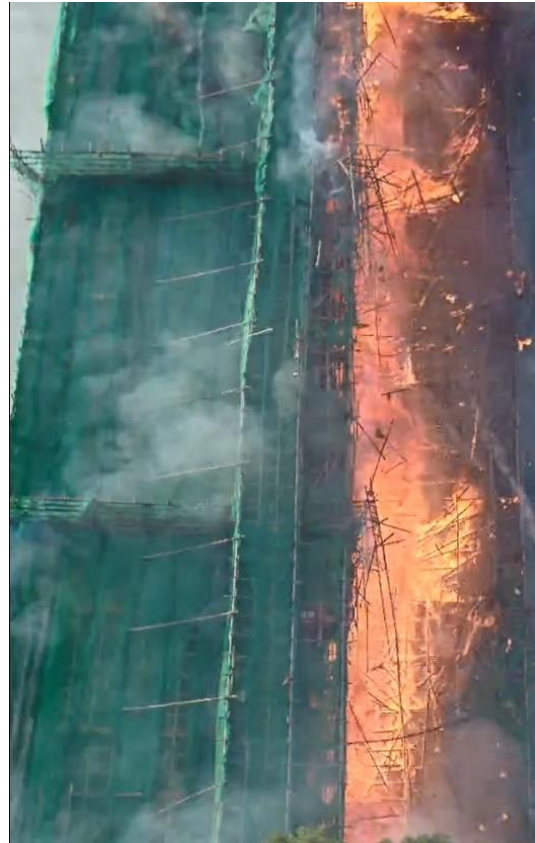
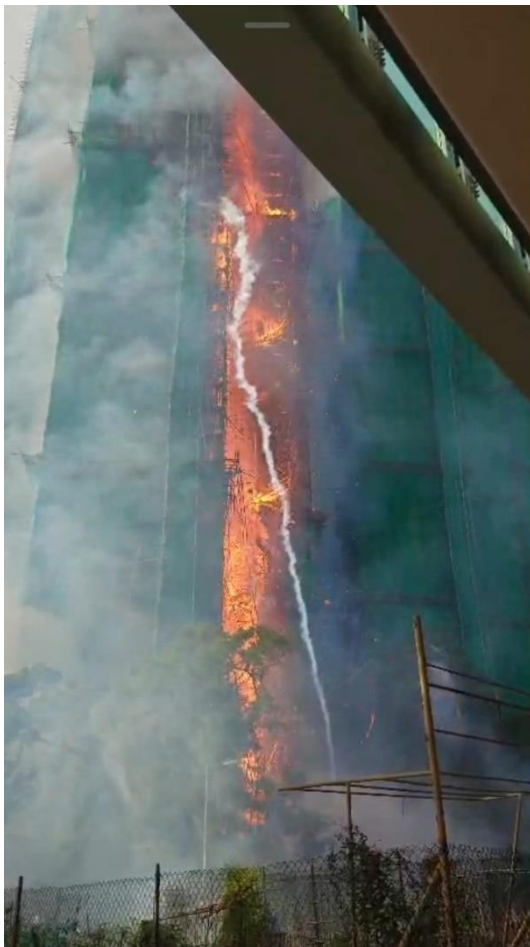
- 5.2.2.2 At 1458 hours, the fire intensified and developed vigorously, accompanied by falling debris, bamboo and construction materials, as shown in **Photos 5-5 (a) to (c)**.

Photos 5-5 (a) to (c) :  
Fire Intensified and Engulfed the Entire  
East Re-Entrant of Wang Cheong House  
With Falling Debris at 1458 Hours

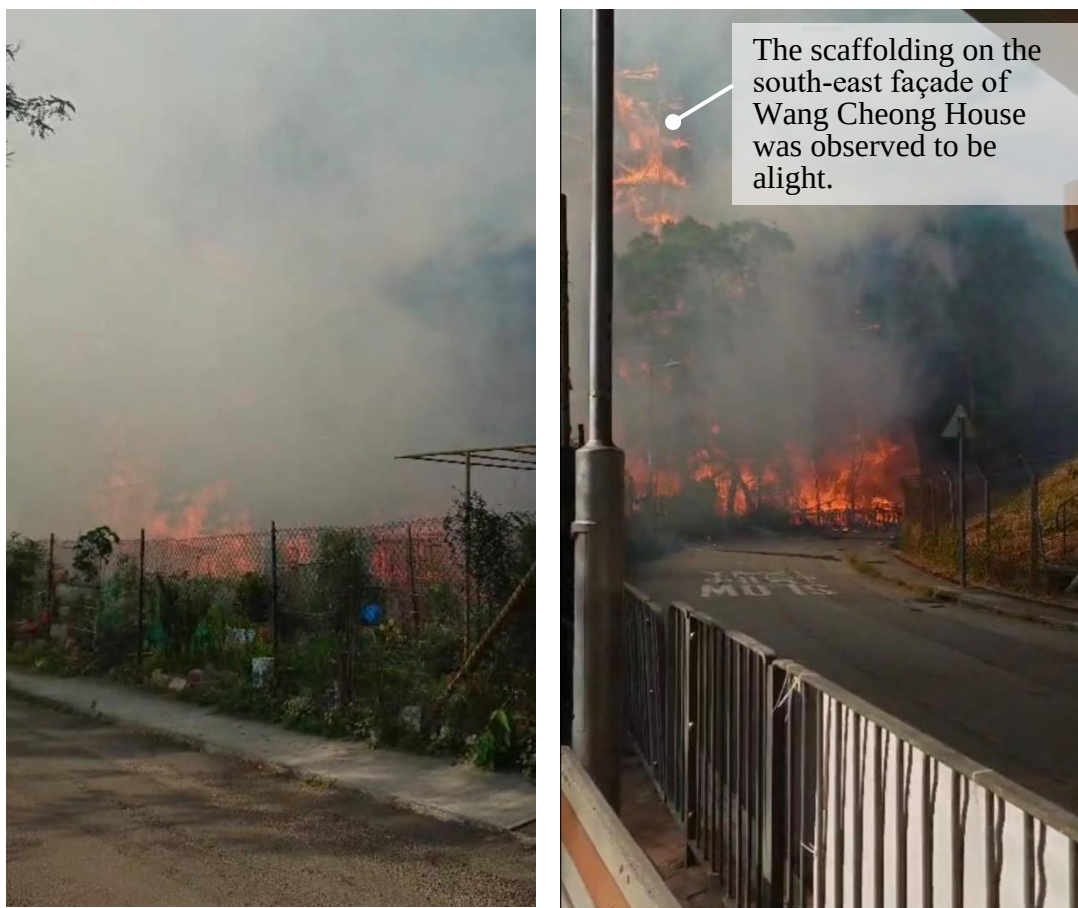
*Photos 5-6 (a) & (b): Fire Spread to the Open Ground outside the South-East Façade of Wang Cheong House at About 1501 Hours*

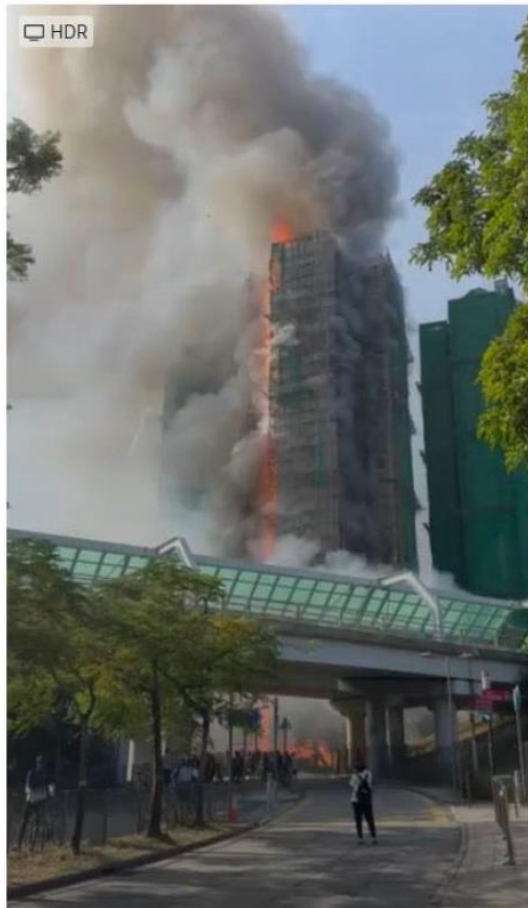
Photo 5-6 (c):  
Fire Spreading Along the South Re-  
Entrant at 1503 Hours

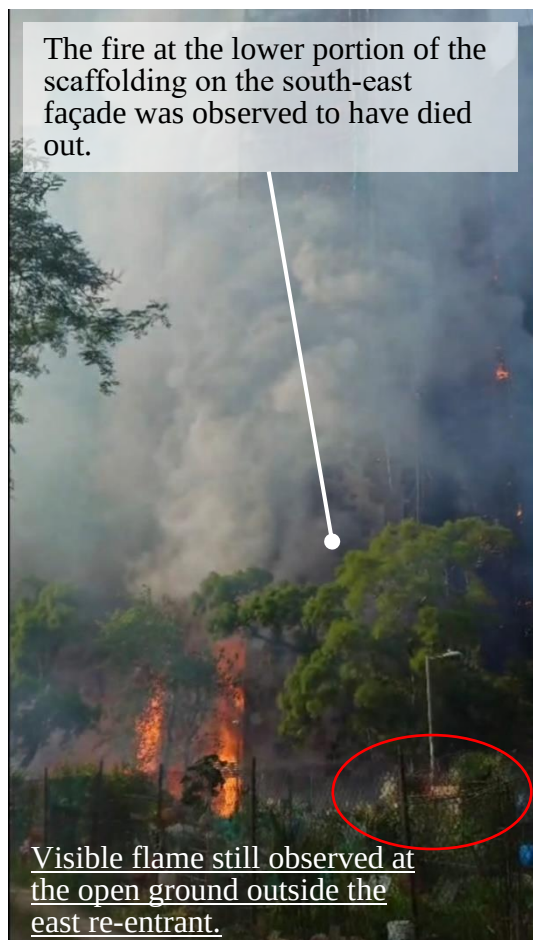
Photo 5-6 (d):  
Visible Flame Still Observed at the Open Ground outside the East Re-Entrant at 1508 Hours

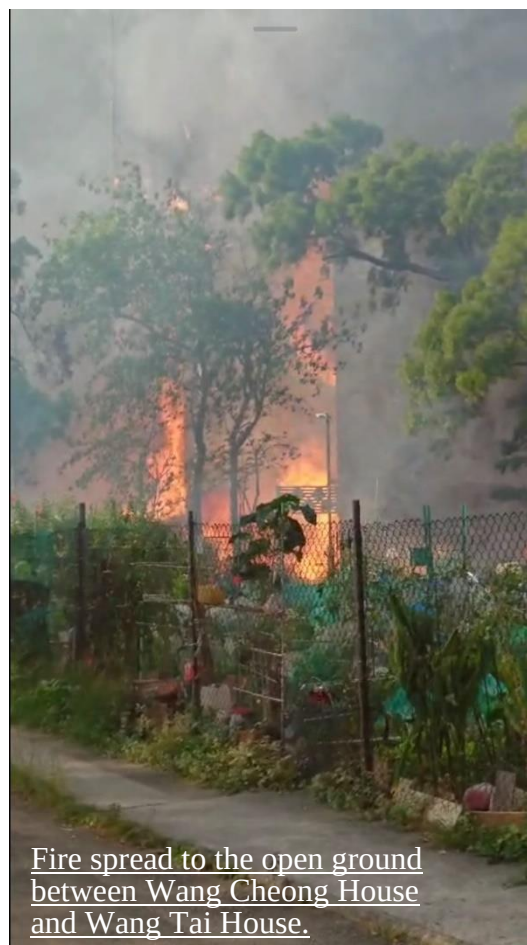
Photo 5-6 (e):  
Fire Spread to the Open Ground Between Wang Cheong House and Wang Tai House

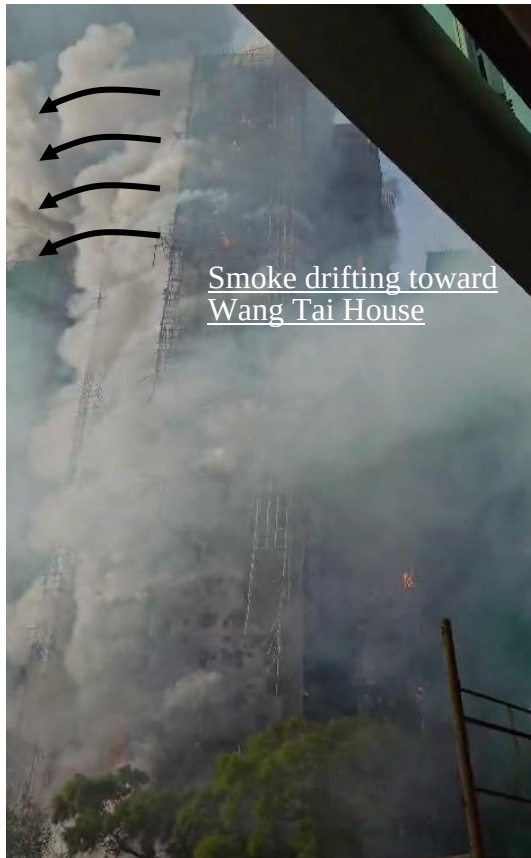
Photo 5-6 (f):  
Heavy Smoke on the South-East Façade  
at 1508 Hours

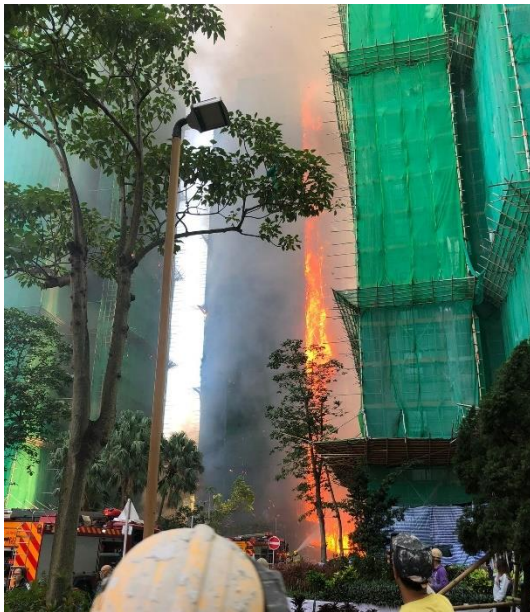
- 5.2.2.5 At about 1509 hours<sup>39</sup>, a photo provided by Mr. CHAN [REDACTED], Occupant of Flat 6 [REDACTED] of Wang Cheong House, showed the fire rapidly spreading from the G/F to the top of the building along the **west re-entrant** of Wang Cheong House, as shown in **Figure 5-8** and **Photo 5-7 (a)**.

Photo 5-7 (a):  
Fire Spreading Along the West  
Re-Entrant at 1509 Hours

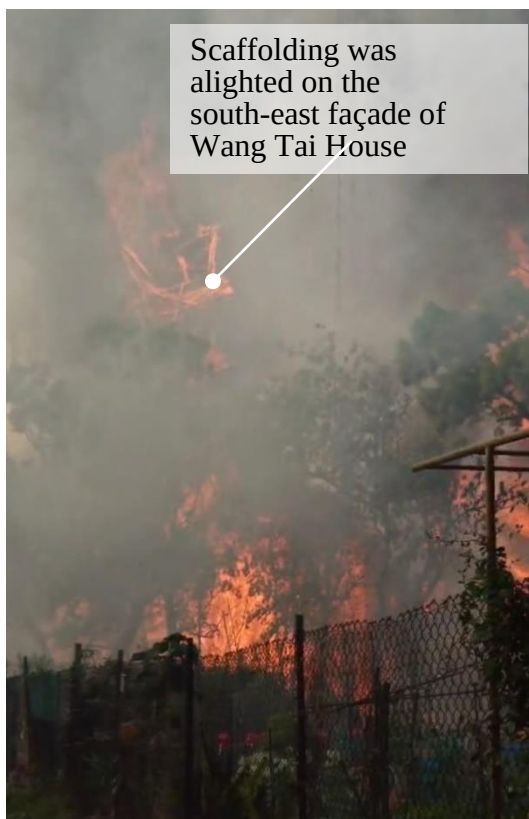
- 5.2.2.7 Around the same time, another video provided by the informant showed that the scaffolding on the **south-east façade of Wang Tai House** was alight and that **an area of vegetation** opposite Wang Cheong House, across Island House Lane, was also on fire, as shown in **Figure 5-9** and **Photos 5-7 (b) & (c)**. Meanwhile, the blaze in the area between Wang Cheong House and Wang Tai House remained severe.

Photo 5-7 (b):  
South-East Façade of Wang Tai House  
Alight at 1515 Hours

- 5.2.3.4 As elaborated in paragraph 5.2.2.7, another video provided by the informant shows that at approximately 1515 hours, the scaffolding on the **south-east façade** of Wang Tai House, facing the cycling track, was alight, as shown in **Figure 5-9** and **Photo 5-7 (b)**.

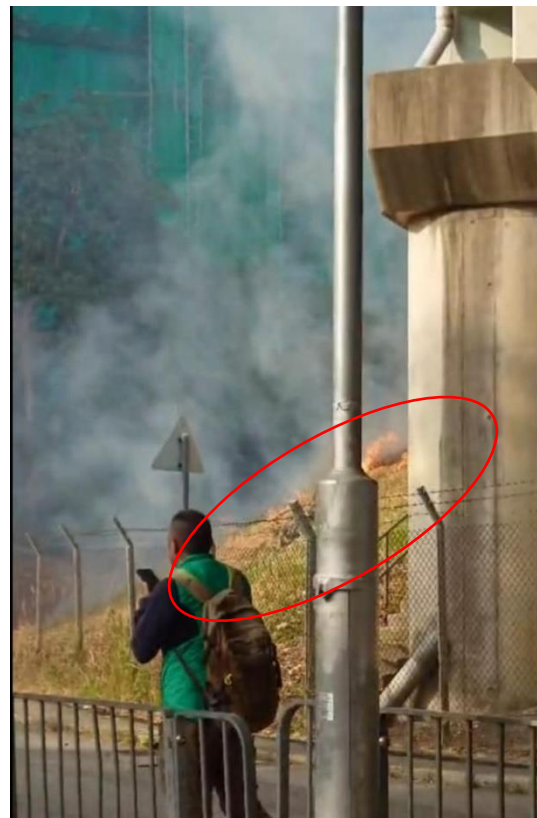
Photo 5-7 (c):  
An Area of Vegetation opposite  
Wang Cheong House Alight  
at 1515 Hours

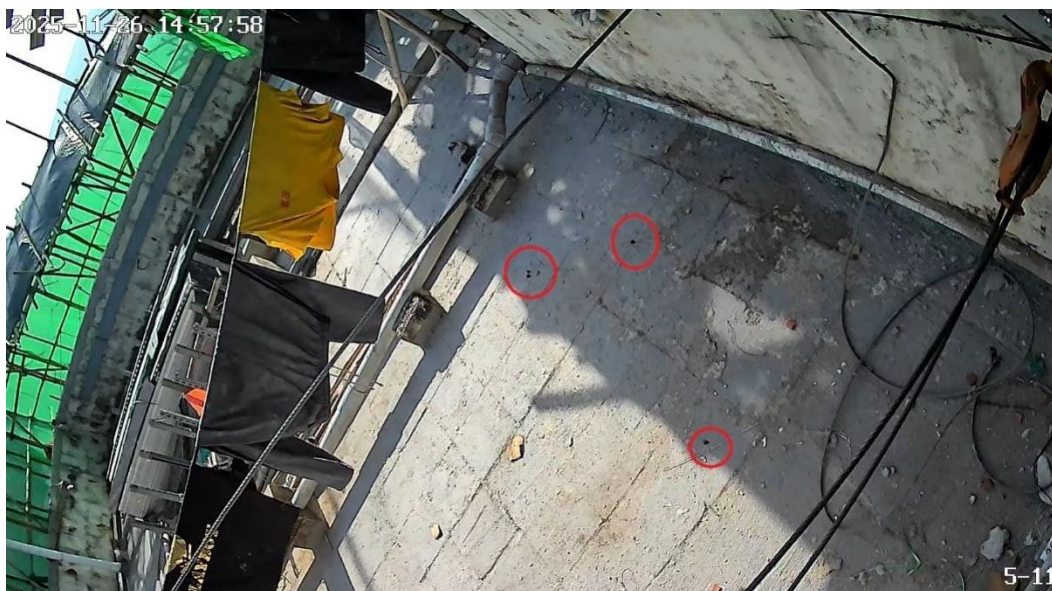
- 5.2.3.1 The fire spread to Wang Tai House via flying embers was observed around 1500 hours. Construction workers<sup>41</sup> reported fire spreading to the safety nets on multiple levels of Wang Tai House, including construction materials on the G/F, safety nets on the 9/F & 10/F and miscellaneous articles on the R/F. The situation at R/F is shown in **Photo 5-9 (a)**; while the situation at the scaffolding is shown in **Photo 5-9 (b)**.

*Photo 5-9 (a): Flying Embers Observed on the R/F of  
Wang Tai House at About 1458 Hours*<sup>45</sup>

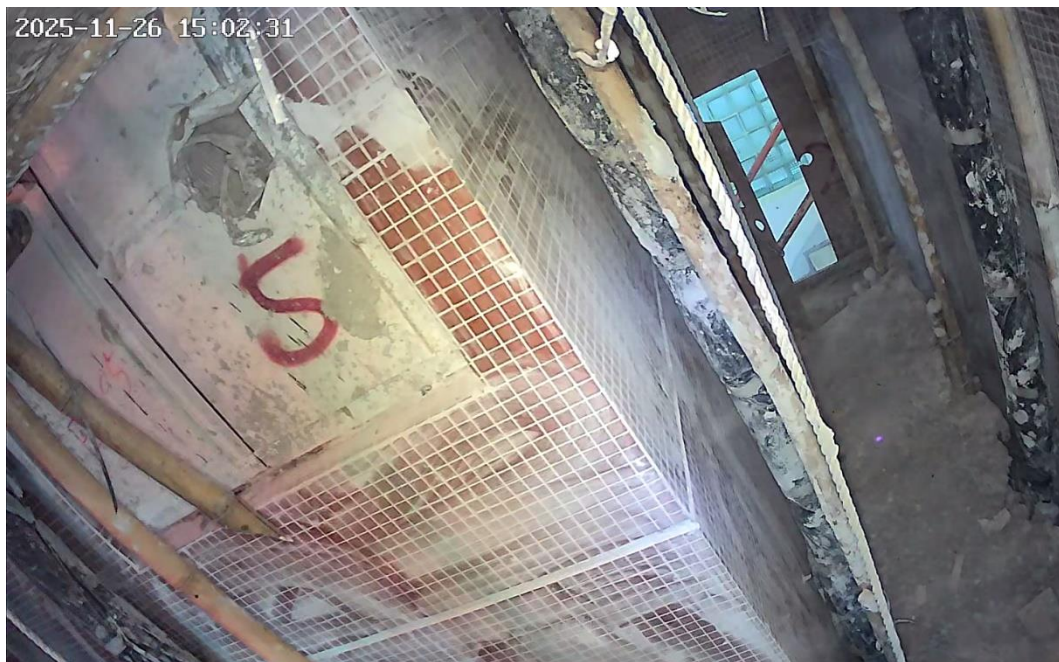
*Photo 5-9 (b): A Reflection of the Fire was Captured by CCTV Installed on the Scaffolding of Wang Tai House at About 1503 Hours<sup>46</sup>*

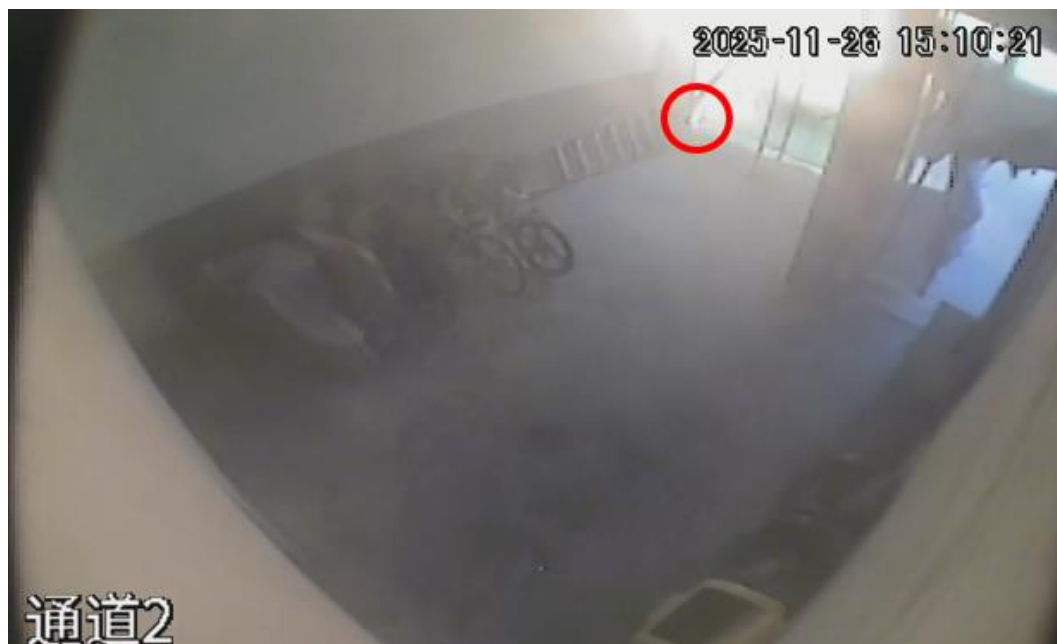
- 5.2.3.3 In addition to witness accounts, CCTV footage provided clear evidence of the fire spreading to Wang Tai House. At approximately 1509 hours<sup>43</sup>, embers were observed falling onto the open ground in between Wang Cheong House and Wang Tai House, igniting nearby combustibles. By 1516 hours, the area was obstructed by fallen burning bamboo debris, as shown in **Photos 5-9 (c) to (e)** and **Figure 5-12**.

Photo 5-9 (c): Embers Falling Onto the Open Ground Outside Wang Tai House

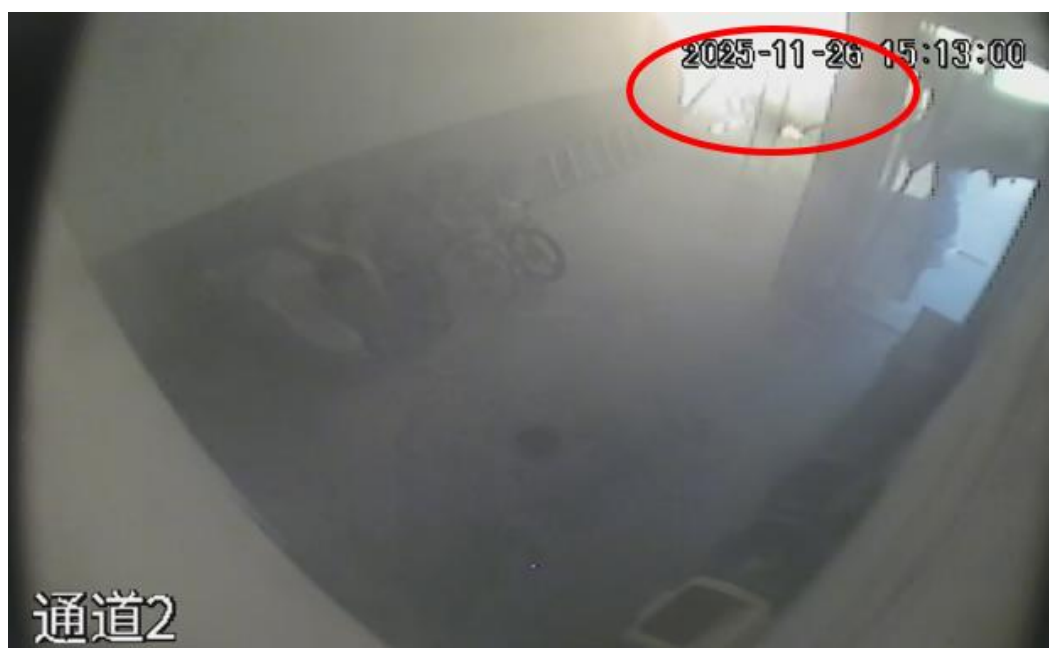
Photo 5-9 (d): Flaming Fire Observed

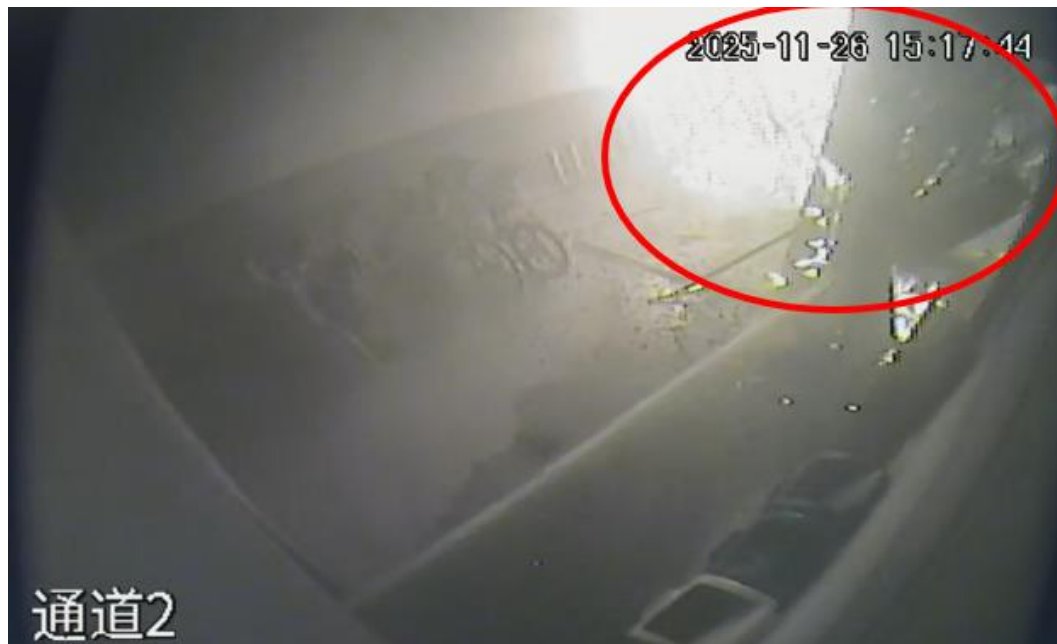
Photo 5-9 (e): Burning Bamboo Debris Piled up

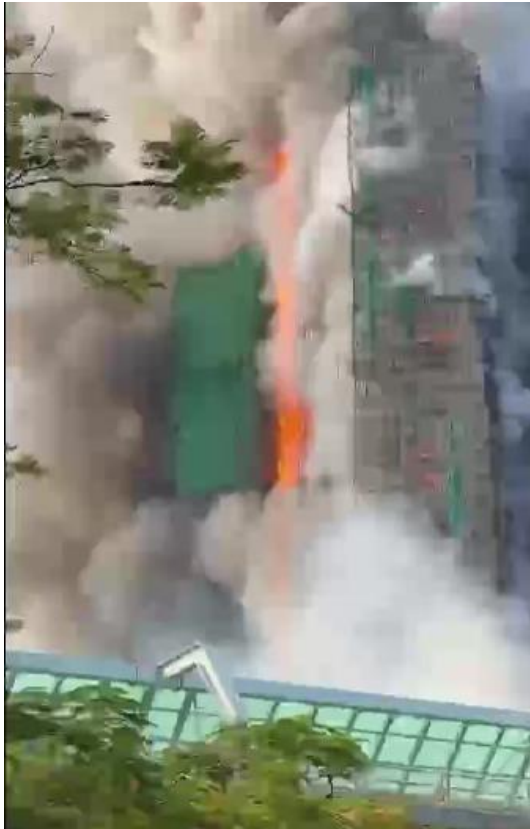
- 5.2.3.5 Rapid vertical fire spread along the re-entrant was observed in three out of the four re-entrants of Wang Tai House, as shown in **Photos 5-10 (a) & (b)**, **Photo 5-11** and **Figure 5-13**. The first instance of vertical fire spread occurred along the **east re-entrant** of Wang Tai House at about 1516 hours (as shown in **Photo 5-10 (a)**). Shortly thereafter, a second instance of vertical fire spread was observed along the **south re-entrant** at about 1517 hours, as shown in **Photo 5-10 (b)**.

Photo 5-10 (a):  
Fire Spread Along the East Re-Entrant  
of Wang Tai House at 1516 Hours

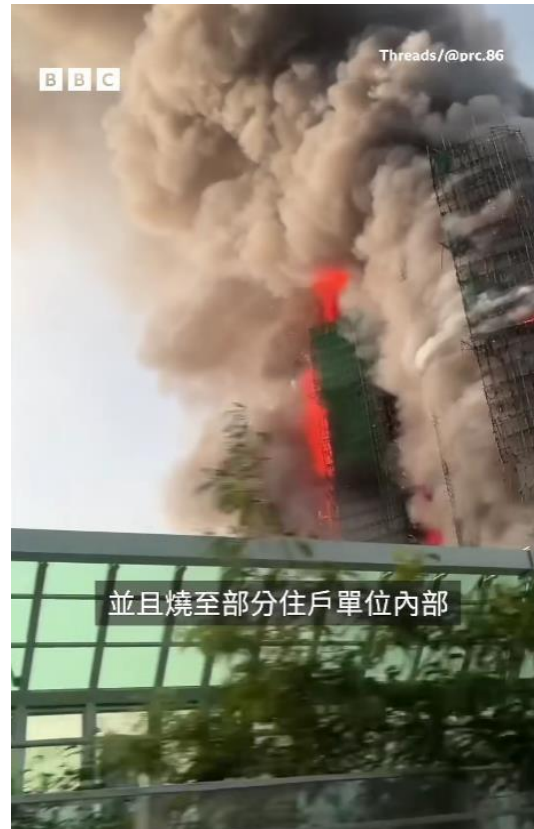
Photo 5-10 (b):  
Fire Spread Along the South  
Re-Entrant of Wang Tai House at  
1517 Hours

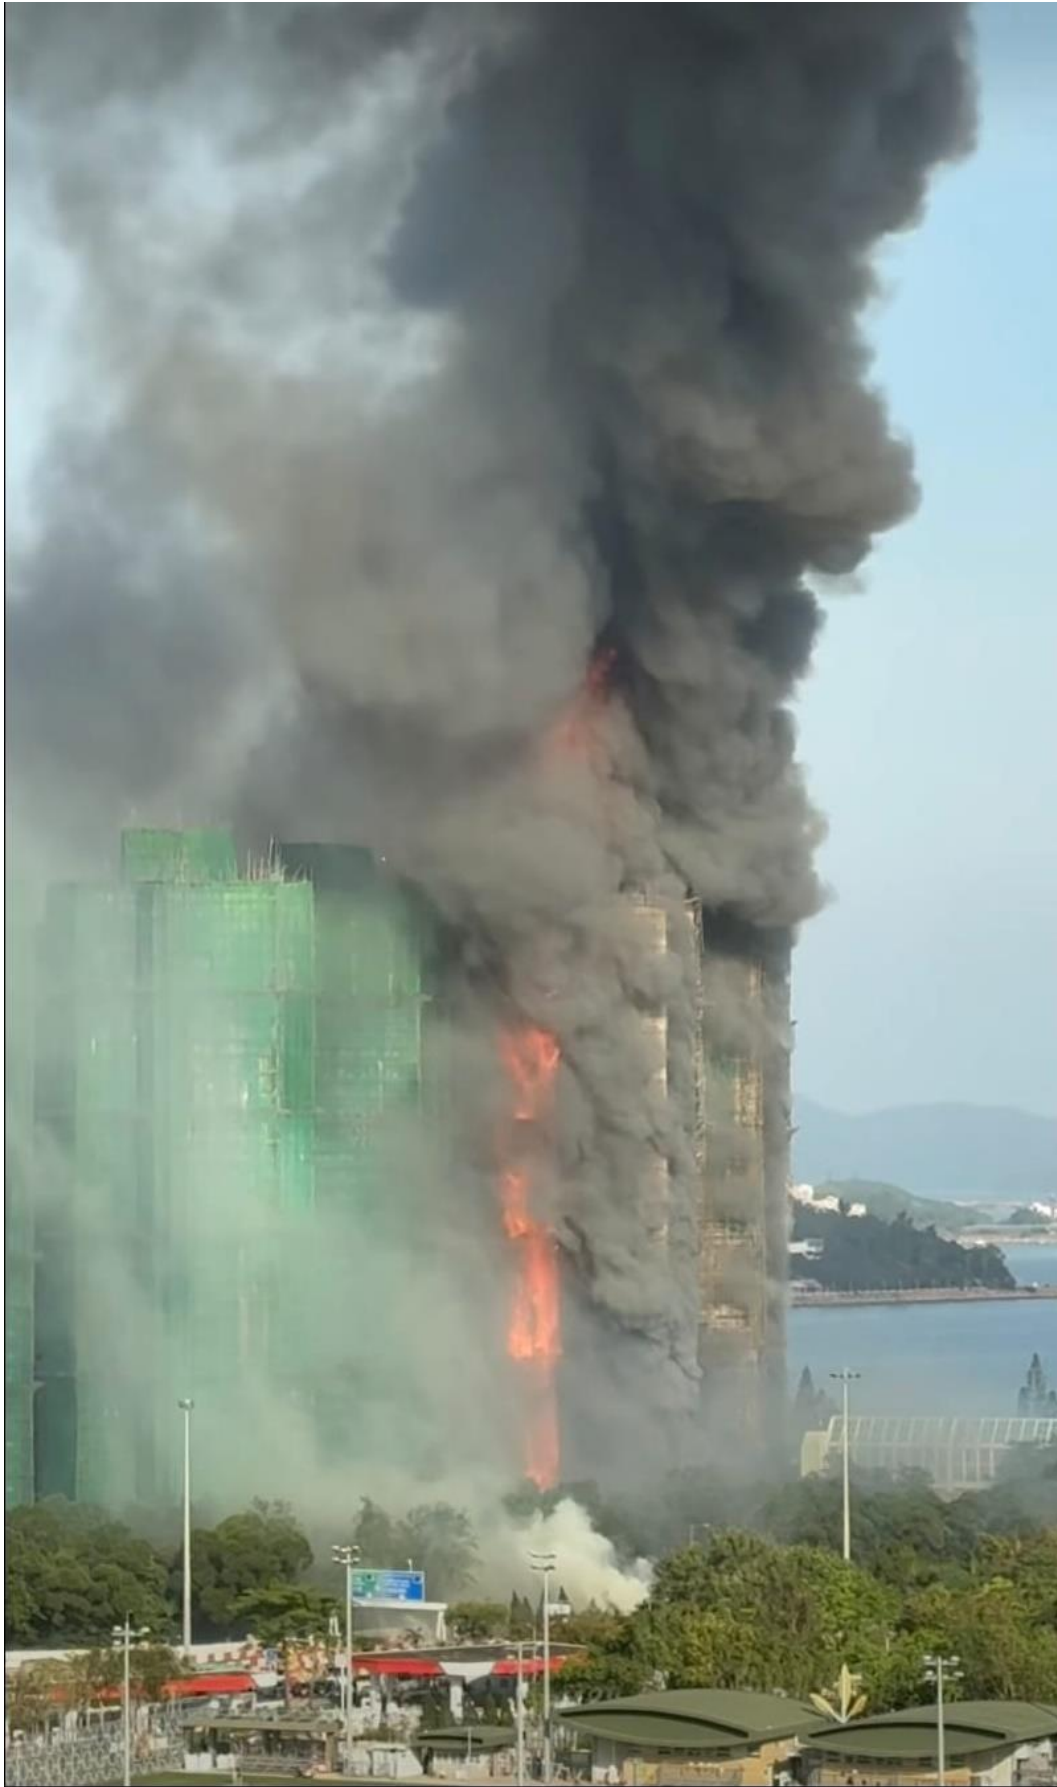
- 5.2.3.7 At 1530 hours, another rapid fire spread was noted at the **west re-entrant** of Wang Tai House, as shown in **Photo 5-11**<sup>44</sup>.
- 5.2.3.8 According to available materials, it was captured in the Cable TV footage that flames, originating from the ignited units, were observed issuing from the upper and mid-levels of the **south-west façade** of Wang Tai House at approximately 1553 hours, as shown in **Photo 5-12**.

<sup>44</sup> After the submission of the interim report, further investigation uncovered the rapid vertical fire spread at the **west re-entrant** of Wang Tai House. The spread is believed to have occurred at 1530 hours.

Photo 5-11: Rapid Fire Spread at the West Re-Entrant of Wang Tai House

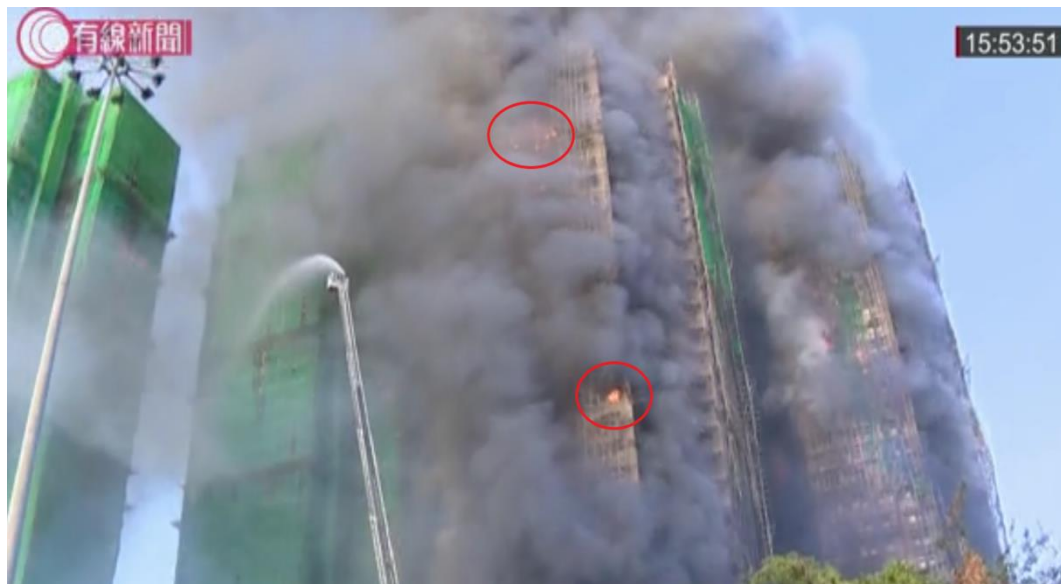
*Photo 5-12: Flames From Ignited Units on the South-West Façade of Wang Tai House*

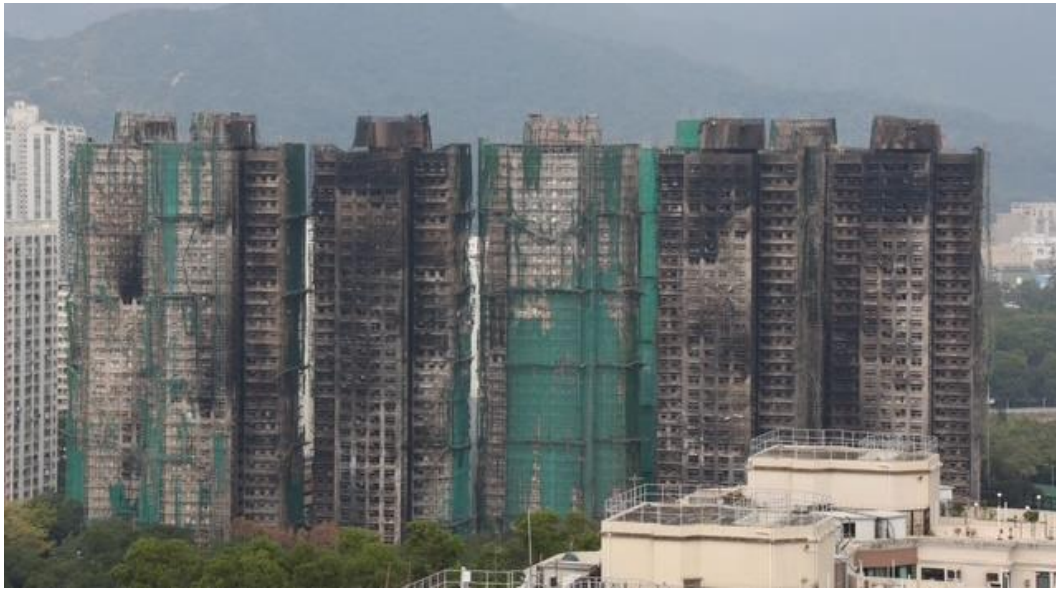
- 5.3.1 Across the seven affected buildings, a total of 1,736 flats were assessed, of which the interiors of 924 flats sustained varying degrees of fire damage, while the interiors of the other 812 flats remained relatively unaffected despite that the exterior of the buildings had been damaged by the high temperature with prolonged exposure to fire. The post-fire conditions of the exterior of Wang Fuk Court are shown in **Photo 5-13**.

*Photo 5-13: Post-Fire Condition of Wang Fuk Court*

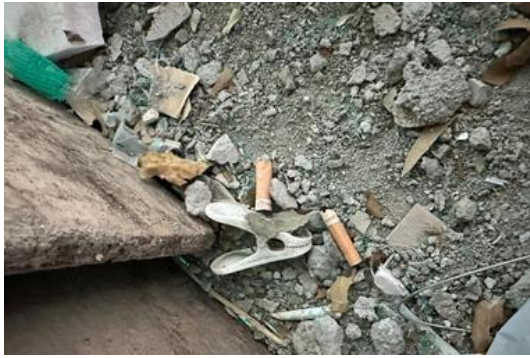
- 6.1.8 Evidence of smoking was observed in multiple locations. Two cigarette ends were found at the affected flat roof. Additionally, numerous cigarette ends were discovered on the bamboo scaffolding of Wang Chi House, indicating that smoking and the improper disposal of cigarette ends were not uncommon practices at construction sites, as shown in **Photos 6-5 (a) to (d)**. Further supporting this observation, CCTV footage captured construction workers smoking on the R/F of Wang Cheong House, as shown in **Photos 6-5 (e) & (f)**. Furthermore, at least 5 occupants of Wang Cheong House had occasionally noticed that the smell of smoke and the presence of cigarette butts on the scaffolding<sup>62</sup>. One of them<sup>63</sup> even reported witnessing a worker smoking on the scaffolding.<sup>64</sup>

Photos 6-5 (a) & (b): Cigarette Ends Found on the  
First Level Scaffolding at Wang Chi House

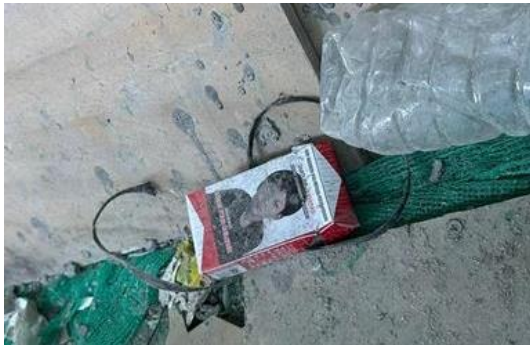
Photos 6-5 (c) & (d): Cigarette Boxes Found on the  
First Level Scaffolding at Wang Chi House
