# Final Investigation Report No.5 Alarm Fire at Wang Fuk Court on 26 November 2025

Inter-Departmental Fire Investigation Task Force

May 2026

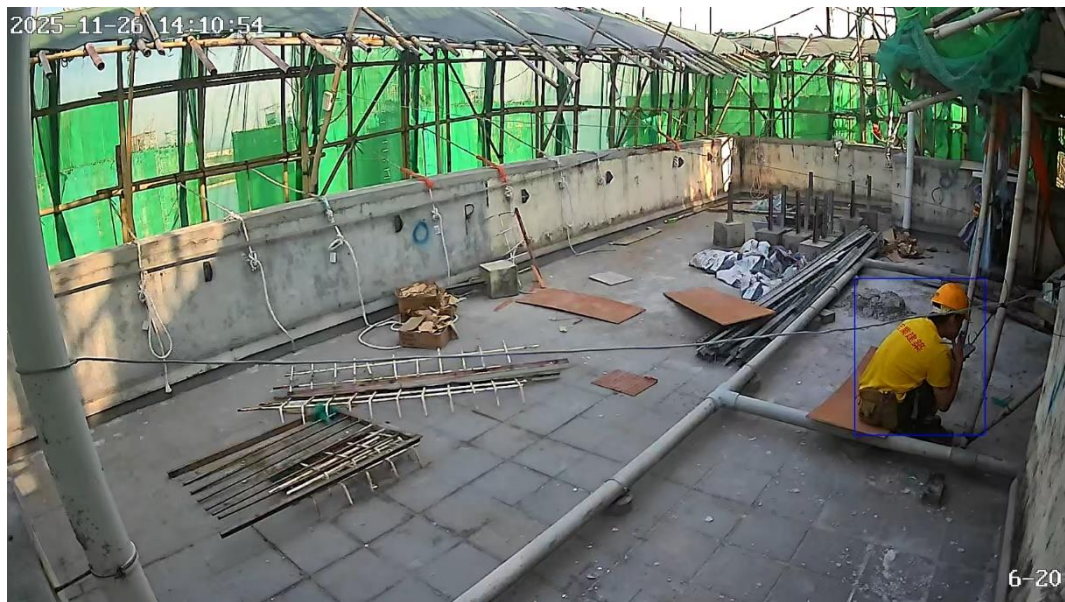
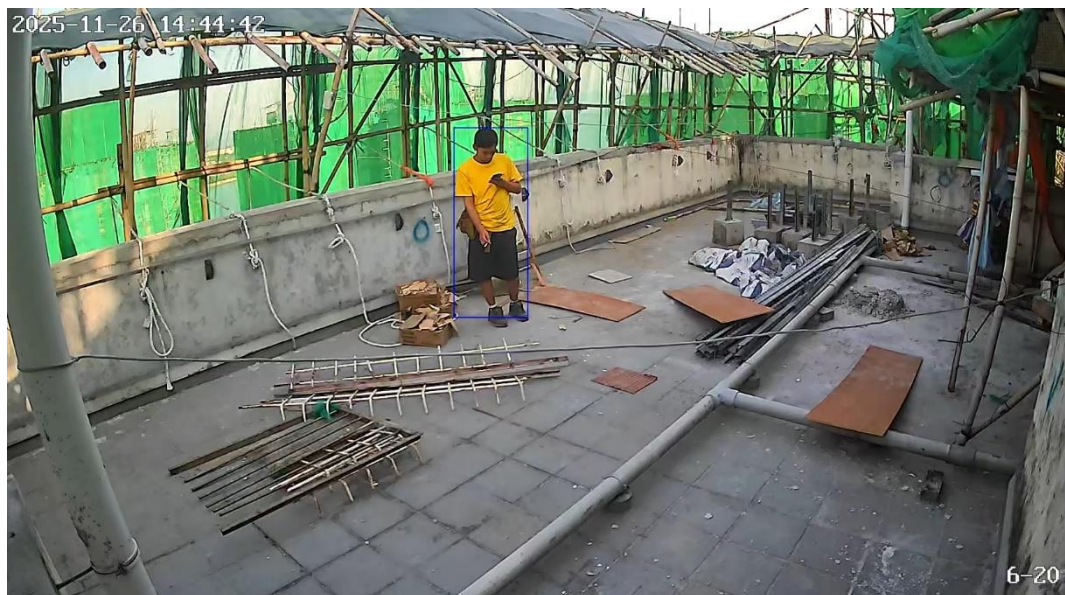
*Photos 6-5 (e) & (f): Construction Workers Were Smoking on R/F of Wang Cheong House at About 1411 hours and 1445 Hours<sup>66</sup>*

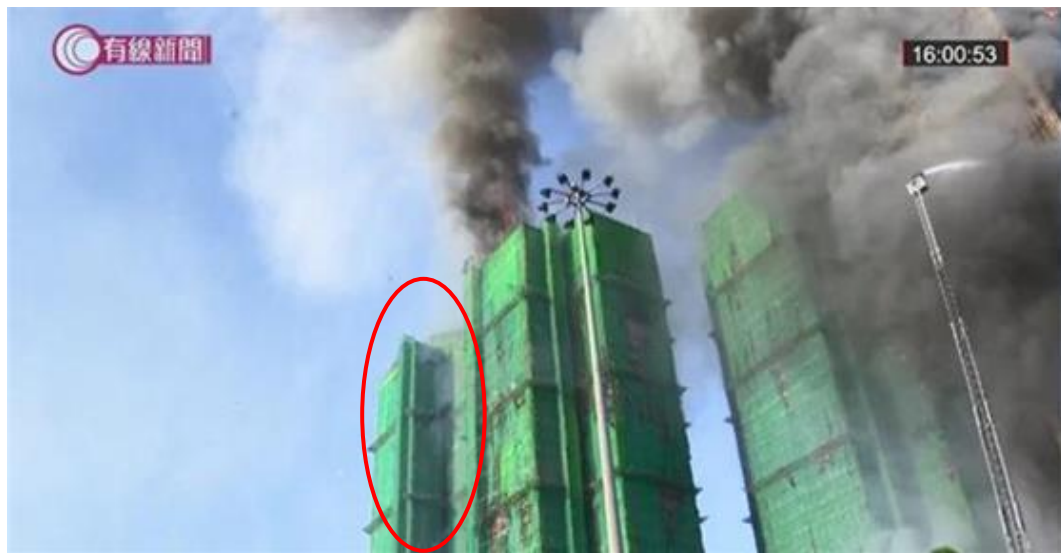
These materials provided a continuous fuel source across multiple levels, enabling rapid vertical fire spread, as shown in **Photos 6-6 (a) & (b)**.

Photos 6-6 (a) & (b): Continuous Fuel Source in the Re-Entrant

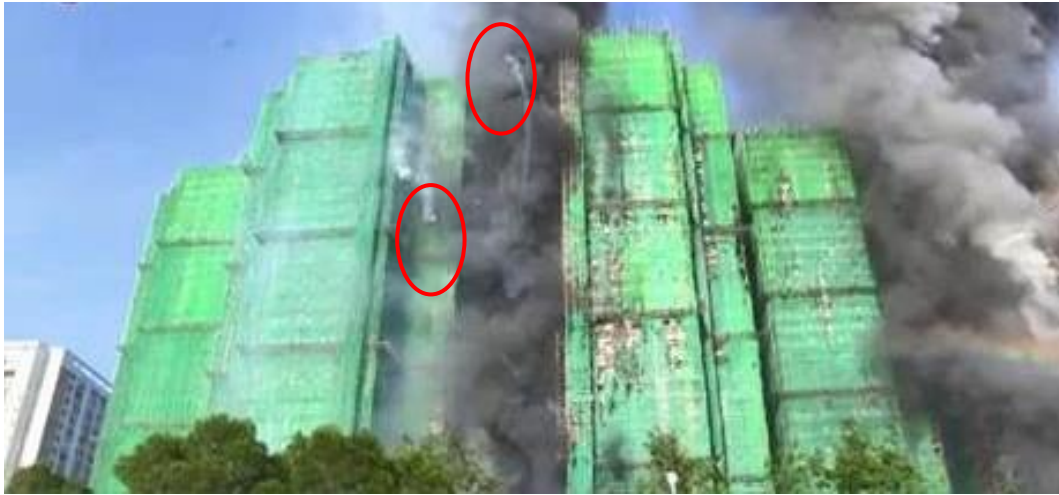
- 6.2.1.11 Cable TV footage provided a clear view of the fire spreading through the re-entrant of Wang Tao House, showing that the rapid vertical fire spread was likely caused by the ignition of pyrolyzed gases, generated from the pyrolysis of combustible materials (such as bamboo scaffolding, safety nets, canvas, wooden planks, toe-boards and polystyrene window covers), which had accumulated within the re-entrant, as shown in **Photos 6-7 (a) to (e)**.

Photo 6-7 (a): The Re-Entrant of Wang Tao House  
Remained Unaffected in 1600 Hours

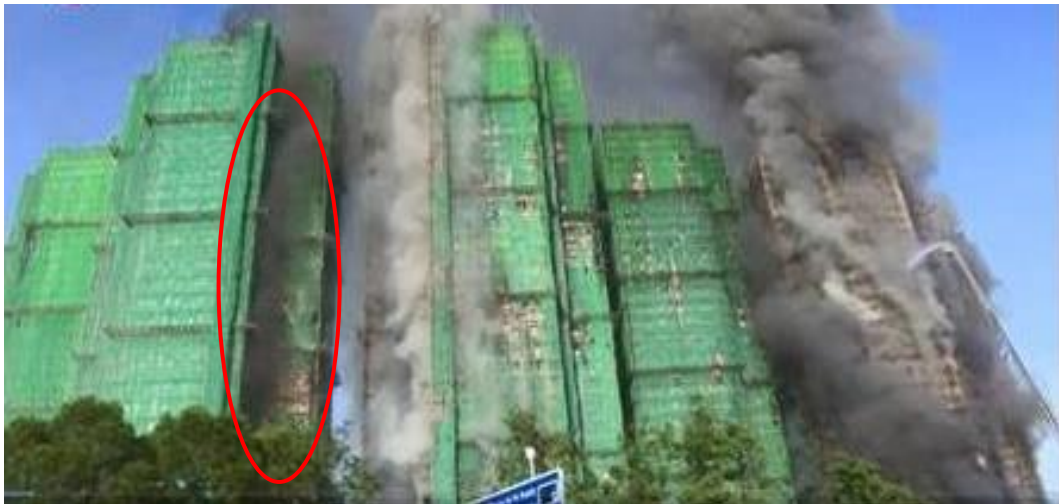
Photo 6-7 (b): Flying Embers and Debris Spreading From Wang Sun House to Wang Tao House

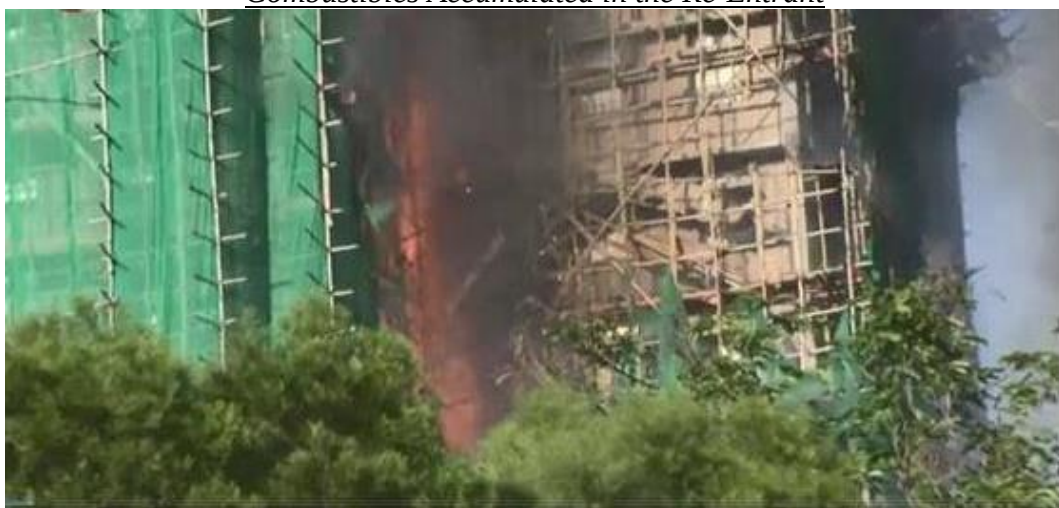
Photo 6-7 (c): Suspected Pyrolyzed Gases From Combustibles Accumulated in the Re-Entrant

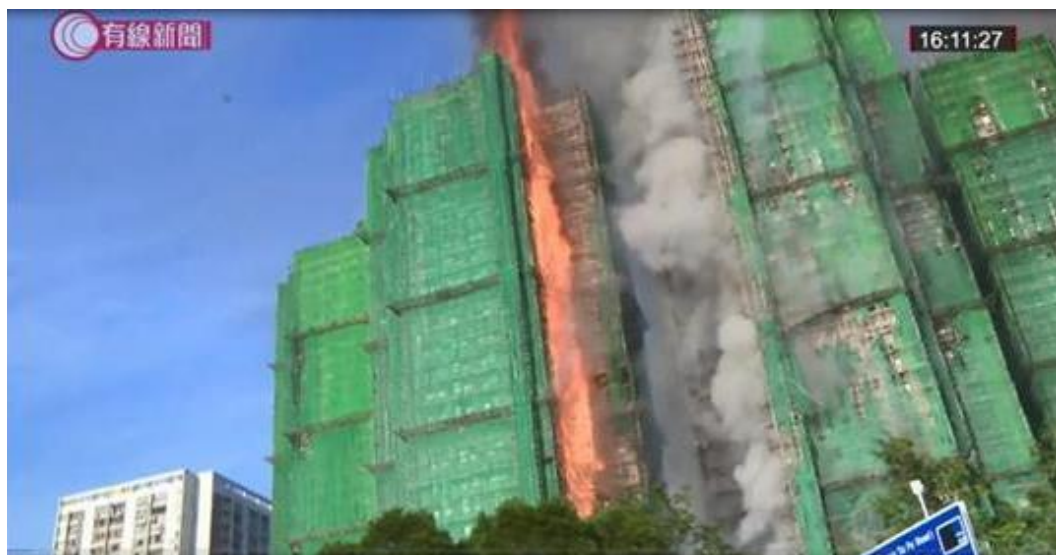
Photo 6-7 (d): Flaming Fire Observed in the Lower Portion of Wang Tao House

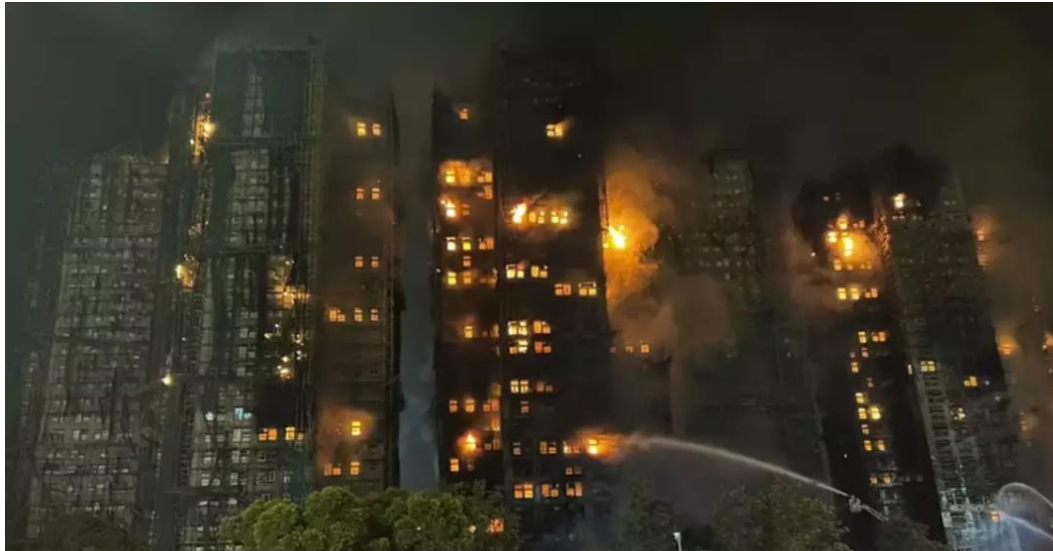
- 6.2.2.3 The enclosed nature of the domestic units further intensified the fire. As more items ignited, the temperature within the units rose, causing additional materials therein to reach their respective ignition temperatures. This chain reaction accelerated the fire development, enabling it to engulf the entire unit, as shown in **Photo 6-8**.

*Photo 6-8: Multiple Units on Fire at Wang Fuk Court*

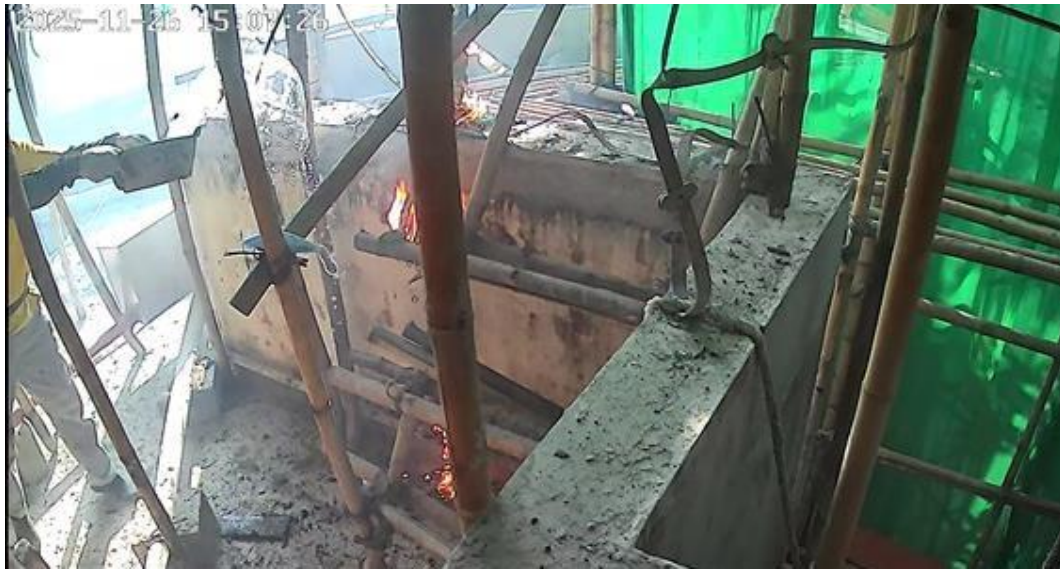
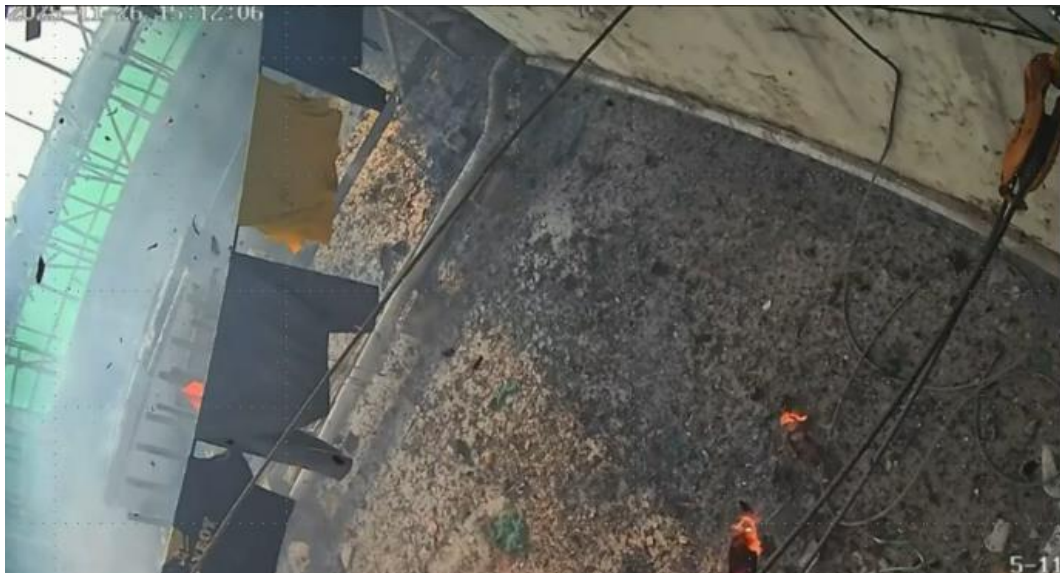
- 6.2.3.1 Witness accounts and CCTV footage, as shown in **Photos 6-9 (a) & (b)**, revealed that **winds carried embers** — small, burning fragments of combustibles — to nearby structures, where they ignited safety nets, construction debris and other combustible materials. These embers posed a significant risk as they could travel long distances, land on exposed surfaces and ignite new fires far from the original source.

Photos 6-9 (a) & (b): Flying Embers Suspected Spreading From  
Wang Cheong House to Wang Tai House at About 1506 and 1511 Hours<sup>73</sup>

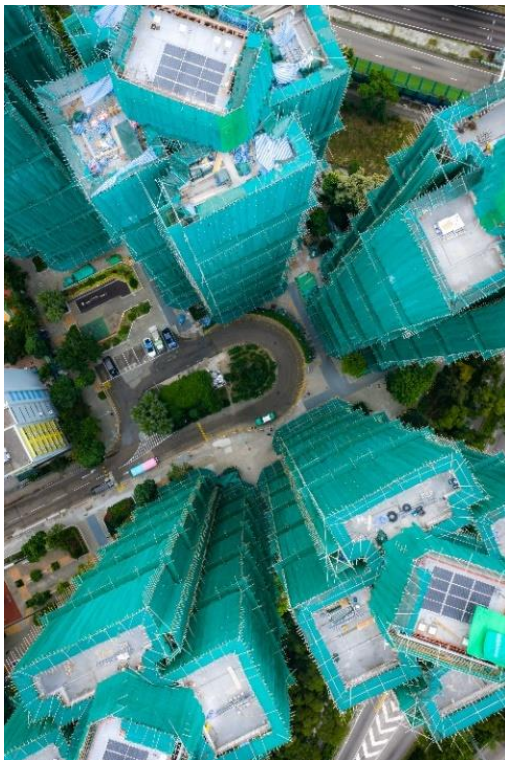
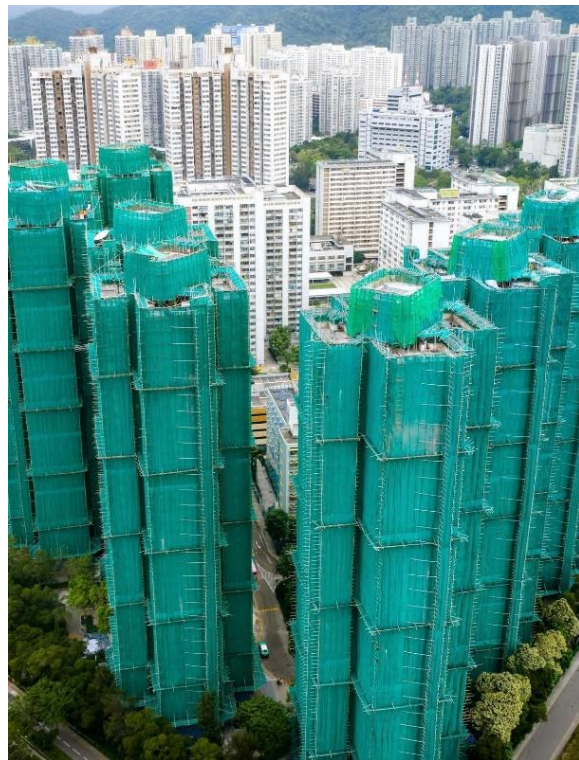
- 6.2.3.4 Among these materials, the buildings in Wang Fuk Court were enclosed by safety nets, as shown in **Photos 6-11 (a) & (b)**. In general, if these nets were made of FR materials, even if ignited, the fire would likely have self-extinguished<sup>72</sup> after the removal of the heat source, thereby minimizing the risk of igniting other combustible materials and reducing the overall spread of the fire.

- 6.2.3.5 The presence of safety nets potentially lacking FR properties, combined with dry and windy conditions created an ideal environment for the fire to spread and for embers to spark additional fires.

*Photos 6-11 (a) & (b): Buildings in Wang Fuk Court Enveloped by Safety Nets*

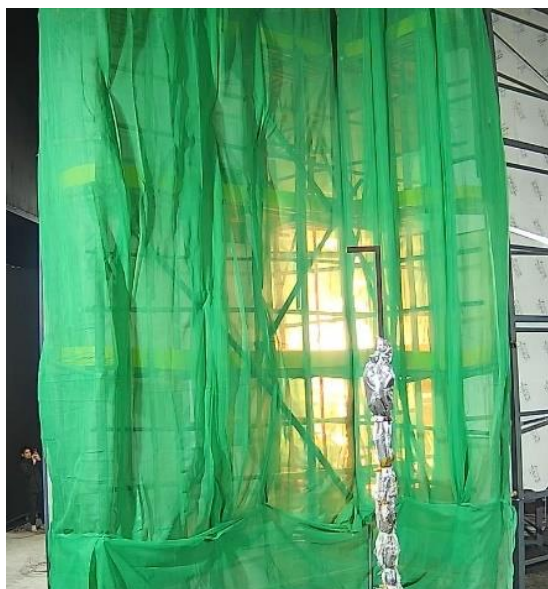
7.2.3.3 A fire test replicating the exact design at Wang Fuk Court<sup>87</sup> was conducted to evaluate fire development and severity. As shown in **Photos 7-3 (a) to (c)**. Initially, the fire developed slowly for the first 30 mins but then grew significantly at a rapid rate afterward.<sup>88</sup> This progression mirrored the rapid fire spread observed at Wang Fuk Court, where the fire engulfed multiple floors within minutes.

Photo 7-3 (a): The Fire Condition at 30 Mins With HRR at About 1MW

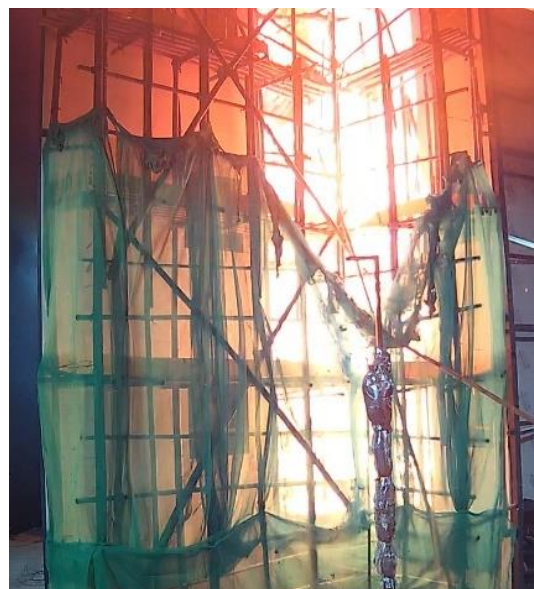
Photo 7-3 (b): The Fire Condition at 34 Mins With HRR Peaked at 29 MW

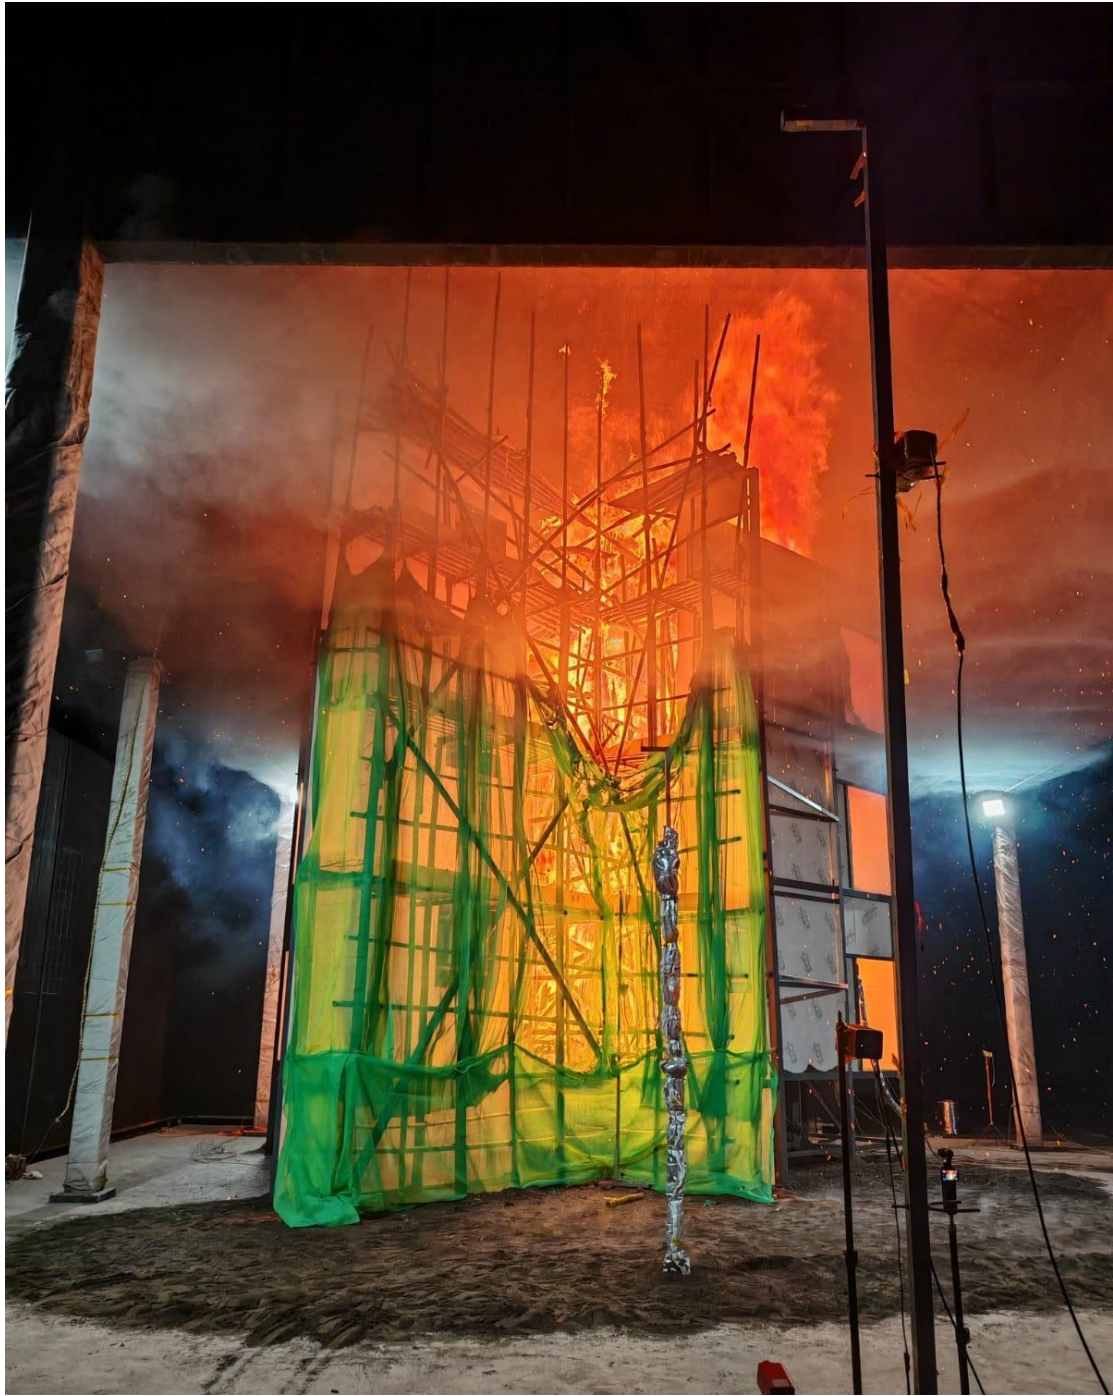
Photo 7-3 (c): Severe Fire Development Observed in the Test

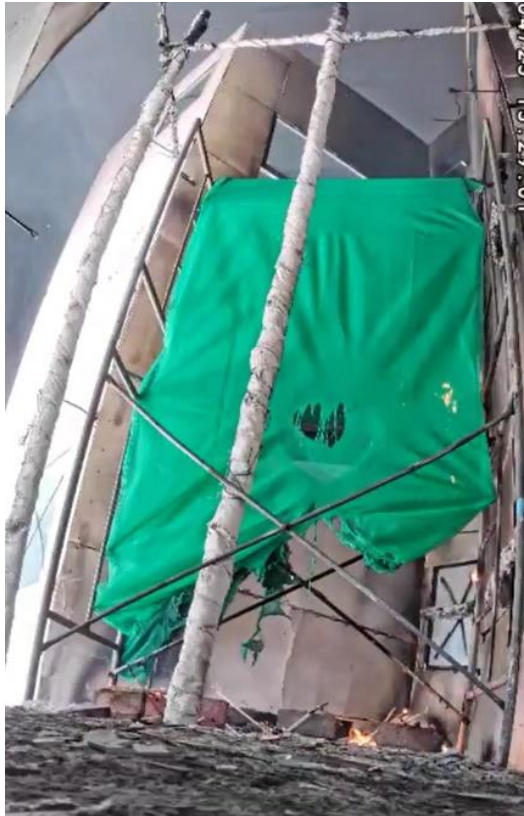
Photo 7-4 (b): Limited Fire Damage on Sample 2 (FR)

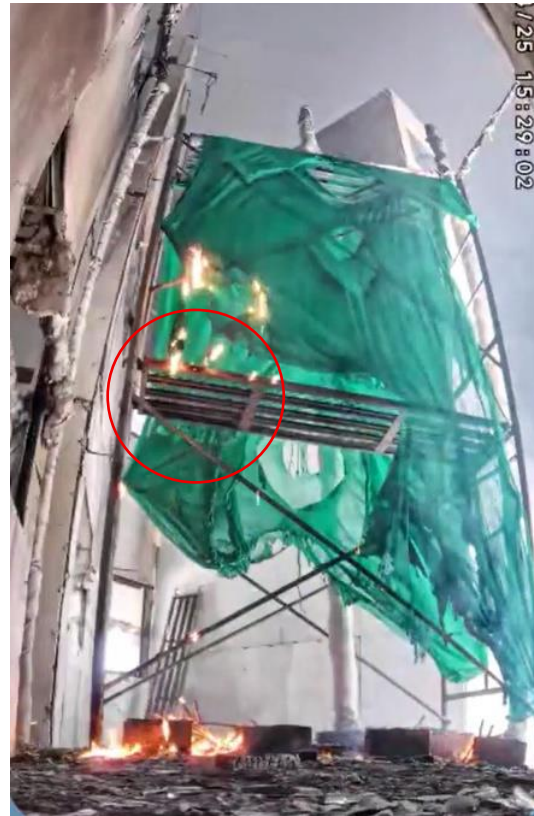
7.2.3.9 In the comparison tests, the safety nets collected from Wang Chi House exhibited a more rapid spread, even when compared to Sample 3 (Non-FR) safety nets, as shown in **Photos 7-4 (b) to (k)**. Furthermore, the safety nets collected from Wang Chi House were completely consumed by the end of the tests.

Photo 7-4 (c): Extensive Fire Spread on Sample 4 (Wang Chi House)

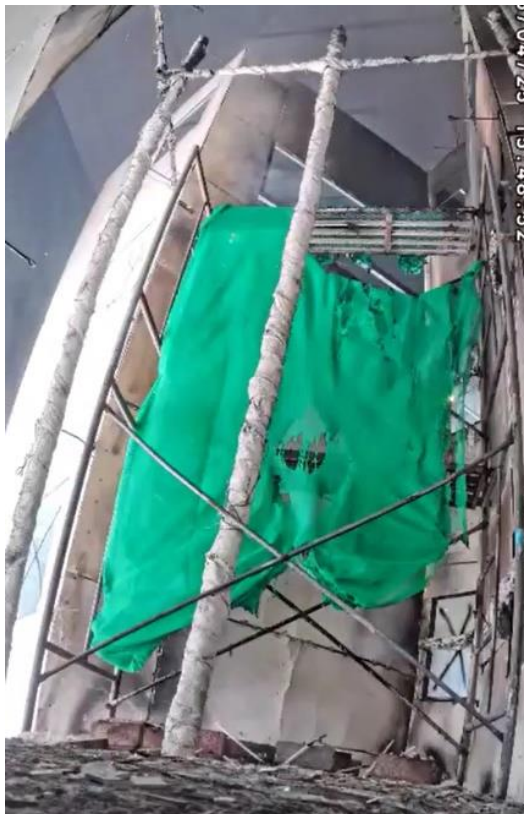
Photo 7-4 (d): Post-Fire Condition of Sample 2 (Partially Intact)

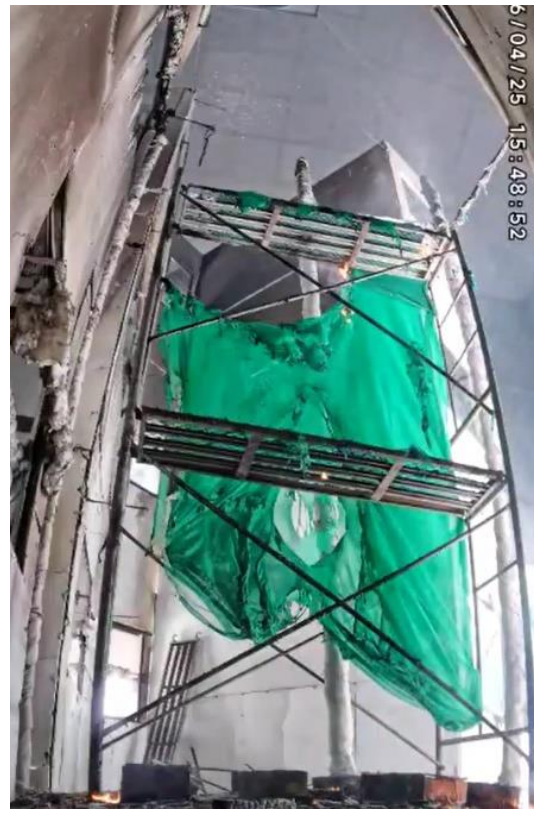
Photo 7-4 (e): Post-Fire Condition of Sample 4 (Fully Consumed)

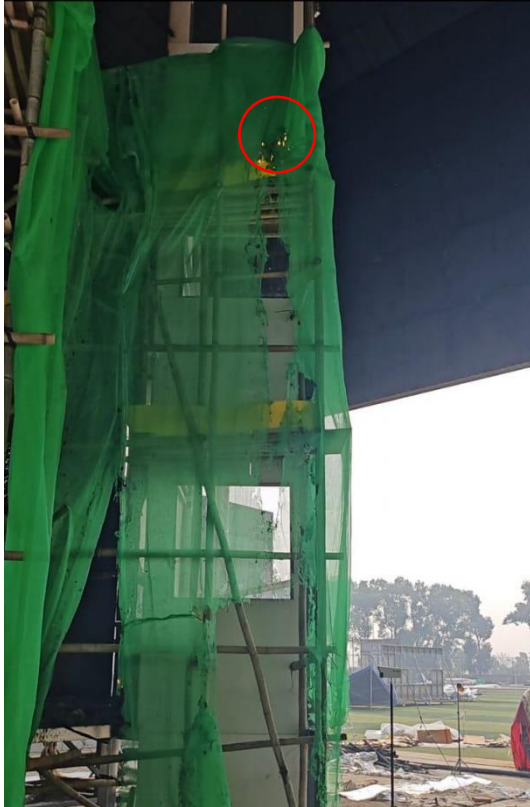
- 7.2.3.13 The following key stages were observed during the secondary ignition process:
- Small fires spreading along the safety nets led to the formation of flaming droplets, as shown in **Photo 7-5 (a)**.

Photo 7-5 (a):  
Small Fires Spreading Along Safety  
Nets, Forming Flaming Droplets

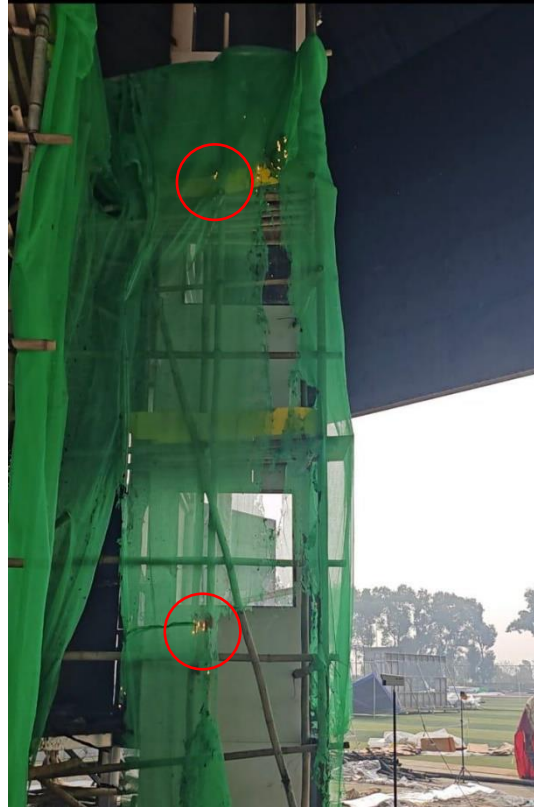
- Flaming droplets dripped, causing additional fire spread, as shown in **Photo 7-5 (b)**.
  - As the fire propagated, fires on the nets or flaming droplets ignited easily ignitable materials, such as nylon strips, as shown in **Photos 7-5 (c) & (d)**.

Photo 7-5 (b):  
Flaming Droplets Dripping and  
Spreading Fire

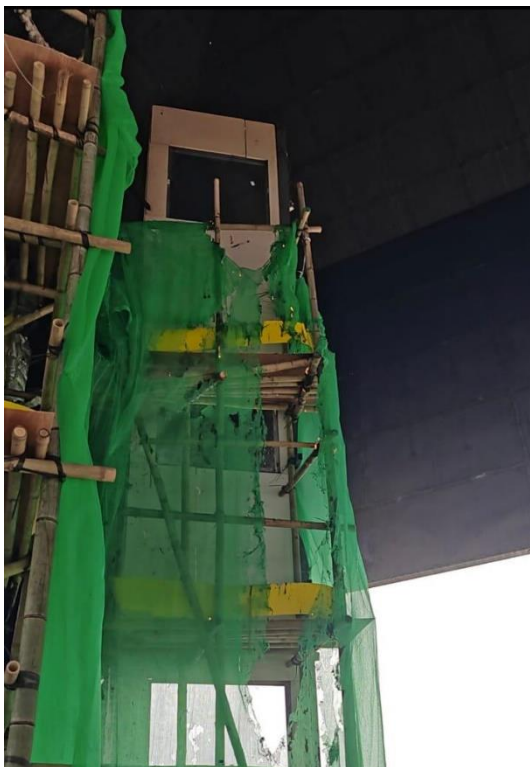
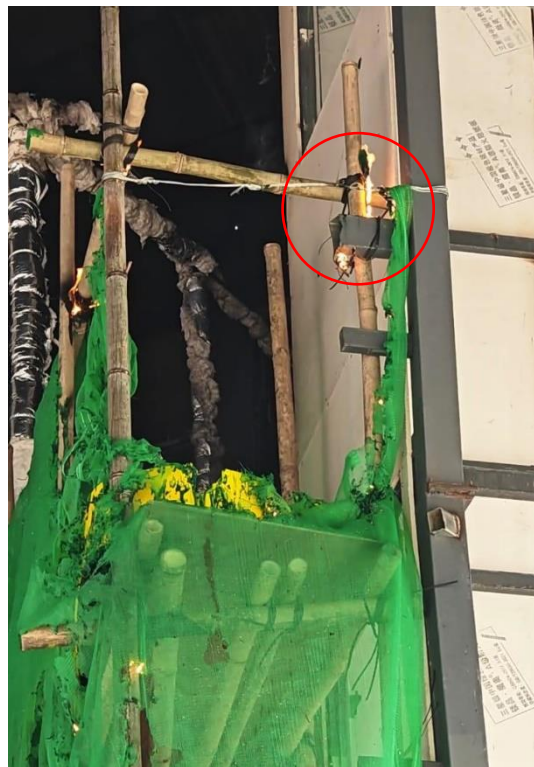
Photos 7-5 (c) & (d): Flaming Droplets Igniting Nylon Strips

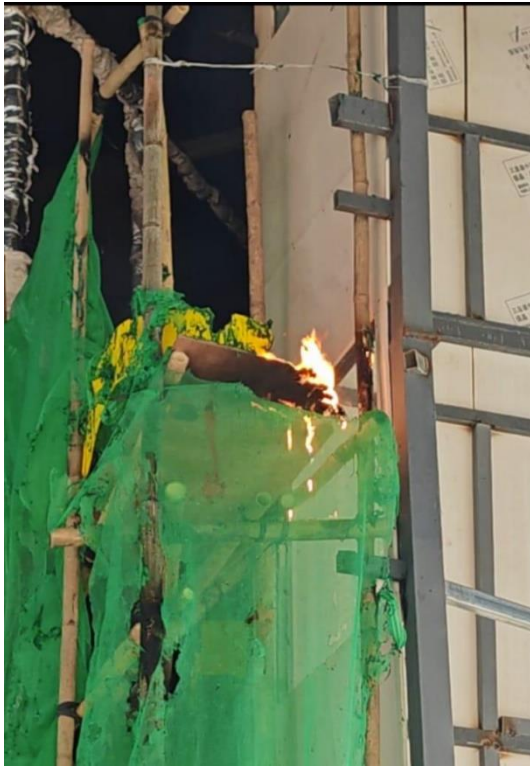
- The fire further spread to nearby combustibles, such as wooden planks and toe-boards, as shown in **Photo 7-5 (e)**.
  - The fire continued to generate flaming droplets, resulting in further fire propagation, as shown in **Photos 7-5 (f) to (h)**.

Photo 7-5 (e):  
Fire Spreading to Wooden Planks and  
Toe-Boards

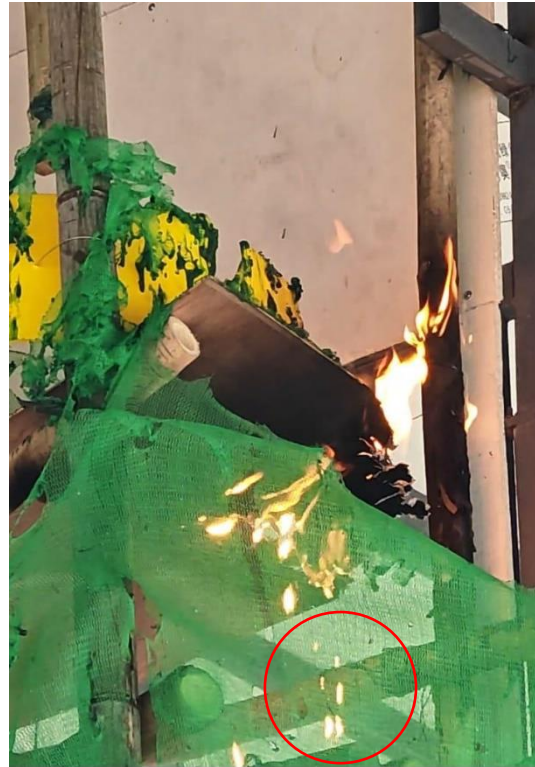
Photo 7-5 (f):  
Flaming Droplets Causing Further Fire  
Propagation

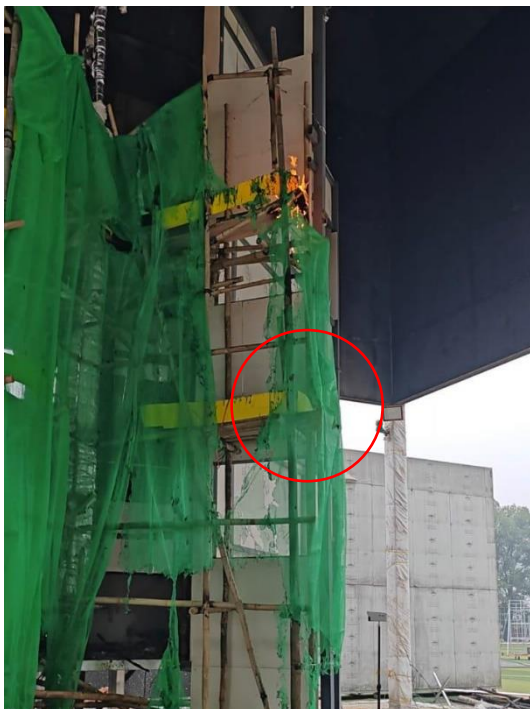
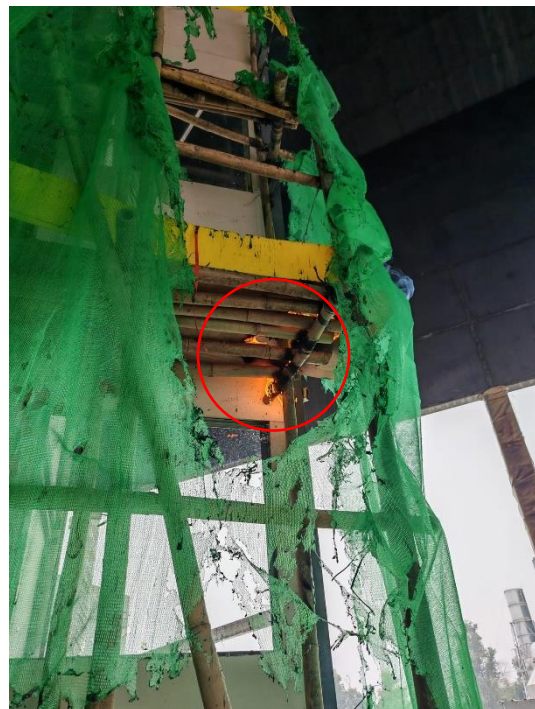
Photos 7-5 (g) & (h): Flaming Droplets Causing Further Fire Propagation

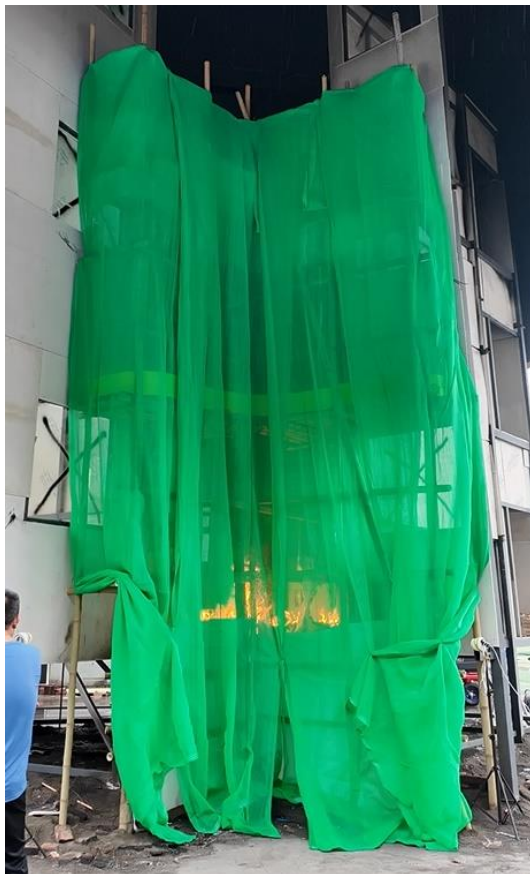
7.2.3.18 Tests demonstrated that FR materials effectively reduce fire severity and limit fire spread to adjacent areas, as shown in **Photos 7-6 (a) to (b)**. In contrast, suspected non-FR materials, such as safety nets collected from Wang Chi House, promoted fire spread through secondary ignition, involving more combustibles and increasing total heat release, as shown in the fire load analysis below. However, the damage to the FR canvas remained limited, as shown in **Photos 7-6 (c) to (d)**.

<sup>94</sup> Only about 32% of the FR canvas (by mass) and no wooden planks were damaged by fire in **Test 11**.

*Photo 7-6 (a):  
No Fire Spread Along Safety Nets  
in Test 11*

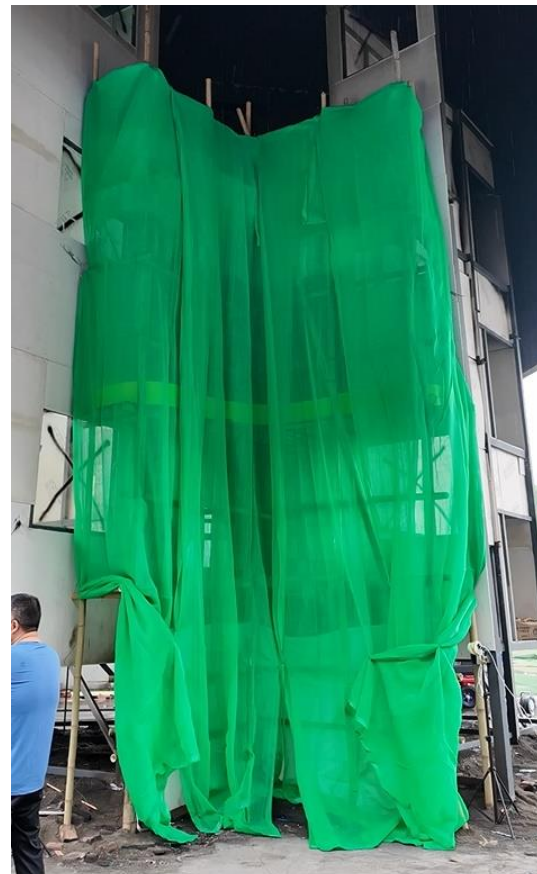
*Photo 7-6 (b):  
Post-Fire Condition in Test 11 Using FR  
Safety Nets and FR Canvas*

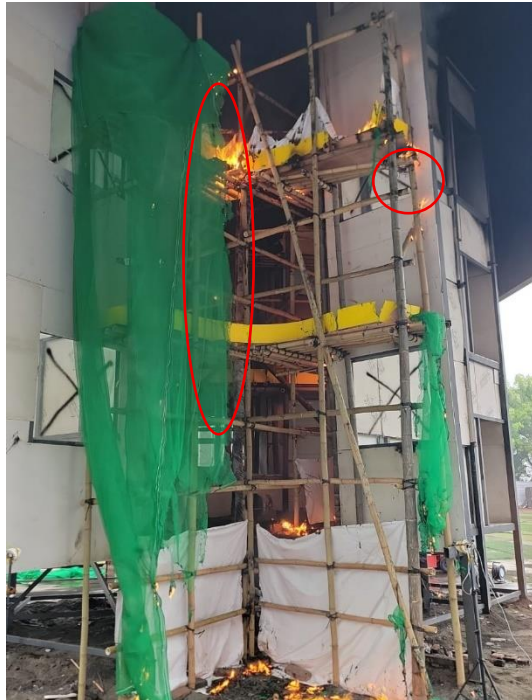
<sup>95</sup> About 48% of the FR canvas and 68% of the wooden planks were damaged by fire in **Test 12**.

Photo 7-6 (c):  
Fire Spread Along Safety Nets in Test 12

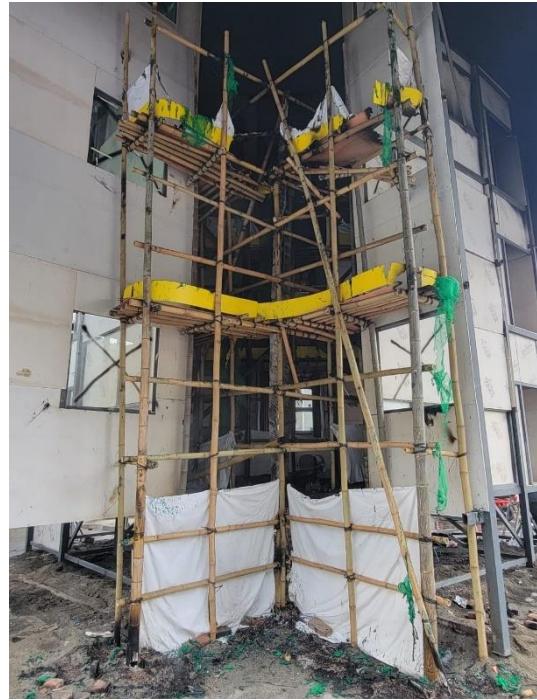
Photo 7-6 (d):  
Post-Fire Condition in Test 12 Using  
Safety Nets Collected From Wang Chi  
House and FR Canvas

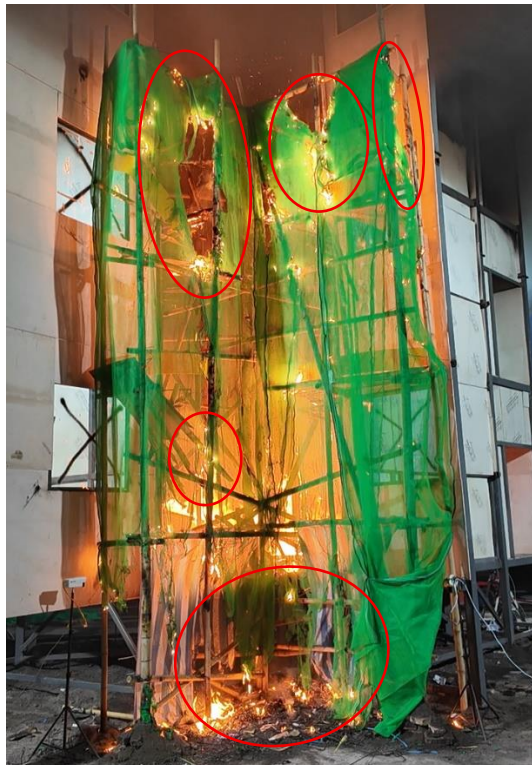
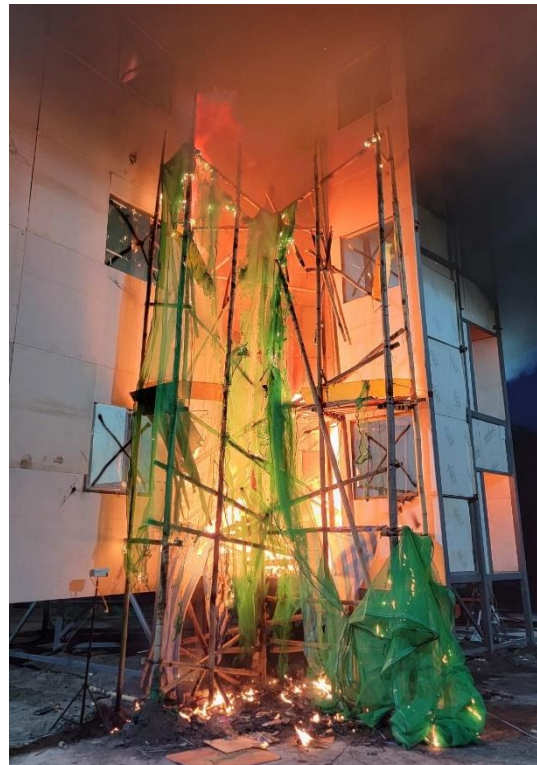
<sup>96</sup> All non-FR canvas and wooden planks were completely consumed by fire in **Test 13**.

Photos 7-6 (e) & (f): Fire Spread Along Safety Nets in Test 13

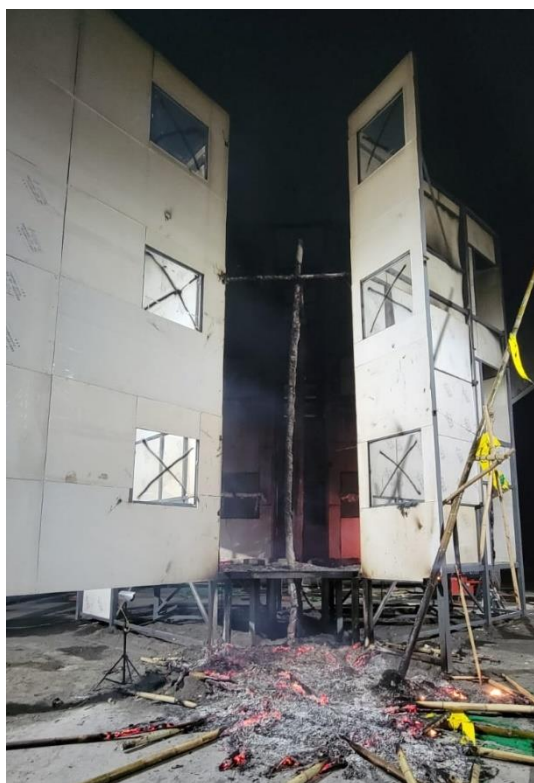
Photo 7-6 (g):  
Post-Fire Condition in Test 13 Using  
Safety Nets Collected From Wang Chi  
House and Non-FR Canvas

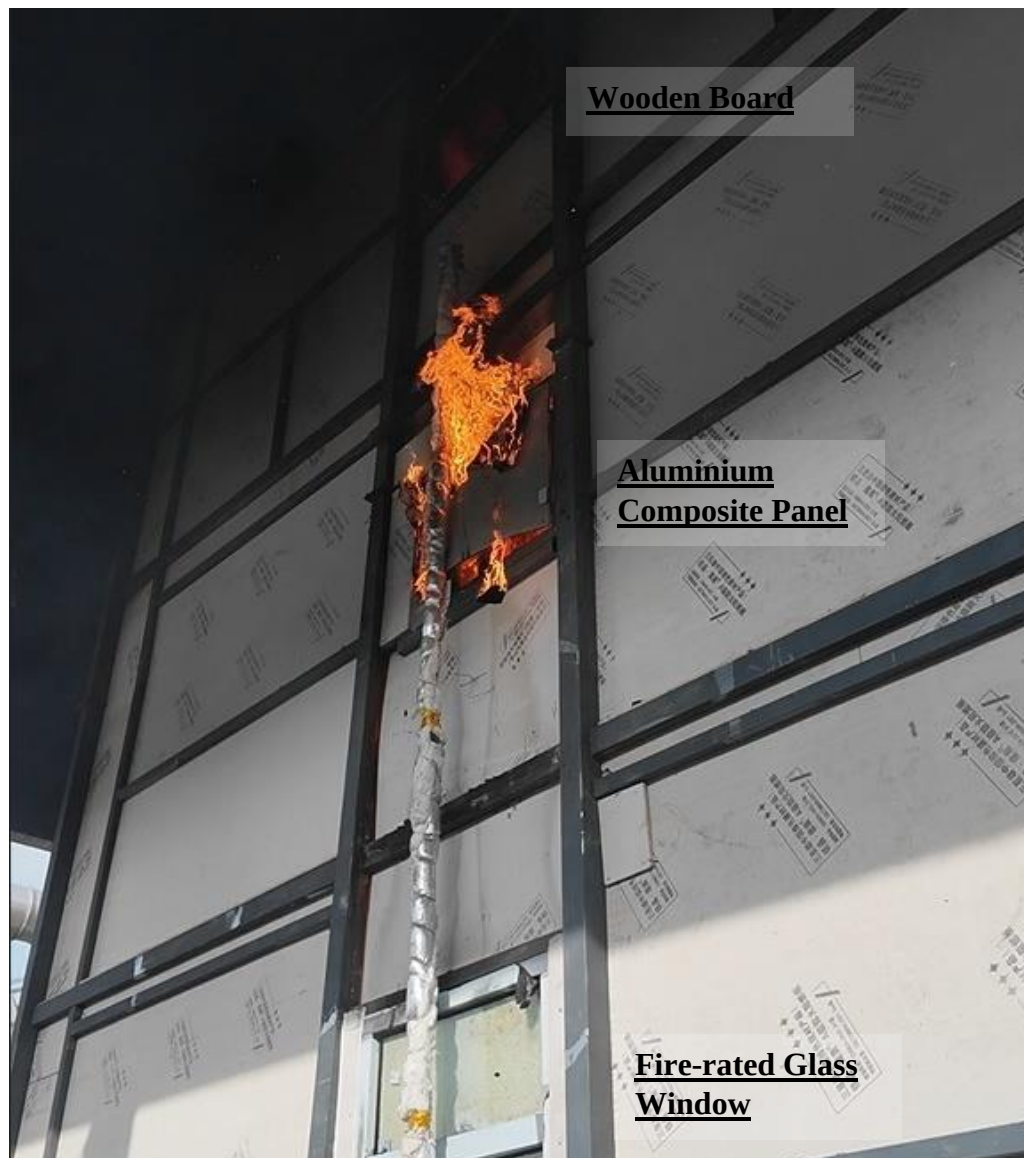
- 7.2.3.20 In Wang Cheong House, escape staircases were positioned next to the re-entrant, as shown in **Figure 7-5**. Post-fire investigations revealed that while fire-rated glass windows had replaced the original ones, some were substituted with movable wooden or aluminium composite boards. These boards had holes and gaps, allowing direct exposure between the staircase and the re-entrant.
- 7.2.3.21 Rapid fire spread along the re-entrant was observed early in the fire. **Test 9** was conducted to evaluate the effectiveness of fire-rated glass windows, aluminium composite panels and wooden boards in covering window openings and their impact on evacuation. A piece of wooden board, aluminium composite panel and fire-rated glass window<sup>97</sup> were installed at the openings on the 3/F, 2/F and 1/F level respectively, as shown in **Photo 7-7**.

*Photo 7-7: Installation of Wooden Board, Aluminium Composite Panel and Fire-rated Glass Window in Test 9*

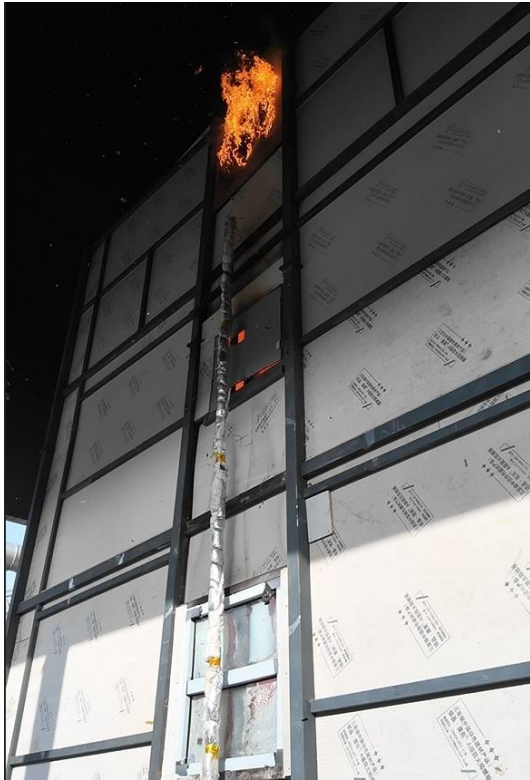
7.2.3.23 During the test, the wooden board on the 3/F (**Photo 7-8 (a)**) ignited at 4 mins 40 secs, followed by the aluminium composite panel on the 2/F (**Photo 7-8 (b)**) at 7 mins 49 secs. Both were completely consumed by fire, while the fire-rated glass window remained intact throughout the test, as shown in **Photo 7-8 (c)**. Although the aluminium composite panel showed delayed ignition, it still allowed smoke and heat to penetrate the staircase and ultimately ignited.

Photo 7-8 (a):  
Ignition of Wooden Board  
(4 Mins 40 Secs)

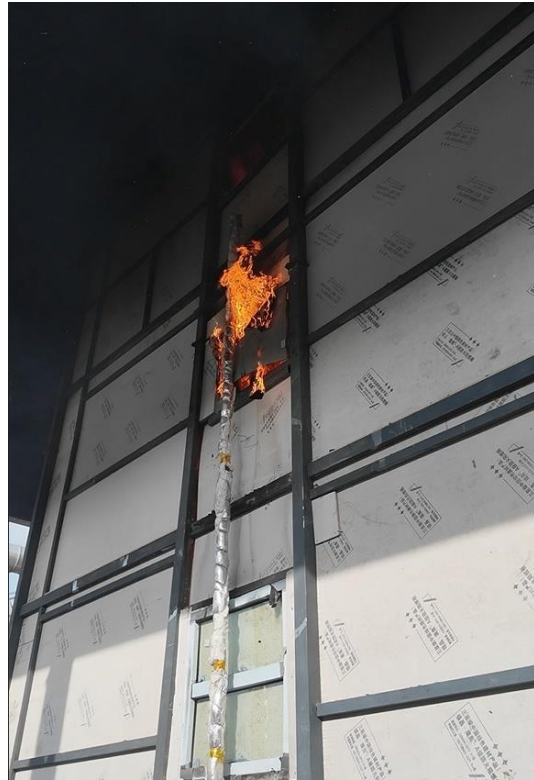
Photo 7-8 (b):  
Ignition of Aluminium Composite Panel  
(7 Mins 49 Secs)

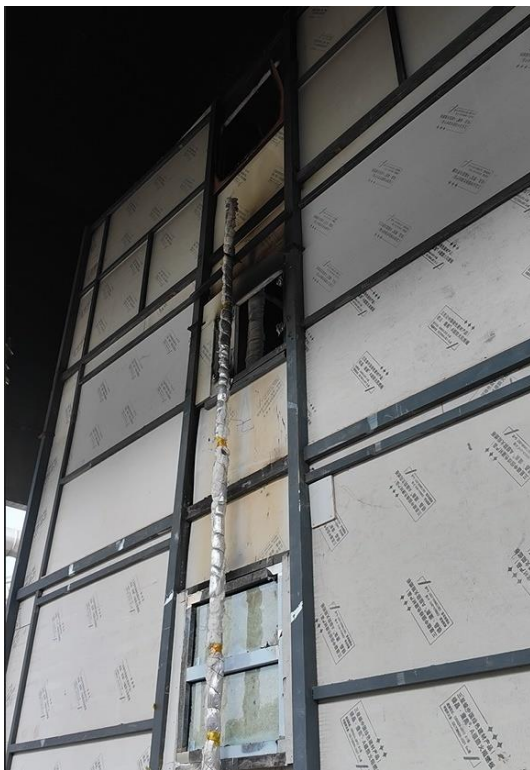
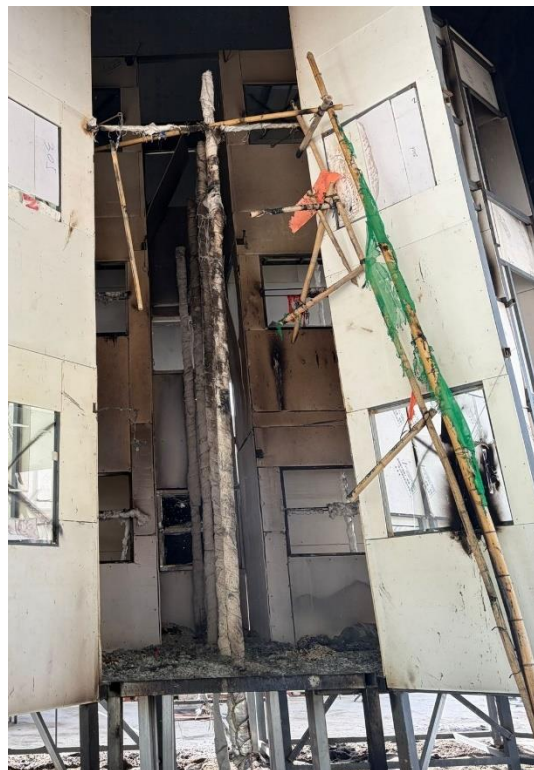
Photos 7-8 (c) & (d): Post-Fire Condition

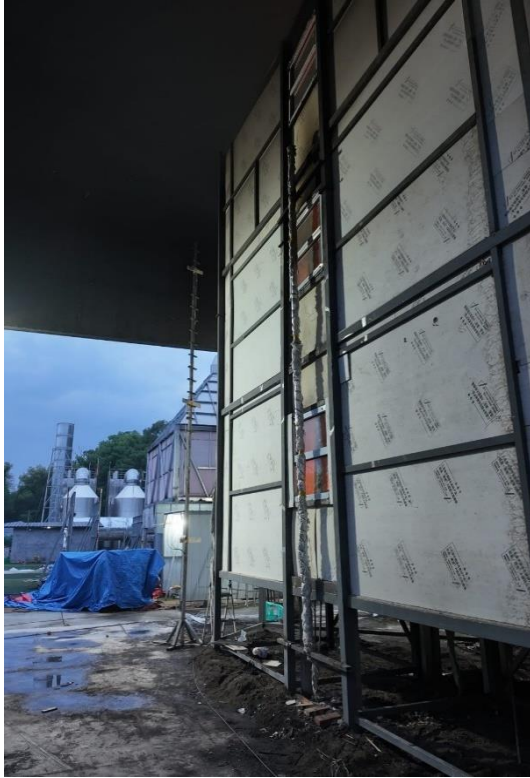
7.2.3.25 The test demonstrated that the fire-rated glass window maintained significantly lower temperatures, ensuring that evacuation remained a viable option at the early stage.<sup>100</sup> This observation is further strengthened by **Test 13**, where all staircase openings were sealed with fire-rated glass windows. The maximum temperatures recorded, as summarized in the table below, further demonstrate that fire-rated glass windows effectively reduced internal temperatures and prevented smoke infiltration into the staircases at the early stage.

Photo 7-9:  
Condition of Fire-rated Glass During Test 13

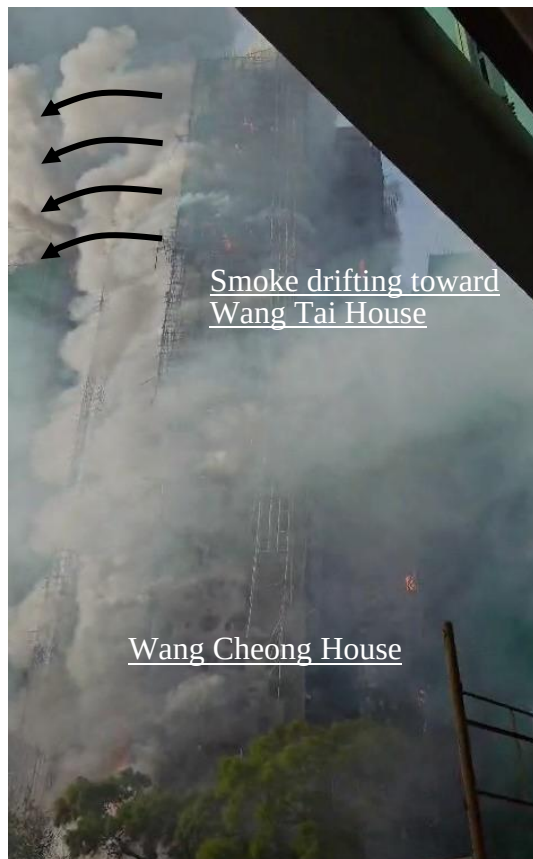
7.3.2.3 Significant smoke drifting was observed during the incipient stage of the fire, as shown in **Photos 7-10 (a) to (c)**. This drifting was effectively replicated and demonstrated by the CFD simulation.

Photo 7-10 (a):  
Heavy Smoke on the South-East Façade  
Wang Cheong House at 1508 Hours
