# Final Investigation Report No.5 Alarm Fire at Wang Fuk Court on 26 November 2025

Inter-Departmental Fire Investigation Task Force

May 2026

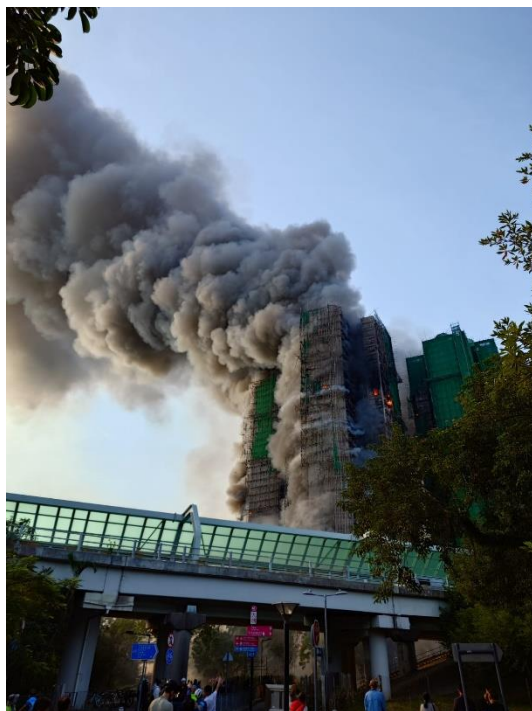
7.3.2.3 Significant smoke drifting was observed during the incipient stage of the fire, as shown in **Photos 7-10 (a) to (c)**. This drifting was effectively replicated and demonstrated by the CFD simulation.

Photo 7-10 (b):  
Heavy Smoke on the South Re-Entrant of  
Wang Cheong House at 1537 Hours

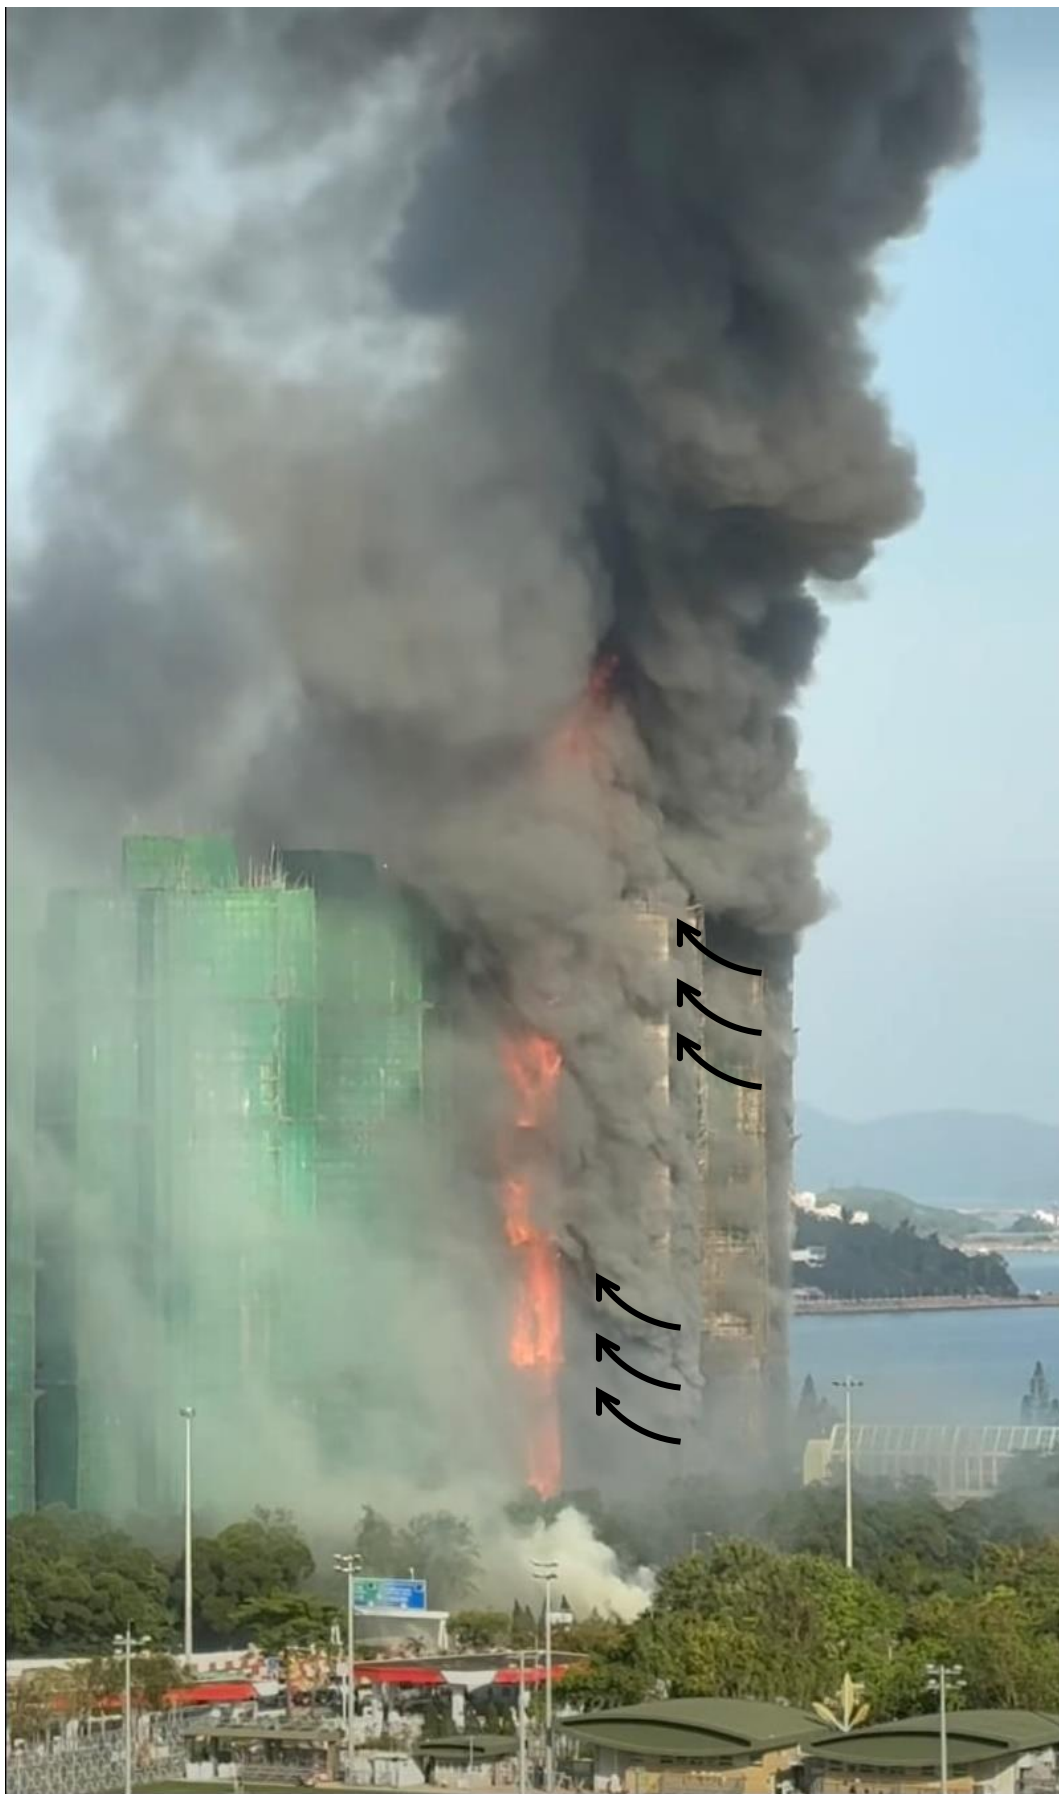
Photo 7-10 (c): Heavy Smoke From Wang Cheong House & Wang Tai House

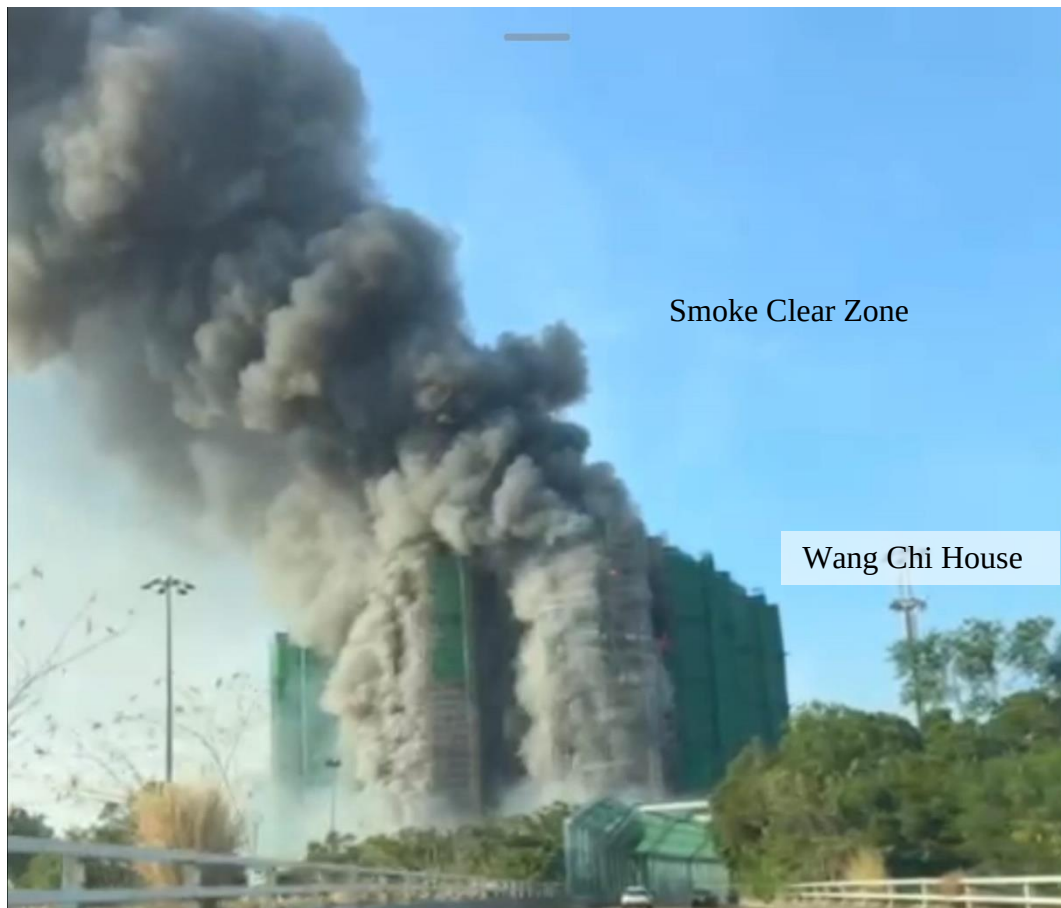
- 7.3.2.4 The wind vector provided valuable insights into the trajectory of flying embers that could ignite new fires. Wang Chi House was the only unaffected building in Wang Fuk Court, a fact that can be explained by the wind profile. As shown in **Figure 7-7 (a)** and **Photo 7-11** buildings experiencing rapid fire spread along re-entrants are marked with red circles. However, as illustrated by the wind vectors, the wind did not carry embers towards Wang Chi House, which may account for its minimal damage.

Photo 7-11: Smoke Clear Zone Above Wang Chi House

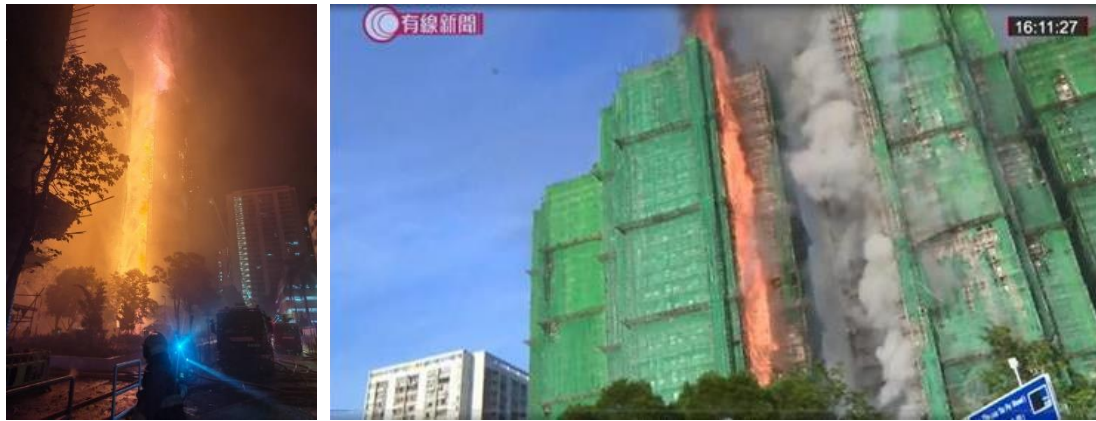
8.2.1 During the fire, multiple instances of rapid vertical fire spread were observed in different re-entrants, where the blaze consumed the entire re-entrant and spread across 31 levels almost simultaneously, as illustrated in **Photos 8-1 (a) & (b)**.

*Photos 8-1 (a) & (b): Rapid Vertical Fire Spread Along the Re-Entrant  
Observed in Wang Tao House and Wang Yan House*

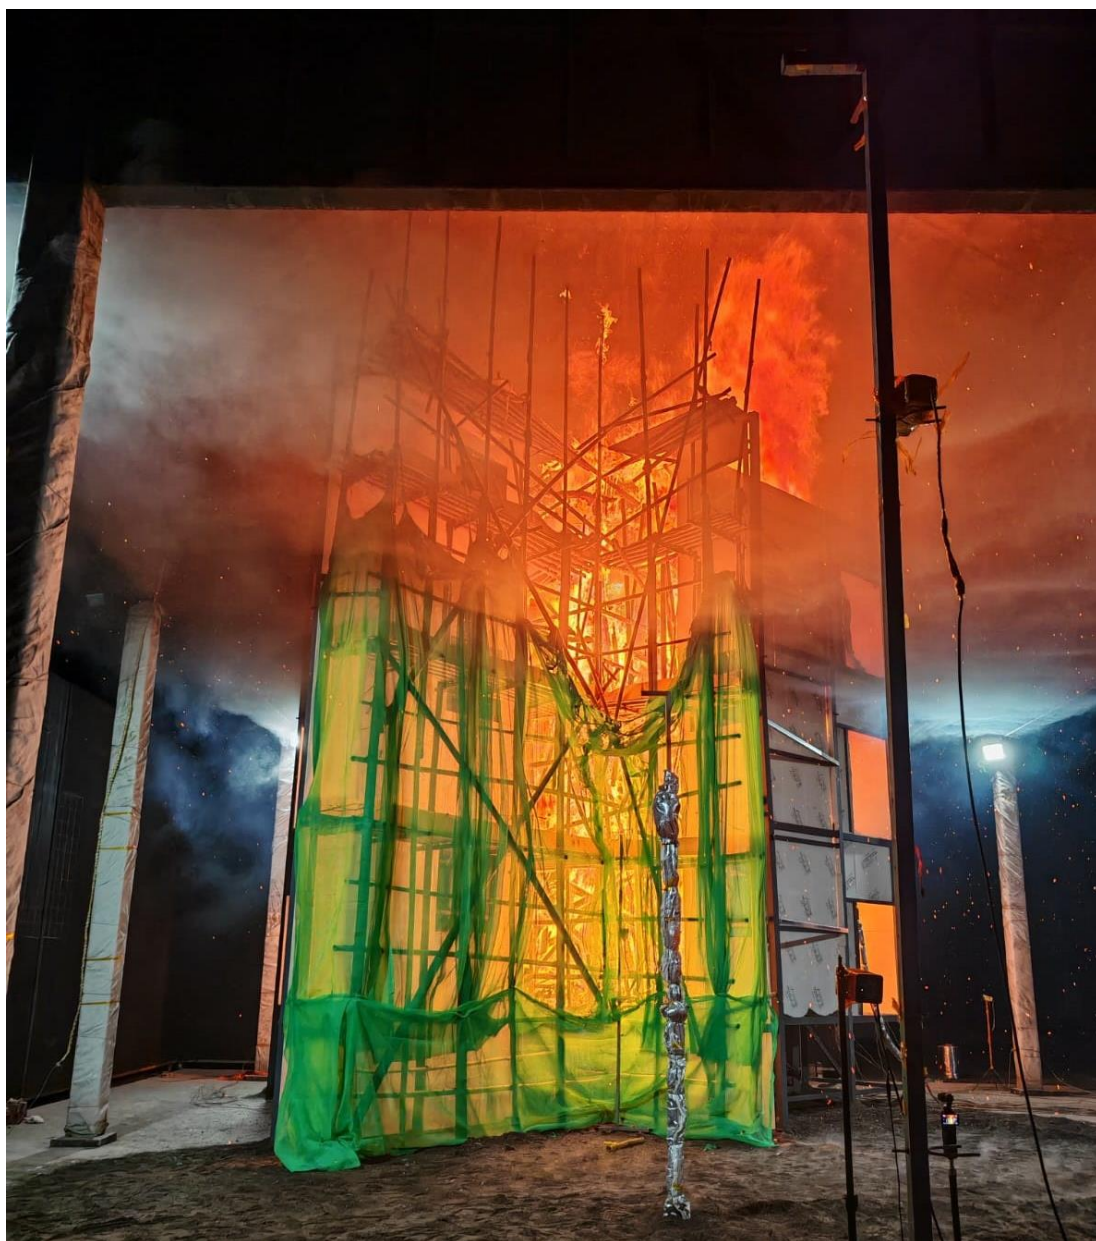
- 8.2.4.2 A fire severity analysis, as detailed in paragraph 7.2.3.3, was conducted to evaluate the impact of the identified combustibles. As illustrated in **Photo 8-2 (a)**, **the fire reached extreme levels of severity even when only the identified materials were included.** The peak HRR for a three-storey mockup reached 29 MW, comparable to the peak fire HRR of a bus or heavy goods vehicle in a tunnel fire. Given that the actual re-entrants span 31 storeys and contained additional combustibles (i.e. canvas, polystyrene window covers and backing papers of mosaic tiles) the fire severity could have escalated dramatically.

Photo 8-2(a): Fire Severity Analysis Showing Extreme Fire Severity

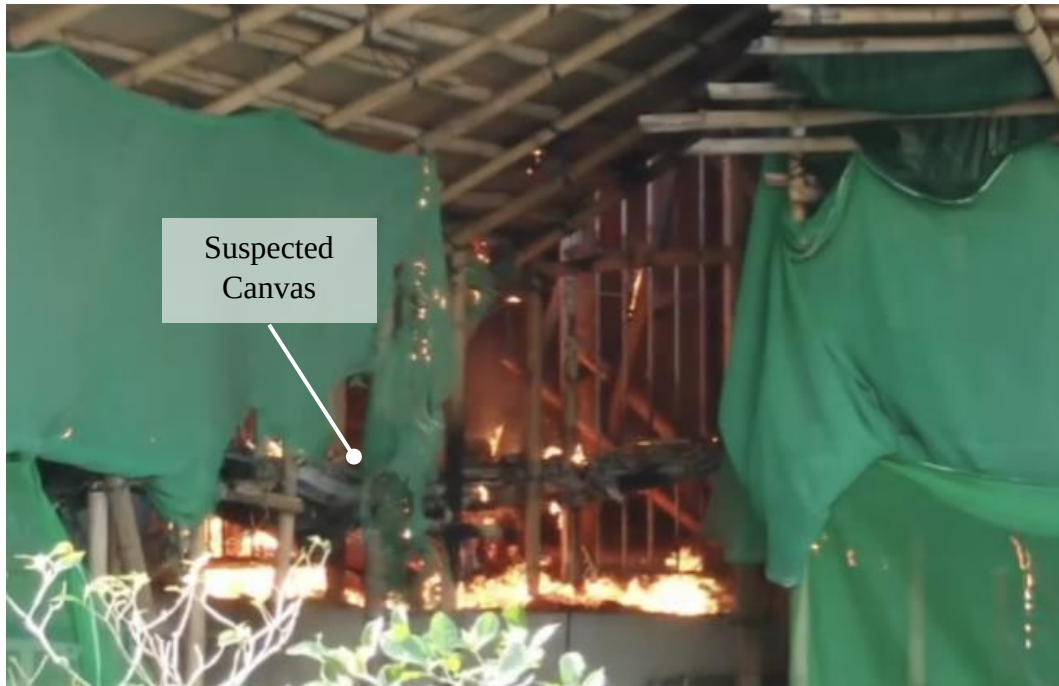
Photo 8-2 (b): Fire Development at the Incipient Stage

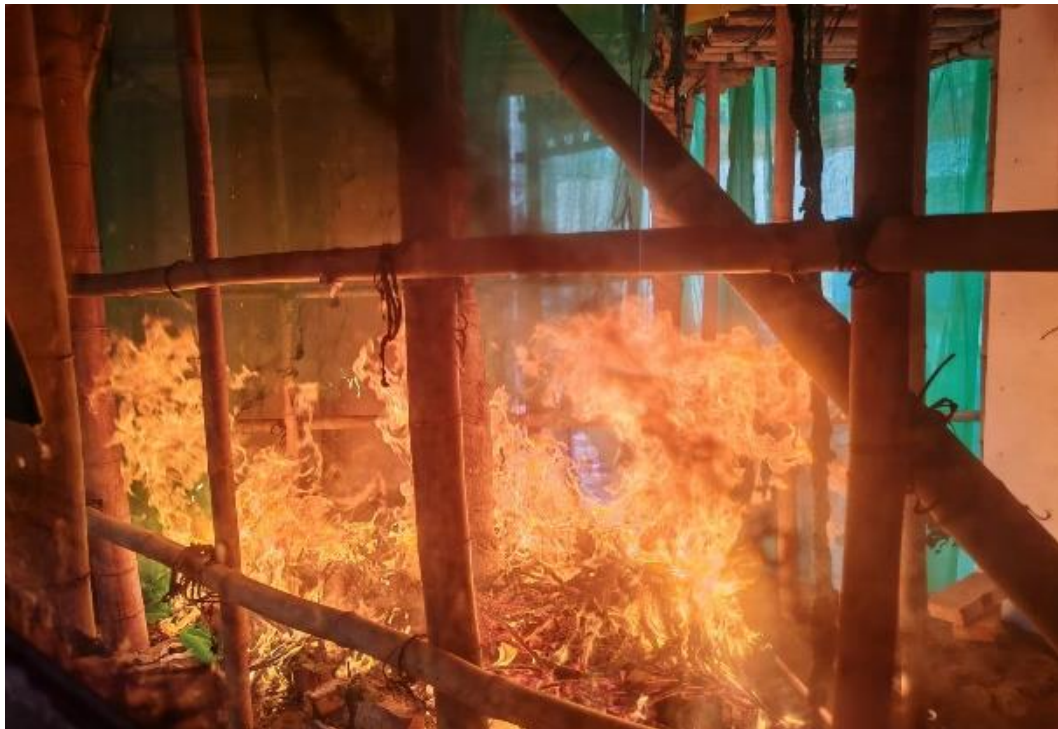
- 8.2.6.2 As demonstrated in **Test 11** conducted in Sichuan, the use of FR safety nets and FR canvas effectively prevented fire spread, keeping fire damage minimal from the source, as shown in **Photo 8-2(c)**.

Photo 8-2 (c): Fire Developed from a Small Fire Source During Fire Tests

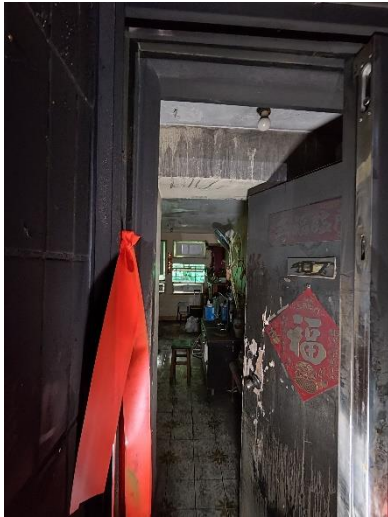
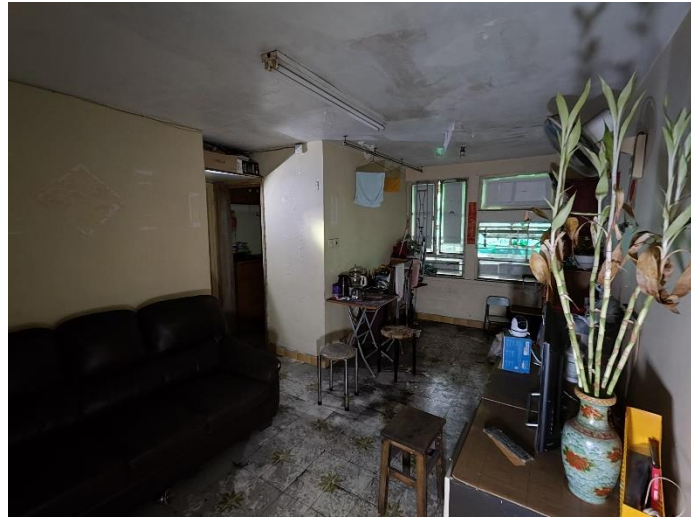
- Red: Extremely severe damage (see **Photo 8-3 (a)**)
- Orange: Severe damage (see **Photo 8-3 (b)**)
- Yellow: Minor damage (see **Photos 8-3 (c) & (d)**)
- Green: Unaffected (see **Photo 8-3 (e)**)

Photos 8-3 (c) & (d): Unit Sustained Minor Damage – Flat 07, Wang Yan House

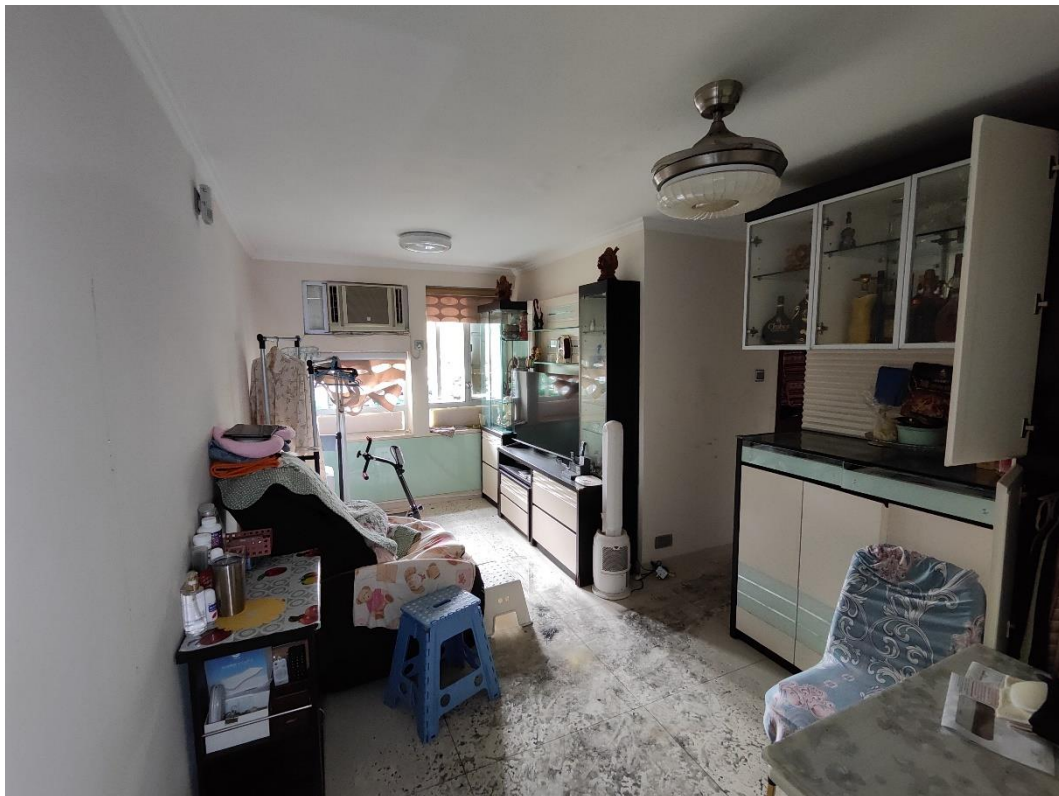
Photo 8-3 (e): Unaffected Unit – Flat 04, Wang Yan House

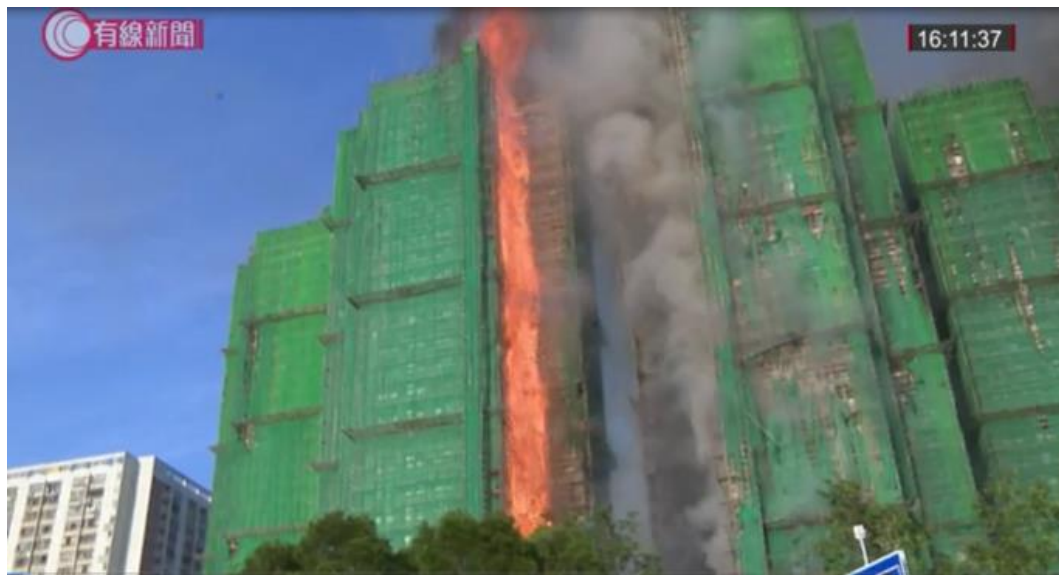
8.3.1.3 As observed in news video footage, the fire had already spread into units following the rapid fire spread along the re-entrant. **Photos 8-4 (a) & (b)** of Wang Tao House illustrate these observations and are provided as references.

*Photo 8-4 (a): South Re-Entrant of Wang Tao House Fully Alight*

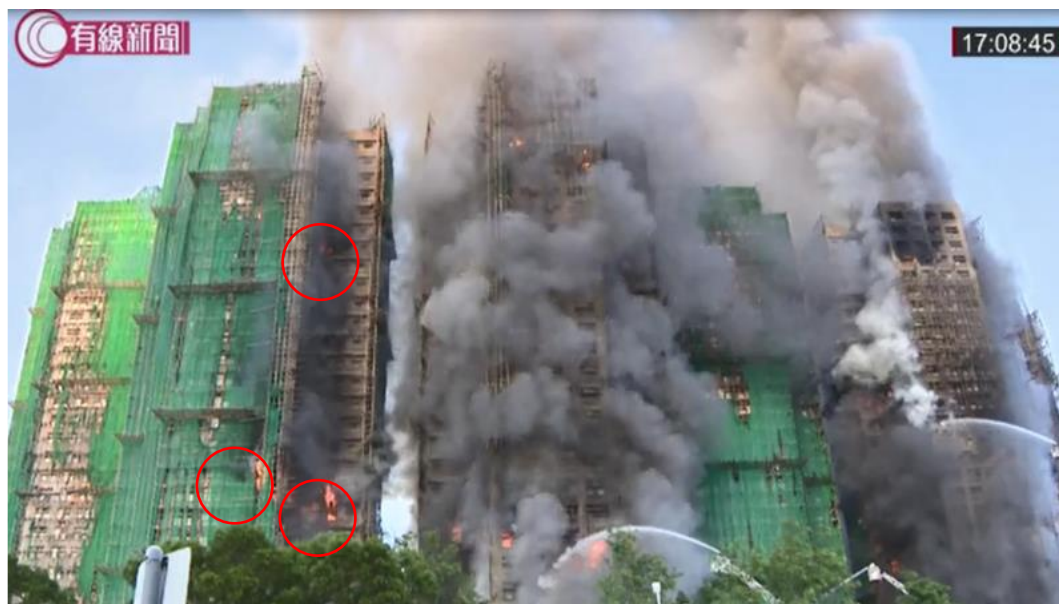
*Photo 8-4 (b): Visible Flames in Flats 1202, 1203 and 2202 of Wang Tao House<sup>112</sup>*

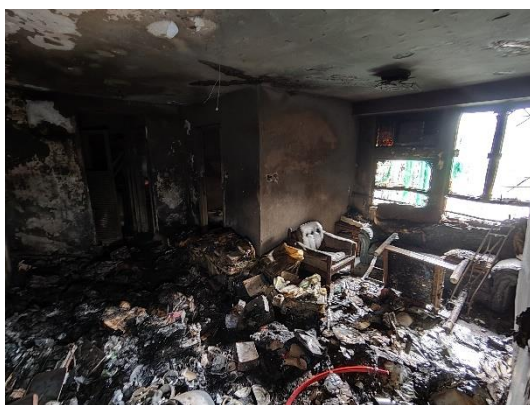
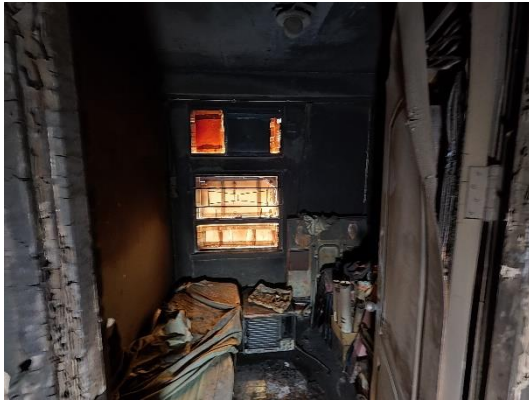
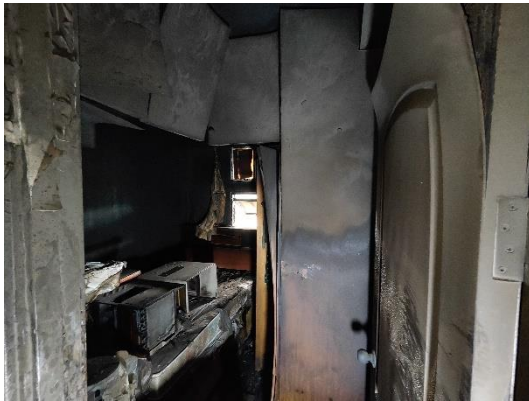
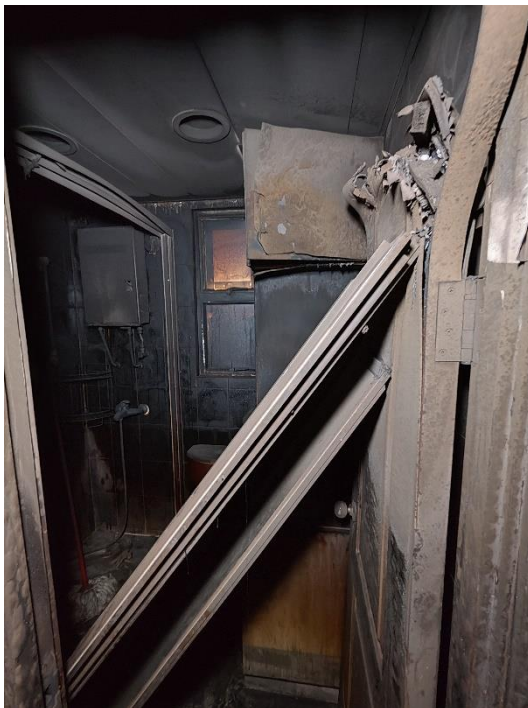
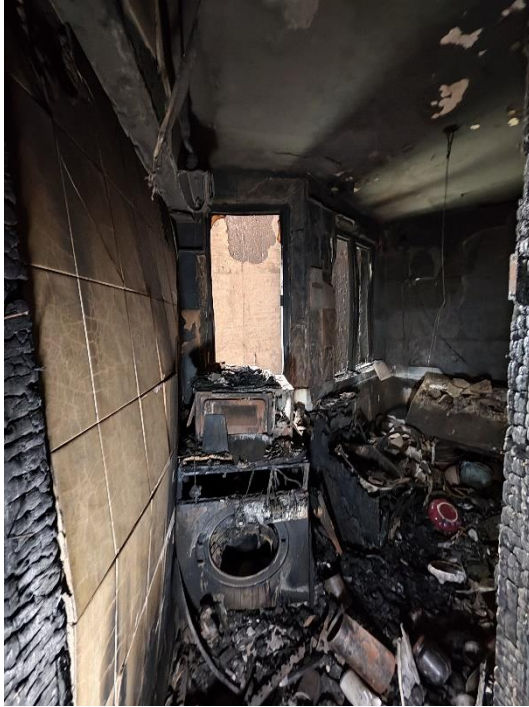
- 8.3.4.3 Upon further examination, the living room (**Photo 8-5 (a)**), bedrooms (**Photos 8-5 (b) & (c)**), toilet (**Photo 8-5 (d)**) and kitchen (**Photo 8-5 (e)**) of Flat ■02 were found to have sustained extremely severe fire damage. However, despite the extreme damage to the bedrooms and toilet, their windows remained intact, indicating that the fire did not spread into these rooms from the building exterior. Instead, the fire likely first spread to the living room and kitchen, which are connected to the re-entrant and then internally spread to the bedrooms and toilet.

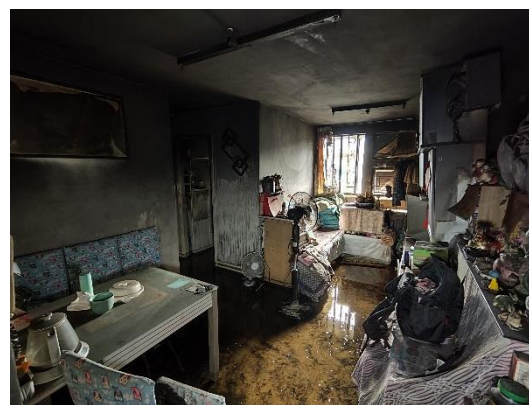
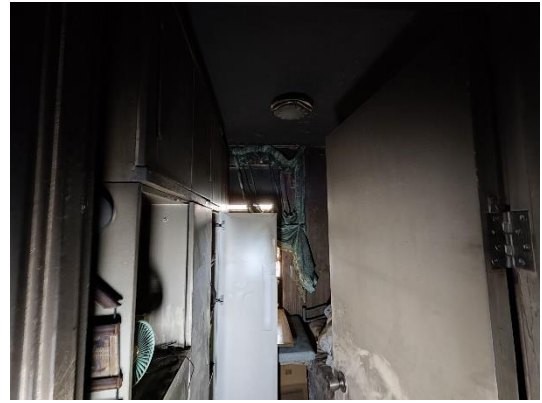
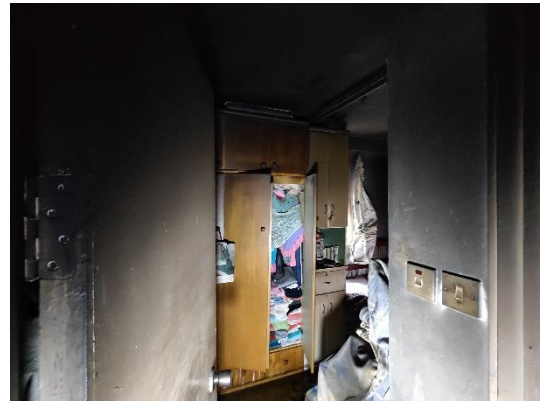
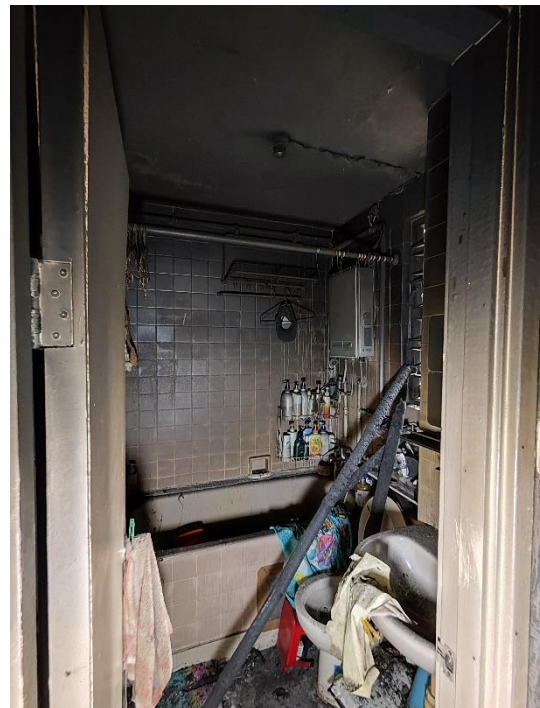
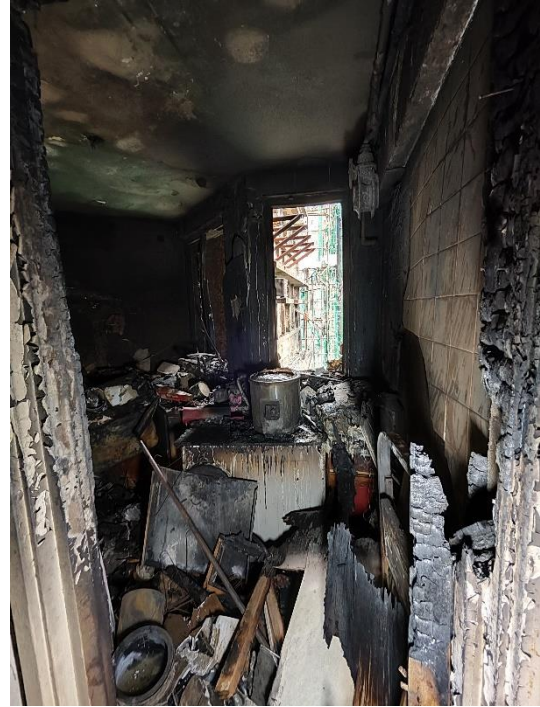
- 8.3.4.4 Conversely, Flat ■03 sustained less severe damage. While the kitchen (**Photo 8-6 (e)**) and toilet (**Photo 8-6 (d)**), which are connected to the re-entrant, suffered extremely severe damage, the fire was largely confined to these areas, leaving the rest of the flat relatively unaffected (**Photos 8-6 (a) to (c)**).

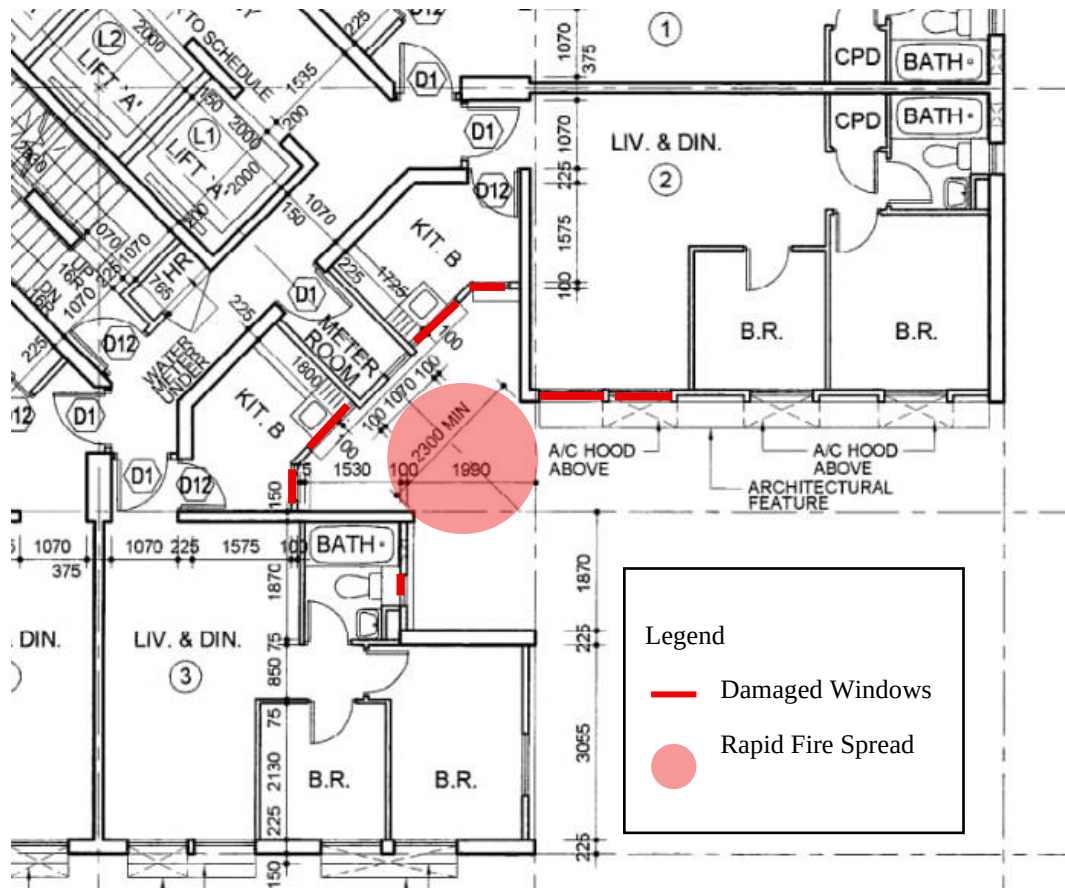
*Figure 8-1: Extract of Floor Plan of Wang Yan House*

- 8.3.4.5 An examination of the layout plan (**Figure 8-1**) revealed that both units are situated equally close to the re-entrant, with both kitchens positioned identically. The key difference noted was that the living room of Flat 02 is immediately adjacent to the re-entrant, while the toilet of Flat 03 is adjacent to the same re-entrant. This asymmetry appears to be unrelated to the kitchens; instead, it is likely attributable to the larger window openings in the living room and the higher fire load present within that space.

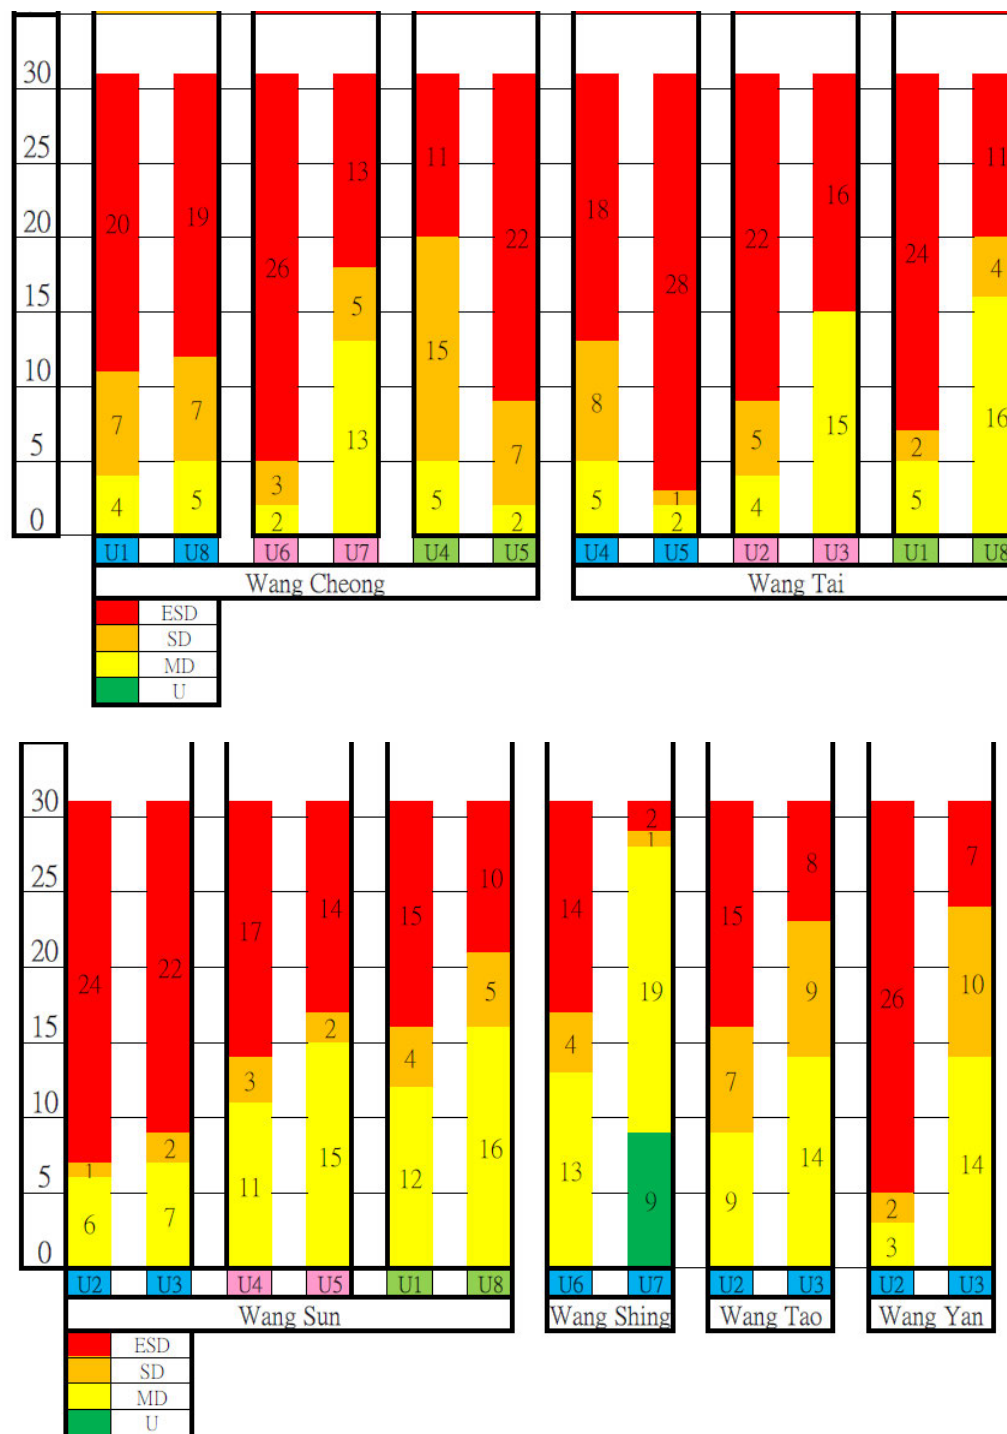
- 8.3.4.6 Similar asymmetry was also observed in 11 other re-entrants by comparing the number of units that sustained extremely severe damage, as shown in **Figure 8-2**. In the case of Wang Cheong House and Wang Sun House, the figures are comparable but still show a trend of asymmetry. This may be because, in these buildings, three out of four re-entrants experienced rapid fire spread. Beyond the spread of fire from the building façade into the units, other modes of severe fire spread, such as internal fire spread, may also contribute and will be discussed later.

*Figure 8-2: Comparison of Fire Damage to Units Immediately Adjacent to the Re-Entrant that Showed Rapid Vertical Fire Spread*

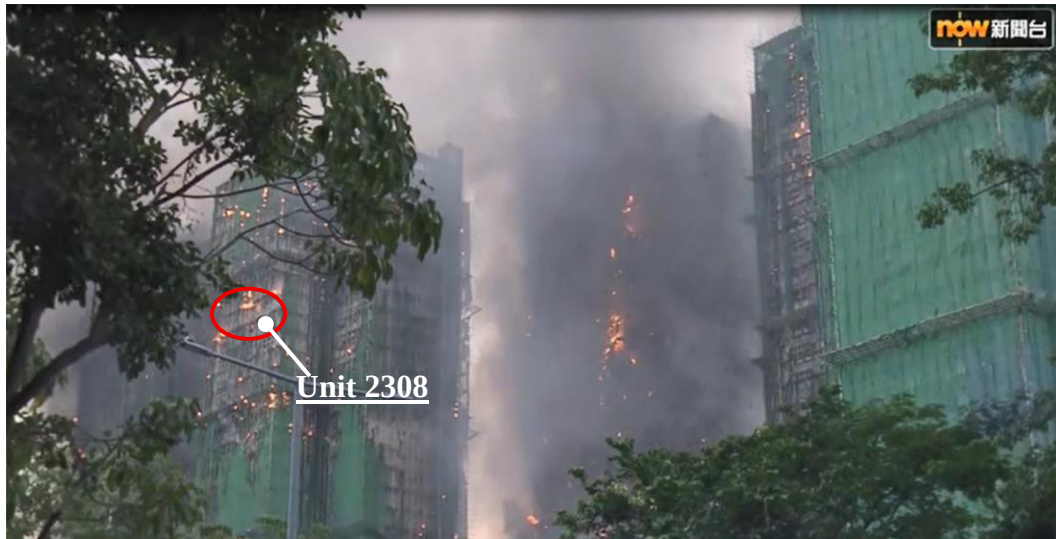
Photo 8-7 (c): Combustible Building Envelope Outside Flat 2308 of Wang Kin House on Fire at 1605 Hours

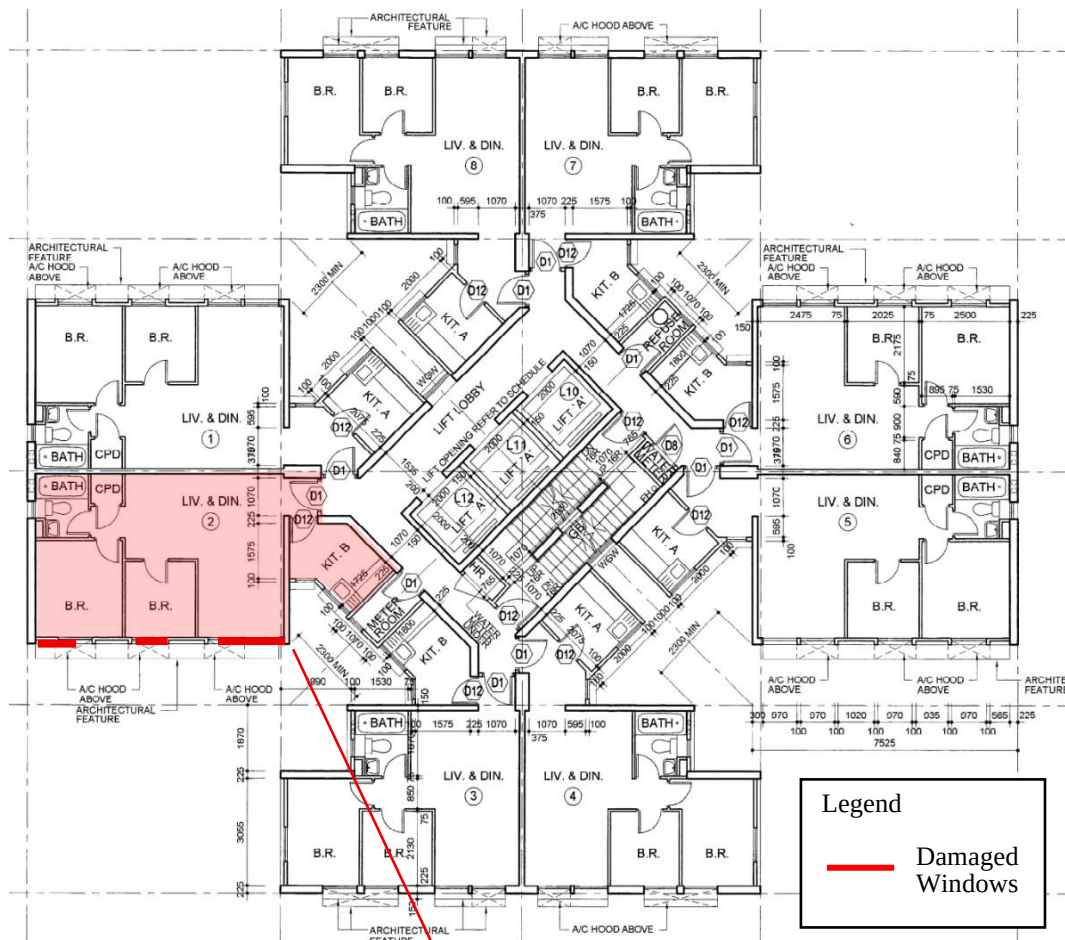
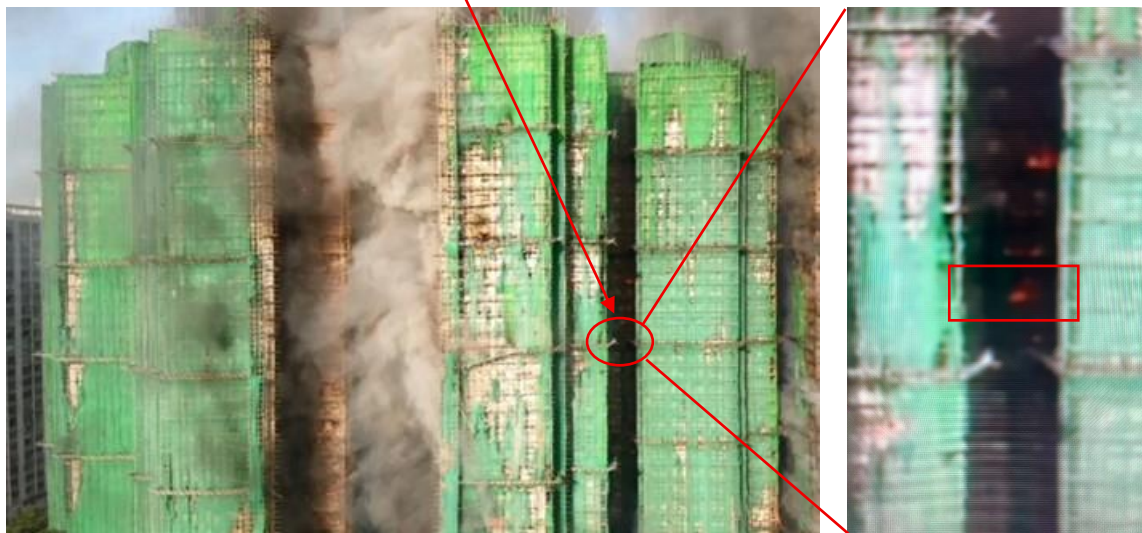
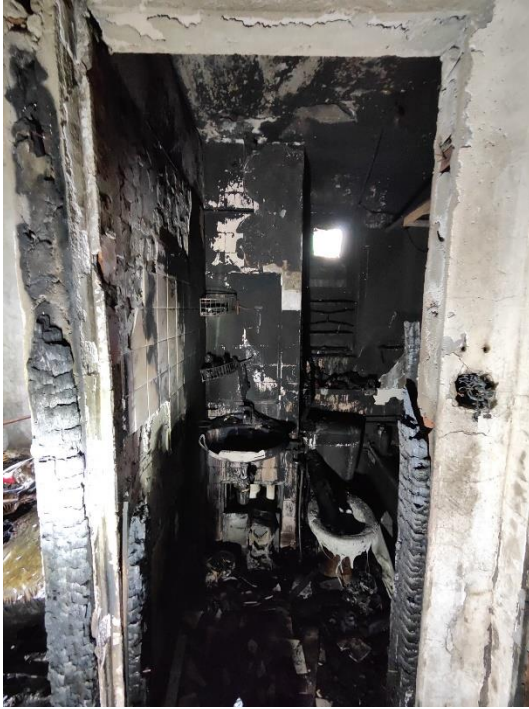
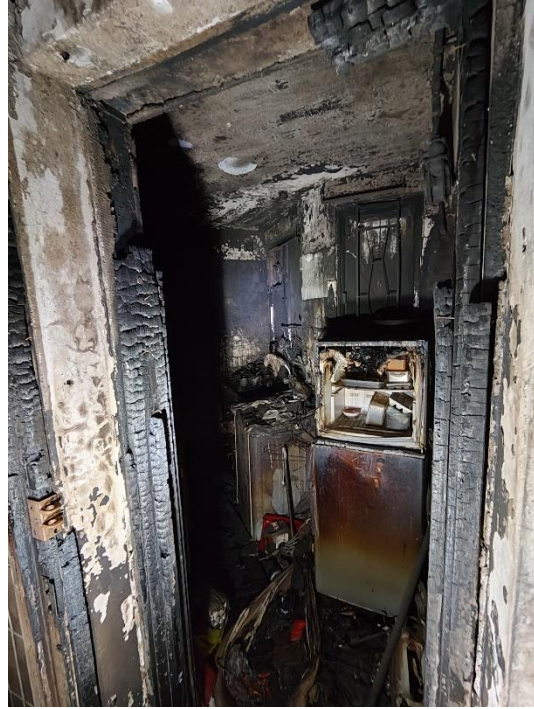
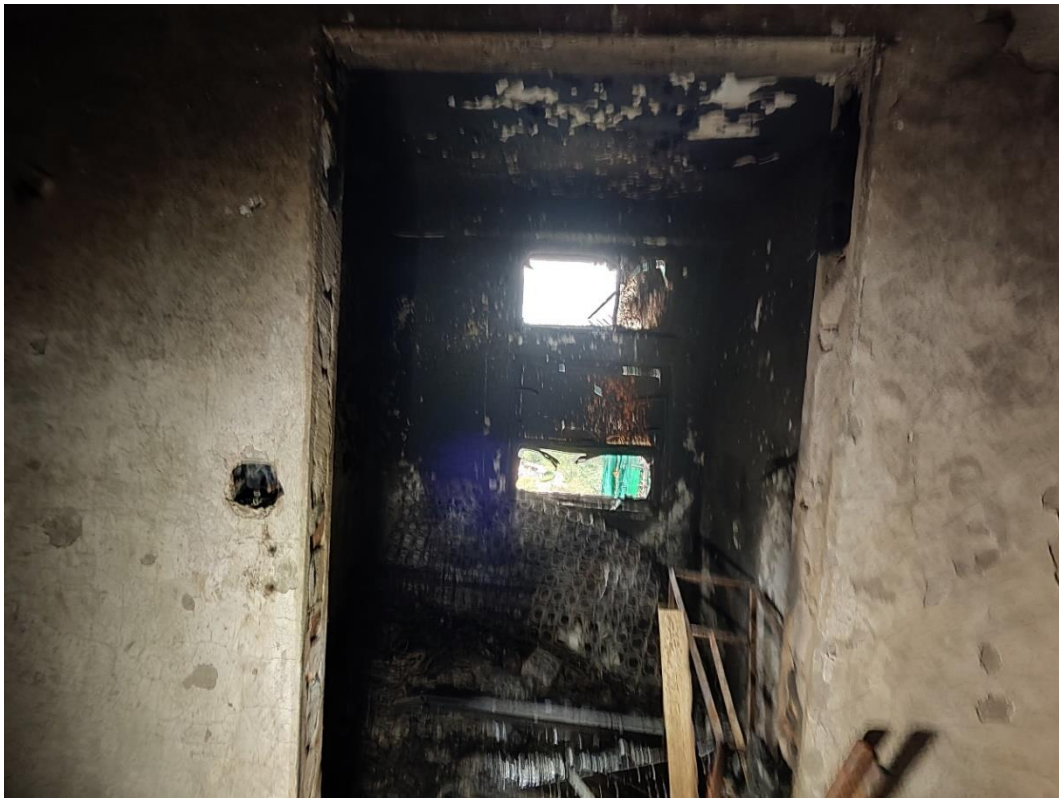
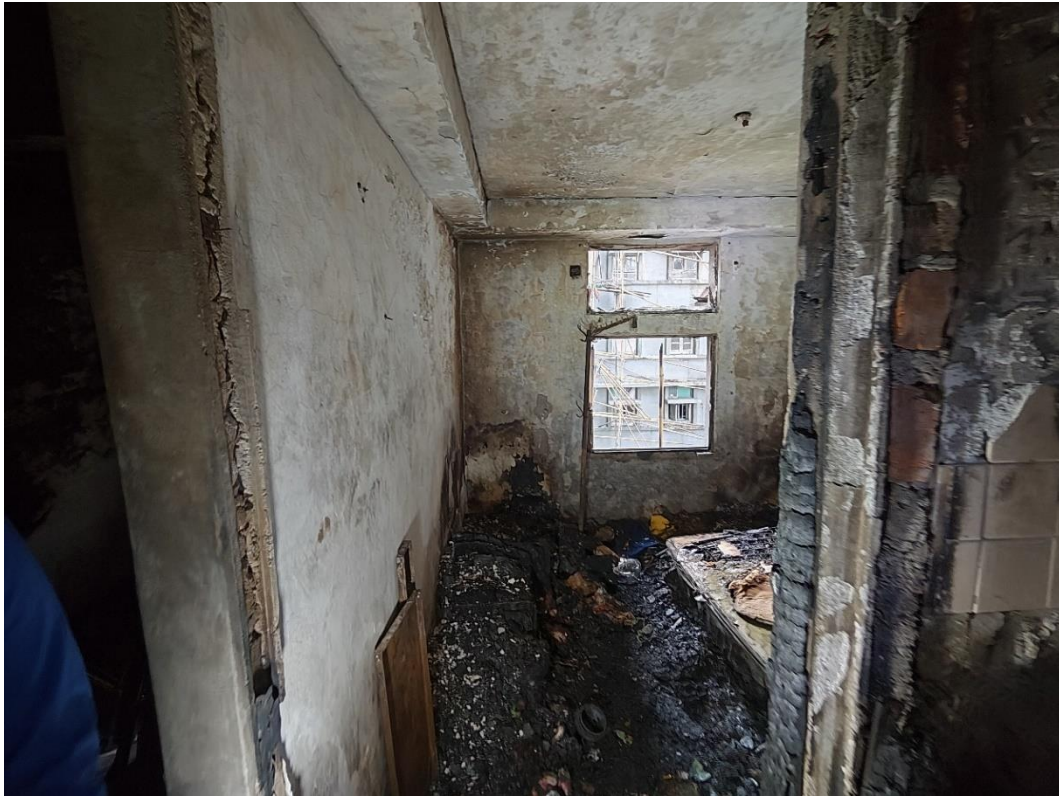
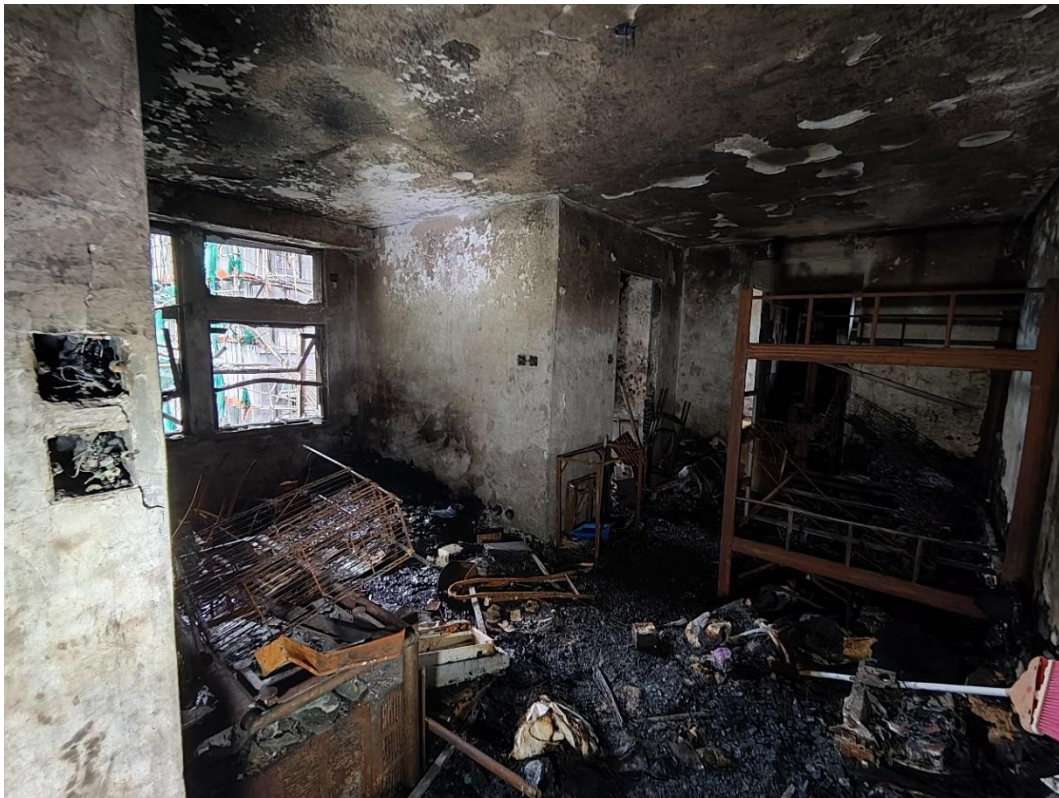
- 8.3.5.3 Flat ■02 of Wang Kin House sustained extremely severe damage, as shown in **Figure 8-3** and **Photos 8-8 (a) to (g)**. Upon inspection, the toilet and kitchen windows were found to be intact. However, most of the windows in the bedrooms and living room were broken, with these areas experiencing extensive fire damage, as shown in **Photos 8-8 (d) to (f)**. This damage is believed to have resulted from the fire spreading into the unit from the exterior.
