# Final Investigation Report No.5 Alarm Fire at Wang Fuk Court on 26 November 2025

Inter-Departmental Fire Investigation Task Force

May 2026

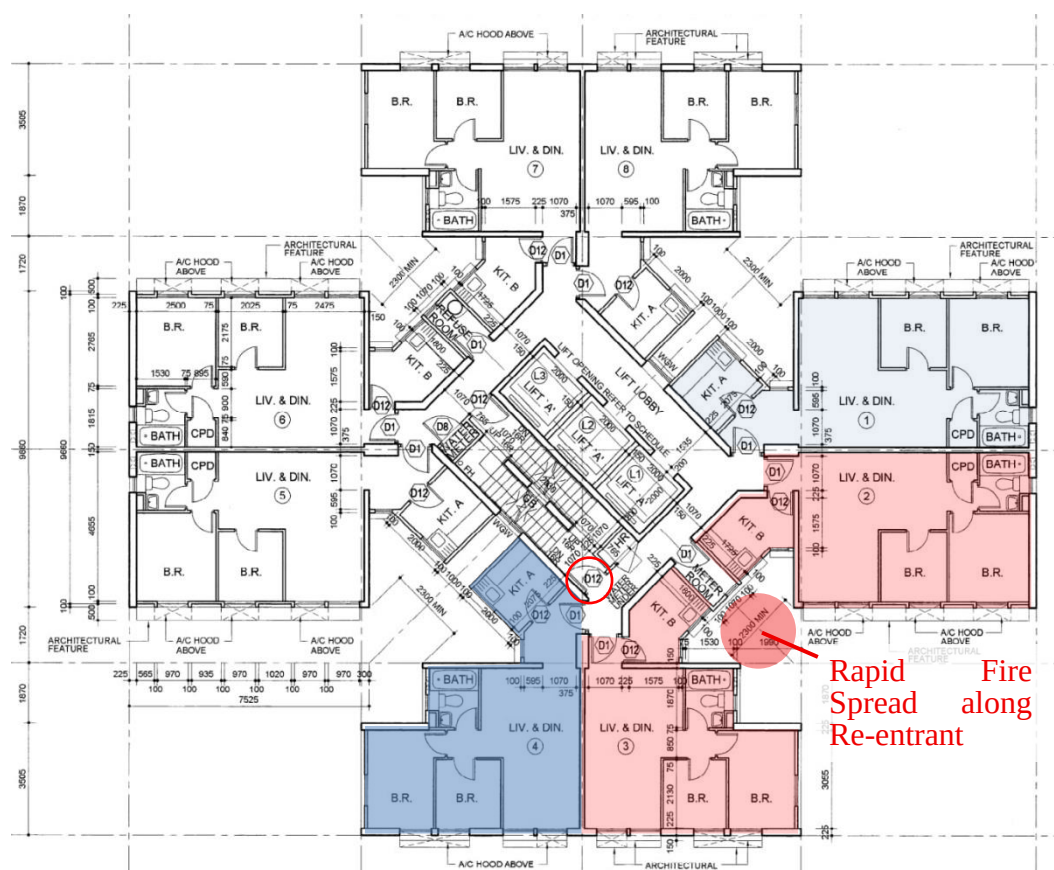
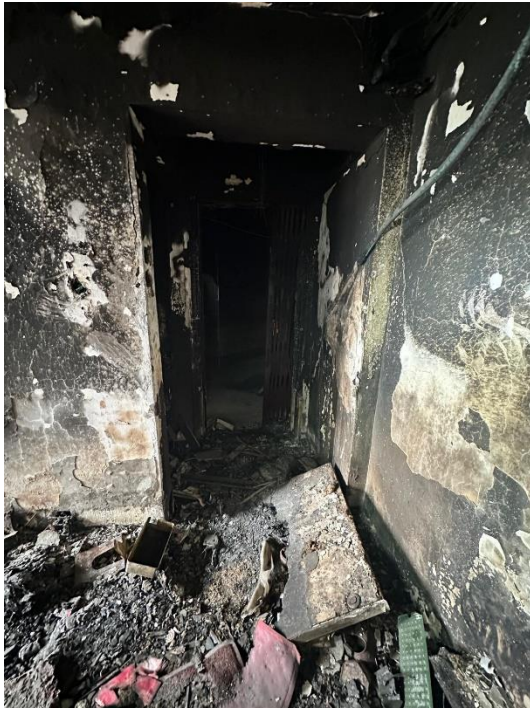
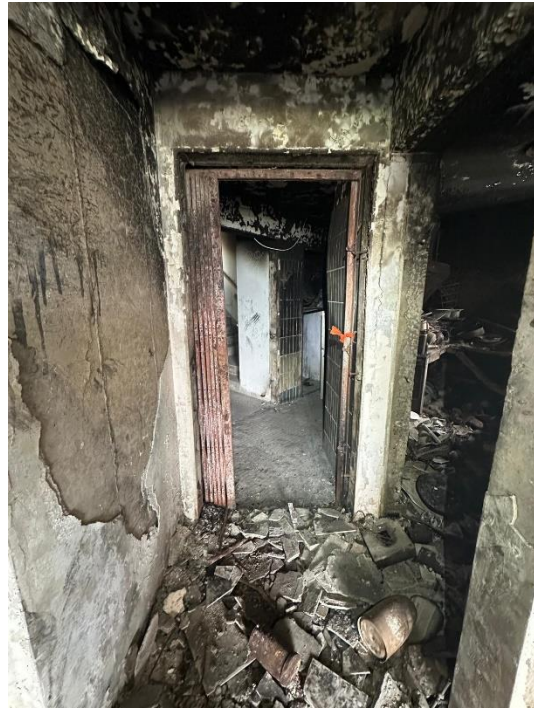
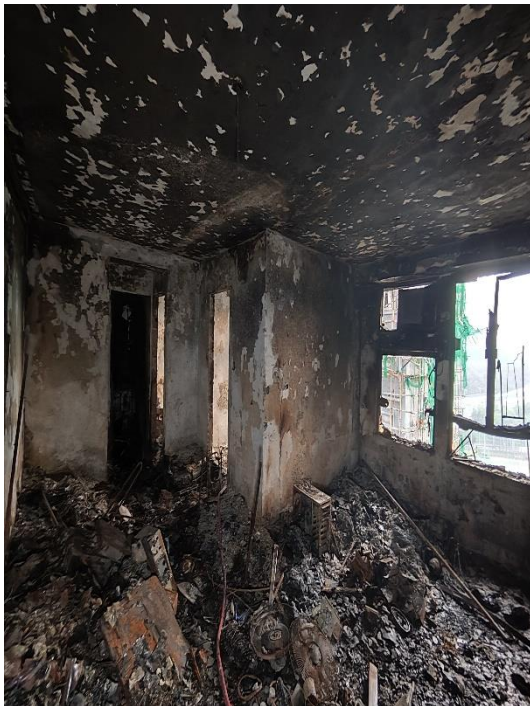
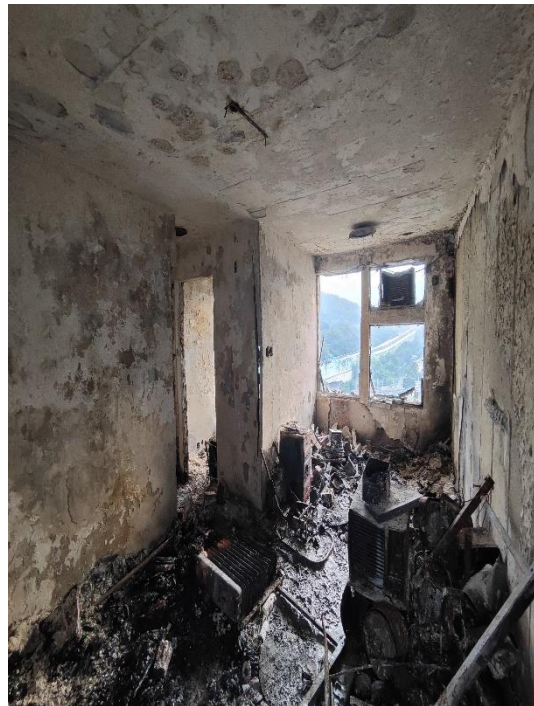
- 8.3.6.2 In the case of Wang Yan House, rapid fire spread was observed only at the re-entrant between Flats 02 and 03, as shown in **Photo 8-9** and **Figure 8-4**. Consequently, Flats 02 and 03 sustained varying degrees of damage, as illustrated in **Photos 8-10 (a) & (b)** and **8-11 (a) & (b)**.

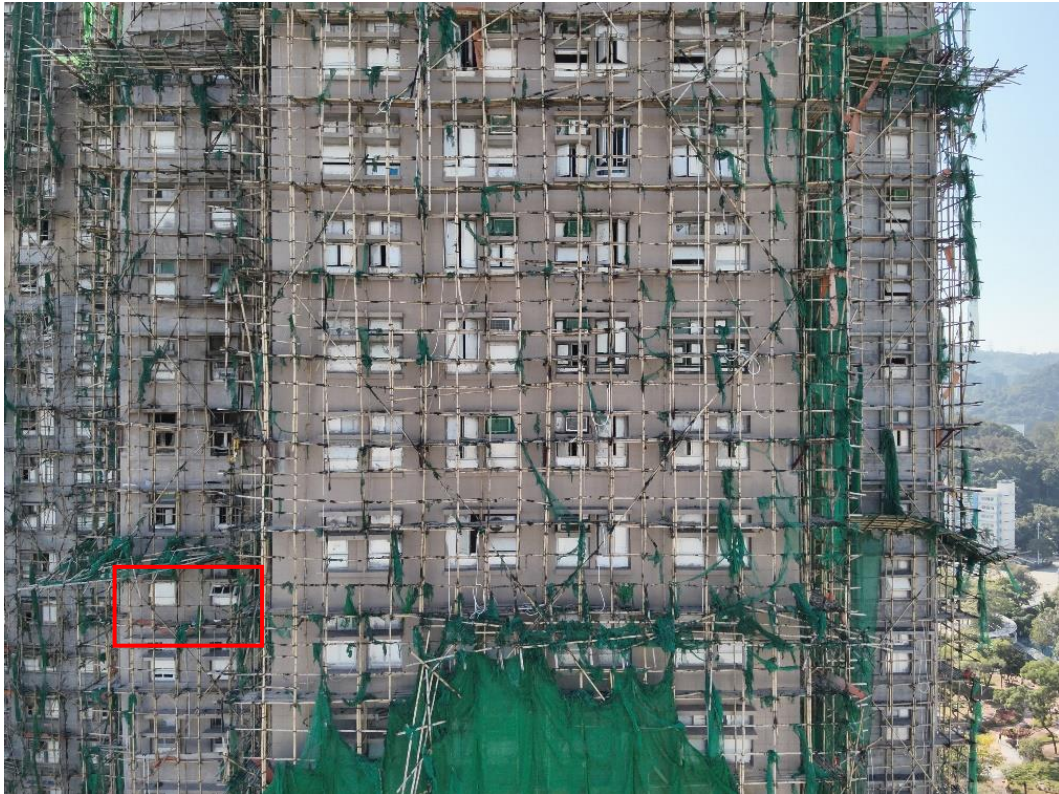
Photo 8-12 (a): External Wall Outside Flat 01, Wang Yan House

- 8.3.6.3 No obvious damage was observed on the exterior of Flat ■ 01 (**Photo 8-12 (a)**). Therefore, the damage within the unit (**Photos 8-12 (c) to (e)**) is highly likely to have resulted from internal fire spread from Flat ■ 02.

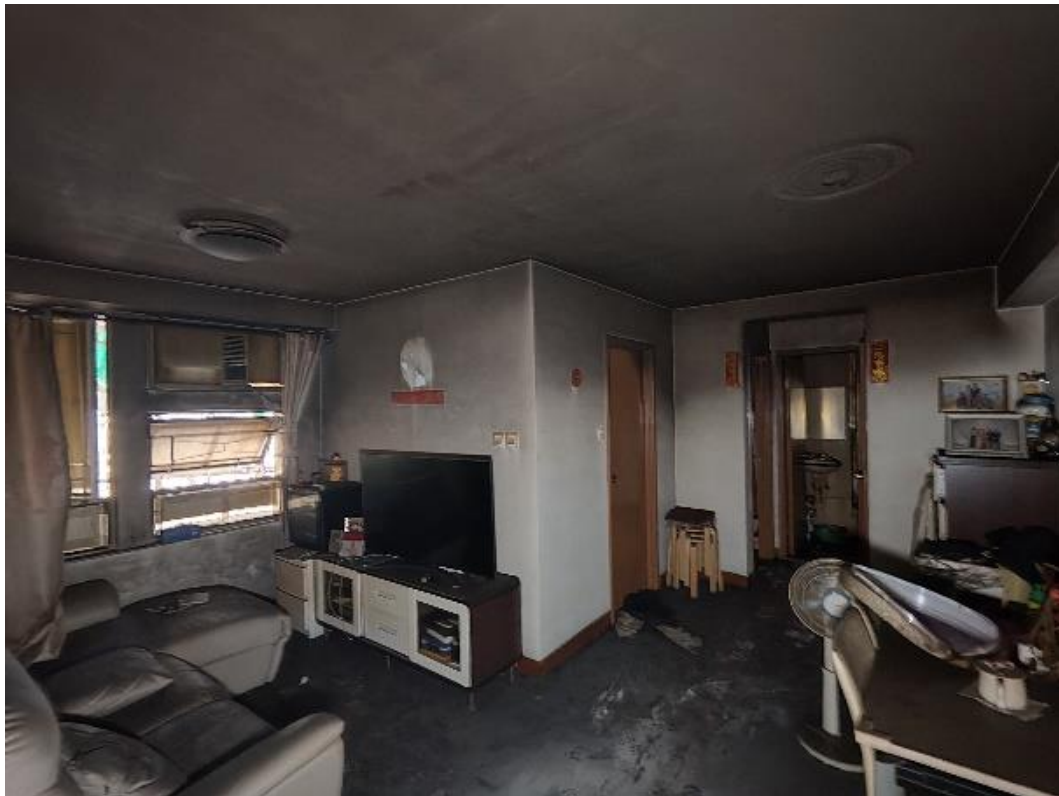
Photo 8-12 (e): Living Room of Flat 01, Wang Yan House<sup>114</sup>

<sup>114</sup> The living room window of Flat 01 remained intact with polystyrene window covers still in place. This further supports the conclusion that external fire spread can be ruled out.

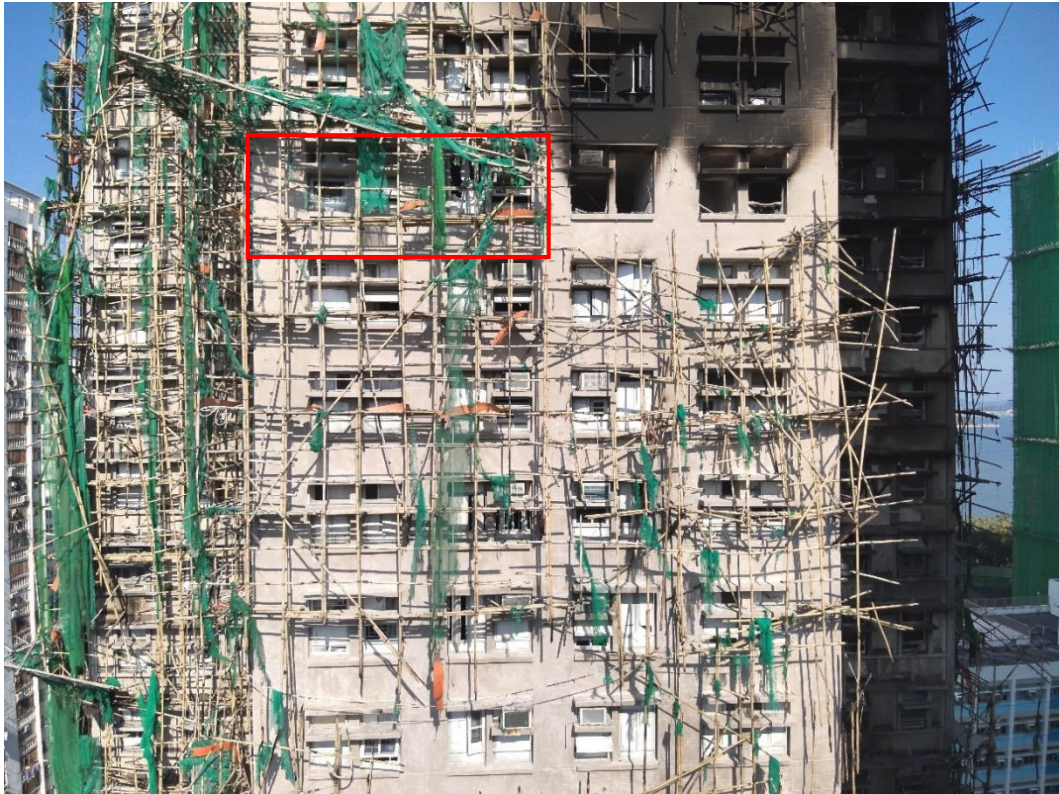
Photo 8-13 (a): External Wall Outside Flat ■ 04, Wang Yan House

8.3.6.4 Similarly, Flat 04 showed no severe damage on the external wall (**Photo 8-13 (a)**). The internal damage within the unit (**Photos 8-13 (b) & (c)**) is also believed to have been caused by internal fire spread from Flat 03.

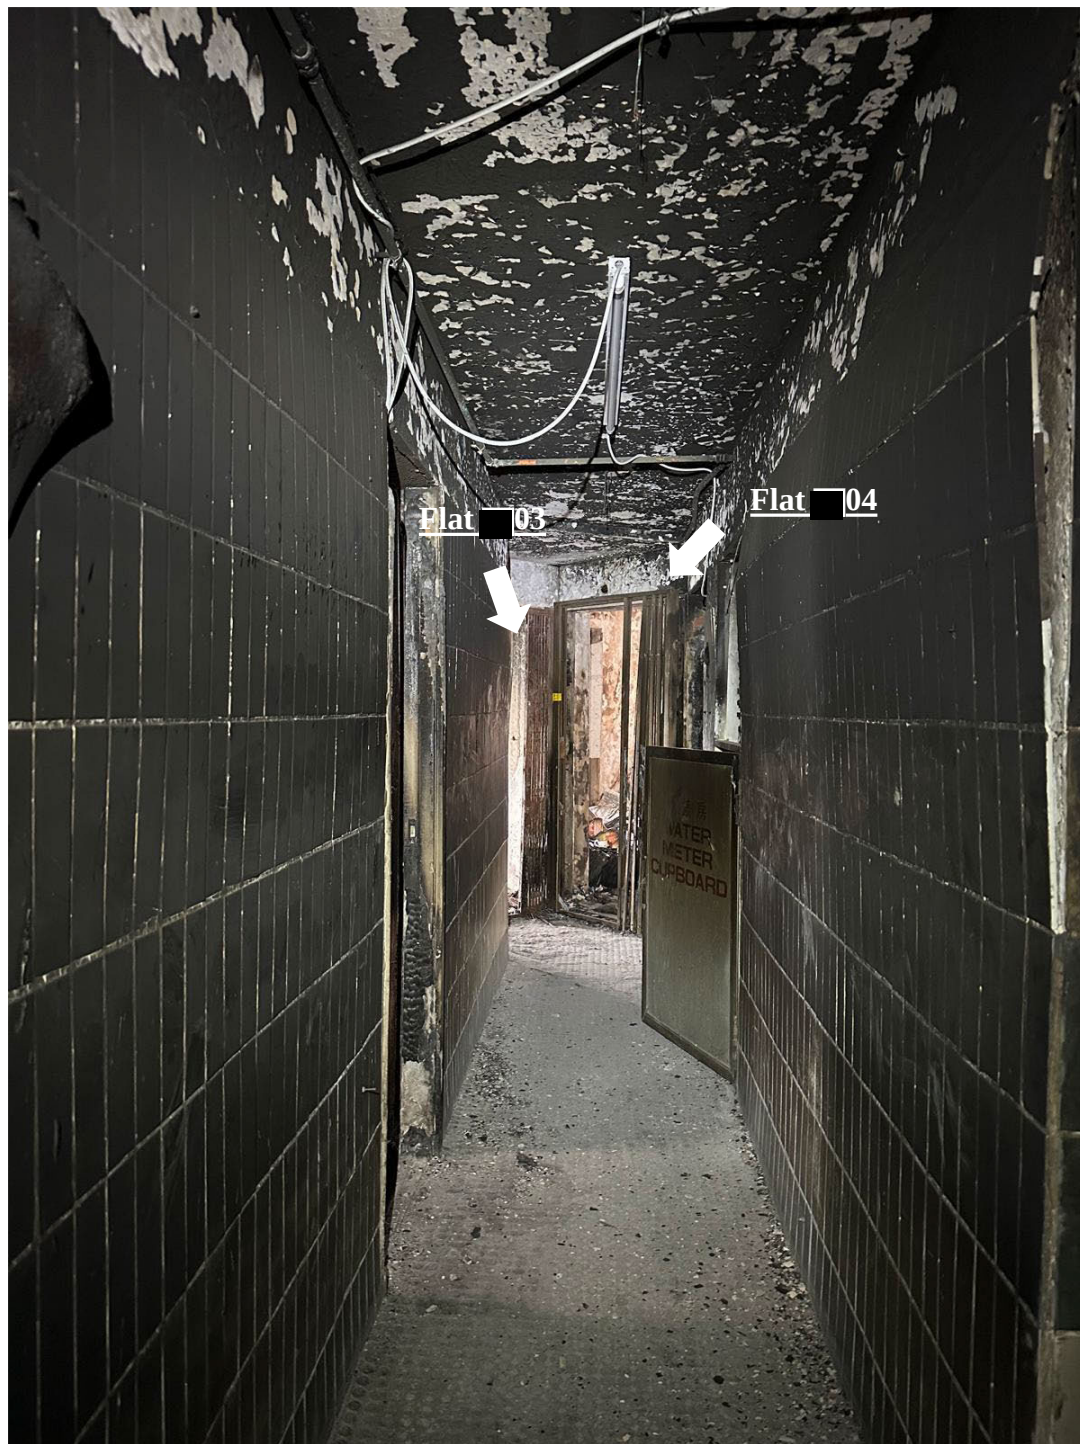
Photo 8-13 (d): Post-Fire Condition in the Common Corridor Connecting  
Flats 03 and 04, Wang Yan House

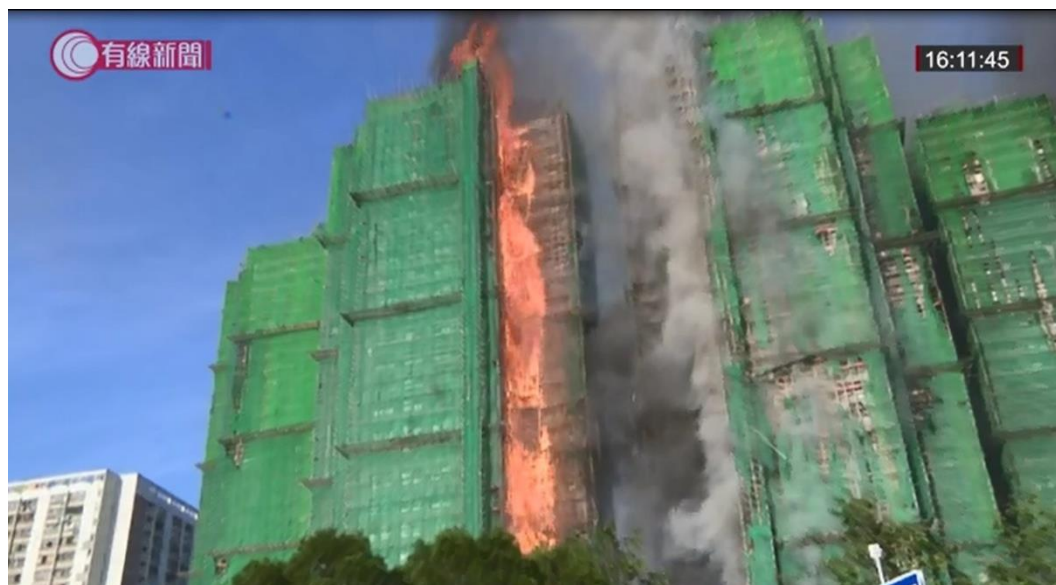
8.4.4.1 Wind-carried embers are pieces of burning debris light enough to be carried by strong winds over considerable distances. The rapid fire spread along the re-entrant played an important role in dispersing embers. During this process, flames from the re-entrant were observed rising higher than the building itself, as shown in **Photos 8-14 & 8-15**. These intense flames lifted embers to great heights, allowing them to follow the wind flow and travel considerable distances before falling, as shown in **Figure 8-5**.

Photo 8-14: Flames From the Re-Entrant Observed  
Rising Higher Than the Building at Wang Tao House

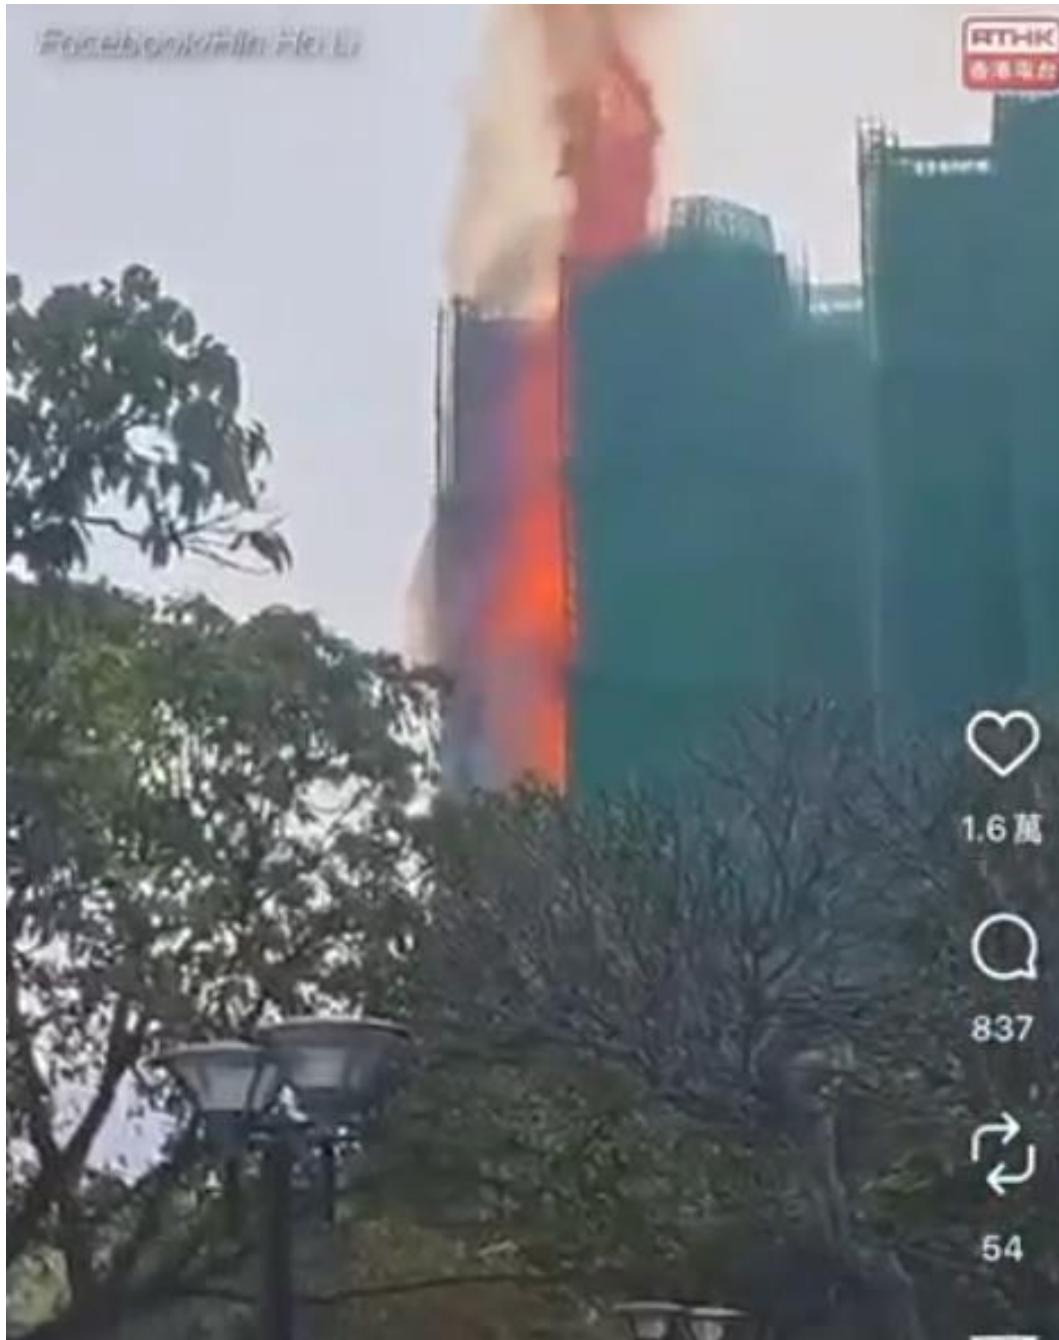
Photo 8-15: Flames From the Re-Entrant Observed  
Rising Higher Than the Building at Wang Cheong House

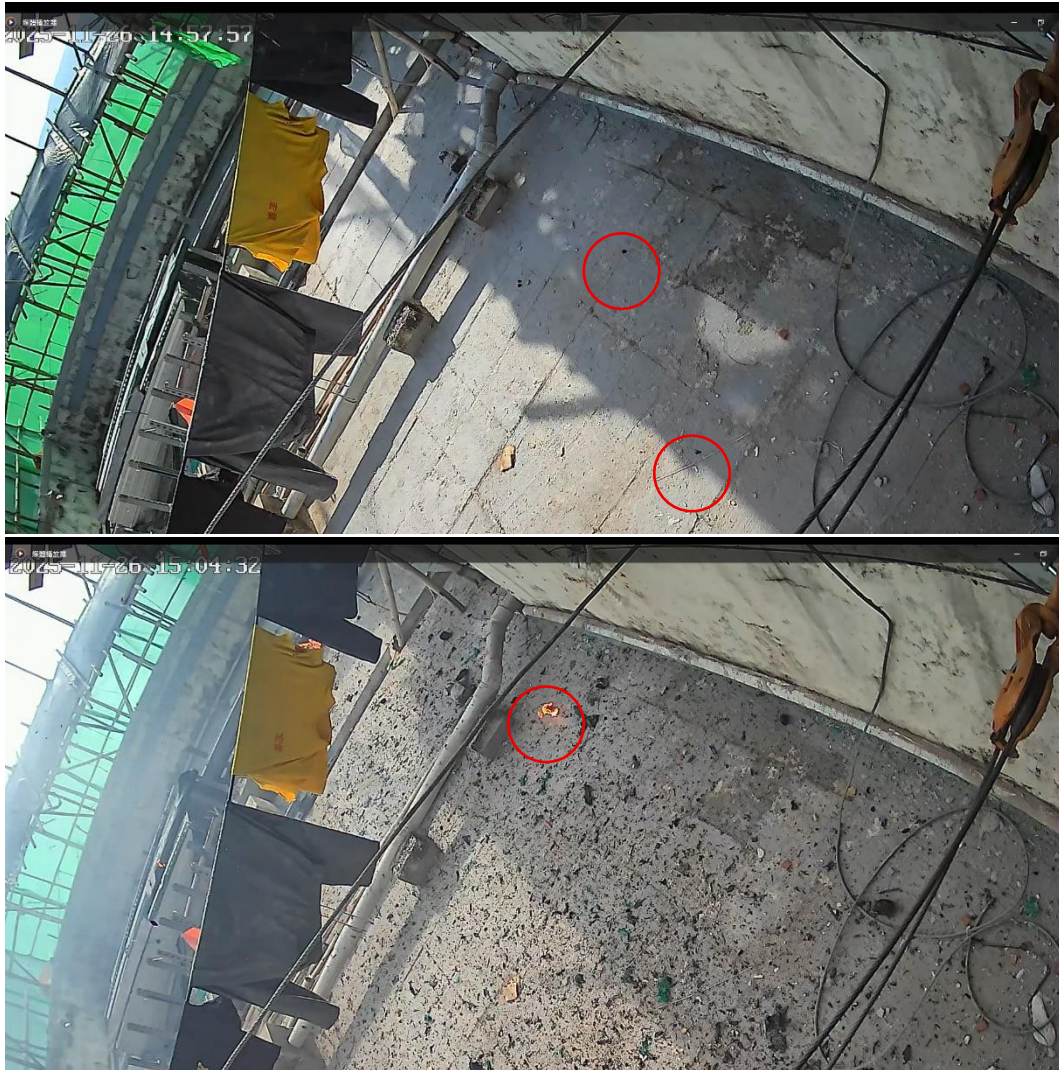
8.4.4.2 The hypothesis is supported by the CCTV footage from the roof of Wang Tai House. At about 1458 hours<sup>116</sup>, embers were observed falling from a high level onto the roof of Wang Tai House, as shown in **Photos 8-16 (a) & (b)**, coinciding with the rapid fire spread recorded in the **east & south re-entrant** of Wang Cheong House at about the same time. It is believed that the vigorous fire activity in the re-entrant lifted embers high above the building, allowing them to travel with wind and fall onto the roof of Wang Tai House.

Photos 8-16 (a) & (b): Embers Falling From a High Level  
Observed on the Roof of Wang Tai House

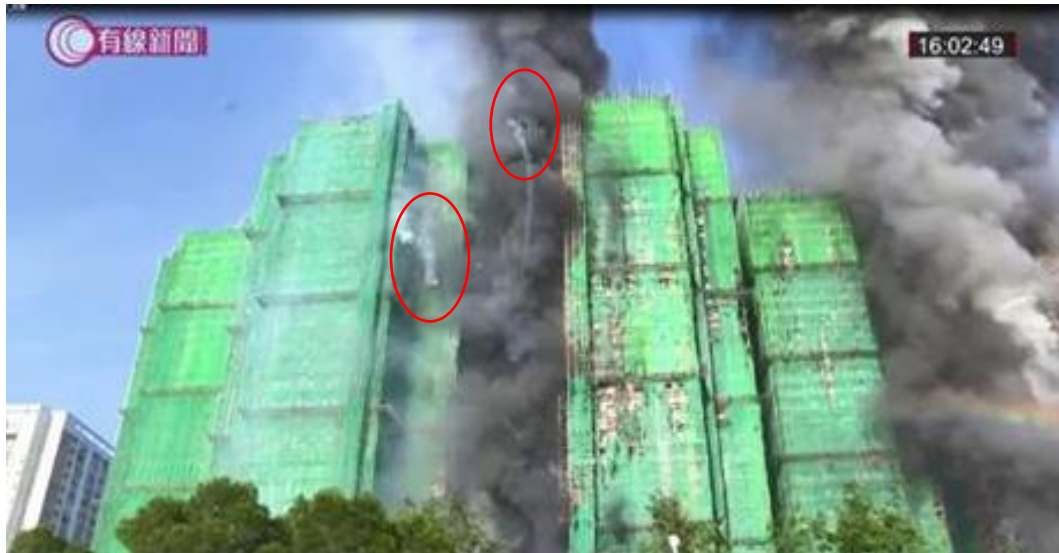
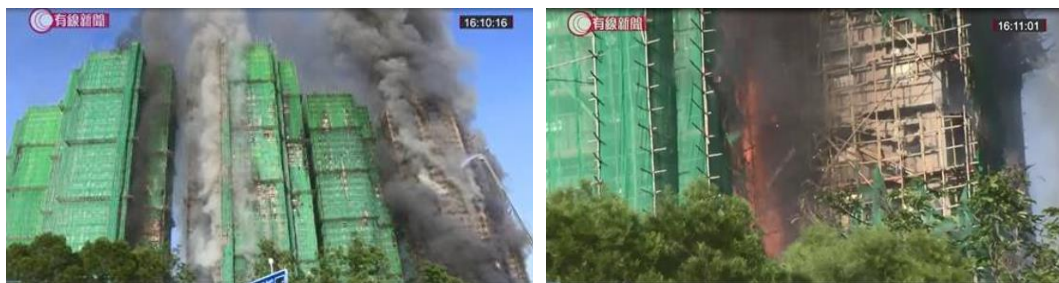
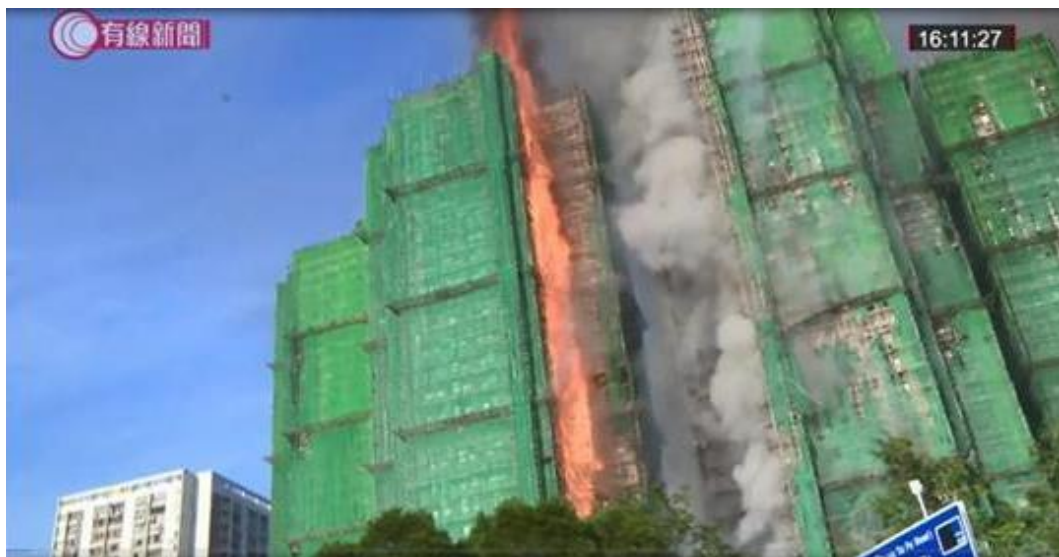
- 8.4.5.2 Additionally, it was observed that the rapid and vigorous fire spread along the re-entrant propelled debris into the surrounding areas. If this debris had fallen into the re-entrants of nearby buildings, it could potentially have triggered another rapid fire spread within those re-entrants, as shown in **Photos 8-18 (a) to (d)**.

Photo 8-18 (a): Debris Falling From Wang Sun House at 1602 Hours

Photos 8-18 (b) & (c): Flaming Fire Observed in the Lower Portion of Wang Tao House at 1611 Hours

Photo 8-18(d): Fire Spread Vertically Throughout the Re-Entrant of Wang Tao House

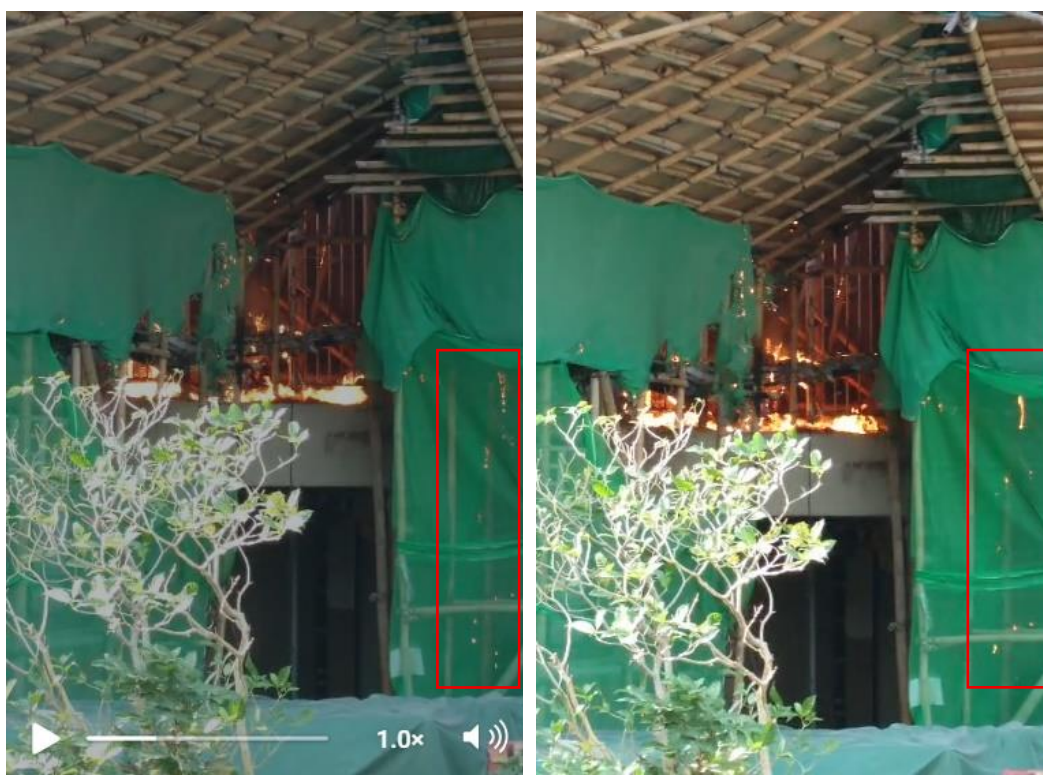
- 8.4.6.2 This phenomenon was observed during the Wang Fuk Court fire incident, with one instance well-documented by the informant during the initial stage of the fire, as shown in **Photos 8-19 (a) & (b)**.

Photos 8-19 (a) & (b): Flaming Droplets Dripping From Burning Materials  
Observed During the Initial Stage of Fire

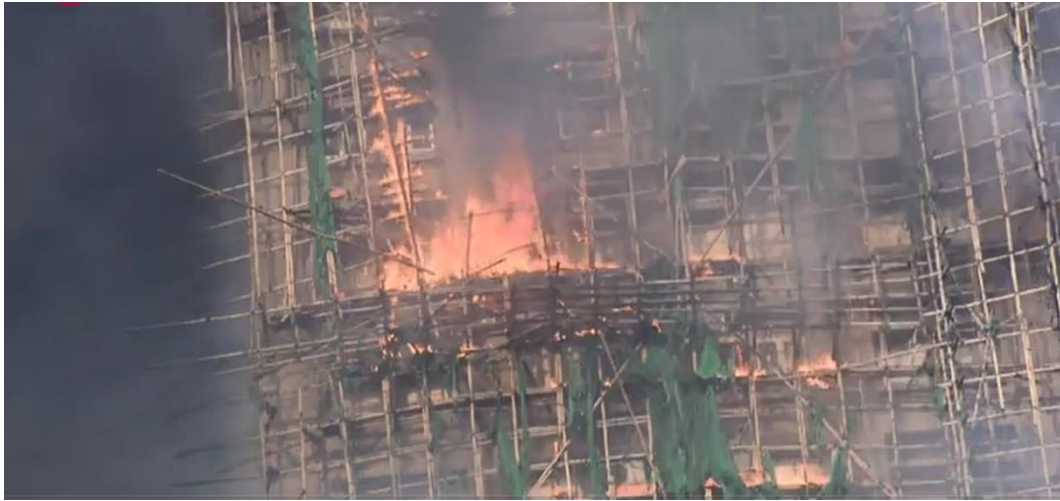
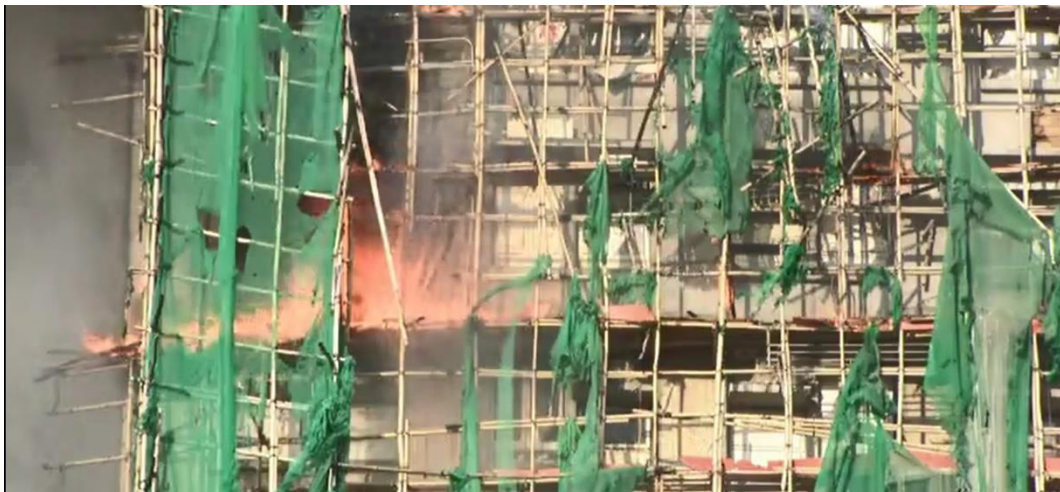
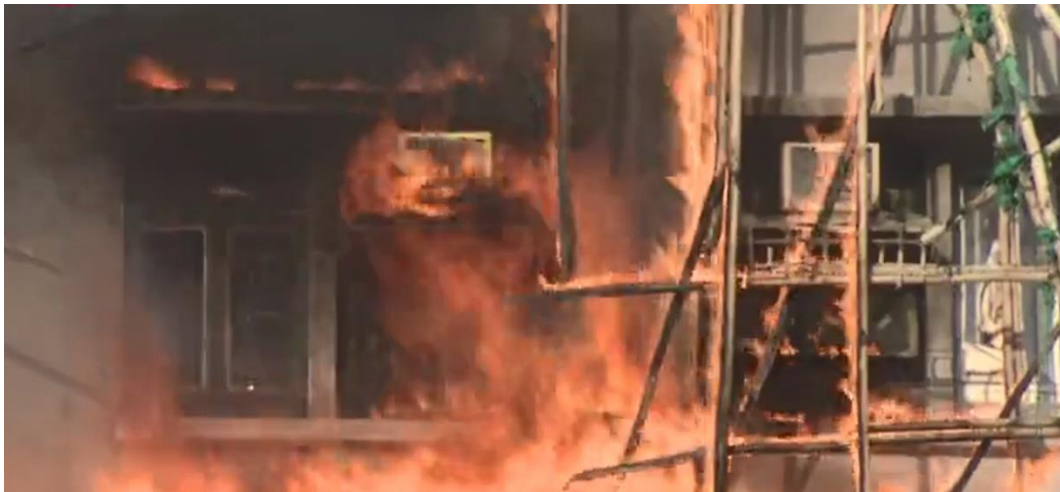
- 8.4.6.5 Various combustibles were identified on the external scaffolding, including bamboo, toe-boards, wooden planks, safety nets, canvas, nylon strips and miscellaneous waste from the works, as shown in **Photo 8-19 (c)**, all of which contributed significant fuel to the façades of all eight buildings in Wang Fuk Court, **Photos 8-19 (d) to (f)**.

Photos 8-19 (d) to (f): Burning of Combustible Envelope Observed During the Fire

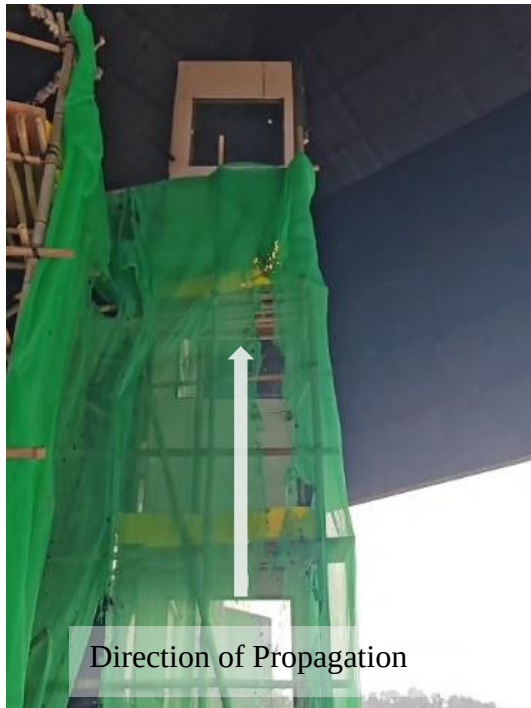
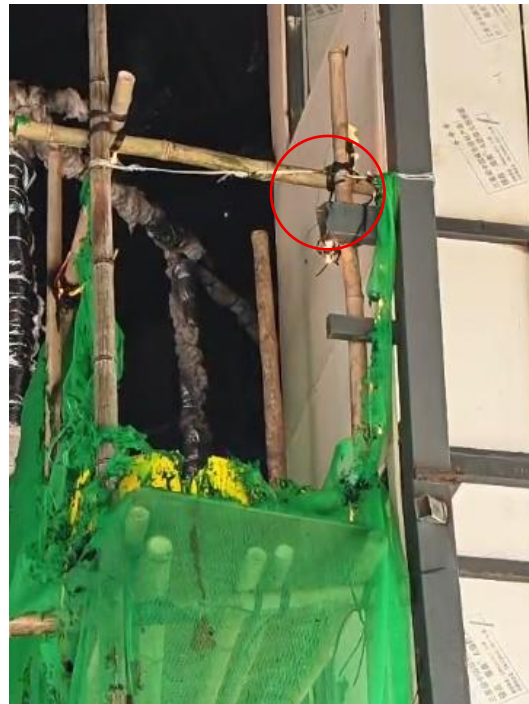
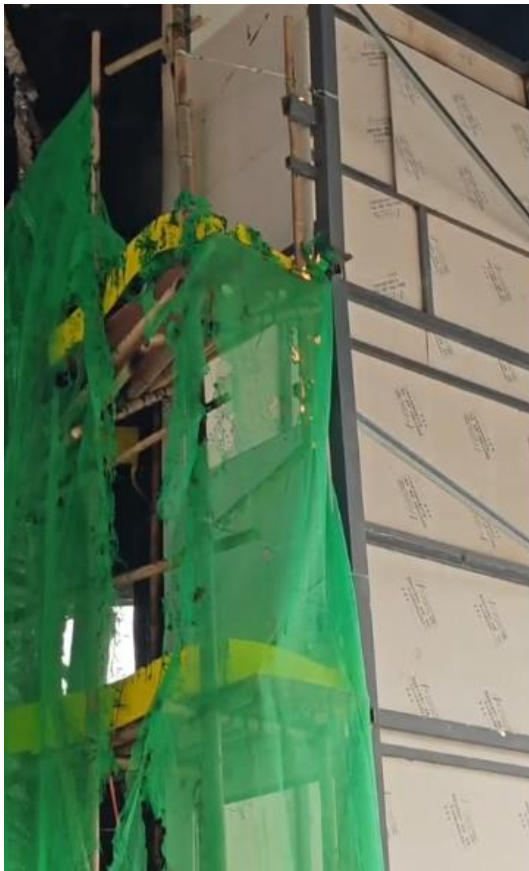
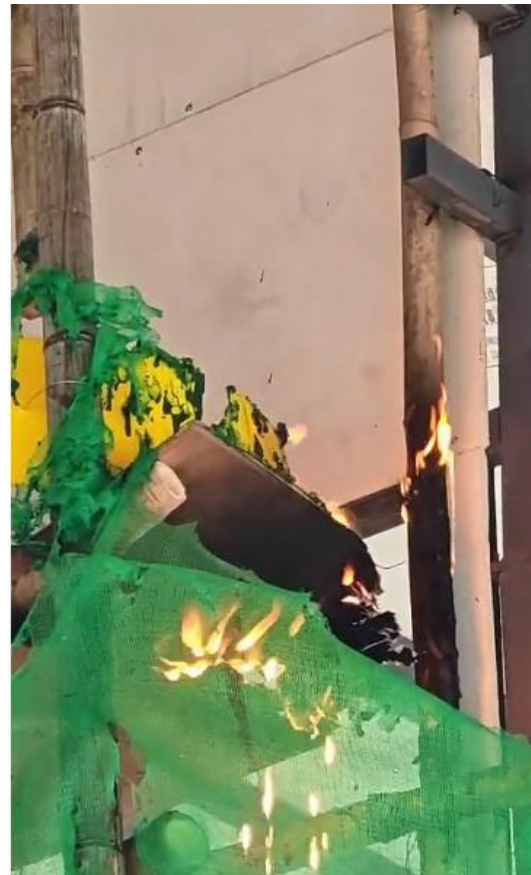
- 8.4.7.4 The fire propagated along the safety nets until it encountered suitable combustibles, such as nylon strips. The ignited strips subsequently set fire to other materials, including toe-boards and wooden planks, further developing and sustaining the fire, as shown in **Photos 8-20 (a) to (d)**.

Photo 8-20 (a):  
Small Fire Propagated Along the  
Safety Net

Photo 8-20 (b):  
Nylon Strips Alight

Photos 8-20 (c) & (d): Other Combustibles  
(Toe-Boards and Wooden Boards) Alight

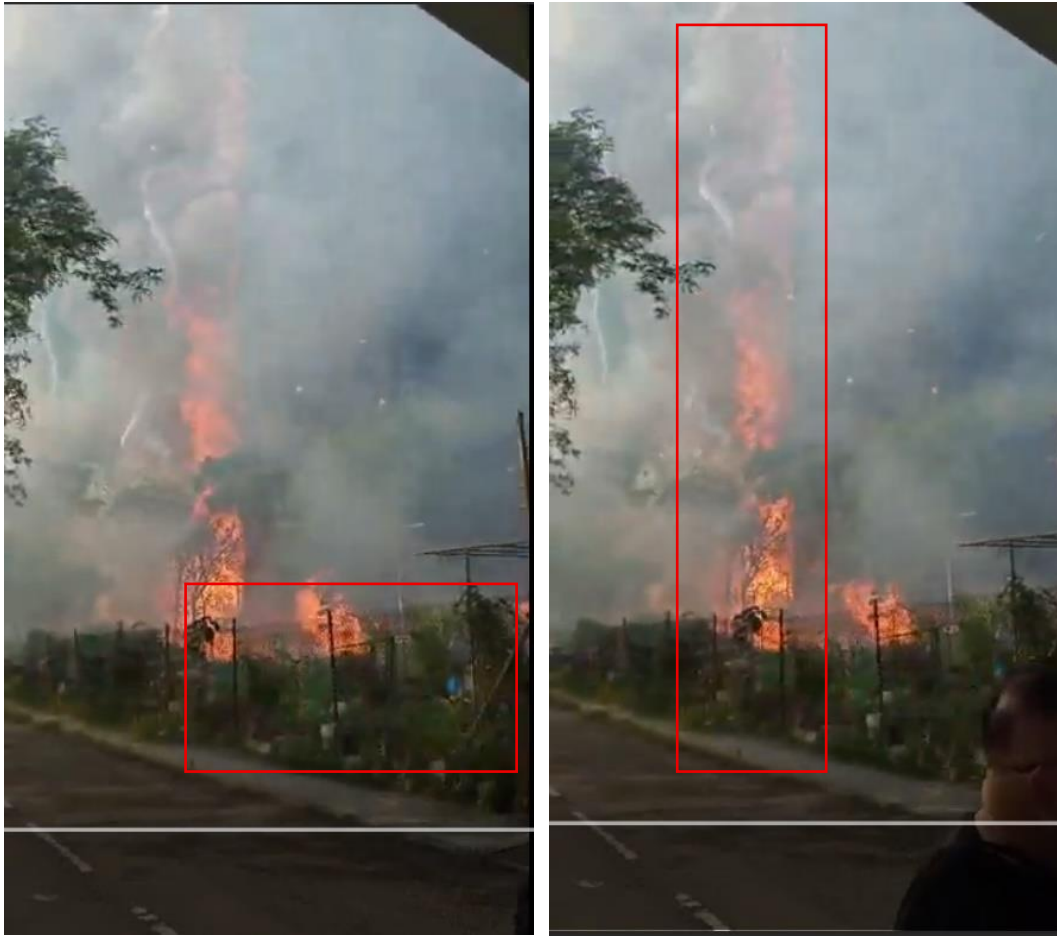
- 8.4.7.5 During the post-fire investigation, it was further observed that wind-carried embers, falling debris and fire droplets not only spread to the combustible envelope but also ignited combustibles and construction materials scattered on the ground floor level. This contributed to the fire's further spread and even the blockage of exits, as shown in **Photos 8-21 (a) to (h)**.

Photos 8-21 (c) & (d): Observed Fire Spread at the Open Ground Between Wang Cheong House and Wang Tai House

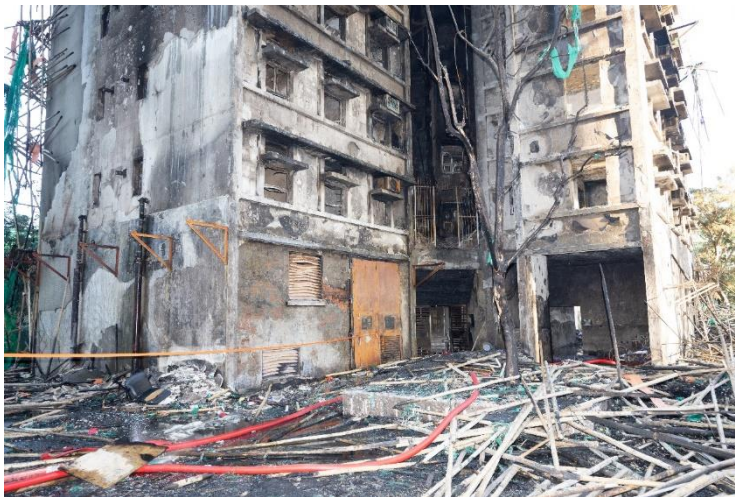
Photo 8-21 (e):  
Post-Fire Condition Outside the West Re-Entrant of Wang Cheong House

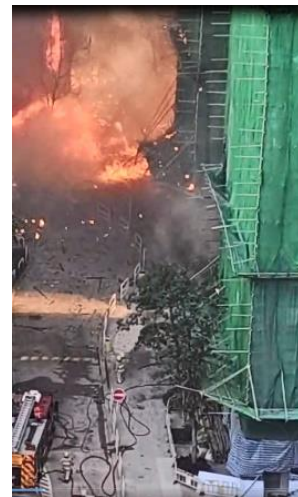
Photo 8-21 (f):  
Observed Fire Spread

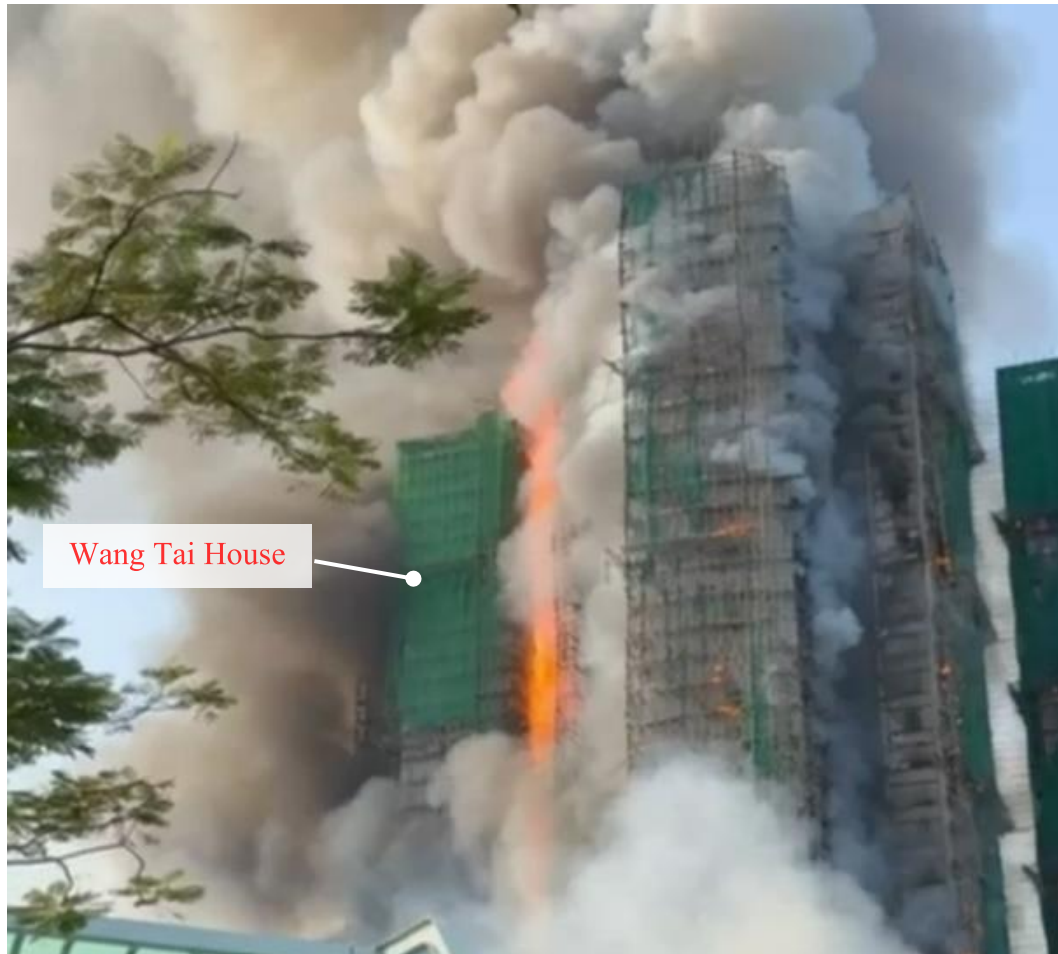
Details of the fire development of Wang Tai House can be referenced in Section 5.2.3. Briefly, the fire spread to Wang Tai House via flying embers, though not on a large scale initially, was observed around 1500 hours. The situation deteriorated quickly and at about 1516 hours, video footage captured the vertical fire spread along the re-entrant on the east side of Wang Tai House, as stated in paragraph 5.2.3.5 and shown in **Photo 9-4**.

Photo 9-4: Rapid Vertical Fire Spread Along  
the East Re-Entrant of Wang Tai House at 1516 Hours

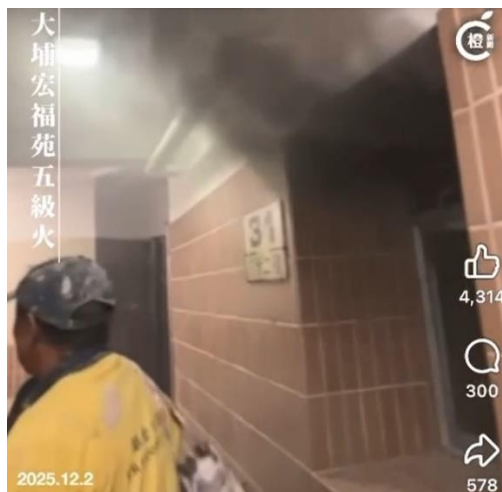
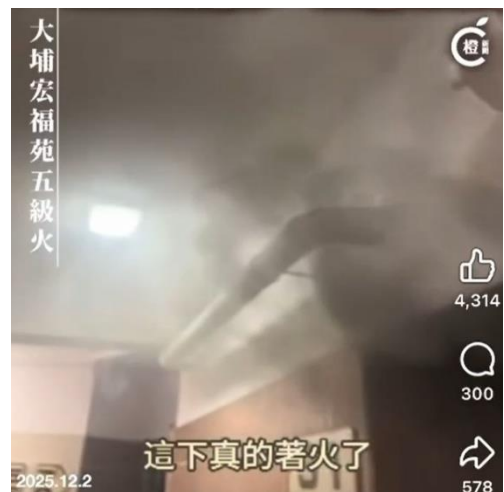
- 9.2.3.3 CCTV footage showed [REDACTED] entering lift L14 of Wang Tai House on the 31/F at about 1520 hours<sup>124</sup>, as shown in **Photo 9-5**. Another video from an online source showed [REDACTED] encountered heavy and dense smoke entering through the upper openable part of the window in the lift lobby, as shown in **Photos 9-6 (a) & (b)**.

Photos 9-6 (a) & (b): Video From Online Source Showing Internal Condition  
of Lift Lobby on 31/F of Wang Tai House

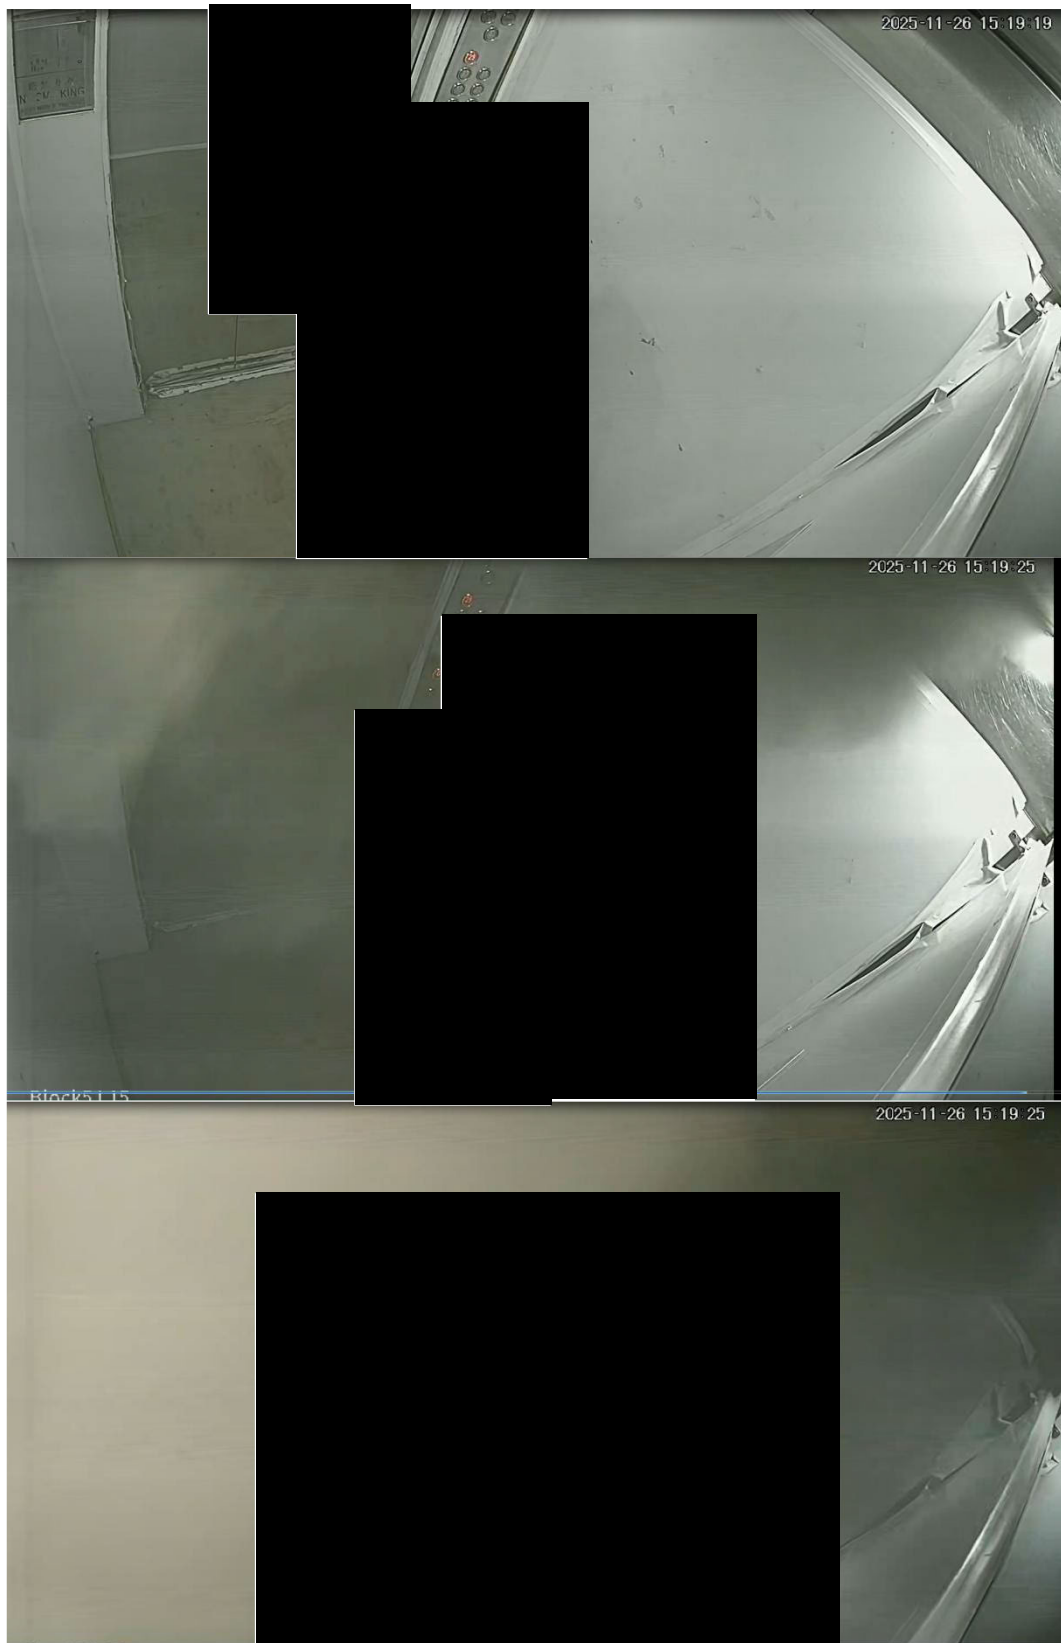
- 9.2.3.4 CCTV footage captured [REDACTED] inside lift L15 of Wang Tai House at about 1521 hours<sup>125</sup>. When the lift doors opened on the 23/F, heavy and dense black smoke entered the lift, as shown in **Photos 9-7 (a) to (c)**.

Photos 9-7 (a) to (c): CCTV Screenshots  
Showing Internal Condition of Lift L15 on 23/F
