# Final Investigation Report No.5 Alarm Fire at Wang Fuk Court on 26 November 2025

Inter-Departmental Fire Investigation Task Force

May 2026

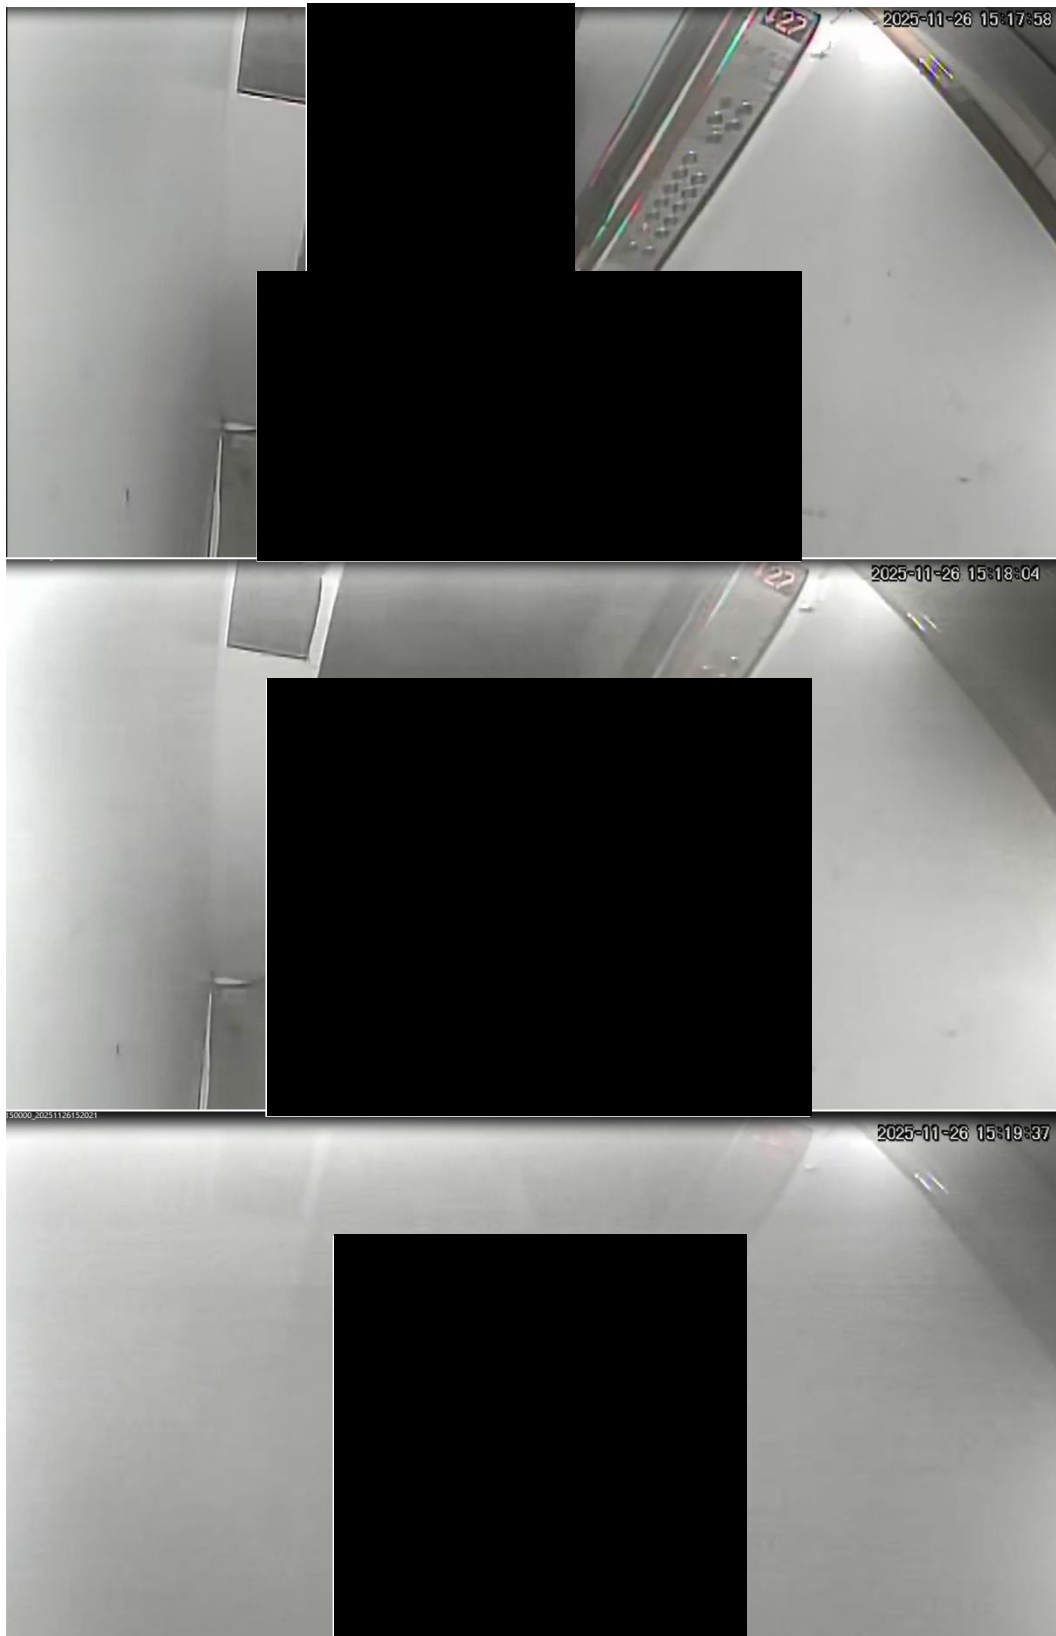
- 9.2.3.5 Another CCTV footage showed [REDACTED] inside lift L13 of Wang Tai House at about 1521 hours<sup>126</sup>. When the lift doors opened on the 24/F, heavy and dense black smoke poured intensely into the lift, as shown in **Photos 9-8 (a) to (c)**. This coincided with Fn HO's dispatch of the Mayday message, highlighting the severely deteriorating conditions at Wang Tai House.

Photos 9-8 (a) to (c): CCTV Screenshots  
Showing Internal Condition of Lift L13 on 24/F

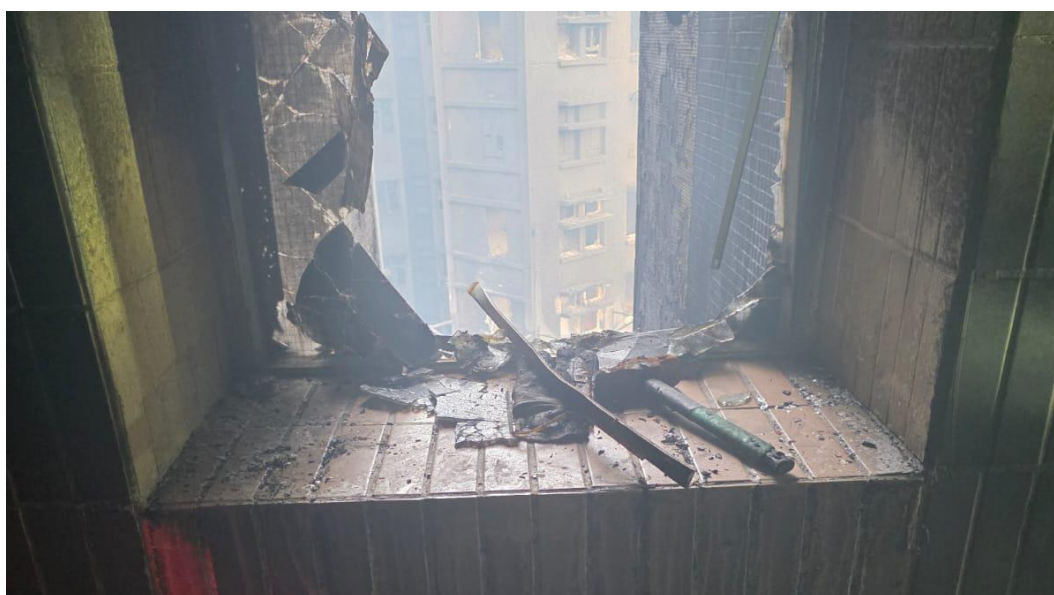
9.2.6.3 Additionally, Fn HO's left hand glove and a hammer were found on the window sill of the lift lobby on the 31/F, near the broken window, as shown in **Photo 9-10**. The boots belonging to Fn HO were recovered separately on the G/F outside Wang Tai House, as shown in **Figure 9-2**, by Acting ADO TSE Kwong-for and PFn [REDACTED] TANG Cheuk-yin respectively.

*Photo 9-10: Photo Showing the Window Sill on the 31/F*

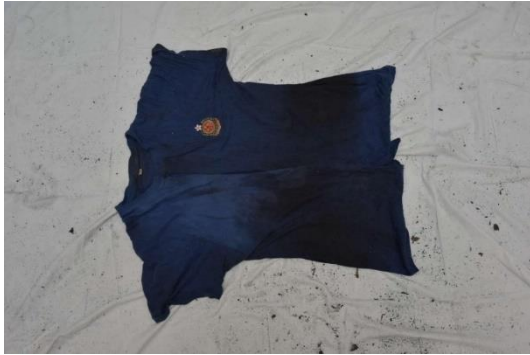
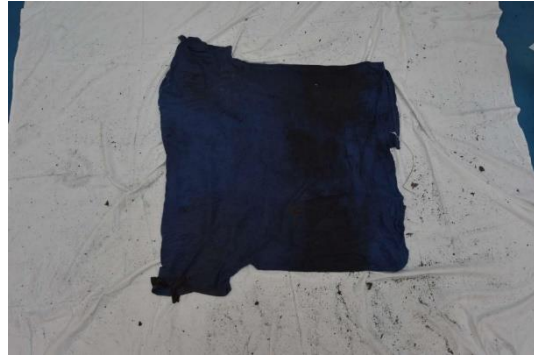
- 9.2.6.4 The post-fire visual inspection revealed that Fn HO might have been in prolonged contact with hot or burning objects, resulting in severe fire damage to his Station T-shirt, No. 3 trousers, PBI Matrix tunic & trousers, anti-flash hood and his helmet, as shown in **Photos 9-11 to 9-16**.

Photo 9-11 (a):  
Station T-shirt (Front)

Photo 9-11 (b):  
Station T-shirt (Back)

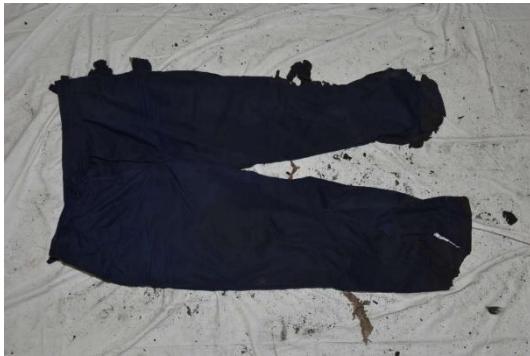
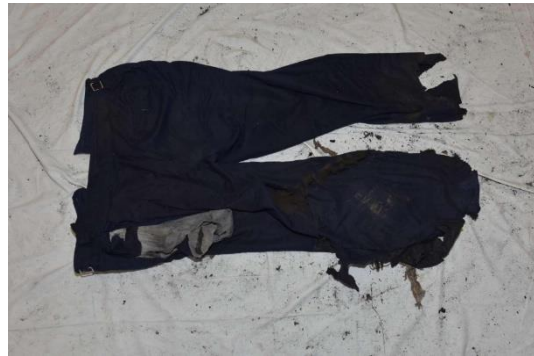
Photo 9-12 (a):  
No. 3 Trousers (Front)

Photo 9-12 (b):  
No. 3 Trousers (Back)

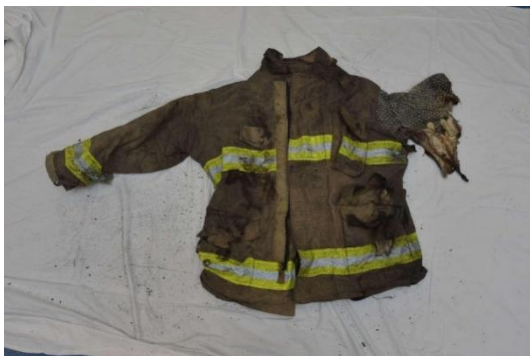
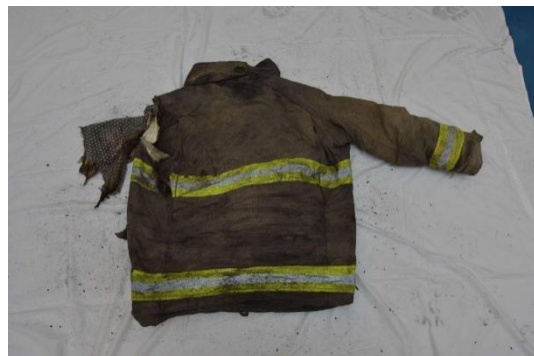
Photo 9-13 (a):  
PBI Matrix Tunic (Front)<sup>132</sup>

Photo 9-13 (b):  
PBI Matrix Tunic (Back)

<sup>132</sup> In accordance with EN 469:2020, PBI Matrix tunic and trousers shall withstand 1,093°C for up to 8 secs.

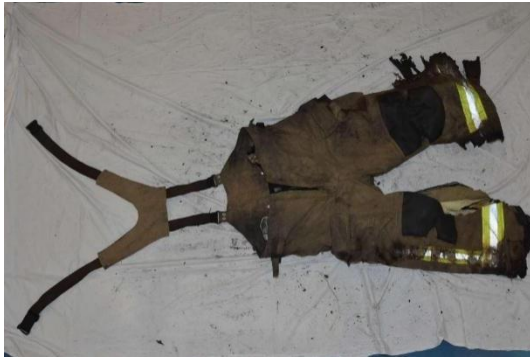
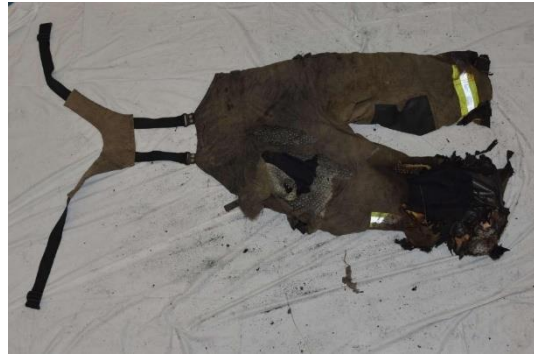
Photo 9-14 (a):  
PBI Matrix Trousers (Front)

Photo 9-14 (b):  
PBI Matrix Trousers (Back)

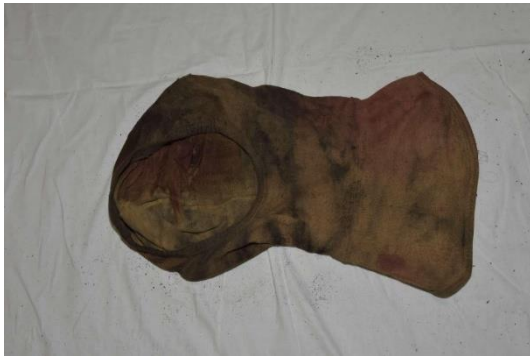
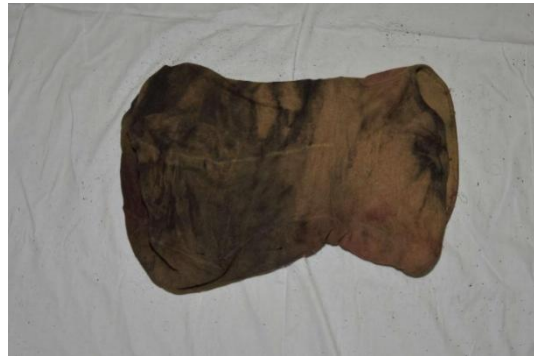
Photo 9-15 (a):  
Anti-flash Hood (Front) <sup>133</sup>

Photo 9-15 (b):  
Anti-flash Hood (Back)

<sup>133</sup> In accordance with EN 13911:2017, anti-flash hood shall be non-flammable and capable of withstanding 260°C for 5 mins without melting or dripping.

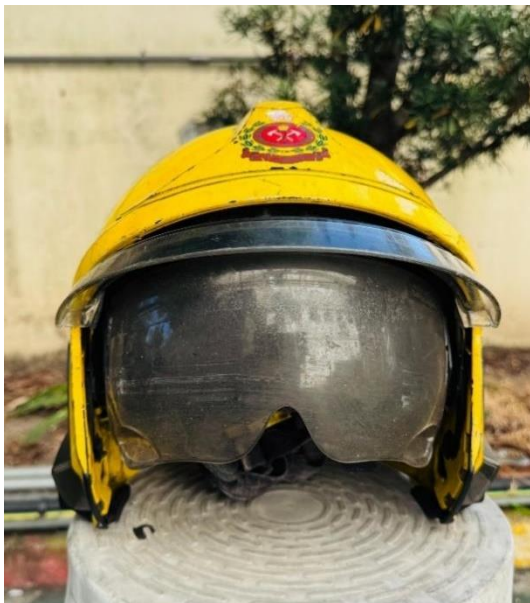
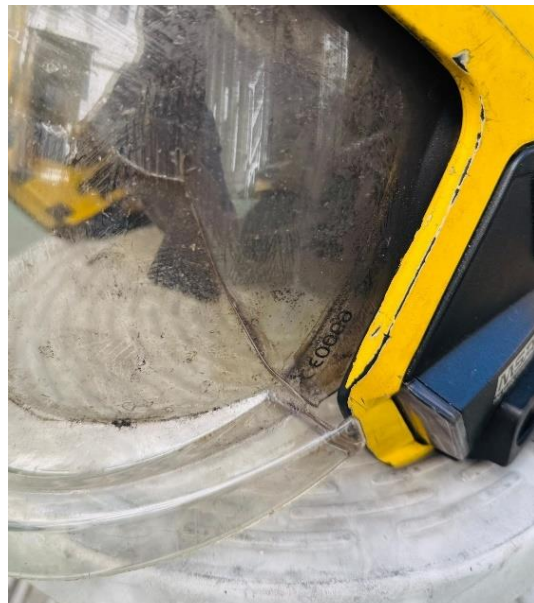
Photo 9-16 (a): The Helmet <sup>134</sup>

Photo 9-16 (b): Crack on Visor

<sup>134</sup> In accordance with EN 443:2008, helmets shall be resistant to flame combustion at 900 – 1,000°C for up to 10 secs and to radiant heat for up to 480 secs, and shall have impact resistance against 5 kg weight and penetration resistance against 1 kg sharp object impact.

- 9.2.6.5 No unusual damage was observed on Fn HO's anti-flash hood and helmet, apart from a crack in the visor, which might have been caused by contact with a sharp or hard object, either prior to or during the fire.
- 9.2.6.6 The post-fire visual inspection revealed that Fn HO's rubber boots might also have been in prolonged contact with hot or burning objects, resulting in severe fire damage. As the boots are designed to provide protection against fire in accordance with European Standard (EN) 15090:2012<sup>135</sup>, it is believed that the intense heat or flames exceeded the boots' protective capacity over an extended period, as shown in **Photos 9-17 (a) & (b)**.

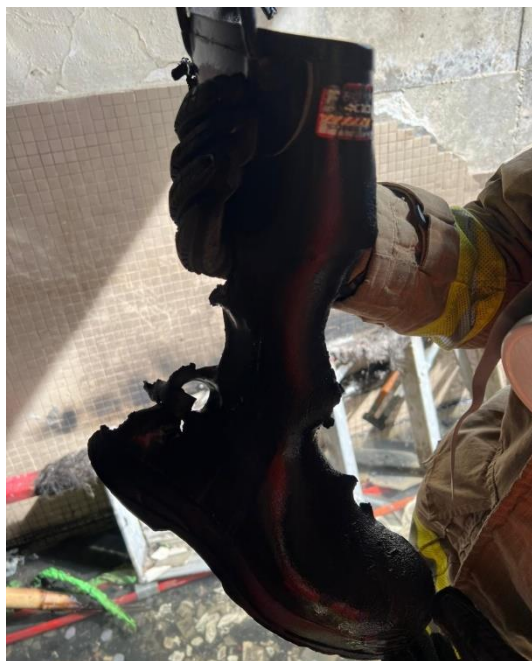
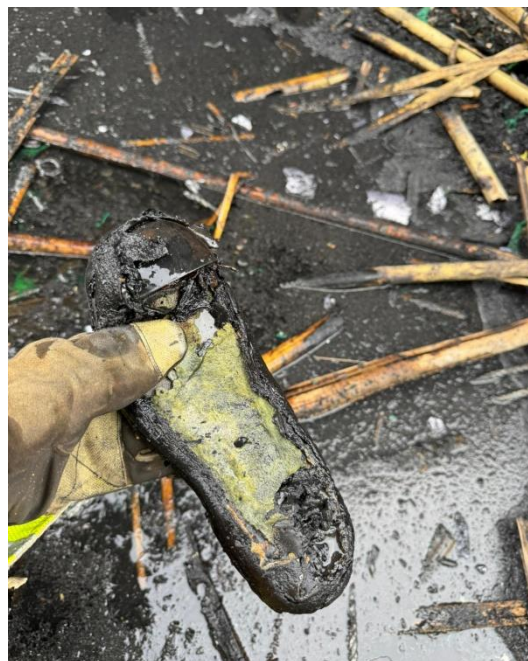
Photo 9-17 (a):  
The Rubber Boot (Right-Foot)

Photo 9-17 (b):  
The Sole of the Boot (Left-Foot)

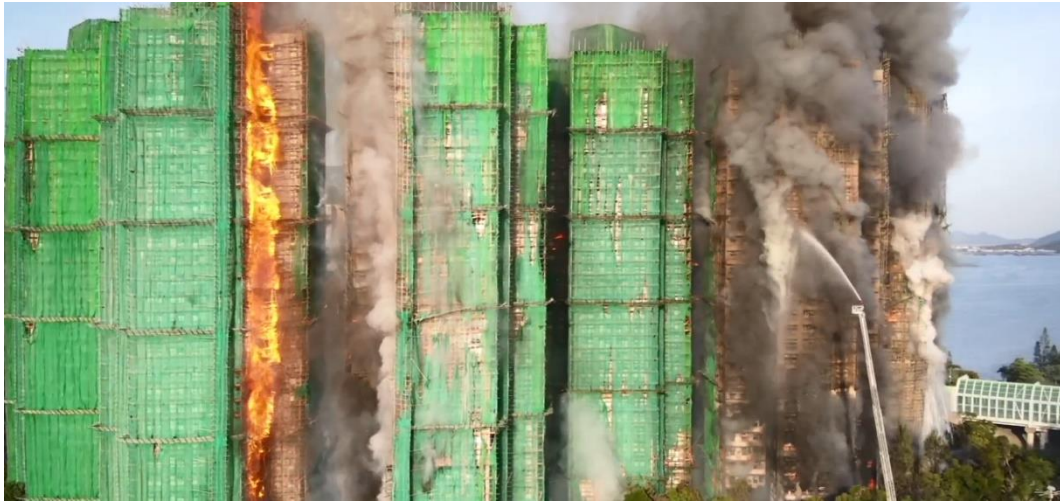
- Rapid vertical fire spread through the chimney-like re-entrant filled with combustible materials (as shown in **Photo 10-1 (a)**);
- Secondary ignitions caused by wind-driven embers, falling debris and flaming droplets (as shown in **Photo 10-1 (b)**);
- Unfavourable weather conditions accelerating fire spread;
- Combustible envelope, such as safety nets, polystyrene window covers, wooden planks, toe-boards, nylon strips and canvas, contributing to fire propagation (as shown in **Photo 10-1 (c)**);
- Fire load inside units prolonging fire duration; and
- The presence of potentially non-FR safety nets and canvas, as detailed in Section 8.2.

*Photo 10-1 (a): Rapid Vertical Fire Spread Along Re-Entrant of Wang Tao House*

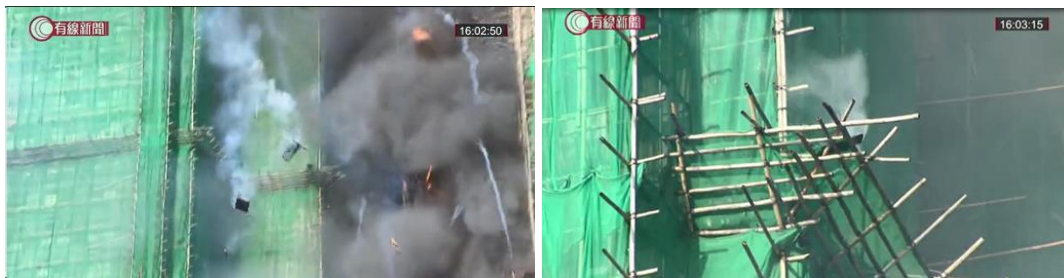
*Photo 10-1 (b): Secondary Ignitions Caused by Falling Debris*

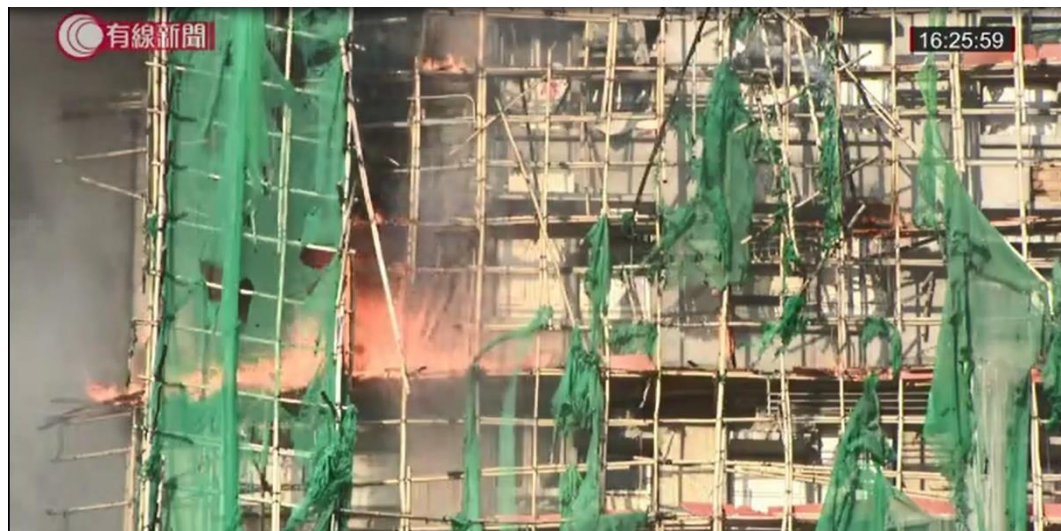
*Photo 10-1 (c): Combustible Envelope Fueling Fire Spread*

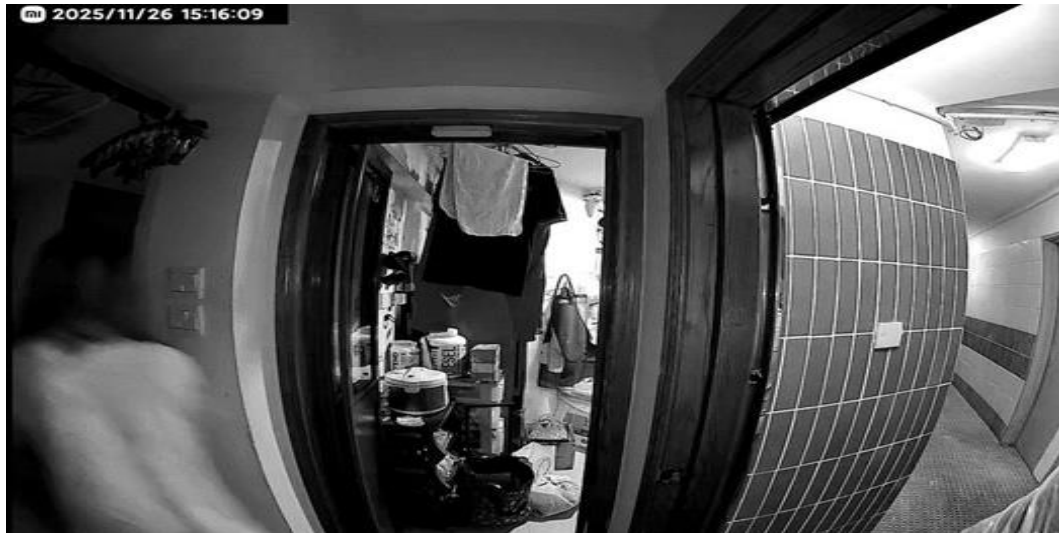
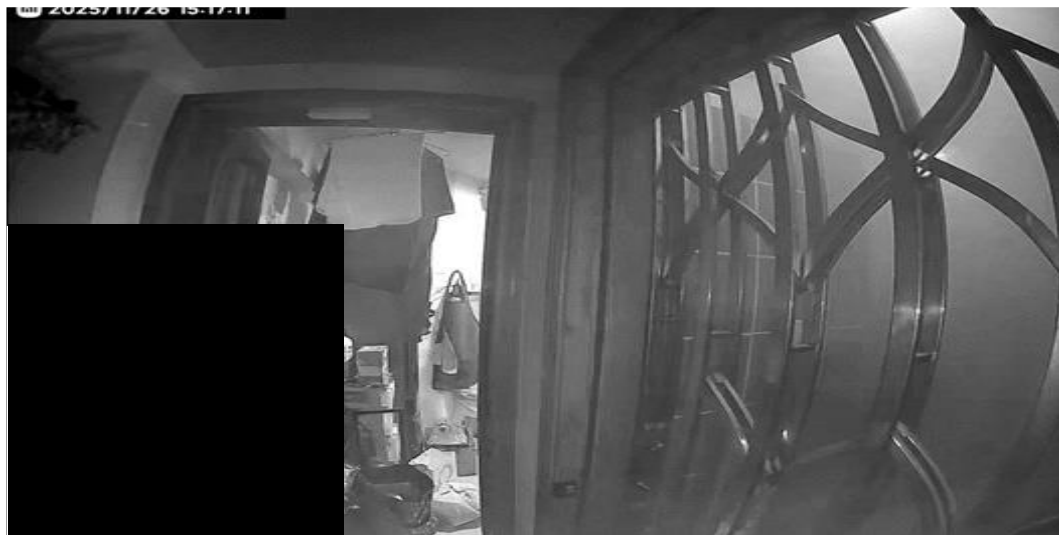
- 10.2.5.2 Mr. CHEUNG [REDACTED], the occupant of Flat [REDACTED]06 in Wang Tai House, stated that at about 1516 hours, he left the unit with his wife and attempted to use the staircase to escape.<sup>159</sup> However, both staircases were heavily smoke-logged. Within one minute, the common corridor became filled with dense smoke, making it extremely difficult to breathe, as shown in **Photos 10-2 (a) & (b)**. Consequently, they returned to their unit.

*Photo 10-2 (a): Security Camera Footage of Flat 06 at 1516 Hours*

*Photo 10-2 (b): Security Camera Footage of Flat 06 at 1517 Hours*

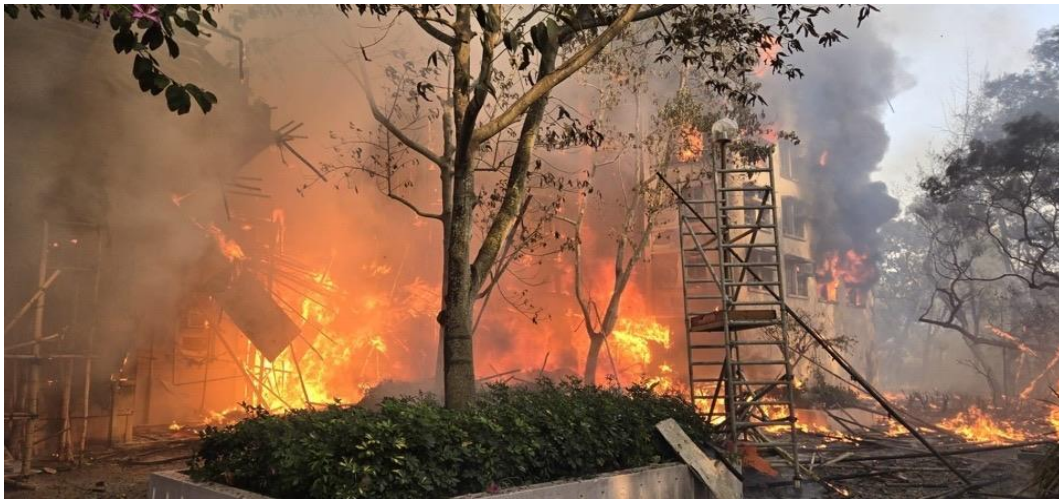
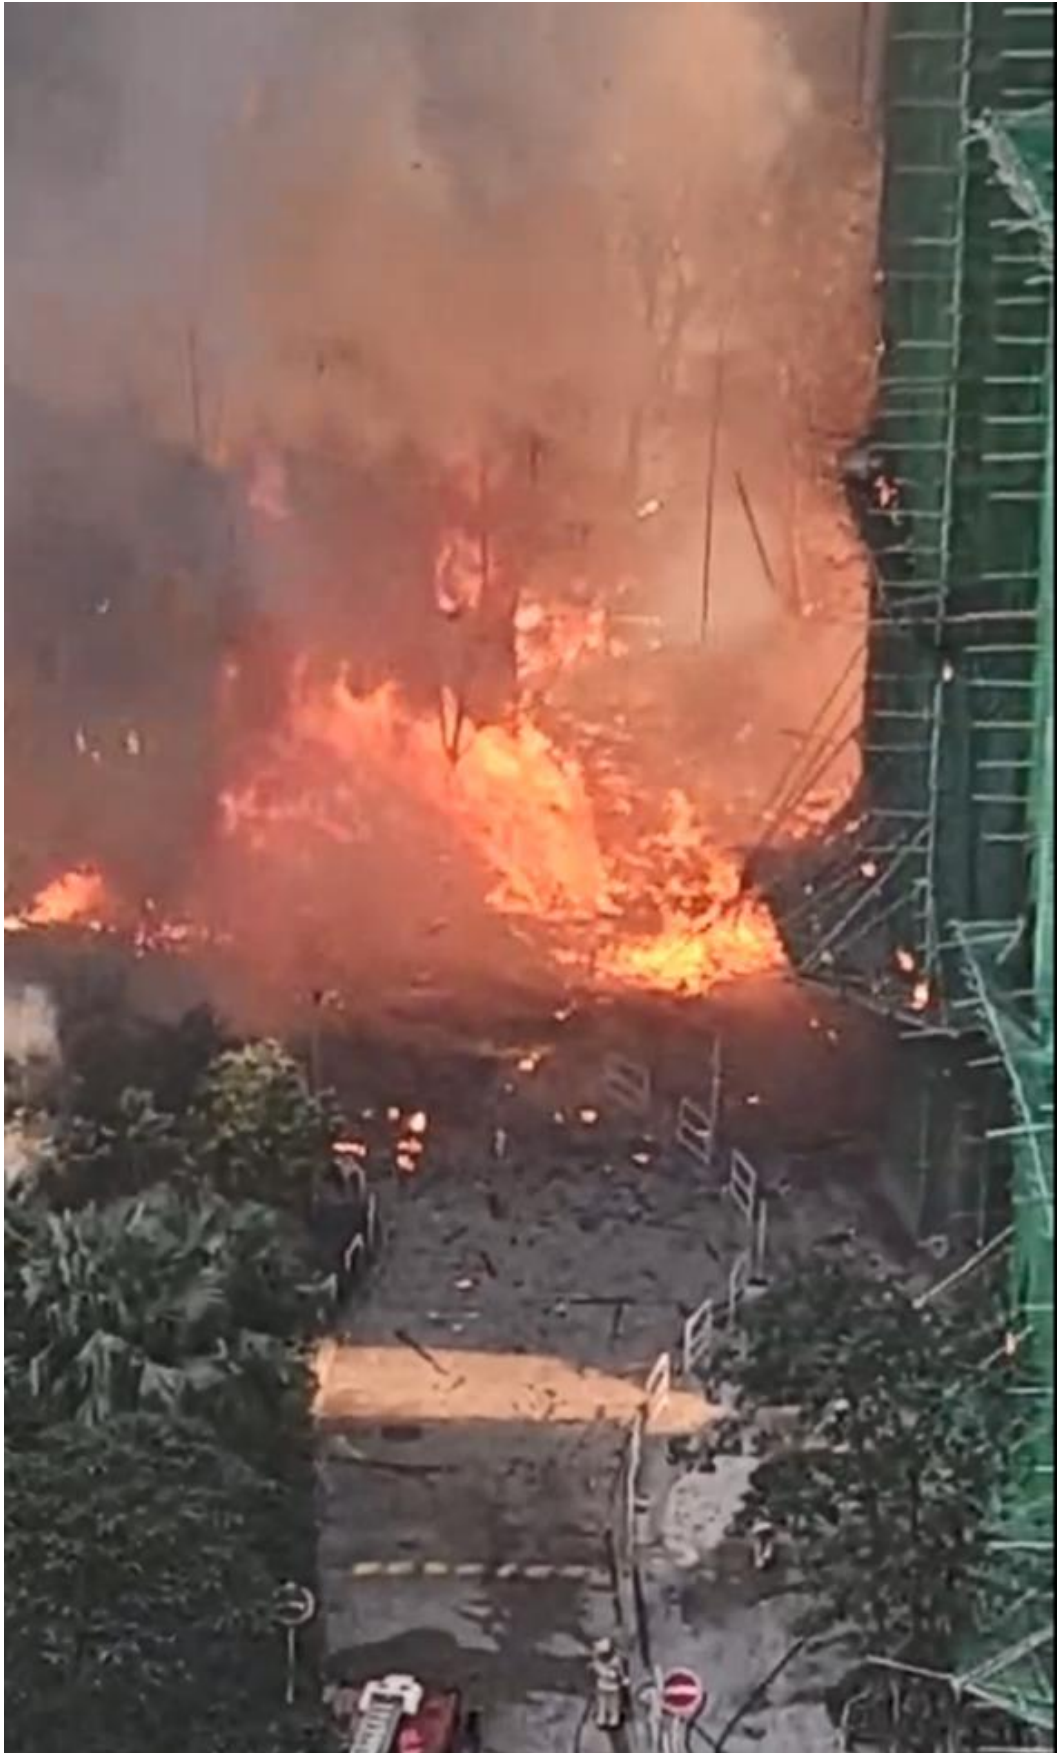
- 10.3.1 Flaming bamboo scaffolding and other construction materials detached from the upper levels during the fire led to the collapse and accumulation of a large amount of burning debris, which piled up on the ground level, resulting in flaming blockages at building entrances, as shown in **Photos 10-3 (a) & (b)**. As a result, both escape for evacuees and access for firefighting personnel were obstructed and in turn delaying escape, rescue efforts and fire suppression.

Photo 10-3 (a): The Burning Debris and Bamboo Scaffolding Blocking Exits

Photo 10-3 (b): Flaming Bamboo Scaffolding and Other Construction Materials  
Detached From the Upper Levels

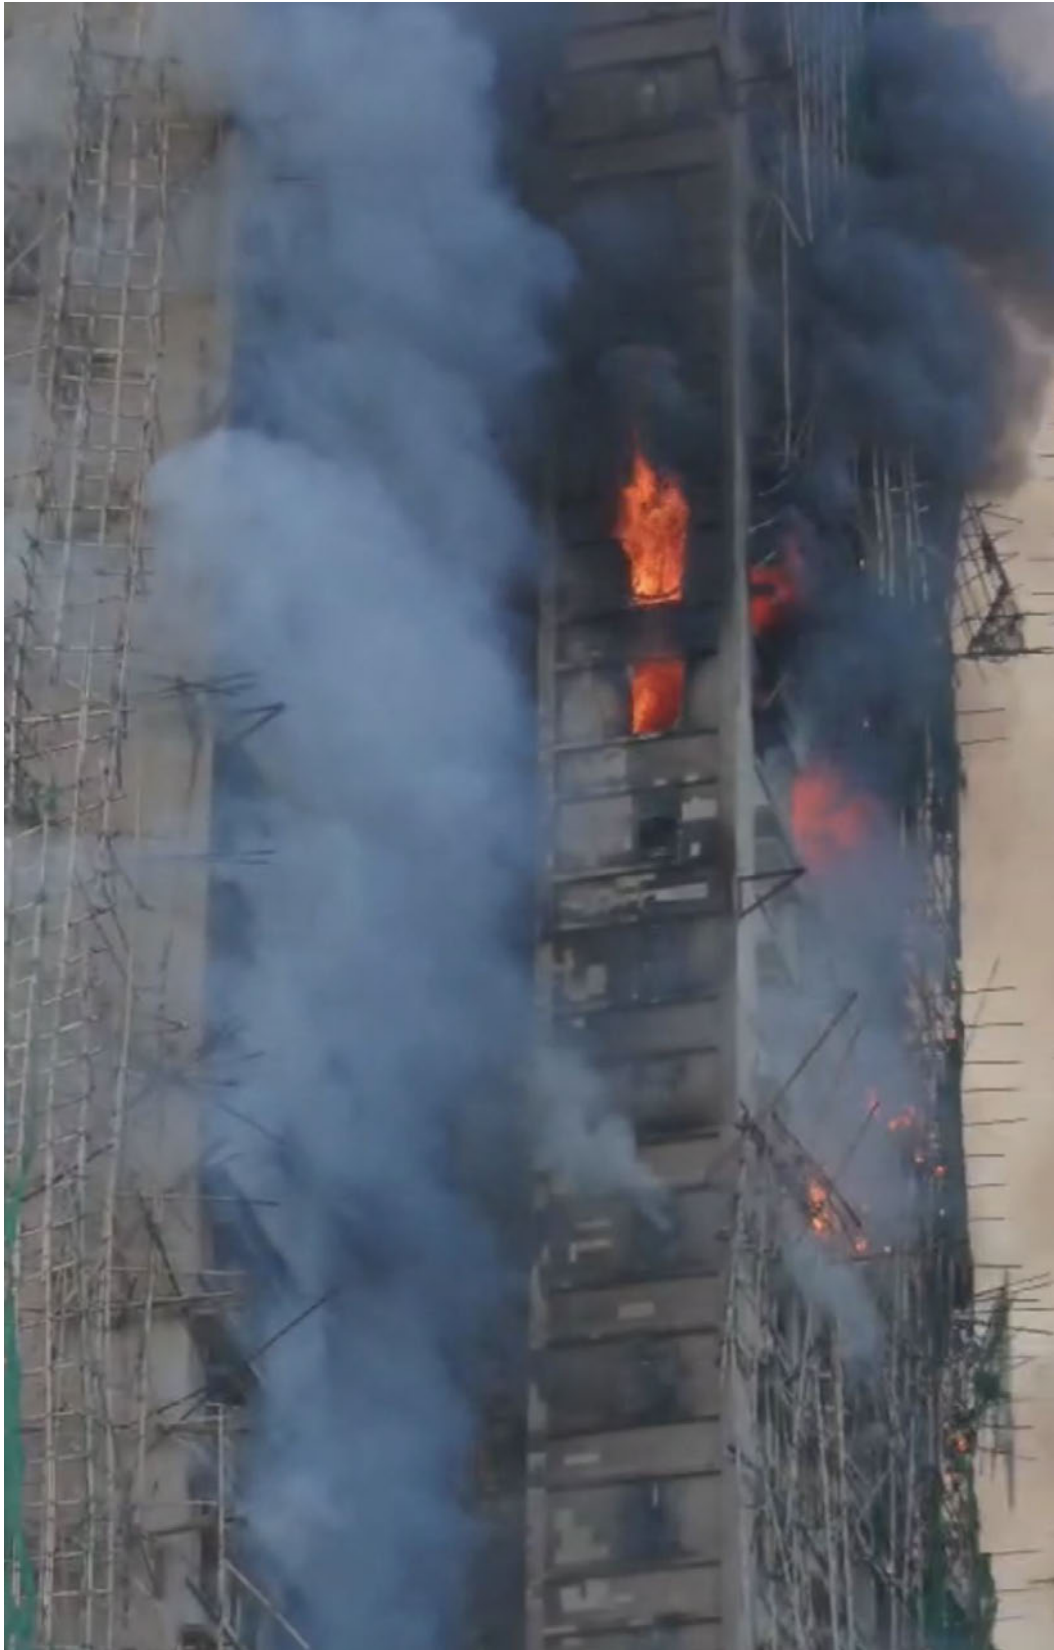
- 10.3.2 As shown in **Photo 10-3 (c)**, which was taken at about 1611 hours, the bamboo scaffolding on the southeast façade of Wang Cheong House had collapsed, likely blocking the rear exit of Wang Cheong House.

Photo 10-3 (c): The Bamboo of the Scaffolding on Southeast Façade of Wang Cheong House Fell and Possibly Blocked the Rear Exit

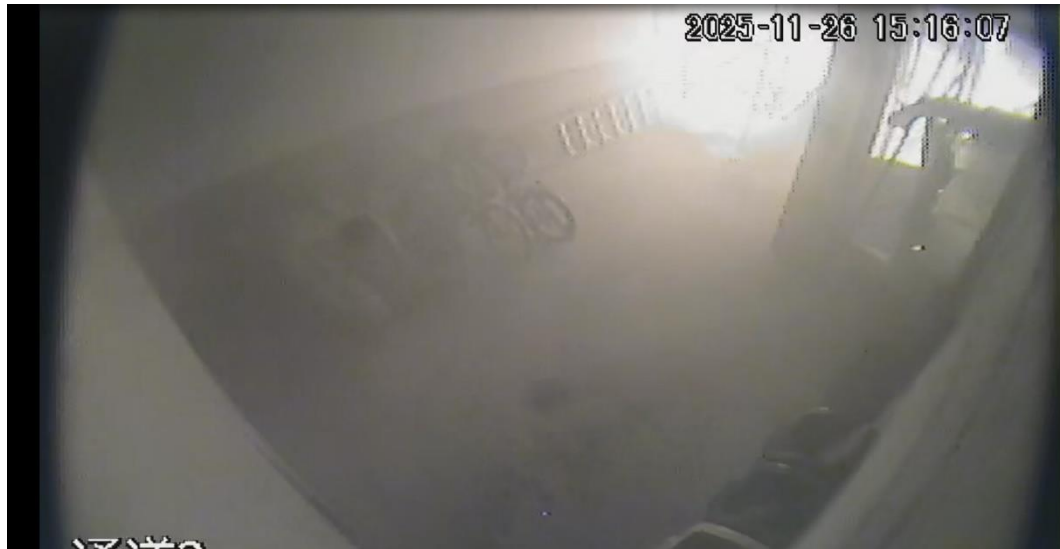
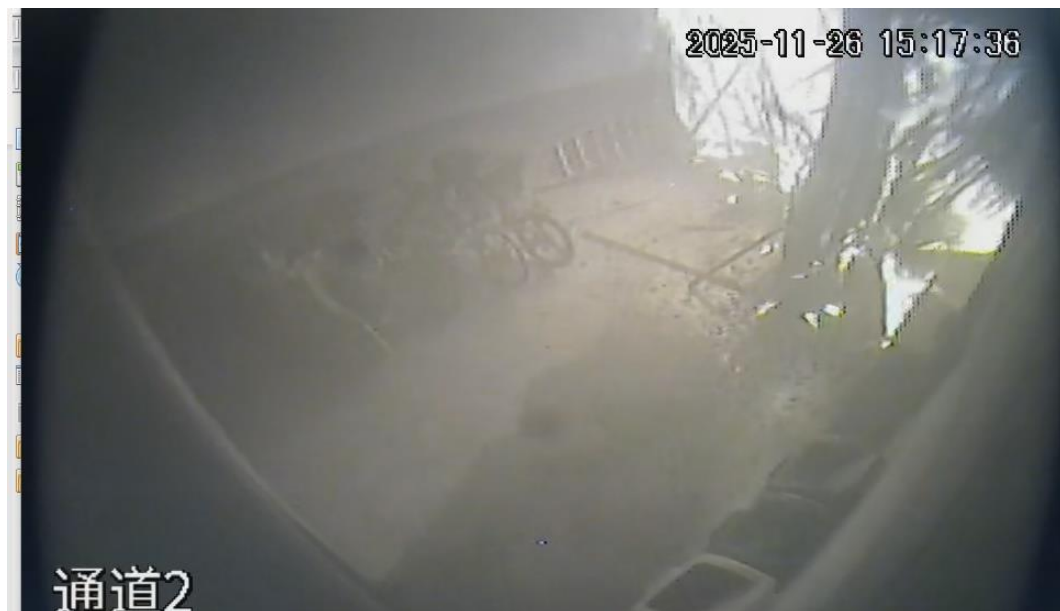
- 10.3.3 According to the initial Incident Commander, SStnO HUI Kin-on, the front entrance and rear exit of Wang Cheong House were blocked by collapsed burning scaffolding at about 1505 hours and 1457 hours respectively. For Wang Tai House, the front entrance and rear exit were similarly obstructed at about 1520 hours and 1530 hours respectively<sup>164</sup>. His observation at Wang Tai House was supported by the following evidence from the building's CCTV footage, as shown in **Photos 10-3 (d) & (e)**, and the following observations.

*Photo 10-3 (d): CCTV Footage G/F, Wang Tai House at 1516 Hours*

*Photo 10-3 (e): CCTV Footage G/F, Wang Tai House at 1518 Hours*

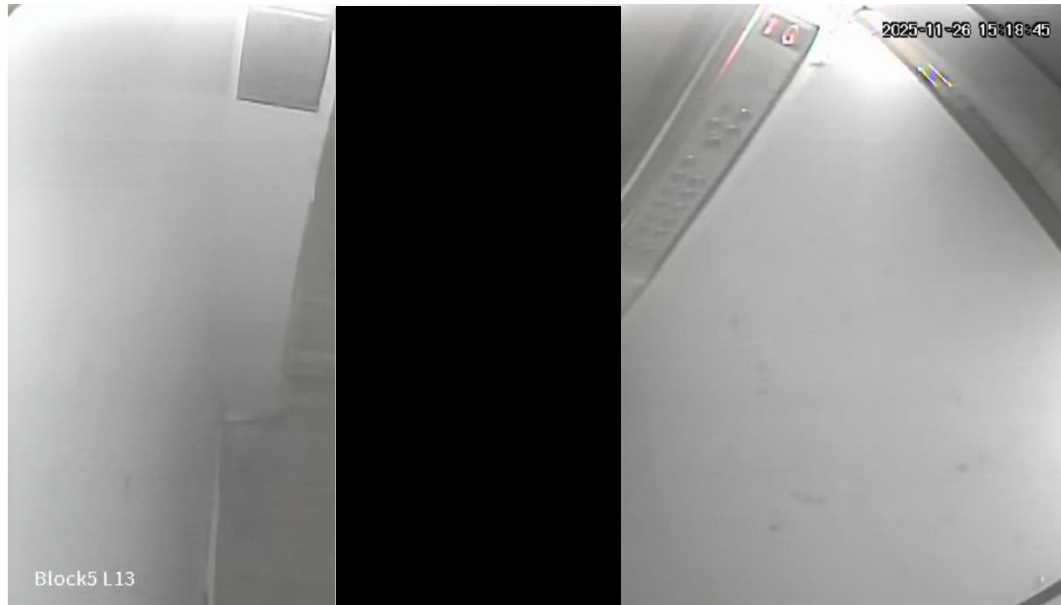
- 10.3.3.2 In **Photo 10-4 (a)**, the [REDACTED], believed to be [REDACTED] arrived at the G/F via lift L13 of Wang Tai House at about 1518 hours for the first time. [REDACTED] hesitated at the lift entrance, briefly peeking out before retreating back into the lift out of fear of the fire. [REDACTED] then shuttled between the 24/F and G/F<sup>166</sup>, arriving at the G/F again at 1520 hours. Tragically, as described in paragraph 9.2.3.5, the rapidly deteriorating conditions in the lift lobbies ultimately led to [REDACTED] deaths.

Photo 10-4 (a): CCTV Footage of Lift L13 on the G/F at 1520 Hours

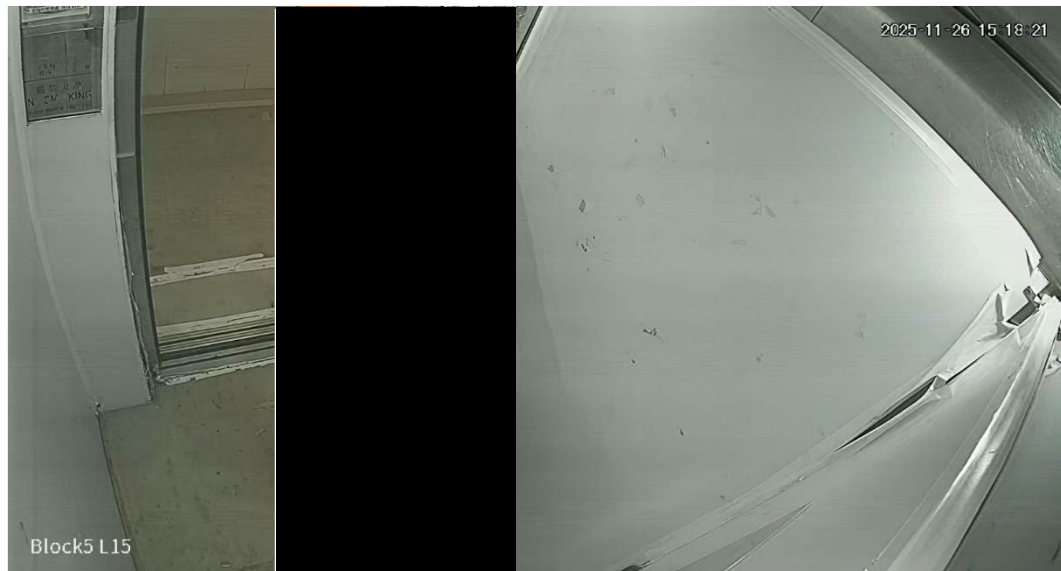
10.3.3.3 In **Photo 10-4 (b)**, the [REDACTED], believed to be [REDACTED], entered lift L15 on the G/F at approximately 1518 hours and travelled to the 11/F, 23/F and 29/F. [REDACTED] then remained in the same lift and returned to the G/F at approximately 1520 hours<sup>167</sup>. The photo captured the flare, highlighting the hazardous conditions at the entrance. [REDACTED] remained in the lift and ascended to the 11/F & 23/F. When [REDACTED] eventually arrived at the 23/F at about 1521 hours, the lift was engulfed by smoke and heat pouring in. Tragically, as detailed in paragraph 9.2.3.4, the worsening conditions in the lift lobbies ultimately led to [REDACTED] death.

Photo 10-4 (b): CCTV Footage of Lift L15 on the G/F at 1520 Hours

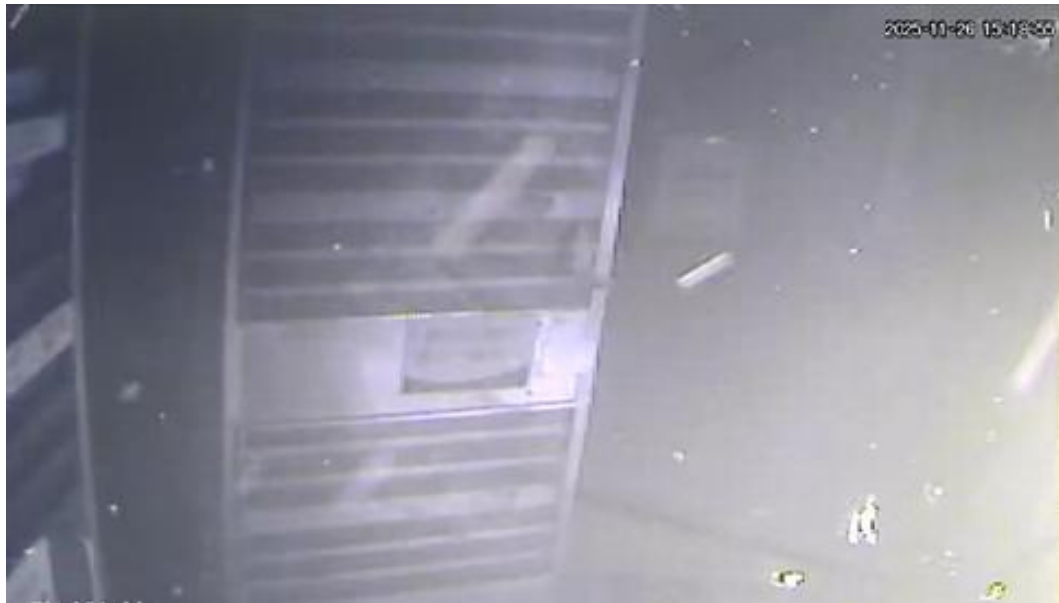
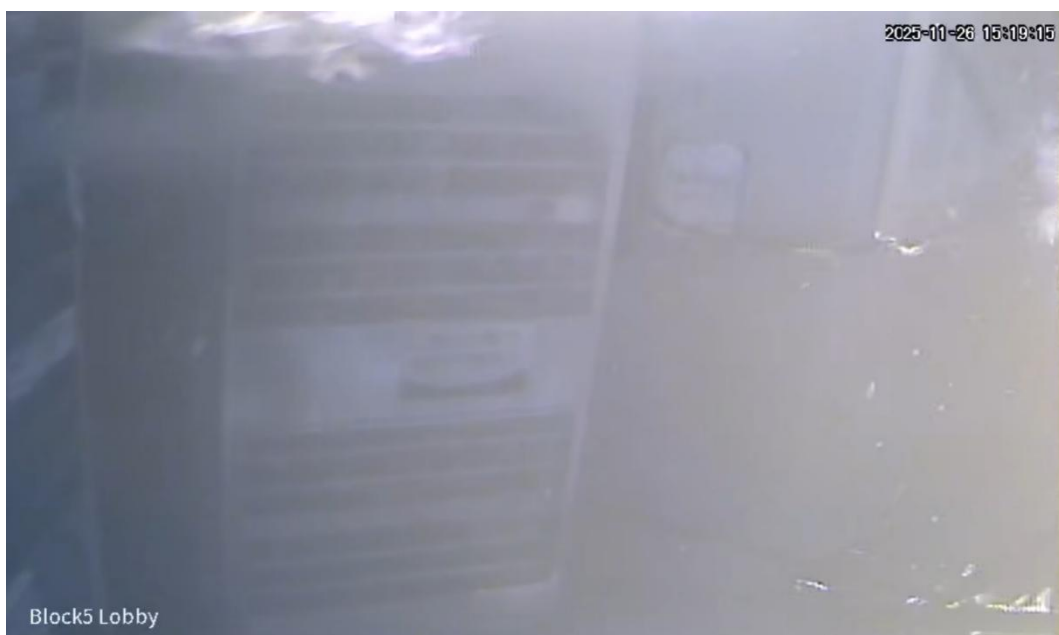
10.3.3.4 As shown in **Photo 10-4 (c)**, sparks were visible at the entrance of Wang Tai House; at about 1521 hours<sup>168</sup>, flames were captured at the same location in **Photo 10-4 (d)**. Under these hazardous conditions, even evacuees who managed to reach the ground floor were unable to escape safely. At the same time, firefighters faced serious challenges in approaching the entrances safely and quickly, as they had to contend with falling, burning materials and intense heat at the base of the buildings. Hence, the blockage of exits was undoubtedly one of the critical contributing factors that led to heavy casualties.

Photo 10-4 (c): CCTV Footage of at the Entrance of Wang Tai House at 1520 Hours

Photo 10-4 (d): Flame was Observed at the Entrance of Wang Tai House at About 1521 Hours

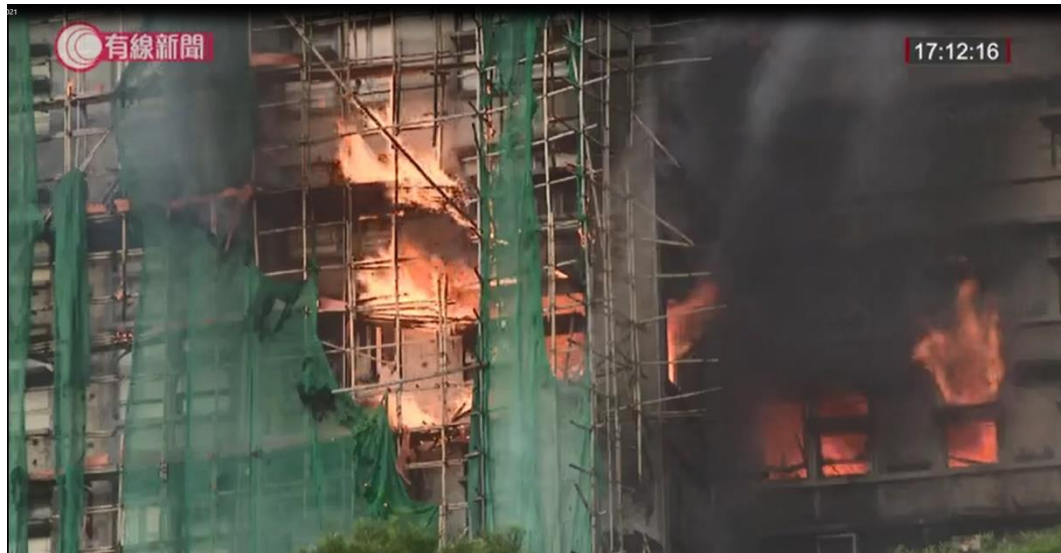
- **Fueling the external fire spread:** Polystyrene panels affixed to windows, as shown in **Photo 10-6 (a)**, burned readily, accelerating fire propagation along the building façade.
- **Falling debris fueling additional fires:** Full-scale fire tests conducted in Sichuan demonstrated that ignited polystyrene panels could detach from the building exterior and fall. Once fallen, they acted as a new source of fire and could spark fires beneath the windows, as shown in **Photo 10-6 (b)**.

Photo 10-6 (a): Polystyrene Panels Fueling Fire Spread on the Building Façade

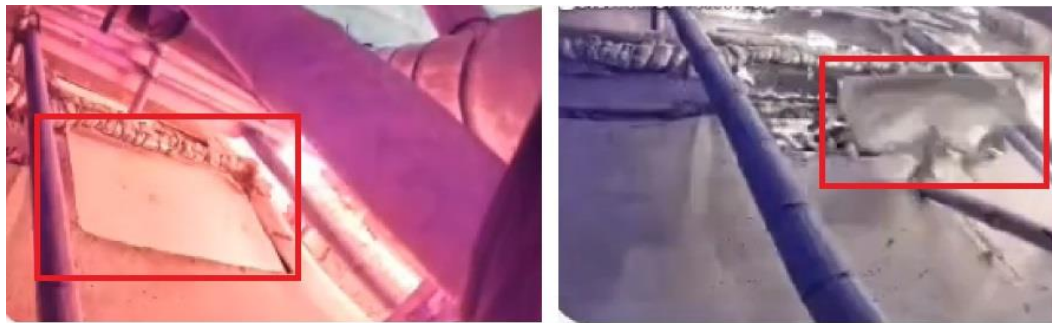
Photo 10-6 (b): Polystyrene Panel Detached From Building Exterior

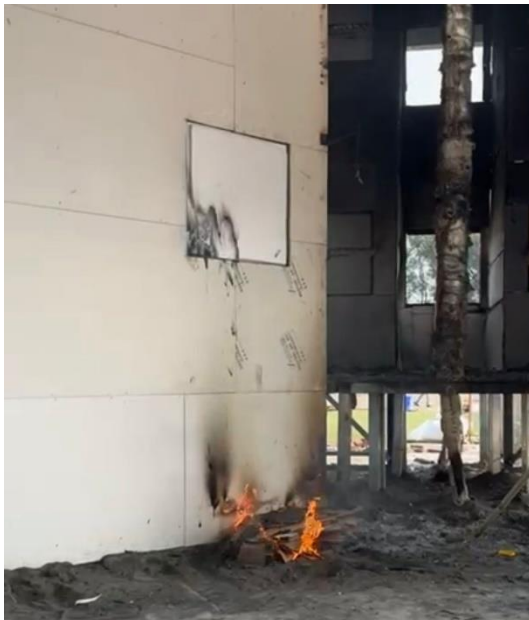
- **Ignited fragments causing secondary fires:** Burning fragments of polystyrene panels were light enough to travel significant distances, potentially igniting secondary fires in adjacent buildings or nearby combustibles. This was particularly relevant given the weather conditions on the day of the incident.
- **Burning droplets causing fire spread:** As observed during full-scale fire tests and GL testing, ignited polystyrene panels generated burning droplets. These droplets dripped onto nearby combustibles, igniting them and causing additional fire spread, as shown in **Photo 10-6 (c)**.

Photo 10-6 (c):  
Burning Droplets From Polystyrene  
Panels Igniting Nearby Combustibles

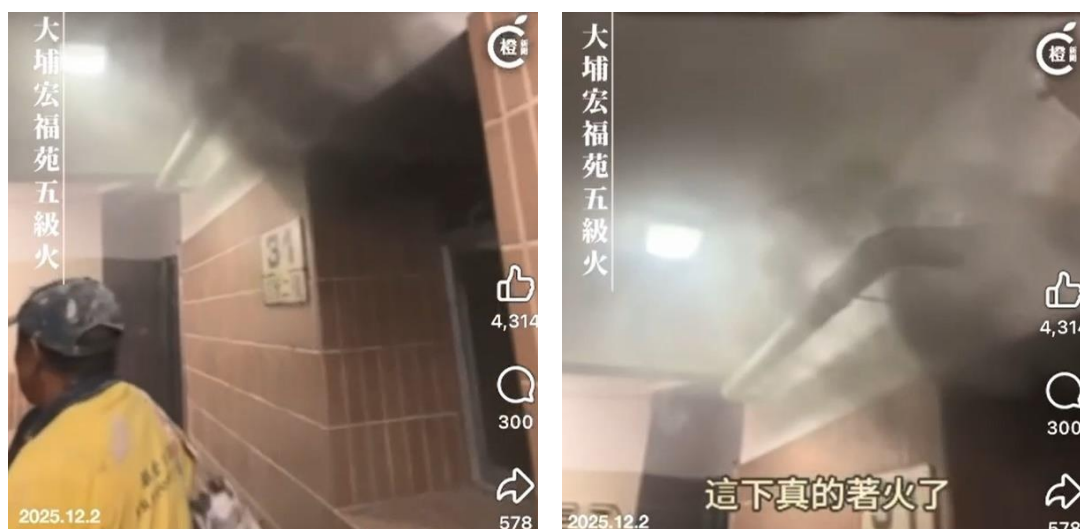
- 10.6.1.1 During the fire, the upper ventilation<sup>181</sup> parts of the windows in the lift lobbies on some floors were left open. This allowed smoke from the burning scaffolding to enter the lift lobbies and corridors, which in turn hindered evacuation, as shown in **Photos 10-7 (a) & (b)**, and further shortened the time for evacuation.

Photos 10-7 (a) & (b): Video From Online Source Showing Smoke Entering Lift Lobby Through the Upper Openable Part of Window of Wang Tai House

<sup>181</sup> As explained in paragraph 4.3.2, the upper part of the windows in the lift lobbies as well as in the staircases of the eight blocks of Wang Fuk Court were openable, while the lower part of the windows was fixed light. Such design was compliant with the prevailing standard at the time of construction of Wang Fuk Court (i.e. Clause 23 of CoP on MOE 1976).

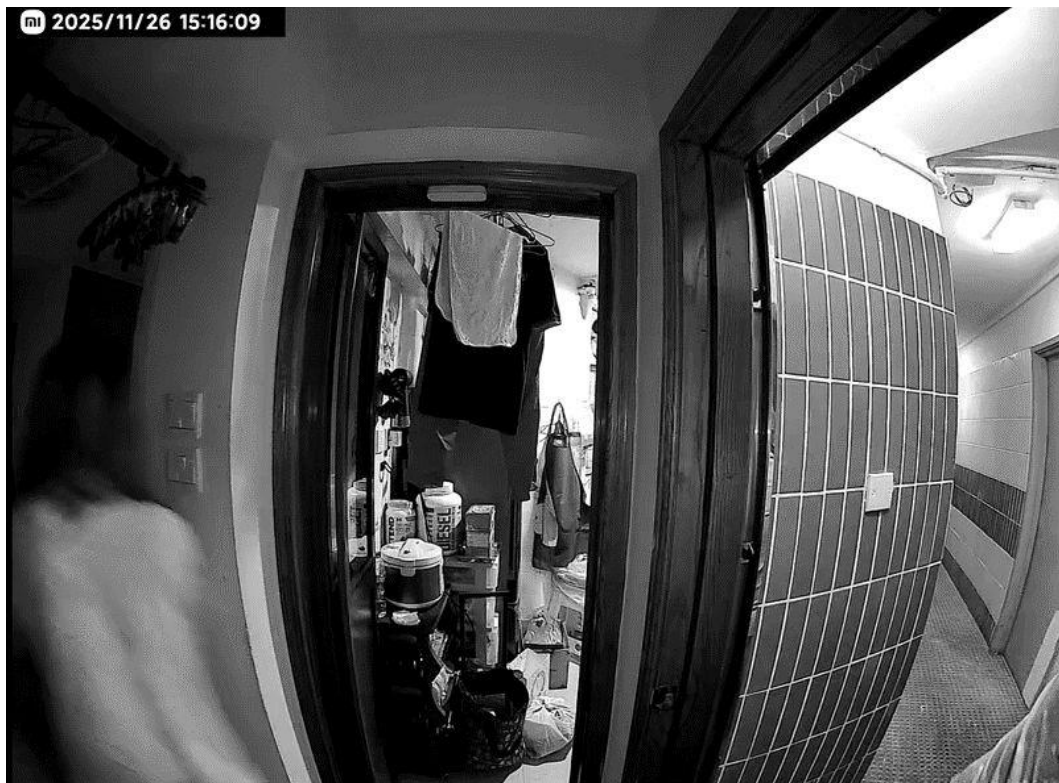
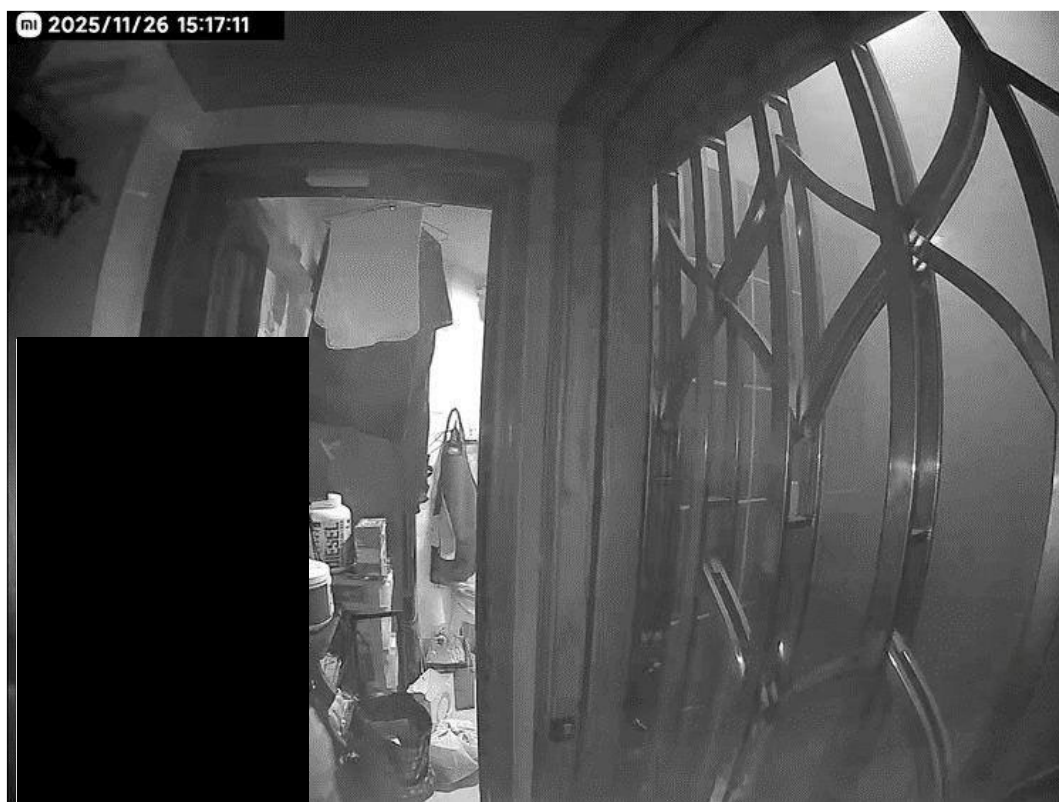
- 10.6.1.2 Security camera footage from Flat ■06 of Wang Tai House shows that the common corridor on the 10/F was clear of smoke at 1516 hours. However, due to the rapid fire spread at the re-entrant adjacent to the lift lobby window of the building, as shown in **Photo 10-7 (e)**, the same corridor was engulfed in dense smoke within the span of one minute, as shown in **Photos 10-7 (c) & (d)**.

*Photo 10-7 (c): Security Camera Footage of Flat 06 of  
Wang Tai House at 1516 Hours*

*Photo 10-7 (d): Security Camera Footage of Flat 06 of  
Wang Tai House at 1517 Hours*
