# Final Investigation Report No.5 Alarm Fire at Wang Fuk Court on 26 November 2025

Inter-Departmental Fire Investigation Task Force

May 2026

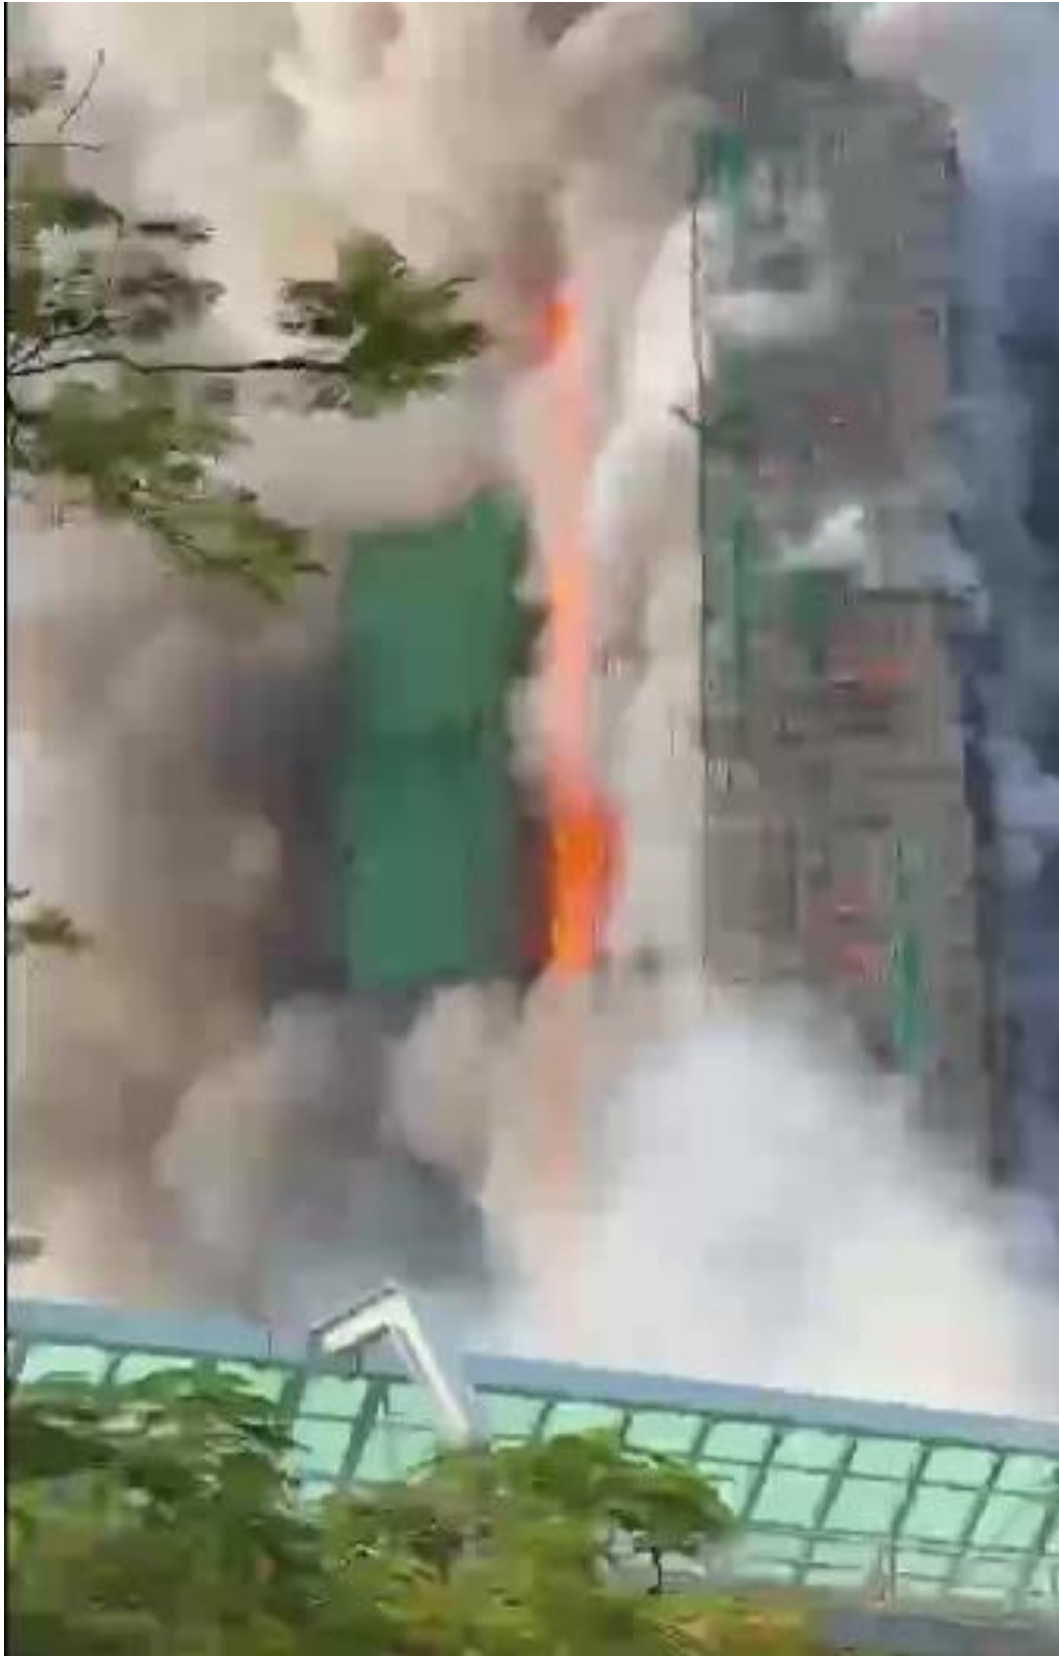
- 10.6.1.2 Security camera footage from Flat ■06 of Wang Tai House shows that the common corridor on the 10/F was clear of smoke at 1516 hours. However, due to the rapid fire spread at the re-entrant adjacent to the lift lobby window of the building, as shown in **Photo 10-7 (e)**, the same corridor was engulfed in dense smoke within the span of one minute, as shown in **Photos 10-7 (c) & (d)**.

Photo 10-7 (e): Rapid Fire Spread at the East Re-Entrant of  
Wang Tai House at 1516 Hours

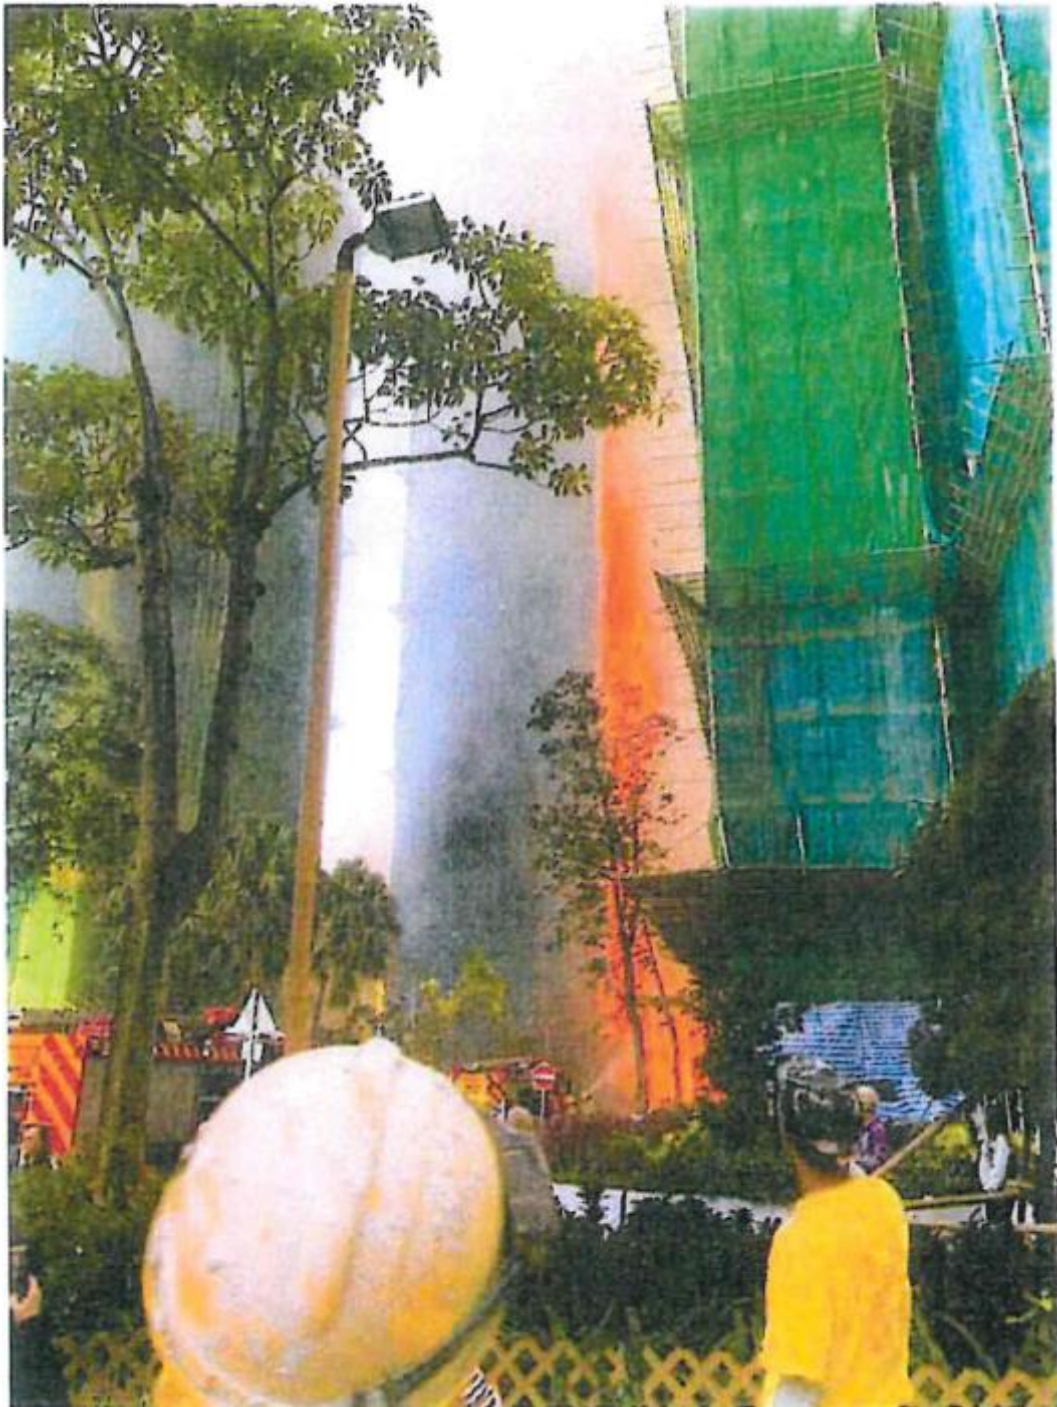
- 10.6.1.3 A similar event took place in Wang Cheong House at about 1509 hours, as shown in **Photo 10-7 (f)**. At that time, there was a rapid fire spread along the re-entrant adjacent to the lift lobby window of the building. The CCTV footage at Flat ■03<sup>182</sup> of Wang Cheong House showed that smoke infiltrated rapidly from the common corridor into the unit between 1500 hours and 1510 hours, as shown in **Photo 10-7 (g) & (h)**.

Photo 10-7 (f): Rapid Fire Spread at the West Re-Entrant of Wang Cheong House at 1509 Hours

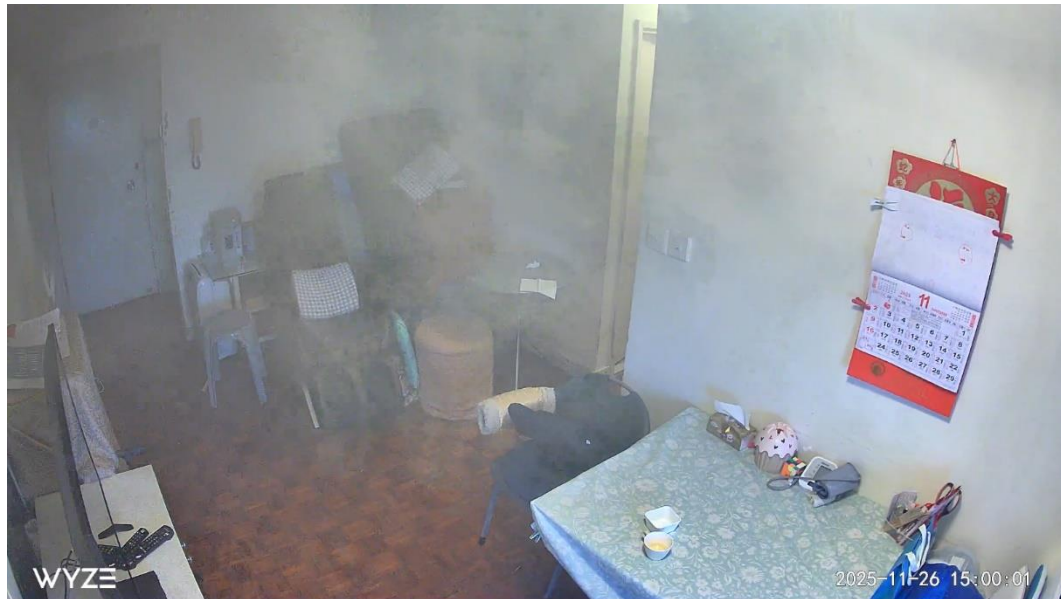
Photo 10-7 (g): Showing the Smoke Entering Flat 03 of Wang Cheong House at 1500 Hours

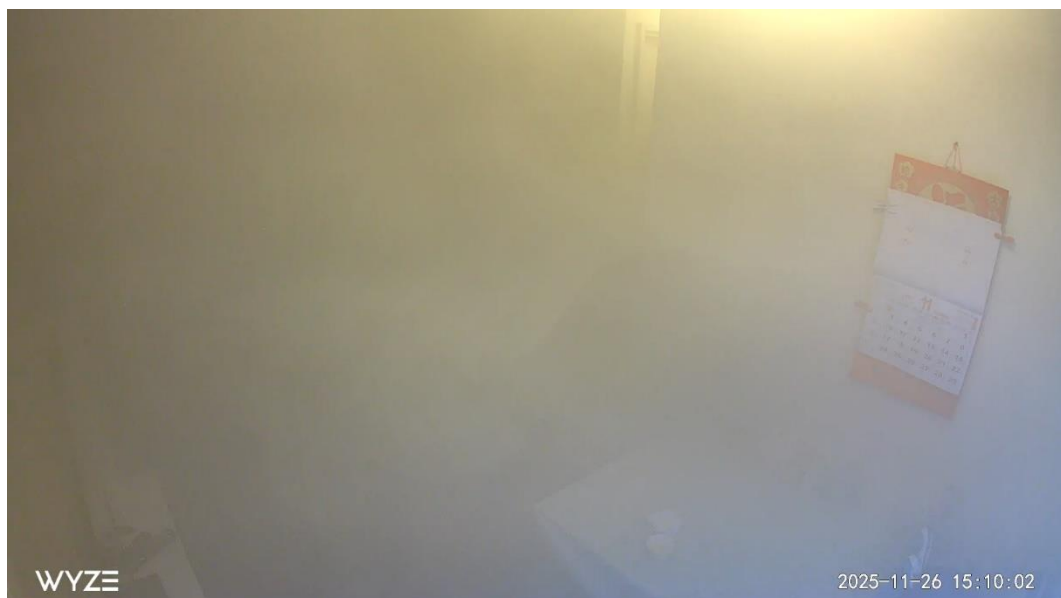
Photo 10-7 (h): Showing the Smoke Condition at Flat 03 of Wang Cheong House at 1510 Hours

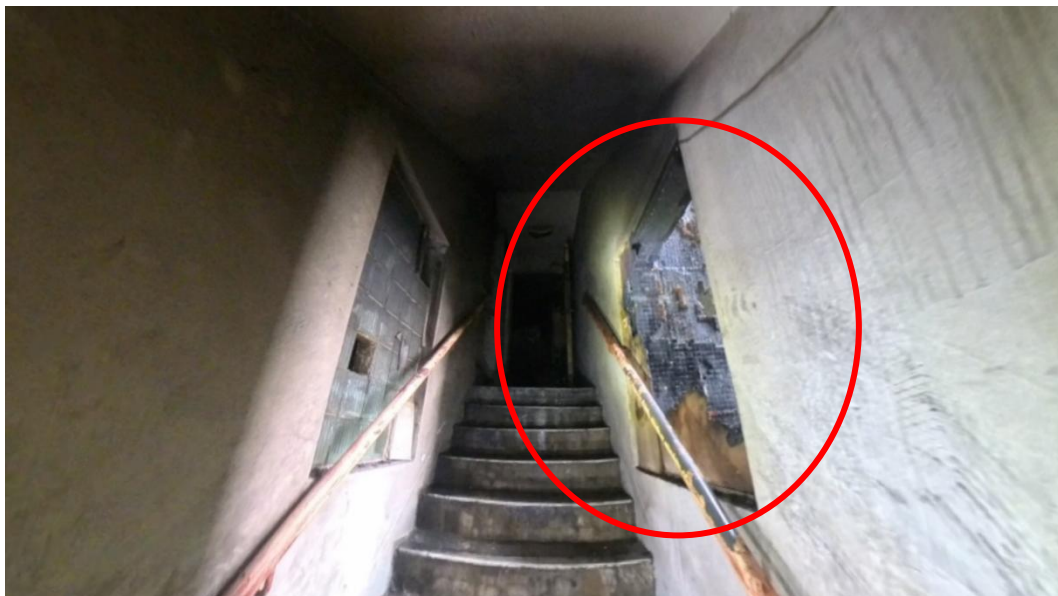
- 10.6.2.1 Some windows in staircases (details in paragraph 4.5.5.4) were replaced with movable boards as access openings to the exterior scaffolding. During the fire, these movable boards permitted smoke and heat to infiltrate the staircases. Severe blackening of ceilings above the opening indicated heavy smoke penetration. As a result, staircases intended to serve as protected escape routes were compromised, leaving residents without safe pathways for evacuation. This also restricted firefighter access, delayed firefighting and rescue operations and reduced the effectiveness of firefighting efforts, as shown in **Photo 10-8 (a)**.

- 10.6.2.2 It is noteworthy that out of the 38 fatalities in the staircases and common areas of Wang Tai House, 26 were found inside the staircase of Wang Tai House. The cause of death for all 26 individuals was inhalation of fire fumes, with one of them also sustaining extensive burns. This tragic outcome can likely be attributed to the compromised openings in the staircase, such as those fitted with movable boards, which allowed smoke and heat to infiltrate. These openings rendered the staircase, intended as a protected escape route and temporary place of safety, incapable of providing a safe environment for evacuation.

Photo 10-8 (a): Windows Replaced by Movable Boards (Damaged by Fire) at  
Escape Staircase of 10-11/F of Wang Tai House

- 10.6.2.14 To maintain the functionality of the exit staircases during repair works, the staircases must remain unobstructed and free from any additional hazards. Furthermore, the integrity of the fire separation for protected escape routes must be properly maintained. As such, the installation of combustible wooden movable boards providing access to the scaffolding, which introduced additional hazards to the exit route, indicates that the construction methods and precautionary measures in place may be inappropriate. The installation of combustible wooden doors and the misuse of staircase openings is a potential violation of several fire safety requirements as stipulated in the Fire Safety Code (FS Code) as well as building regulations, including the Building (Construction) Regulations (B(C)R) (Cap.123Q) and the Building (Planning) Regulations (B(P)R) (Cap.123F).

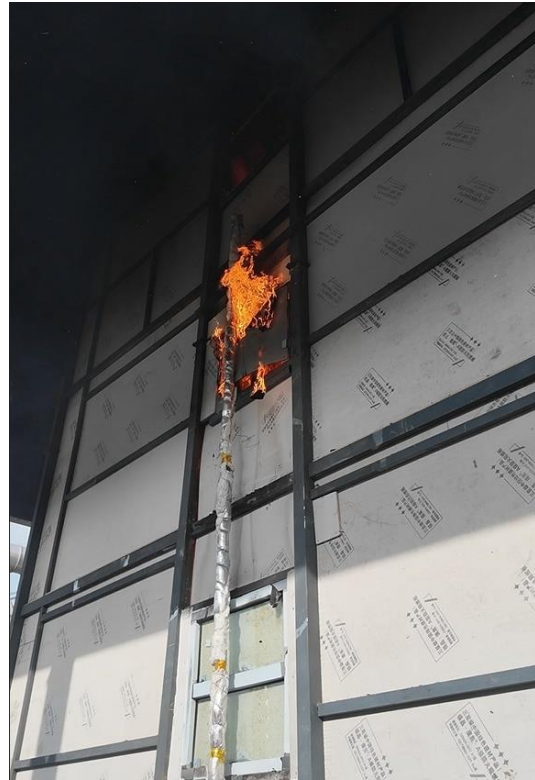
- 10.6.2.3 Full-scale fire tests conducted in Sichuan replicated the conditions within the re-entrant, where staircase windows had been replaced with wooden boards and aluminium composite panels, as detailed in paragraphs 7.2.3.20 to 7.2.3.25. Wooden board, aluminium composite panel and fire-rated glass window were installed at the openings on the 3/F, 2/F and 1/F levels respectively. During the test, the wooden board ignited at 4 min 40 sec and the aluminium composite panel ignited at 7 min 49 sec, as shown in **Photos 10-8 (b) & (c)**.

- 10.6.2.4 The test results indicate that both the wooden board and aluminium composite panel are unsuitable for protecting the staircase openings. These materials fail to provide adequate protection, unlike the fire-rated glass window<sup>183</sup>, which remained intact and maintained a lower interior temperature, therefore ensuring a safer environment for evacuation.<sup>184</sup>

Photo 10-8 (c):  
Ignition of Aluminium Composite Panel  
(7 Mins 49 Secs)

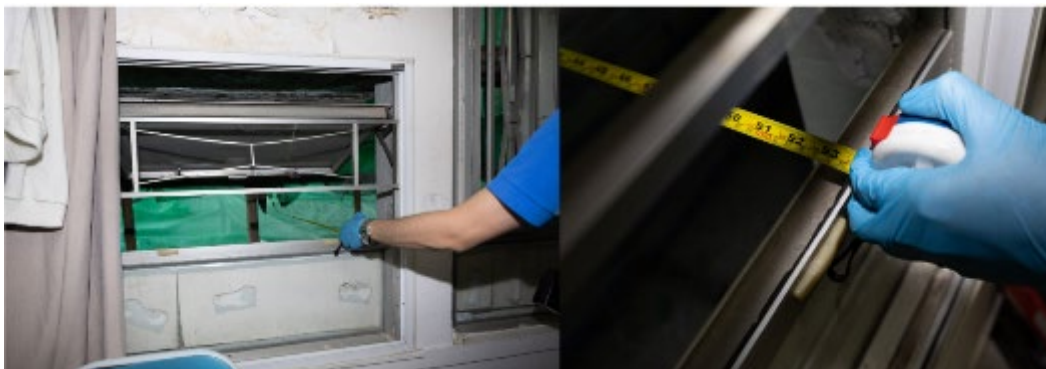
Photo: The distance between bamboo scaffolding and residential units is about 134 cm.

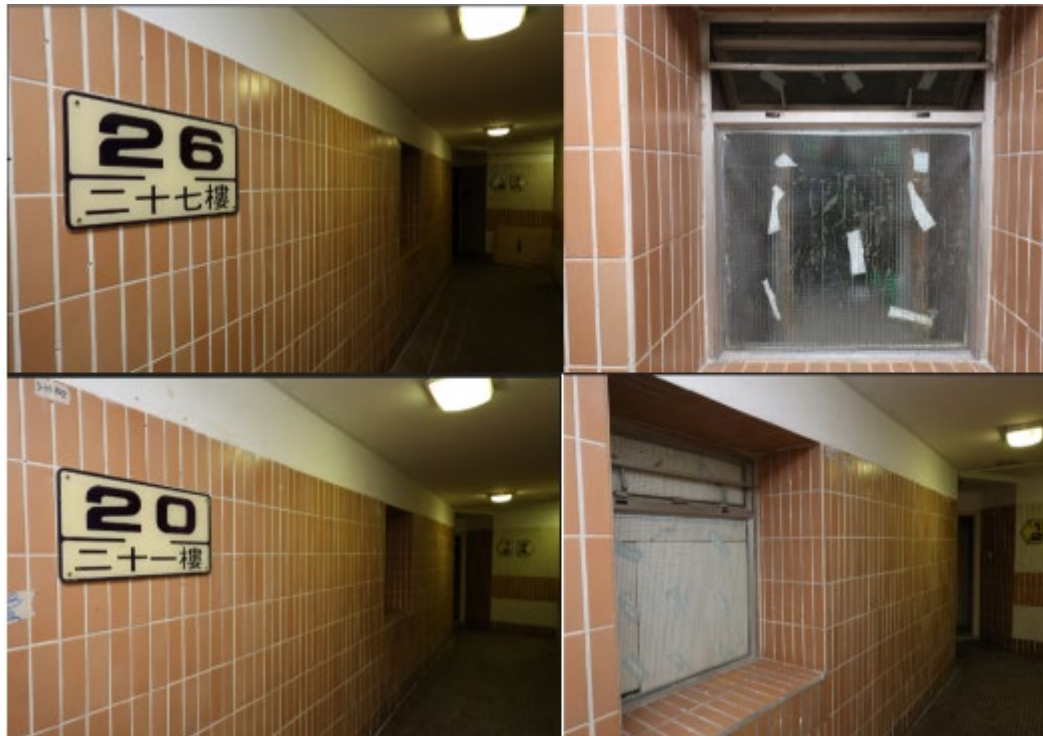
Photo: One large, fixed window and aThe upper part of the windows at the lift lobbies is smaller and openable, while the lower part of the windows is larger and fixed. The majority of the windows at the lift lobbies of different floors are typically left open, promoting ventilation across residential areas. Some of such windows were covered with foam boards.

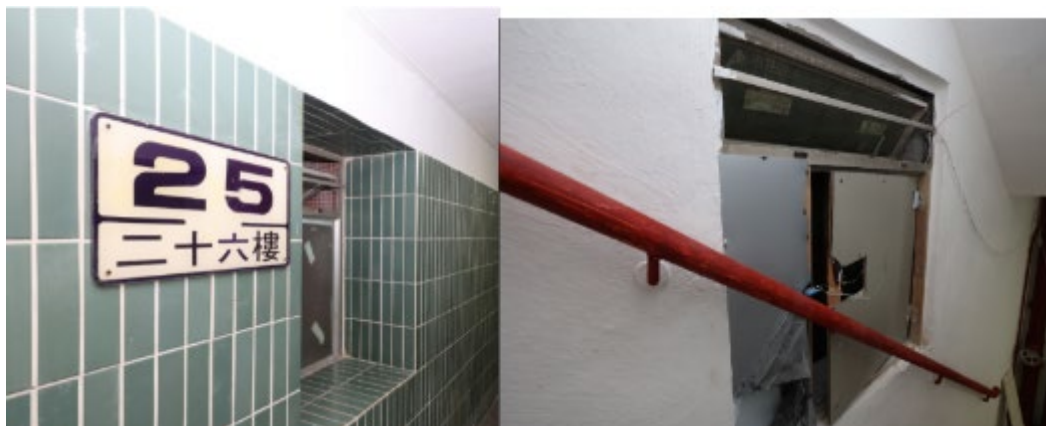
Photo: External windows at the staircase on twenty-fifth floor removed and replaced with wooden boards and locks.

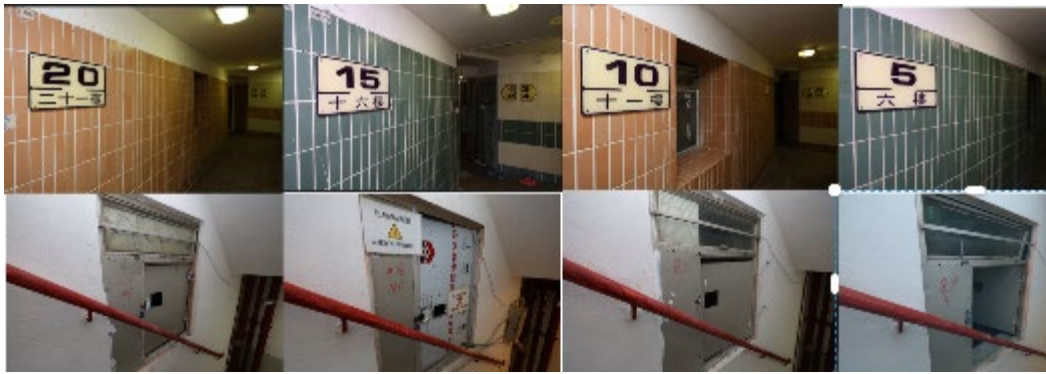
Photo: Other situations on fifth, tenth, fifteenth, and twentieth floors of Wang Chi House

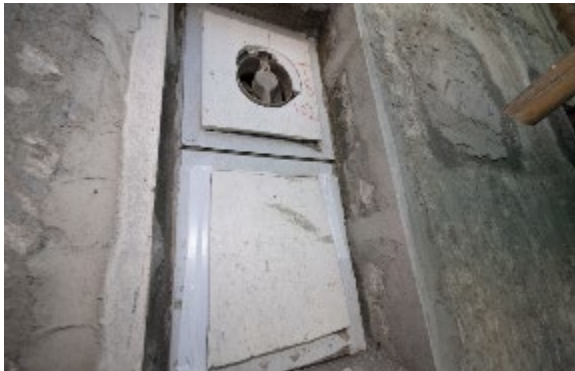
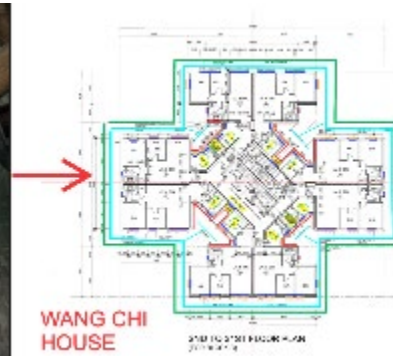
Photo: Bathroom windows of Unit 102 were covered externally by foam board

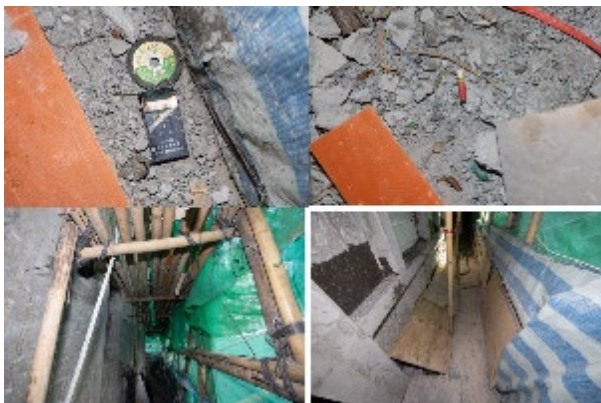
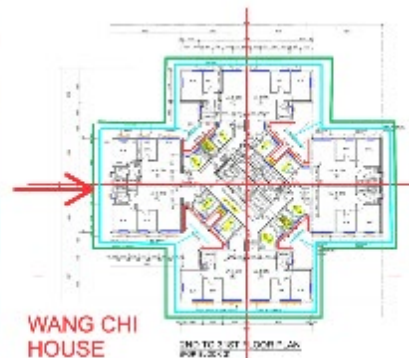
Photo: Cigarette box, cigarette end, bamboo scaffoldings, safety net, plastic sheets, plastic toe board and wooden planks located outside Units 101 and 102

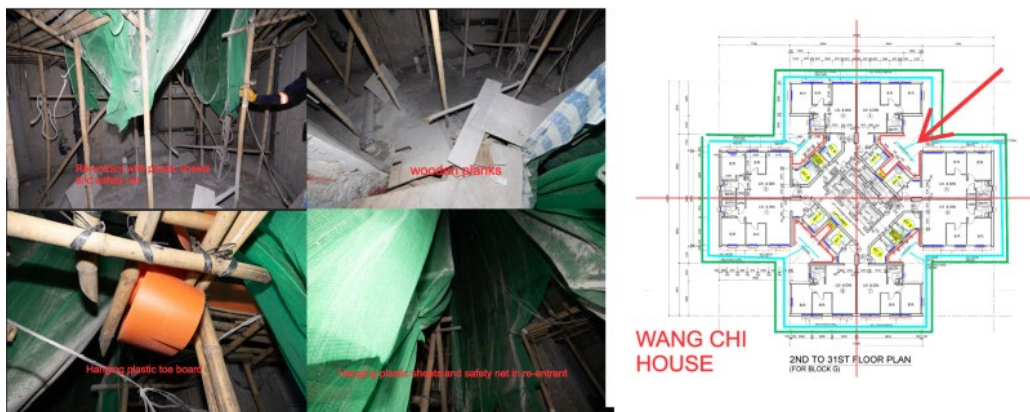
replaced with movable boards were believed to serve as access for construction workers to the working platforms of scaffolding, it has been observed that housekeeping in the associated re-entrant with the aforesaid workers' access is considerably poorer than in the other three re-entrants. The upper part of the windows at the lift lobbies is smaller and openable, while the lower part of the windows is larger and fixed. It is observed that the majority of the windows at the lift lobbies of different floors are typically left open, promoting ventilation across residential areas. Some of the windows in the lift lobbies are covered by foam board.

Photo: Re-entrant between Units 104 and 105 and staircases. Poorer housekeeping than other three.

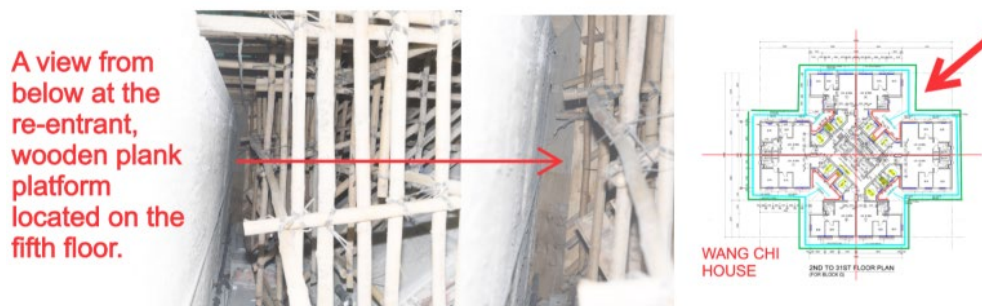
Photo: A view from below at the re-entrant between Units 104, 105 and staircases

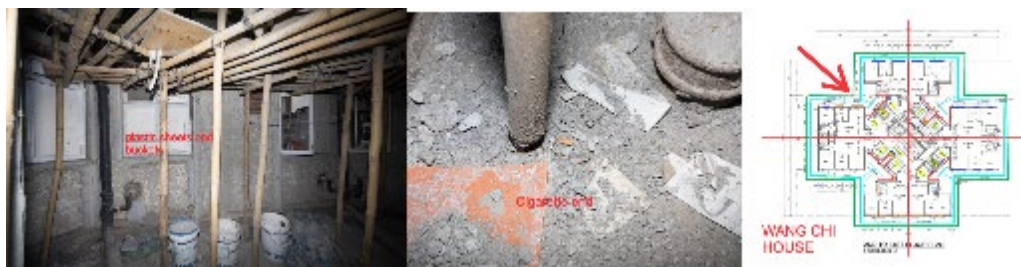
Photo: Re-entrant between Units 102, 103 and meter room

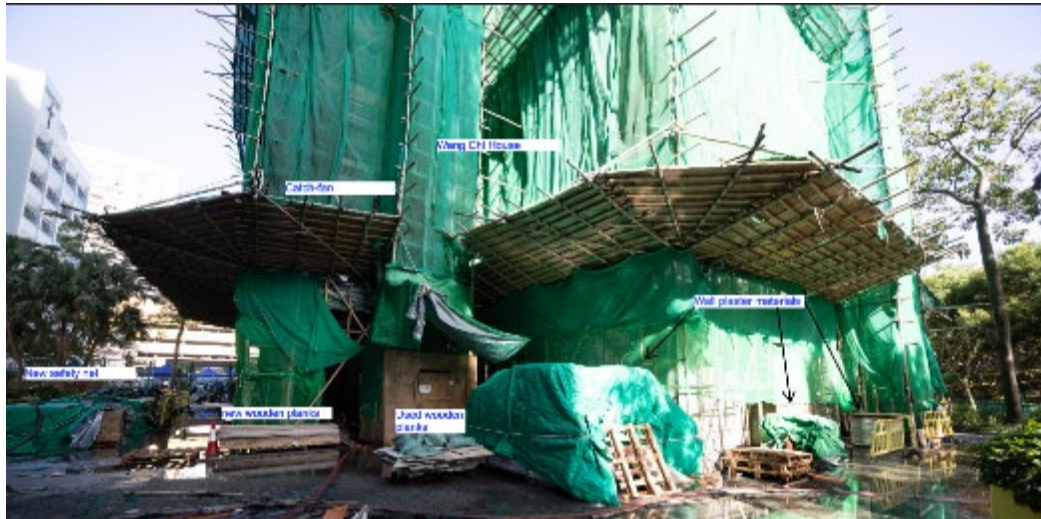
Externally, a large quantity of combustible materials, including safety nets, wooden planks, bamboo, and plastic sheets used for covering construction materials, were scattered on the ground level around Wang Fuk Court. When burning objects fell onto these materials, they would be ignited, starting a fire. The fire subsequently grew and spread to the adjacent building, resulting in widespread fire damage.

Photo: combustible materials outside Wang Chi House

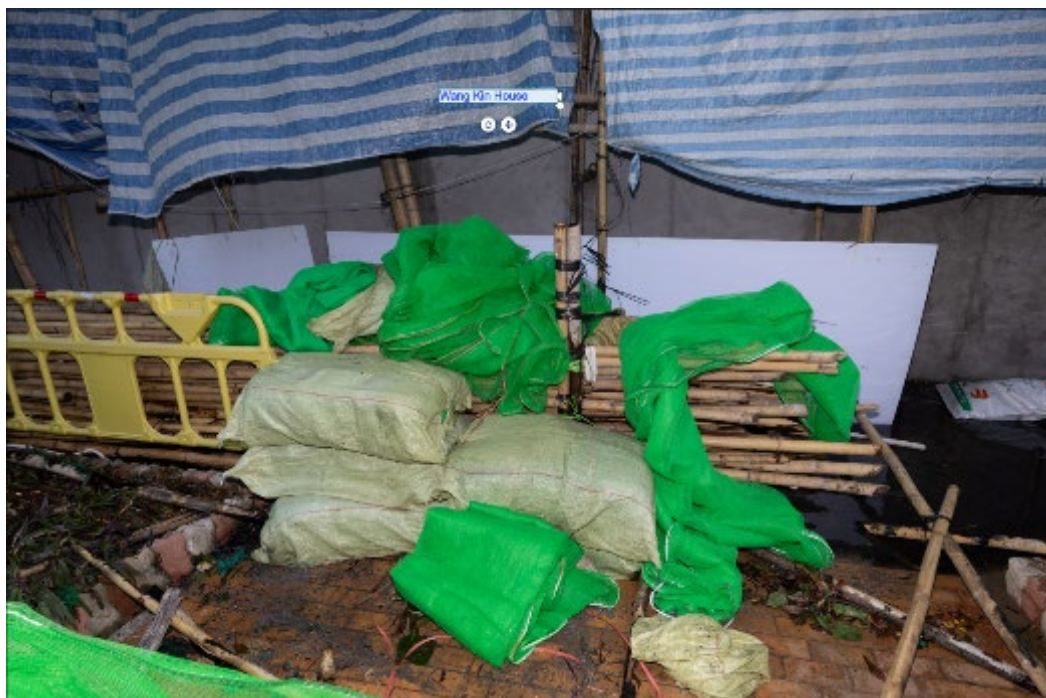
Photo: Safety net and bamboo outside Wang Kin House

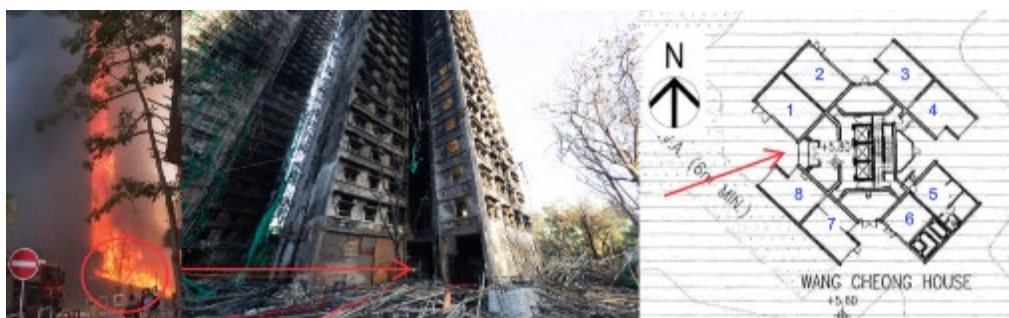
Photo: Ground floor fire plume<sup>2</sup> at building entrance and resulting damage following the incident at Wang Cheong House

The large amount of combustible materials, including safety nets, scaffoldings and foam boards, etc. discovered on site, is expected to be a critical factor for sustaining fire spread both from outside to inside of the building; and building to building. In addition, the windows at staircases (for example at Wang Chi House, three windows at the front staircase from 4/F to 5/F, 14/F to 15/F and 24/F to 25/F as well as two windows at rear staircase from 9/F to 10/F and 19/F to 20/F) had been converted to openable access covered with movable boards for construction convenience. Such alterations may have impaired the building's fire-resisting features and facilitated additional smoke movement, particularly into the staircases, which served both as means of escape as well as means of access<sup>3</sup> of the building. This likely intensified smoke spread during the incident and resulting in untenable conditions<sup>4</sup> within the staircases for occupant evacuation and hindering fire-fighting and rescue operations

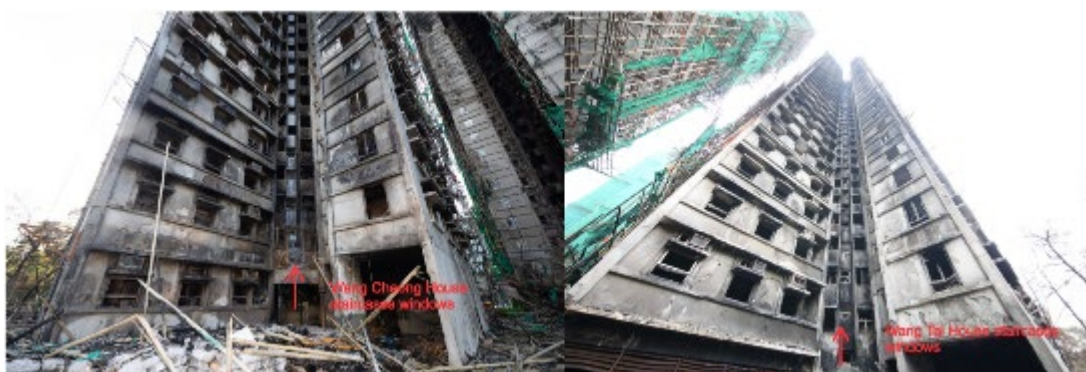
Photo: Most of staircases' windows of Wang Cheong House and Wang Tai House were damaged by fire.

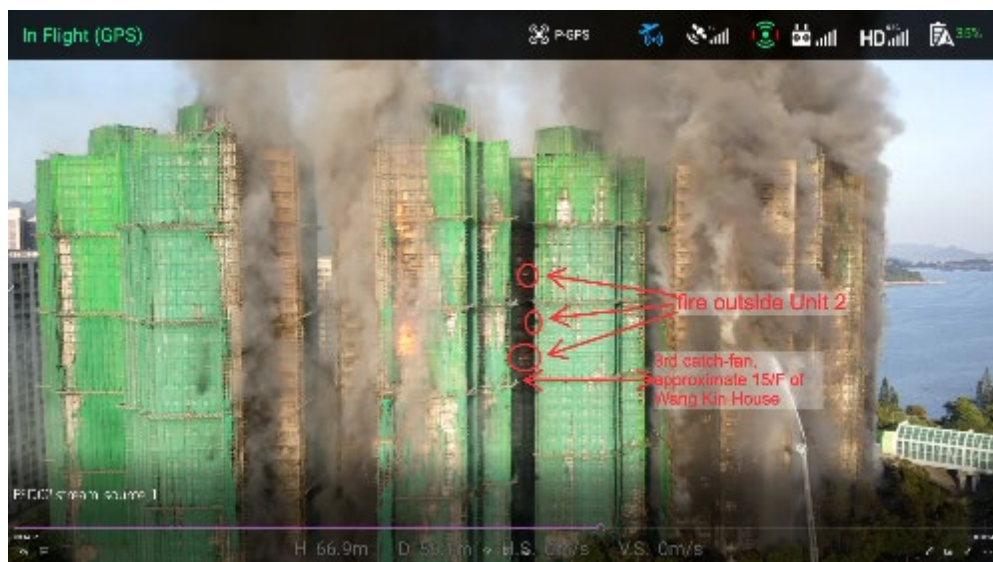
Approximately 97% of units (240 out of 248), 97% of common corridors (30 out of 31) and 100% of staircases (62 out of 62) were found to be undamaged. Analysis of footage revealed multiple ignition points at the external bamboo scaffolding of Wang Kin House. The fire subsequently propagated into the living room, guest bedroom, and master bedroom of Unit 2 on the 16th floor, eventually resulting in ESD for that unit. The fire then extended along the common corridor, affecting Units 1, 5, 6, 7, and 8 of same floor, with damage limited to the areas around their entryways. Furthermore, Unit 8 on the 23rd Floor and Unit 3 on the 20th Floor exhibited fire spread pattern similar to that observed in Unit 2 on the 16th Floor, as previous detailed.

Photo: Capture from UAS's video

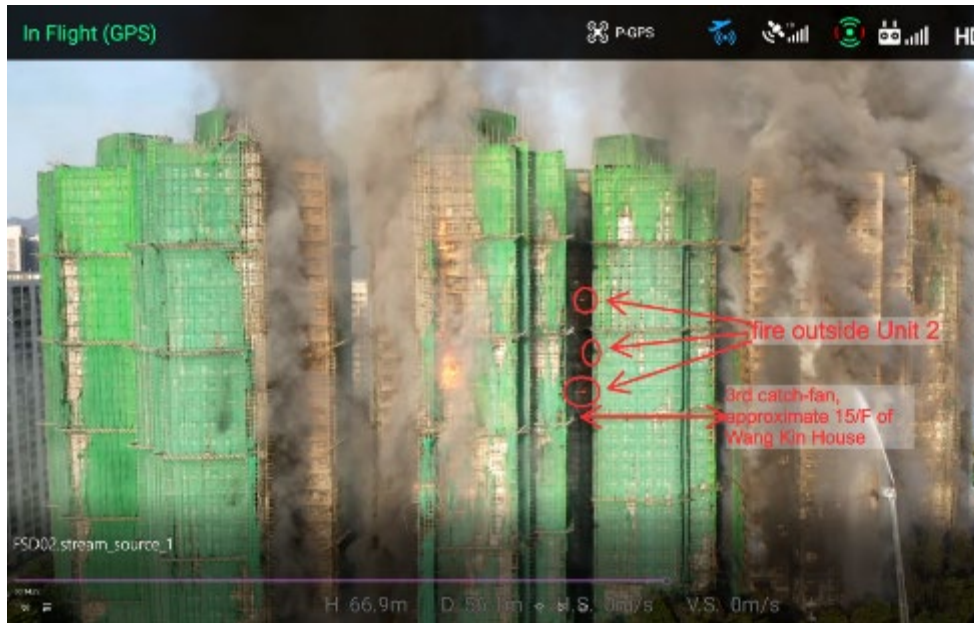
Stage 4.2 of Wang Kin House, i.e. fire spread from other buildings to Wang Kin House

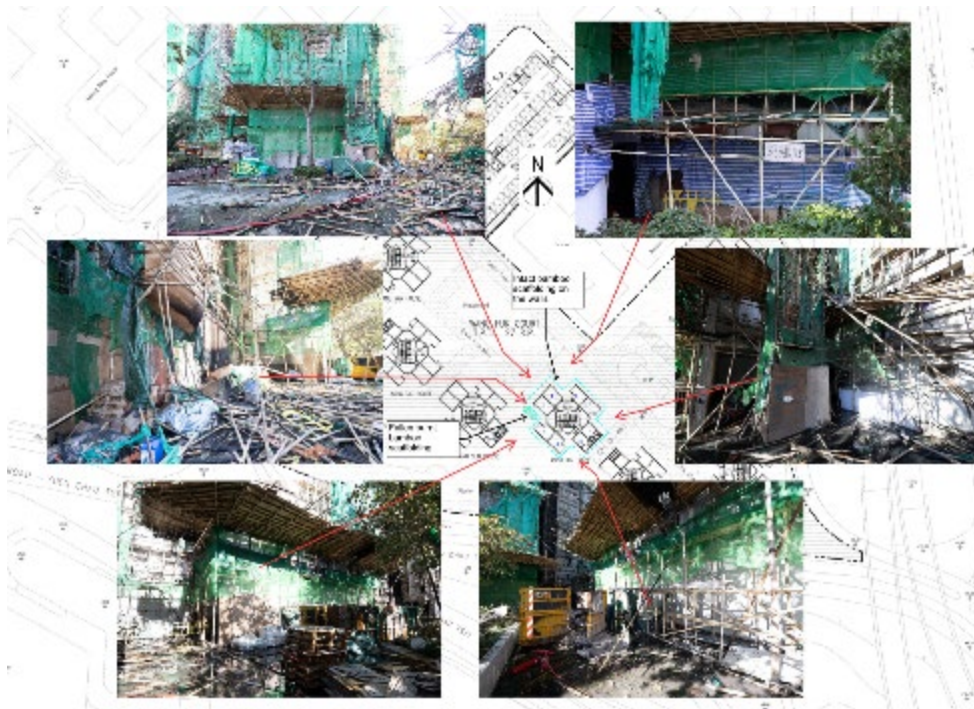
Diagram showing situation on ground floor of Wang Kin House

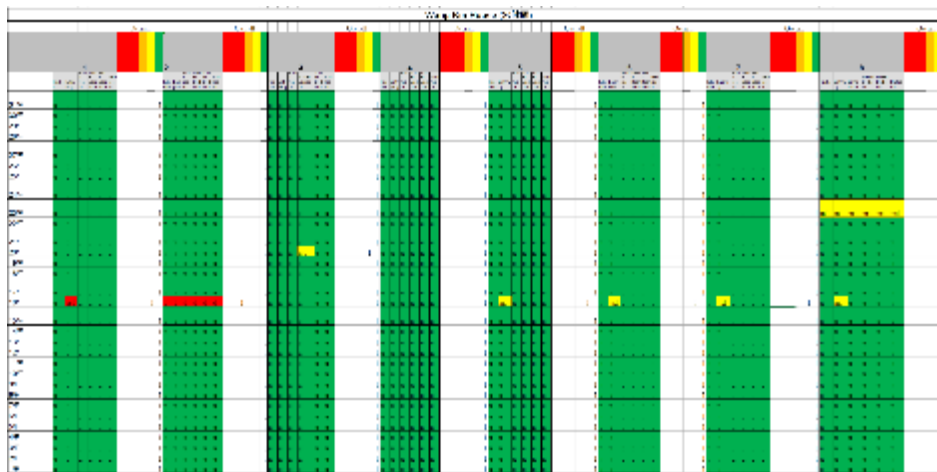
Unit damage diagram of Wang Kin House

Externally, portions of the safety net sustained fire damage, while most of the bamboo scaffolding remained intact except for some sections outside Unit 2 that had collapsed to the ground. Internally, assessments indicate that 240 out of 248 units were undamaged. Footage analysis revealed multiple points of ignition on the bamboo scaffolding at Wang Kin House. The fire subsequently spread to the living room, guest bedroom, and master bedroom of Unit 2 on the 16th floor, ultimately resulting in the total involvement of this unit. The fire then extended along the common corridor, impacting Units 1, 5, 6, 7, and 8, where damage was confined to areas adjacent to their entryways. Additionally, Unit 8 on the 23rd floor and Unit 3 on the 20th floor demonstrated damage patterns consistent with those identified in Unit 2 on the 16th floor; however, the severity of damage in these units is less pronounced than that observed in Unit 2. Overall, the findings suggest that the likelihood of fire spreading from bamboo scaffolding to residential units remains relatively low provided that the re-entrant is not involved in the fire.

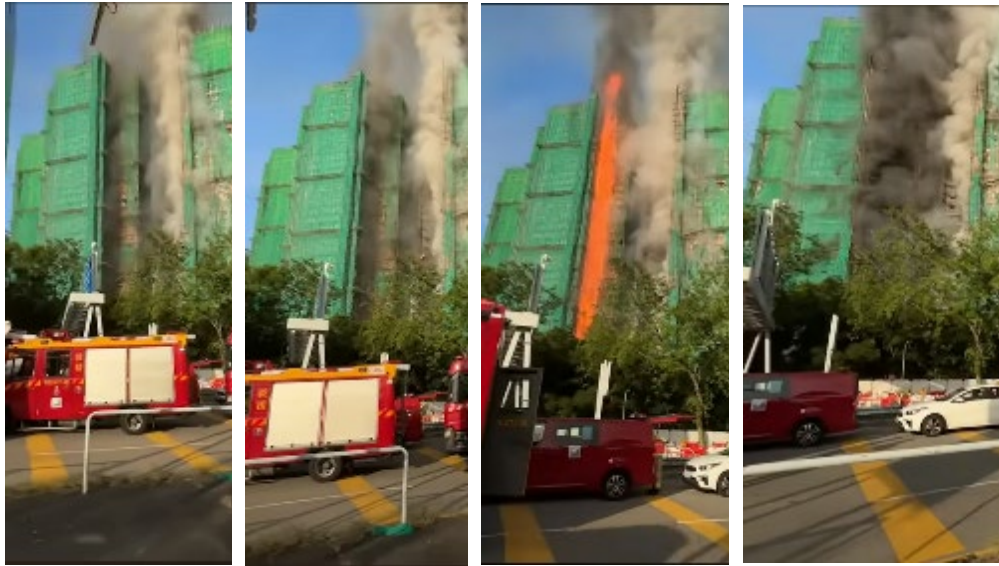
Stage 4 of Wang Sun House (right), i.e. secondary fire spread from Wang Sun House to Wang Tao House (left)

Stage 1 of Wang Tao House, fire developed at the re-entrant of Units 2 and 3

Stage 2 of Wang Tao House, a jet flame occurred at the re-entrant of Units 2 and 3

Stage 3 of Wang Tao House, the jet flame subsided; however, fire had already rapidly spread to all units 2 and 3 emerging dense black smoke.

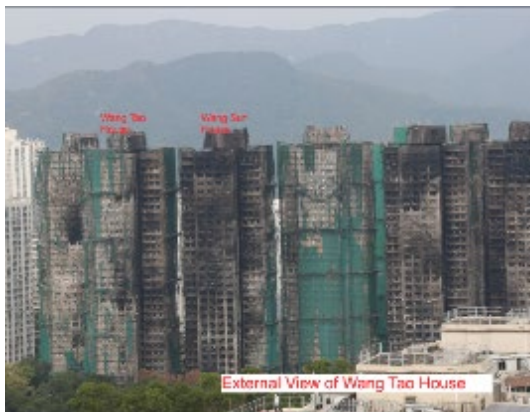
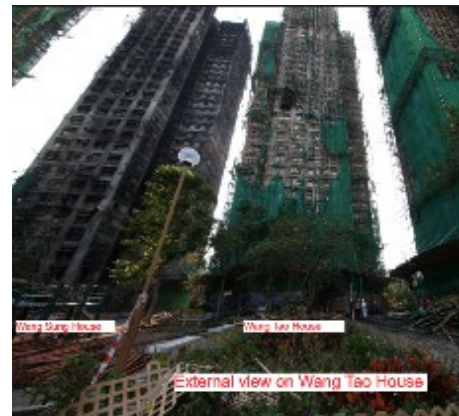
Photos: External view of Wang Tao House

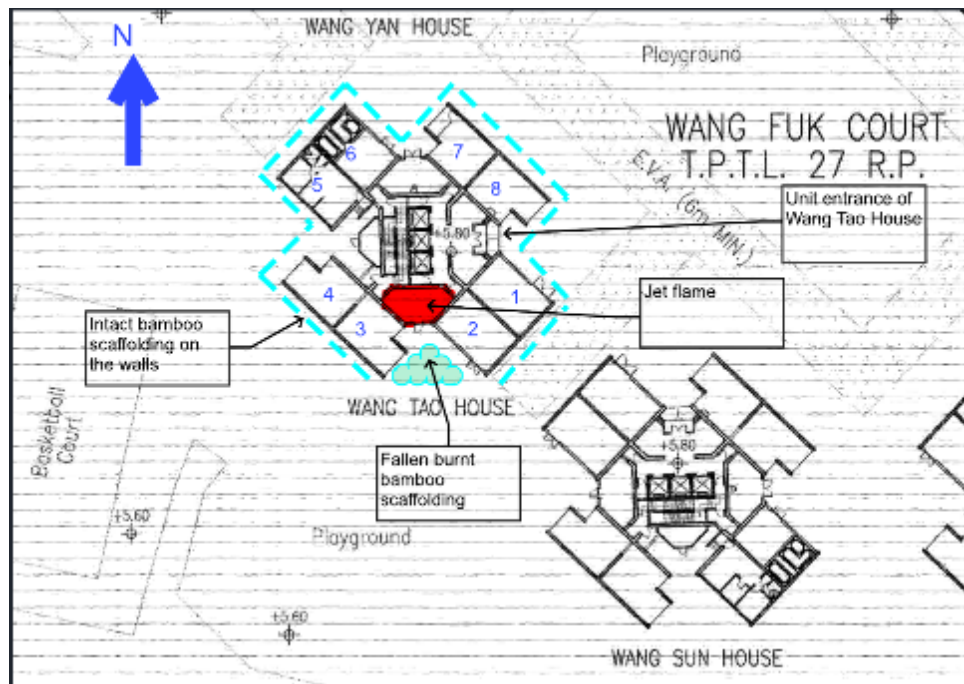
Diagram showing external damage of Wang Tao House

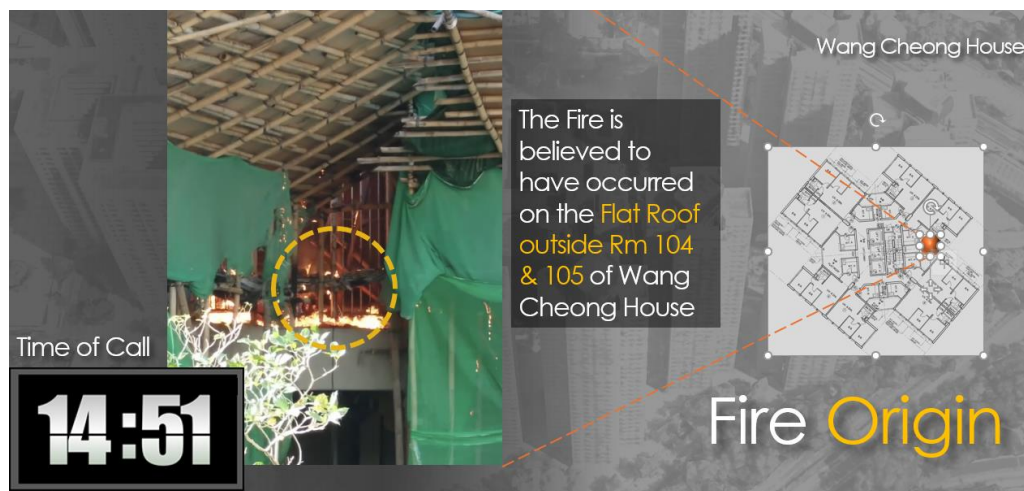
- 1.1 At 1451 hours on 26.11.2025, FSD received a report of scaffolding on the external wall of Wang Cheong House being on fire. However, CCTV footage later revealed that at 1443 hours, burning debris had already fallen from the podium area between Flats 104 and 105 of Wang Cheong House. **All available evidence indicates that the fire originated at the flat roof outside Flats 104 and 105 of Wang Cheong House** as shown in the *Figure A18-1*.

Figure A18-1 – Showing the Fire Origin at Flat Roof outside Flat 104 and 105 of Wang Cheong House

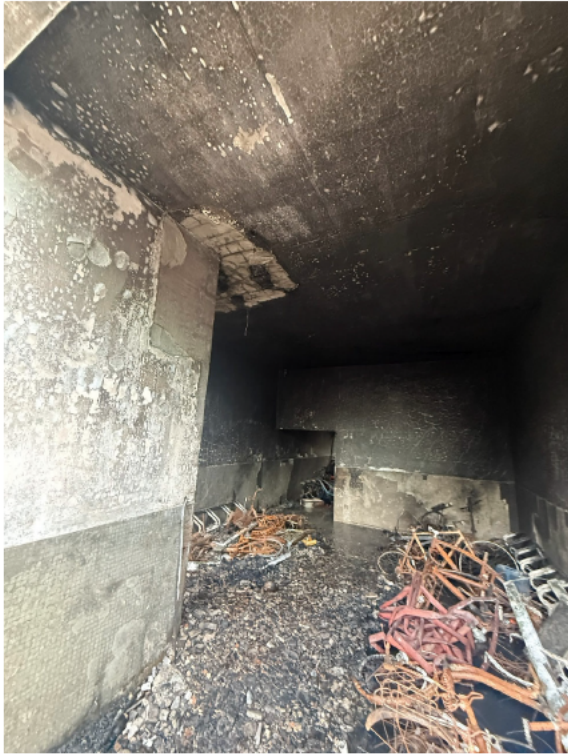
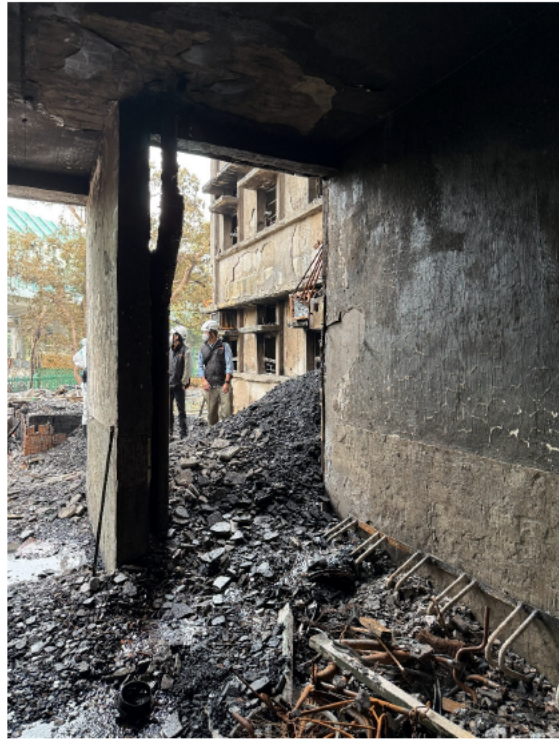
Bicycle Parking Space Overview  
(Photo G1)

5. On the ground floor, there was a bicycle parking space consisting of two compartments. There were two ceiling mounted lighting and a CCTV near the compartment closer the Lightwell Platform (Photo G1 to G2). The lighting and the CCTV were seriously burnt by fire externally (Photo G3 to G4). Besides, there were an electrical distribution board with cables, two ceiling mounted lighting and an outdoor unit of air conditioner in the compartment further away from the Lightwell Platform (Photo G5 to G6). These electrical installations were relatively intact but affected by external fire slightly. There was no sign of electrical fault identified from these fixed electrical installations. No electrical product was found in bicycle parking space near the Lightwell Platform. There was no evidence to show the fire was initiated from fixed electrical installation in bicycle parking space and the fire is not electrically related.

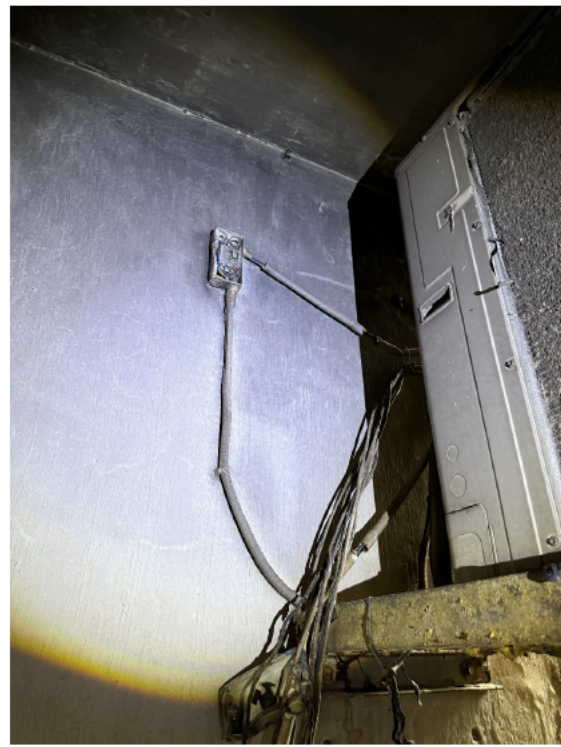
Air Conditioner in Bicycle Parking Space  
(Photo G6)

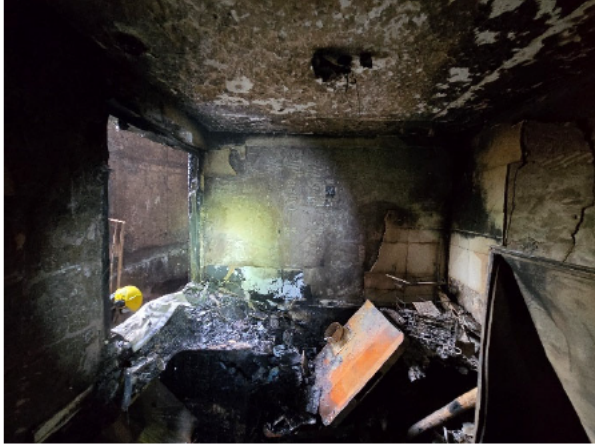
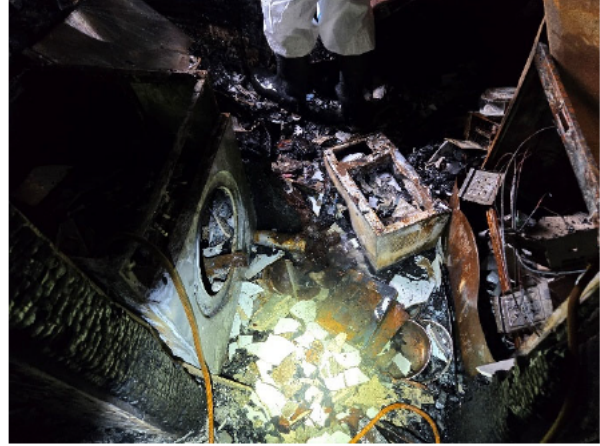
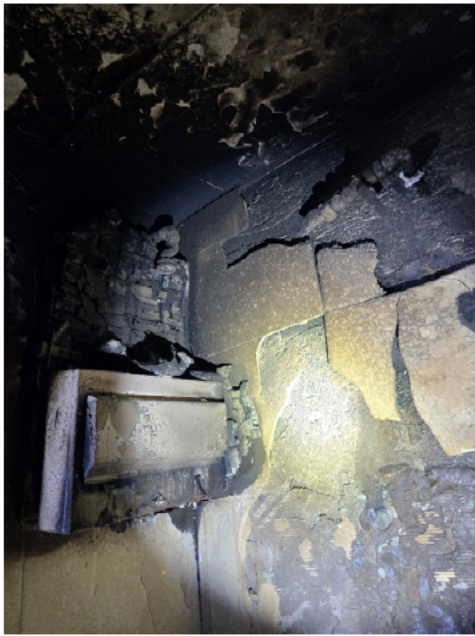
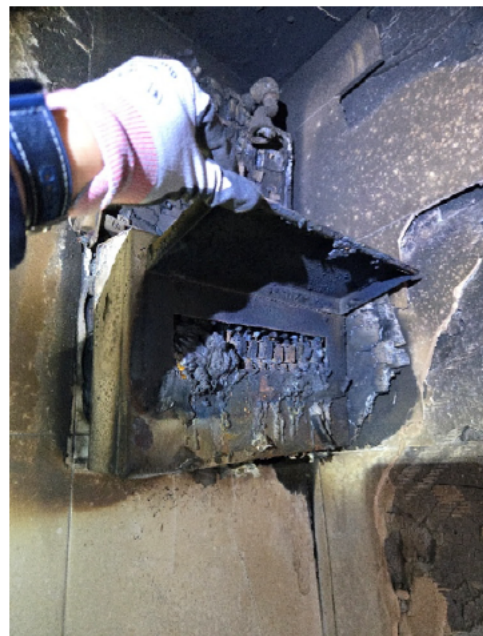
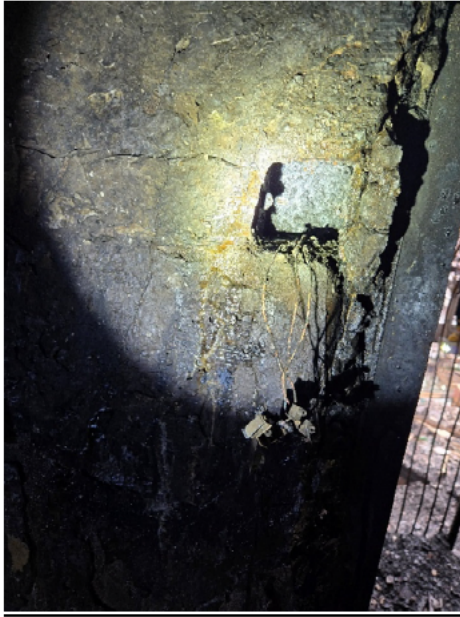
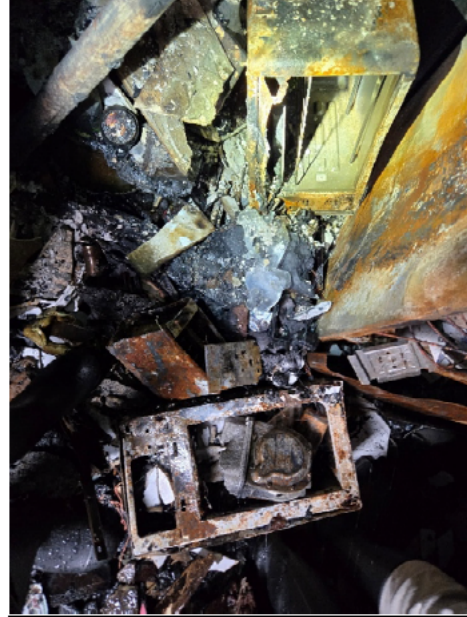
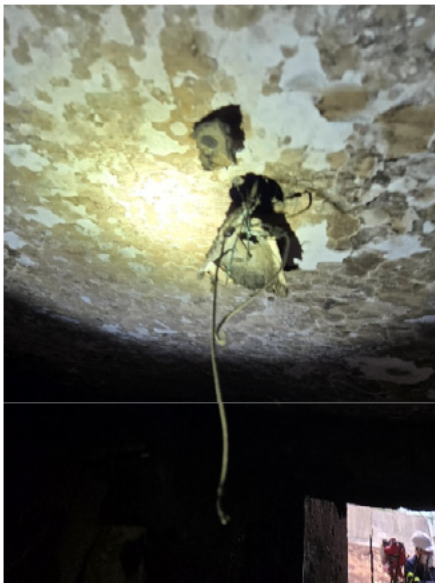
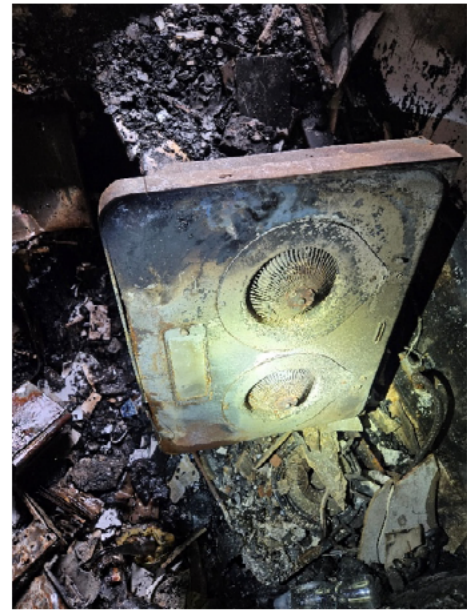
7. In the kitchen of Flat 104, the fixed electrical installations and electrical products were found seriously burnt by fire externally. The fixed electrical installations and electrical products included a ceiling lighting, a range hood, a washing machine, a refrigerator, a microwave oven, a conventional oven, toaster, a distribution board and socket outlet. There was no sign of electrical fault identified from these fixed electrical installations and electrical products (Photo A1 to A8). Other areas of Flat 104 (i.e. Living and Dining Rooms, Bedrooms, Bathroom) were also affected by fire externally (Photo A9 to A12). There was no evidence to show the fire was initiated from fixed electrical installation nor electrical product in Flat 104 and the fire is not electrically related.
