# Final Investigation Report No.5 Alarm Fire at Wang Fuk Court on 26 November 2025

Inter-Departmental Fire Investigation Task Force

May 2026

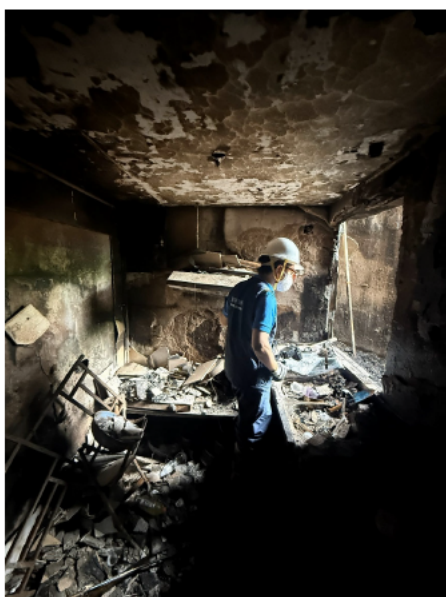
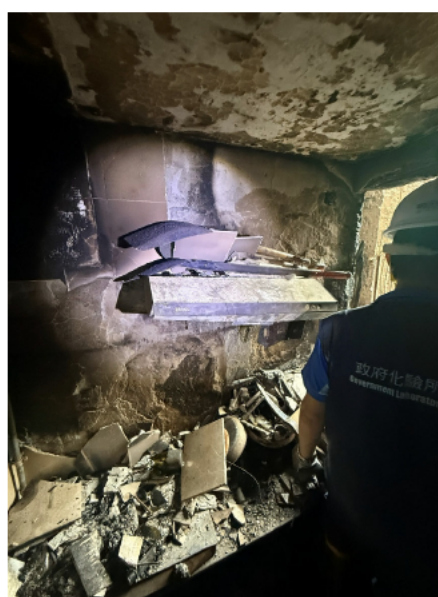
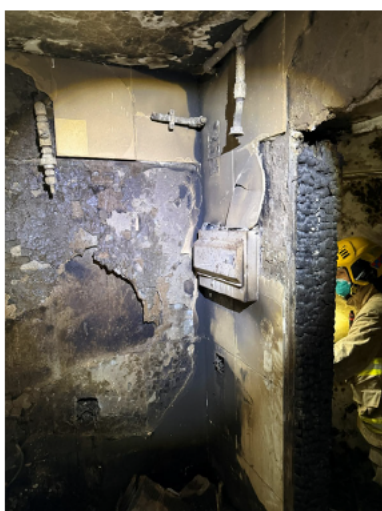
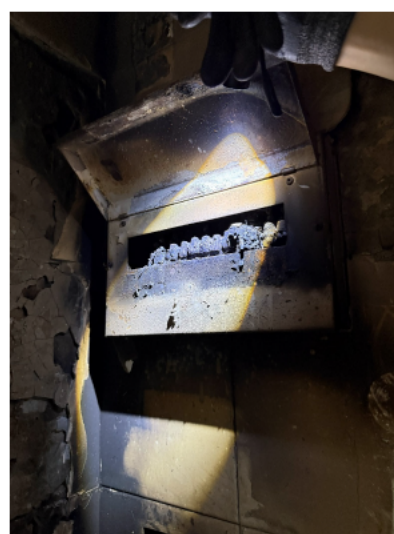
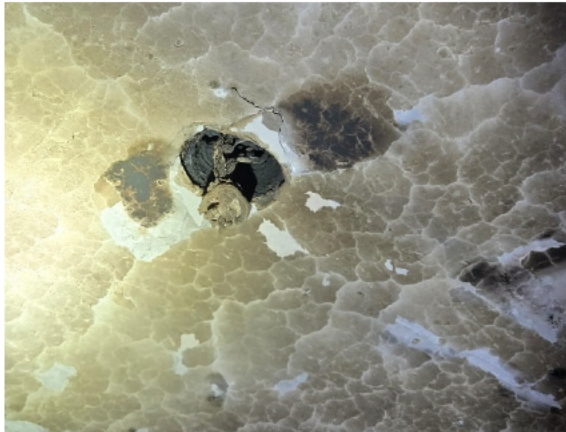
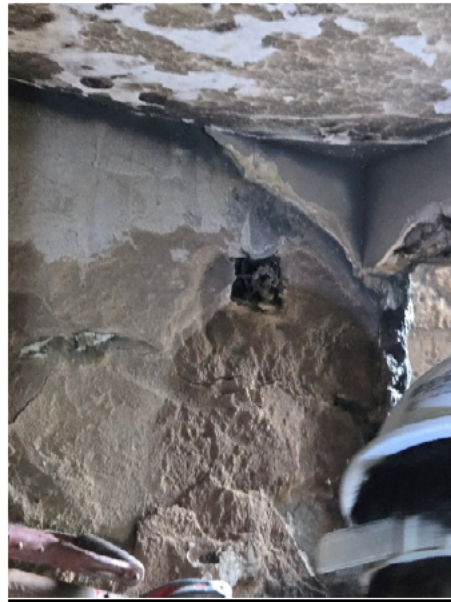
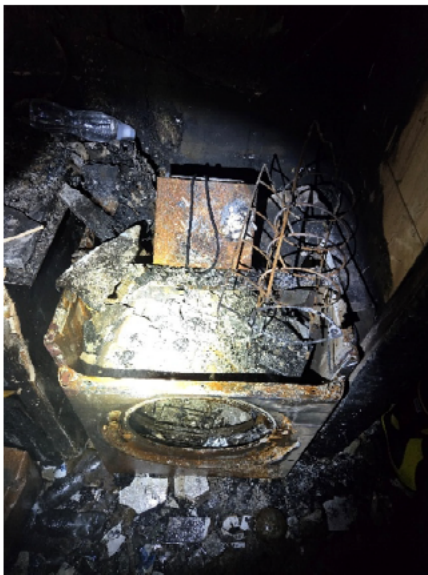
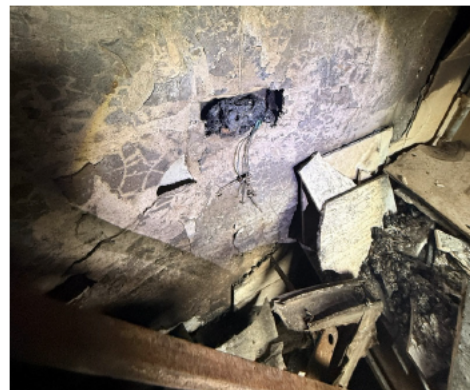
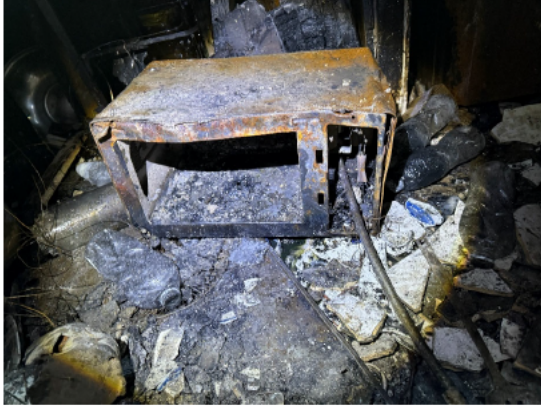
8. In the kitchen of Flat 105, the fixed electrical installations and electrical products were found seriously burnt by fire externally. The fixed electrical installations and electrical products included a ceiling lighting, a range hood, a washing machine, a microwave oven, a distribution board and socket outlets (Photo B1-B9). Other areas of Flat 105 (i.e. Living and Dining Rooms, Bedrooms, CPD, Bathroom) were also affected by fire externally (Photo B10-B14). There was no evidence to show the fire was initiated from fixed electrical installation nor electrical product in Flat 105 and the fire is not electrically related.

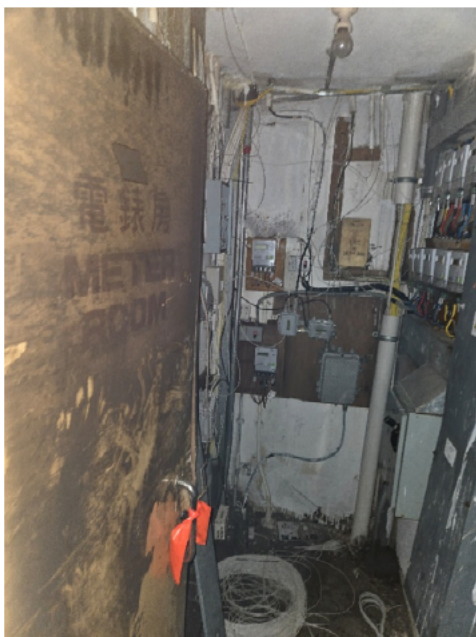
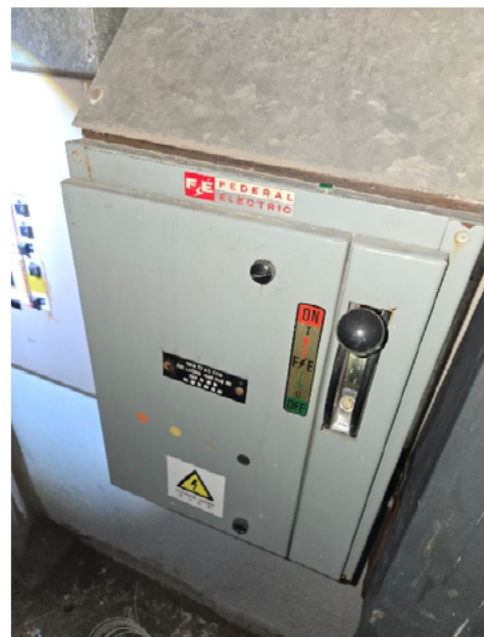
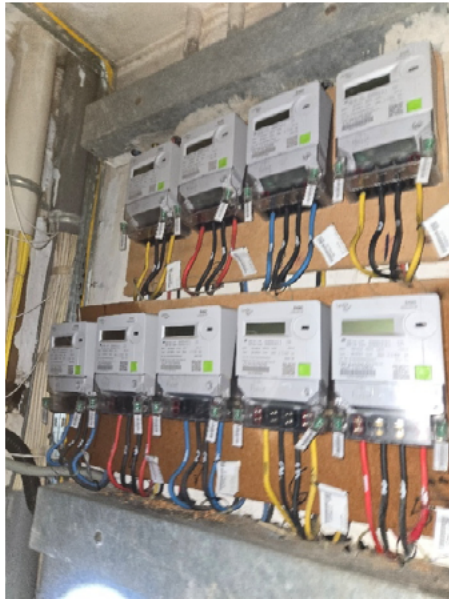
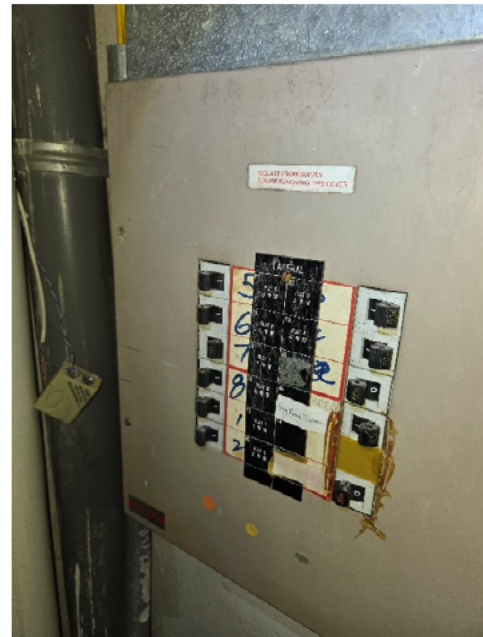
9. In the meter room, all the fixed electrical installations were intact (Photo M1-M4). The MCB for Flat 104 and 105 was at ON position indicating no electric fault occurred at both flats.

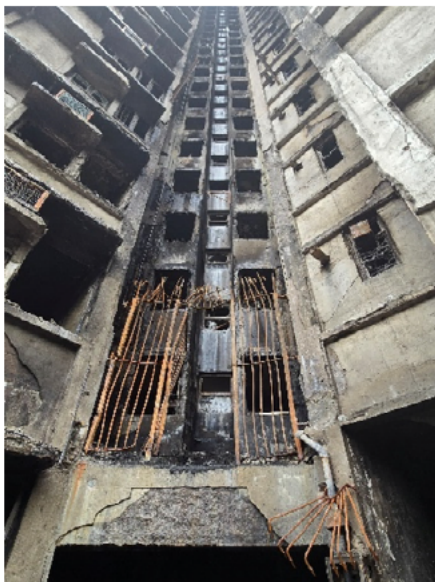
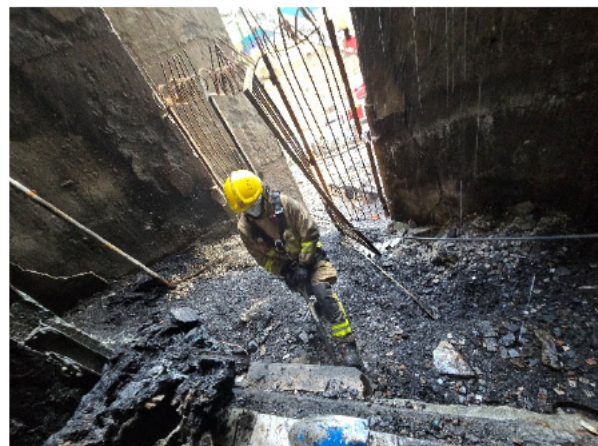
10. At the Lightwell Platform, which was the suspected fire origin, there was no fixed electrical installation nor electrical product found that require ELD to inspect. (Photo R1 to R2).

11. According to the above observations / findings, there was no fixed electrical installation nor electrical product found at the Lightwell Platform that require ELD to inspect. In the vicinity of the Lightwell Platform, Flat 104 and 105 on the first floor and bicycle parking space on the ground floor were inspected. There was no sign of electrical fault identified and there was no evidence to show the fire was initiated from these areas.

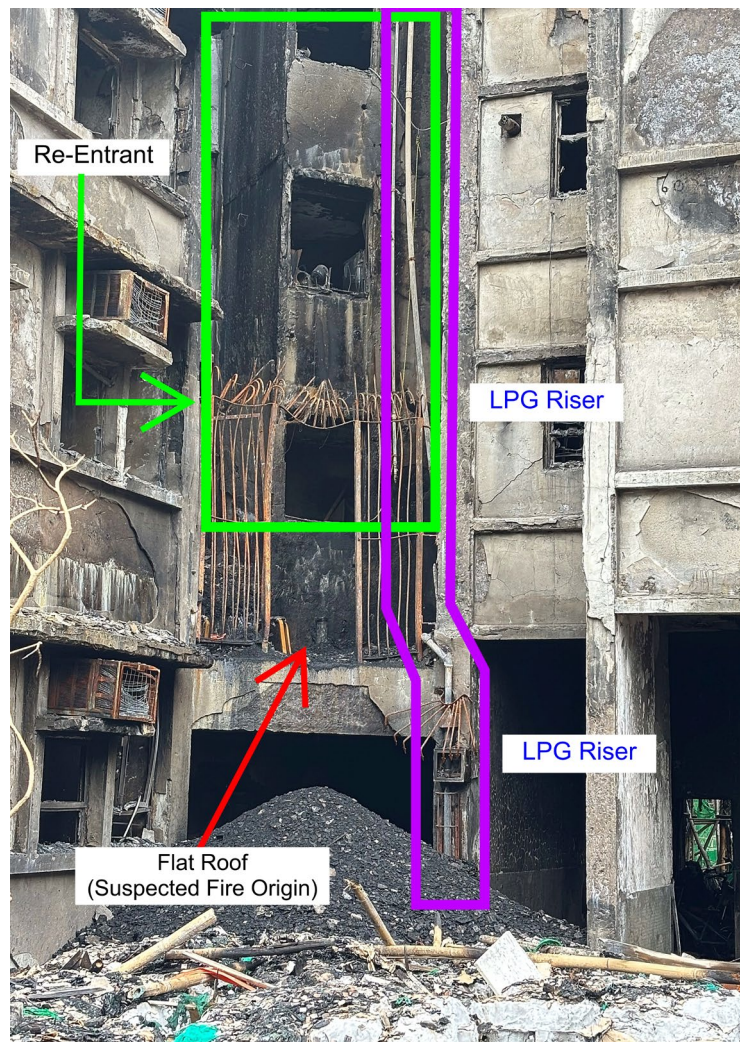
**Photo 1 - The arrangement of LPG riser at the re-entrant of Wang Cheong House**

2.2.2 There is an LPG riser laid horizontally on the Flat Roof along the external wall outside the bathroom of Room 104. This pipe section extends upwards in the re-entrant to the roof of the building and is mounted on the re-entrant external wall (see [Photo 1](#)).

2.2.3 All joints along the LPG riser are welded, except three elbow threaded joints connecting the vertical and horizontal pipe sections at the Flat Roof.

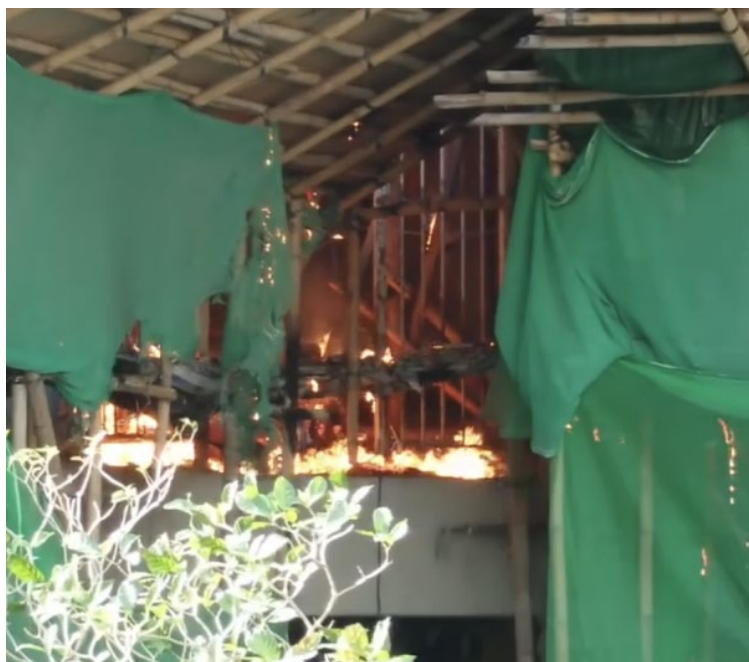
**Photo 2 – Flame appearance during fire initiation captured from video footage**

- (i) As observed from video footage<sup>1</sup> taken by a member of the public during the initiation of the fire, **the flames at the Flat Roof were not originated from the LPG riser or downers (Photo 2).**
- (ii) The flames captured in the video footage did not exhibit the form or behavior characteristics of an ignited vapour LPG leak from a pressurized source. If the fire was caused by an LPG leakage from the LPG pipe, the flame would have been jet-like, which would be more intense, highly directional and elongated in a conical shape with its flame base close to the leak point of the LPG pipe. However, the observed flames in the video footage lacked these defining features.

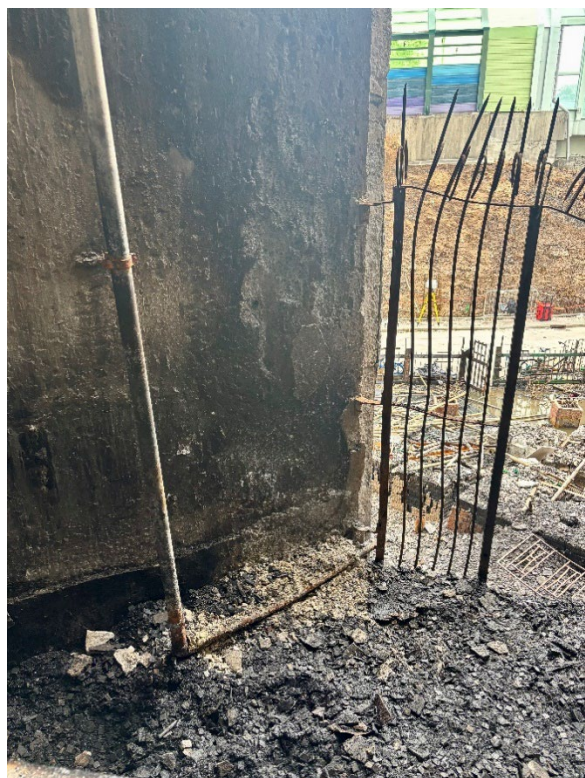
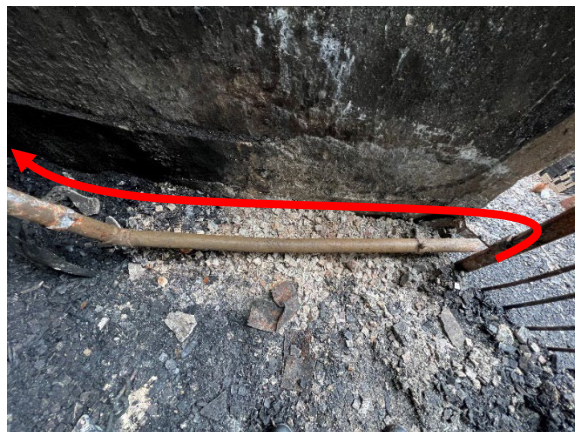
- (i) The EMSD conducted a visual inspection of the LPG riser on the Flat Roof on 4 December 2025, focusing on the horizontal pipe section and the lower section of the vertical pipe near the suspected fire origin. The inspection revealed burn marks on the LPG riser sections with its surface coatings damaged and peeled off from the pipe after subjected to high heat in the fire. A slight bend was also observed in the horizontal pipe section (Photos 3 and 4), likely resulting from external impact by falling objects during the fire.
- (ii) The structural integrity of the above-mentioned pipe sections remained intact. **No signs of perforations, cracks or severe localised corrosion** were observed on the pipe surfaces, which could have contributed to a pre-fire leak.

4.2.4 Based on the findings above, there is **no evidence to suggest that the cause of fire is LPG related**.

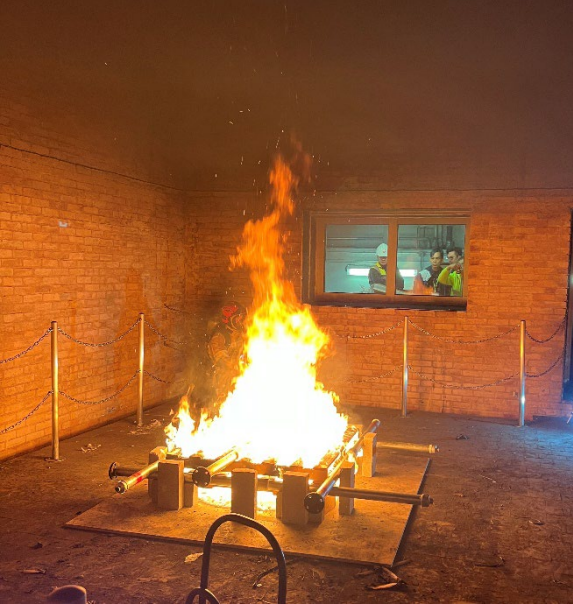
- 1. A fire is set up to simulate the fire scenario of the suspected fire origin during fire initiation. Six steel pipes with threaded joints are exposed to fire for various durations (i.e. 3, 5, 7, 9, 12 and 15 minutes<sup>1</sup>) (Photo 6). One steel pipe with a welded joint is exposed to fire for 15 minutes.
- 2. The diameter and specifications of the tested steel pipes and fittings are equivalent to those of the LPG risers installed in Wang Fuk Court.
- 3. After fire attack and cooling down of the steel pipes, soapy leakage tests are conducted on the steel pipes at a pressure of 15 psig with compressed air (Photo 7). Pressure readings for each pipe are recorded.
- 4. If leakage at the joints is detected, the leakage volume flow rate would be estimated based on the recorded pressure drop and duration.

| Photo 6 – Steel pipes under fire attack | Photo 7 – Leakage test after fire attack |

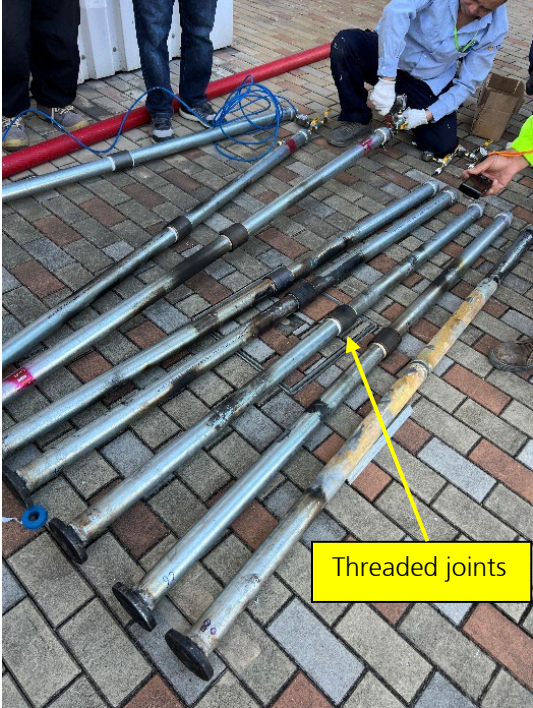
- 1. Minor leakage was observed at the threaded joints of all tested pipes after fire attack. According to the test reports provided by the competent person, the estimated leakage rates ranged from 0.015 to 1.736 litres/minute at atmosphere pressure.
- 2. Based on the above estimated leakage rate, the estimated heat power due to LPG leakage at the threaded joints ranged from 0.03 kW to 3.36 kW, which is comparable to the power of a portable cassette cooker, which typically ranges from 2.6 kW to 3.5 kW.
- 3. No leakage was found at the welded joint of the tested pipe.

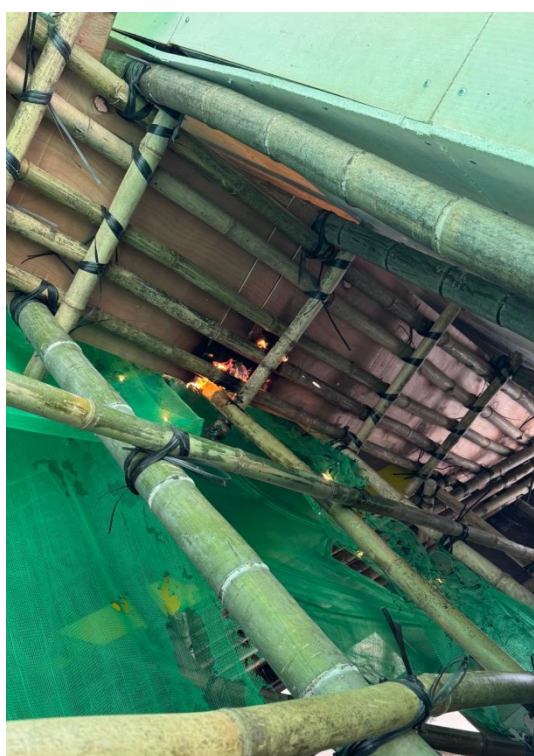
2.3.1 In Test 1, the fire spread to other materials on the scaffolding, including nylon strips, wooden planks and toe-boards, via the ignited uncertified safety nets (as shown in Photos 2-1 (a) & (b)). Although the fire source had burnt out, localized ignition of the uncertified safety nets persisted for over an hour, with slow fire propagation continuing to ignite other combustible materials on the scaffolding. In Test 2, the FR safety nets either did not ignite or self-extinguished upon ignition (as shown in Photos 2-1 (c) & (d)).

Photo 2-1 (a): Fire Spread to Wooden Plank in Test 1

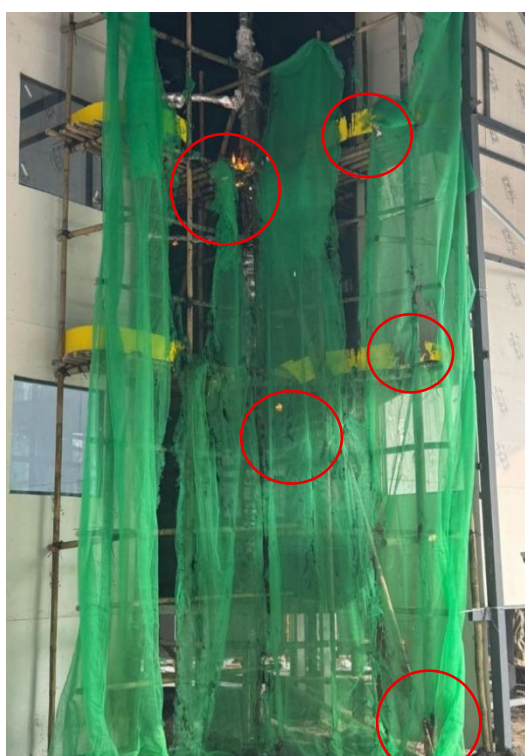
Photo 2-1 (b): Fire Spread along Uncertified Safety Nets

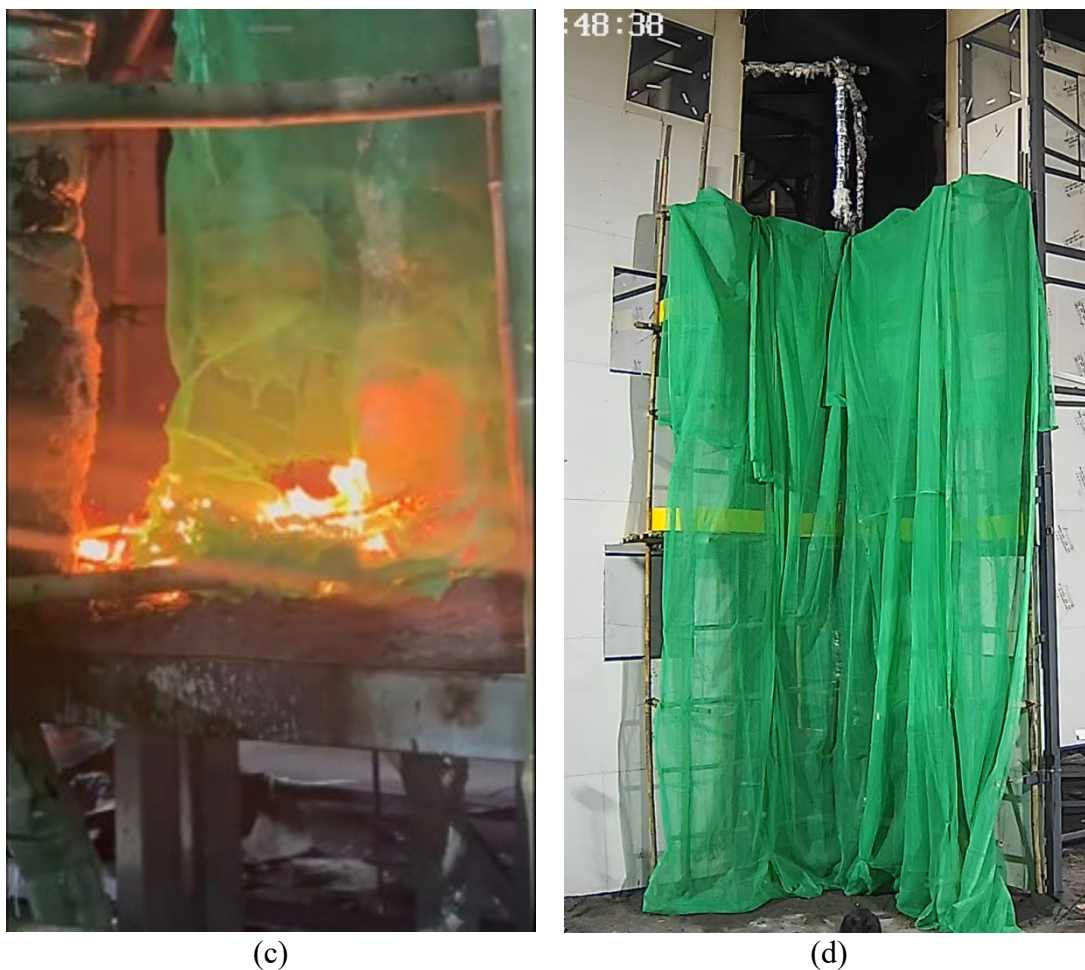
Photo 2-1 (c) & (d): No Spread of Fire along FR Safety Nets Observed  
Comparison of Fire Spreading Behaviour for FR and Uncertified Safety Nets under Relatively Large Fire Conditions (Heat Release Rate of about 2.5 MW)

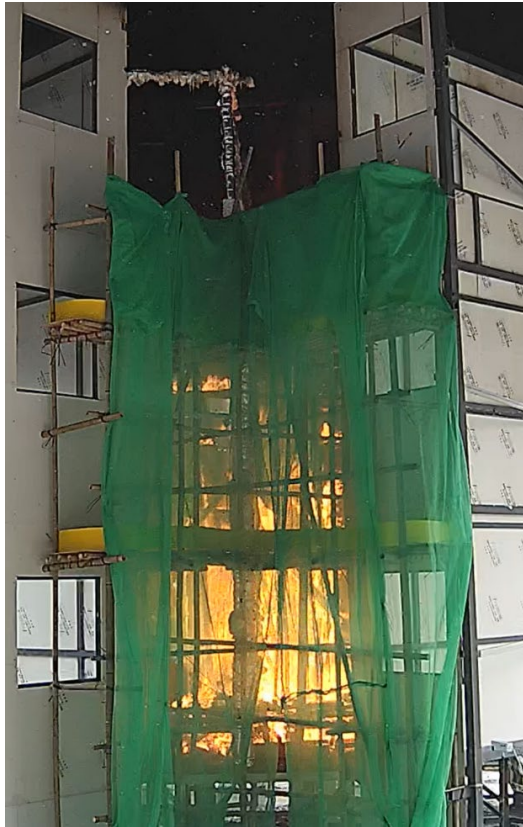
2.3.3 In both Tests 3 and 4, relatively large fire source<sup>8</sup> was used and most of the combustible materials within the re-entrant, including bamboo scaffolding, safety nets, toe-boards and wooden planks, were burnt by the end of the tests (as shown in Photos 2-2 (a) & (b)).

Photo 2-2 (a): Fully Developed Fire in Test 3 (Uncertified Safety Nets)

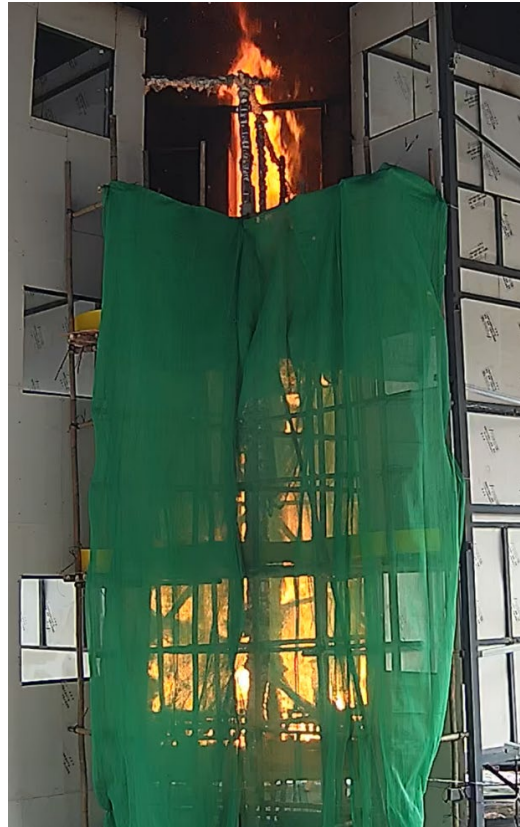
Photo 2-2 (b): Fully Developed Fire in Test 4 (FR Safety Nets)

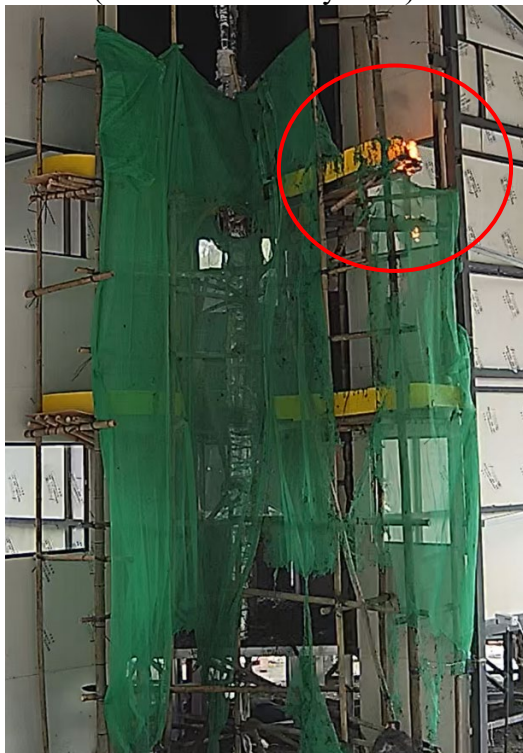
localized ignition of the uncertified safety nets persisted. Slow propagation of small fire continued, eventually resulting in secondary ignitions at various locations on the scaffolding, occurring between 50 and 120 minutes after the re-entrant fire entered the decay stage (as shown in Photo 2-2 (c)). Further details can be found in the timeline analysis in *Annex C of Appendix A*.

Photo 2-2 (c): Secondary Ignition Occurred in Test 3

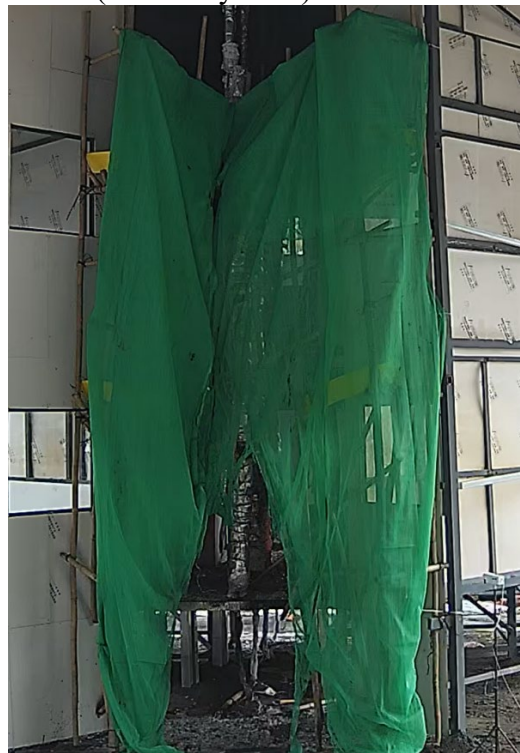
- 2.3.6 The observation as mentioned in paragraph 2.3.5 was not noted in Test 4. Even though the FR safety nets were ignited by embers or flaming construction materials, the fire self-extinguished once the external fire source diminished (as shown in Photo 2-2 (d)).
- 2.3.7 Key Observation (3):

Photo 2-2 (d): No Secondary Ignition Occurred in Test 4

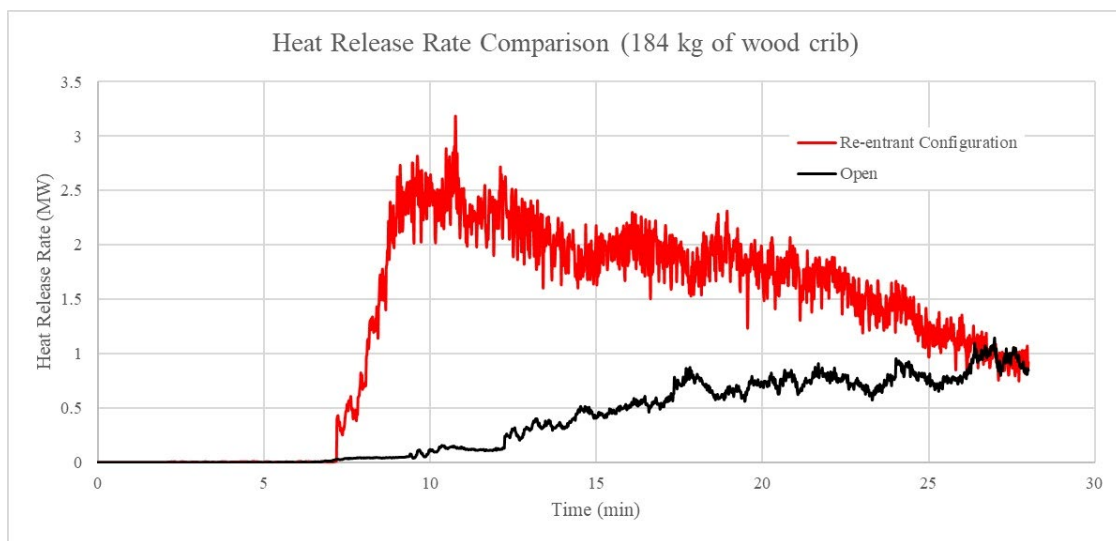
The results indicated that the re-entrant configuration increased the peak HRR to slightly over 3 MW, compared to about 1 MW in the open configuration. Furthermore, the HRR growth rate was significantly faster in the re-entrant configuration (see Fig. 2-1).

Fig. 2-1: Comparison of HRR for Wooden Cribs

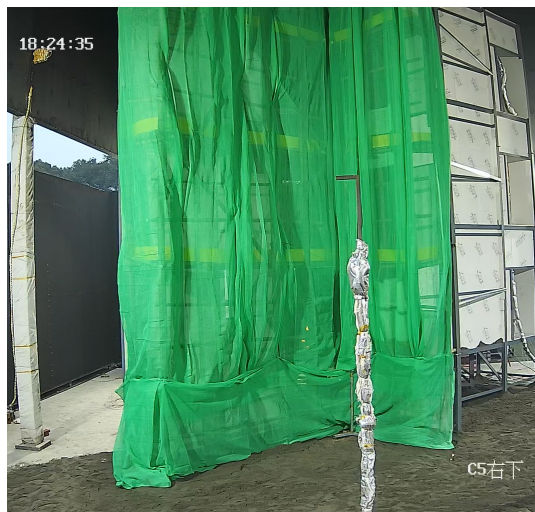
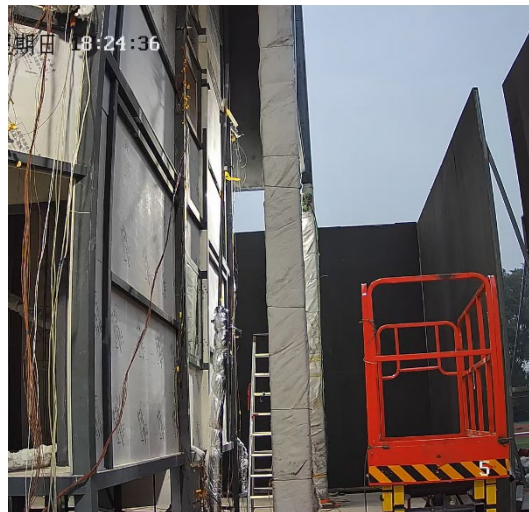
(a)  $t = 5 \text{ min}$

HRR: 0 MW

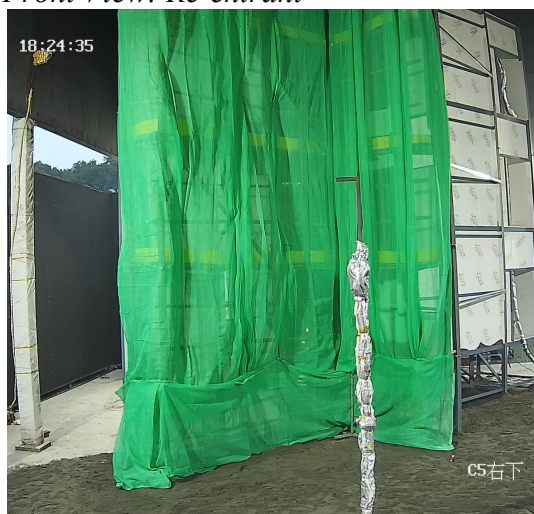
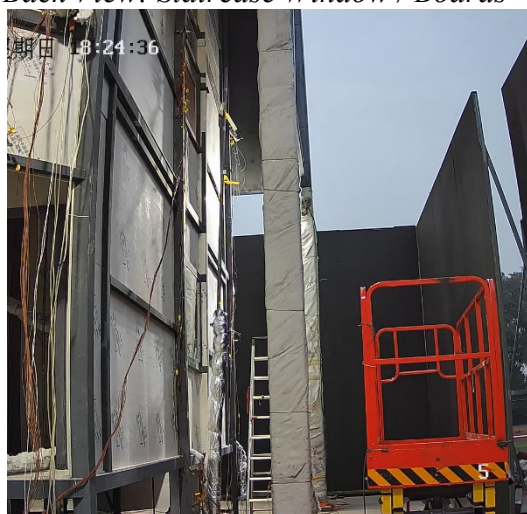
(b)  $t = 25 \text{ min}$

HRR: 0.326 MW

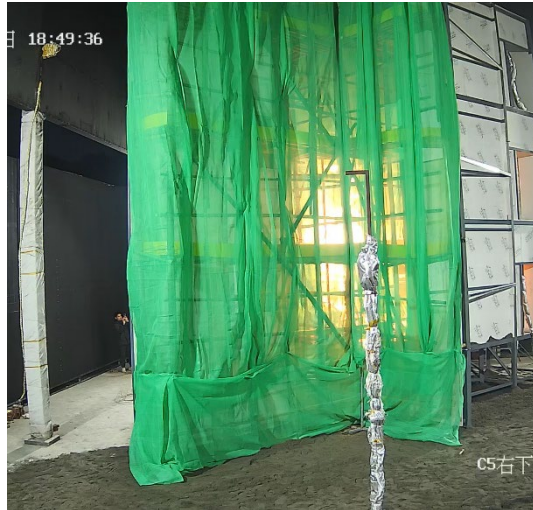
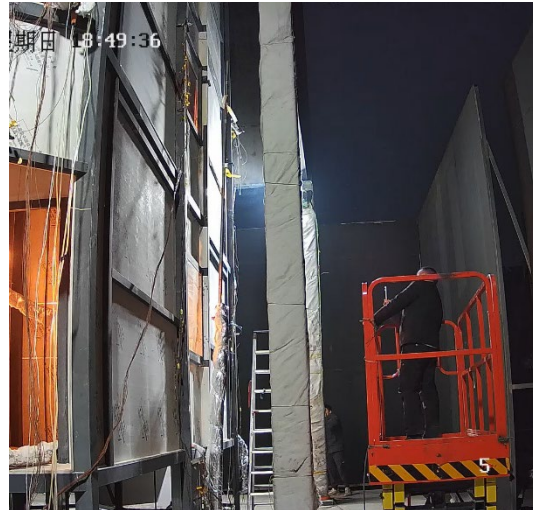
(c)  $t = 30$  min

- 2.6.2 The fire development during the analysis is shown in Photos 2-4 (a) to (i). Initially, the fire spread slowly for the first 30 minutes, but then grew significantly and spread upward at a rapid rate.
- 2.6.3 The HRR increased from **1 MW at 30 min** to **24 MW at 34 min**, peaking at **29 MW** shortly after. This mirrors the rapid vertical fire spread observed at Wang Fuk Court, where multiple floors were engulfed within minutes.
- 2.6.4 Recorded footage showed heavy smoke penetrating the wooden board on the 2/F, which ignited at 32 minutes. By the end of the test, the 2/F wooden board was completely burned, as shown in Photo 2-5 (a).
- 2.6.5 At Wang Fuk Court, similar openings were connected to escape staircases, likely exacerbating evacuation conditions.

HRR: 1.102 MW

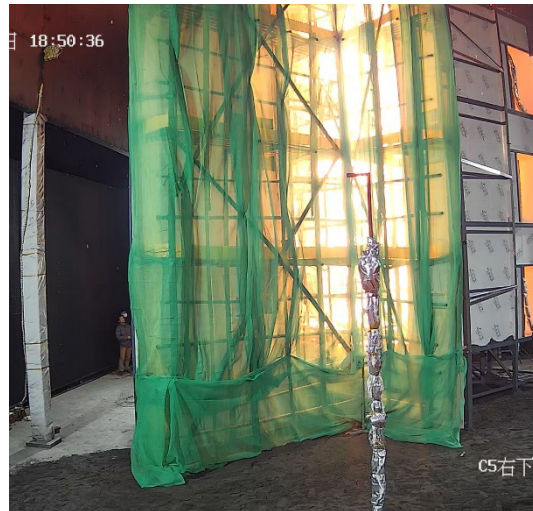
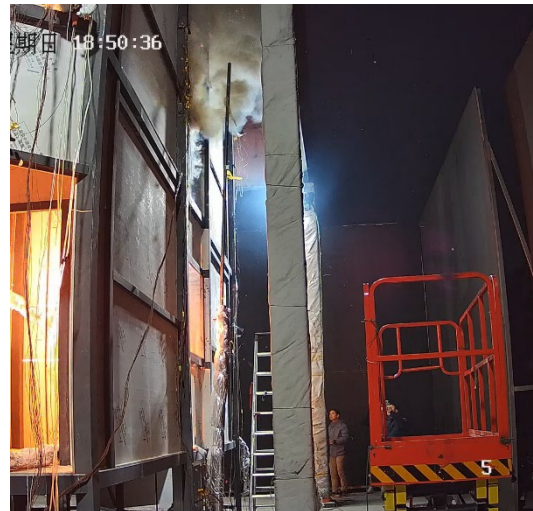
(d)  $t = 31$  min

HRR: 1.744 MW

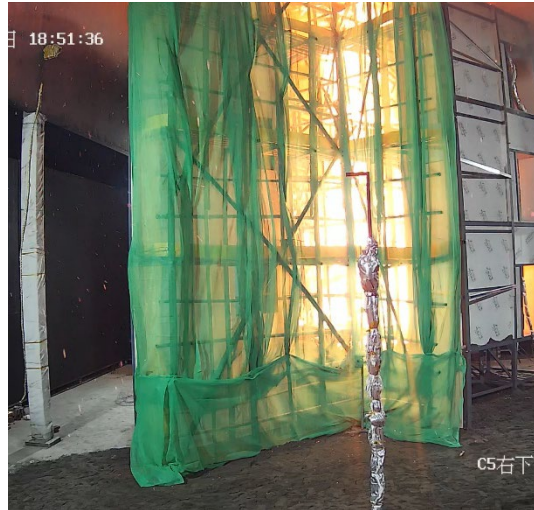
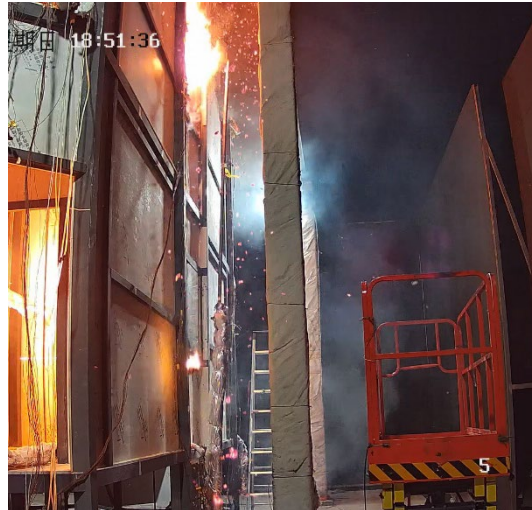
(e)  $t = 32$  min

HRR: 4.235 MW

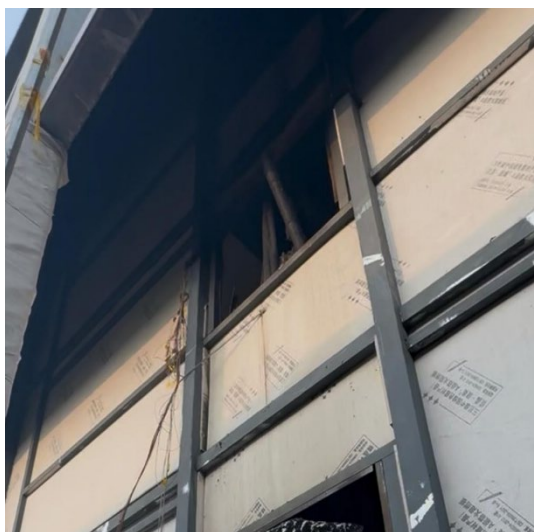
Photo 2-5 (a):  
Fully Burnt Wooden Board on the 2/F

2.6.6 During the Fire Severity Analysis, the wooden movable boards (as shown in Photo 2-5 (a)) located between the re-entrant zone and the escape staircase void were completely burnt away. As shown in Photos 2-6 (a) to (c), smoke and flame infiltrated the staircase region through the gaps and holes in the wooden movable boards before they were burnt out.

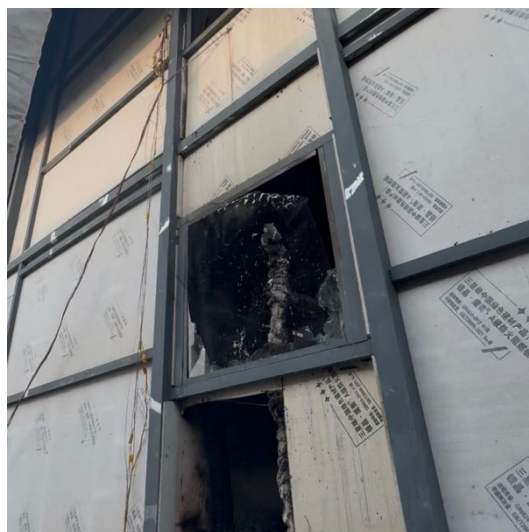
Photo 2- 5 (b):  
Broken Glass Window on the 1/F

- 2.6.14 During the Fire Severity Analysis, approximately 5 kg of cardboard and 5 kg of clothing were placed on the unexposed sides of the kitchen and foyer windows. After the test, all windows near the re-entrant broke, and all combustible materials placed near the windows were completely burned.

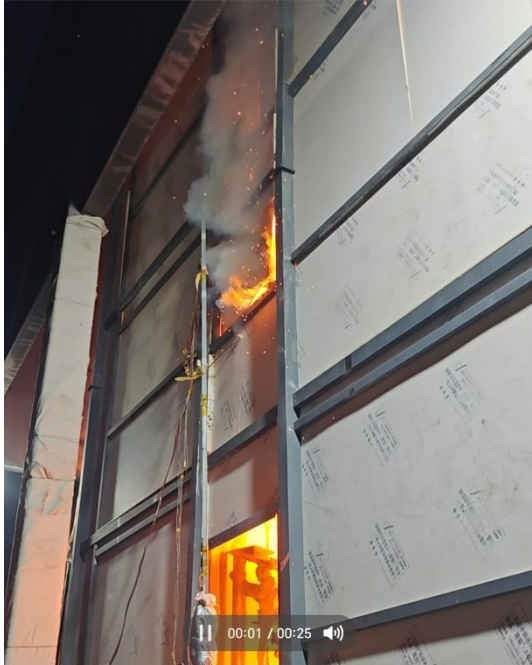
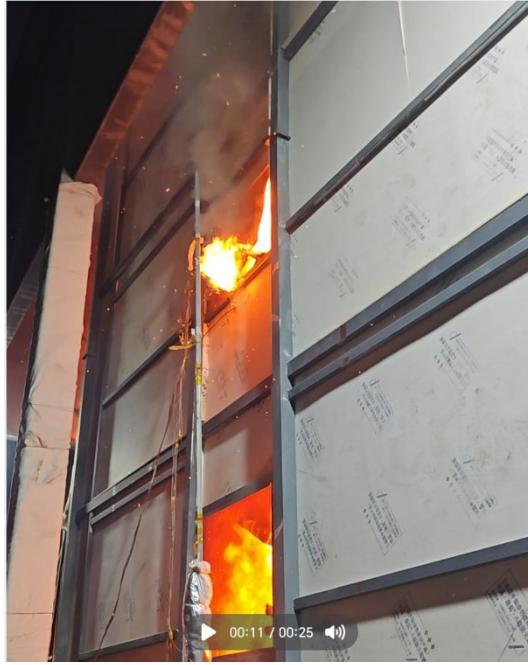
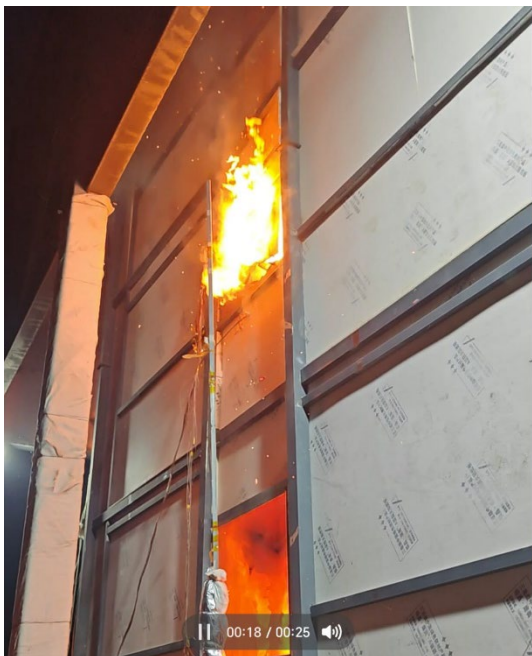
Fire and smoke could infiltrate the escape staircase through the gaps and holes in the movable boards, even before they were completely burned out. Such infiltration would make the use of staircase for evacuation impractical in the actual fire scene.

Photos 2-6 (a) to (c):  
Smoke and Flame Infiltration into the  
Simulated Staircase Region

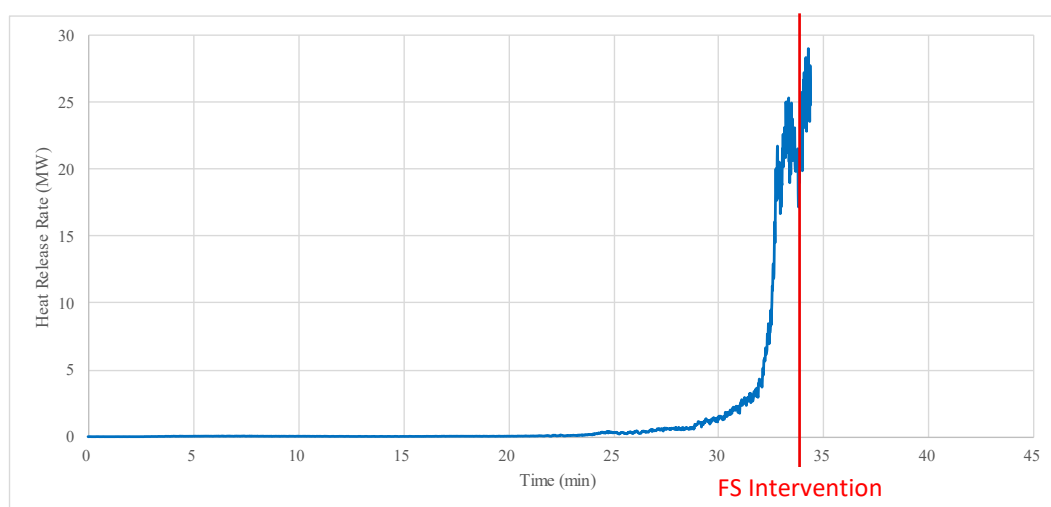
2.6.8 The HRR peaked at 29 MW<sup>15</sup> at 34 min, comparable to the burning of a bus or heavy goods truck.

The HRR provided a quantified measurement of fire severity. During the test, the HRR growth was initially gradual, with relatively slow fire development observed during the first 30 min. However, after this period, the HRR increased dramatically in a few minutes and peaked at 29 MW (see Fig. 2-2).

Fig. 2-2: HRR against Time Graph for the Fire Severity Analysis<sup>16</sup>

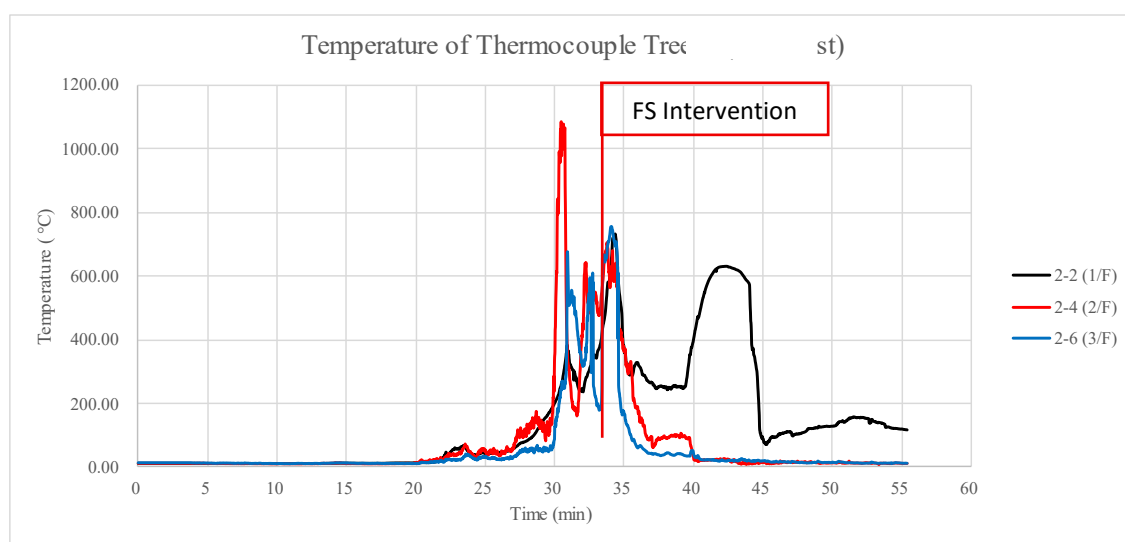
2.6.10 Temperature versus time graphs for thermocouple tree number 2 (located near the centre of the re-entrant) and number 4 (positioned at the staircase window / wooden boards) are shown in Figs. 2-3 (a) & (b) respectively. Both thermocouple trees recorded maximum temperatures exceeding 1,000°C in the re-entrant.

Fig. 2-3 (a): Temperature against Time Graph for Thermocouple Tree No.2 (at the Centerline of Re-entrant) in the Fire Severity Analysis

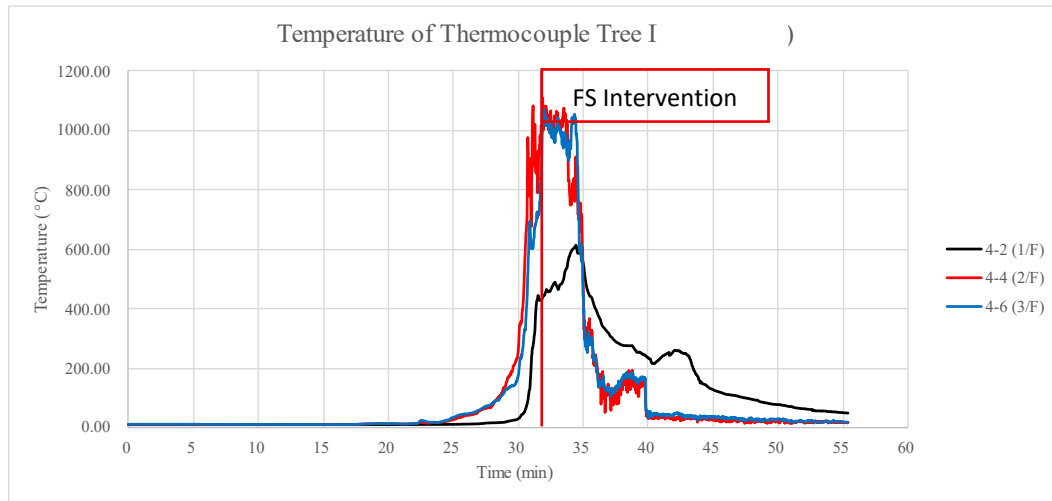
Fig. 2-3 (b): Temperature against Time Graph for Thermocouple Tree No.4 (at the Staircase Window / Wooden Boards) in the Fire Severity Analysis

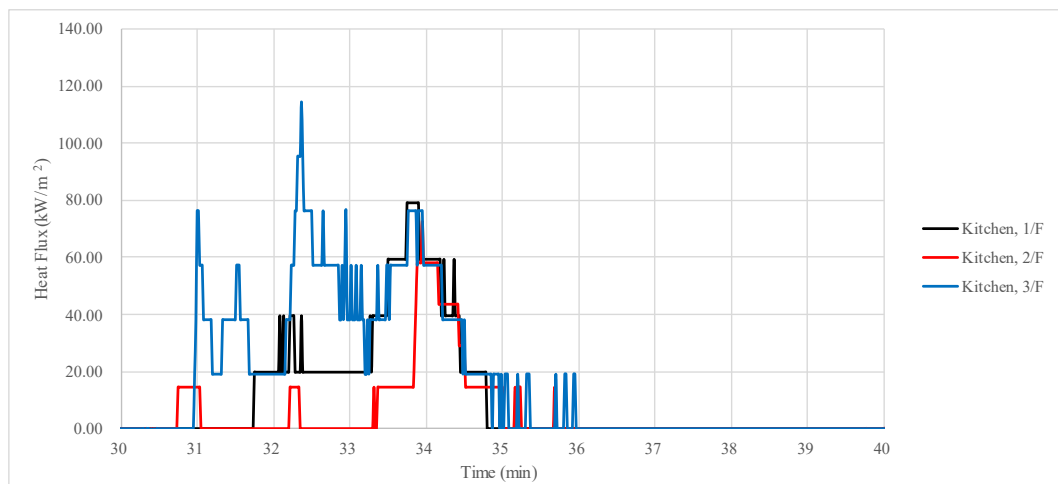
2.6.12 The heat flux (i.e. heat energy transfer per unit area per unit time) against time graphs for foyer windows at different floors and that for kitchen windows at different floors are provided at Figs. 2-4 (a) & (b). The maximum heat flux of both groups of windows exceeds  $100\text{kW/m}^2$ . The foyer window group and the kitchen window group reached the threshold of flashover<sup>17</sup> at about 31 min and 32 min respectively.

Both the foyer and kitchen window groups were exposed to extreme external heat fluxes, peaking at over  $100\text{ kW/m}^2$  and reaching the radiative ignition thresholds of  $20\text{ kW/m}^2$ <sup>18</sup>, the kitchen at approximately 31 min and the foyer at about 33 min. At these levels, the piloted or spontaneous<sup>19</sup> ignition of combustibles is likely to occur.

Fig. 2-4 (a): Heat Flux against Time Graph for Kitchen Windows in the Fire Severity Analysis

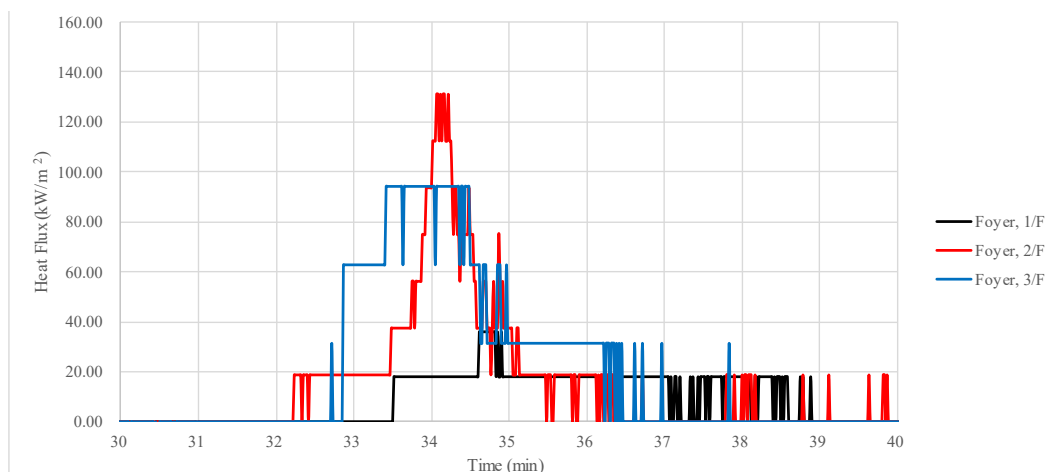
Fig. 2-4 (b): Heat Flux against Time Graph for Foyer Windows in the Fire Severity Analysis

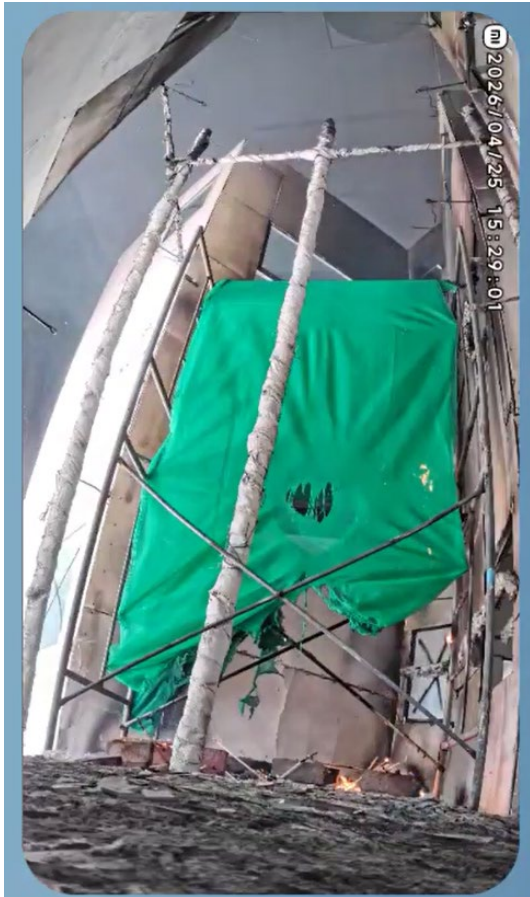
- 2.8.2 The fire development of both safety nets is visually shown in Photos 2-9 (a) to (d). Fire spread was observed in the Sample 4 (Wang Chi House) safety nets (as shown in Photo 2-9 (b)), where the fire spread along the safety nets until the entire safety nets were consumed (as shown in Photo 2-9 (d)).
- 2.8.3 In contrast, the Sample 2 (FR) safety nets experienced fire consumption only in the lower portion, without spreading along the rest of the safety nets. A significant portion of the Sample 2 (FR) safety nets remained intact, as shown in Photos 2-9 (a) & (b).

Photo 2-9 (a): Limited Fire Damage on Sample 2 (FR)

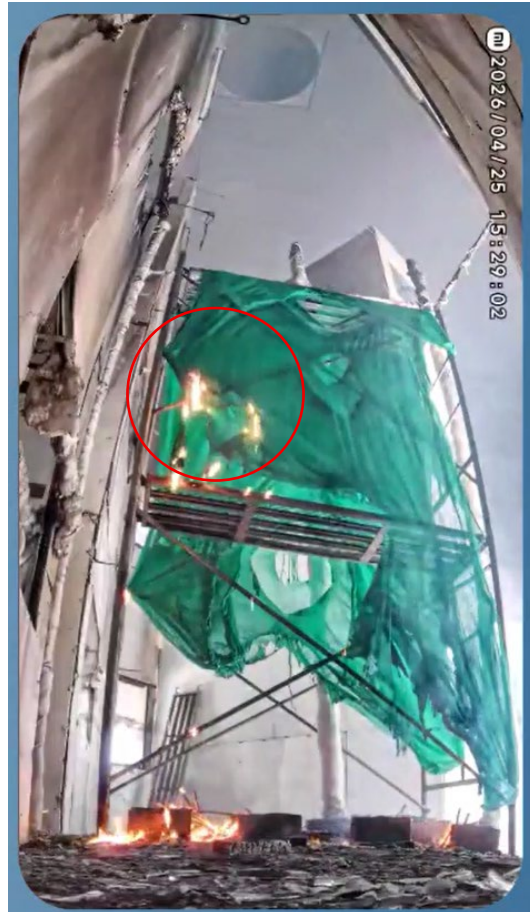
Photo 2-9 (b): Extensive Fire Spread on Sample 4 (Wang Chi)

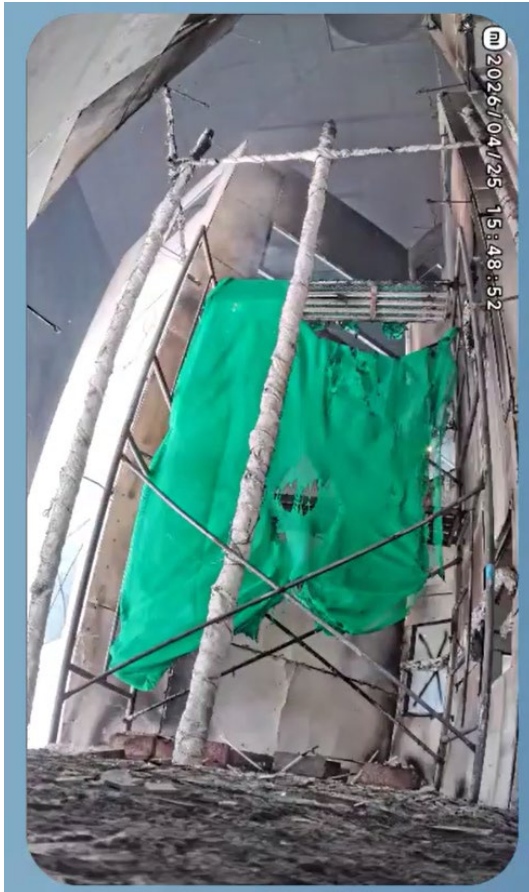
Photo 2-9 (c): Post-Fire Condition of Sample 2 (FR) (Partially Intact)
