# Final Investigation Report No.5 Alarm Fire at Wang Fuk Court on 26 November 2025

Inter-Departmental Fire Investigation Task Force

May 2026

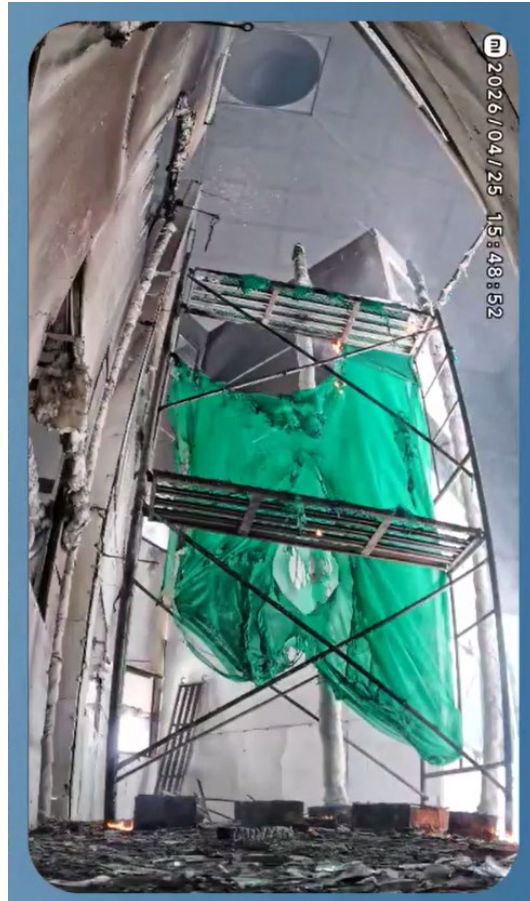
- 2.8.2 The fire development of both safety nets is visually shown in Photos 2-9 (a) to (d). Fire spread was observed in the Sample 4 (Wang Chi House) safety nets (as shown in Photo 2-9 (b)), where the fire spread along the safety nets until the entire safety nets were consumed (as shown in Photo 2-9 (d)).
- 2.8.3 In contrast, the Sample 2 (FR) safety nets experienced fire consumption only in the lower portion, without spreading along the rest of the safety nets. A significant portion of the Sample 2 (FR) safety nets remained intact, as shown in Photos 2-9 (a) & (b).

Photo 2-9 (d): Post-Fire Condition of Sample 4 (Wang Chi) (Fully Consumed)

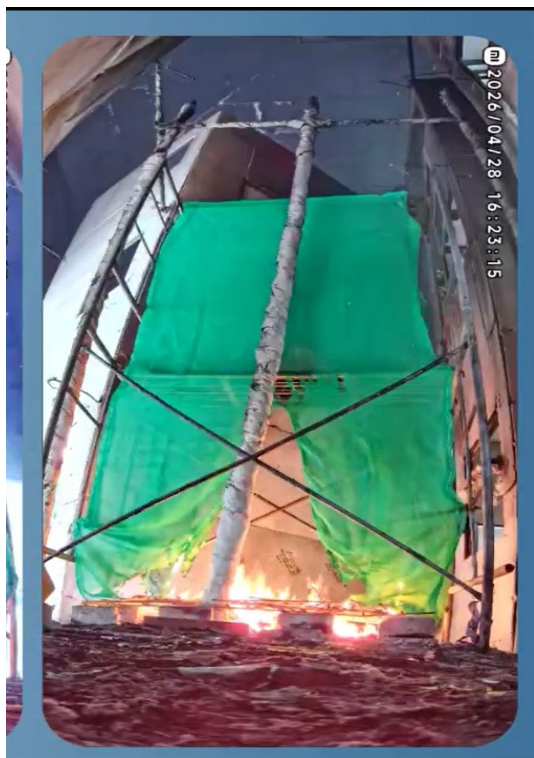
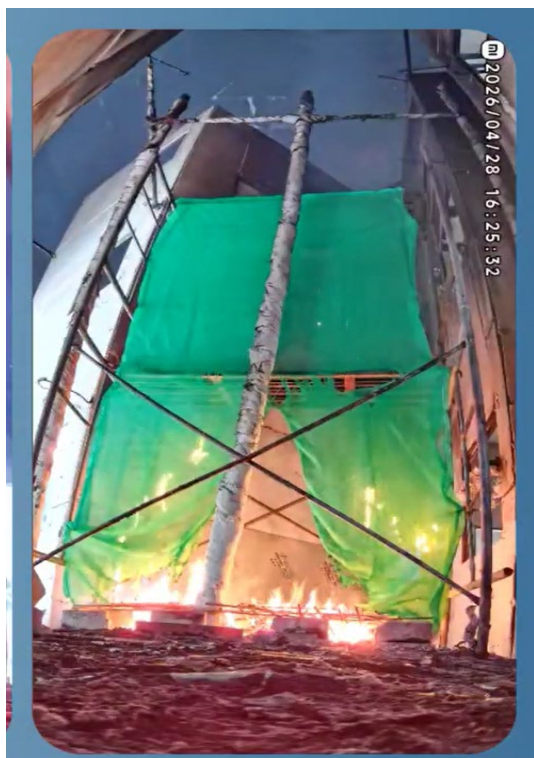
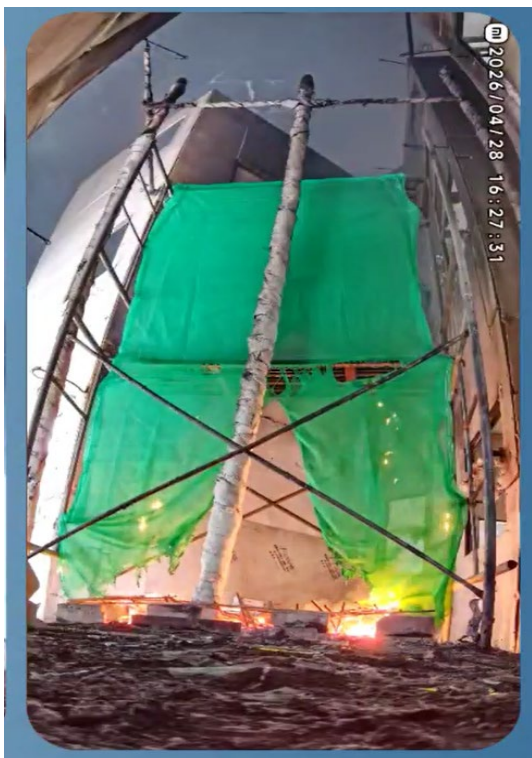
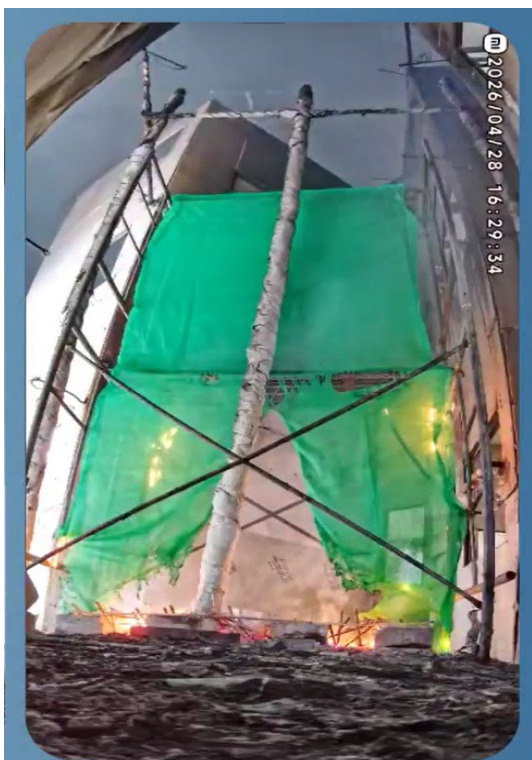
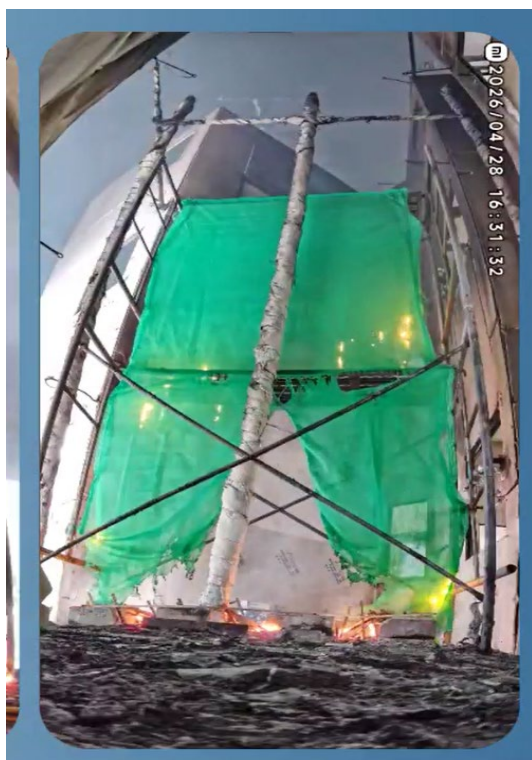
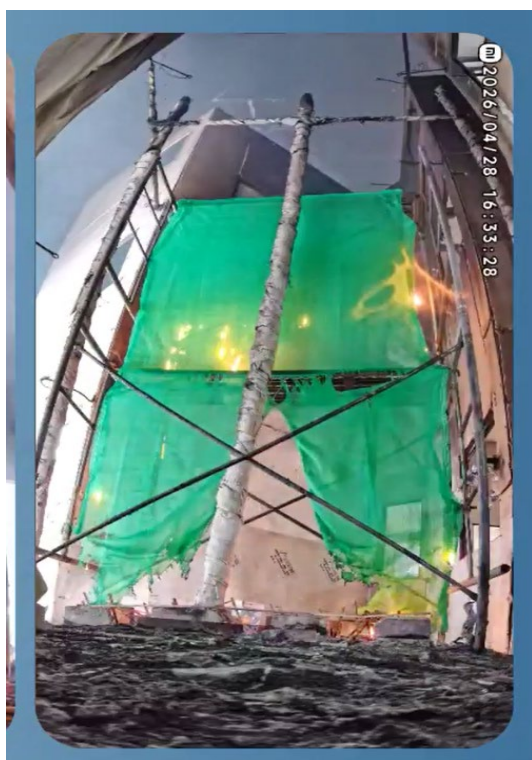
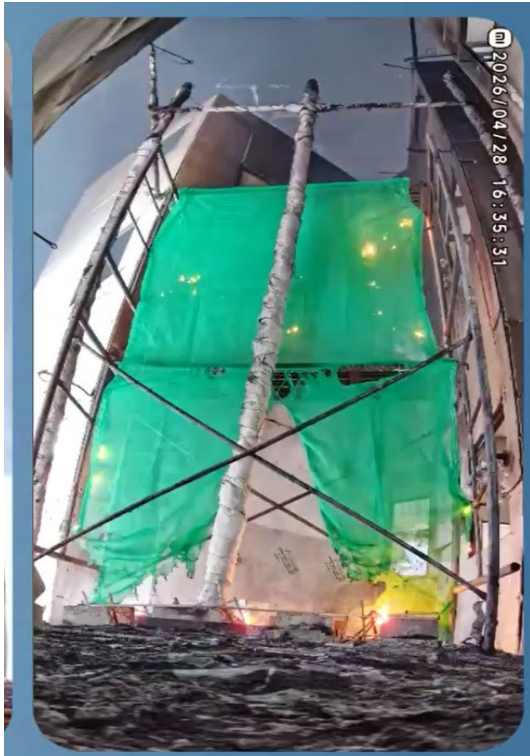
- 2.8.4 The fire development of both safety nets, captured at 2-minute intervals, are shown in Photos 2-10 (a) to (ab). It was noted that safety nets collected from Wang Chi House exhibited a faster rate of spread compared to Sample 3 (non-FR) safety nets. The fire continued to propagate until the entire safety nets were consumed, as illustrated in Photos 2-10(ab).

Photo 2-10 (a): Fire Spread  
on Sample 3 (Non-FR) (2 min)

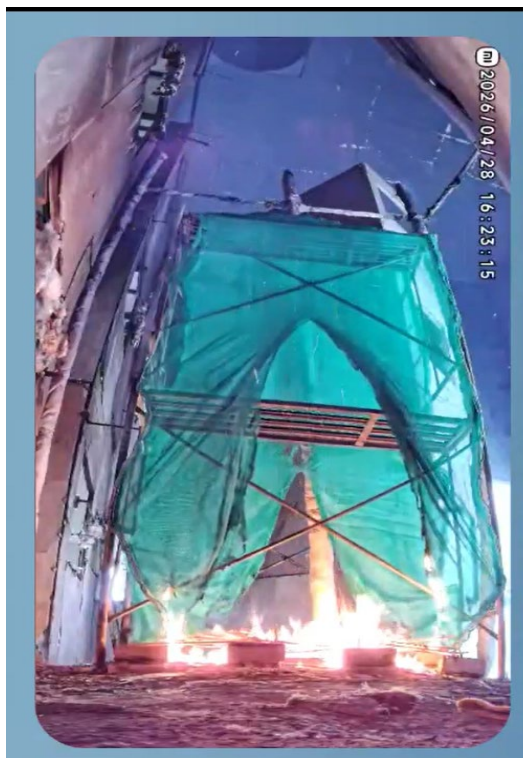
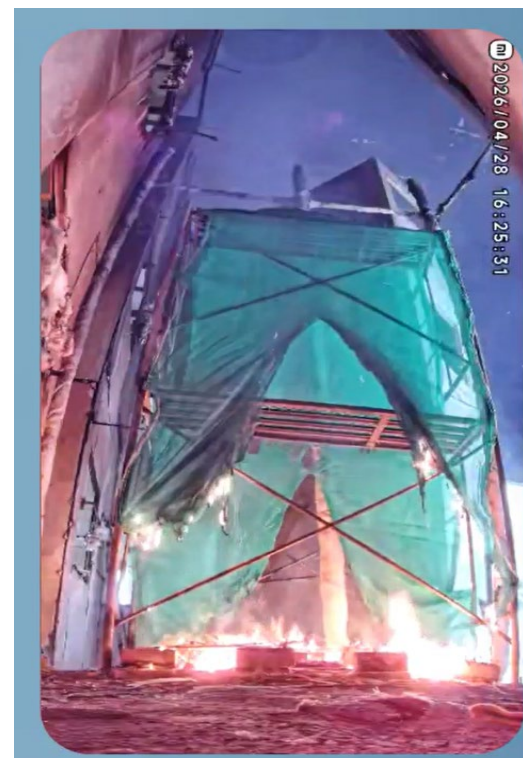
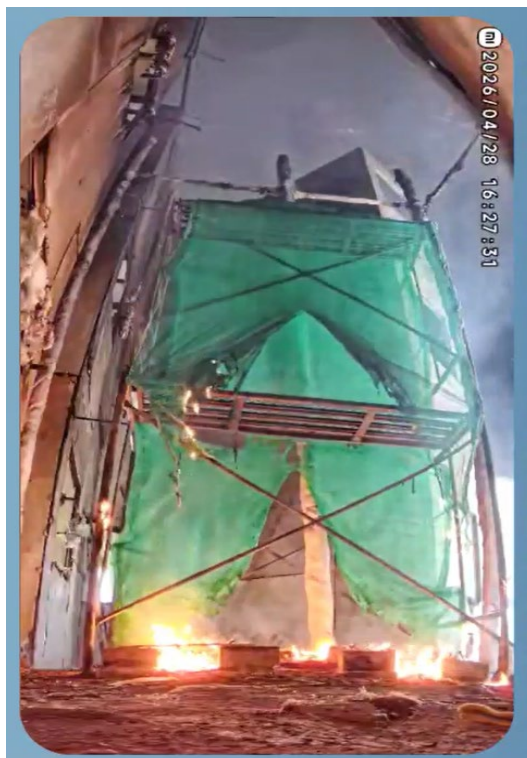
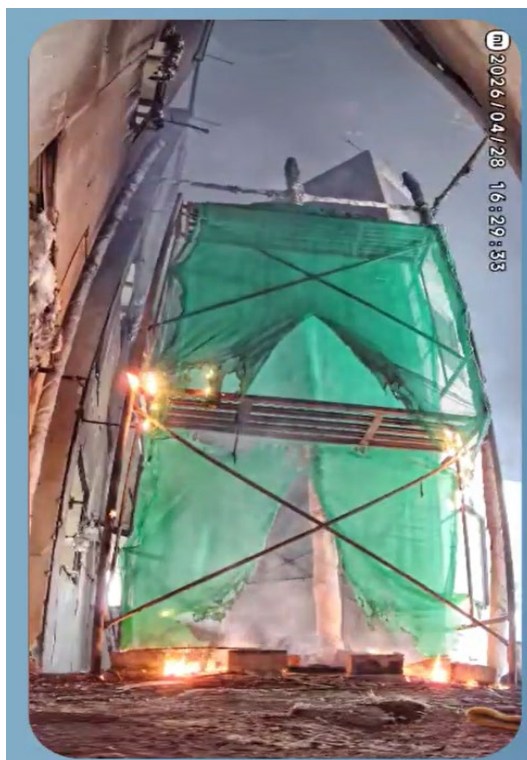
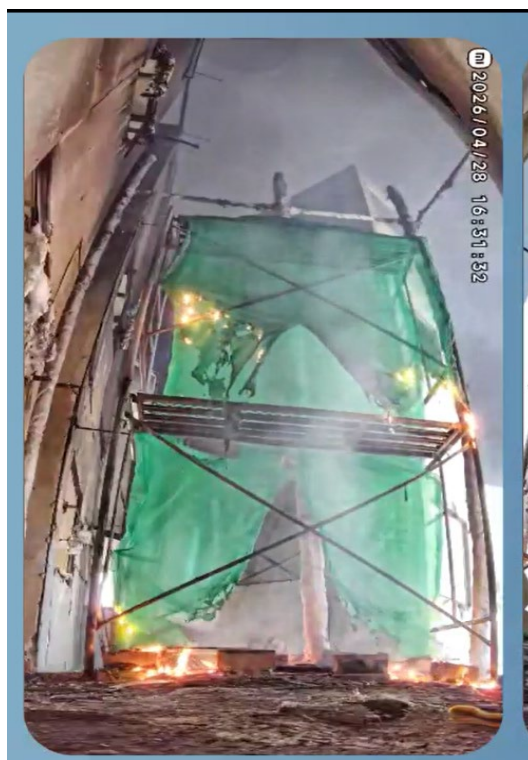
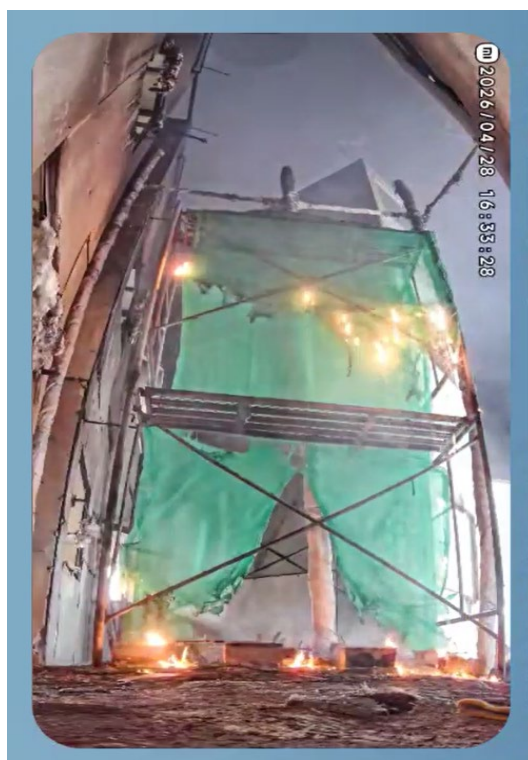
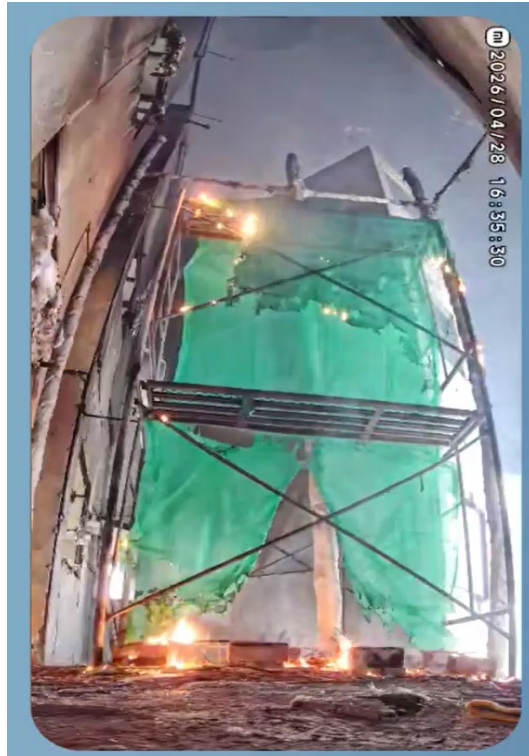
Photo 2-10 (b): Fire Spread  
on Sample 4 (Wang Chi) (2 min)

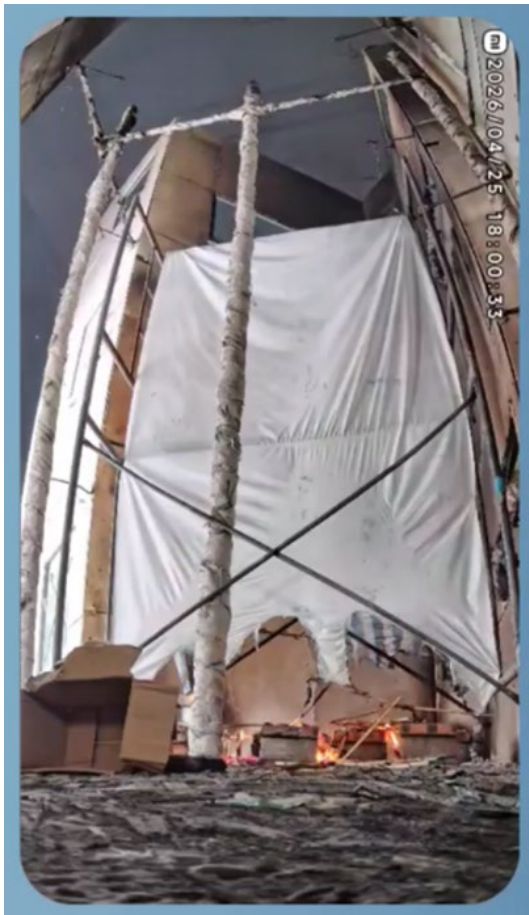
- 2.8.5 The fire development of both FR or non-FR canvas is visually shown in Photos 2-10 (ac) to (af). Fire spread was observed in the non-FR canvas (as shown in Photo 2-10 (ad)), where the fire spread along the canvas until majority of the canvas was consumed (as shown in Photo 2-10 (af)).
- 2.8.6 In contrast, the FR canvas experienced fire consumption only in the lower portion, without spreading along the rest of the canvas. A significant portion of the FR canvas remained intact (as shown in Photos 2-10 (ac) & (ae)).

Photo 2-10 (ac): Limited Fire Damage on FR Canvas (White Color)

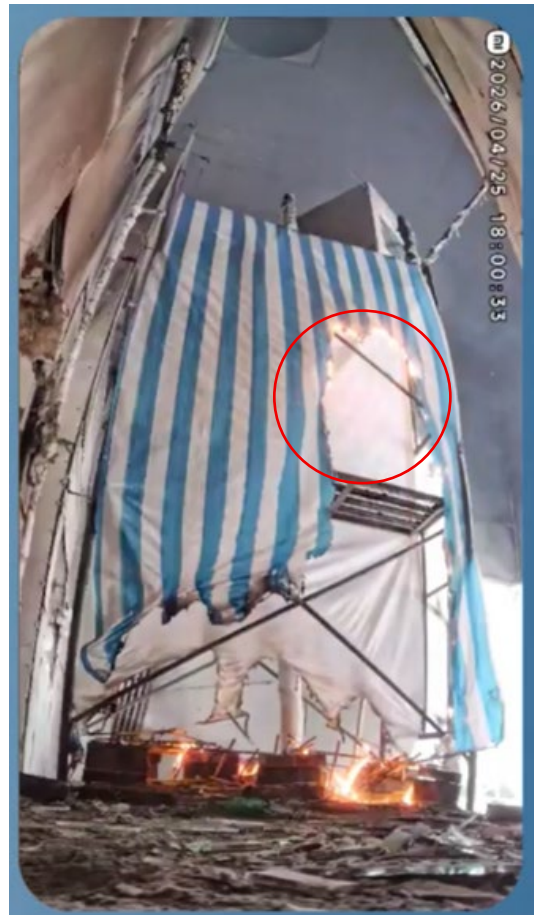
Photo 2-10 (ad): Extensive Fire Spread on Non-FR Canvas (White & Blue Striped)

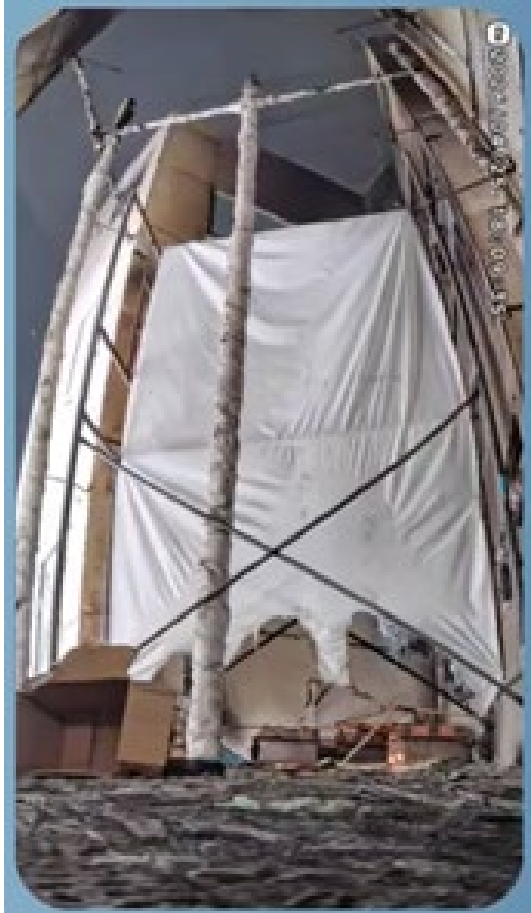
Photo 2-10 (ae): Post-Fire Condition of FR Canvas (Partially Intact)

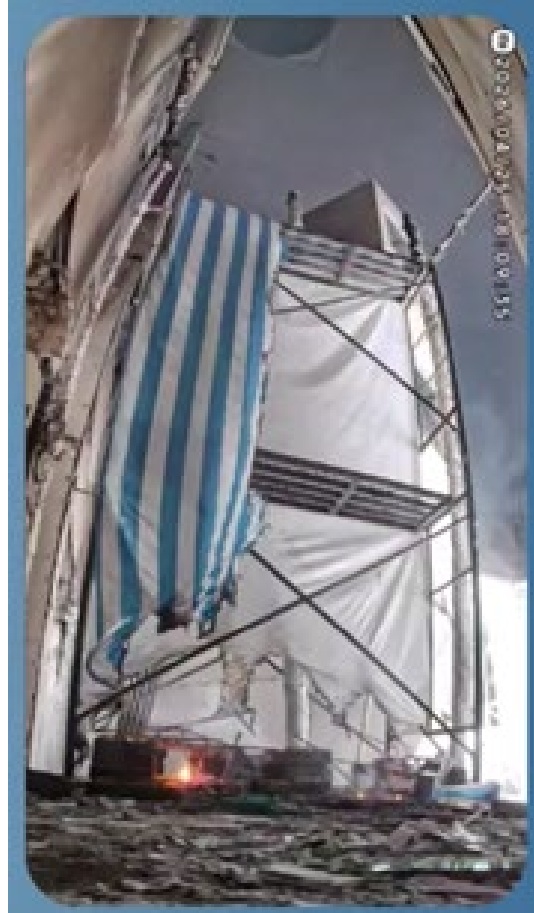
Photo 2-10 (af): Post-Fire Condition of Non-FR Canvas (Mostly Consumed)

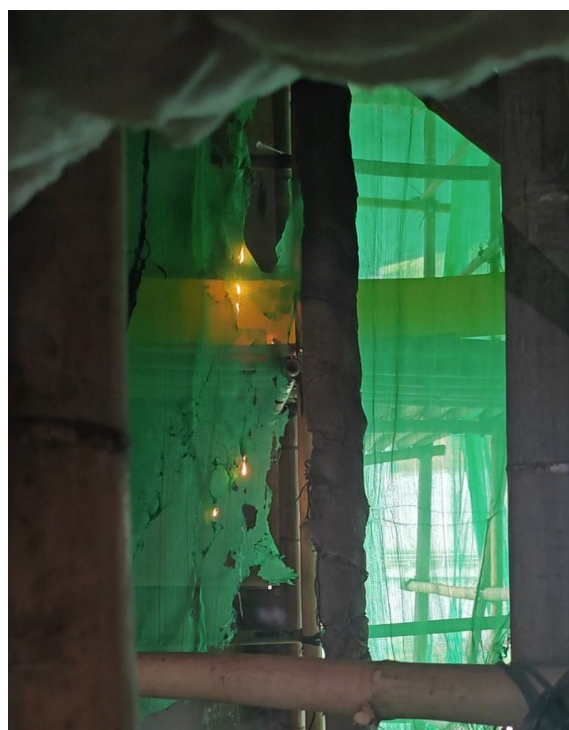
- 2.9.1 To assess the influence of FR properties without interference from the fire source or combustibles, HRR was compared under small fire conditions<sup>25</sup> (<1.5 MW) using artificially deteriorated non-FR safety nets to avoid uncertainties from uncertified safety nets.
- 2.9.2 Secondary fire spread was observed in Sample 3 (non-FR) safety nets, as shown in Photo 2-11 (b). The behaviour was similar to that of Sample 1 (Uncertified) safety nets and supports the validity of Key Observation (1) for non-FR safety nets.

Photo 2-11 (b): Fire Spread in Test 7 Using Non-FR Safety Nets

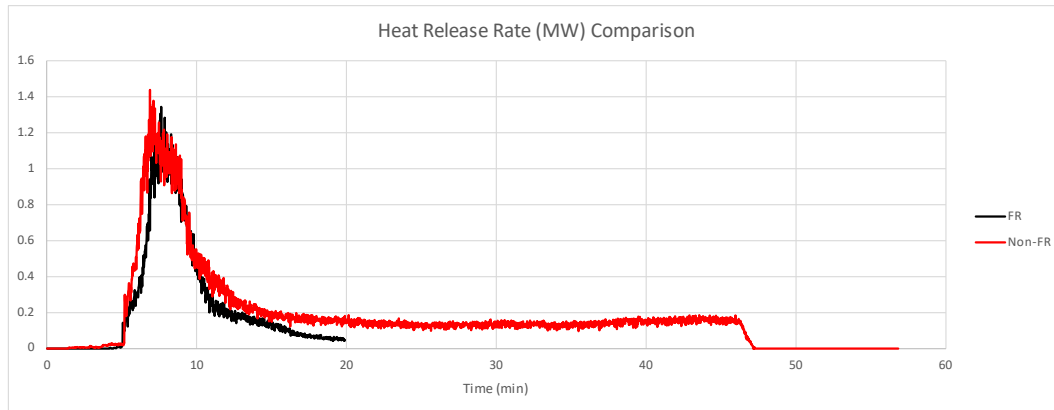
2.9.3 The use of non-FR safety nets exhibited a slightly higher peak HRR and slightly faster growth compared to the FR safety nets, as shown in Fig. 2-5.

Fig. 2-5: HRR Comparison between Test 2 (FR) Safety Nets and Test 7 (Non-FR) Safety Nets

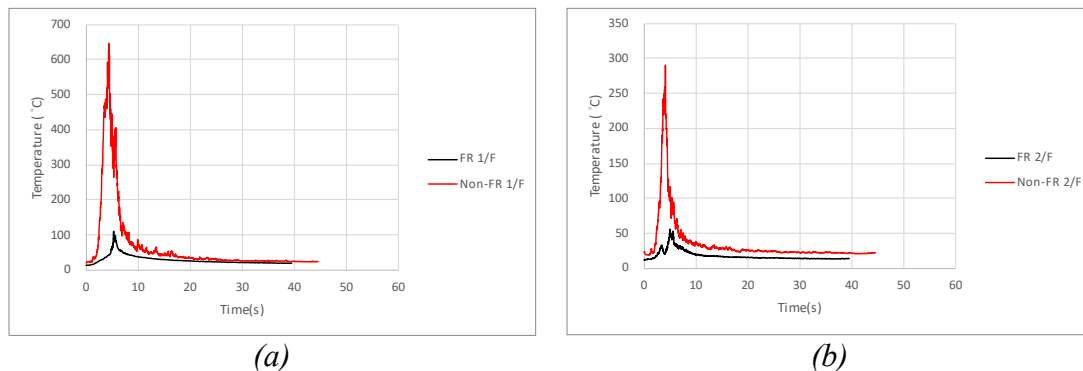
2.9.4 The temperature measured during the tests was found generally higher in Test 7 than in Test 2, as shown in Figs. 2-6 (a) to (d). For example, in Test 7, Sample 3 (non-FR) safety nets recorded centerline temperatures exceeding 600°C on the 1/F and 300°C on the 2/F. In contrast, Sample 2 (FR) safety nets in Test 2 recorded significantly lower centerline temperatures of 100°C on the 1/F and 50°C on the 2/F.

Figs. 2-6 (a) & (b): Temperature against Time Graphs for Thermocouple at the Centerline of the Re-entrant in Test 2 (FR) Safety Nets and Test 7 (Non-FR) Safety Nets

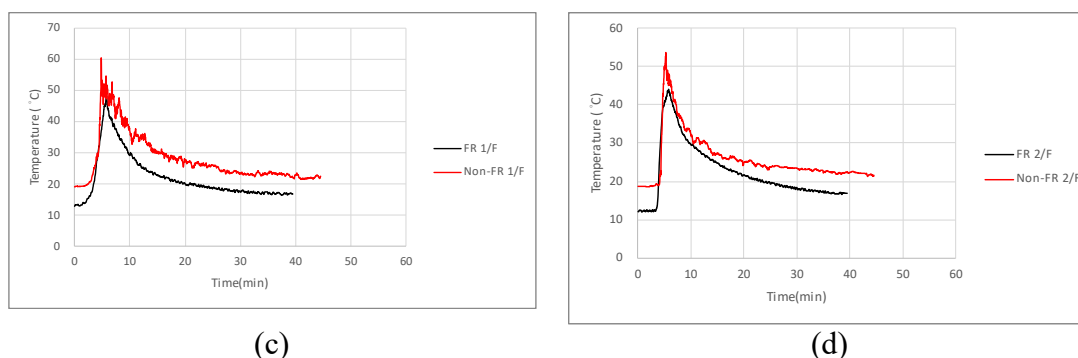
Figs. 2-6 (c) & (d): Temperature against Time Graphs for Thermocouple at the Staircase Window / Wooden Boards in Test 2 (FR) Safety Nets and Test 7 (Non-FR) Safety Nets

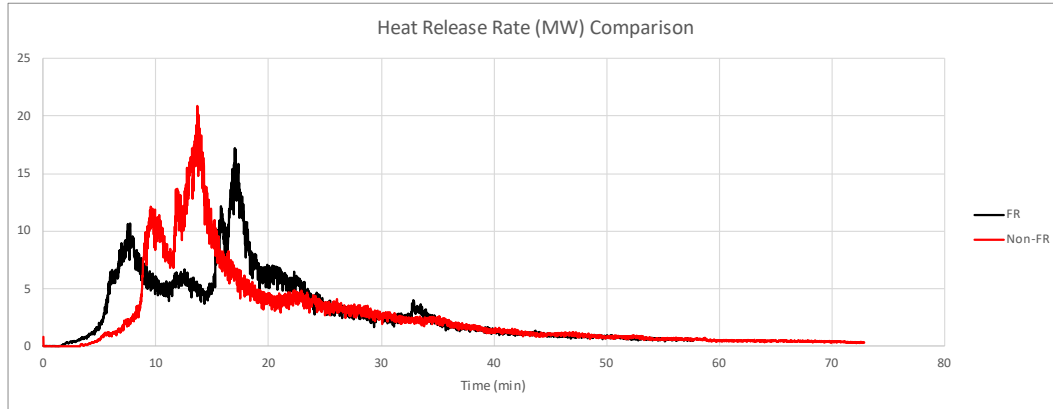
2.10.2 The use of non-FR safety nets exhibited a higher peak HRR and faster growth compared to the FR safety nets, as shown in Fig. 2-7.

Fig. 2-7: HRR Comparison between Test 4 (FR) Safety Nets and Test 8 (Non-FR) Safety Nets

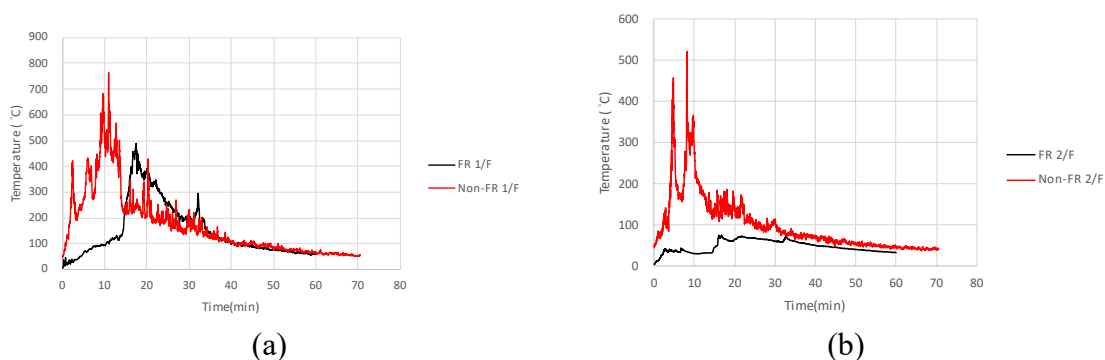
2.10.3 The temperature measured during the tests was found generally higher in Test 8 than in Test 4, as shown in Figs. 2-8 (a) to (d). For example, in Test 8, Sample 3 (non-FR) safety nets recorded centerline temperatures near 700°C on the 1/F and 500°C on the 2/F. In contrast, Sample 2 (FR) safety nets in Test 4 recorded significantly lower centerline temperatures of about 500°C on the 1/F and below 100°C on the 2/F.

Figs. 2-8 (a) & (b): Temperature against Time Graph of Thermocouple at the Centerline of the Re-entrant in Test 4 (FR) Safety Nets and Test 8 (Non-FR) Safety Nets

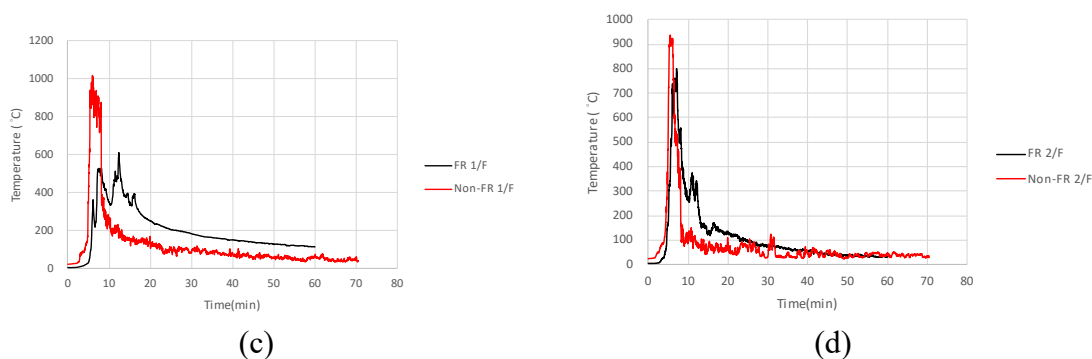
Figs. 2-8 (c) & (d): Temperature against Time Graph of Thermocouple at the Staircase Window / Wooden Boards in Test 4 (FR) Safety Nets and Test 8 (Non-FR) Safety Nets

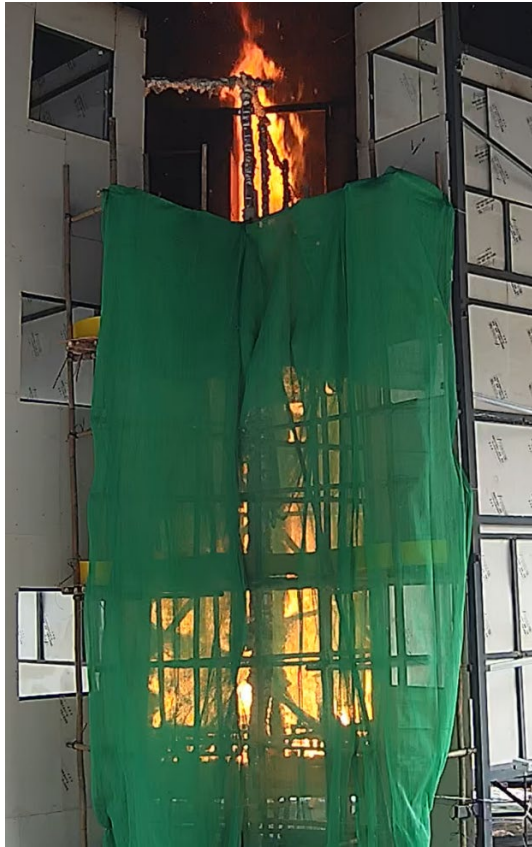
Photo 2-12 (a): Full Developed Fire in Test 4 using FR Safety Nets

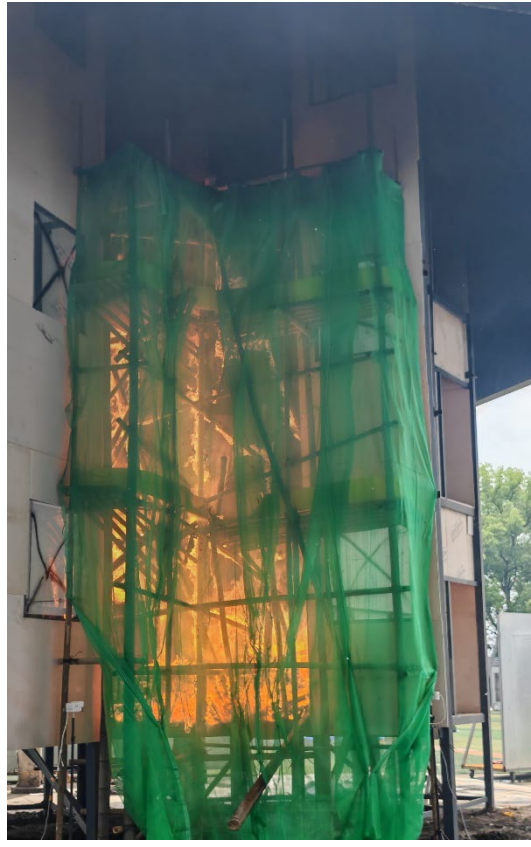
Photo 2-12 (b): Full Developed Fire in Test 8 using non-FR Safety Nets

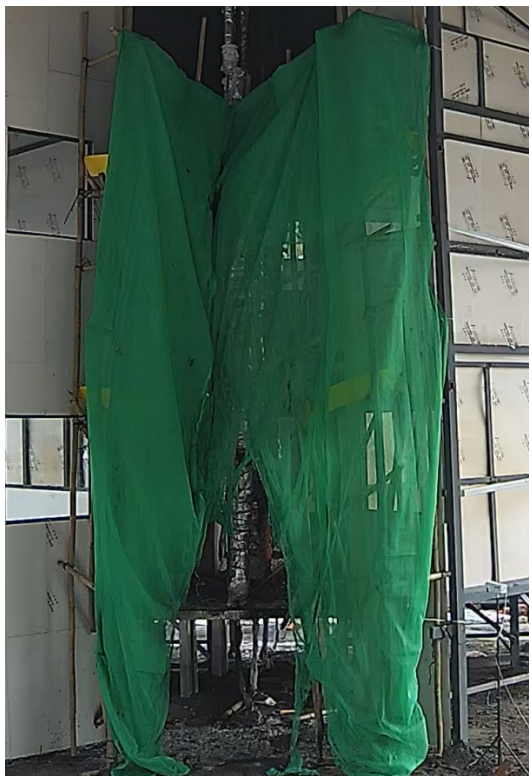
Photo 2-12 (c): Post-Fire Condition in Test 4 using FR Safety Nets

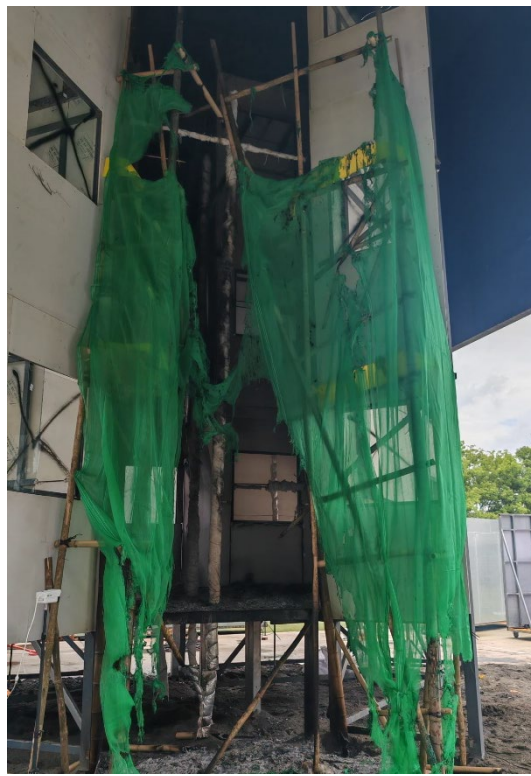
Photo 2-12 (d): Post-Fire Condition in Test 8 using non-FR Safety Nets

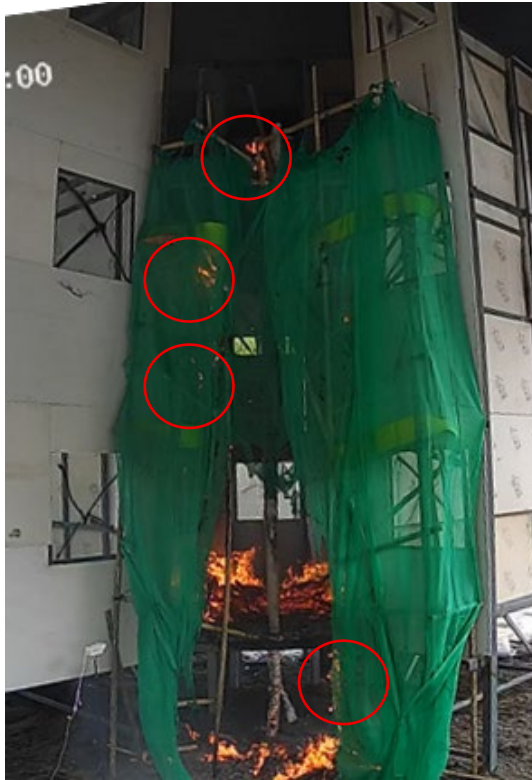
2.10.9 Like Test 3 with Sample 1 (Uncertified) safety nets, secondary ignition was also observed in Test 8 with Sample 3 (non-FR) safety nets.

Photo 2-12 (e): Secondary Ignition Occurred in Test 8

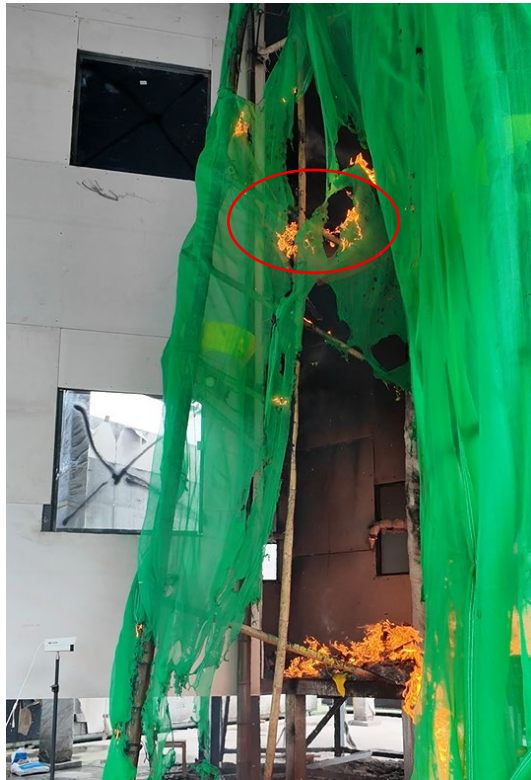
Photo 2-12 (f): Fire Spread to Other Construction Materials in Test 8

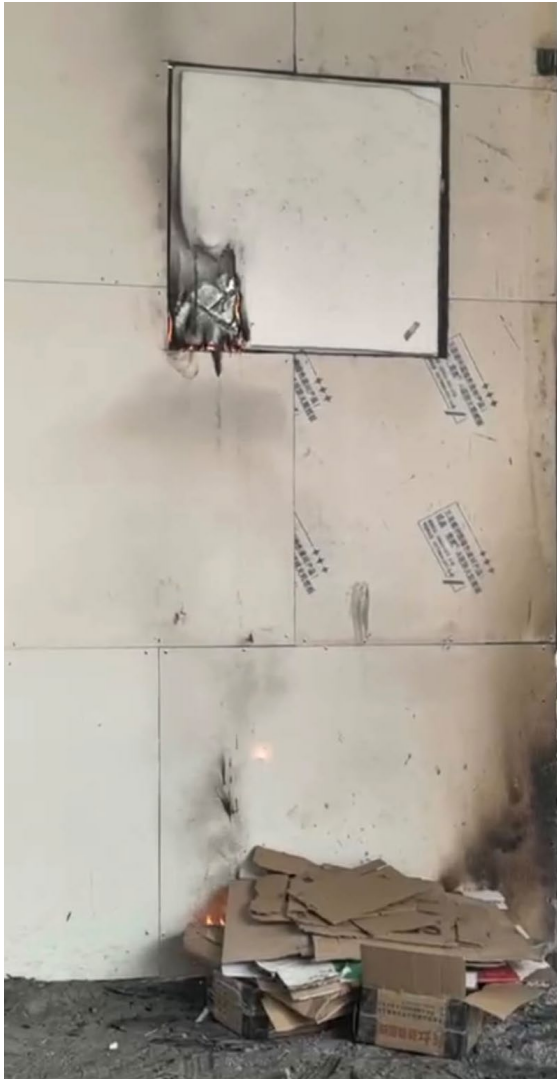
- 2.11.4 According to GL's observations, as reported in GL, Statement of Witness, Reference 25C2825, polystyrene window covers are readily ignitable when exposed to a naked flame<sup>26</sup>. During testing, burning droplets were observed, which could act as a source of secondary ignition. These findings were further confirmed through testing conducted in Sichuan<sup>27</sup>, as shown in Photos 2-13 (a) & (b).
- 2.11.5 Additionally, fire tests revealed that ignited polystyrene panels could detach from the building exterior and fall, as shown in Photo 2-13 (c). Once fallen, these panels acted as a new source of fire, potentially igniting materials beneath the windows. This highlights the significant fire hazards associated with polystyrene materials and their potential to contribute to rapid fire spread.

Photo 2-13 (a): Formation of Burning Droplets from the Ignited Polystyrene Window Covers

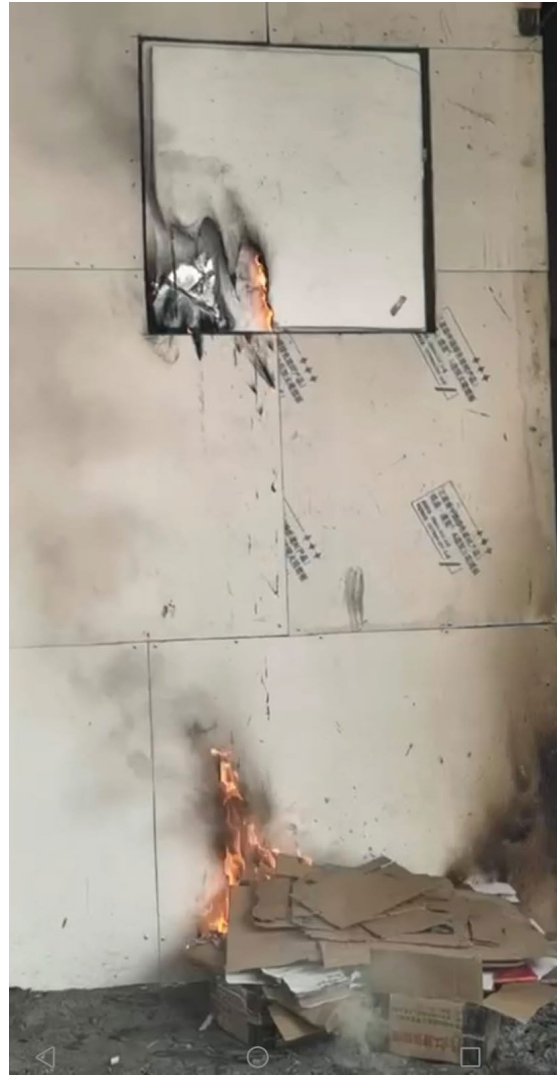
Photo 2-13 (b): Ignition of Nearby Combustibles

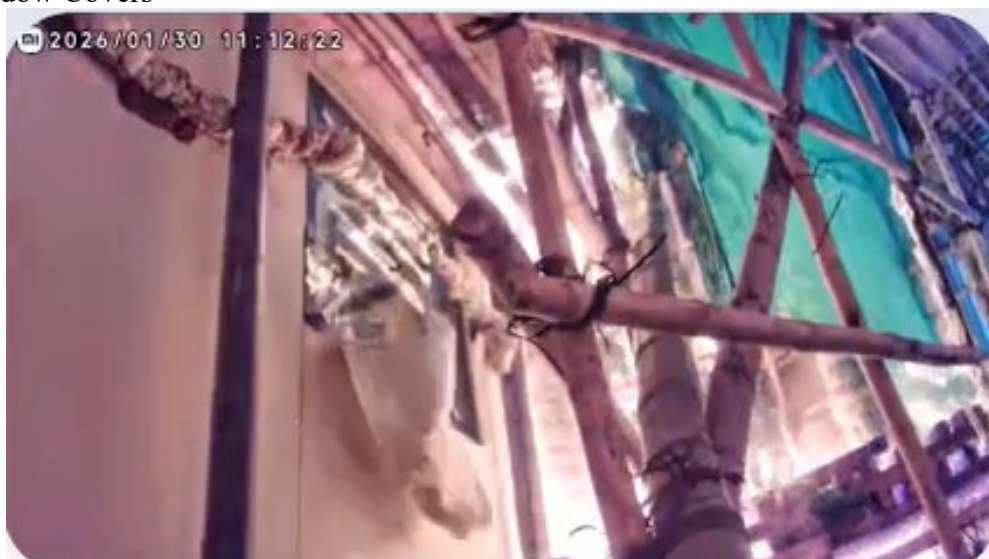
Photo 2-13 (c): Fallen Polystyrene Window Covers Potentially Sparking Secondary Fires

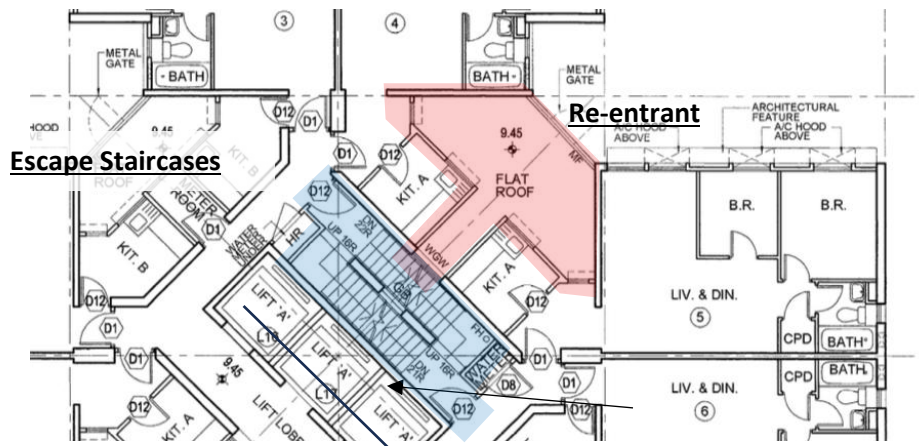
- 2.12.1 In Wang Cheong House, escape staircases were positioned next to the east re-entrant, as shown in Fig. 2-9. Post-fire investigations revealed that while fire-rated glass windows had replaced the original ones, some were substituted with movable wooden or aluminium composite boards. These boards had holes and gaps, allowing direct exposure between the staircase and the re-entrant.

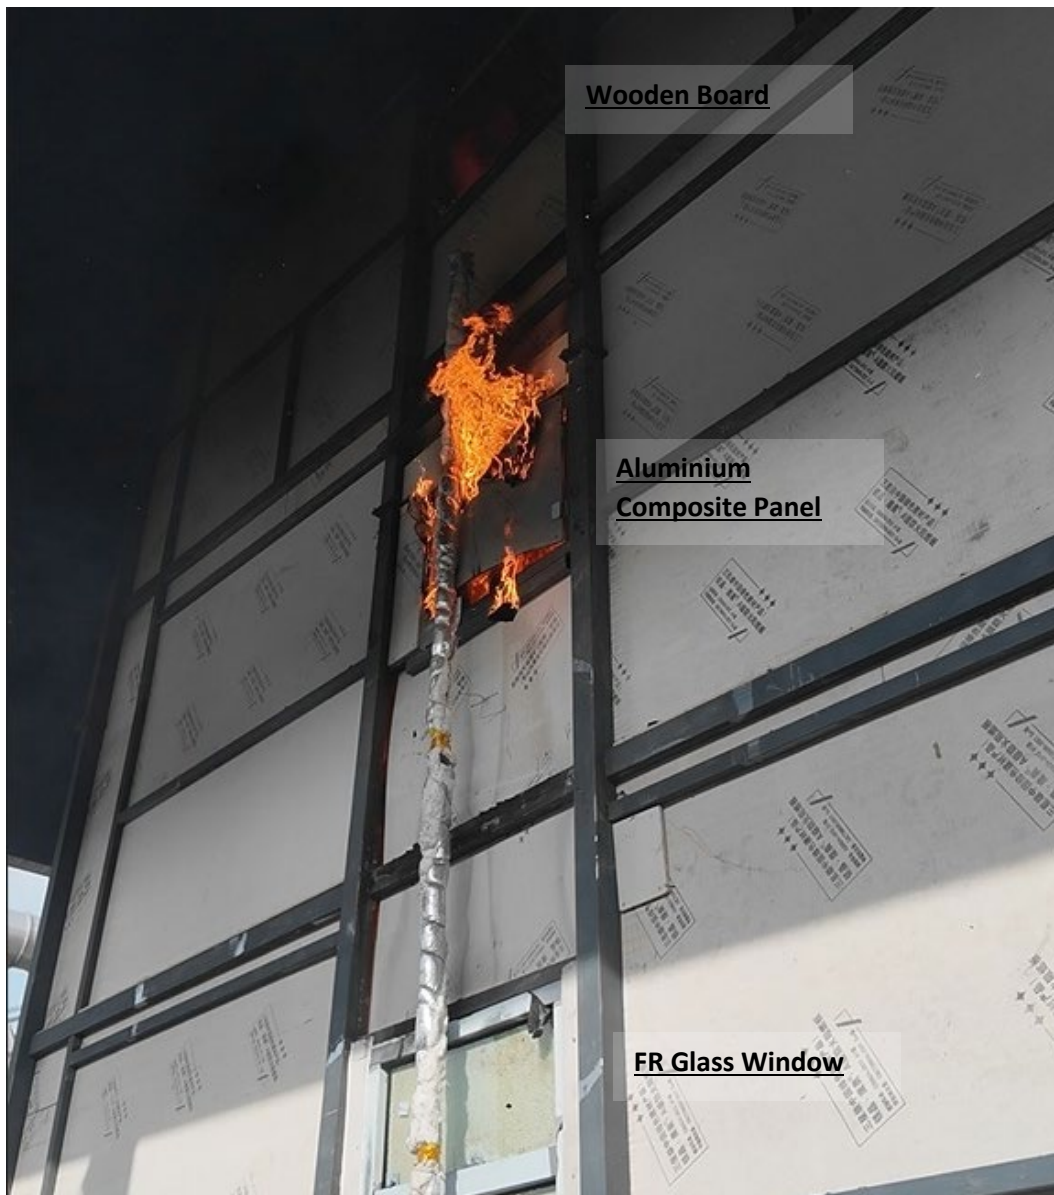
- 2.12.2 Rapid fire spread along the re-entrant was observed early in the fire. A test was conducted to evaluate the effectiveness of fire-rated glass windows, aluminium composite panels, and wooden boards in covering window openings and their impact on evacuation. A piece of wooden board, aluminium composite panel, and fire-rated glass window<sup>29</sup> were installed at the openings on the 3/F, 2/F, and 1/F level respectively in Test 9 and Test 10, as shown in Photo 2-14.

Photo 2-14: Installation of Wooden Board, Aluminium Composite Panel and Fire-rated Glass Window in both Test 9 and Test 10

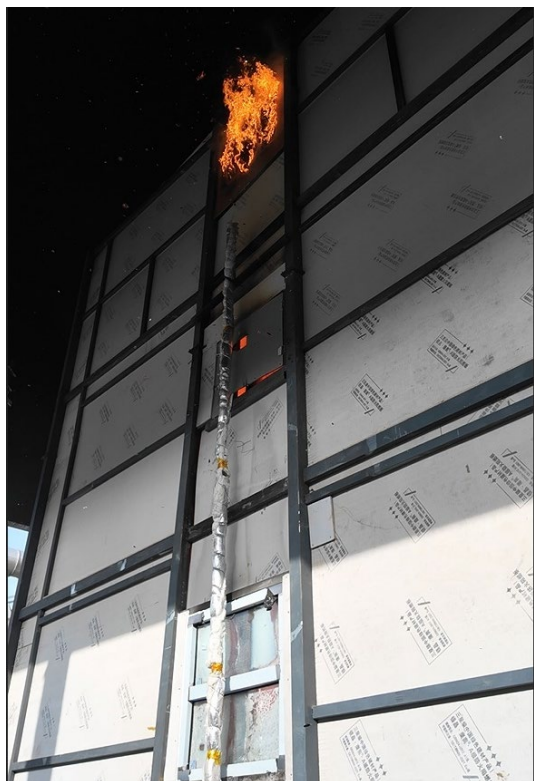
(a)

- 2.12.4 In Test 9, the wooden board on 3/F (Photo 2-15 (a)) ignited at 4 min 40 sec, followed by the aluminum composite panel on 2/F (Photo 2-15 (b)) at 7 min 49 sec. Both were completely consumed by fire, while the fire-rated glass window remained intact throughout the test, as shown in Photo 2-15 (c).

Photo 2-15 (a): Test 9  
Ignition of Wooden Board  
(4 min 40 sec)

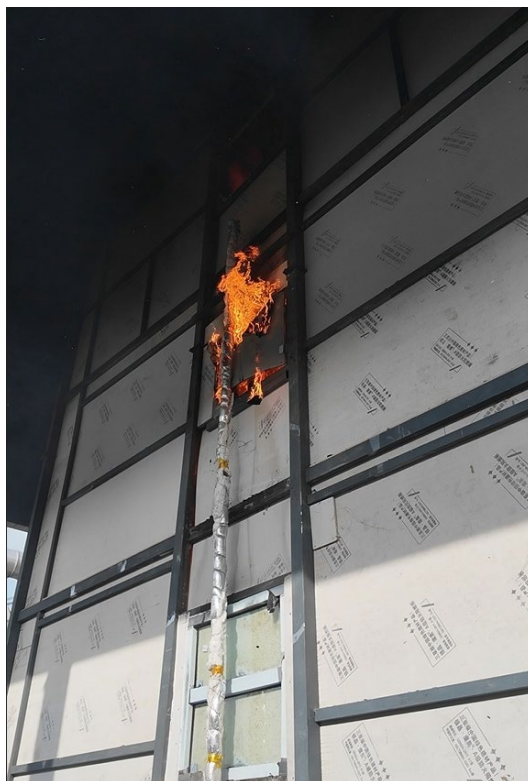
(b)

Photo 2-15 (b): Test 9  
Ignition of Aluminium Composite Panel  
(7 min 49 sec)

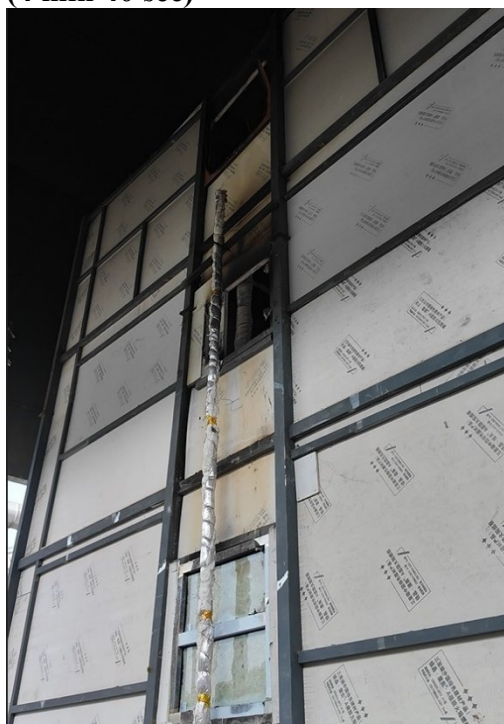
Photos 2-15 (c) & (d): Test 9 – Post-Fire Condition

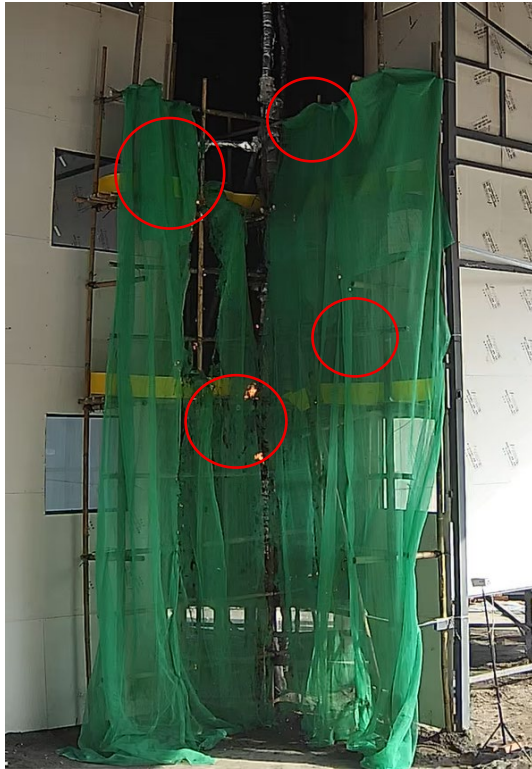
Photo 2-16 (a): Secondary Ignition in Test 1 [Sample 1 (Uncertified)]

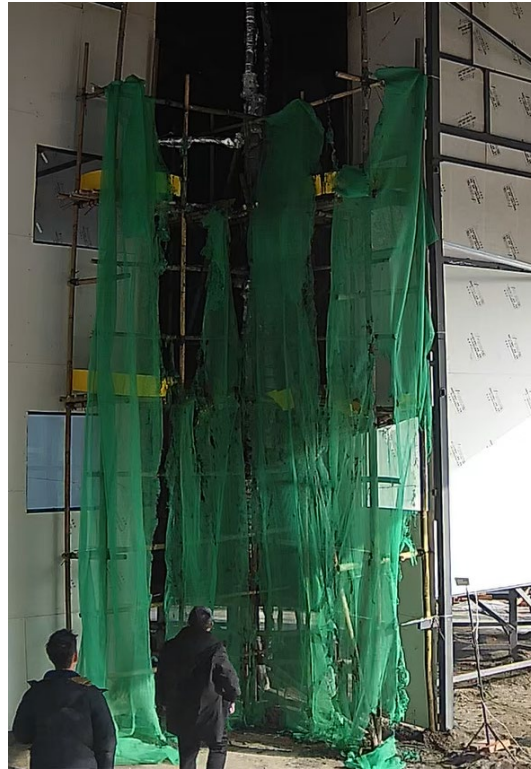
Photo 2-16 (b): Post-Fire Condition in Test 1 [Sample 1 (Uncertified)]

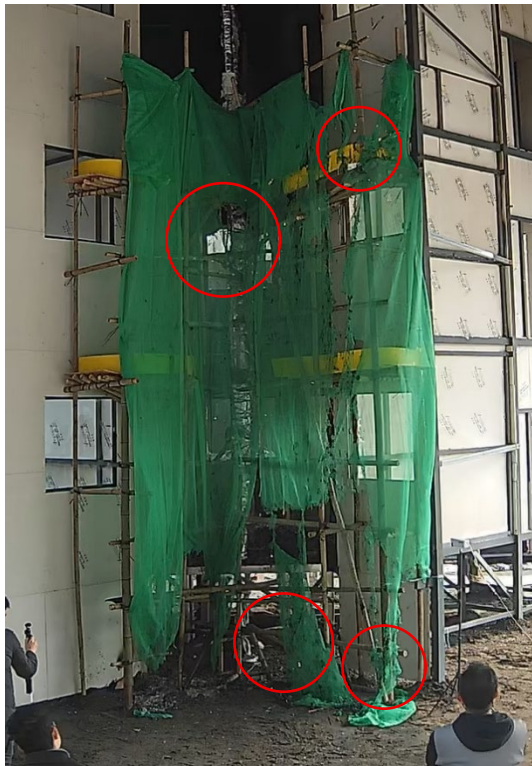
Photo 2-16 (c): Secondary Ignition in Test 3 [Sample 1 (Uncertified)]

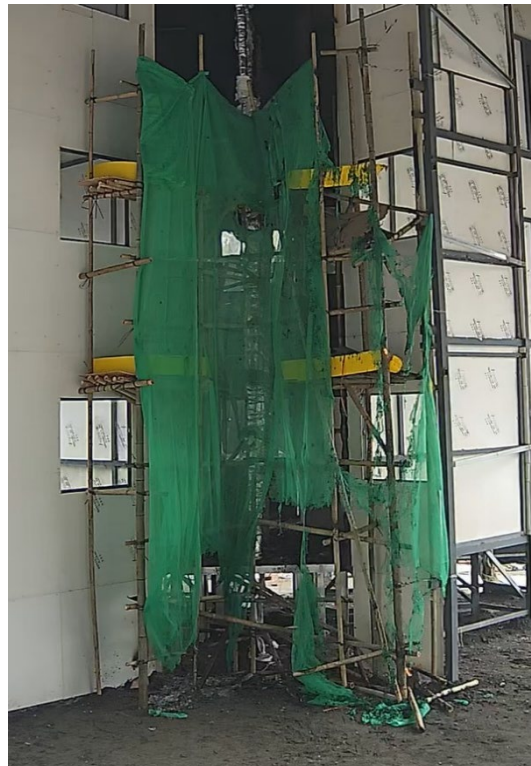
Photo 2-16 (d): Post-Fire Condition in Test 3 [Sample 1 (Uncertified)]

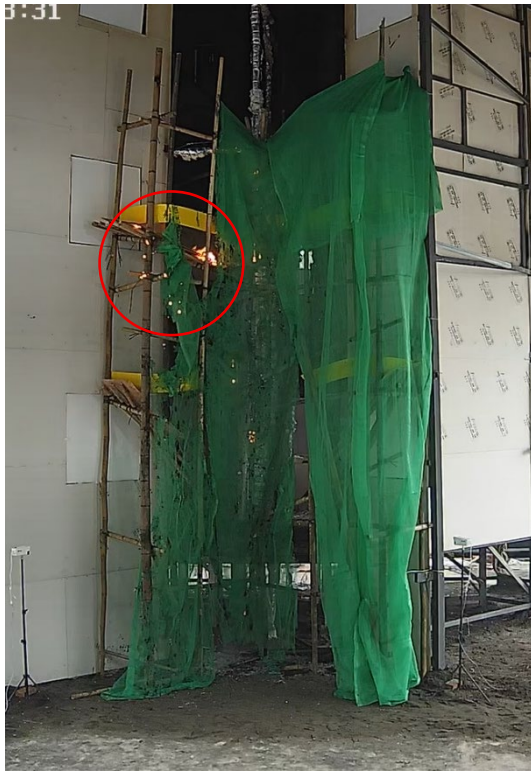
Photo 2-16 (e): Secondary Ignition in Test 5 [Sample 1 (Uncertified)]<sup>34</sup>

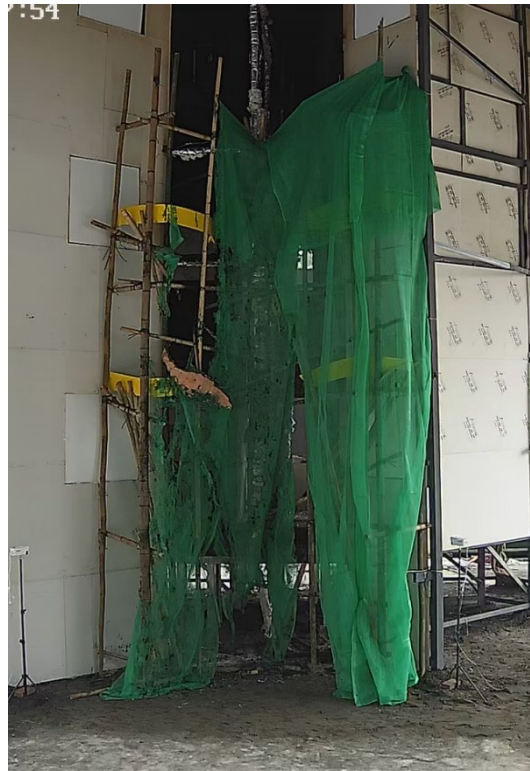
Photo 2-16 (f): Post-Fire Condition in Test 5 [Sample 1 (Uncertified)]
