# Final Investigation Report No.5 Alarm Fire at Wang Fuk Court on 26 November 2025

Inter-Departmental Fire Investigation Task Force

May 2026

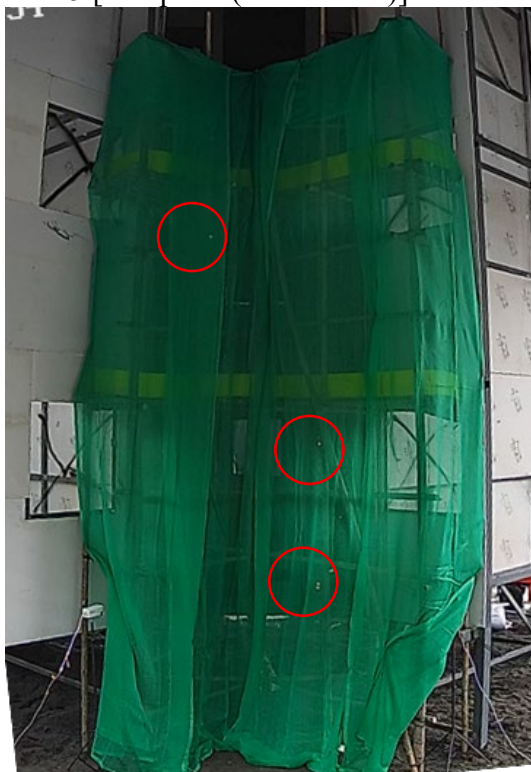
Photo 2-16 (g): Secondary Ignition in Test 7 [Sample 3 (Non-FR)]

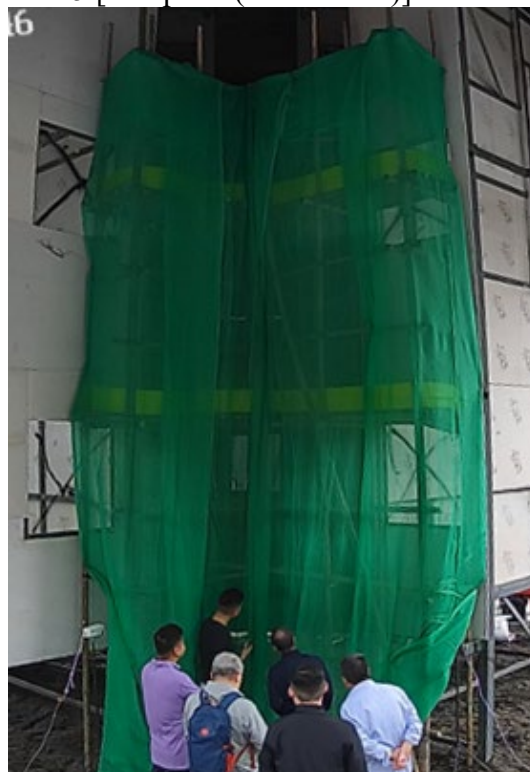
Photo 2-16 (h): Post-Fire Condition in Test 7 [Sample 3 (Non-FR)]

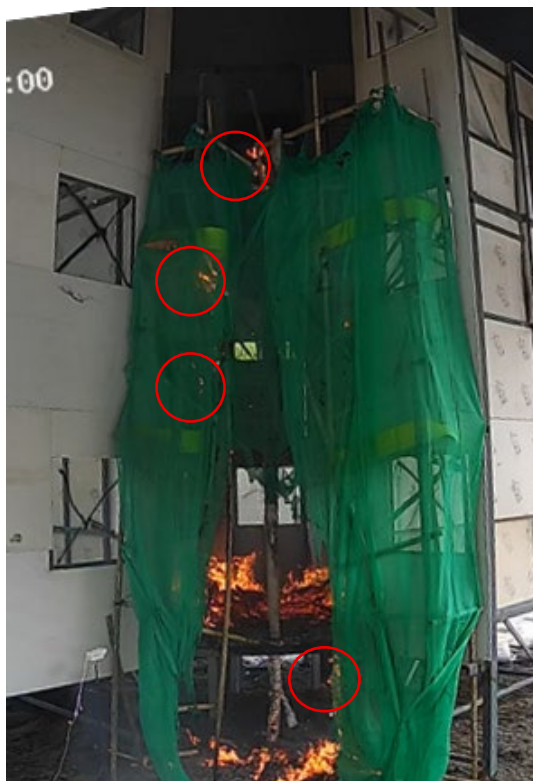
Photo 2-16 (i): Secondary Ignition in Test 8 [Sample 3 (Non-FR)]

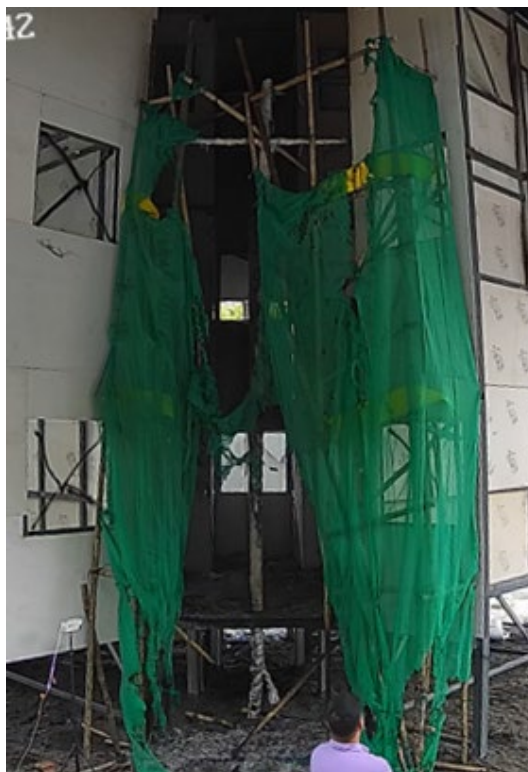
Photo 2-16 (j): Post-Fire Condition in Test 8 [Sample 3 (Non-FR)]

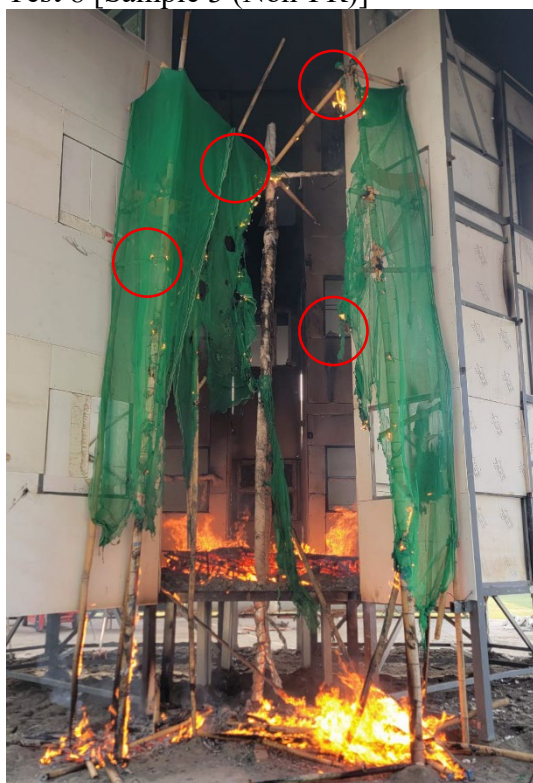
Photo 2-16 (k): Secondary Ignition in Test 9 [Sample 4 (Wang Chi House)]

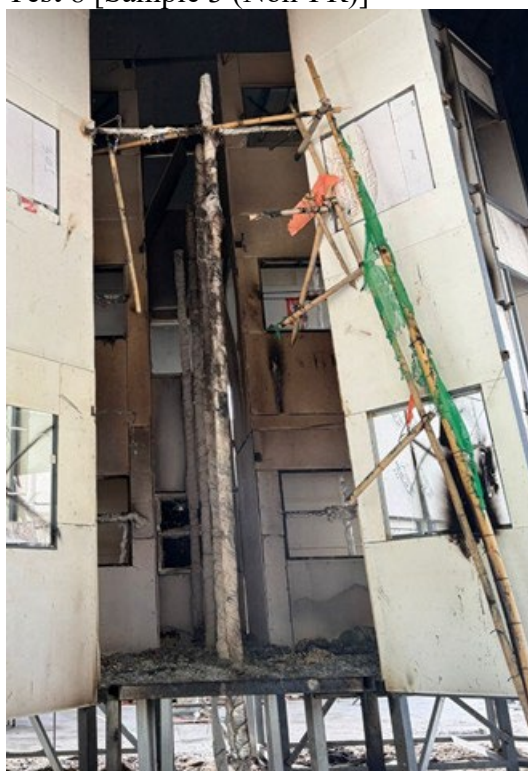
Photo 2-16 (l): Post-Fire Condition in Test 9 [Sample 4 (Wang Chi House)]<sup>[35]</sup>

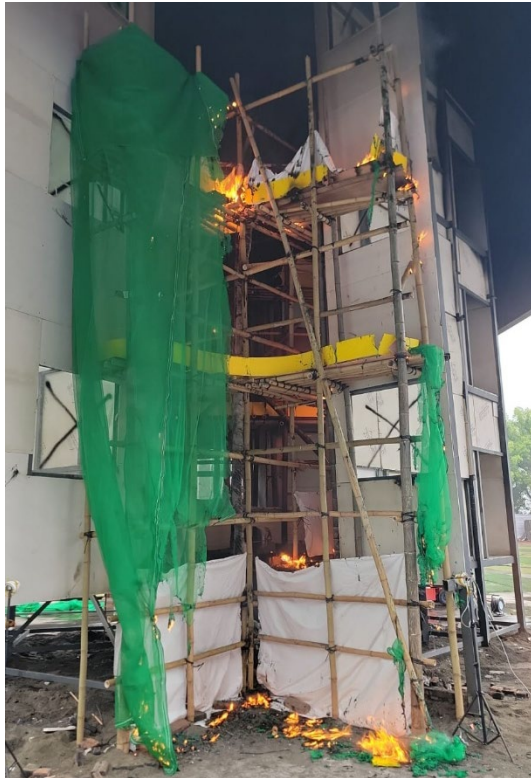
Photo 2-16 (m): Secondary Ignition in Test 12 [Sample 4 (Wang Chi House)]<sup>36</sup>

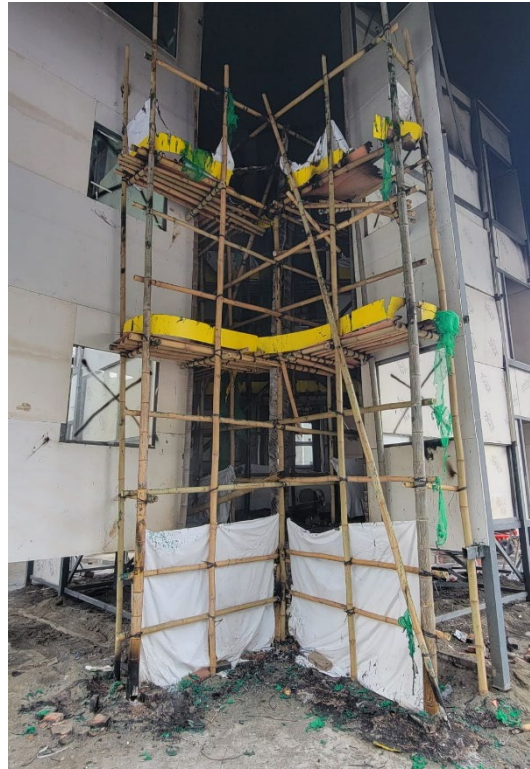
Photo 2-16 (n): Post-Fire Condition in Test 12 [Sample 4 (Wang Chi House)]

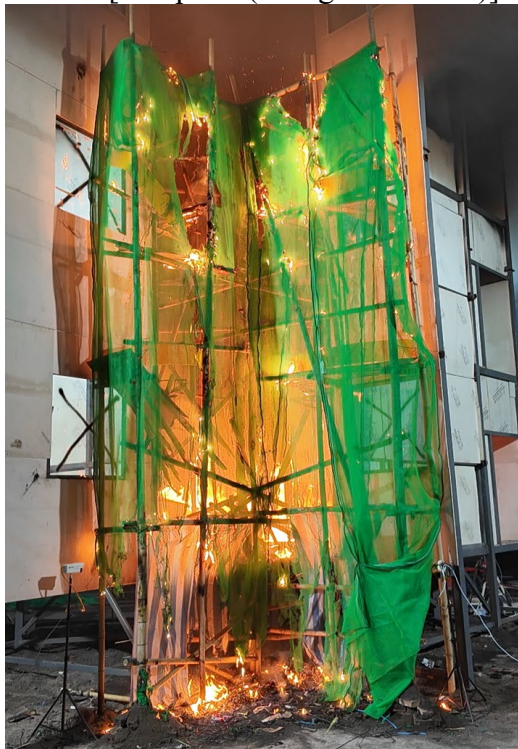
Photo 2-16 (o): Secondary Ignition in Test 13 [Sample 4 (Wang Chi House)]<sup>37</sup>

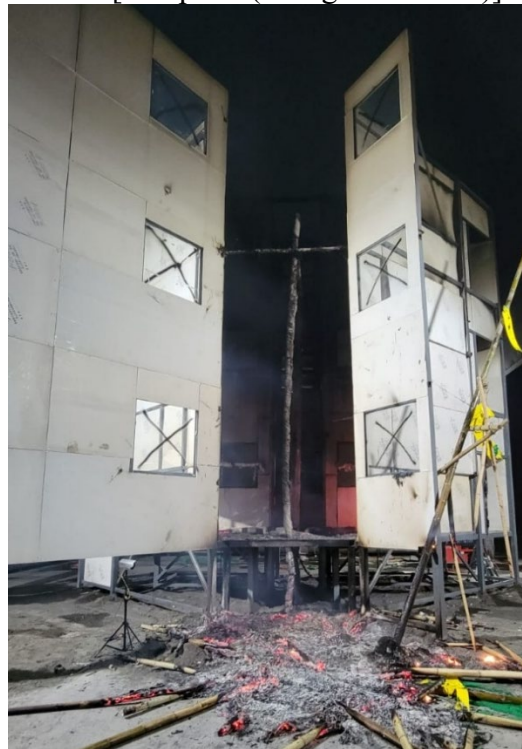
Photo 2-16 (p): Post-Fire Condition in Test 13 [Sample 4 (Wang Chi House)]

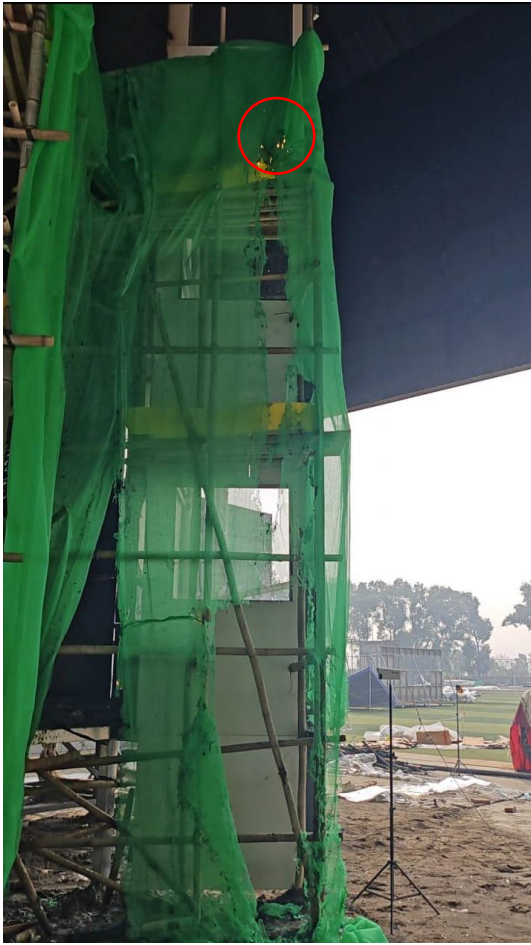
- Small fires spreading along the safety nets led to the formation of flaming droplets, as shown in Photo 2-17 (a).
- Flaming droplets dripped, causing additional fire spread, as shown in Photo 2-17 (b).
- As the fire propagate, fires on the safety nets or flaming droplets ignited easily ignitable materials, such as nylon strips, as shown in Photos 2-17 (c) & (d).
- The fire spread to nearby combustibles, such as wooden planks and toe-boards, as shown in Photo 2-17 (e).
- The fire continued to generate flaming droplets, resulting in further fire propagation, as shown in Photos 2-17 (f) to (h).

Photo 2-17 (a):  
Small Fires Spreading Along Safety  
Nets, Forming Flaming Droplets

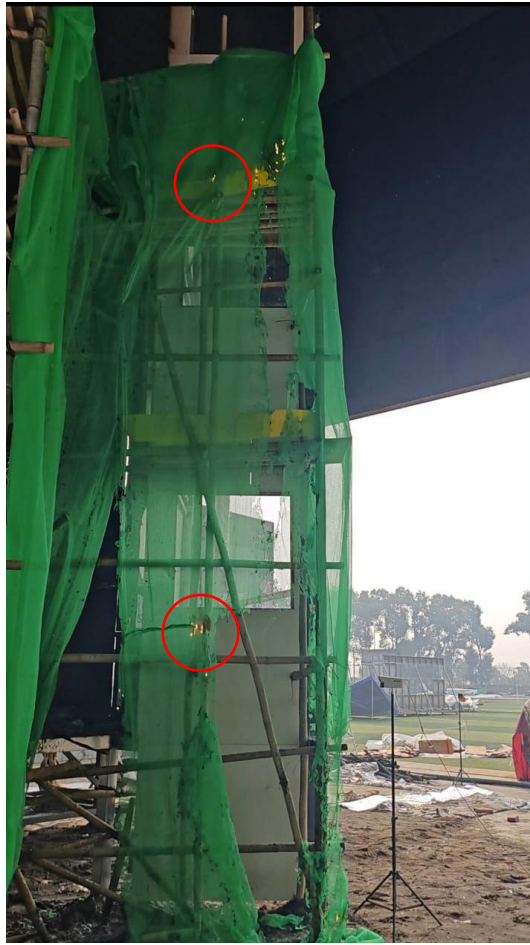
Photo 2-17 (b):  
Flaming Droplets Dripping and  
Spreading Fire

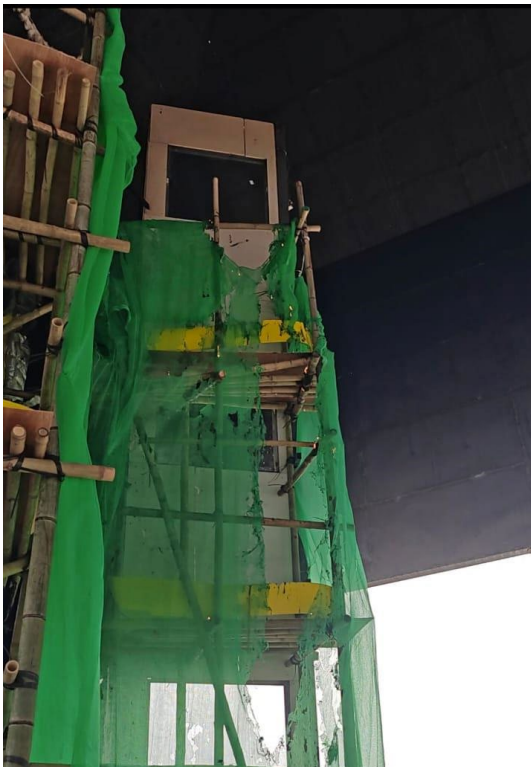
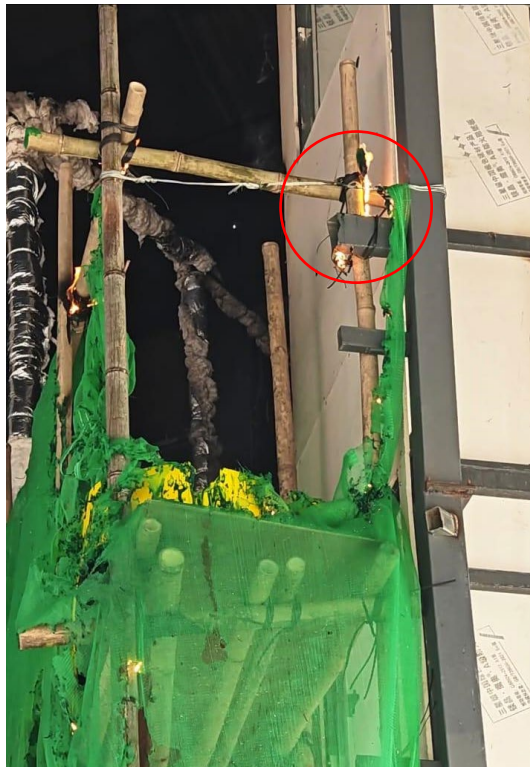
Photos 2-17 (c) & (d): Flaming Droplets Igniting Nylon Strips

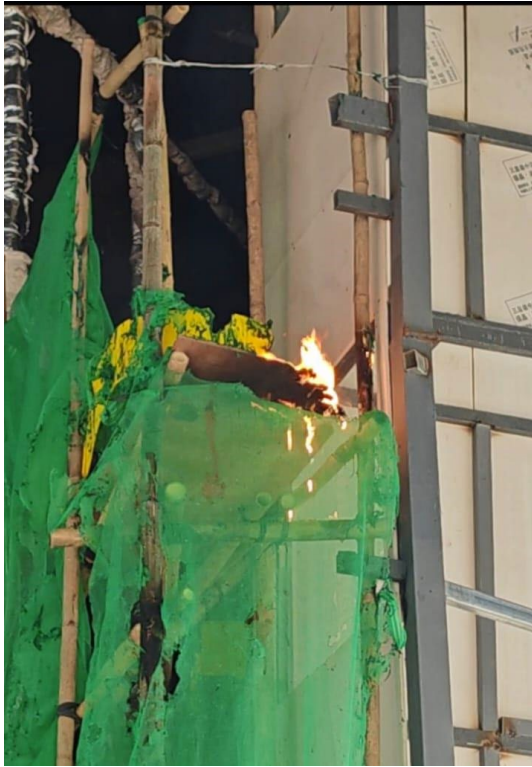
Photo 2-17 (e):  
Fire Spreading to Wooden Planks and  
Toe-Boards

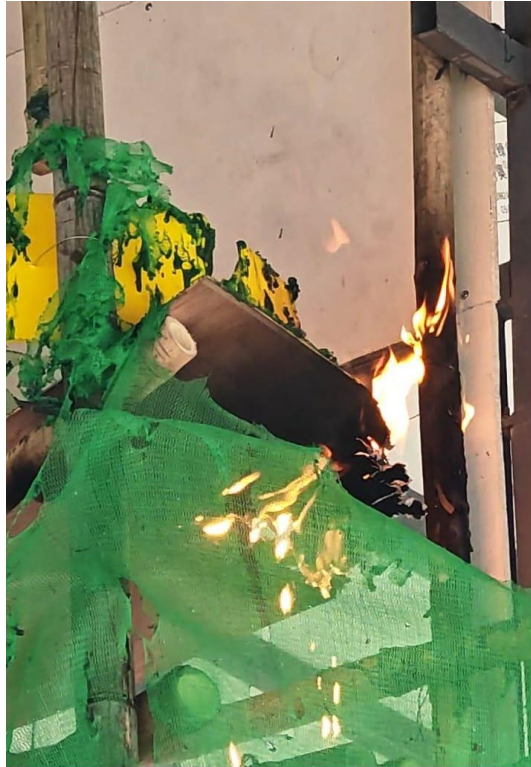
Photo 2-17 (f):  
Flaming Droplets Causing Further Fire  
Propagation.

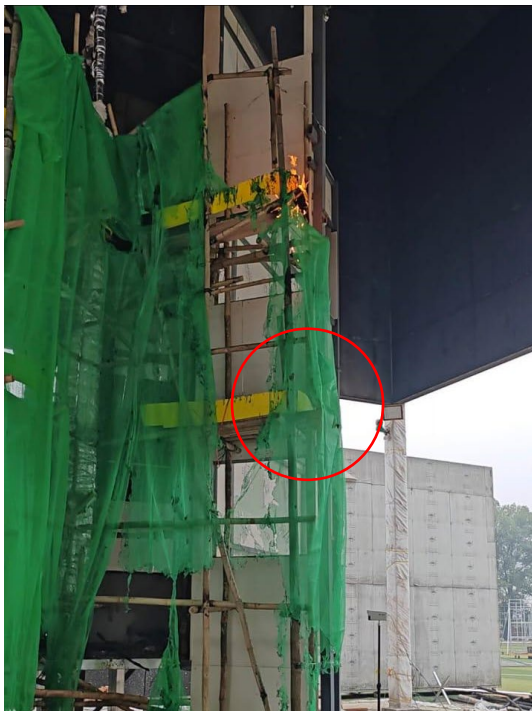
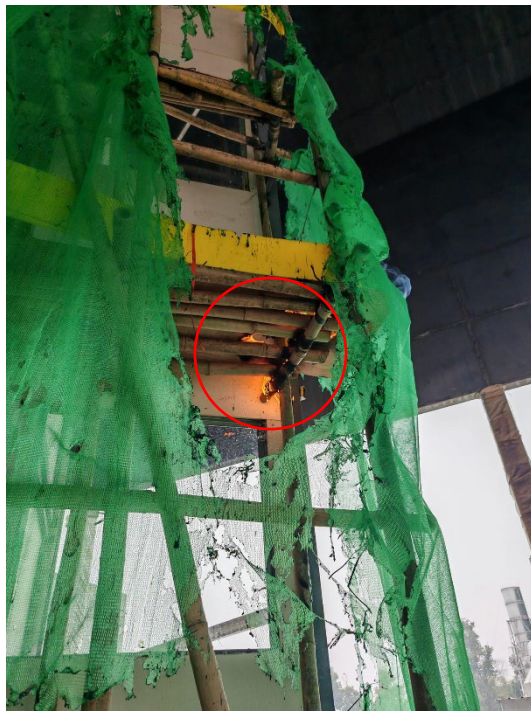
Photos 2-17 (g) & (h): Flaming Droplets Causing Further Fire Propagation.

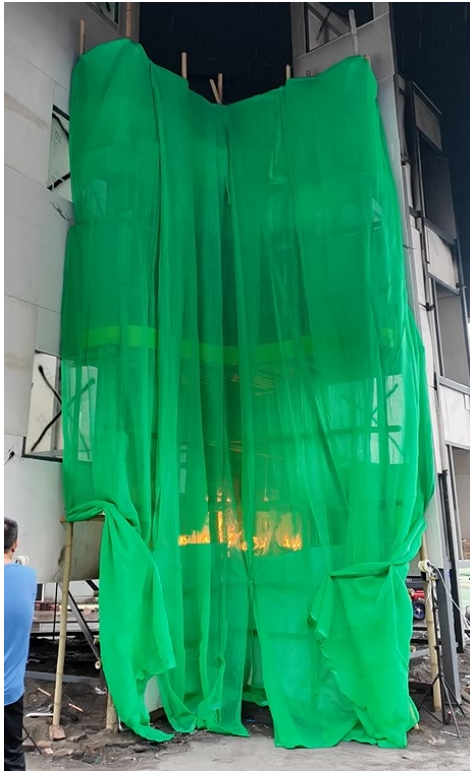
Photo 2-18 (a): No Fire Spread along Safety Nets in Test 11

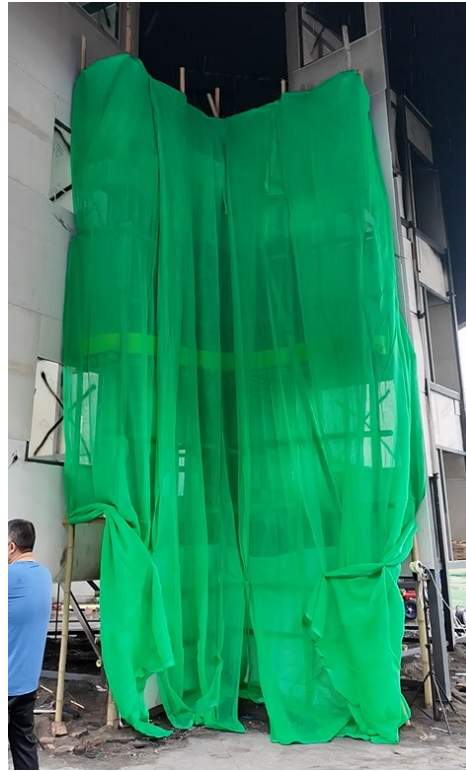
Photo 2-18 (b): Post-Fire Condition in Test 11 using FR Safety Nets and FR Canvas

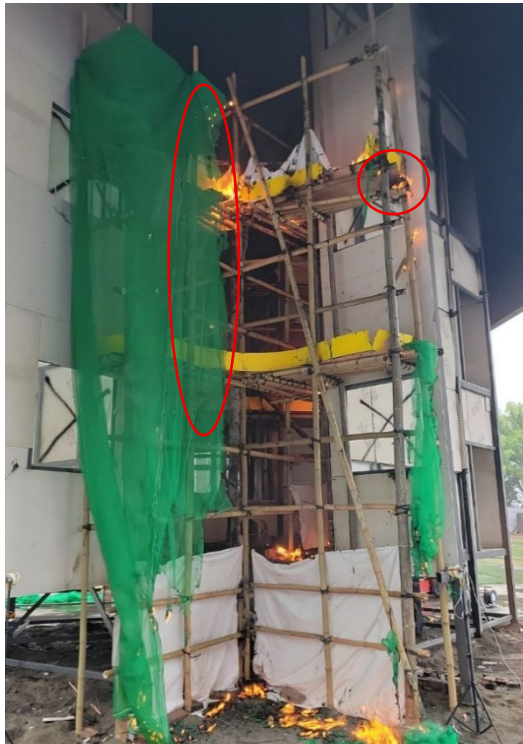
Photo 2-18 (c): Fire Spread along Safety Nets in Test 12

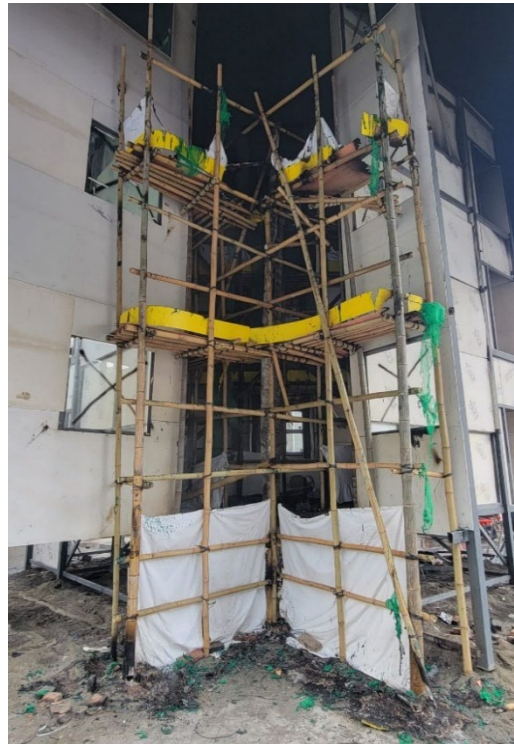
Photo 2-18 (d): Post-Fire Condition in Test 12 using Safety Nets collected Wang Chi House and FR Canvas

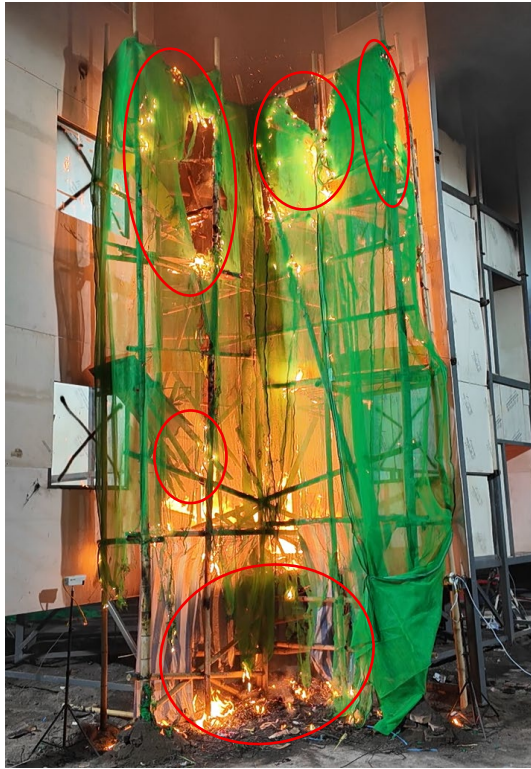
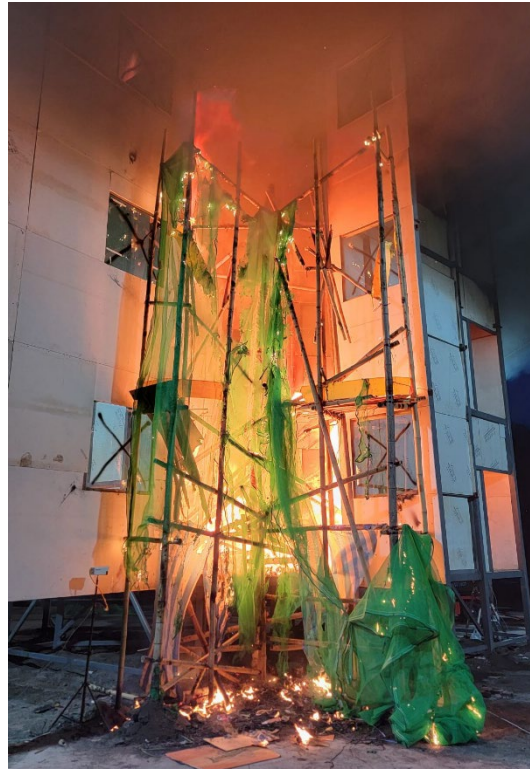
Photos 2-18 (e) & (f): Fire Spread along Safety Nets in Test 13

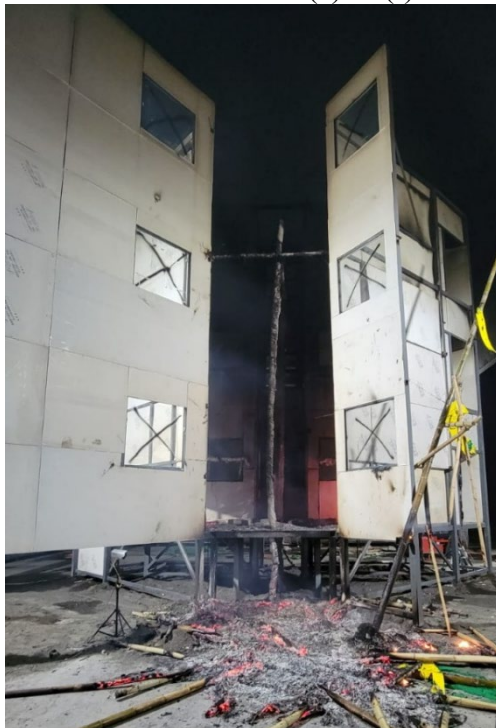
Photo 2-18 (g): Post-Fire Condition in Test 13 using Safety Nets collected Wang Chi House and non-FR Canvas

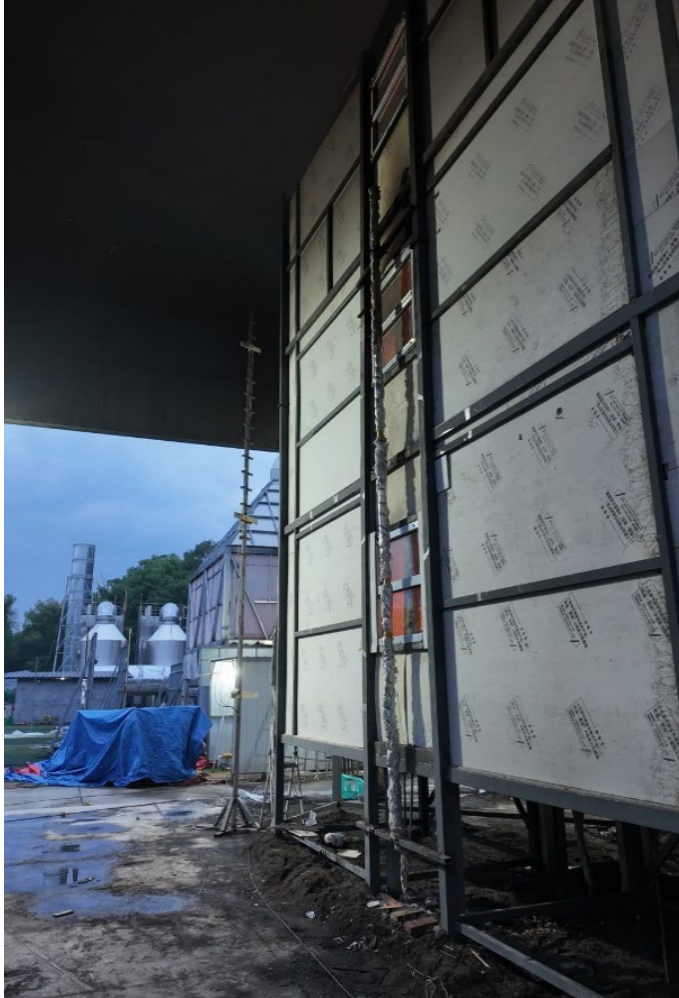
Photo 2-18 (h):  
Condition of Fire-rated  
Glass during Test 13

The tests further reinforce that fire-rated glass windows effectively maintained significant temperature reductions and would have prevented the entry of smoke into staircases in the actual fire scene, ensuring safe evacuation remained a viable option.

- 2.13.5 In the full-scale fire tests, the fire-rated glass windows along the staircase remained intact in the end. Moreover, the fire-rated glass windows can keep the temperature at a suitable level for escape. The use of fire-rated glass windows in Wang Fuk Court could have provided occupants with additional time for evacuation before conditions became fatal.
- 2.13.6 Overall, the tests demonstrated that FR safety nets, FR canvases and fire-rated glass windows can provide sufficient protection for prevention of fire spread and safe escape staircase. On the other hand, if non-FR safety nets, non-FR canvases and polystyrene boards are used, the simulation of fire spread would be similar to the real situation of Wang Fuk Court. The window openings also allowed smoke and fire to enter the staircase.

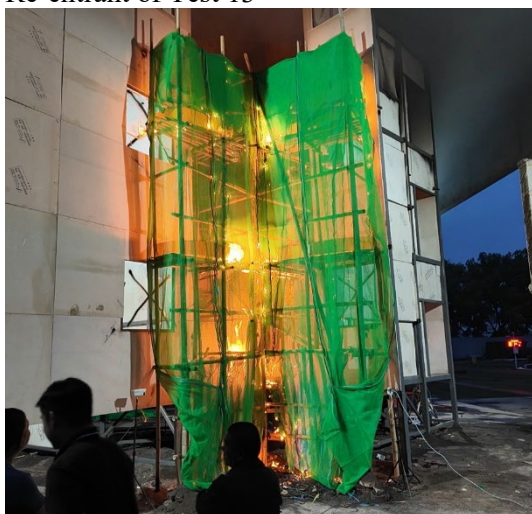
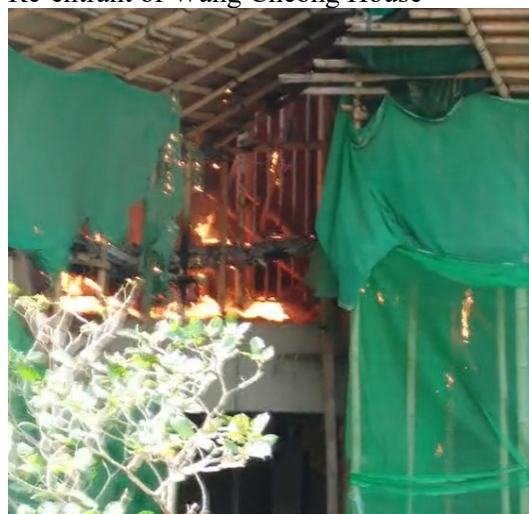
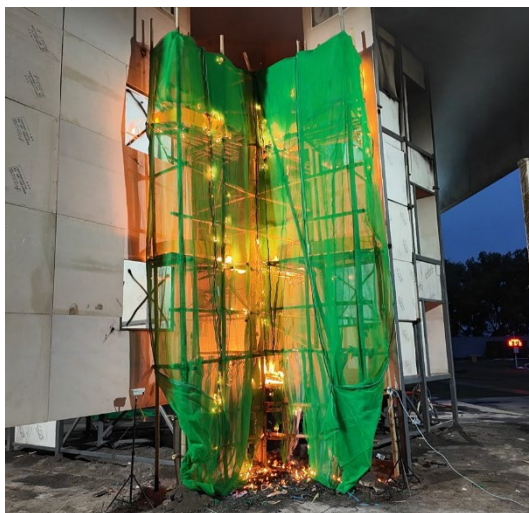
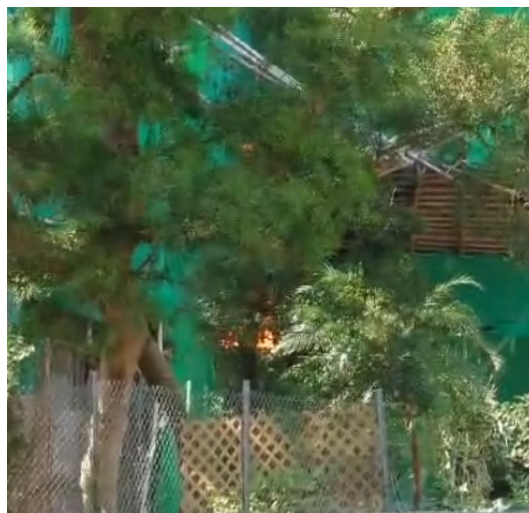
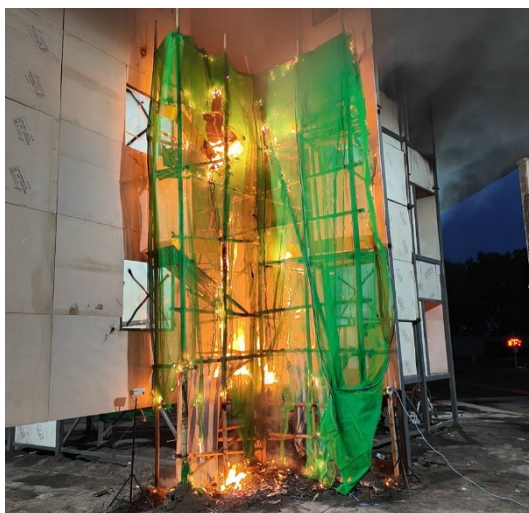
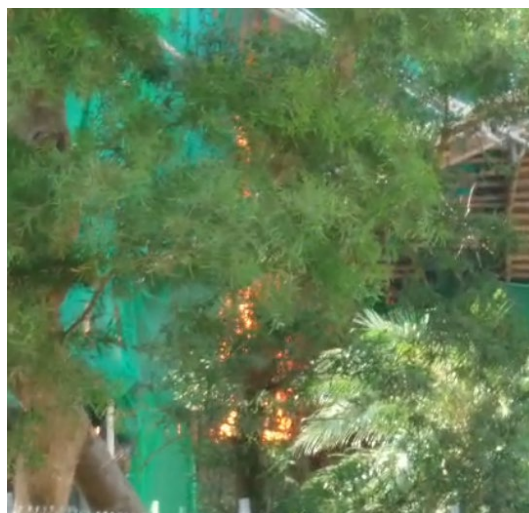
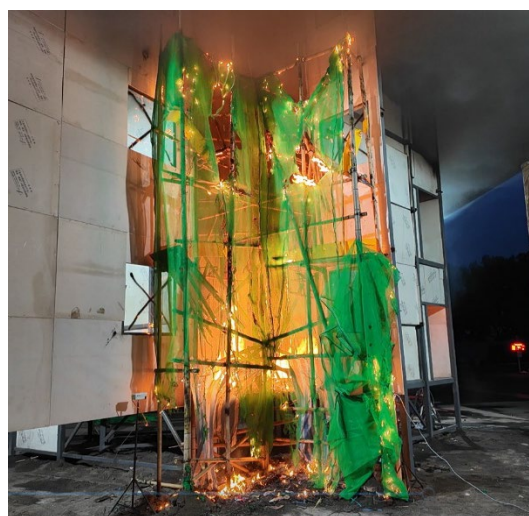
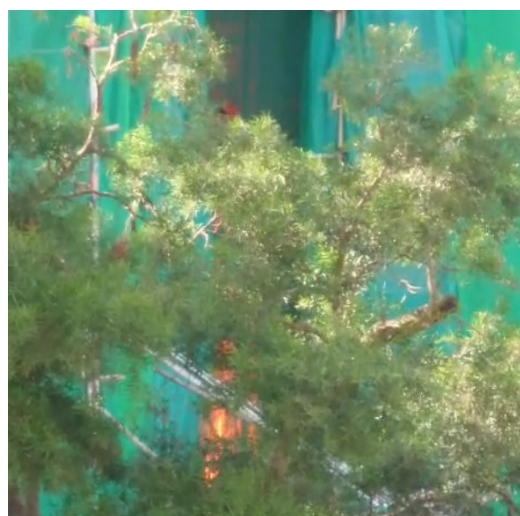
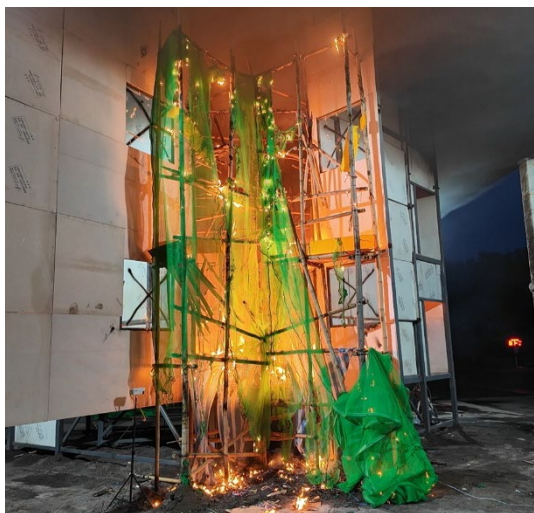
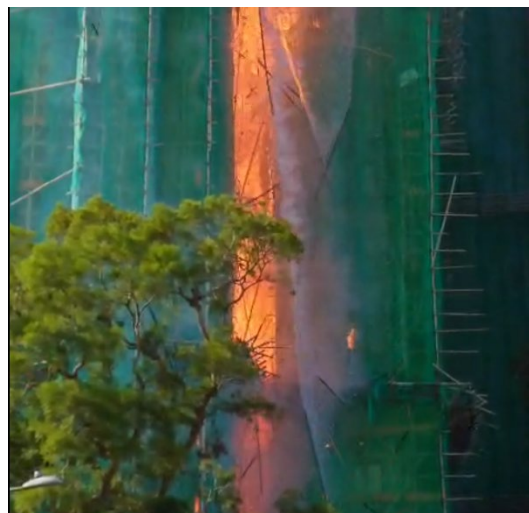
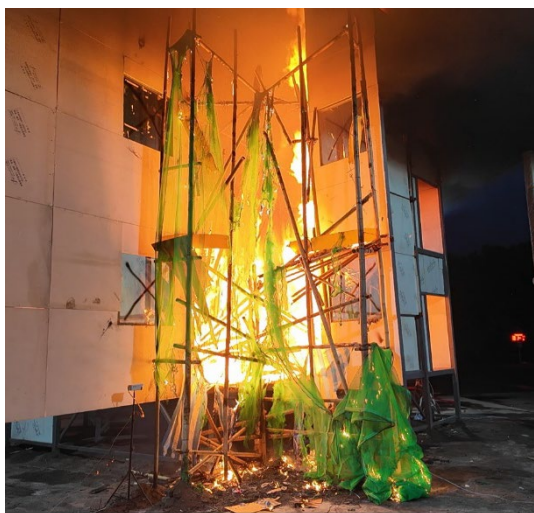
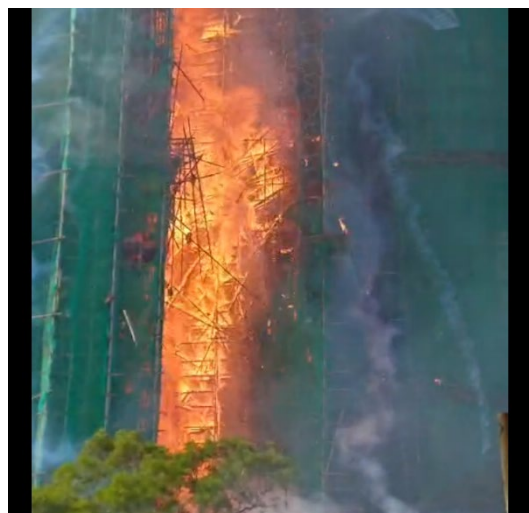
Photos 2-19: Fire Development Comparison between Test 13 and Wang Cheong House

- 2.13.1 After completion of the 13 fire tests, various combinations of materials were tested to examine the fundamentals of the rapid vertical fire spread. Rapid vertical fire spread was observed only in fire tests with large fire size and Test 13 (where a small fire size was used).
- 2.13.2 Based on the test parameters, the combination adopted in Test 13 – involving safety nets collected from Wang Chi House and non-FR canvas with composition verified to be similar to those present at scene <sup>48</sup> – was considered the most comparable to the actual fire scene. Accordingly, a qualitative comparison between the visual image of Test 13 and that of the actual fire scene was presented in Photos 2-19.

2.13.3 The results of Tests 11 and 13 suggested that the risk of ignition and fire propagation can be significantly reduced under small fire conditions when FR safety nets and FR canvases are used. Therefore, the rapid development of the fire (which could even be presumably small) at the origin of the actual fire is likely due to the use of non-FR safety nets and non-FR canvases. If FR materials had been used, the fire would have self-extinguished and not caused the combustible materials inside the re-entrant to catch fire so the fire might not develop.

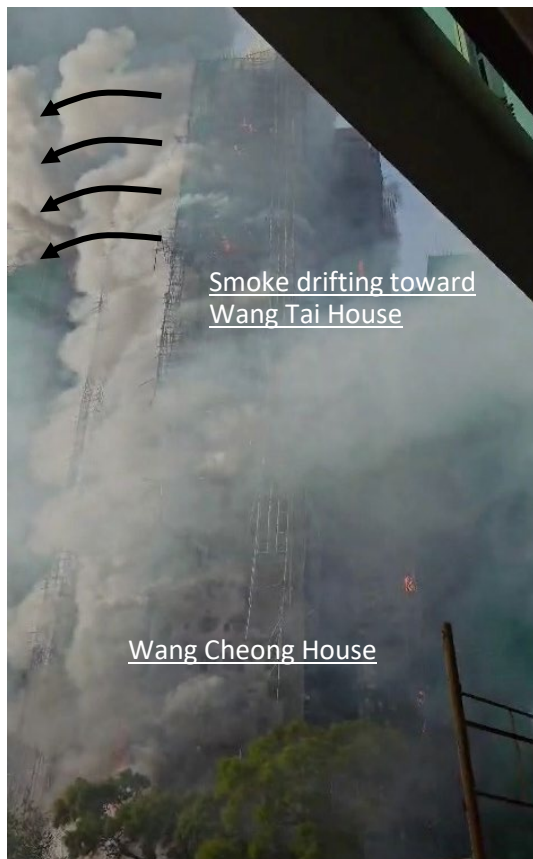
Photo 3-1 (a):  
Heavy Smoke on the South-east Façade  
of Wang Cheong House at 1508 hours

3.2.3 Significant smoke drifting was observed during the incipient stage of the fire, as shown in Photos 3-1 (a) to (c). This drifting was effectively replicated and demonstrated by the CFD simulation, as illustrated in Fig. 3-2.

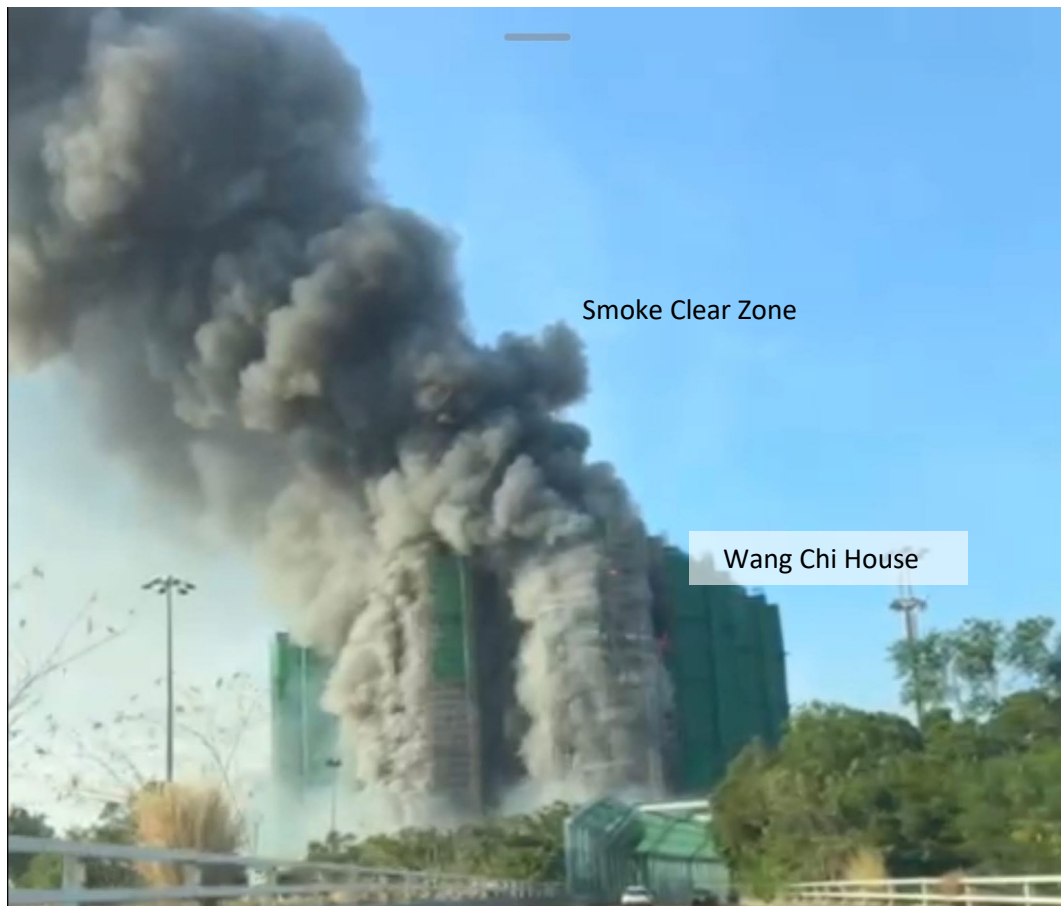
Photo 3-2: Smoke Clear Zone Above Wang Chi House

Court, a fact that can be explained by the wind profile. As shown in Fig. 3-3 (a) and Photo 3-2, buildings experiencing rapid fire spread along re-entrants are marked with red circles. However, as illustrated by the wind vectors, the wind did not carry embers towards Wang Chi House, which may account for its minimal damage.

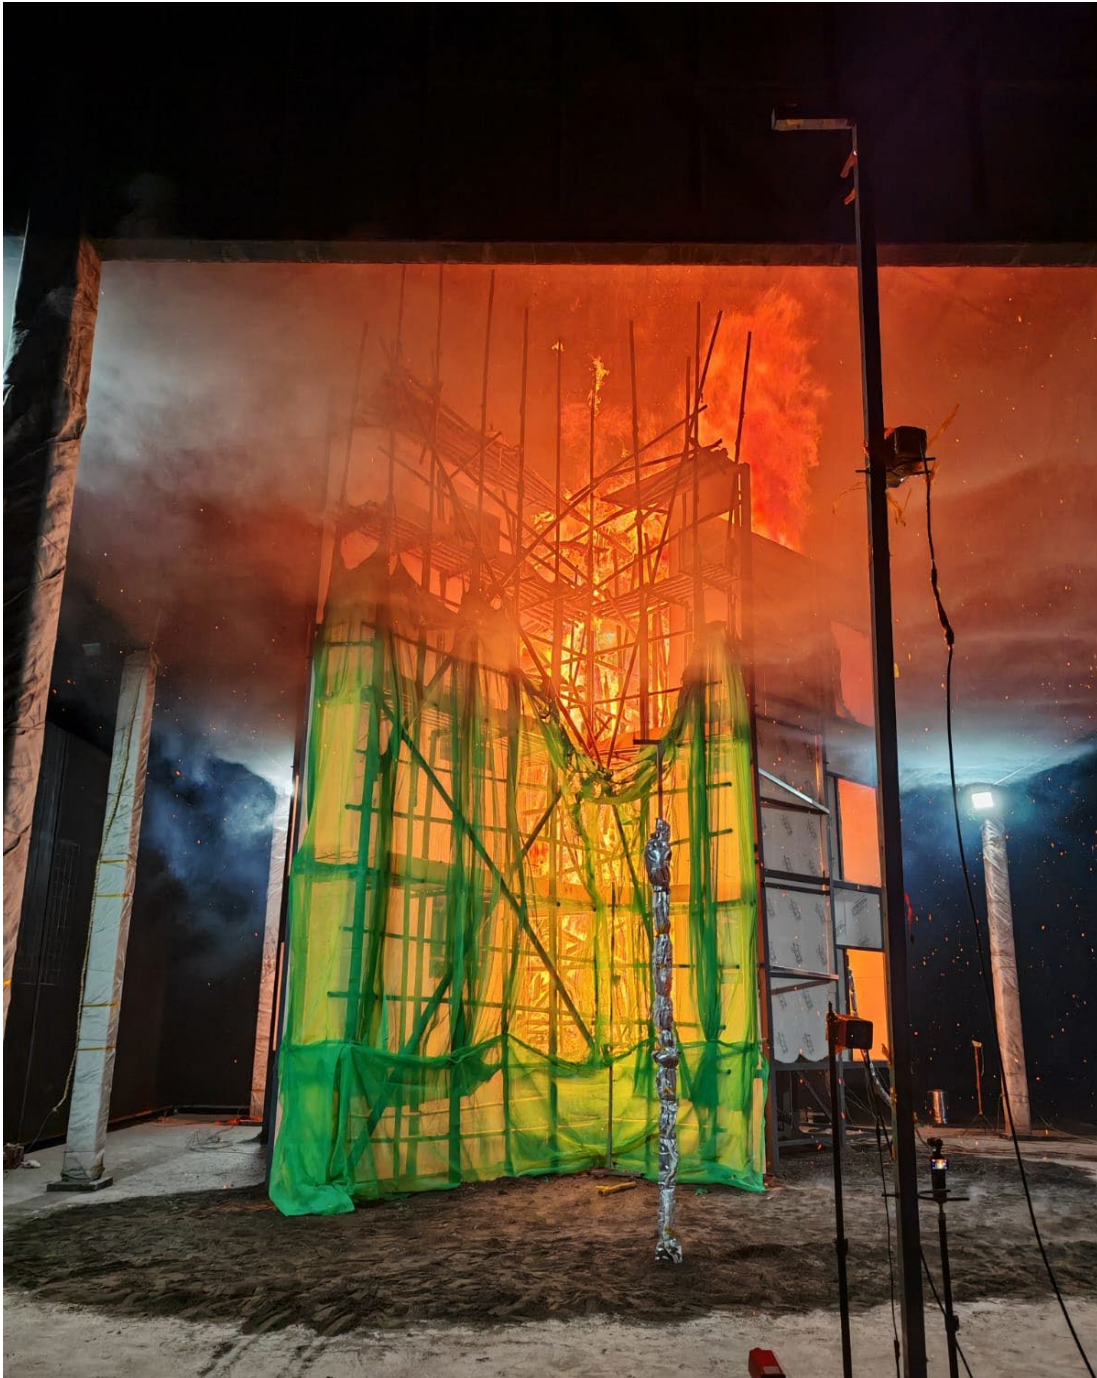
- 4.2.6 To evaluate the impact of the significant accumulation of combustibles identified in the re-entrant area (i.e. bamboo, safety nets, toe-boards and wooden planks), a Fire Severity Analysis, as detailed in Section 2.6, was conducted.
- 4.2.7 Results showed that even with only the identified materials included, the fire exhibited extreme severity, as shown in Photo 4-1. The peak HRR reached 29 MW for a 3-storey setup, equivalent to the peak fire HRR of a bus or heavy goods vehicle in a tunnel fire. In a realistic scenario, with re-entrants spanning 31 storeys and containing additional combustibles (i.e. canvas, polystyrene window covers and backing papers of mosaic tiles), the fire severity could escalate dramatically.

Photo 4-1: Fire Severity Analysis Showing Extreme Fire Severity

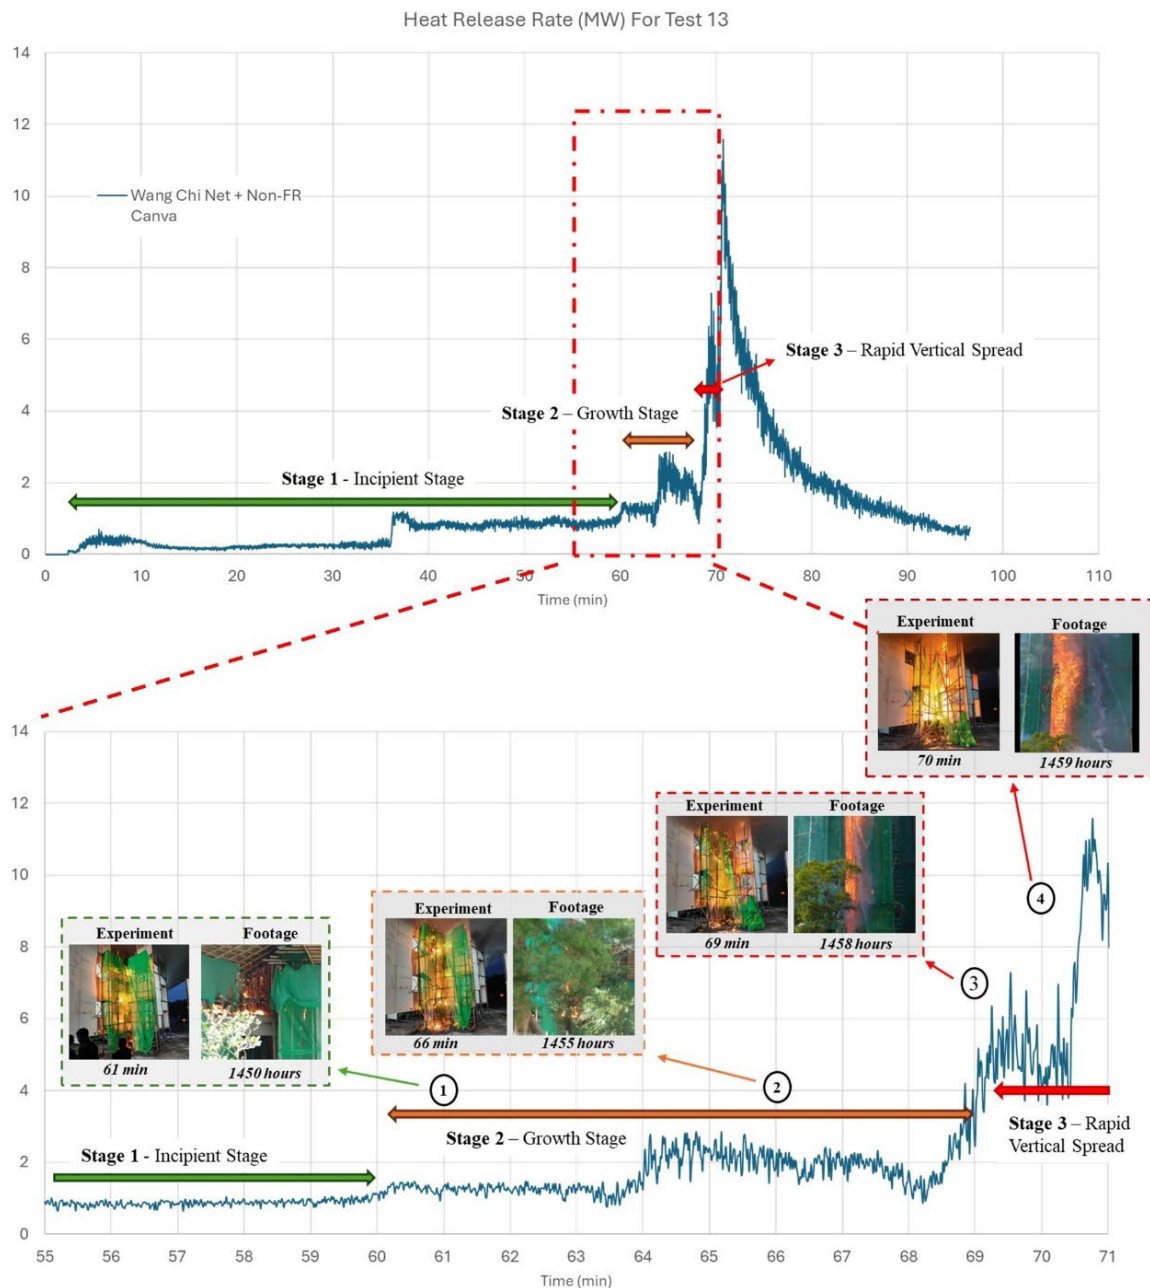
- 4.2.8 The fire spread occurrence observed in Test 13 (with safety nets collected from Wang Chi House and non-FR canvas) and that observed in the Wang Cheong House fire scene are compared in Photo 4-2 and Photo 4-3. The figures in Photo 4-2 show the fire

Photo 4-2: Comparison of fire developments from Wang Cheong House footage and experiment Test 13 at different time snapshots.

- 4.2.12 In Test 13, when safety nets collected from Wang Chi House was combined with non-FR canvas, the fire grew rapidly, producing excessive heat sufficient to ignite bamboo sticks and causing a significant spike in HRR, as shown in Photo 4-2.

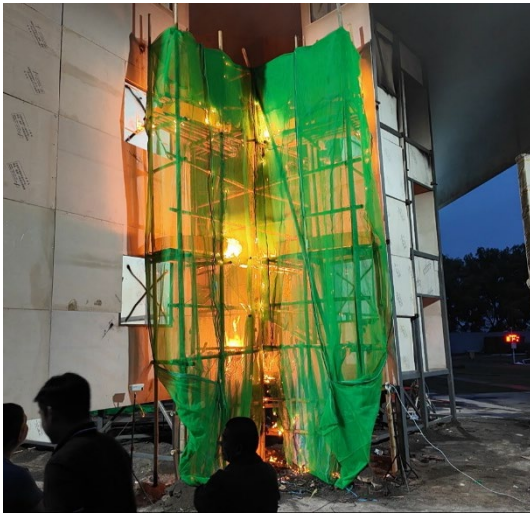
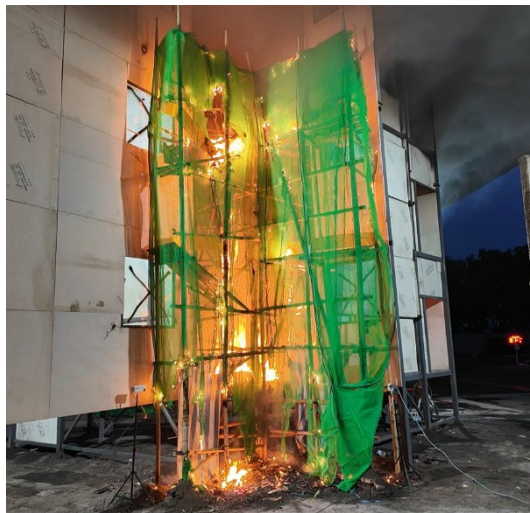
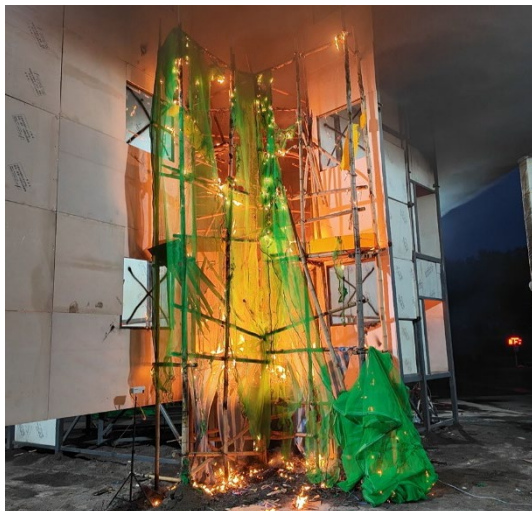
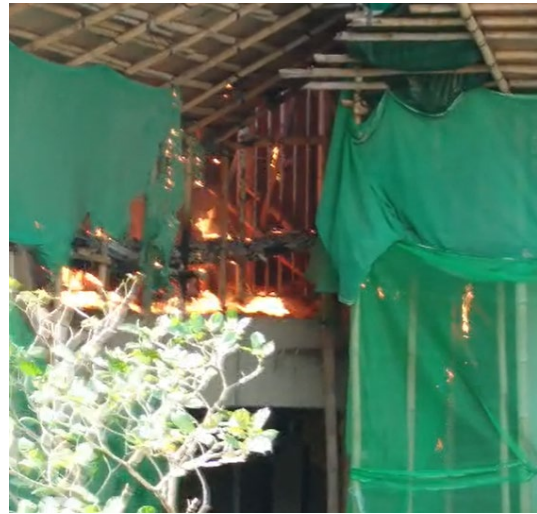
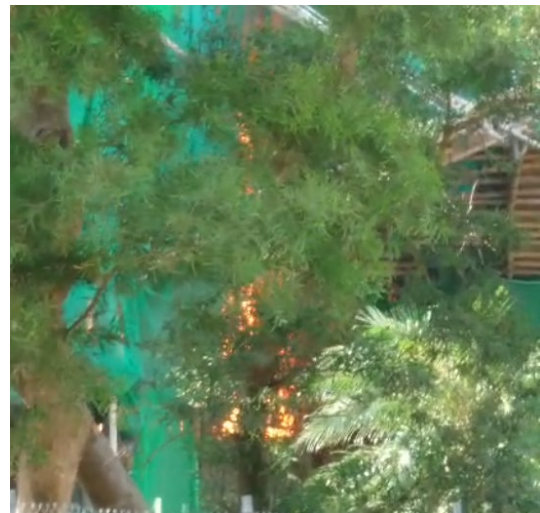
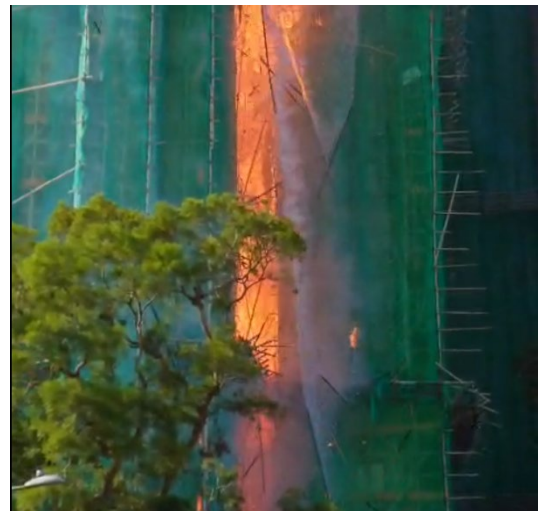
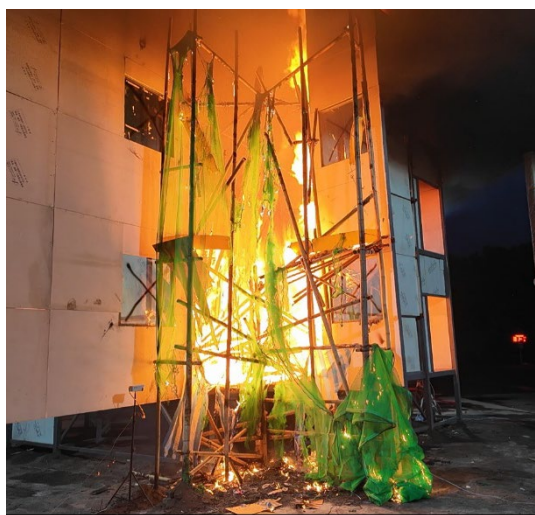
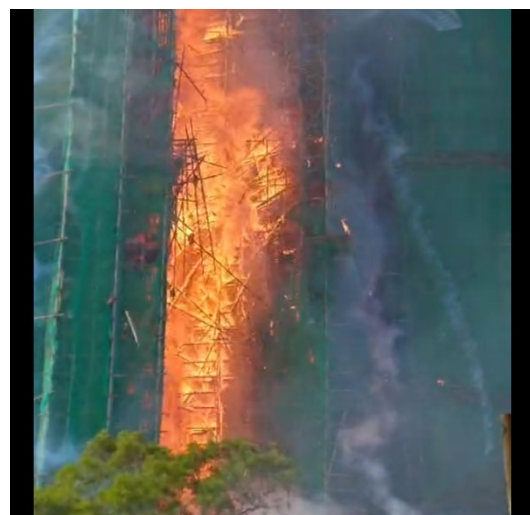
development from the incipient stage to the rapid vertical spread stage. The stages in the Wang Cheong House fire scene and the Test 13 experiment were compared side-by-side in Photos 4-3. The comparison shows that the two fire developments are visually comparable to each other. **Such observations from fire experiments confirm the fundamentals and detailed understandings of the actual fire development on site to be discussed in the subsequent paragraphs.**

Photo 4-3: Comparison of fire developments from Wang Cheong House footage and Test 13 in different fire development stages.
