# Final Investigation Report No.5 Alarm Fire at Wang Fuk Court on 26 November 2025

Inter-Departmental Fire Investigation Task Force

May 2026

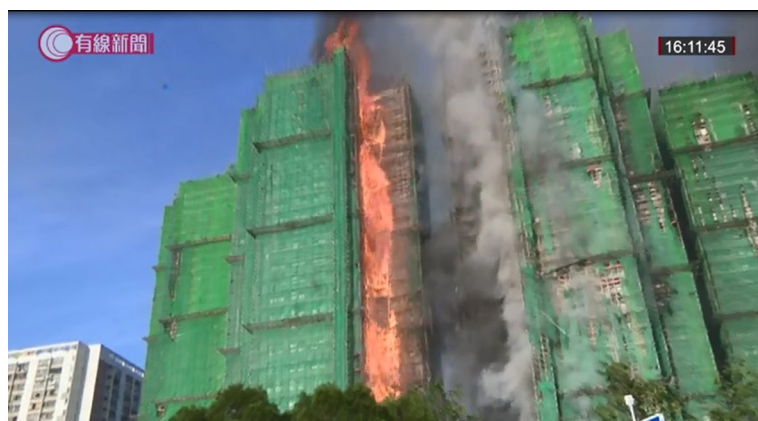
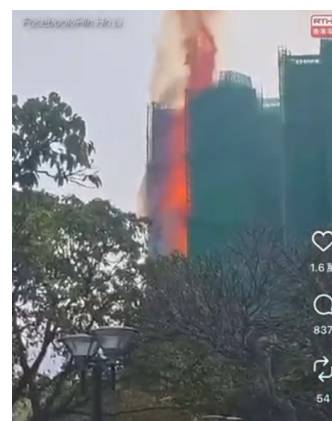
- 4.3.5 The fire spread at Wang Fuk Court was extensive involving seven residential blocks and causing serious damage. Wind-carried embers, falling debris, and fire droplets ignited surrounding combustible materials, significantly contributing to the fire's propagation. During this process, flames from the re-entrant were observed rising higher than the building itself, as shown in Photos 4-4 (a) & (b). These intense flames carried embers to great heights, allowing them to follow the wind flow and travel considerable distances before falling, as shown in Fig. 4-2.

Photos 4-4 (a) & (b): Flames from the Re-entrant Observed Rising Higher than the Building at Wang Cheong House & Wang Tao House

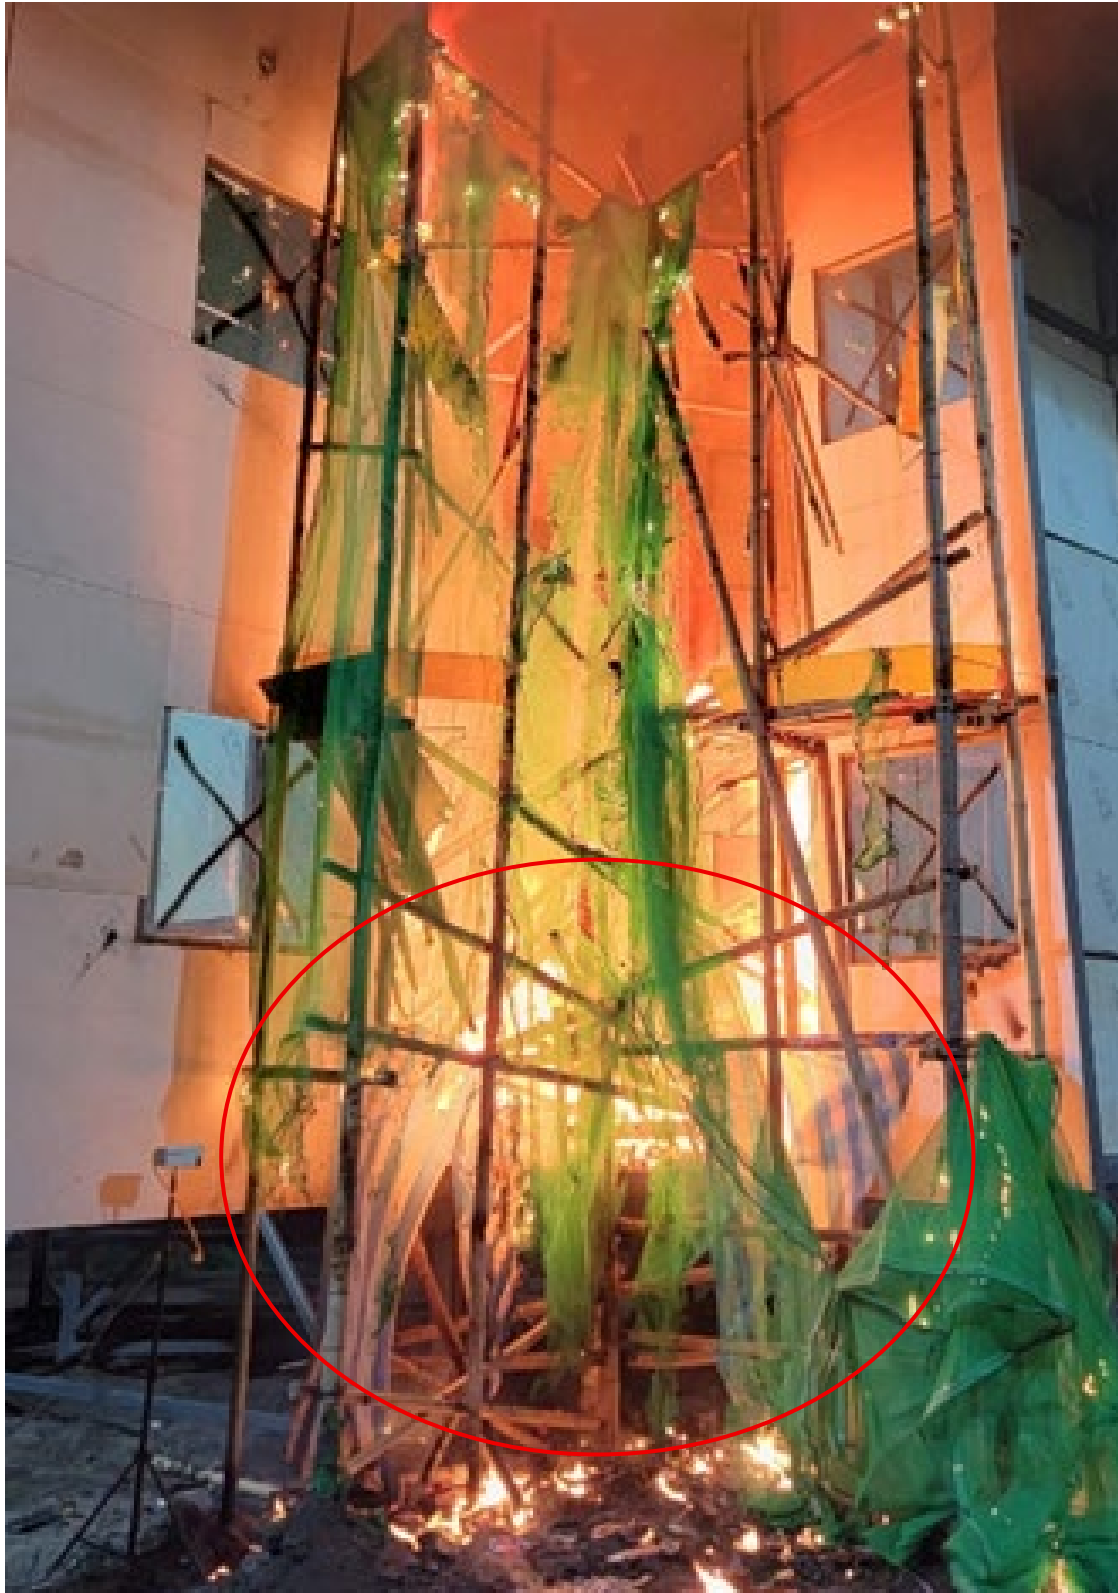
- 4.3.6 The test setup involved bamboo scaffolding, where bamboo poles were secured with nylon strips and numerous combustible materials were placed on or attached to the building envelope. From the fire tests, it was observed that fire damage to the bamboo and nylon strips resulted in a loss of stability of the scaffolding structure, as shown in Photo 4-6. When the fire spread caused severe damage to the bamboo scaffolding and nylon strips, burning components and other combustibles fell to the lower or ground level (as shown in Photo 4-7), further intensifying the fire spread.

Photo 4-6: Collapsed Burning Bamboo from the Damaged Bamboo Scaffolding in Fire Test

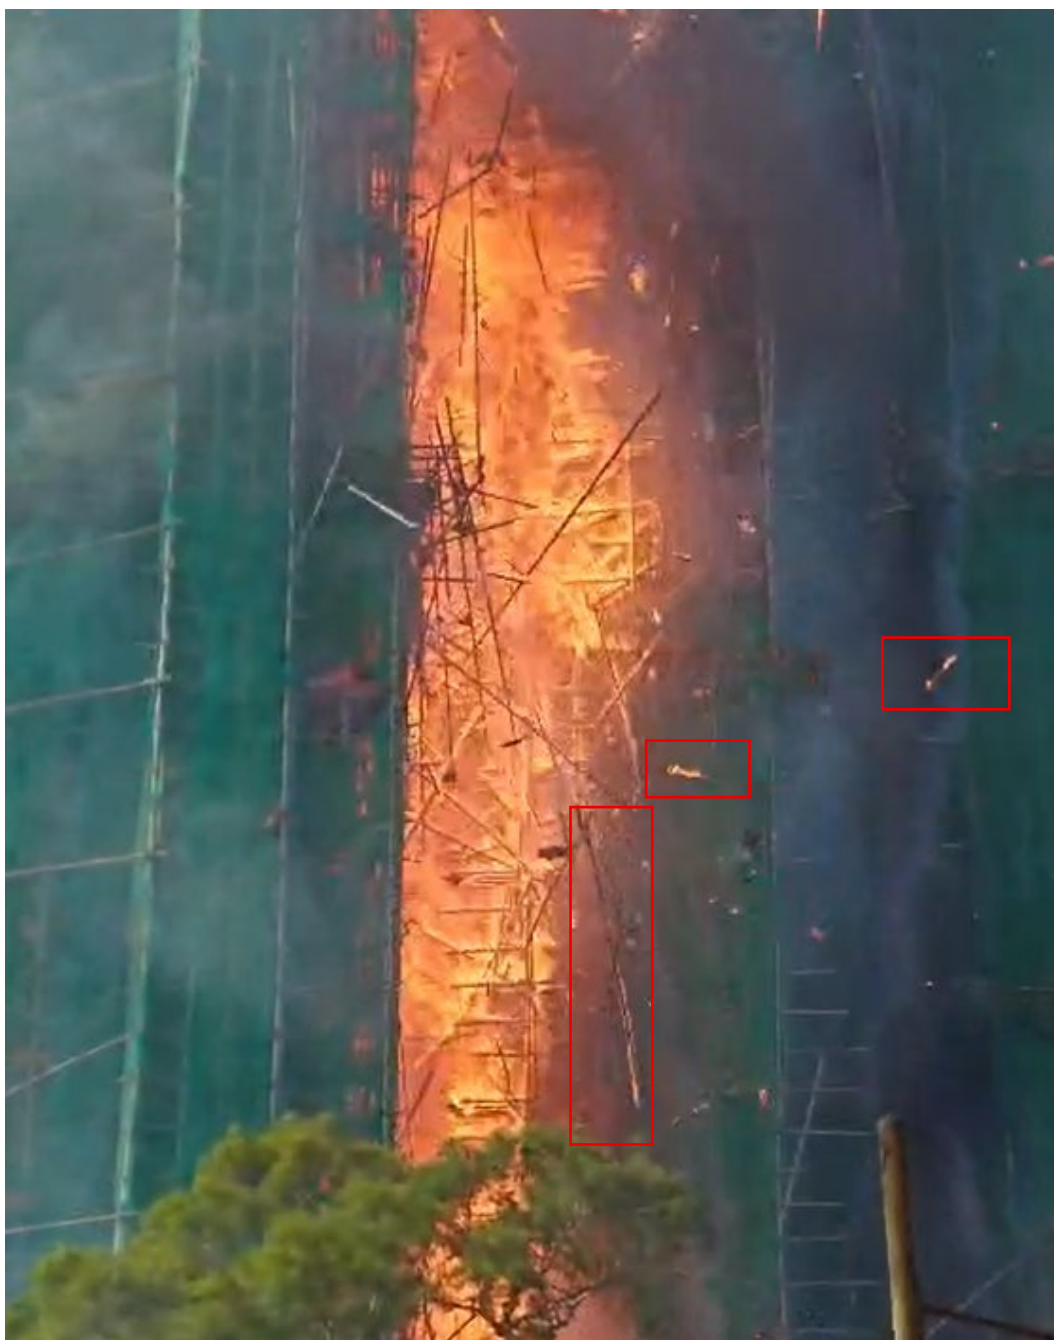
Photo 4-7: Collapsed Burning Debris from the Damaged Bamboo Scaffolding

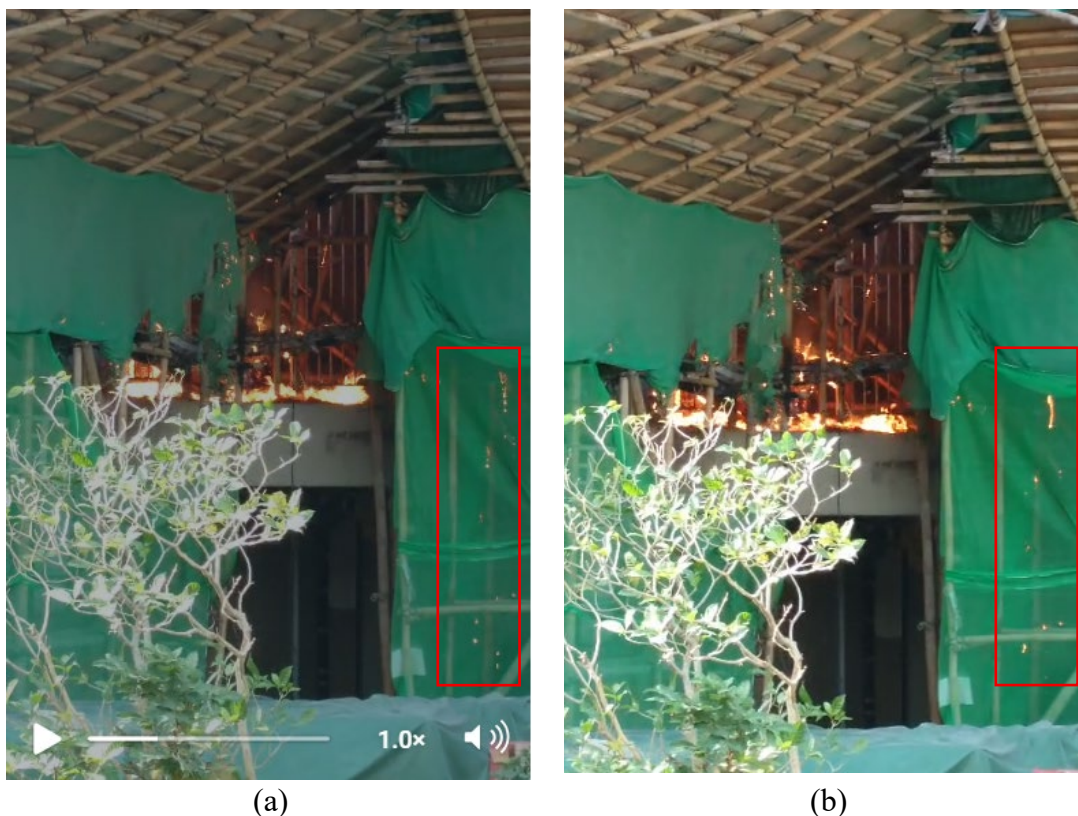
- 4.3.8 This phenomenon could be observed at the initial stages of the Wang Fuk Court fire incident as shown in Photos 4-7 (a) & (b).
- 4.3.9 According to the test results from GL<sup>60</sup>, the burning of safety nets, foam boards and toe-boards demonstrated the formation of fire droplets. In the fire test in paragraph 2.11.5, the significant fire hazard associated with foam board materials (polystyrene window covers) was demonstrated and their potential risk contributing to rapid fire spread was also validated.

Photos 4-7 (a) & (b): Fire droplets Dripping from Burning Materials  
Observed During the Initial Stage of Fire

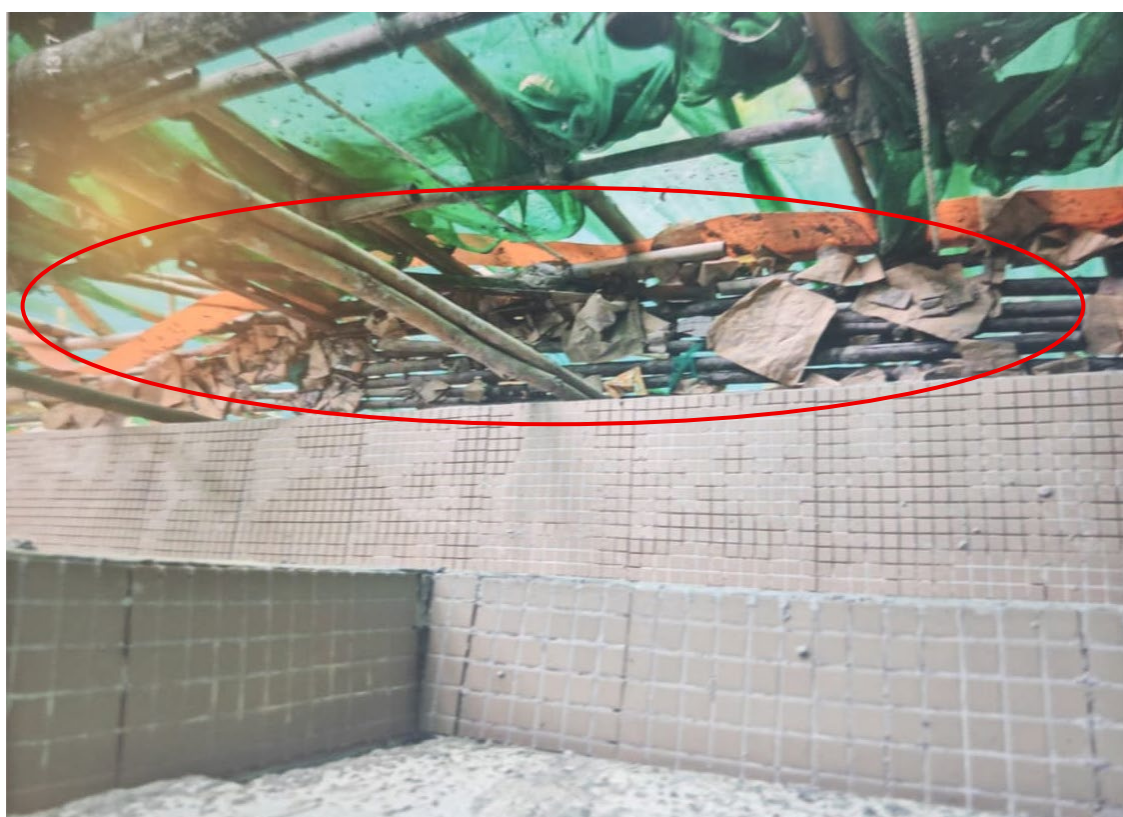
- 4.3.10 In addition to ignition sources, the presence of combustible materials significantly influenced the fire development. Surrounded by combustible envelopes, including bamboo, toe-boards, wooden planks, safety nets, canvas, nylon strips, and even miscellaneous waste from the works, the buildings in Wang Fuk Court possessed an abundant fuel source, sustaining and intensifying the fire, as shown in Photos 4-7 (c) to (f).

Photos 4-7 (c): Combustible materials on the External Scaffolding

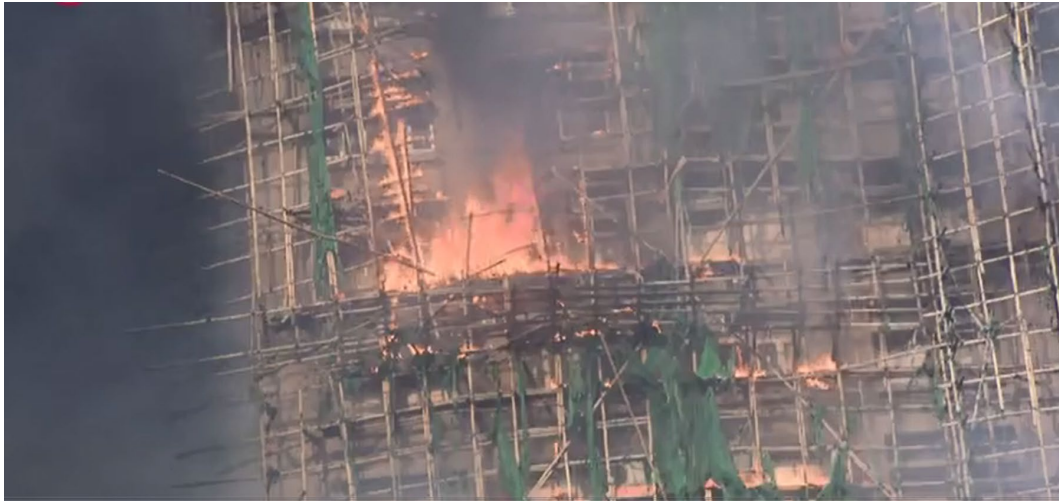
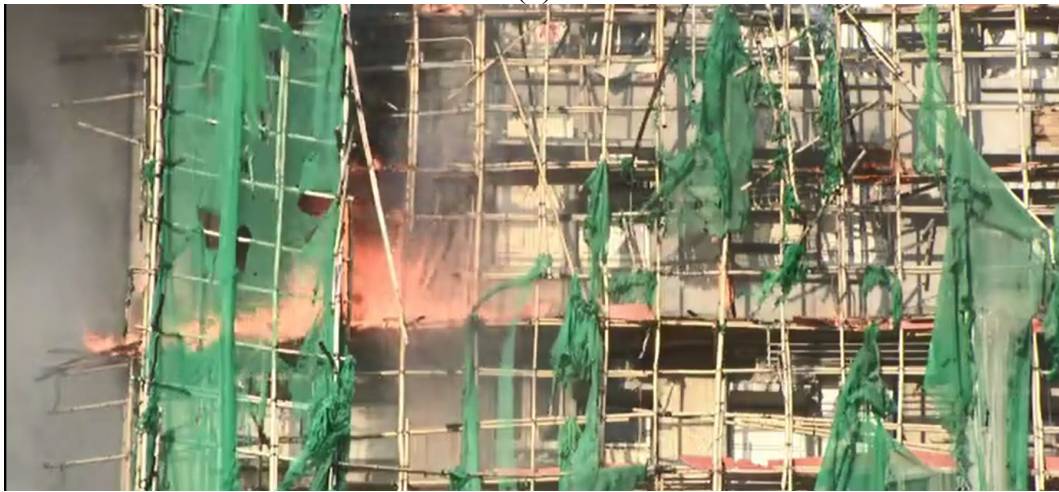
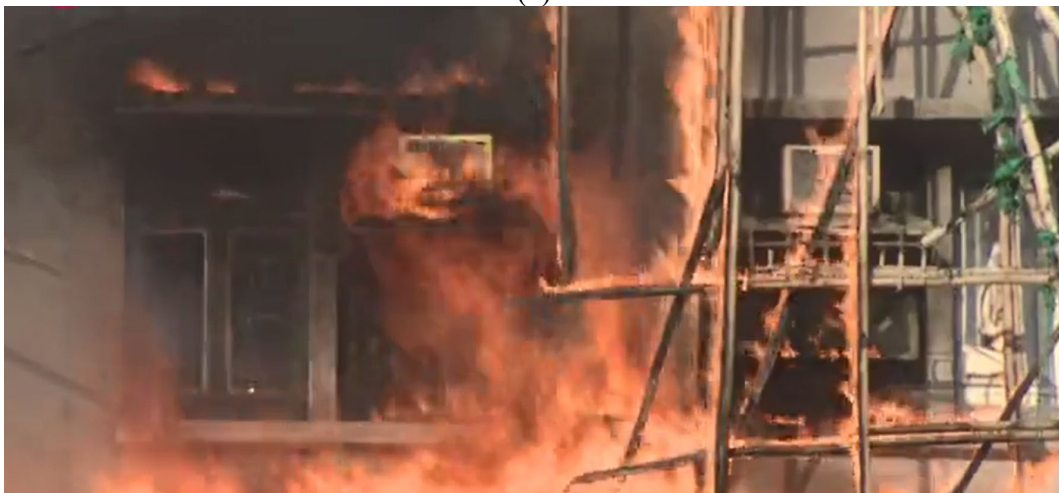
Photos 4-7 (d) to (f): Combustible Envelope Burning in Fire Development

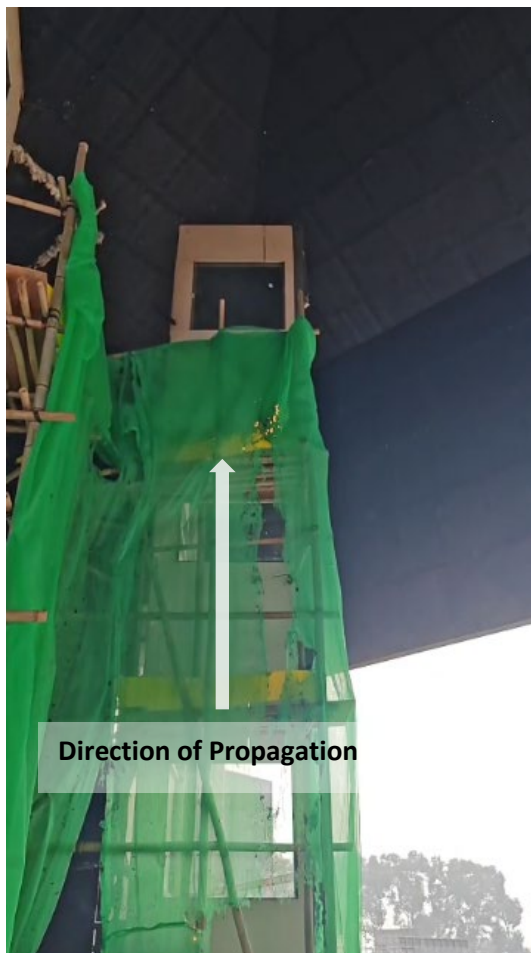
- 4.3.15 The fire propagated along the safety nets until it encountered suitable combustibles, such as nylon strips. The ignited strips subsequently set fire to other materials, including toe-boards and wooden planks, further developing and sustaining the fire, as shown in Photos 4-8 (a) to (d).
- 4.3.16 During the post-fire visit, it was further observed that wind-carried embers, falling debris, and fire droplets not only spread to the combustible envelope but also ignited combustibles and construction materials scattered on the ground floor level. This contributed to the fire's further spread and exacerbated the damage, as shown in Photos 4-9 (a) to (h).

Photo 4-8 (a): Small Fire Propagated along the Safety Net

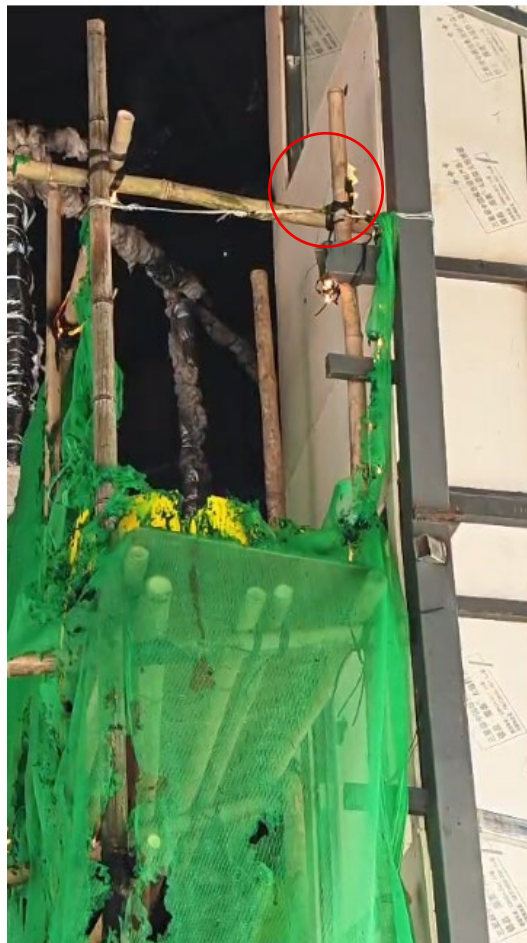
Photo 4-8 (b): Nylon Strips Alight

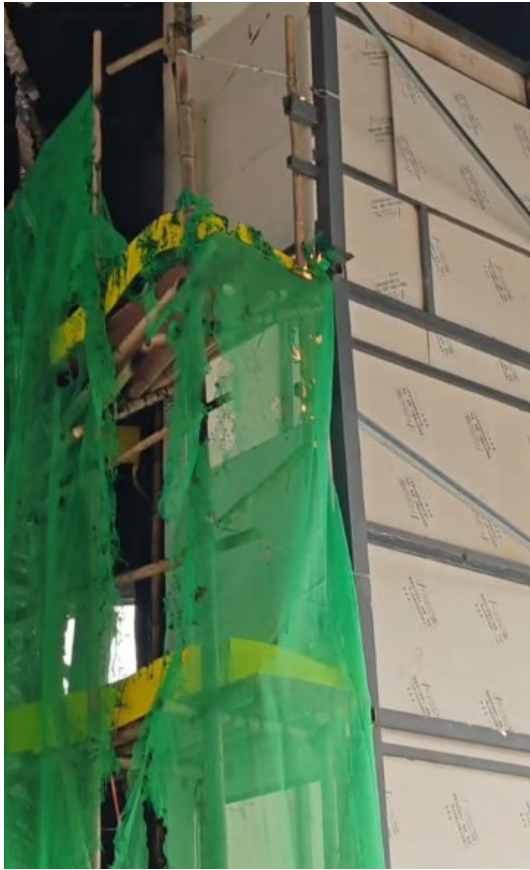
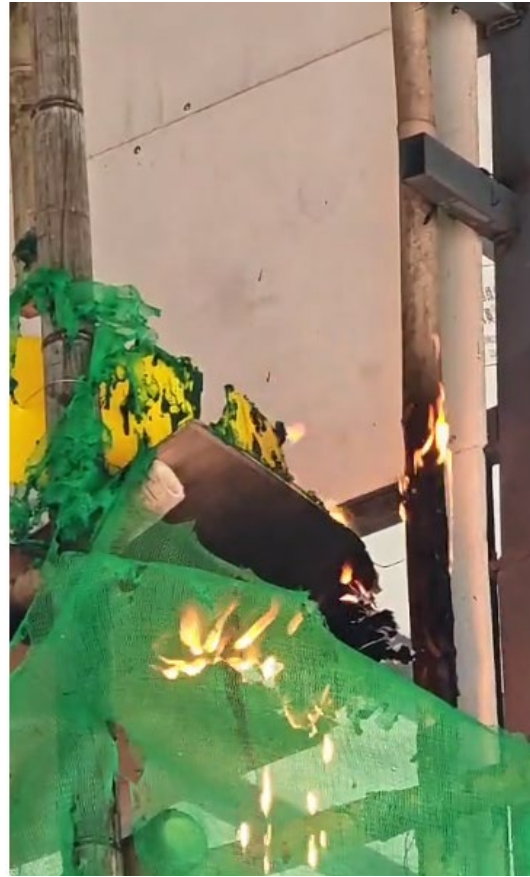
Photos 4-8 (c) & (d): Other Combustibles (Toe-Boards and Wooden Planks) Alight

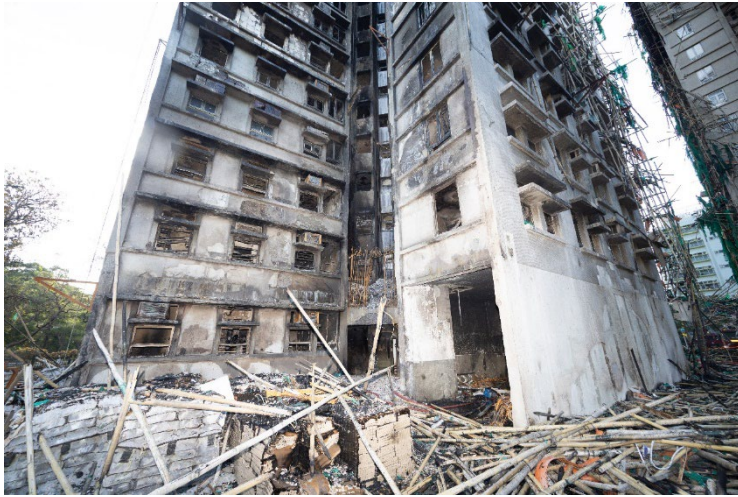
Photo 4-9 (a):  
Post-Fire Condition outside the East Re-entrant of Wang  
Cheong House

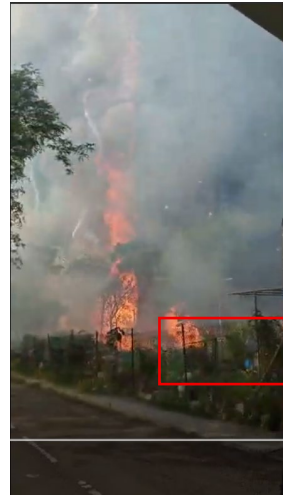
Photo 4-9 (b):  
Observed Fire Spread

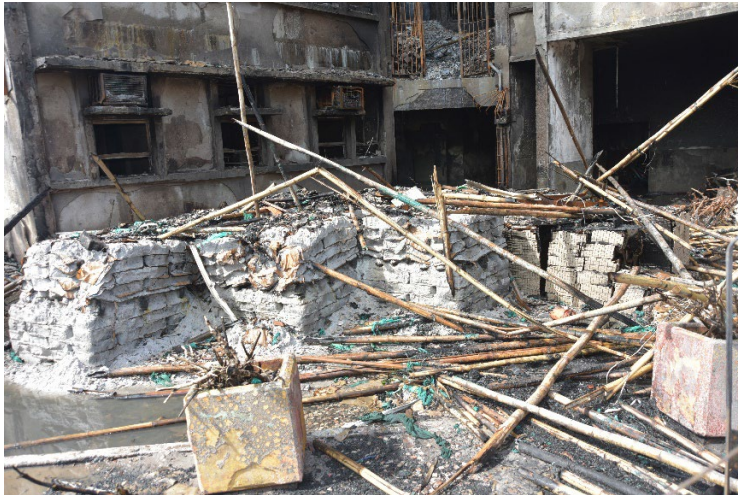
Photo 4-9 (c): Post-Fire Condition outside the  
East Re-entrant of Wang Cheong House

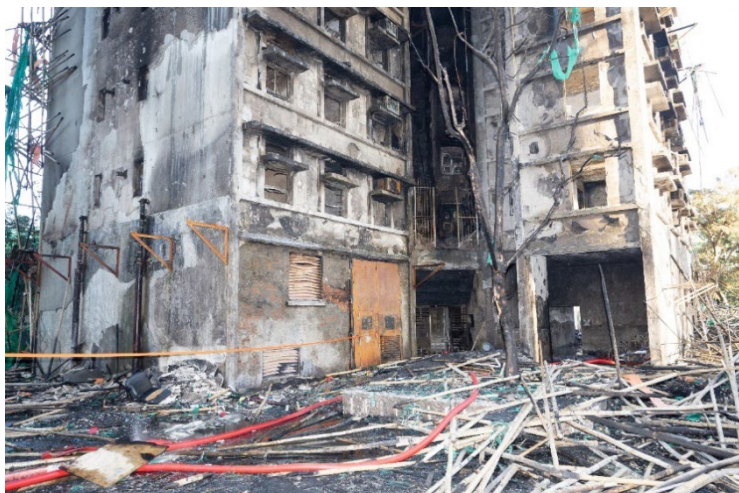
Photo 4-9 (d):  
Post-Fire Condition outside the West Re-entrant of  
Wang Cheong House

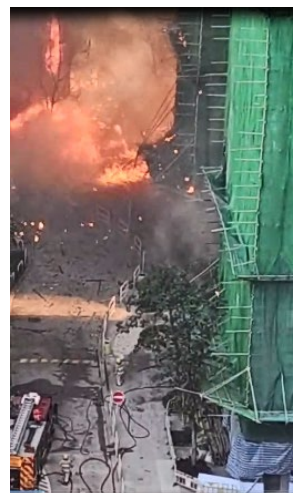
Photo 4-9 (e):  
Observed Fire Spread

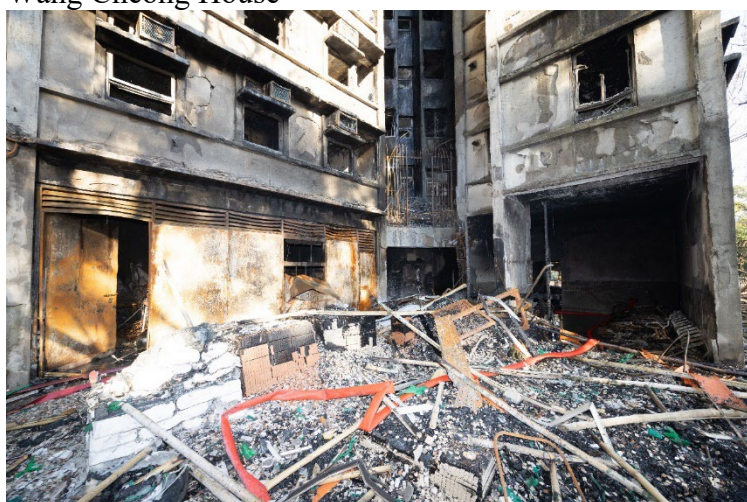
Photo 4-9 (f):  
Post-Fire Condition outside the East Re-entrant of Wang  
Tai House Facing Wang Cheong House

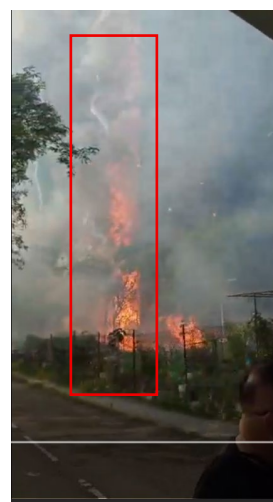
Photo 4-9 (g):  
Observed Fire Spread

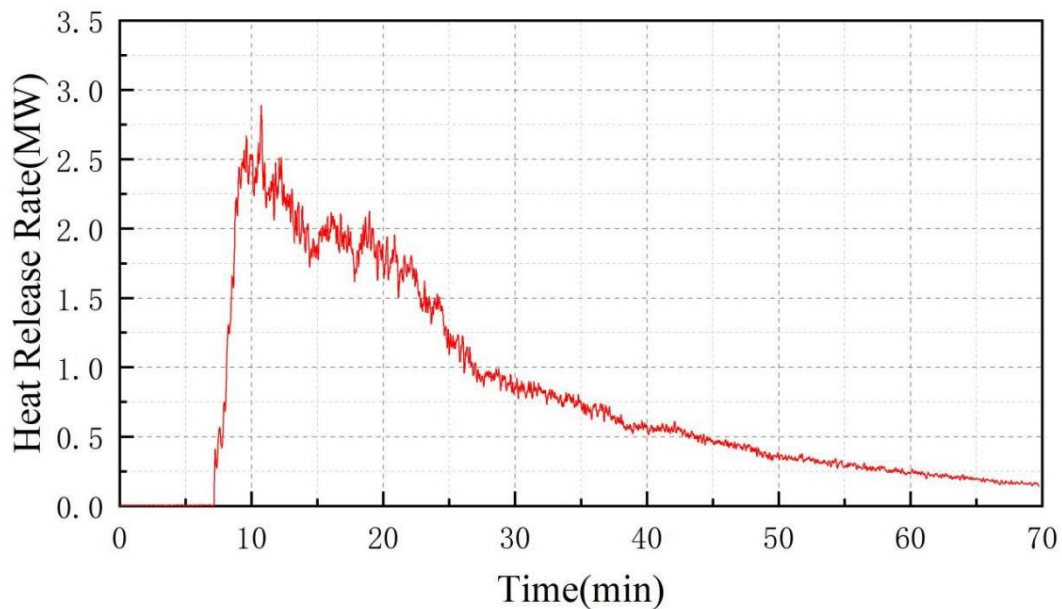
Fig. 2.13 Heat release rate of the wood crib

The peak heat release rate of the wood crib combustion was measured to be approximately 2.5 MW.

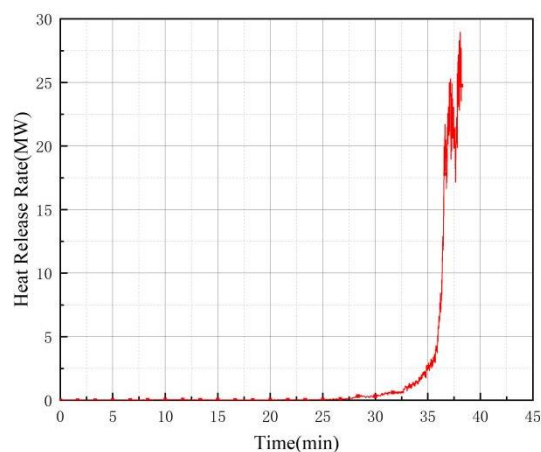
Fig. 2.15 HRR curve

As shown in Table 2.1, fire-retardant-net, windows-without-foam and 4 layers of horizontal bamboo were adopted in this experiment. The ignition time of the experiment was at 18:19:36 on 11 January 2026. The Heat Release Rate (HRR) reached its peak at 18:53:52, with a value of 28.974 MW. This indicated the intense combustion phase of bamboo scaffolding and wooden blocks, with a further increasing trend in fire intensity. To avoid damage to the testing

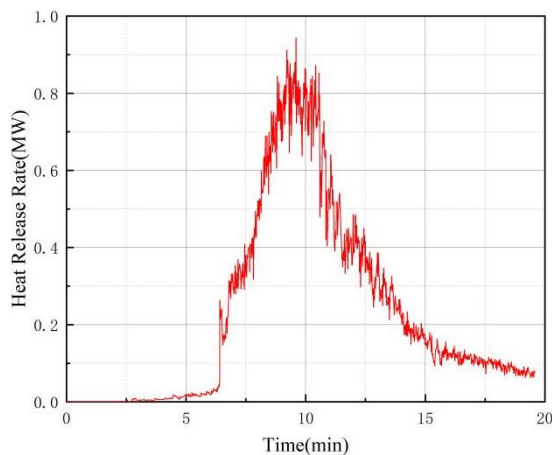
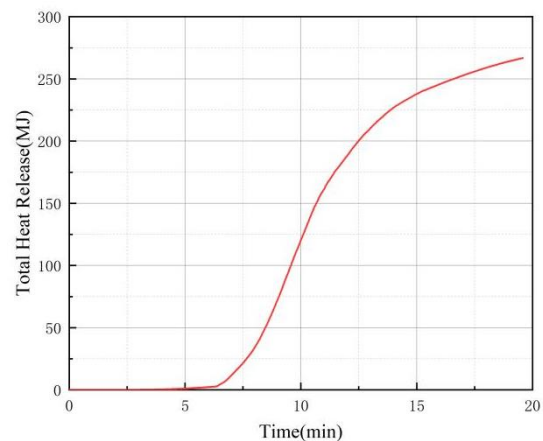
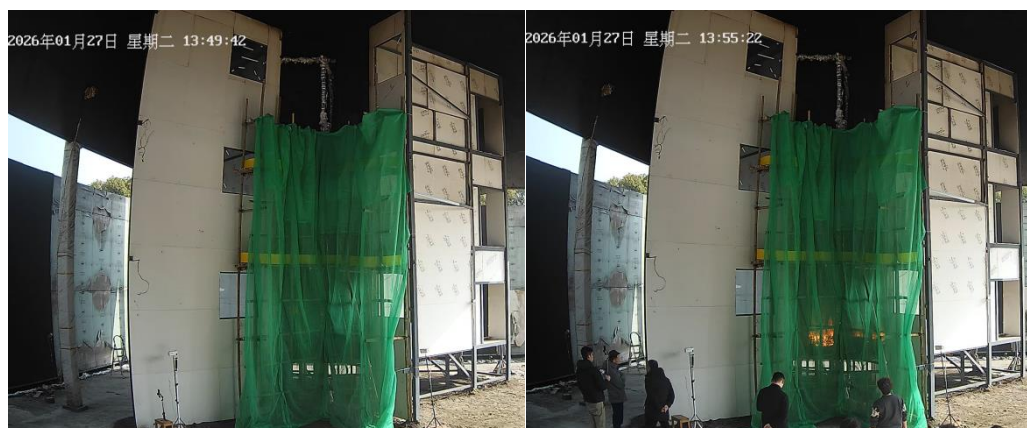
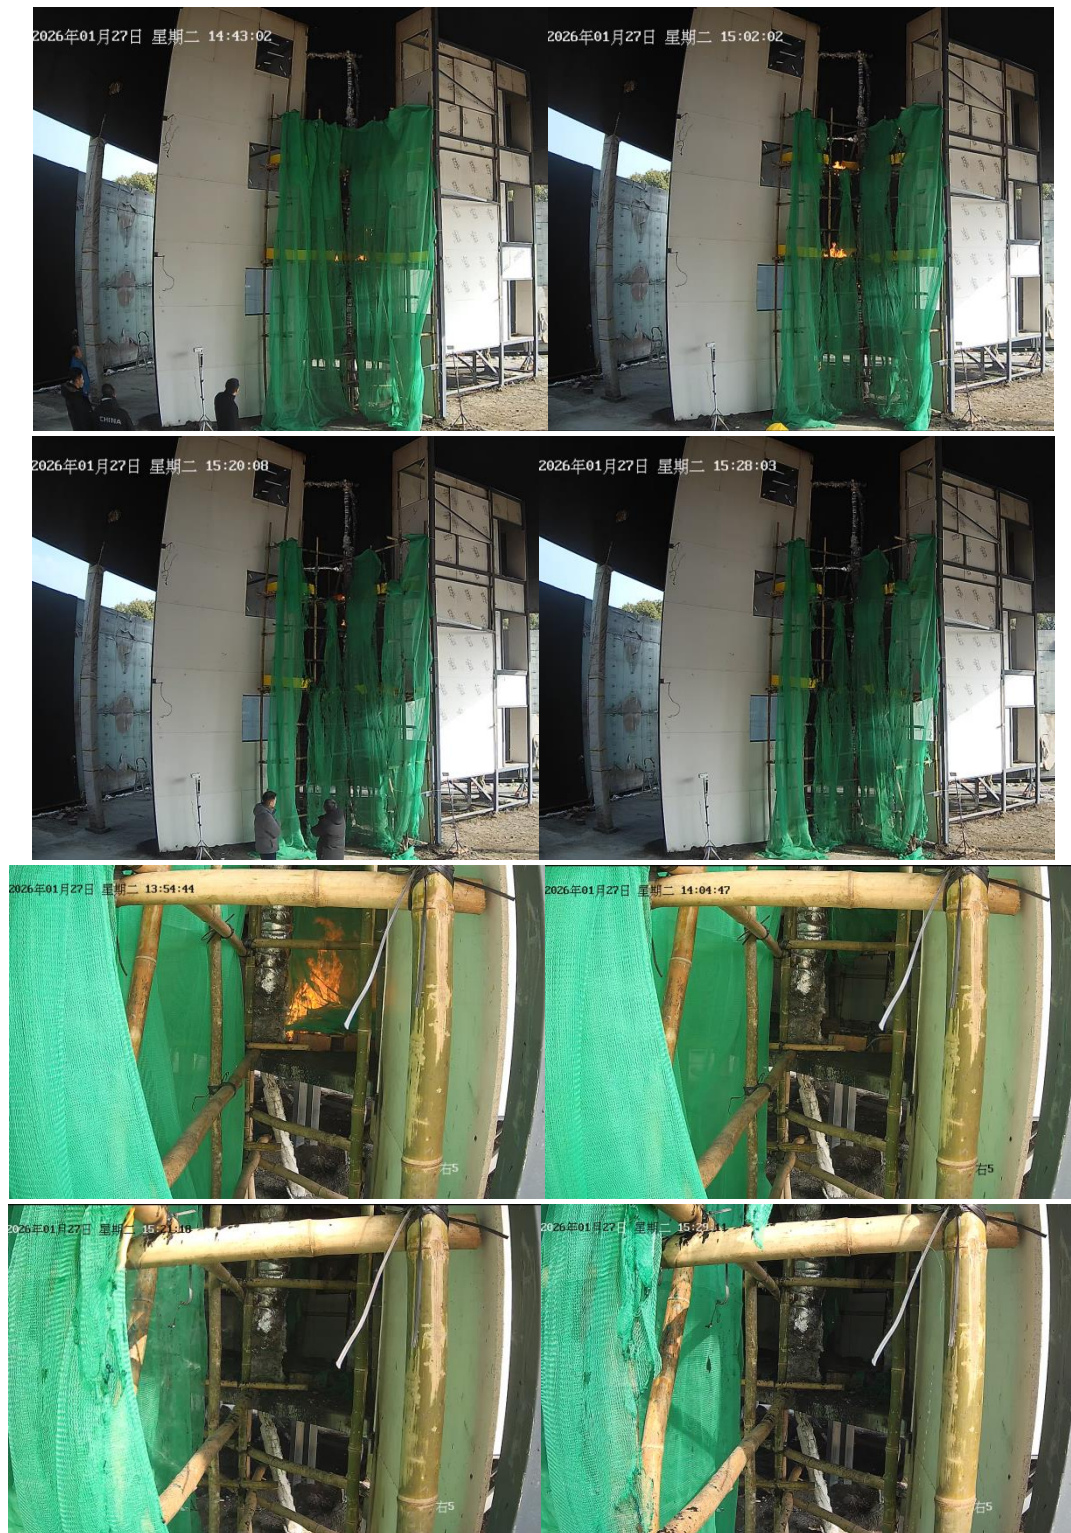
It was noted that the fire caused ignition of the non-FR safety net but did not ignite the bamboo scaffolding. When the fire source began to decay, localised ignition of the non-flame-retardant safety net persisted, and the material continued to support slow flame propagation.

In this test, since comparably much smaller fire source was adopted, except the non-FR safety net exhibited persistent burning, nearly all other combustible contents remained unburnt till the end of the fire test. Also, the glass breakage and burning out of the plywood hinged doors were not observed.

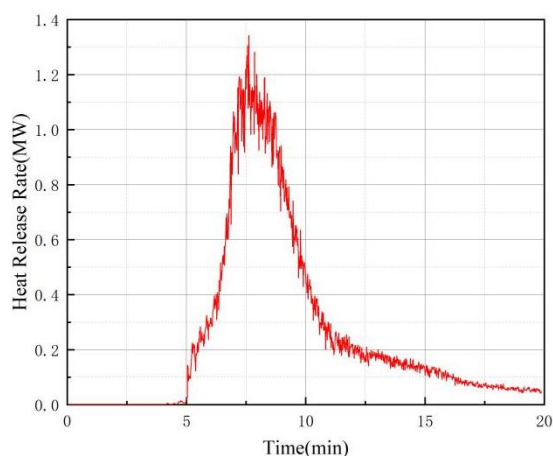
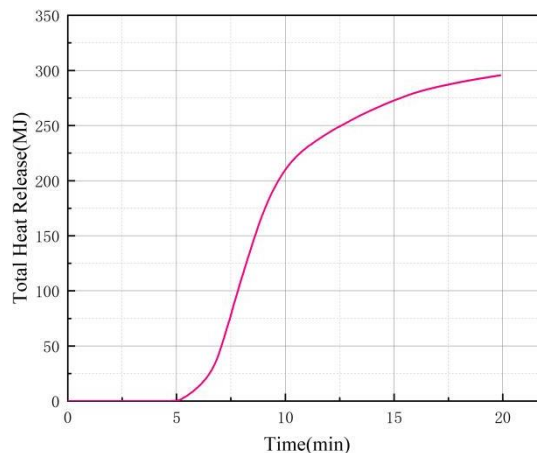
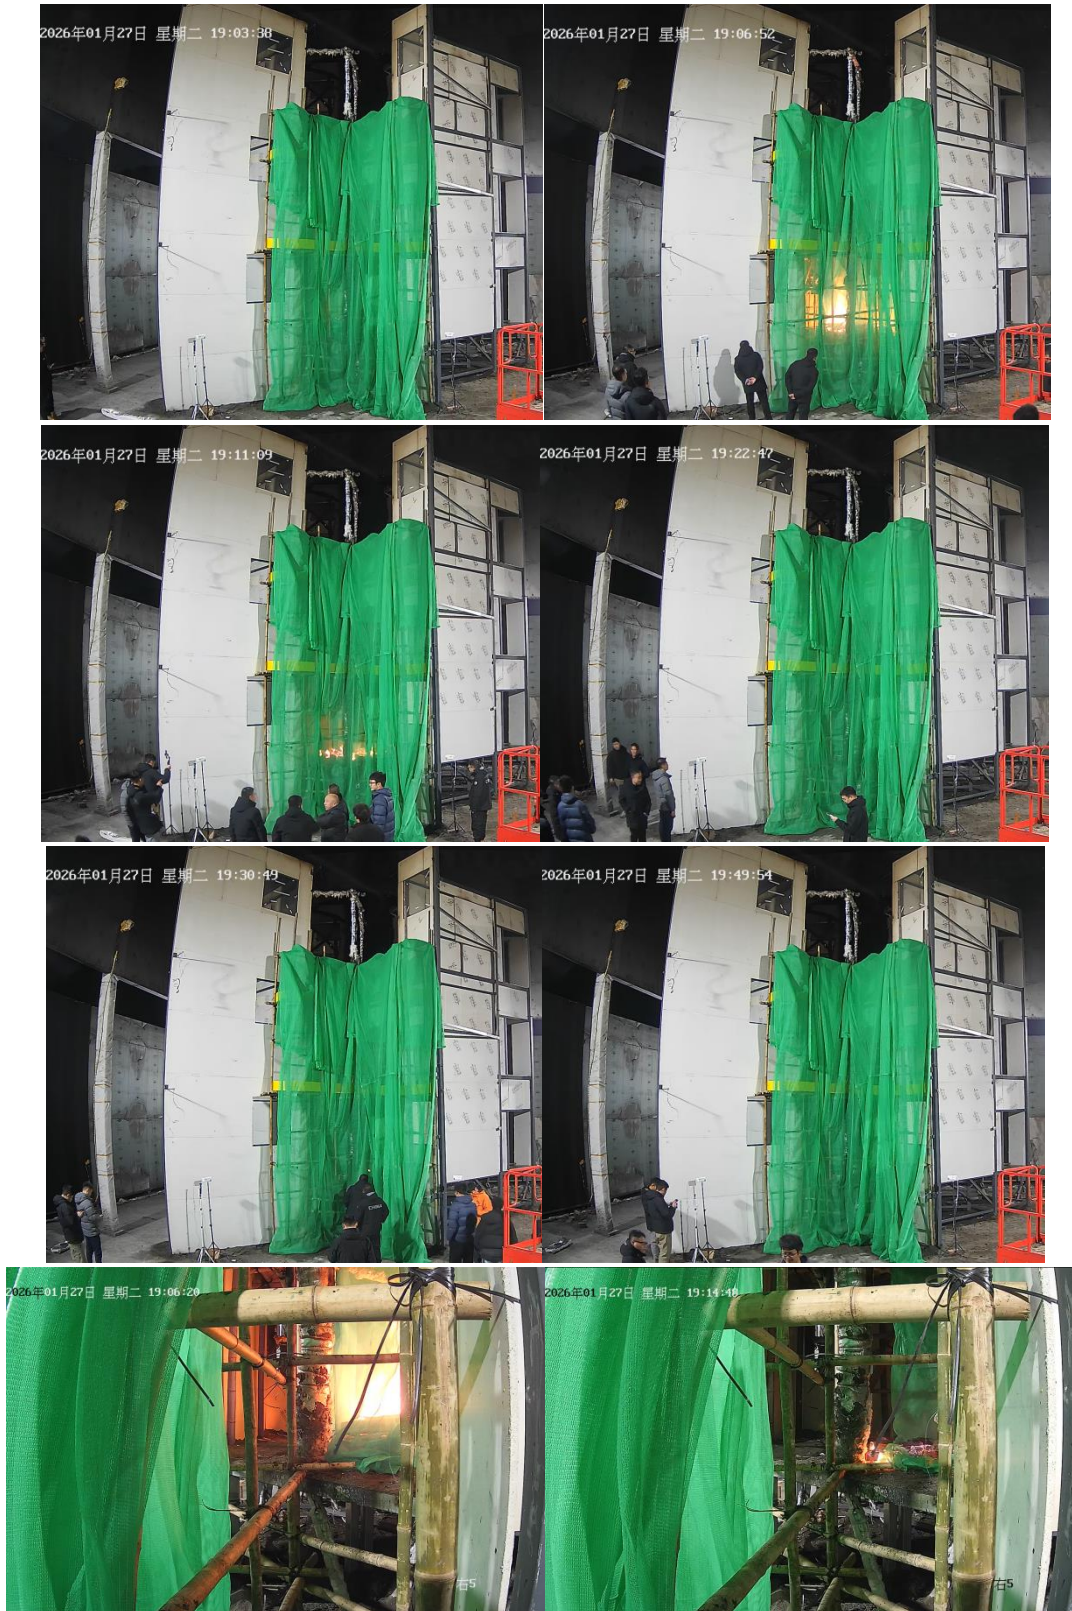
This experiment was designed to study the flame spread behaviour of scaffolding fitted with FR safety net under a small fire size of not more than 0.5 MW at incipient stage. The ignition time of the experiment was 19:01:35 on 27 January 2026, and the HRR reached its peak at 19:09:12, which was 1.342 MW. The FR mesh partially melts at high temperatures without sustaining combustion. The wooden stack automatically extinguished after burning for 10 minutes.

It was observed that, following the decay of the fire source, no persistent flaming, surface ignition, or lateral flame propagation occurred in the FR safety net.

In this test, since comparably much smaller fire source was adopted, nearly all combustible contents remained unburnt till the end of the fire test. Also, the glass breakage and burning out of the plywood hinged doors were not observed.

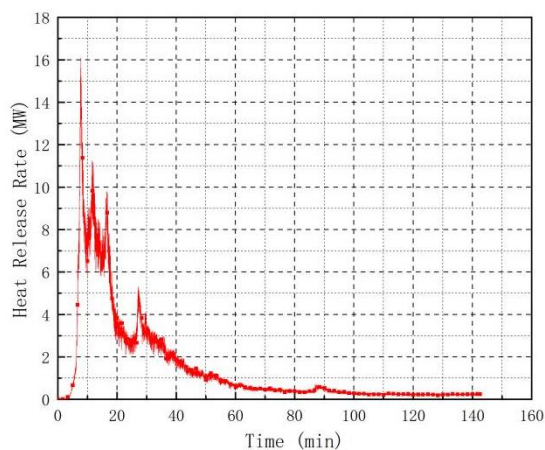
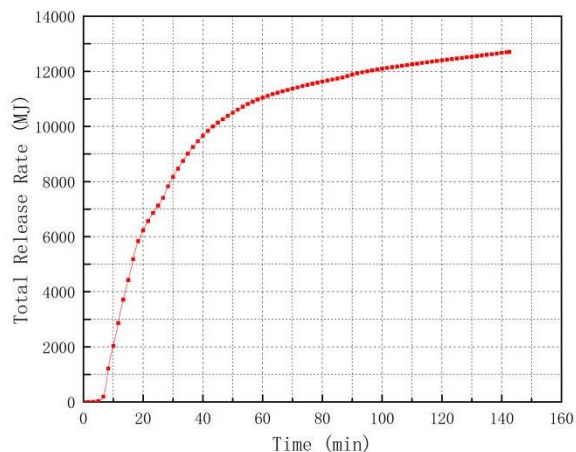
As shown in Table 2.1, non-FR net, windows-without-foam and 2 layers of horizontal bamboo were adopted in this experiment. The ignition time of the experiment was 10:50:24 AM on 18 January 2026. The HRR reached its peak at 10:58:12 AM, which was around 16.097 MW and the total heat released was around 12,705 MJ.

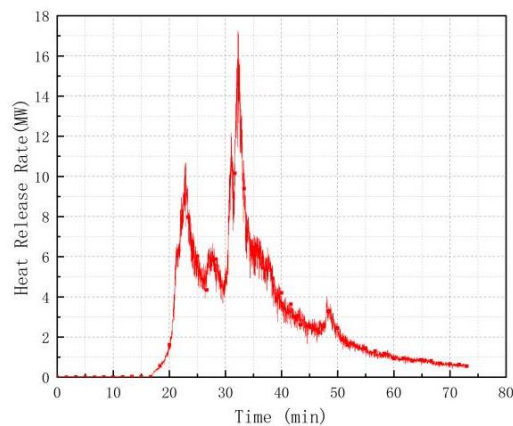
Fig. 2.40 HRR curve

4.12. For Test No. 4 with FR safety net, windows-without-foam and two layers of horizontal bamboo, it was noted that the heat release rate curve as shown in Fig. 2.40 in para. 2.3.5.2 of Annex B depicted after the growth phase reached 2 peaks at around 20 minutes (approximately 10 MW) and at around 30 minutes (approximately 17 MW), respectively, with the latter peak reflecting the accelerated spread of the fire and the extensive combustion of combustible materials. The total heat release was 11,043 MJ as shown in Fig. 2.41 as shown in para. 2.3.5.2 of Annex B.

Fig. 2.40 depicts the experimental heat release rate curve: the 0-15 minute period represents the ignition delay phase (with a heat release rate close to 0); after 15 minutes, it entered the growth phase, reaching its first peak at around 20 minutes (approximately 10 MW). After a brief decline, it reached its main peak at around 30 minutes (approximately 17 MW), reflecting the accelerated spread of the fire and the extensive combustion of combustible materials. After 30 minutes, it entered the decay phase, with the heat release rate gradually decreasing, and it approached 0 at around 75 minutes. The total heat released is 11,043 MJ as shown in Fig. 2.41.

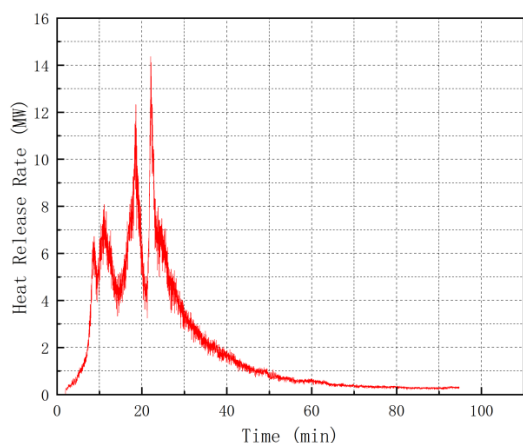
Fig. 2.50 HRR curve

4.14. For Test No. 5 with non-FR safety nets, windows-with-foam and two layers of horizontal bamboo, as shown in Fig. 2.50 in para. 2.3.6.2 of Annex B, the HRR exhibited a rapid increase overall with a number of peaks of approximately 8 MW, approximately 12.5 MW, approximately 14.5 MW, respectively spanning over a period of around 11 minutes. The total heat release was around 11,585 MJ.

As shown in Fig. 2.50, the heat release rate exhibited a rapid increase overall. The first peak, approximately 8 MW, appeared around 11 minutes, followed by the second peak, approximately 12.5 MW, around 19 minutes, and the third peak, approximately 14.5 MW, around 22 minutes. After 22 minutes, the heat release rate declined rapidly, and by around 45 minutes, it had dropped to 1 MW. The total calorific value was around 11,585 MJ as shown in Fig. 2.51.

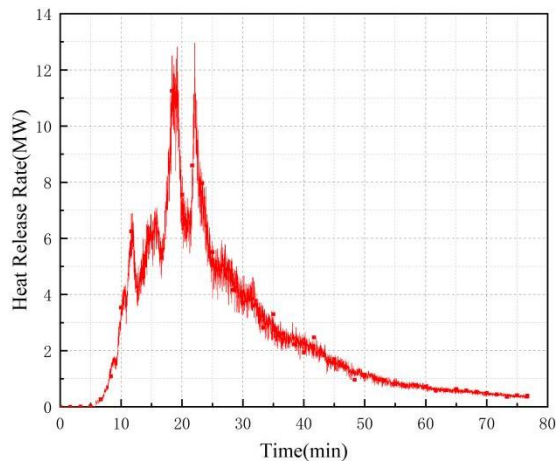
Fig. 2.60 HRR curve

4.15. For Test No. 6 with FR safety nets, windows-with-foam and two layers of horizontal bamboo, as shown in Fig. 2.60 of para. 2.3.7.2 of Annex B, the HRR exhibited a rapid upward trend overall. There was a significant growth phase around 10 minutes and there were 3 peaks of approximately 6 MW, 13 MW and 14.5 MW at around 13, 20 and 22 minutes, respectively. The total heat release was around 11,443 MJ.

As shown in Fig. 2.60, the heat release rate exhibits a rapid upward trend overall. It entered a significant growth phase around 10 minutes, reached its first peak of approximately 6 MW at around 15 minutes, and then experienced a second peak of about 13 MW at around 20 minutes. The heat release rate peaked at approximately 14.5 MW at around 22 minutes. It then began to decay rapidly after 22 minutes. The final total calorific value was around 11,443 MJ as shown in Fig. 2.61.
