# Final Investigation Report No.5 Alarm Fire at Wang Fuk Court on 26 November 2025

Inter-Departmental Fire Investigation Task Force

May 2026

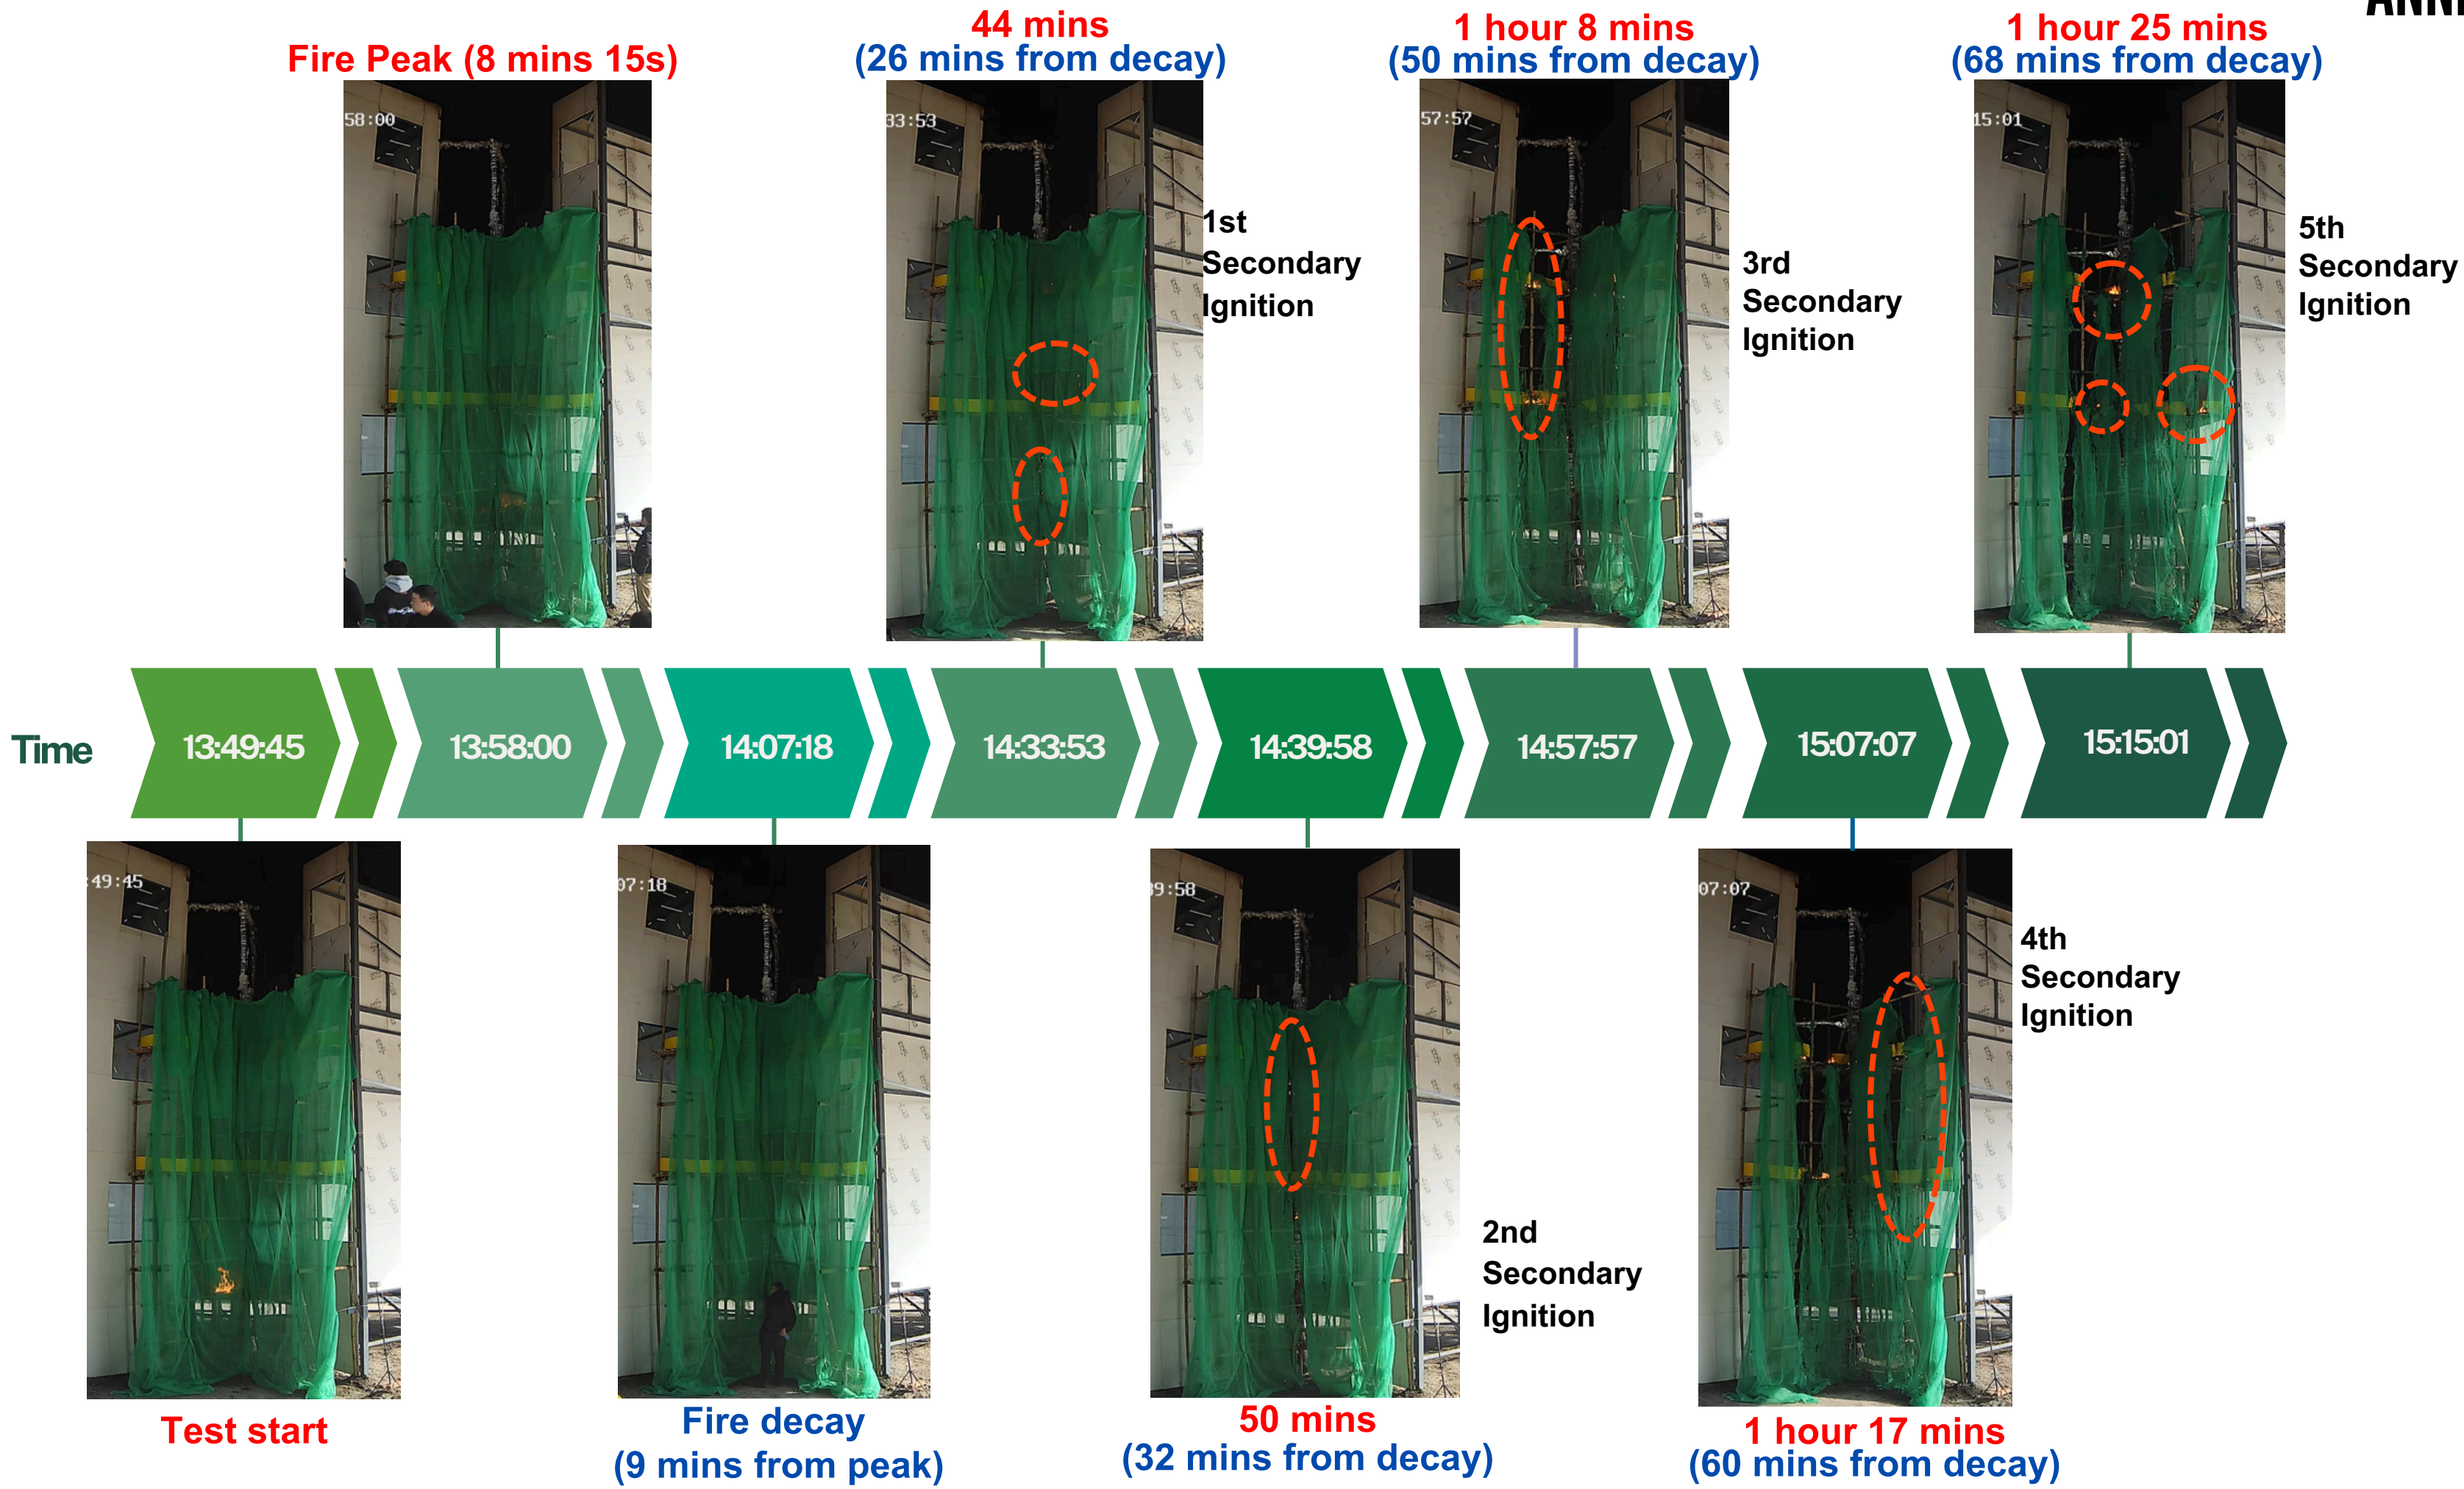
### **PROGRESSION OF SECONDARY IGNITION**

Fire Peak (7 mins 45s)

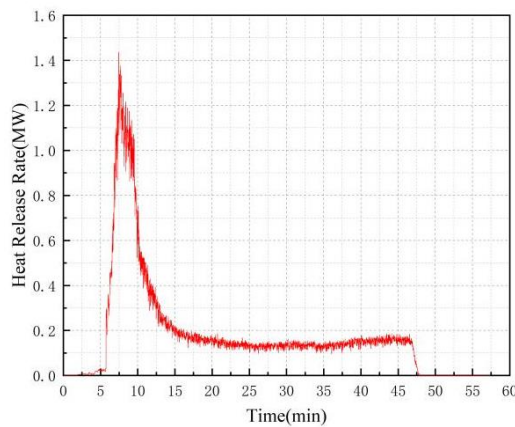
Fig. 4 HRR curve

Sample 3 (Non-FR) safety nets, windows-without-foam and two layers of horizontal bamboo were adopted in this experiment (small fire size). The ignition time of the experiment was 9:23:25 AM on April 11, 2026. The HRR reached its peak at 9:30:52 AM, which was around 1.437 MW and the total heat released was around 609.218 MJ.

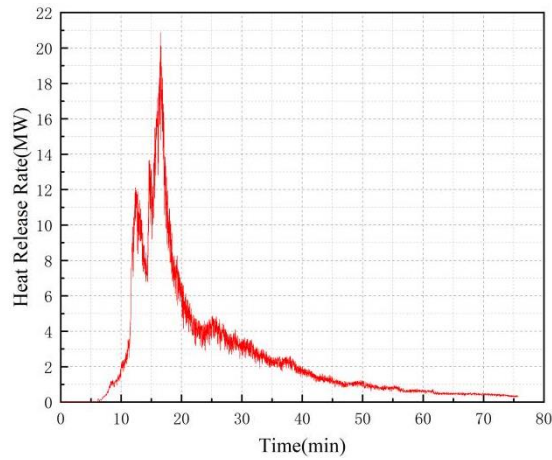
Fig. 10 HRR curve

Sample 3 (Non-FR) safety nets, windows-without-foam and two layers of horizontal bamboo were adopted in this experiment (large fire size). The ignition time of the experiment was 12:03:00 PM on April 11, 2026. The HRR reached its peak at 12:15:50 PM, which was around 20.881 MW and the total heat released was around 11317 MJ.

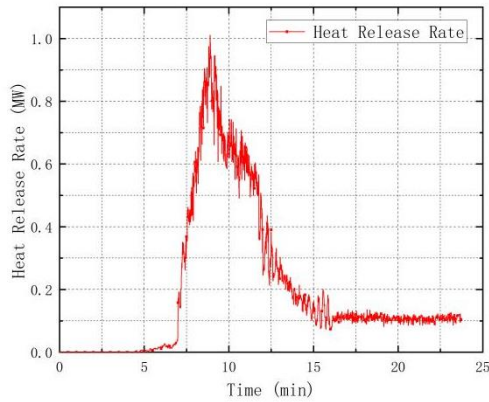
Fig. 56 HRR curve

Sample 2 (FR) safety nets, windows-without-foam and two layers of horizontal bamboo were adopted in this experiment (small fire size). The ignition time of the experiment was 9:19:04 AM on April 27, 2026. The HRR reached its peak at 9:27:58 AM, which was around 1.011 MW and the total heat released was around 281.573 MJ.

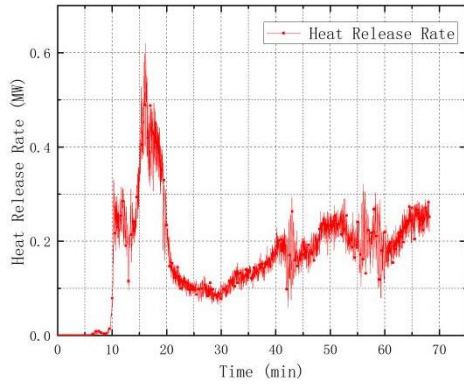
**Fig. 62 HRR curve**

Sample 3 (non-FR) safety nets, windows-without-foam and two layers of horizontal bamboo were adopted in this experiment (small fire size). The ignition time of the experiment was 12:09:16 AM on April 27, 2026. The HRR reached its peak at 12:25:27 AM, which was around 0.620 MW and the total heat released was around 1453.573 MJ.

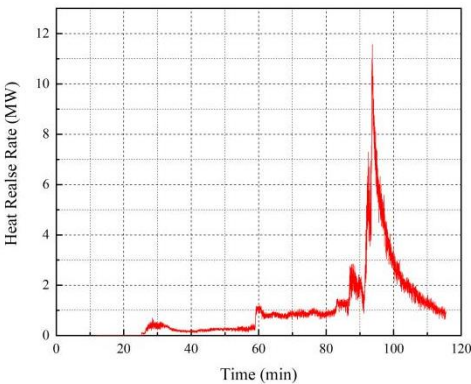
Fig. 68 HRR curve

Sample 4 (Wang Chi House) safety nets, windows-without-foam and two layers of horizontal bamboo were adopted in this experiment (small fire size). The ignition time of the experiment was 18:47:30 PM on April 27, 2026. The HRR reached its peak at 19:58:09 PM, which was around 11.576 MW and the total heat released was around 6886 MJ.

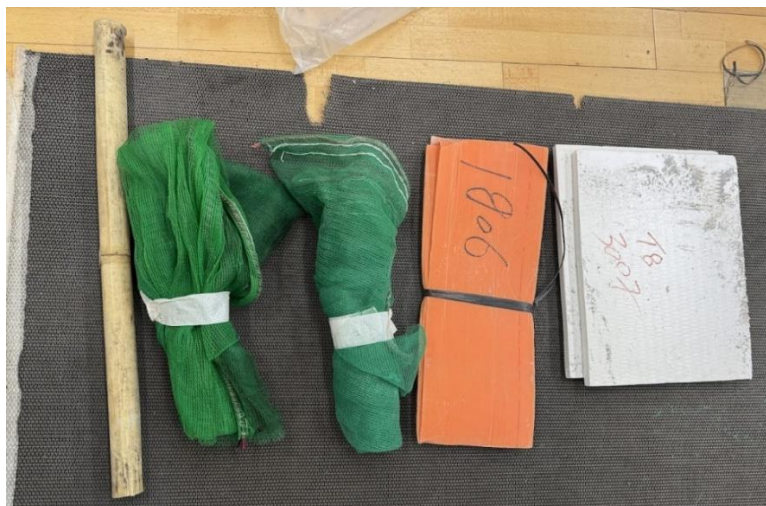
1. Samples collected from Wang Chi House on 17 March 2026 with assistance from the Fire Services Department (FSD), which include (i) one bamboo sample, (ii) one green safety net sample from higher level and one green safety net sample from low level, (iii) orange toe-board and (iv) polystyrene window covers (sample shown in Figure 1).
2. Samples of non-flame retardant (“**non-FR**”) safety nets<sup>1</sup> from Sichuan on 9 April 2026 (Figure 2a).
3. Non-FR blue-white canvas collected from the FSD on 9 April 2026 (Figure 2b).
4. FR white canvas collected from the Hong Kong Police Force on 30 April 2026 (Figure 2c).
5. Carton box samples from packaging boxes in CityU laboratory.

**Figure 1.** Image of the samples collected from Wang Chi House on 17 March 2026.

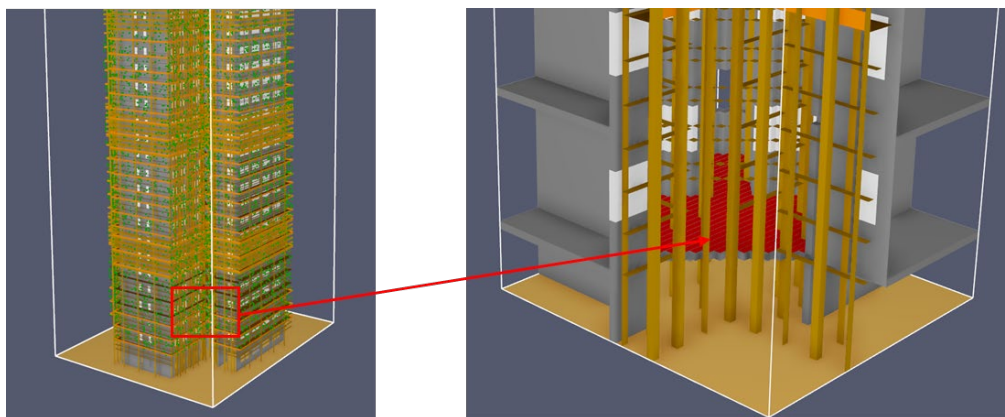
**Figure. 3** Location of the initial fire.

The suspected origin was at the 1/F platform outside Flats 104 and 105 of Wang Cheong House. The simulations utilize a  $t^2$ -growing fire model prescribed to represent the rapid involvement of initial combustible materials (see Figure 3):

- for the large fire size cases (Cases 1–3), a 1 MW fire source is applied;
- and for the small fire size cases (Cases 4–6), a 700 kW fire source is applied.

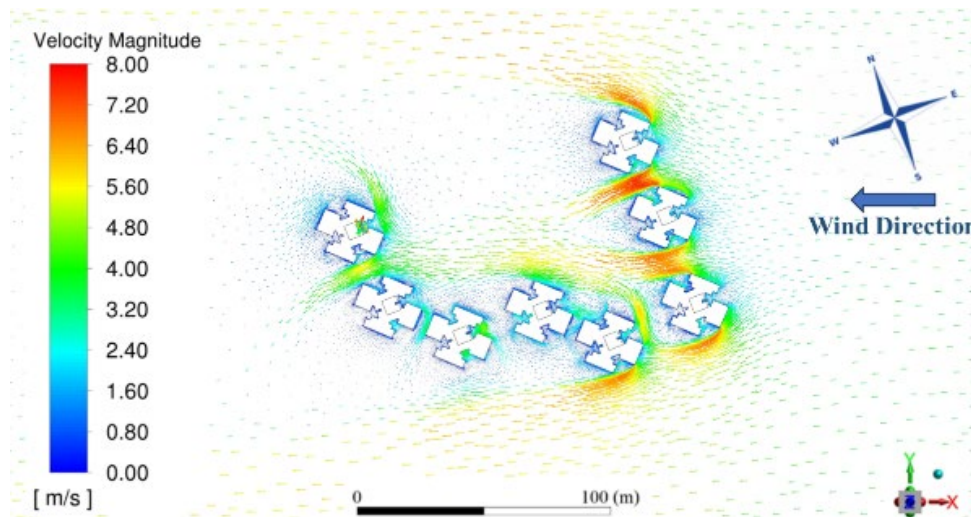
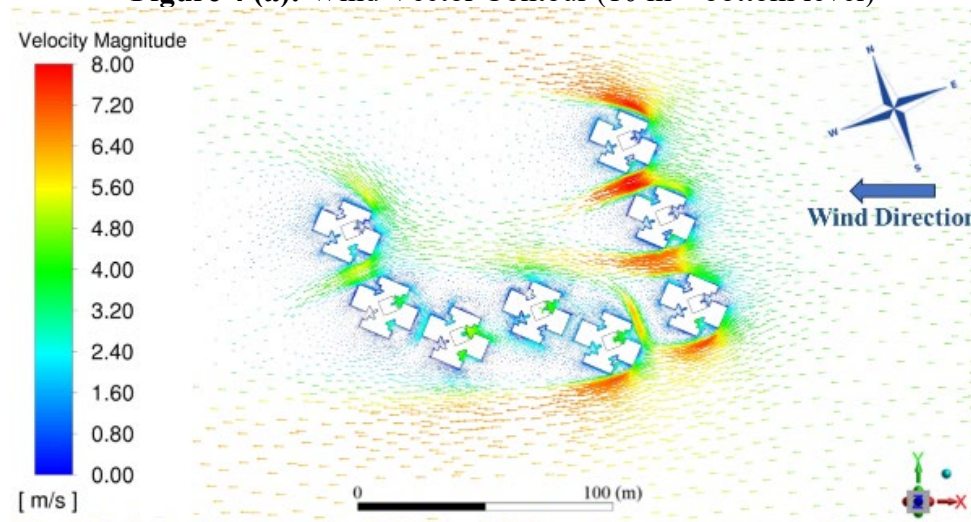
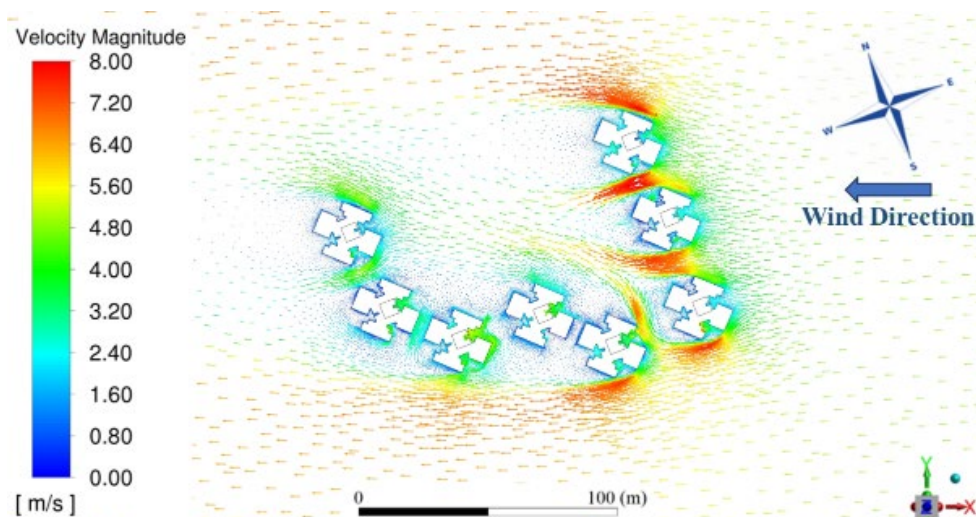
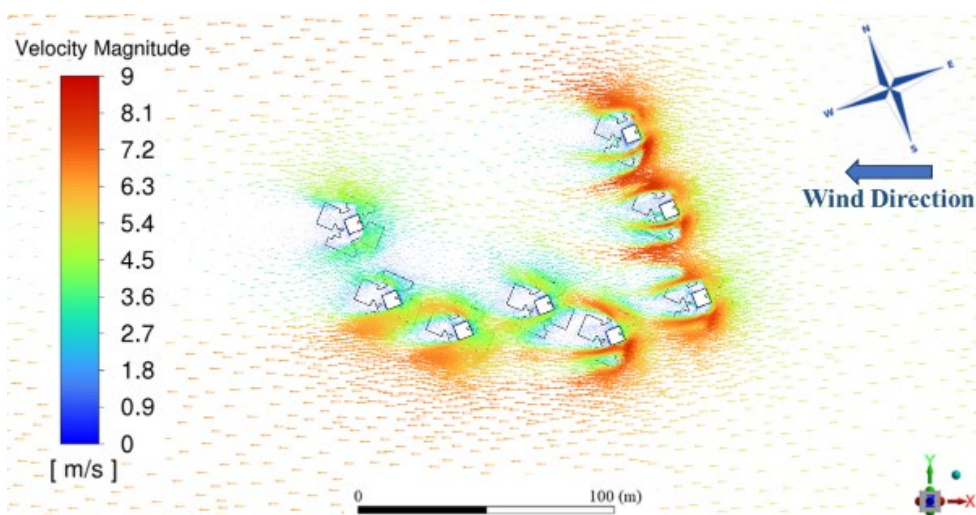
Wind vector contours at heights of 10 m (bottom level), 40 m (middle level), 80 m (top level), 97 m (rooftop level), and 120 m (above the buildings) are presented in Figures 4 (a) to (e). The simulated wind vectors provided critical insights into the trajectory of flying embers, which served as secondary ignition sources for nearby structures. The wind profile demonstrated a notable increase in velocity as it flowed over the structures and through the narrow gaps between adjacent buildings. For instance, the vector plots show a high velocity region in the gap between Wang Cheong House and Wang Tai House which aligns with the smoke drifting that was observed during the actual fire as shown in Figure 5 (a) to (c).

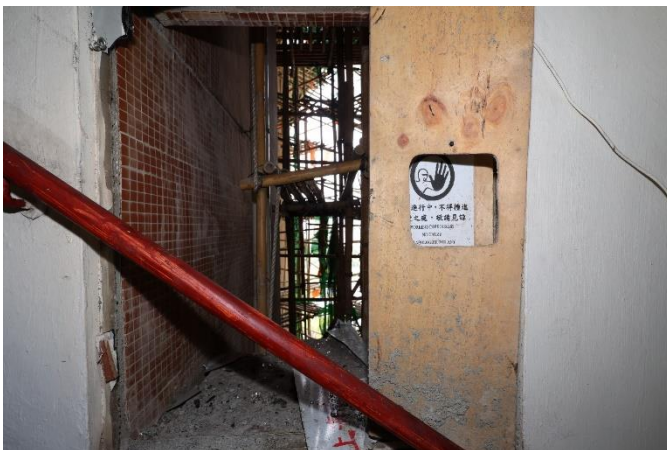
Wang Yan House Front staircase between 24/F & 25/F

| Block | Staircase Opening | Quantity | Types | Condition |
|---|---|---|---|---|
| | Between 24/F and 25/F | 1 | wooden and aluminium composite panel | Partially Damaged |

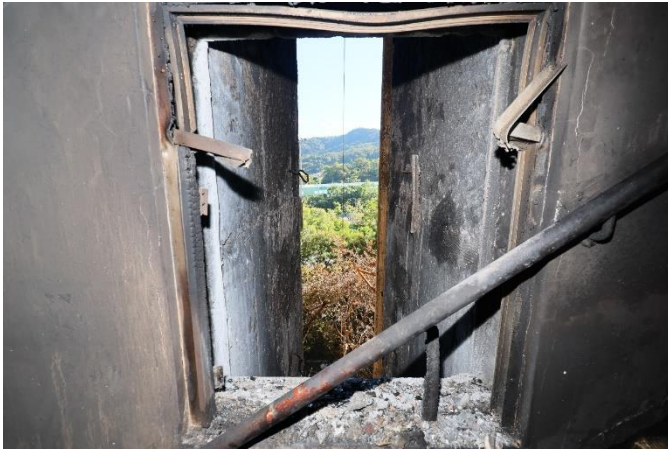
Wang Sun House Rear staircase between 5/F & 6/F

| Block | Staircase Opening | Quantity | Types | Condition |
|---|---|---|---|---|
| Wang Sun House (Block C) | Between 5/F and 6/F | 1 | wooden panel | Completely Damaged |

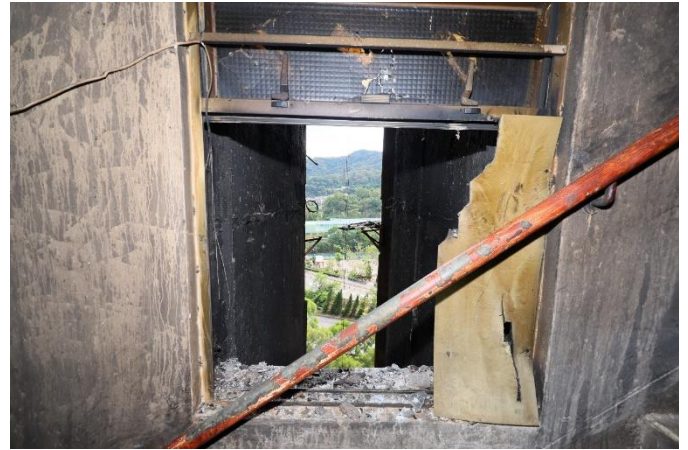
Wang Sun House Front staircase between 10/F & 11/F

| Block | Staircase Opening | Quantity | Types | Condition |
|---|---|---|---|---|
| | Between 10/F and 11/F | 1 | wooden panel | Partially Damaged |

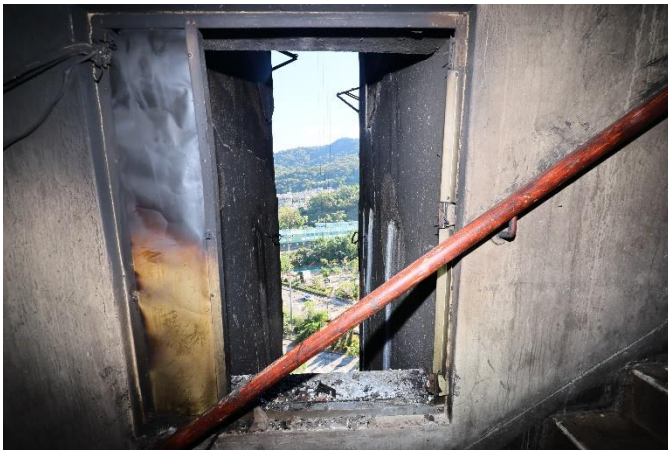
Wang Sun House Rear staircase between 15/F & 16/F

| Block | Staircase Opening | Quantity | Types | Condition |
|---|---|---|---|---|
| | Between 15/F and 16/F | 1 | wooden panel | Completely Damaged |

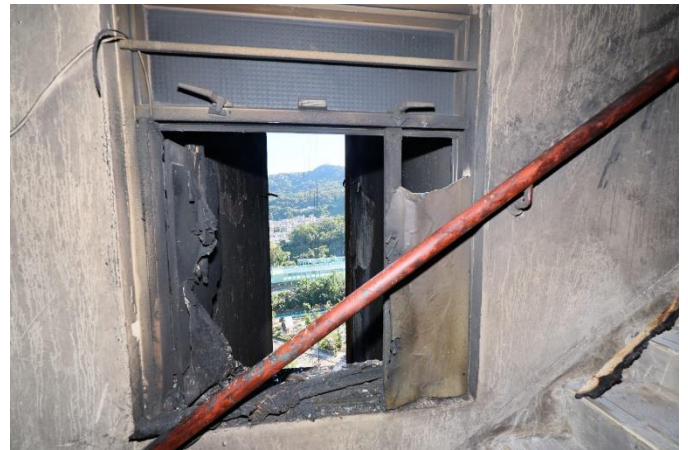
Wang Sun House Rear staircase between 19/F & 20/F

| Block | Staircase Opening | Quantity | Types | Condition |
|---|---|---|---|---|
| | Between 19/F and 20/F | 1 | wooden panel | Almost Completely Damaged |

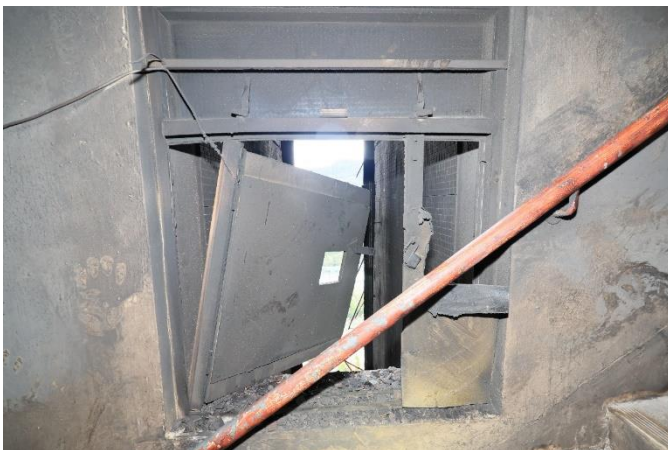
Wang Sun House Front staircase between 24/F & 25/F

| Block | Staircase Opening | Quantity | Types | Condition |
|---|---|---|---|---|
| | Between 24/F and 25/F | 1 | wooden and aluminium composite panel | Slightly Damaged |

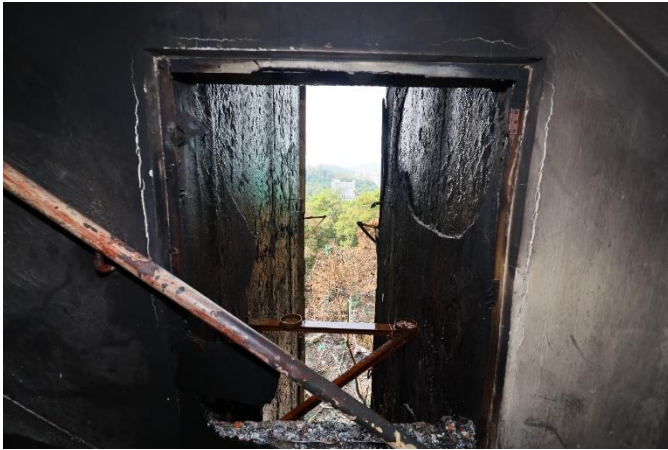
Wang Tai House Rear staircase between 5/F & 6/F

| Block | Staircase Opening | Quantity | Types | Condition |
|---|---|---|---|---|
| Wang Tai House (Block E) | Between 5/F and 6/F | 1 | wooden panel | Completely Damaged |

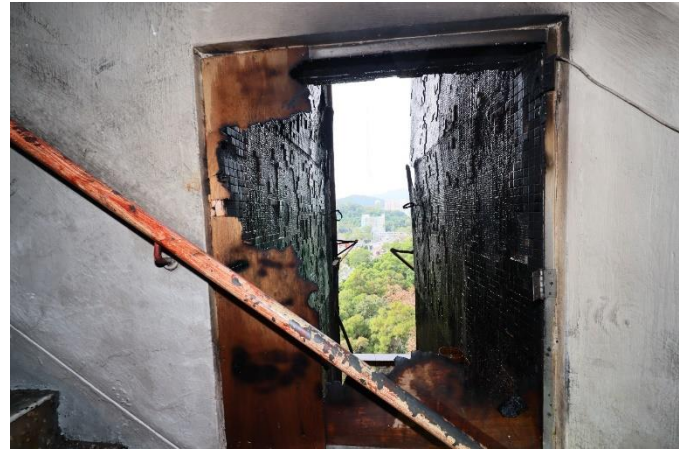
Wang Tai House Front staircase between 10/F & 11/F

| Block | Staircase Opening | Quantity | Types | Condition |
|---|---|---|---|---|
| | Between 10/F and 11/F | 1 | wooden panel | Almost Completely Damaged |

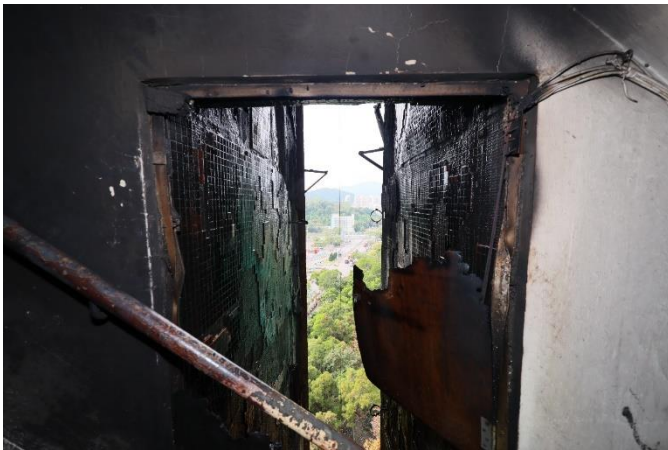
Wang Tai House Rear staircase between 15/F & 16/F

| Block | Staircase Opening | Quantity | Types | Condition |
|---|---|---|---|---|
| | Between 15/F and 16/F | 1 | wooden panel | Almost Completely Damaged |

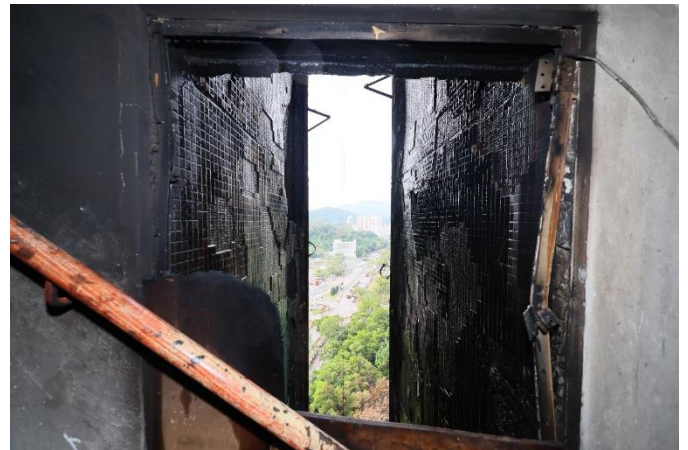
Wang Tai House Front staircase between 20/F & 21/F

| Block | Staircase Opening | Quantity | Types | Condition |
|---|---|---|---|---|
| | Between 20/F and 21/F | 1 | wooden panel | Almost Completely Damaged |

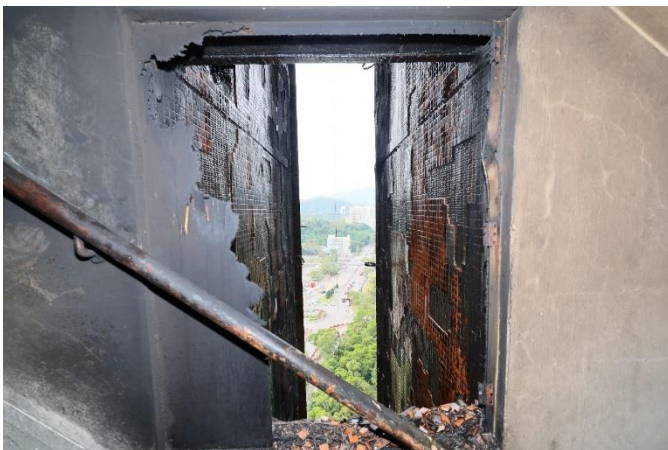
Wang Tai House Rear staircase between 25/F & 26/F

| Block | Staircase Opening | Quantity | Types | Condition |
|---|---|---|---|---|
| | Between 25/F and 26/F | 1 | wooden panel | Almost Completely Damaged |

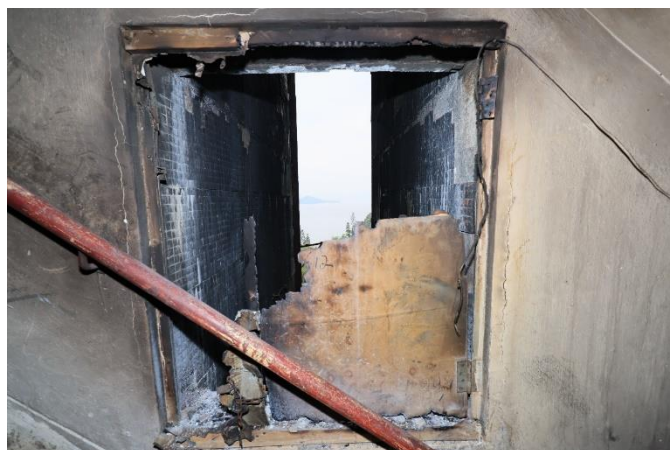
Wang Cheong House Front staircase between 10/F & 11/F

| Block | Staircase Opening | Quantity | Types | Condition |
|---|---|---|---|---|
| | Between 10/F and 11/F | 1 | wooden panel | Almost Completely Damaged |

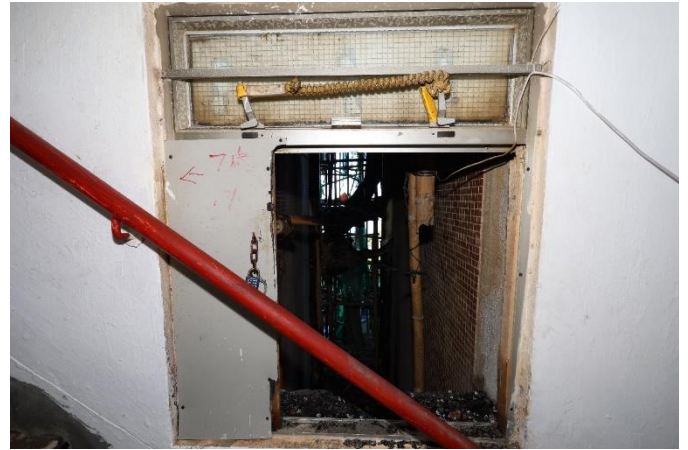
Wang Shing House Rear staircase between 9/F & 10/F

| Block | Staircase Opening | Quantity | Types | Condition |
|---|---|---|---|---|
| | Between 9/F and 10/F | 1 | wooden and alumium composite panel (the wooden panel part was completely burnt) | Almost Completely Damged |

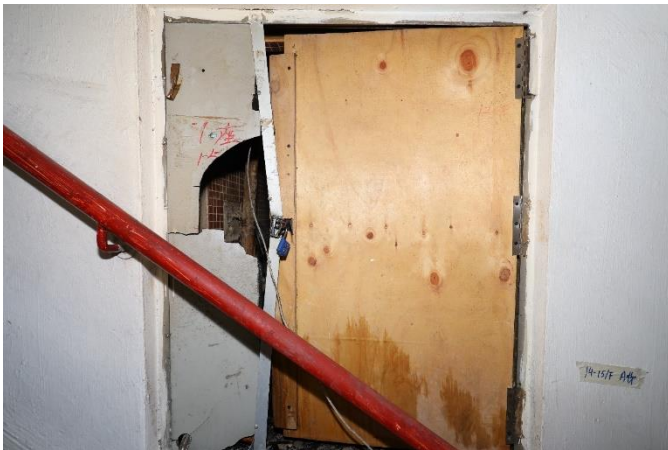
Wang Shing House Front staircase between 14/F & 15/F

| Block | Staircase Opening | Quantity | Types | Condition |
|---|---|---|---|---|
| | Between 14/F and 15/F | 1 | wooden and alumium composite panel | Slightly Damaged |

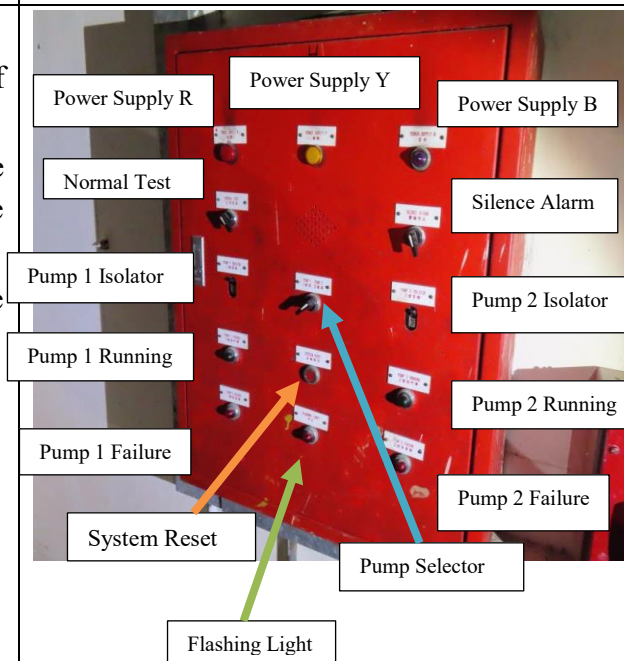
Wang Chi House  
(Photo taken on 1.12.2025)

- ii. The FAS of Wang Sun House (Block C) was momentarily actuated at the incipient phase of the fire;
- iii. The fuses of pump panel in Wang Shing House (Block G) was found mouldy; FS pump and fire alarm could be actuated after replacing the fuse into pump panel of Wang Chi House (Block H);

- iv. The fuses of pump panel of Wang Chi House (Block H) was sealed and sent to a laboratory for examination, and findings indicated that they operated normally. The results suggested that the fuses were damaged due to overcurrent.

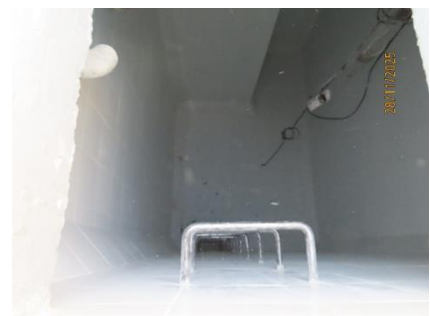
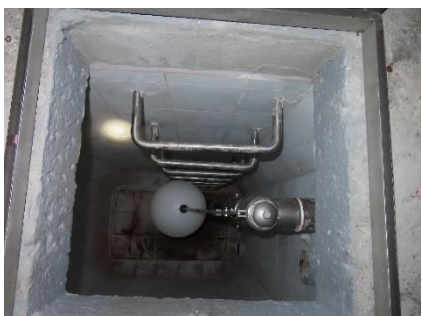
| <u>Building</u> | <u>FS Tank (Inspection Date/Time)</u> | <u>Transfer Tank (Inspection Date/Time)</u> |
|---|---|---|
| Wang Yan House (Block A) | Empty<br>(28.11.2025 / 1500 hrs) | Empty<br>(28.11.2025 / 1600 hrs) |

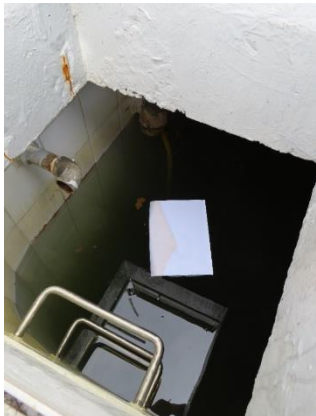
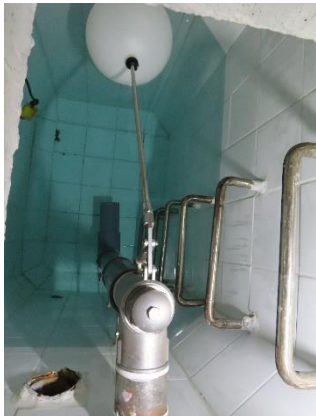
| <u>Building</u> | <u>FS Tank (Inspection Date/Time)</u> | <u>Transfer Tank (Inspection Date/Time)</u> |
|---|---|---|
| Wang Tao House (Block B) | With Water<br>(1.12.2025 / 1100 hrs) | With Water<br>(2.12.2025 / 1330 hrs) |

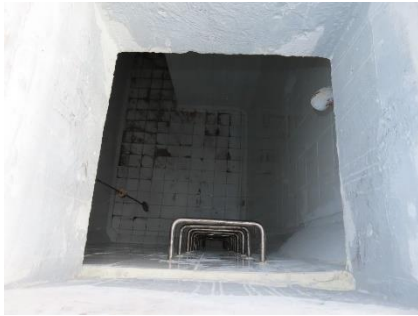
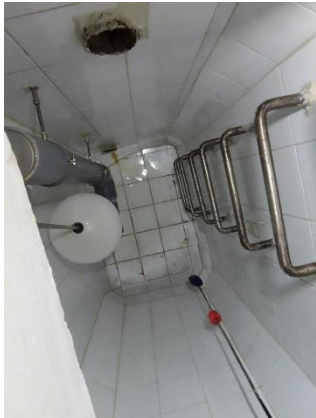
| <u>Building</u> | <u>FS Tank (Inspection Date/Time)</u> | <u>Transfer Tank (Inspection Date/Time)</u> |
|---|---|---|
| Wang Sun House (Block C) | Empty<br>(1.12.2025 / 1100 hrs) | Empty<br>(2.12.2025 / 1148 hrs) |

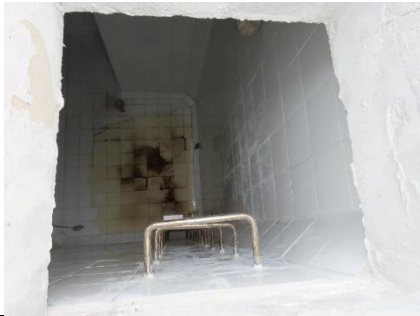
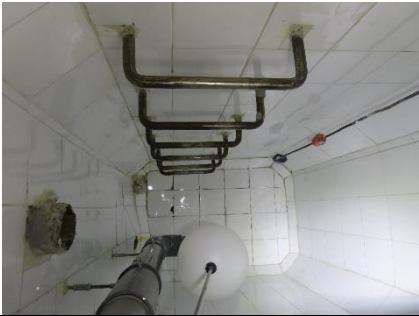
| Wang Kin House<br>(Block D) | Empty<br>(30.11.2025 / 1020 hrs) | Empty<br>(30.11.2025 / 1208 hrs) |

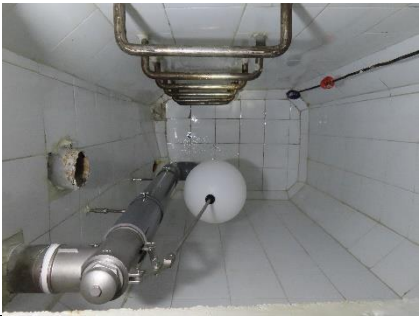
| | | Empty<br>(2.12.2025 / 1417 hrs) |

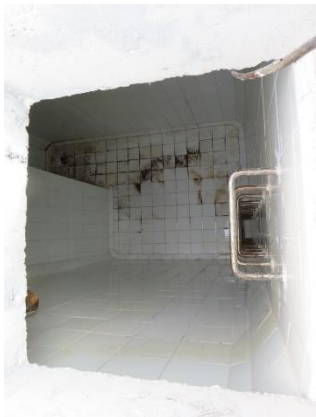
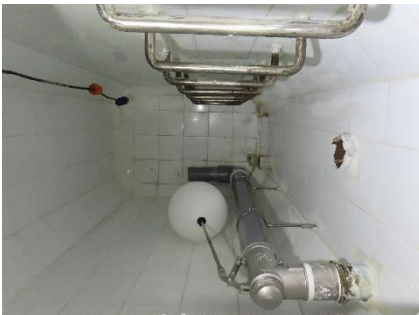
| Wang Tai House<br>(Block E) | Empty<br>(1.12.2025 / 1109 hrs) | Empty<br>(2.12.2025 / 1445 hrs) |

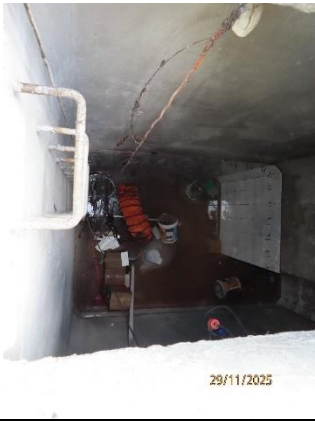
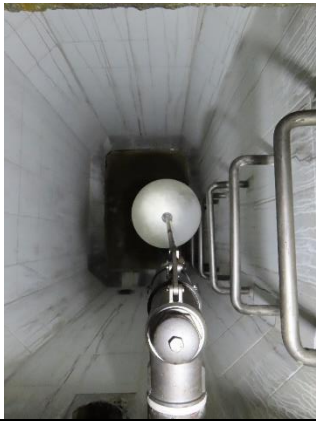
| Wang Cheong House (Block F) | Empty<br>(29.11.2025 / 1033 hrs)<br> | Empty<br>(2.12.2025 / 1502 hrs)<br> |

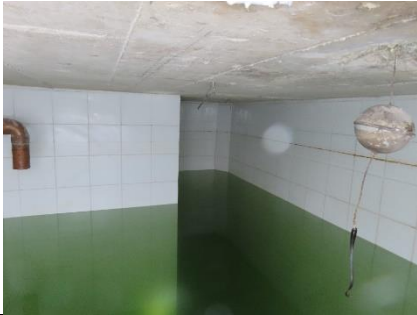
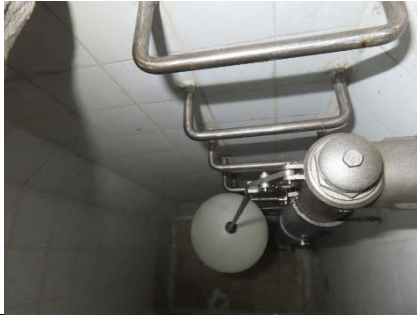
| Wang Shing House (Block G) | With Water<br>(1.12.2025 / 1136 hrs)<br> | Empty<br>(2.12.2025 / 1046 hrs)<br> |

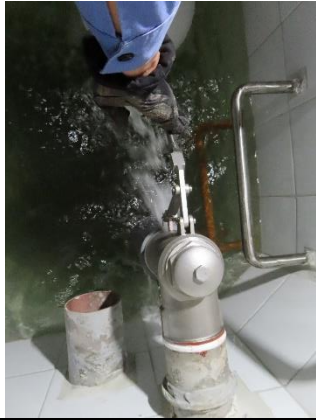
| Wang Chi House<br>(Block H)<br>(Unaffected by the<br>fire) | Empty<br>(26.11.2025 / 1628 hrs)<br>(from Witnesses Statement) | With Water<br>(2.12.2025 / 1022 hrs) |

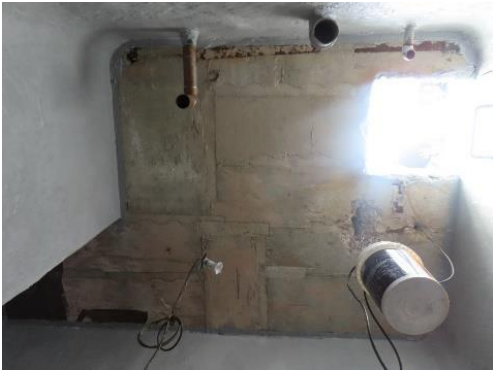
| | Empty<br>(1.12.2025 / 1117 hrs)<br>(Photo) | |

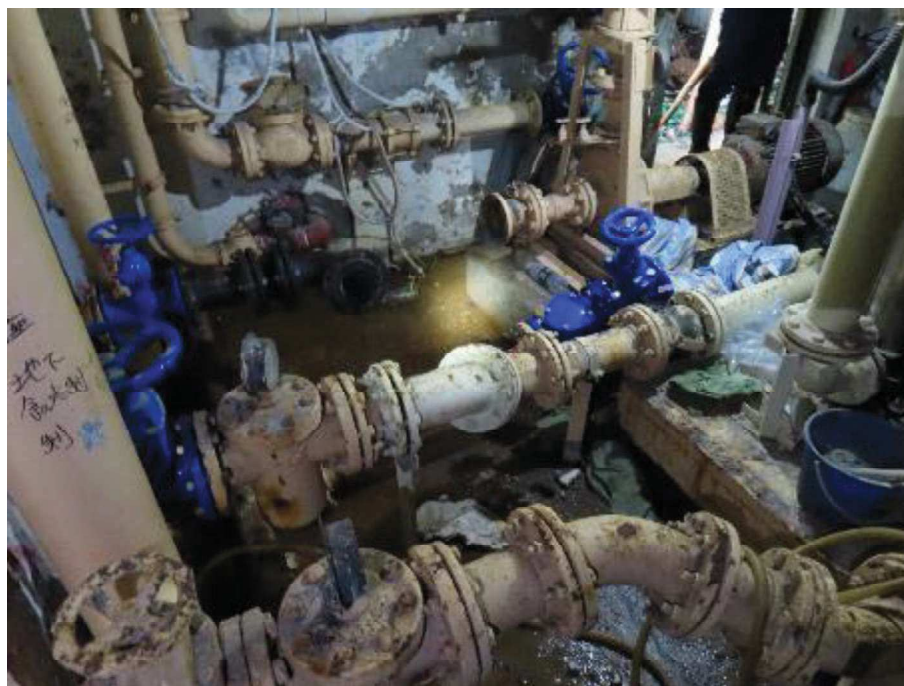
Photo showing the piping of upfeed water pump (Disconnected)

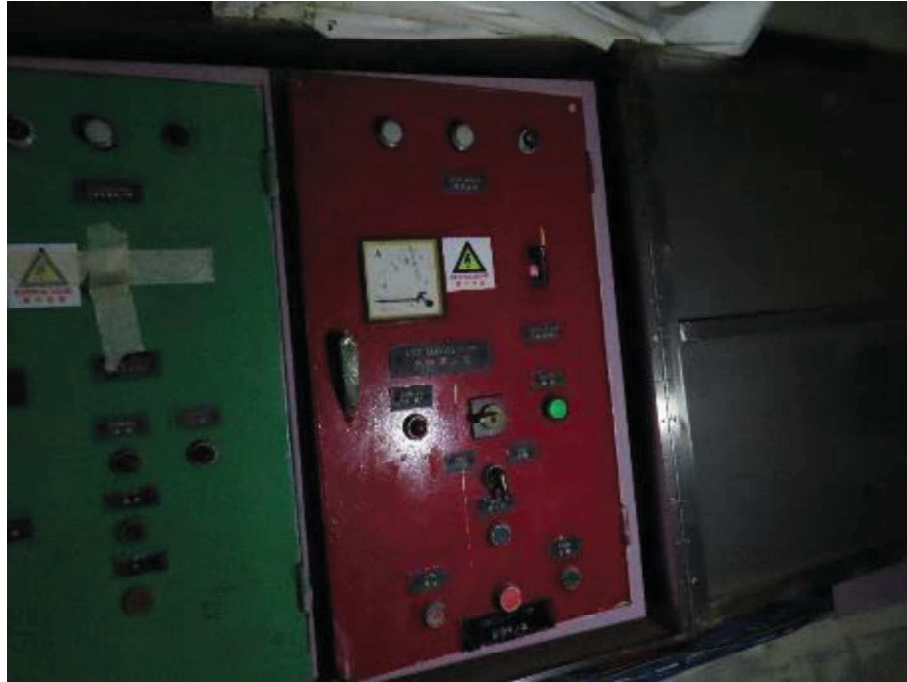
Photo showing the control panel of upfeed water pump (Power unavailable)

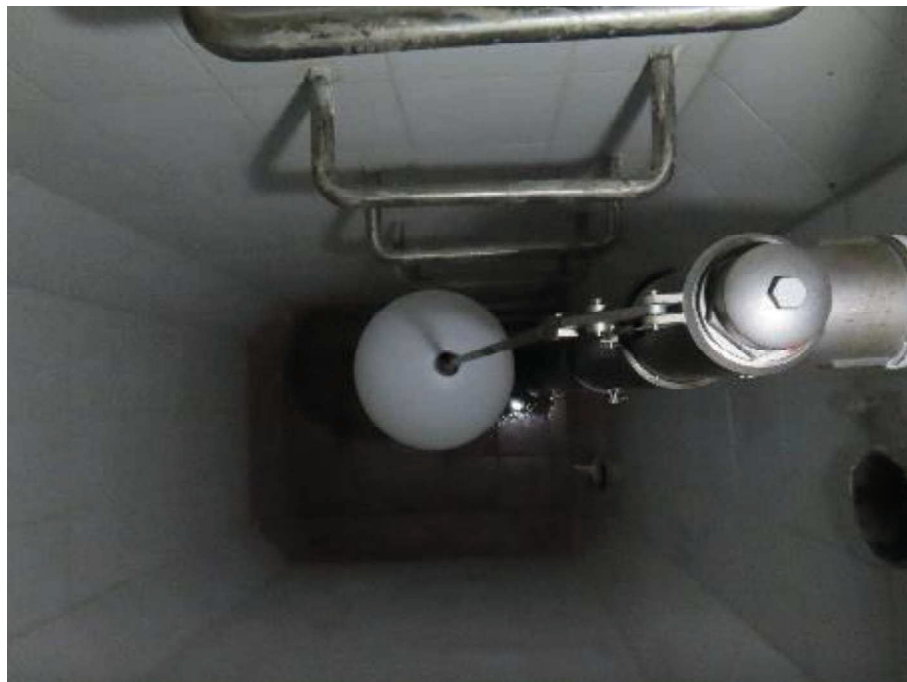
Photo showing the F.S. Up-feed tank of upfeed water pump (Water unavailable)

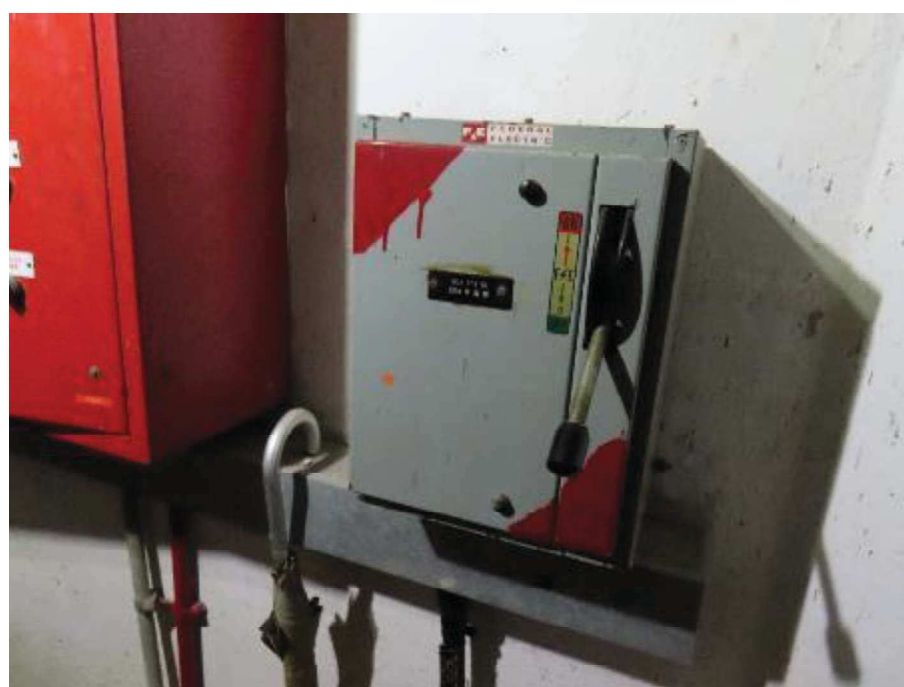
Photo showing the 100A TPN switch of fire booster pump panel (Power off position)

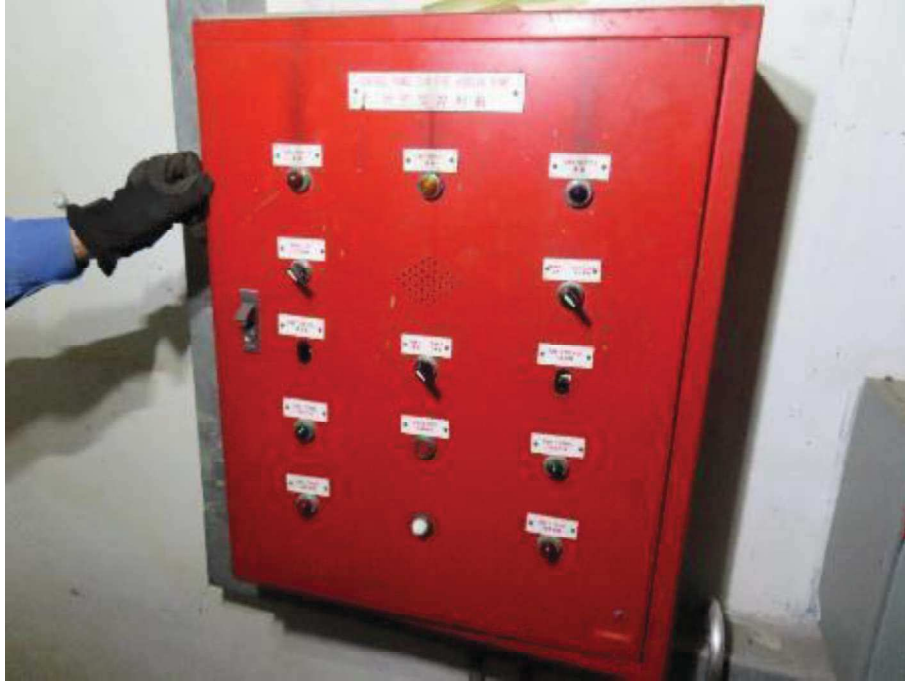
Photo showing the control panel of fire booster pump (Power unavailable)

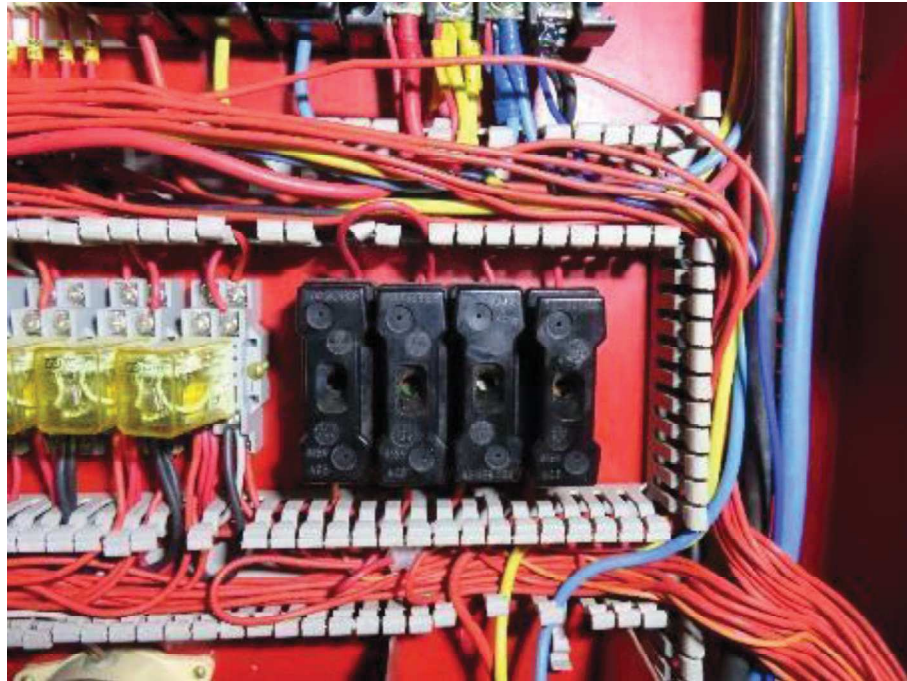
- i. All FS pumps were designed as fixed pump and intermediate booster pump; All fuses of pump panels of individual building were found blown, except the one found normal at Wang Cheong House (Block F); All main power switch of pump panels of individual buildings were in “OFF” position, except Wang Sun House (Block C);

Photo showing the fuses of the control panel wiring of fire booster pump control panel

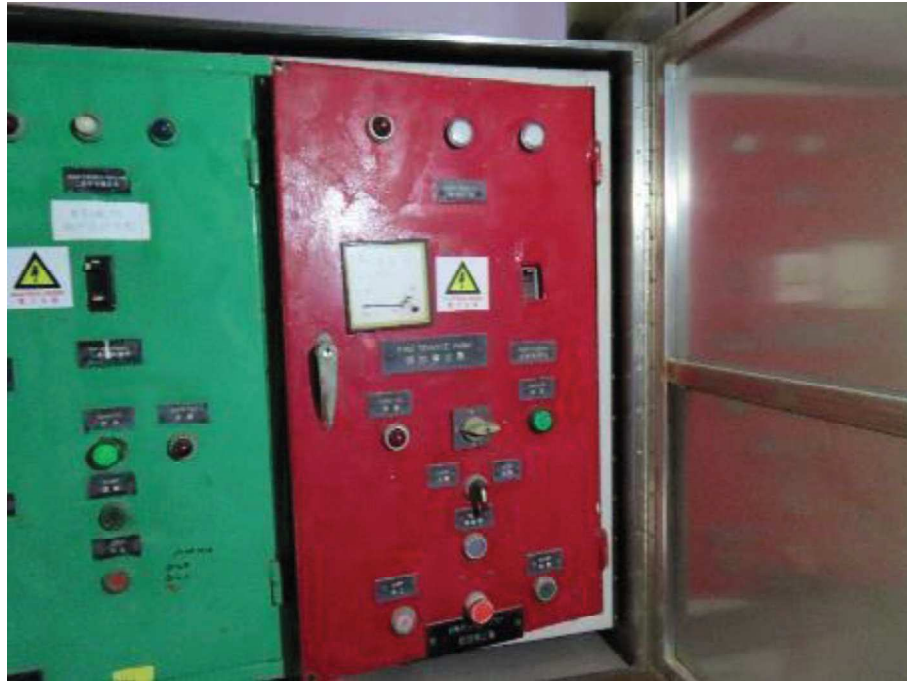
Photo showing the control panel of upfeed water pump (Power unavailable)

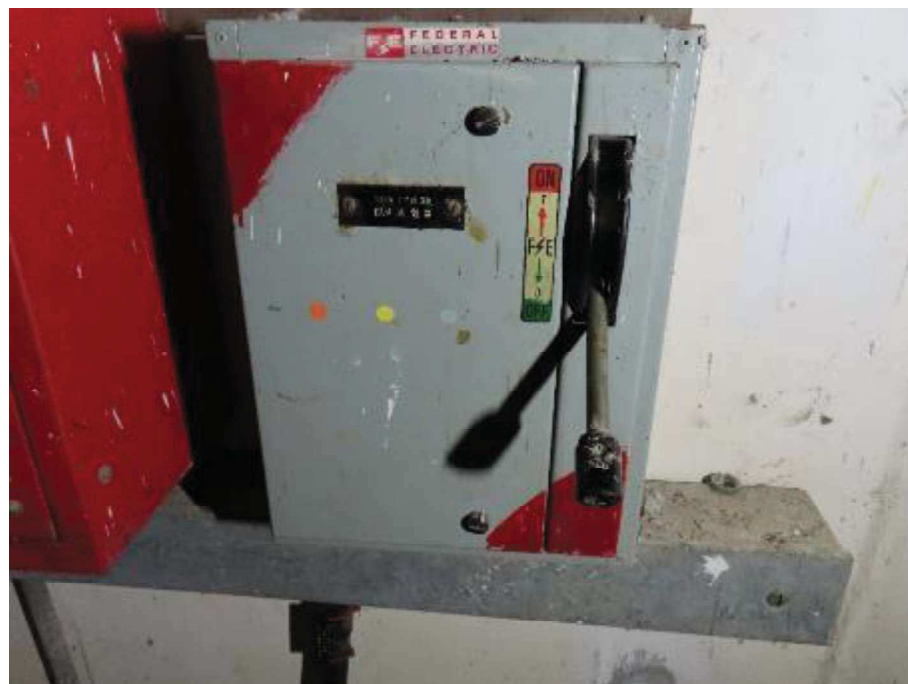
Photo showing the 100A TPN switch of fire booster pump panel (Power off position)

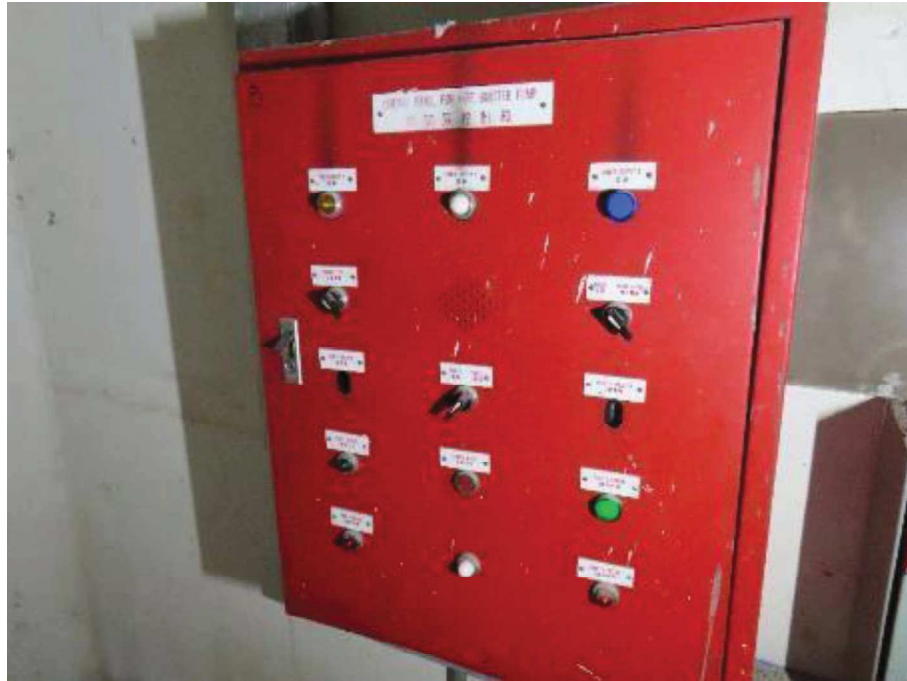
Photo showing the control panel of fire booster pump (Power unavailable)
