# Final Investigation Report No.5 Alarm Fire at Wang Fuk Court on 26 November 2025

Inter-Departmental Fire Investigation Task Force

May 2026

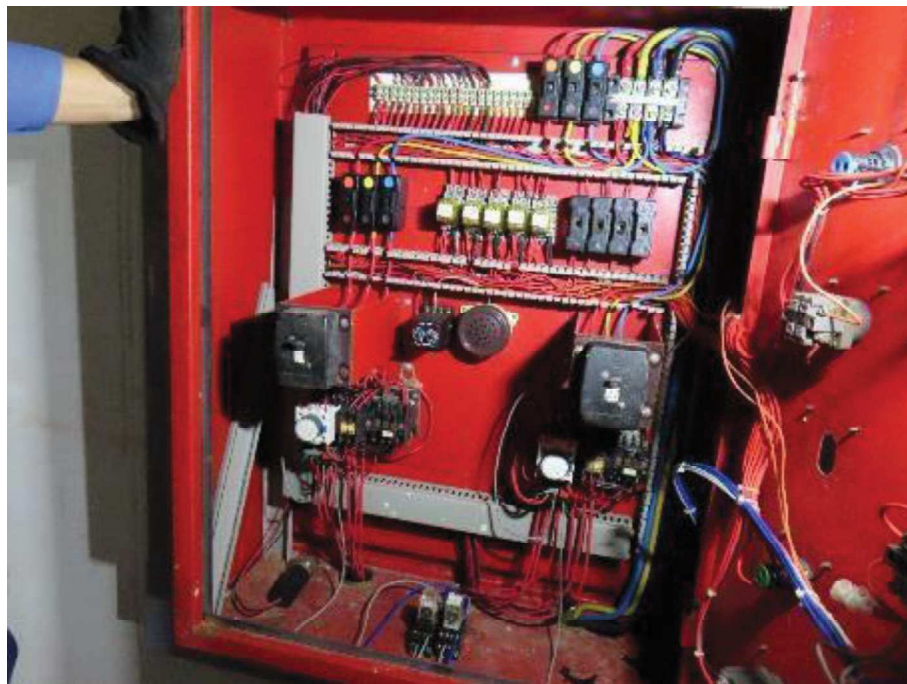
Photo showing the control panel wiring of fire booster pump control panel

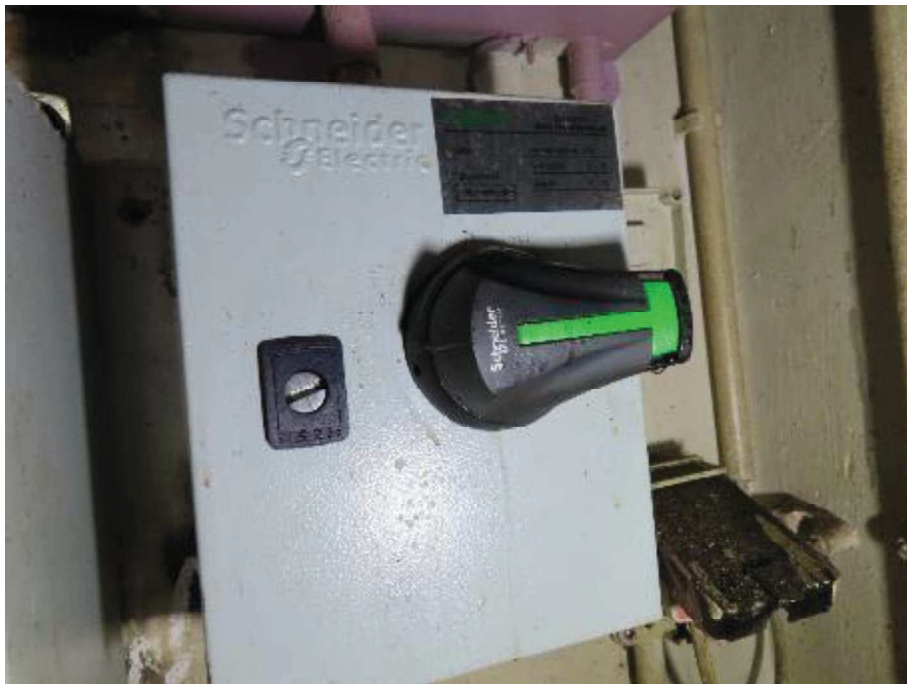
Photo showing the main switch of upfeed water pump (Power off position)

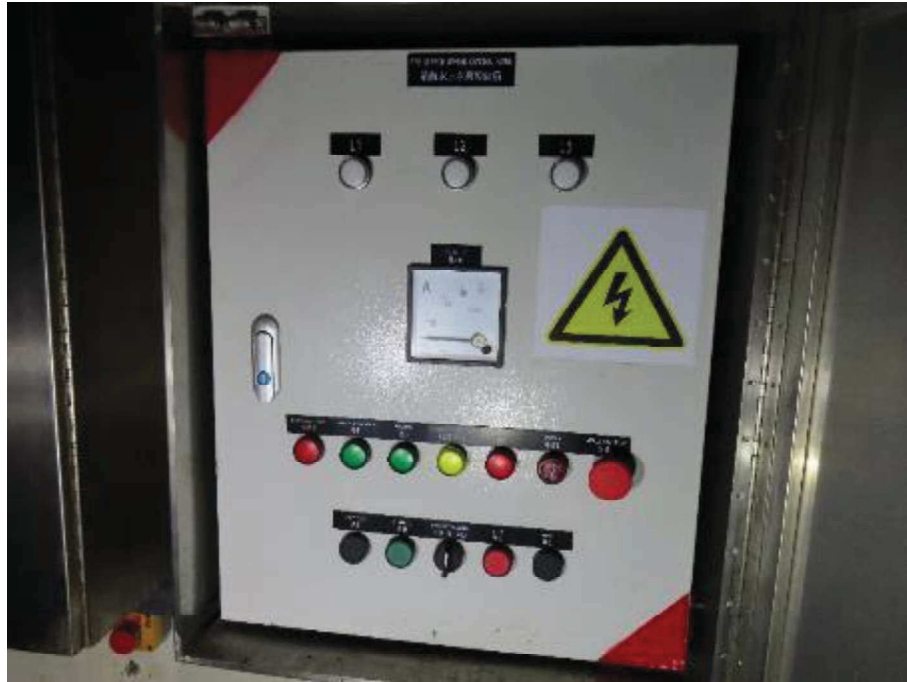
Photo showing the control panel of upfeed water pump (Power unavailable)

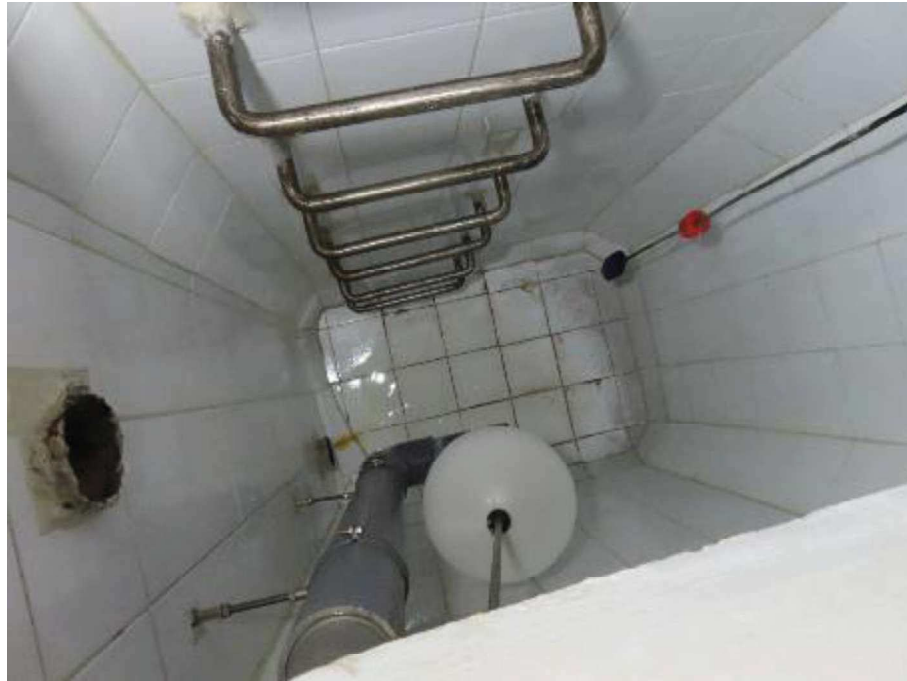
Photo showing the F.S. Up-feed tank of upfeed water pump (Water unavailable)

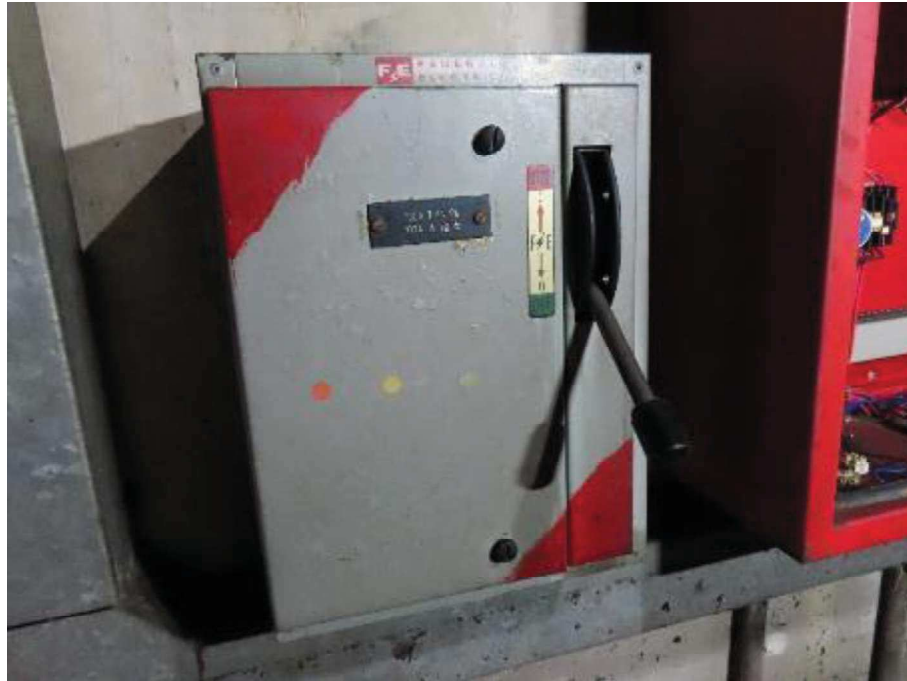
Photo showing the 100A TPN switch of fire booster pump panel (Power off position)

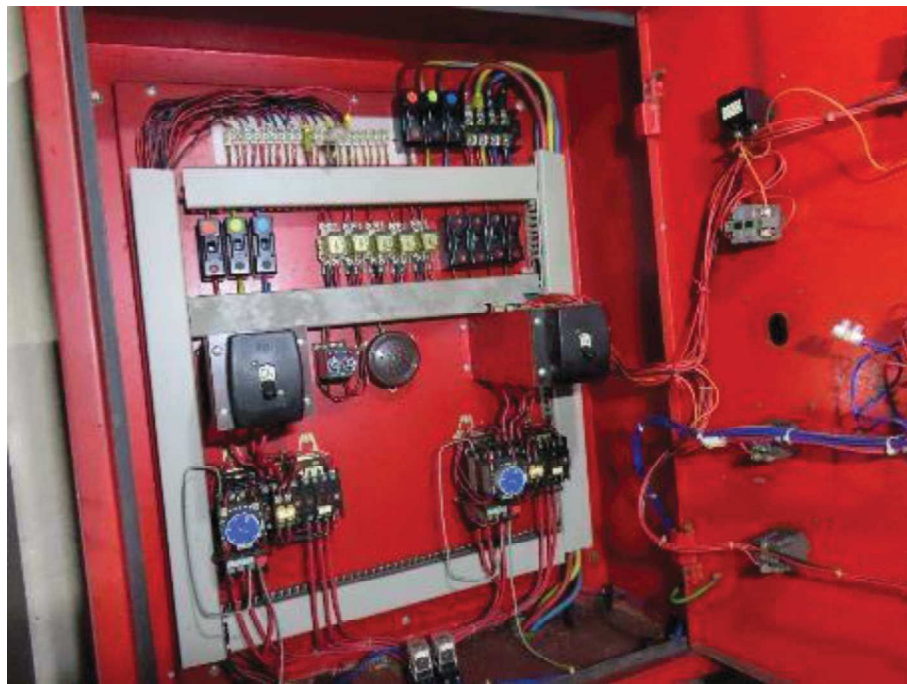
Photo showing the control panel of fire booster pump (Power unavailable)

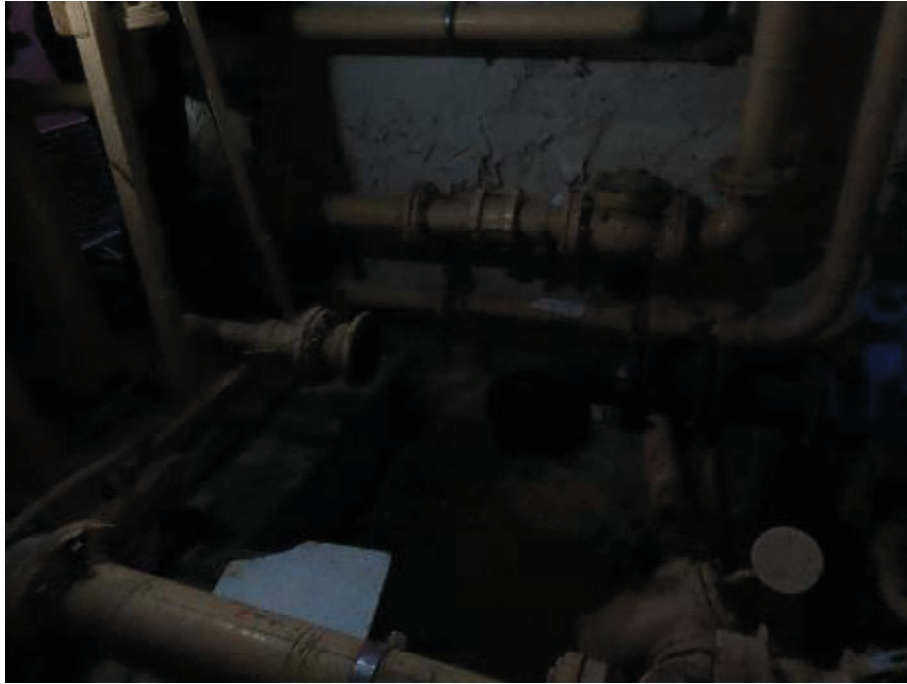
Photo showing the piping of upfeed water pump (Disconnected)

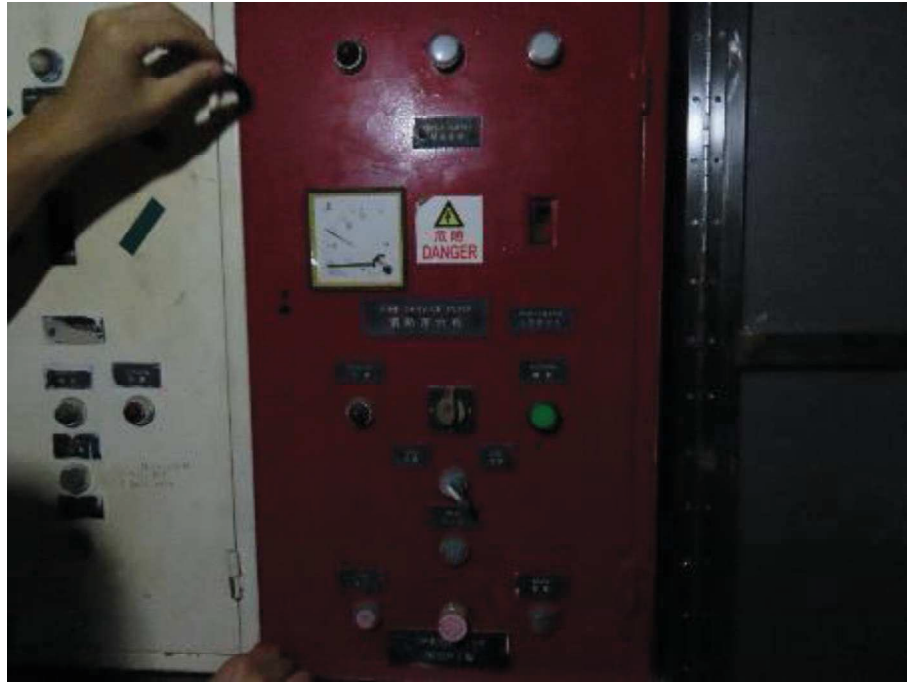
Photo showing the control panel of upfeed water pump (Power unavailable)

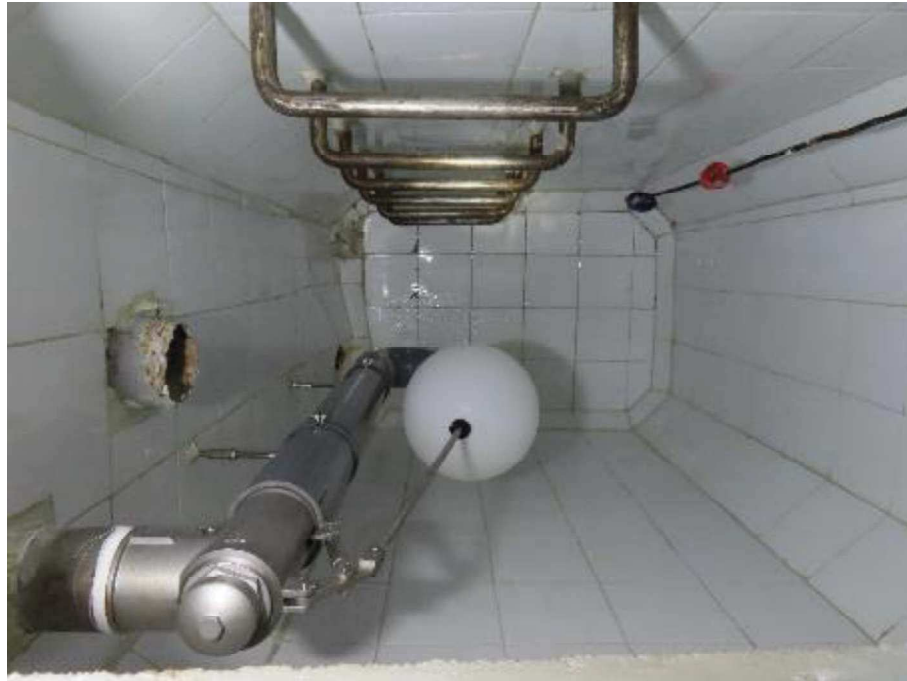
Photo showing the F.S. Up-feed tank of upfeed water pump (Water unavailable)

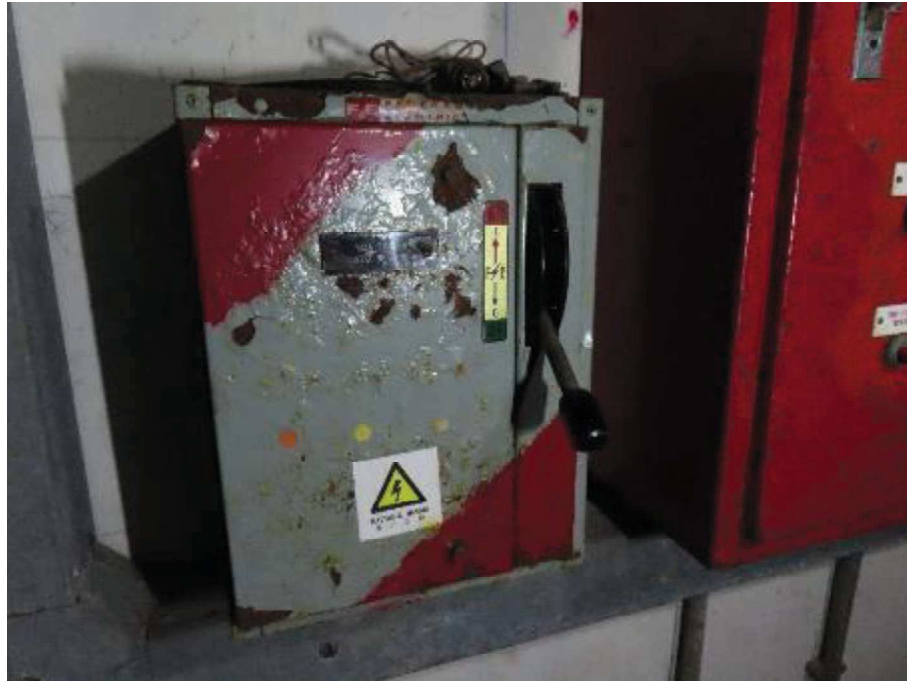
Photo showing the 100A TPN switch of fire booster pump panel (Power off position)

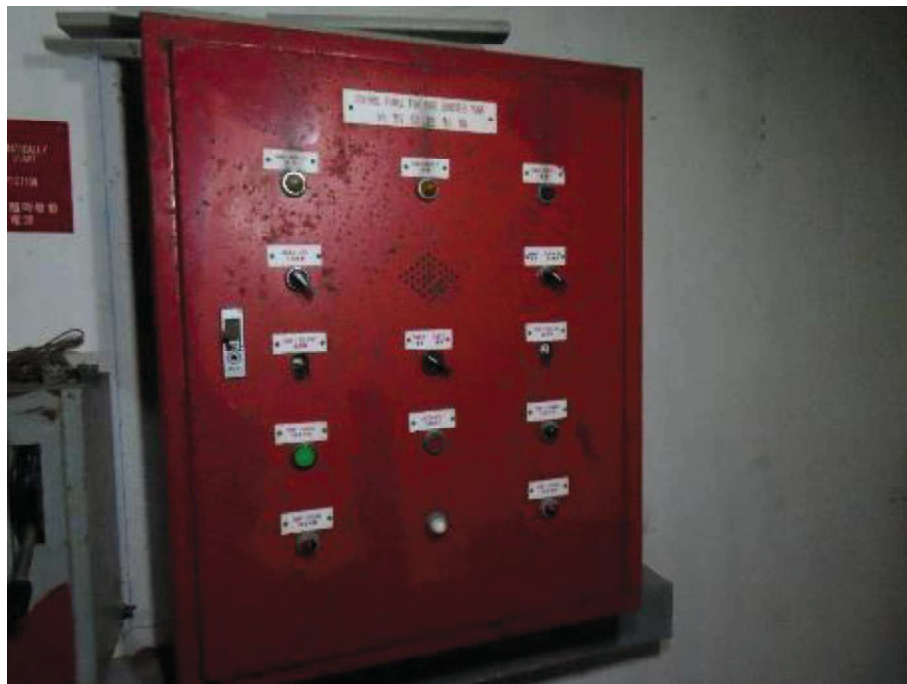
Photo showing the control panel of fire booster pump (Power unavailable)

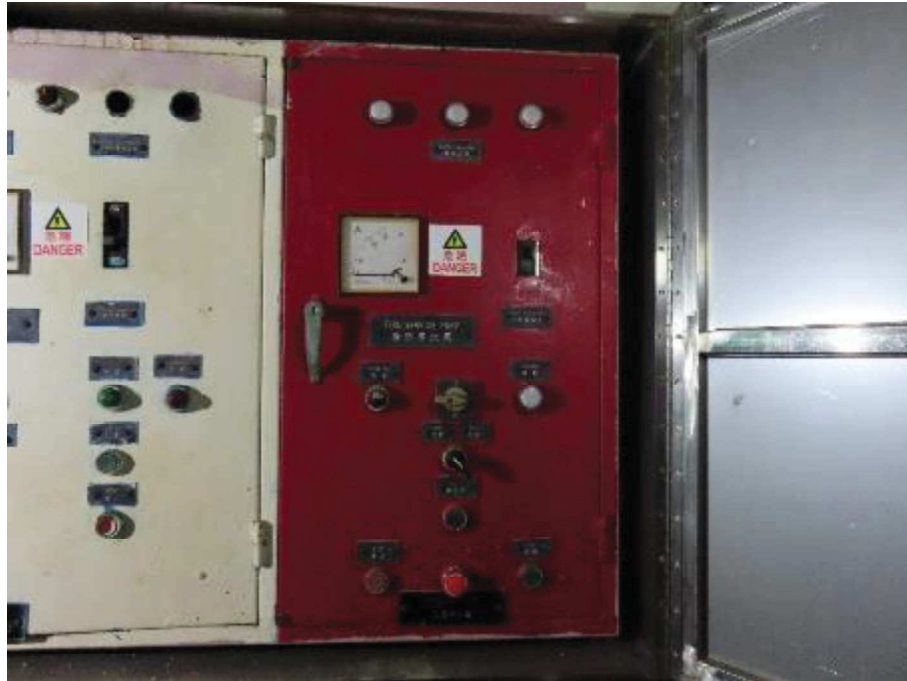
Photo showing the control panel of upfeed water pump (Power unavailable)

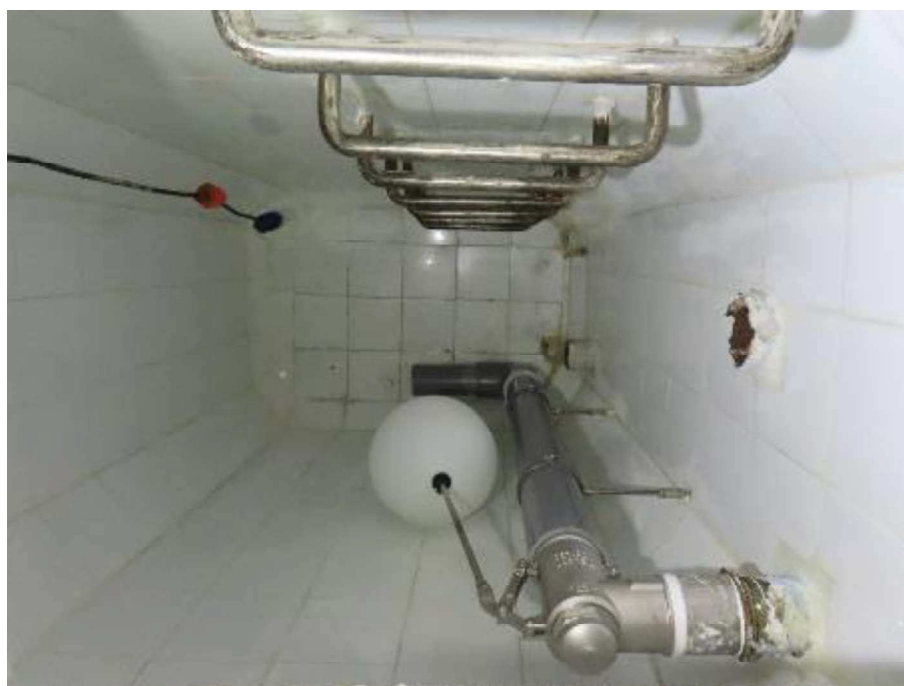
Photo showing the F.S. Up-feed tank of upfeed water pump (Water unavailable)

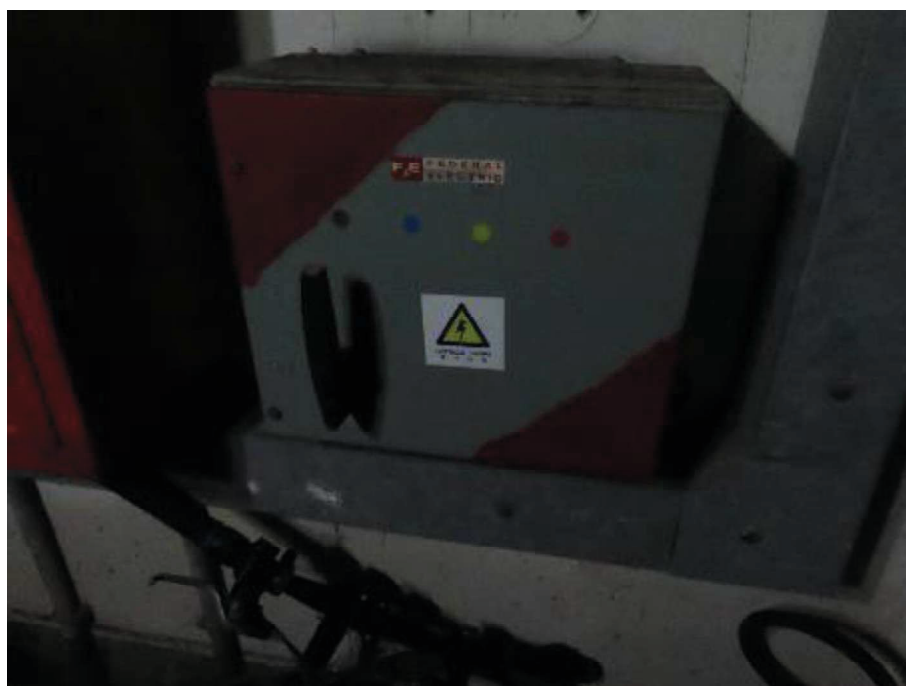
Photo showing the 100A TPN switch of fire booster pump panel (Power off position)

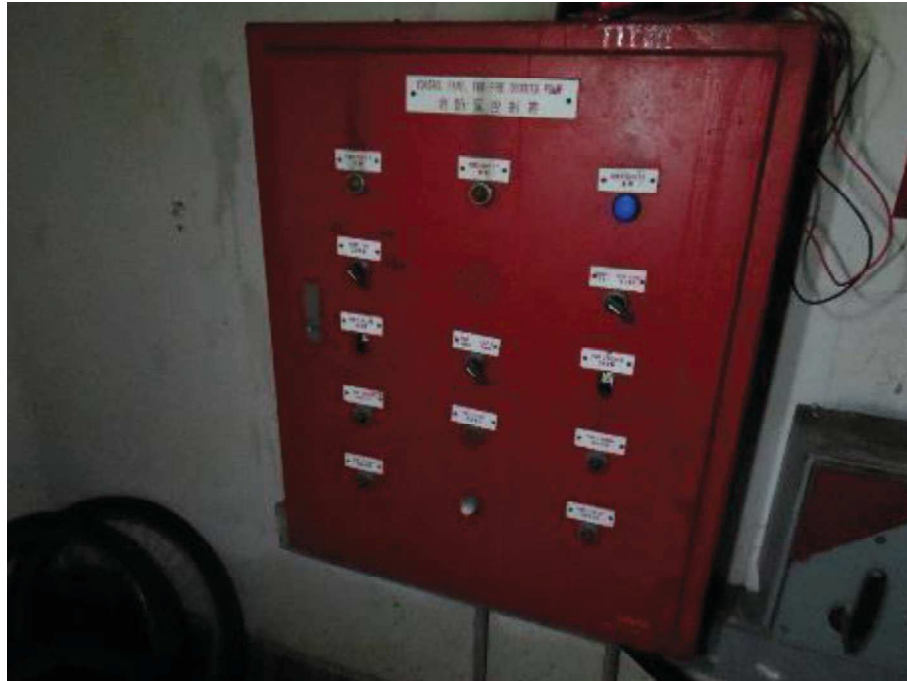
Photo showing the control panel of fire booster pump (Power unavailable)

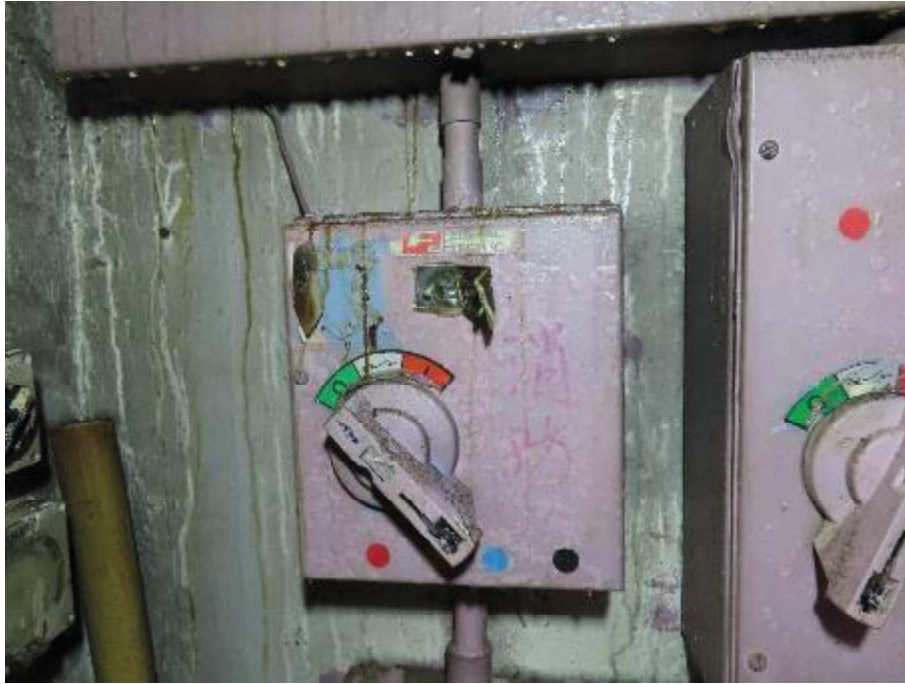
Photo showing the main switch of upfeed water pump (Power off position)

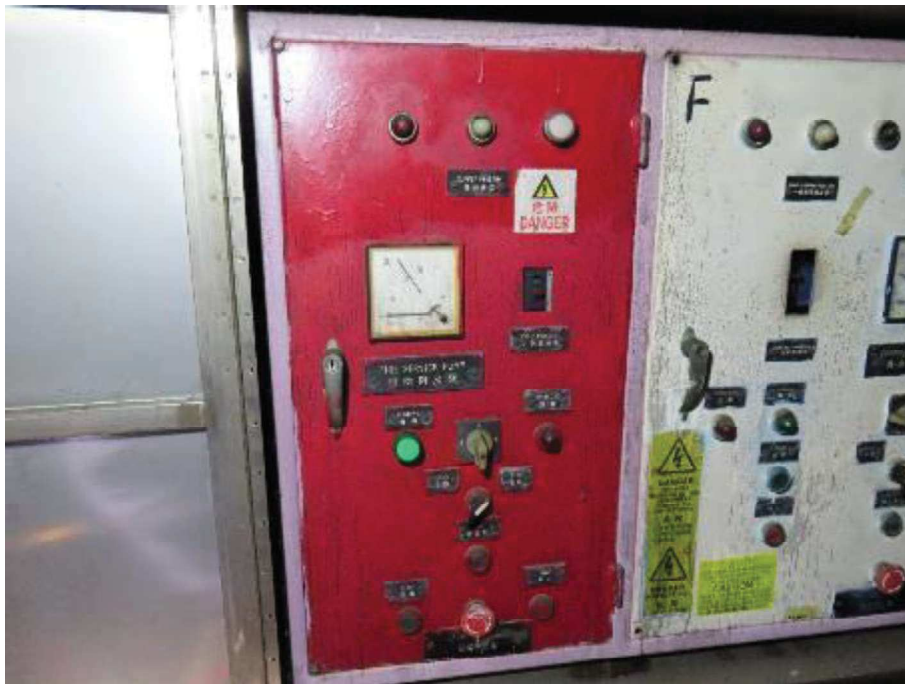
Photo showing the control panel of upfeed water pump (Power unavailable)

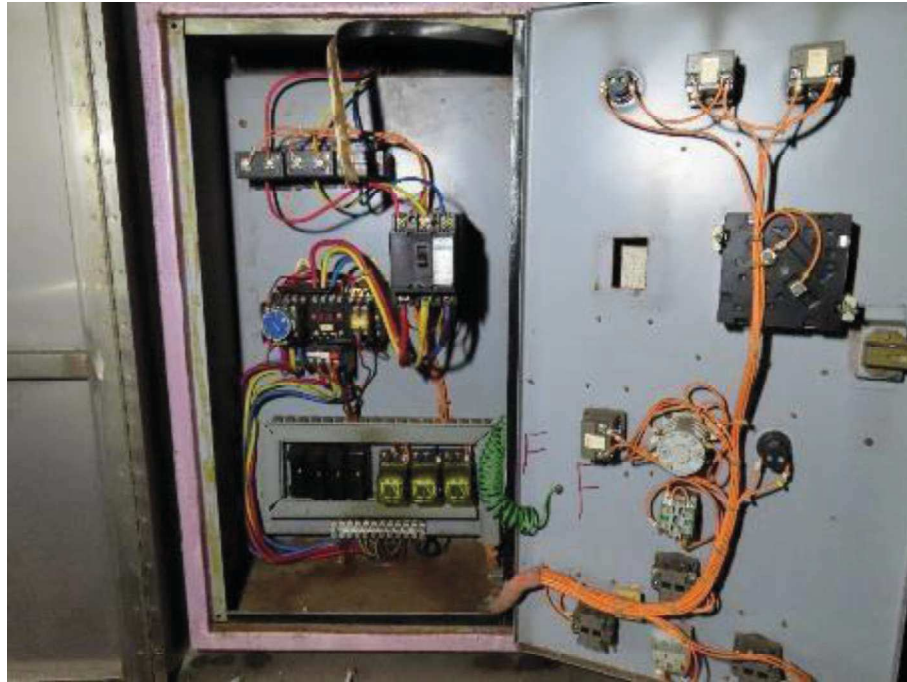
Photo showing the power breaker of the control panel of upfeed water pump (Power off position)

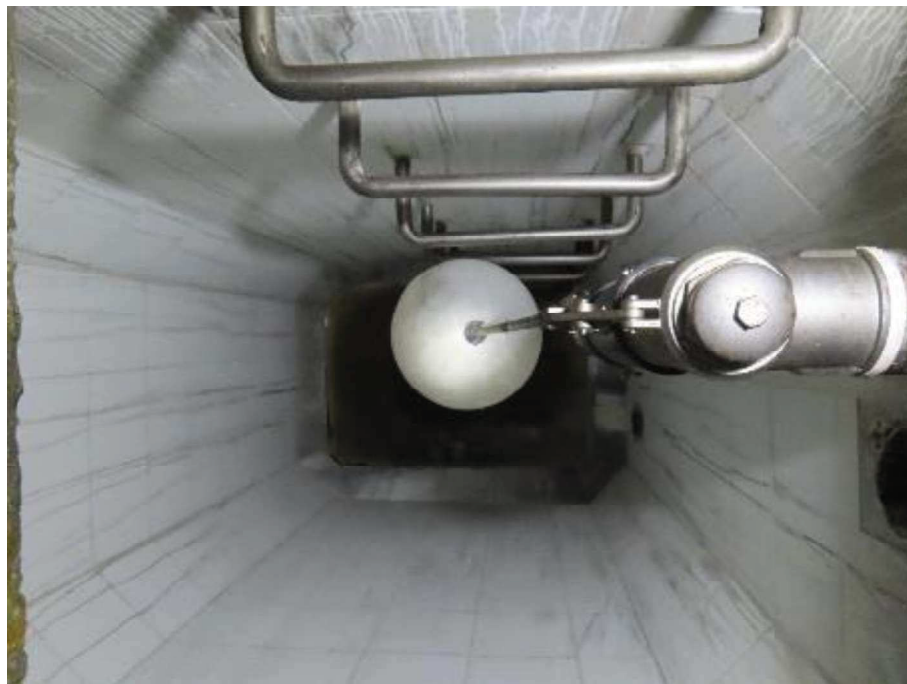
Photo showing the F.S. Up-feed tank of upfeed water pump (Water unavailable)

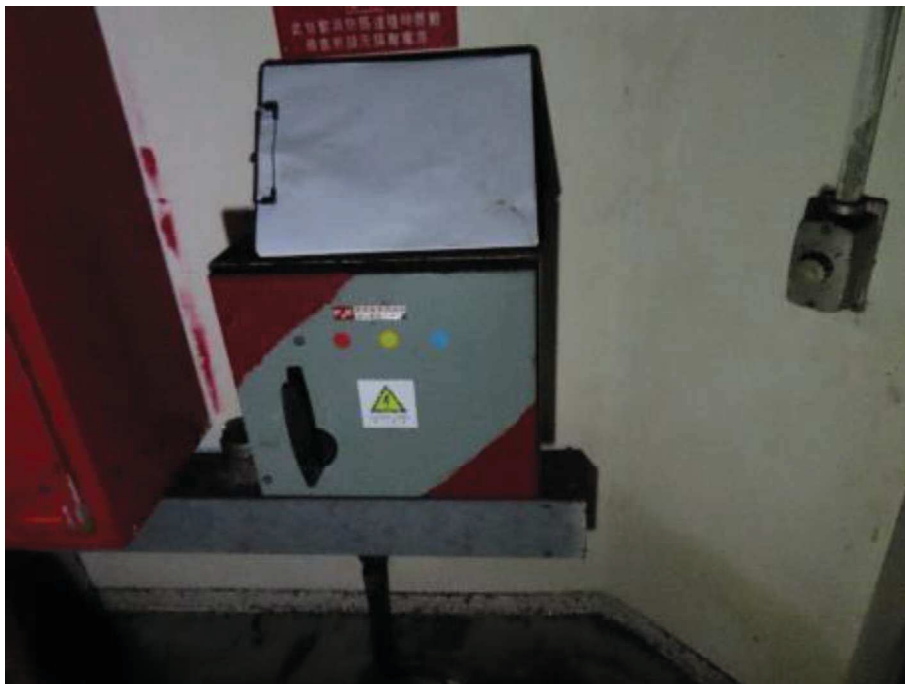
Photo showing the 100A TPN switch of fire booster pump panel (Power off position)

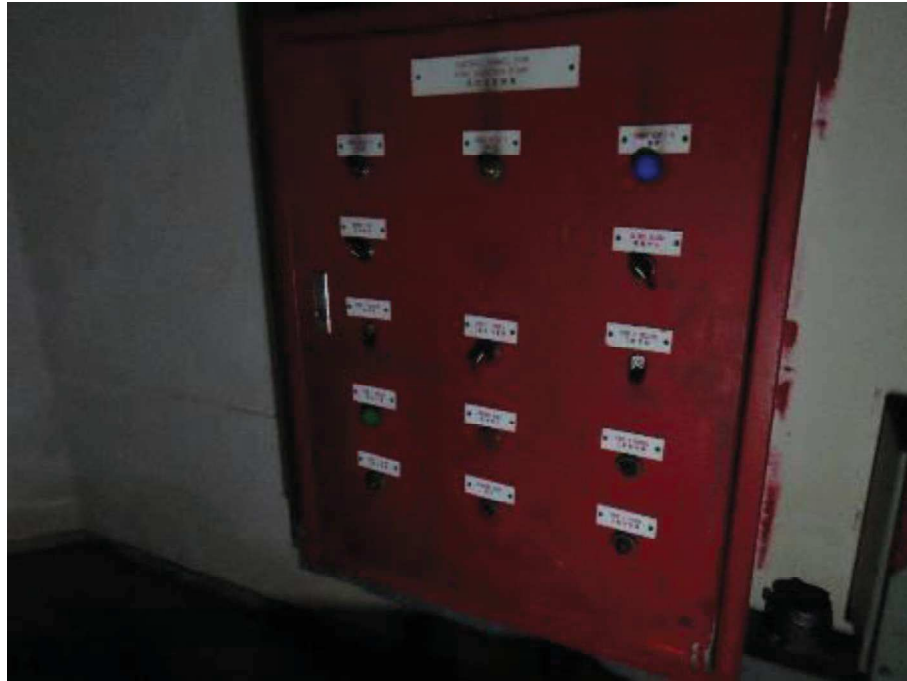
Photo showing the control panel of fire booster pump (Power unavailable)

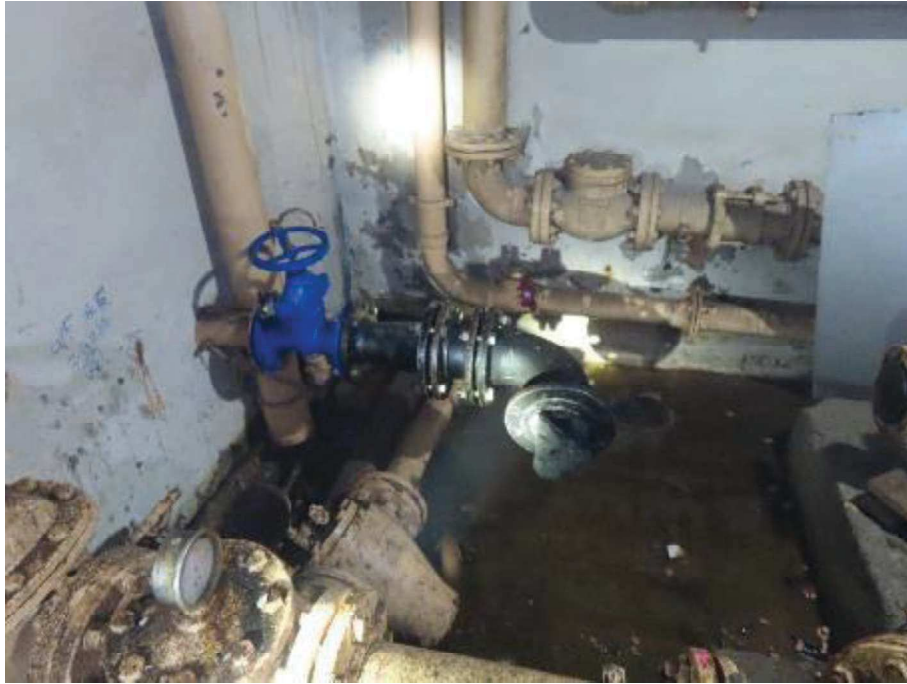
Photo showing the new installed piping of upfeed water pump (Disconnected)

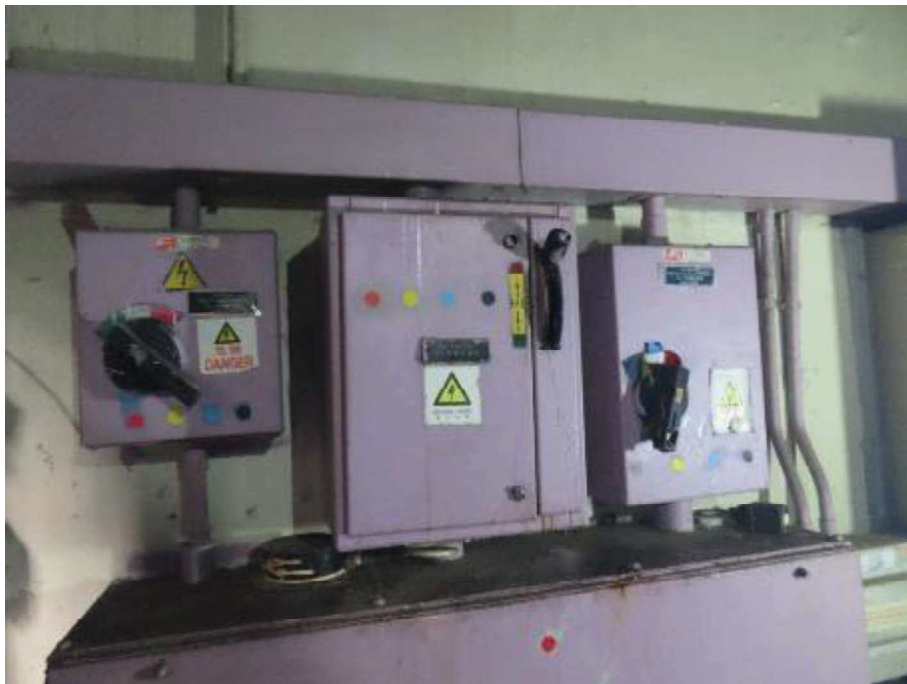
Photo showing the main switch of upfeed water pump (Power off position)

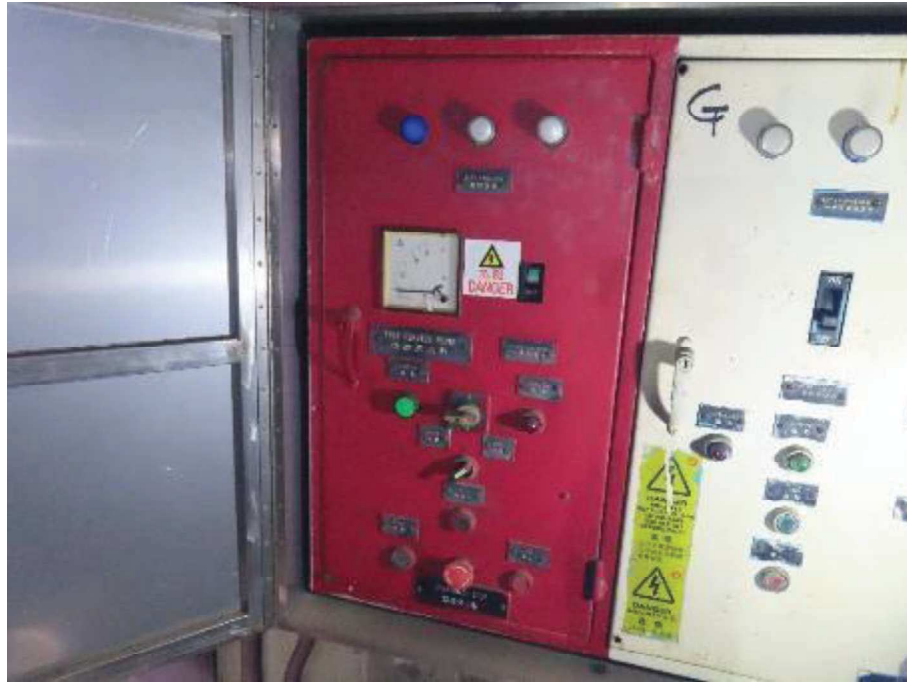
Photo showing the control panel of upfeed water pump (Power unavailable)

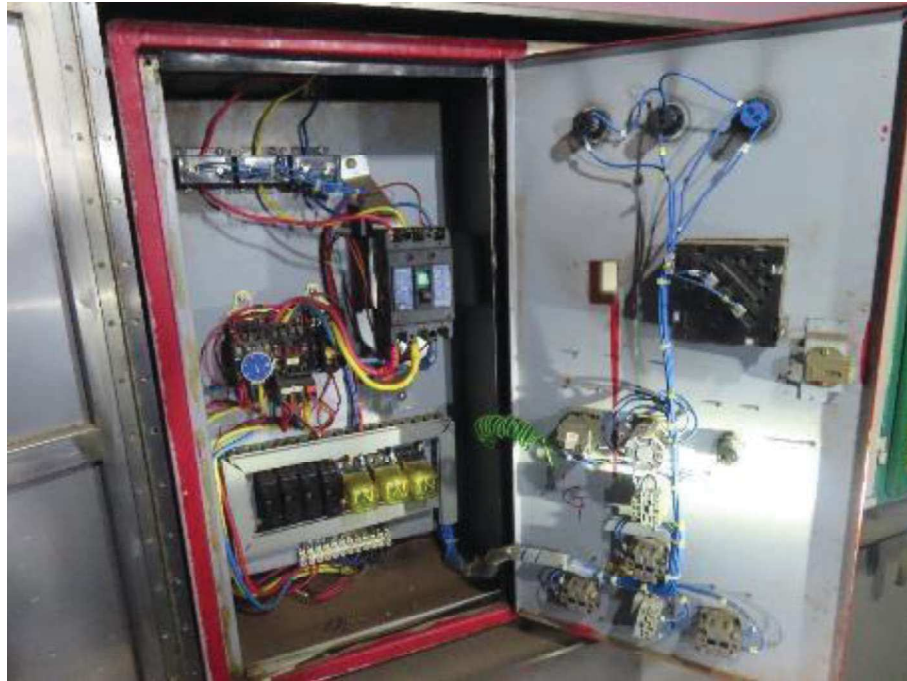
Photo showing the power breaker of the control panel of upfeed water pump (Power off position)

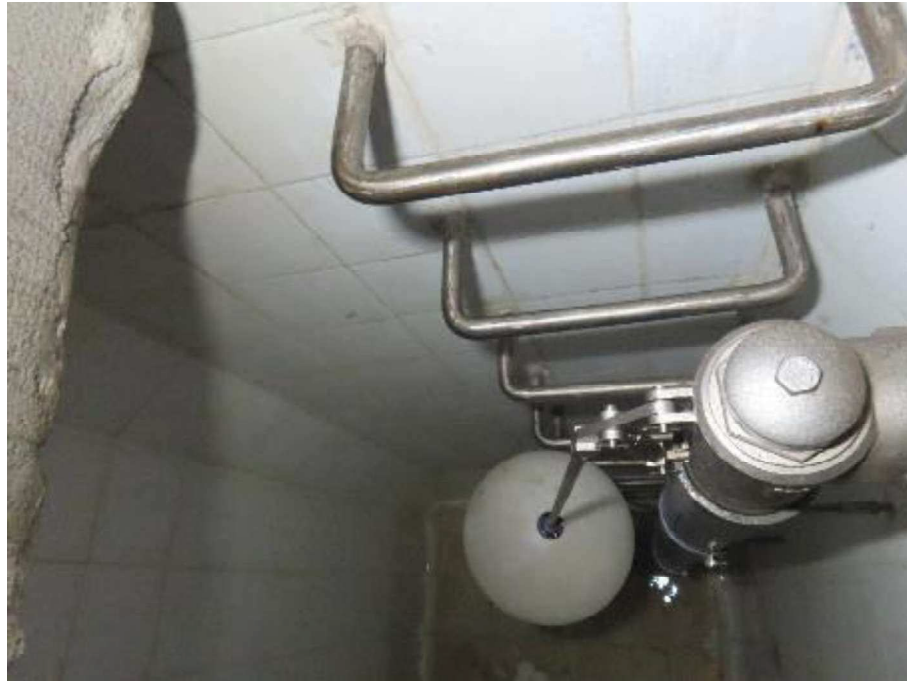
Photo showing the F.S. Up-feed tank of upfeed water pump (Water unavailable)

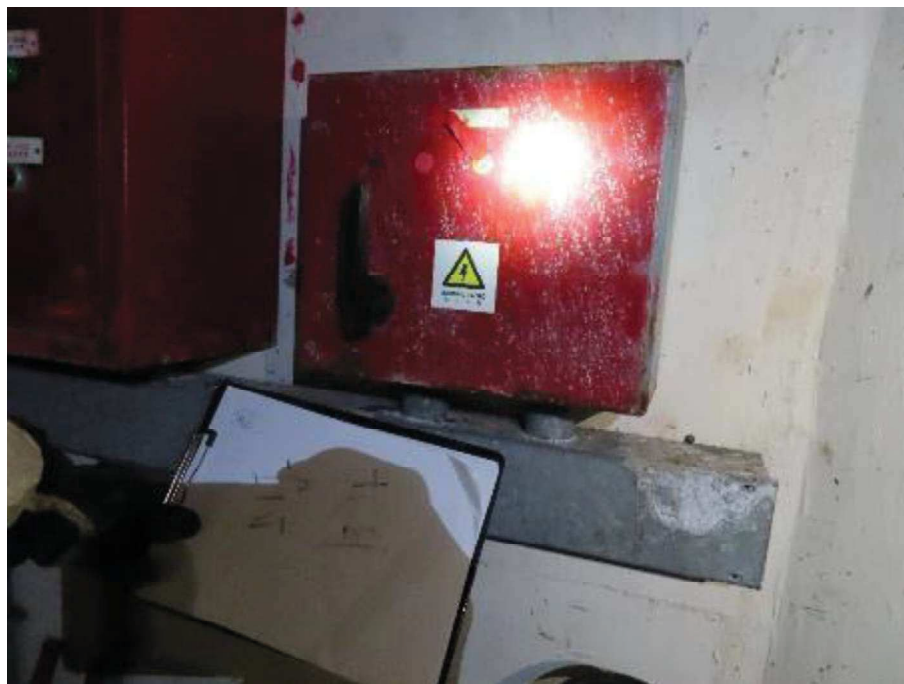
Photo showing the 100A TPN switch of fire booster pump panel (Power off position)

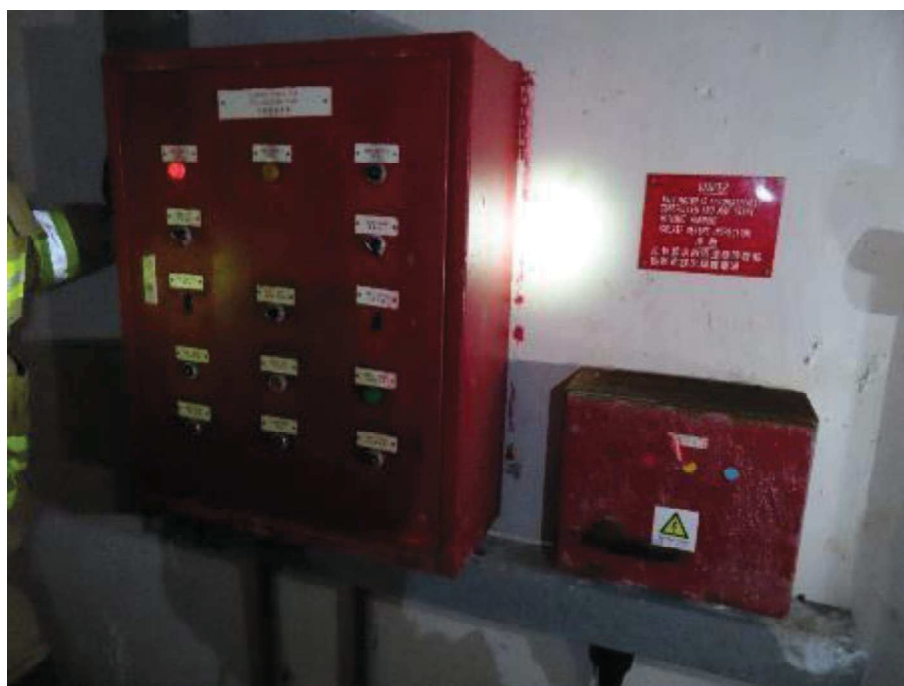
Photo showing the control panel of fire booster pump (Power available after switch on)

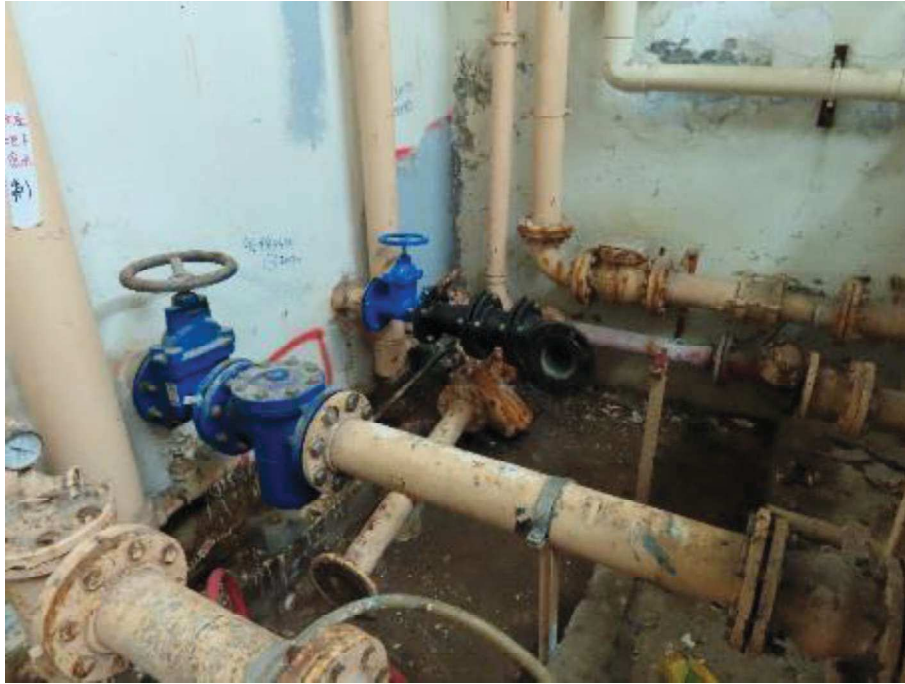
Photo showing the new installed piping of upfeed water pump (Disconnected)

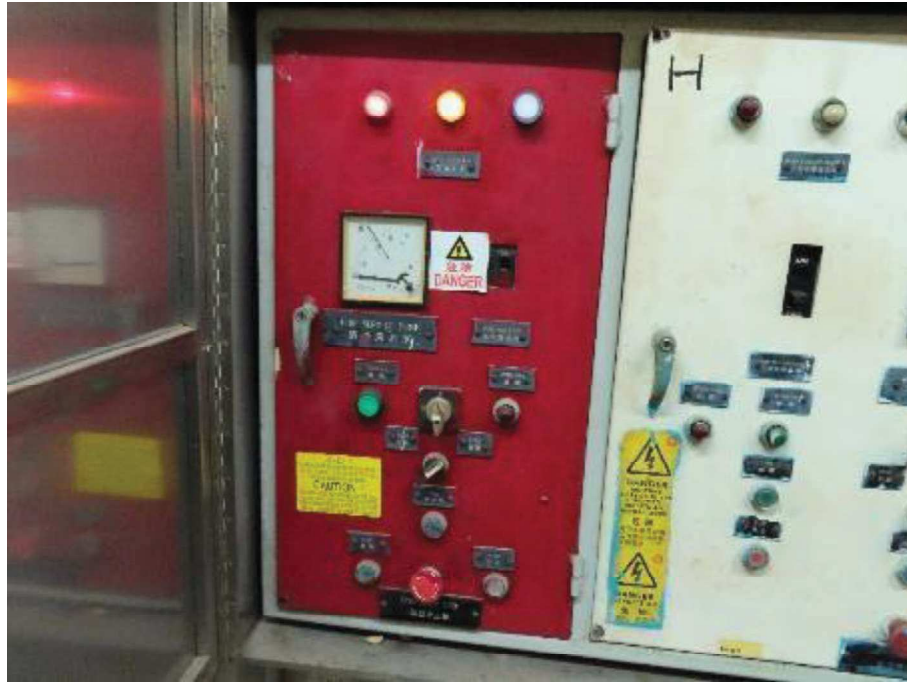
Photo showing the control panel of upfeed water pump (Power unavailable)

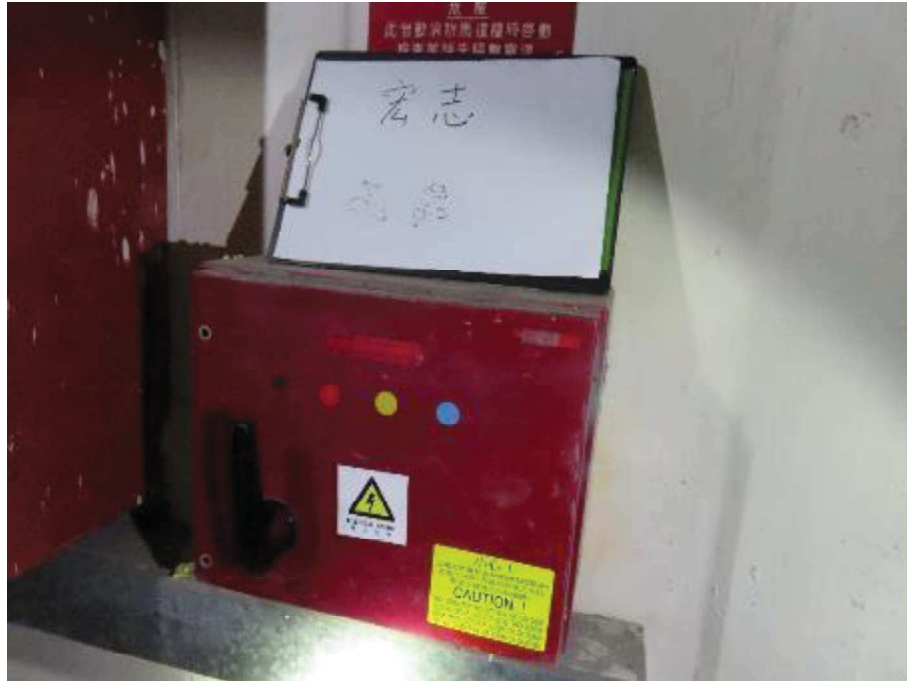
Photo showing the 100A TPN switch of fire booster pump panel (Power off position)

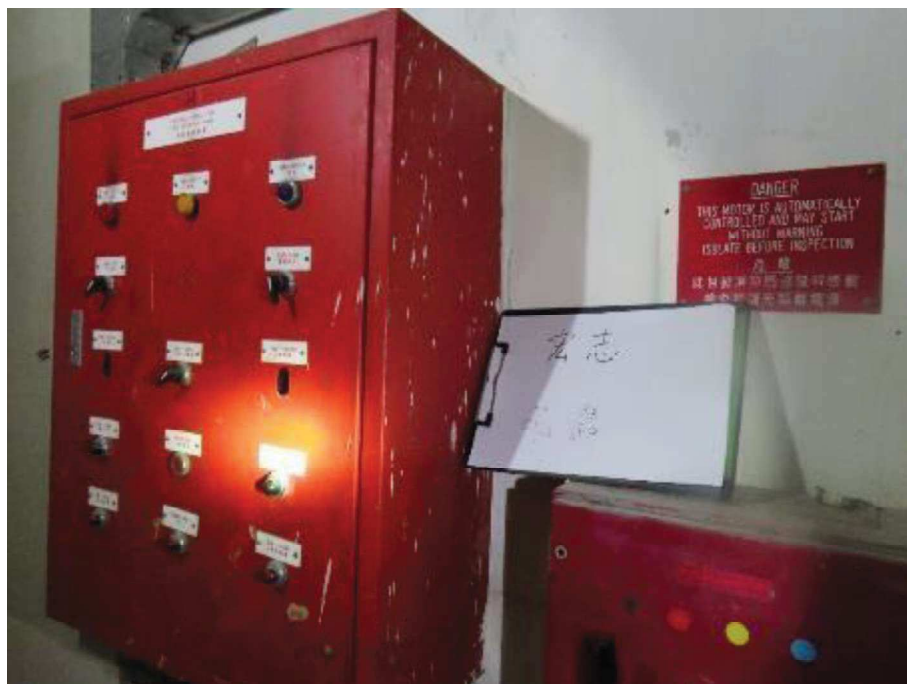
Photo showing the control panel of fire booster pump (Power unavailable)
