# Interim Investigation Report No.5 Alarm Fire at Wang Fuk Court on 26 November 2025

Inter-Departmental Fire Investigation Task Force

February 2026

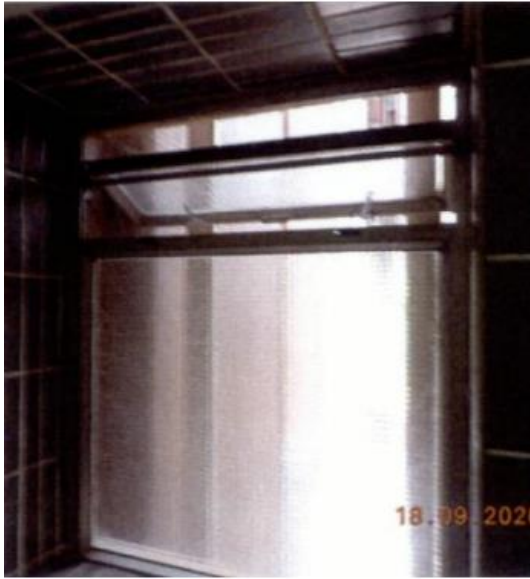
Photo 4-2 (a):  
Lift Lobby Window  
(Before renovation works)

- 4.3.1 At the time of construction of Wang Fuk Court, the prevailing standard on fire resisting construction was stipulated in the Building (Construction) Regulations as well as the Code of Practice on Provision of Means of Escape in Case of Fire and Allied Requirements 1976 (CoP on MOE 1976).
- 4.3.2 According to the CoP on MOE 1976, windows in the external walls of the staircases were not required to be fire-rated unless they oppose and are within 6m of (i) the opposite side of a street; (ii) the lot boundary, not being a common boundary with the street; or (iii) any other building on the same lot. As such, the upper part of the windows at the lift lobbies as well as in the staircases of the eight blocks of Wang Fuk Court was openable, while the lower part of the windows were fixed lights (see **Photos 4-2 (a) & 4-3 (a)**).

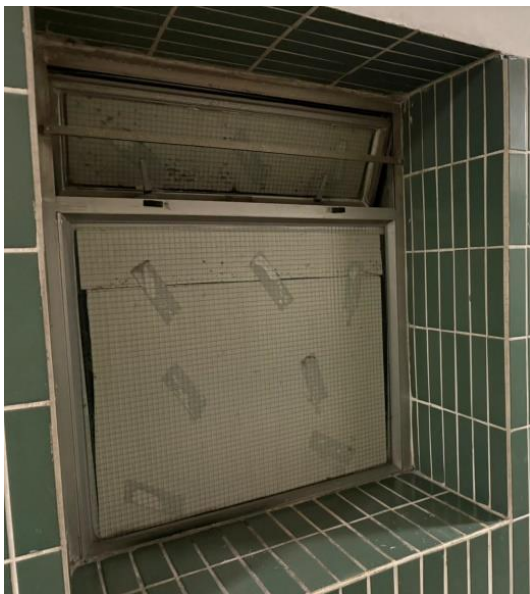
Photo 4-2(b): Lift Lobby Window  
(Photo taken after the fire)

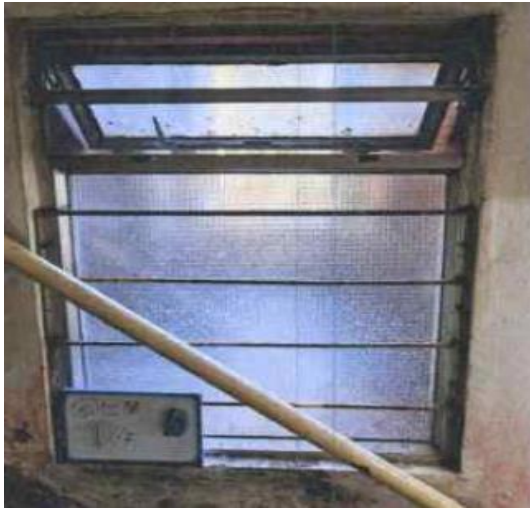
Photo 4-3 (a):  
Staircase Window  
(Before renovation works)

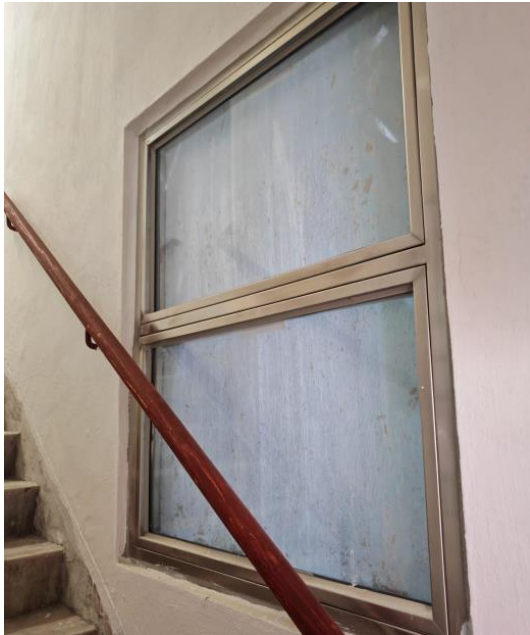
Photo 4-3(b): Staircase Window  
(Photo taken after the fire)

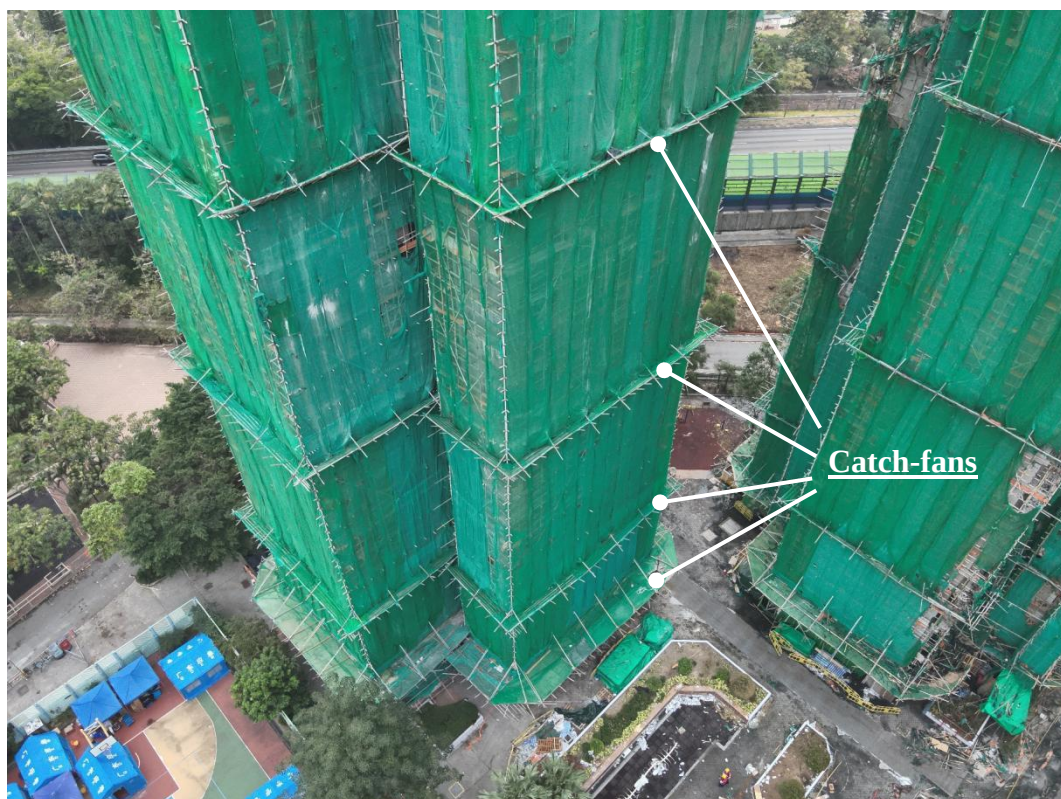
*Photo 4-6: Catch-fans outside the Scaffoldings*

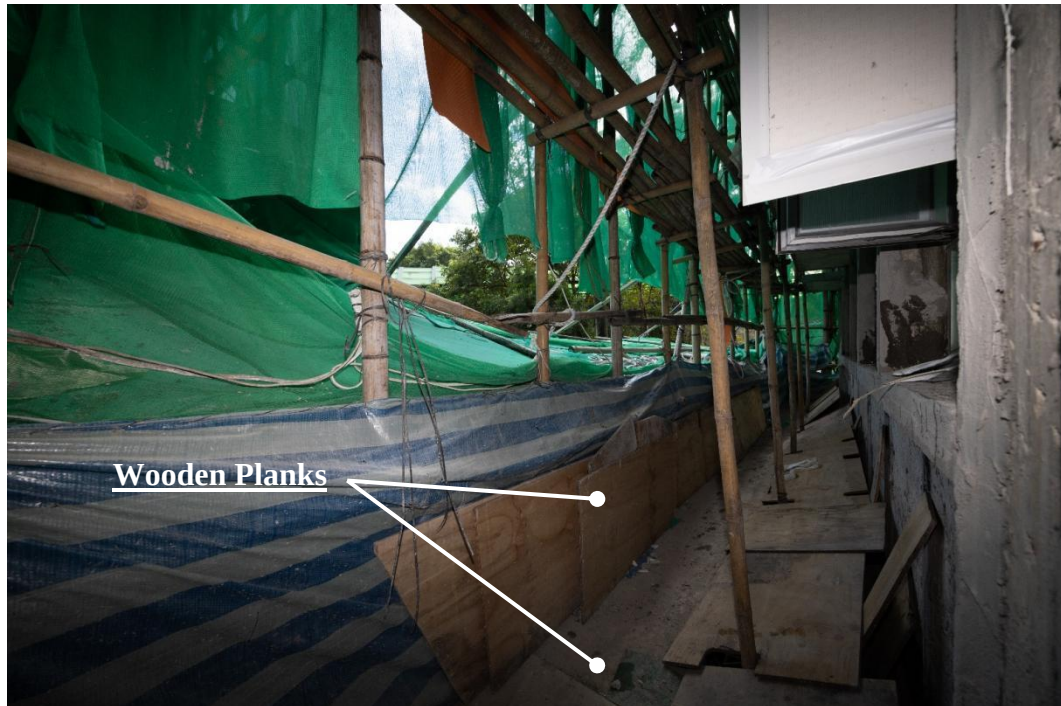
- 4.5.5.2 Wooden planks<sup>20</sup> were laid as working platforms to facilitate workers carrying out work at the building exterior and to prevent them from falling from height (as shown in **Photo 4-7**).

*Photo 4-7: Close-up View of the Working Platforms*

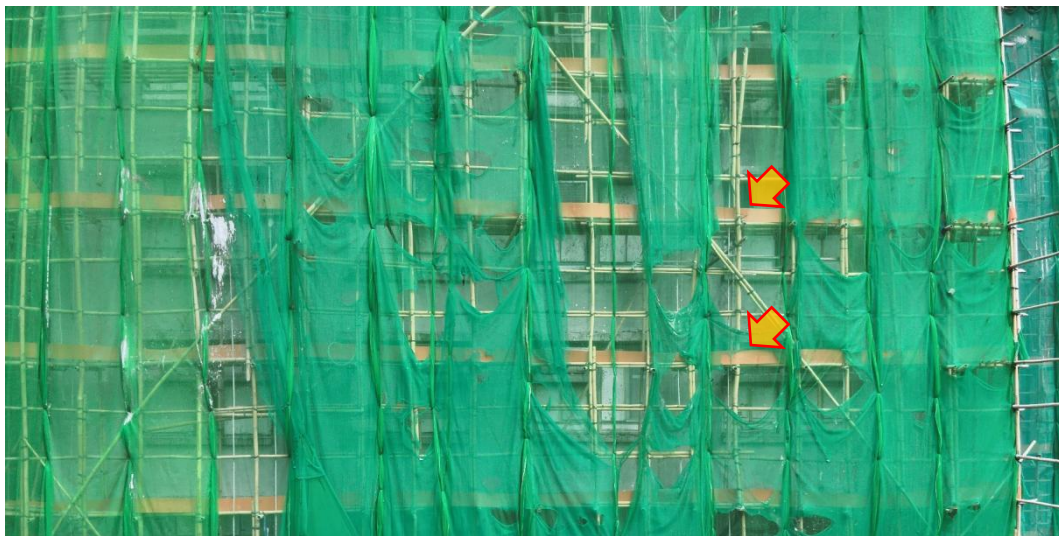
*Photo 4-8: Toe-boards on the Working Platforms inside Scaffolding*

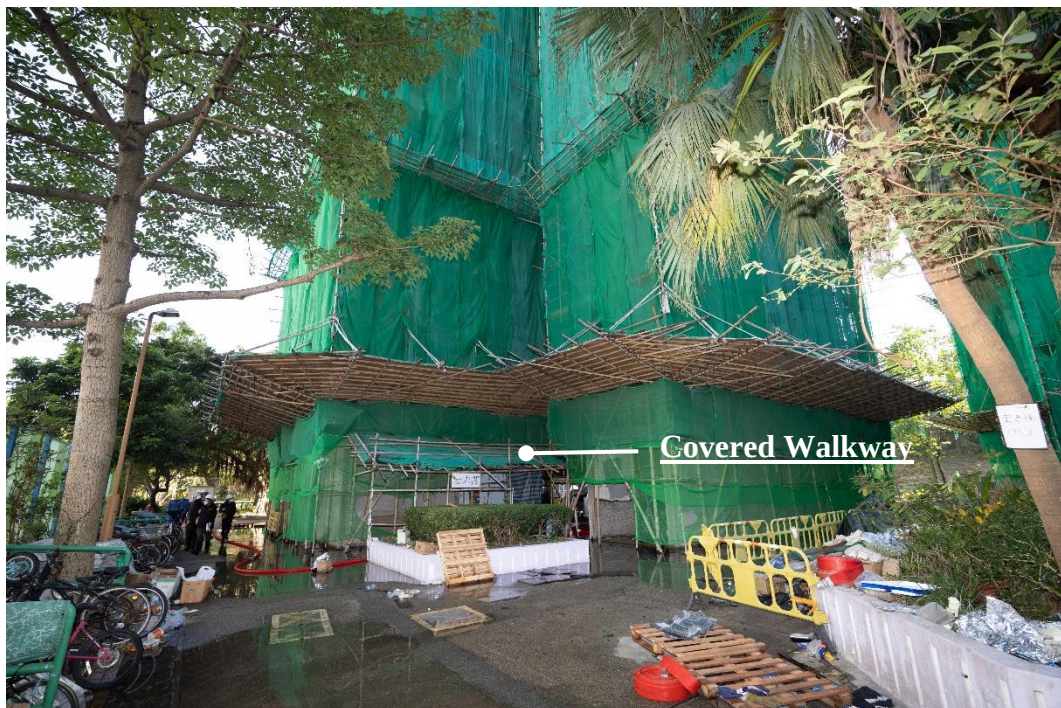
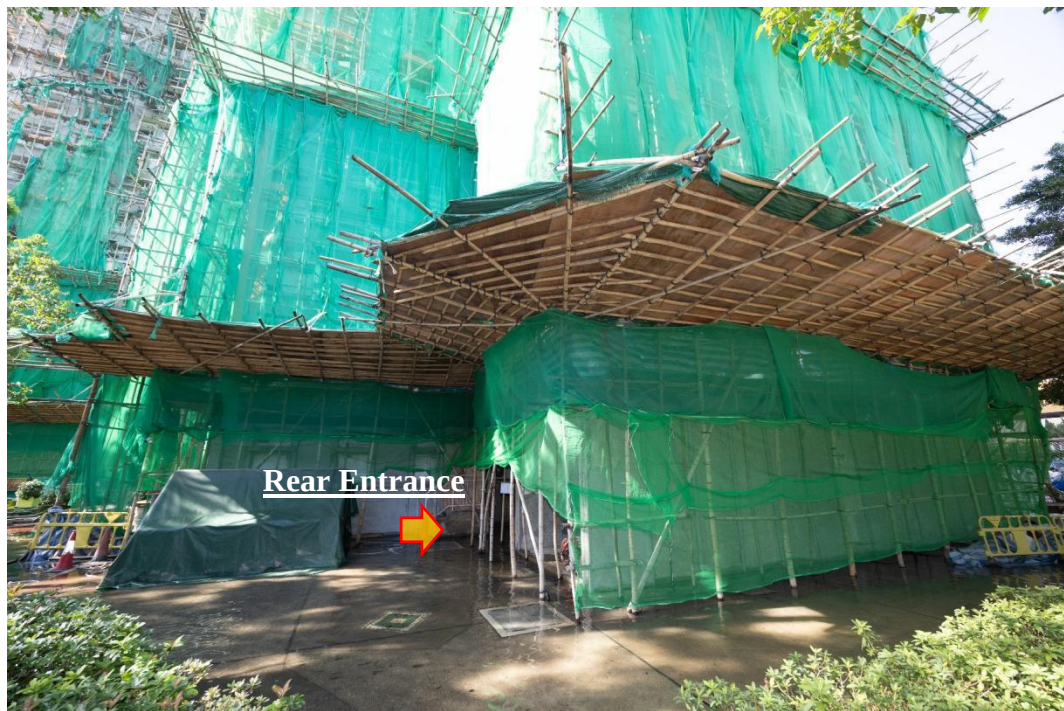
- 4.5.6.2 A covered walkway was provided at the building entrance, shielding personnel underneath from falling debris (as shown in **Photos 4-11 (a) & (b)**).

*Photo 4-11 (a): Covered Walkway at the Main Entrance of Wang Chi House*

*Photo 4-11 (b): Rear Entrance of Wang Chi House*

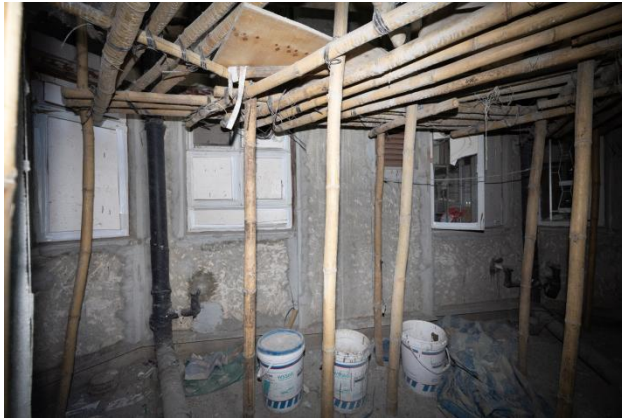
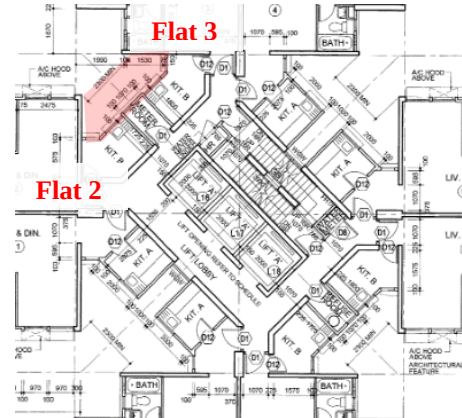
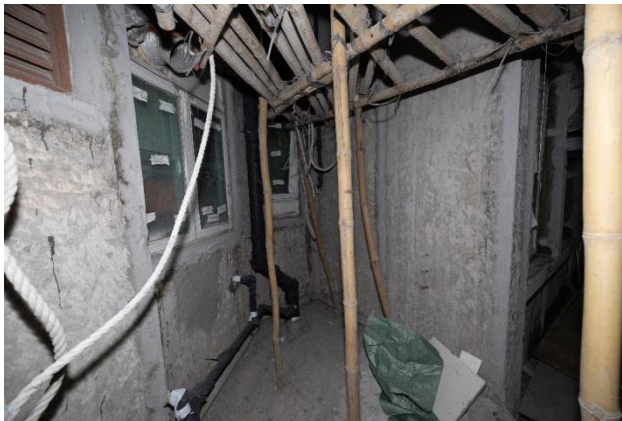
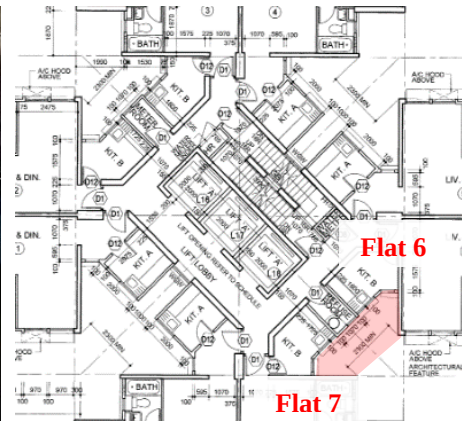
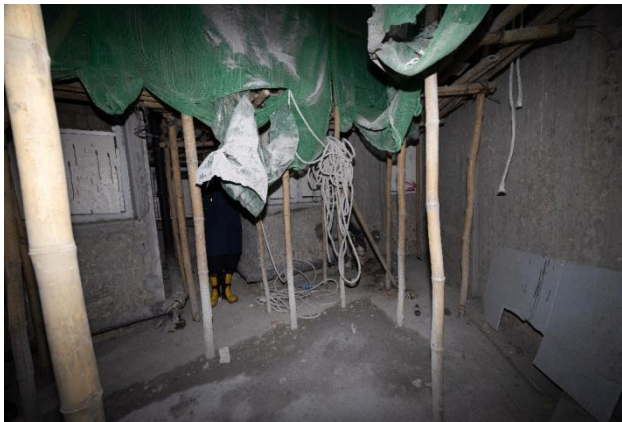
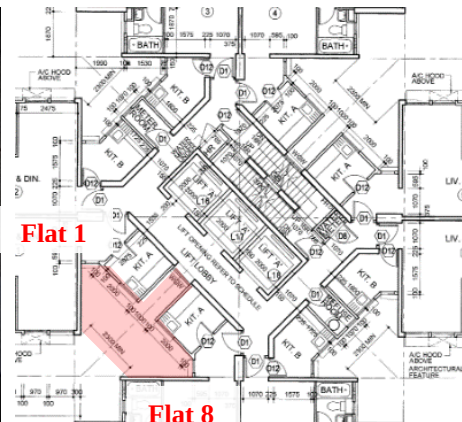
- 4.5.6.3 A considerable amount of combustibles, including bamboos, wooden planks, safety nets, nylon strips and canvas, was located at the re-entrants (as shown in **Photos 4-12 (a) to (d)**). Especially at the re-entrants with windows immediately outside the lift lobby and staircases, where a triangular channel extending from the flat roof to the roof level was observed (as shown in **Photo 4-13**).

*Photos 4-12 (a) to (d): Re-entrants at Wang Chi House*

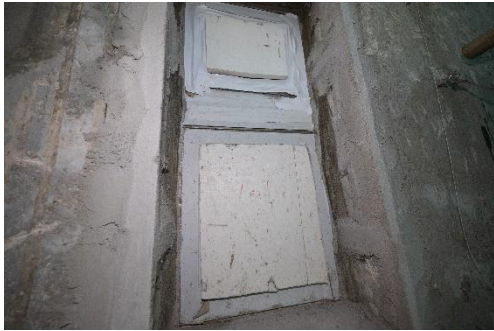
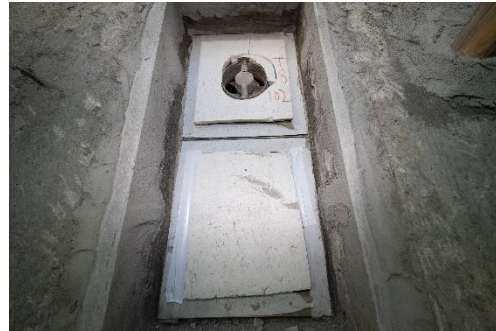
- 4.5.6.4 Polystyrene window covers<sup>24</sup> were found covering the windows of most flats, lift lobbies and staircases to protect window glass from accidental impacts (as shown in **Photos 4-14 (a) to (c)**).

Photos 4-14 (a) to (c): Polystyrene Window Covers

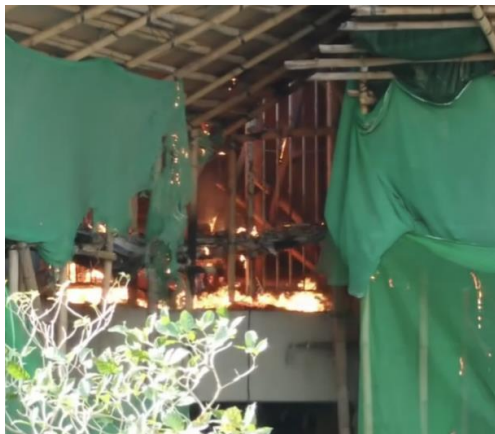
5.1.1 At 1451 hours, the informant, Mr. YIP [REDACTED]<sup>25</sup>, who was at the cycling path near Wang Cheong House, discovered a fire at Wang Fuk Court and immediately called 999 to report the fire (Location Map at **Figure 5-1**). According to the video provided by Mr. YIP, the fire was observed to have started on the flat roof outside Flats 104 and 105 of Wang Cheong House (Screenshot shown in **Photo 5-1** and layout plan at **Figure 5-2**).

Photo 5-1:  
Screenshot from the Informant's Video  
at about 1451 hours (Discovery)

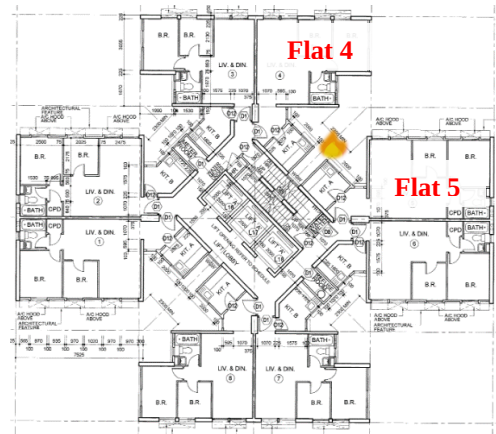
Figure 5-2:  
Layout Plan Showing the Fire Origin

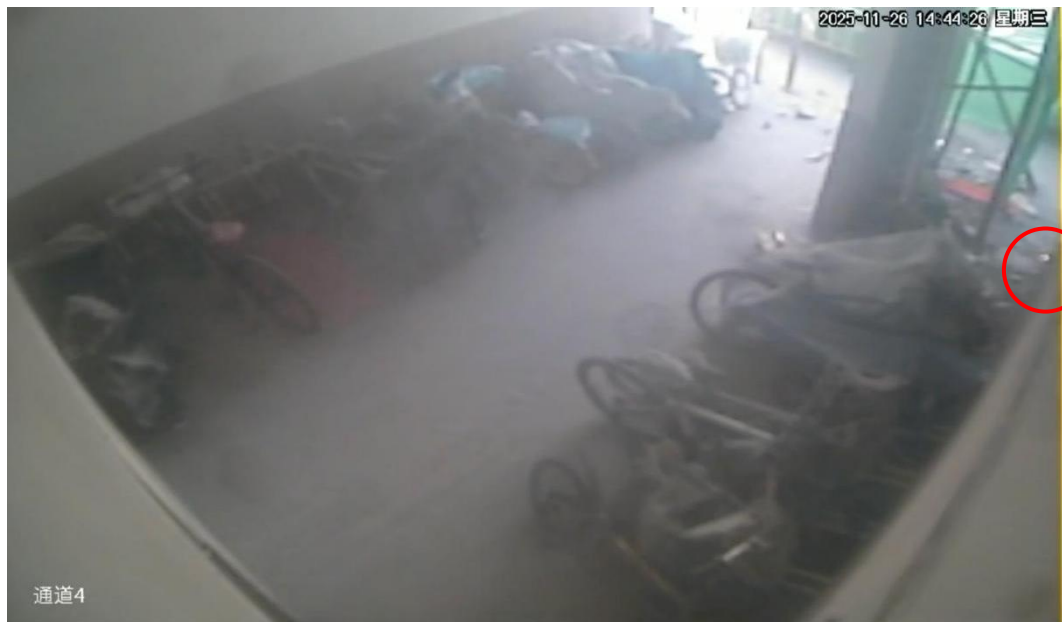
5.1.2 However, the investigation revealed that the fire might have started prior to Mr. YIP's report. According to CCTV footage, embers were observed falling onto the bicycle parking area of Wang Cheong House at approximately 1443 hours<sup>26</sup> (Screenshot shown in **Photo 5-2**).

*Photo 5-2: Embers Falling onto Bicycle Parking Area*

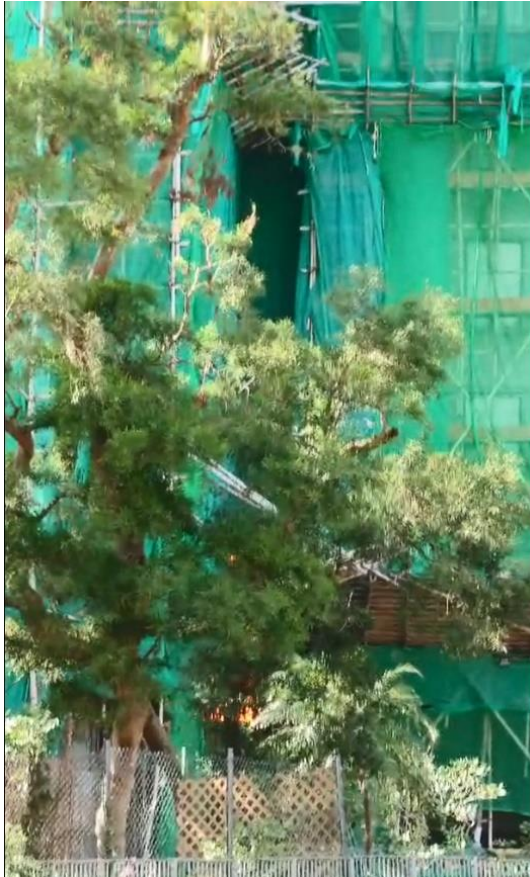
- 5.2.2.1 The video provided by the informant clearly showed the fire spreading through the **east re-entrant** of Wang Cheong House. **Photo 5-3** illustrates the fire spreading to about 4/F at about 1455 hours; while **Photo 5-4** shows the fire spreading to about 8/F at about 1457<sup>33</sup> hours, shortly after the FS arrival at 1456 hours.

Photo 5-3:  
Fire Spread to about 4/F  
at about 1455 hours

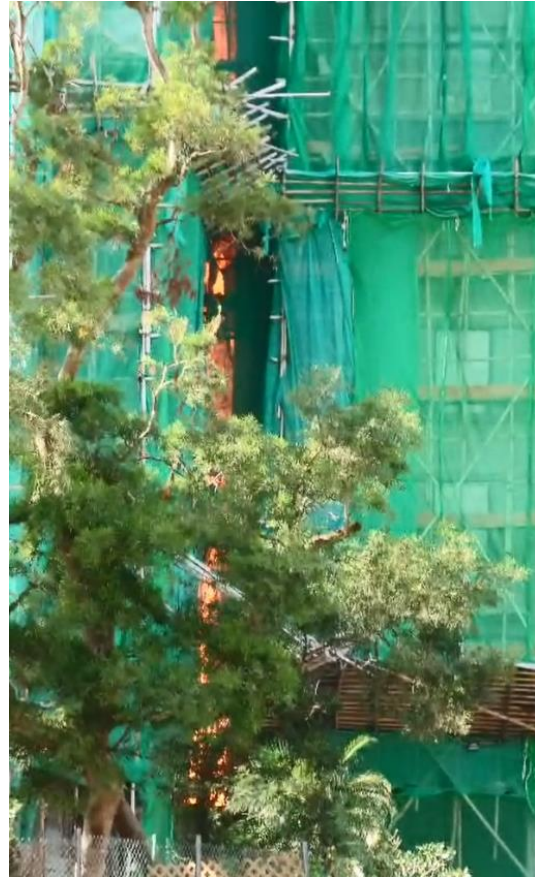
Photo 5-4:  
Fire Spread to about 8/F  
at about 1457 hours

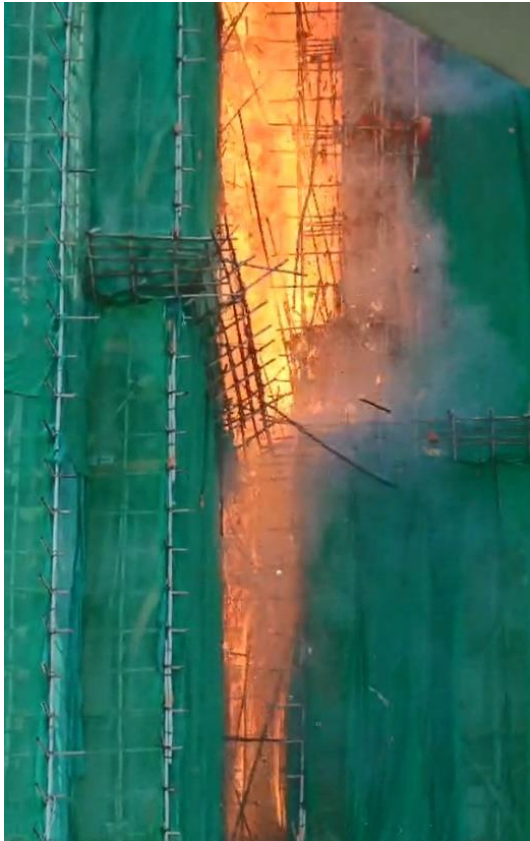
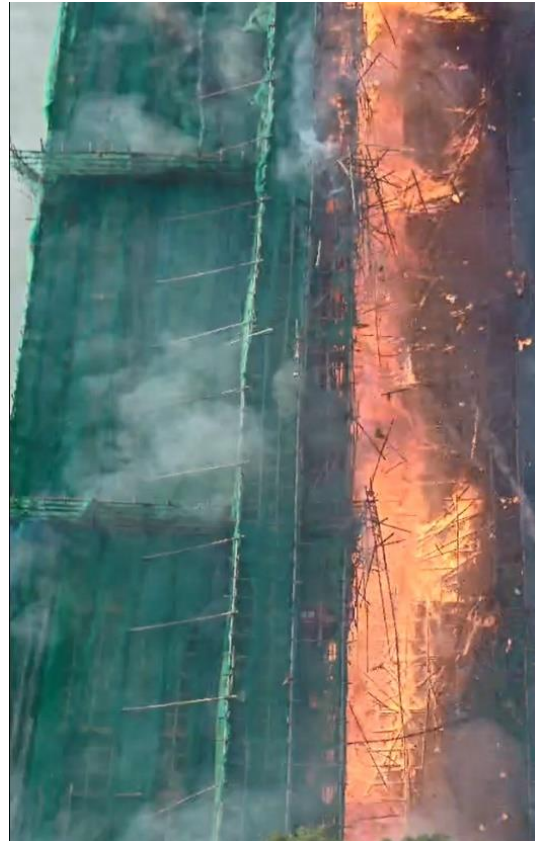
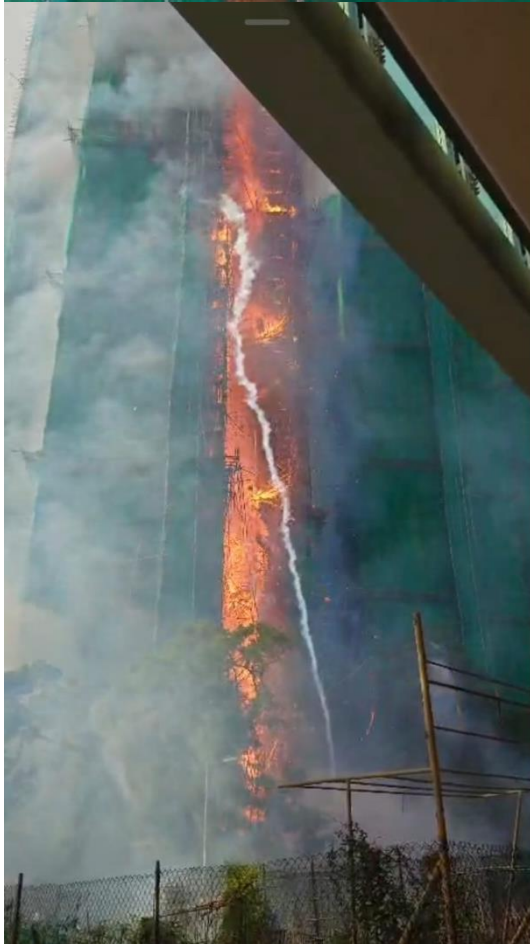
- 5.2.2.2 At 1458 hours, the fire intensified and developed vigorously, accompanied by falling debris, bamboo, and construction materials (as shown in **Photos 5-5 (a) to (c)**).

Photos 5-5 (a) to (c) :  
Fire Intensified and Engulfed the Entire  
East Re-entrant of Wang Cheong House  
with Falling Debris at 1458 hours

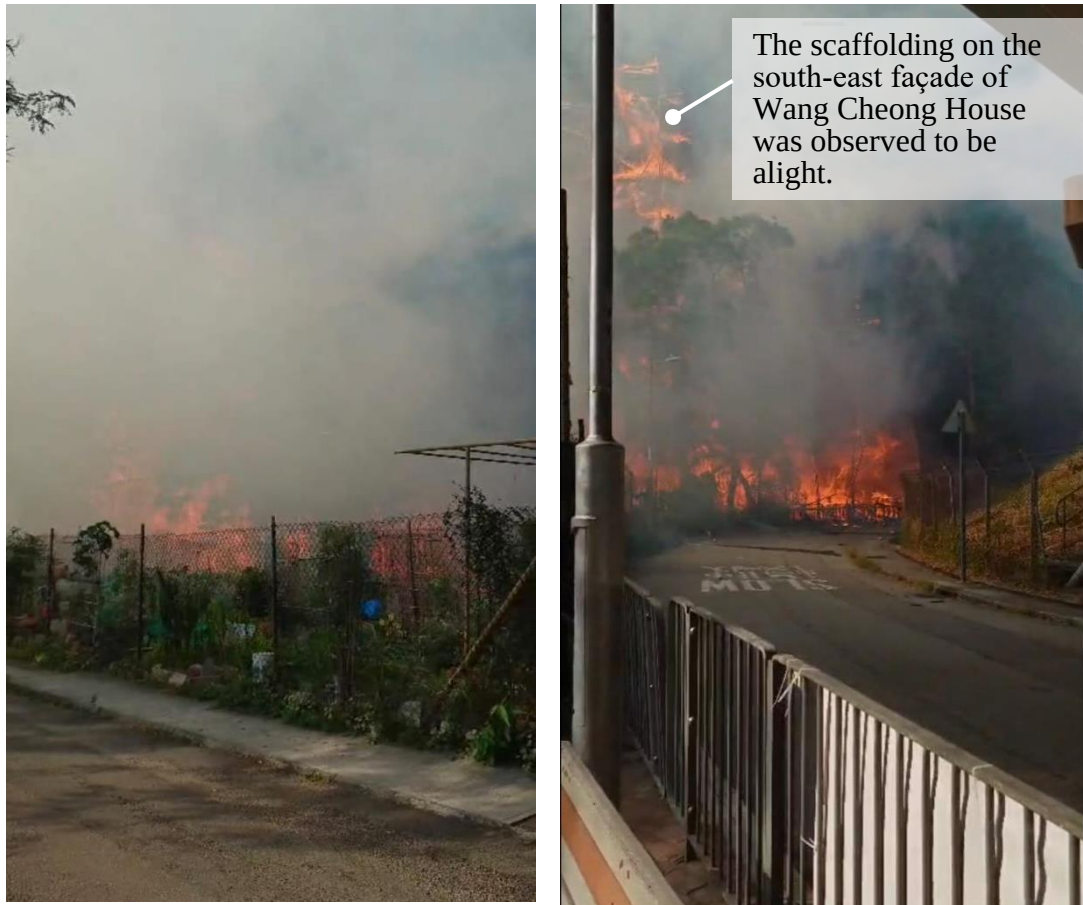
- 5.2.2.3 A severe fire was then observed on the open ground outside the **south-east façades** of Wang Cheong House at approximately 1501 hours, indicating that the fire had spread beyond the building (as shown in **Figure 5-4** and **Photos 5-6 (a) & (b)**).

*Photos 5-6 (a) & (b): Fire Spread to the Open Ground outside the South-east Façades of Wang Cheong House at about 1501 hours*

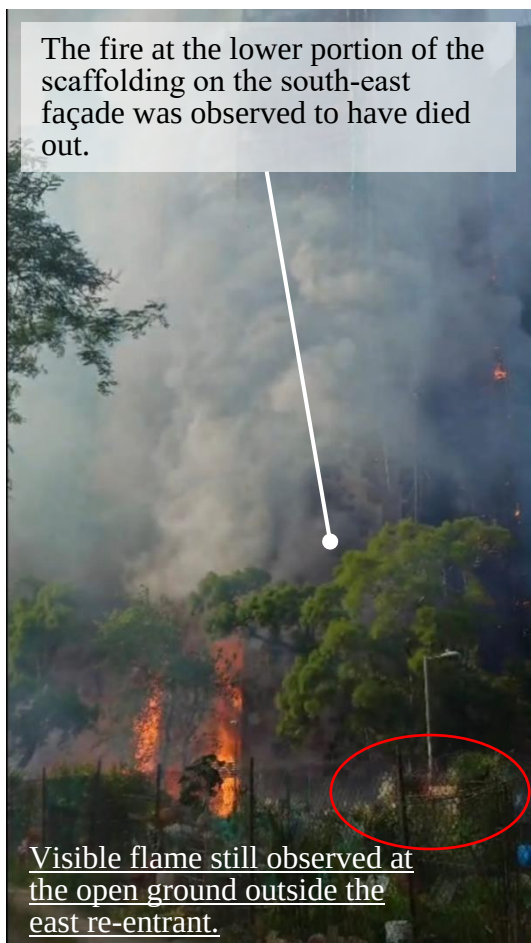
- 5.2.2.4 Although the fire at the lower portion of the scaffolding on the **south-east façade** was observed to have died out at approximately 1508 hours, visible flames were still present on the open ground outside the **east re-entrant**. Video footage provided by the informant clearly shows that the fire had spread to the open ground outside the **south-west façades** of Wang Cheong House, in the area between Wang Cheong House and Wang Tai House, at about 1508 hours (as shown in **Figure 5-5** and **Photos 5-6 (c) & (d)**). At the same time, heavy smoke was observed pouring along the **south re-entrant** and drifting towards Wang Tai House, likely under the influence of wind<sup>34</sup>, as shown in **Figure 5-6** and **Photo 5-6 (e)**.

Photo 5-6 (c):  
Visible Flame still Observed at the Open Ground outside the East Re-entrant at 1508 hours

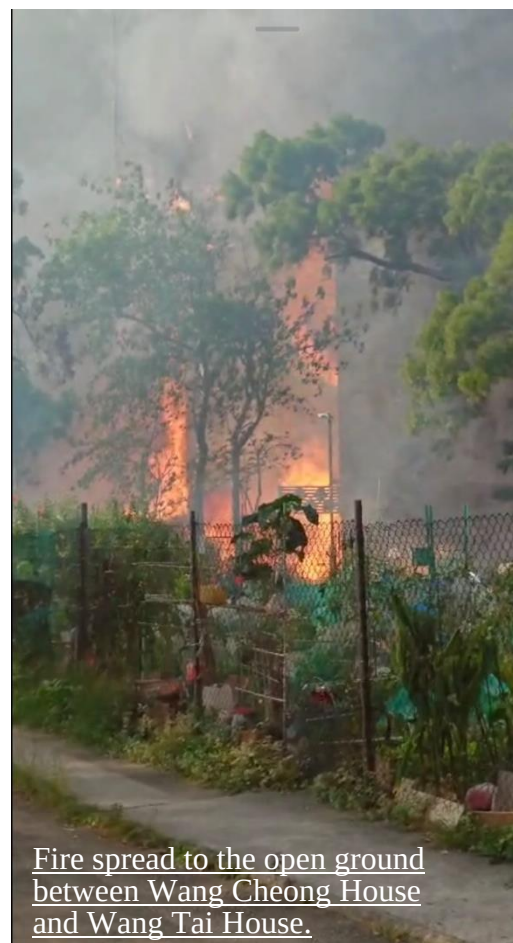
Photo 5-6 (d):  
Fire Spread to the Open Ground between Wang Cheong House and Wang Tai House

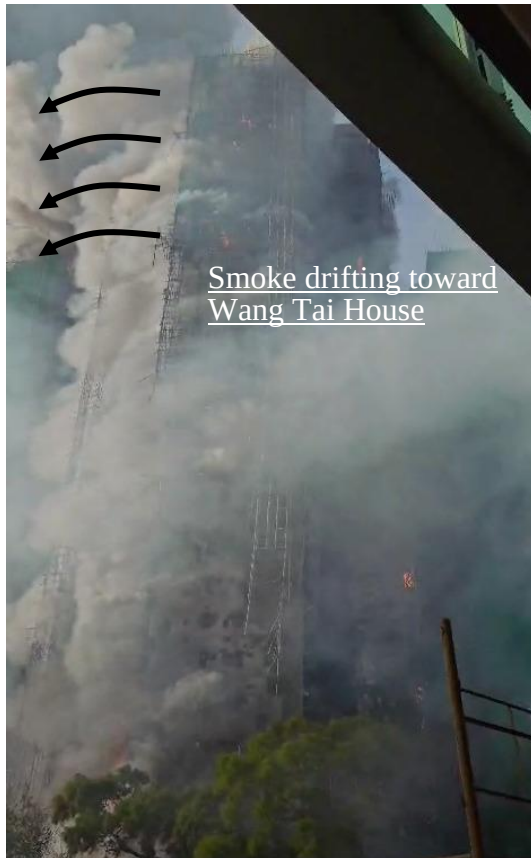
Photo 5-6 (e):  
Heavy Smoke on the South-east Façade  
at 1508 hours

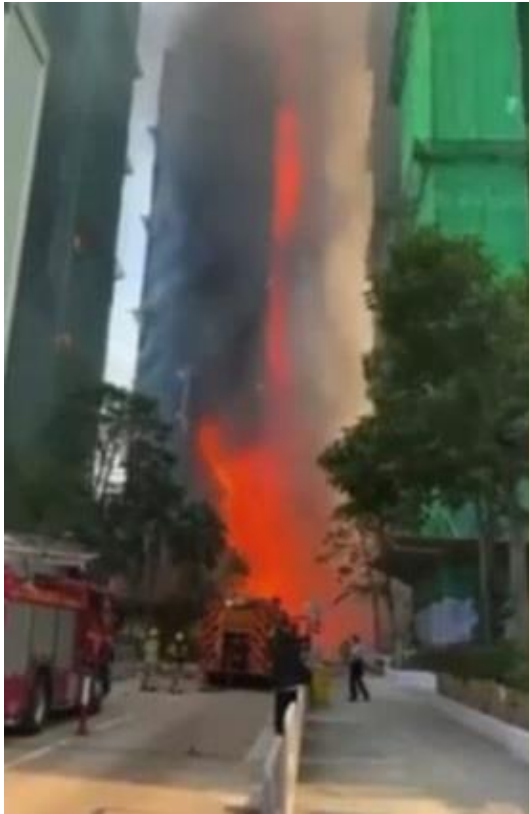
Photo 5-7 (a):  
Fire Spreading along the West Re-  
entrant at 1511 hours

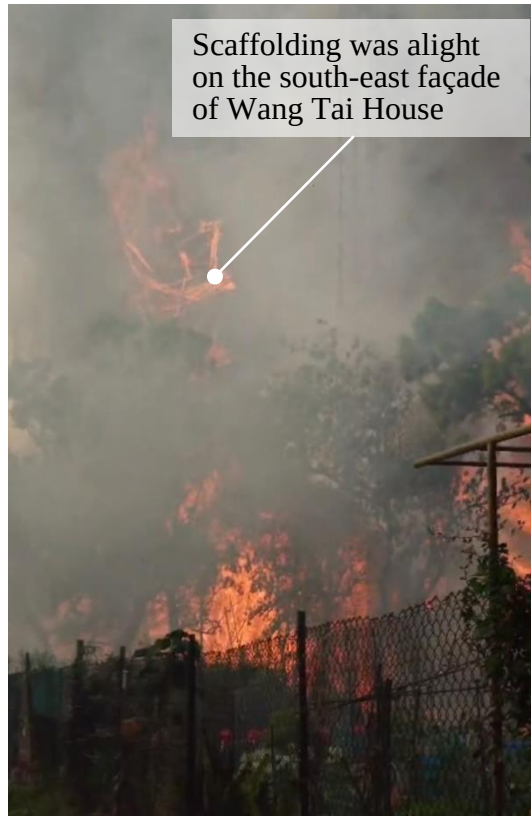
Photo 5-7 (b):  
South-east Façade of Wang Tai House  
Alight at 1515 hours

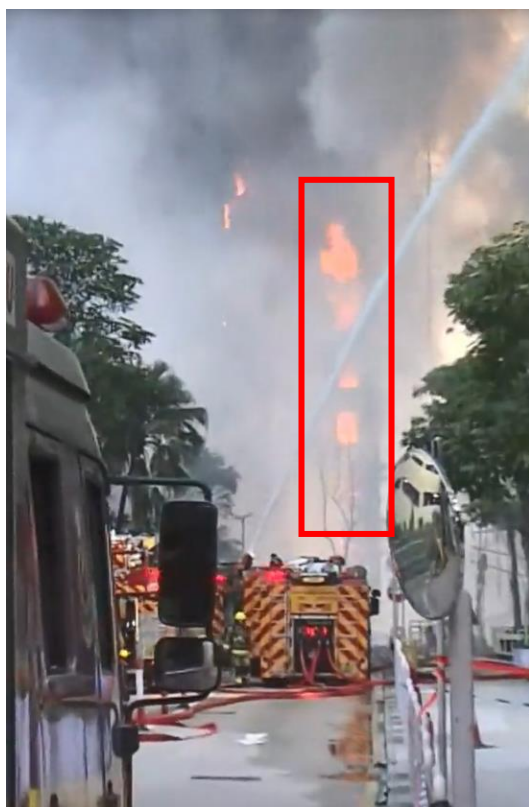
Photo 5-8:  
Fire Spread into the Unit of  
Wang Cheong House at 1545 hours

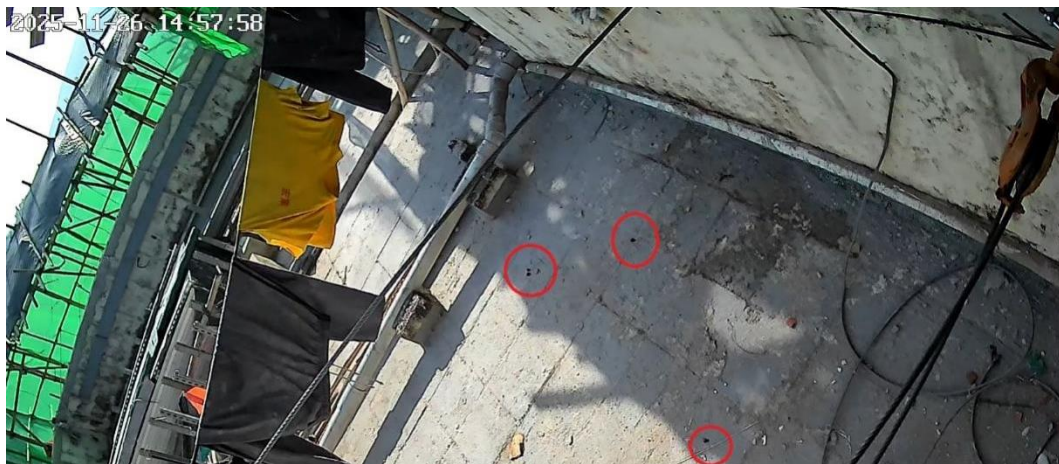
5.2.3.1 The fire spread to Wang Tai House via flying embers was observed around 1500 hours. Construction workers<sup>36</sup> reported fire spreading to the safety net on multiple levels of Wang Tai House, including construction materials on G/F, safety nets on 9/F & 10/F and miscellaneous articles on R/F. The situation at R/F is shown in **Photo 5-9 (a)**; while the situation at the scaffolding is shown in **Photo 5-9 (b)**.

*Photo 5-9 (a): Flying Embers Observed on the R/F of Wang Tai House at about 1458 hours<sup>39</sup>*

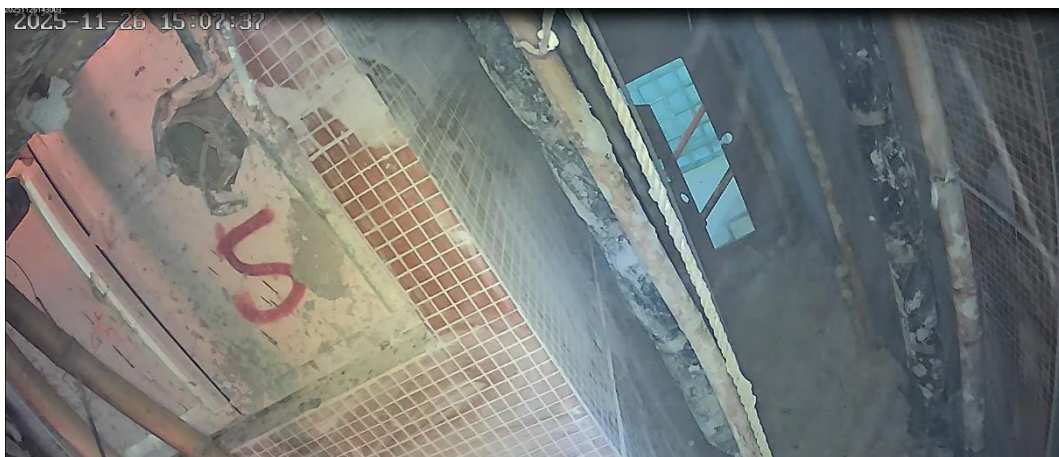
*Photo 5-9 (b): A Reflection of the Fire was Captured by CCTV Installed on the Scaffolding of Wang Tai House at about 1503 hours<sup>40</sup>*

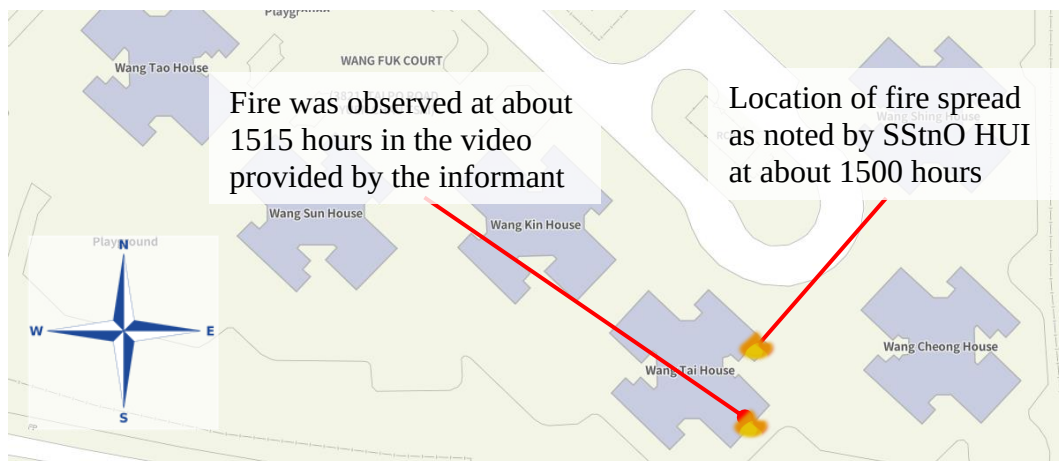
5.2.3.2 A similar observation was reported by SStnO HUI Kin-on<sup>37</sup>, the initial officer-in-charge of the fire incident, who noted the fire spreading to the safety nets on the **east façade** of Wang Tai House, facing Wang Cheong House at approximately 1500 hours (as shown in **Figure 5-11**).

*Figure 5-11: Fire Spreading to the Safety Nets of Wang Tai House*

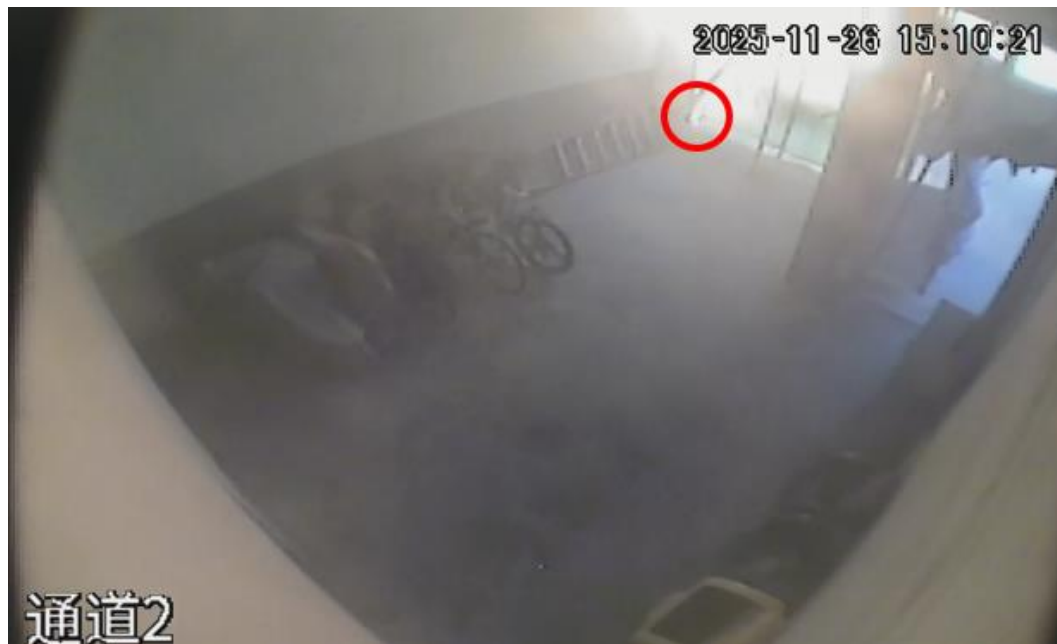
- 5.2.3.3 In addition to witness accounts, CCTV footage provided clear evidence of the fire spreading to Wang Tai House. At approximately 1509 hours<sup>38</sup>, embers were observed falling onto the open ground in between Wang Cheong House and Wang Tai House, igniting nearby combustibles within the next three minutes. By 1516 hours, the area was obstructed by fallen burning bamboo debris (as shown in **Photos 5-9 (c) to (e)** and **Figure 5-12**).

Photo 5-9 (c): Embers Falling onto the Open Ground outside Wang Tai House

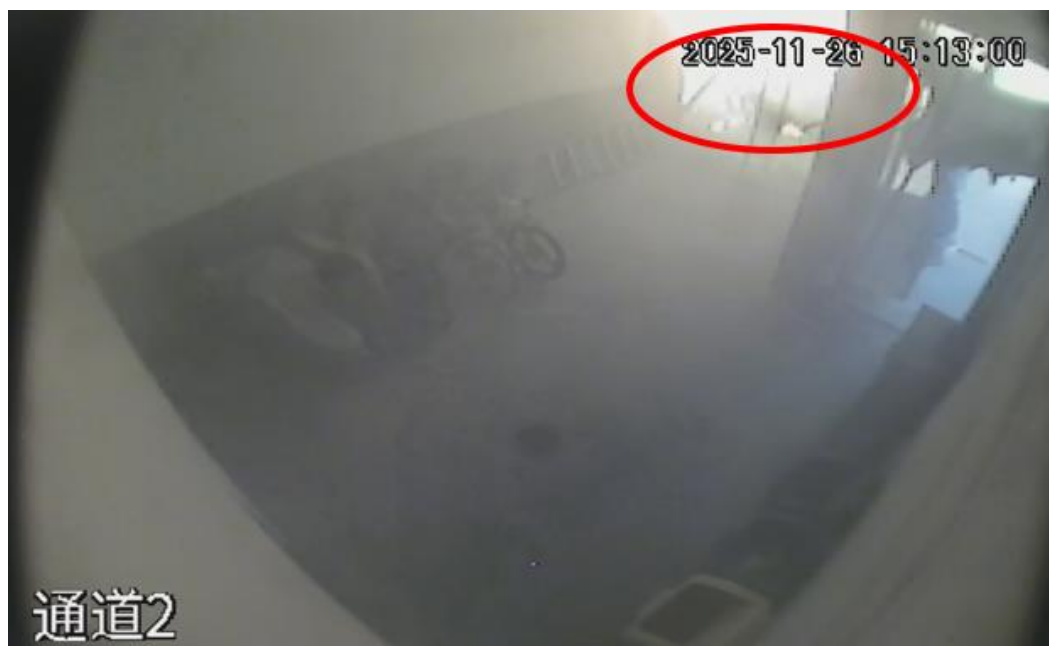
Photo 5-9 (d): Flaming Fire Observed

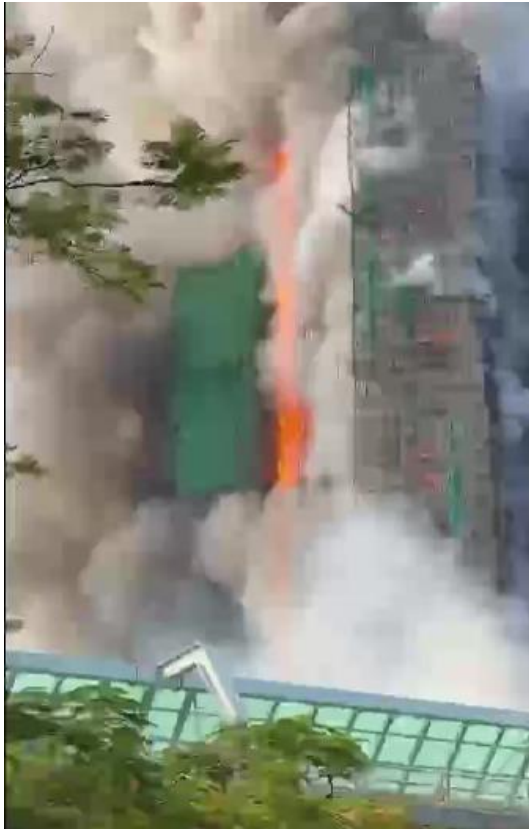
- 5.2.3.5 Rapid vertical fire spread along the re-entrant was observed in two out of the four re-entrants of Wang Tai House (as shown in **Photos 5-10 (a) & (b)** and **Figure 5-13**). The first instance of vertical fire spread occurred along the **east re-entrant** of Wang Tai House at about 1516 hours (as shown in **Photo 5-10 (a)**). Shortly thereafter, a second instance of vertical fire spread was observed along the **south re-entrant** at about 1517 hours (as shown in **Photo 5-10 (b)**).

Photo 5-10 (a):  
Fire Spread along the East Re-entrant  
of Wang Tai House at 1516 hours

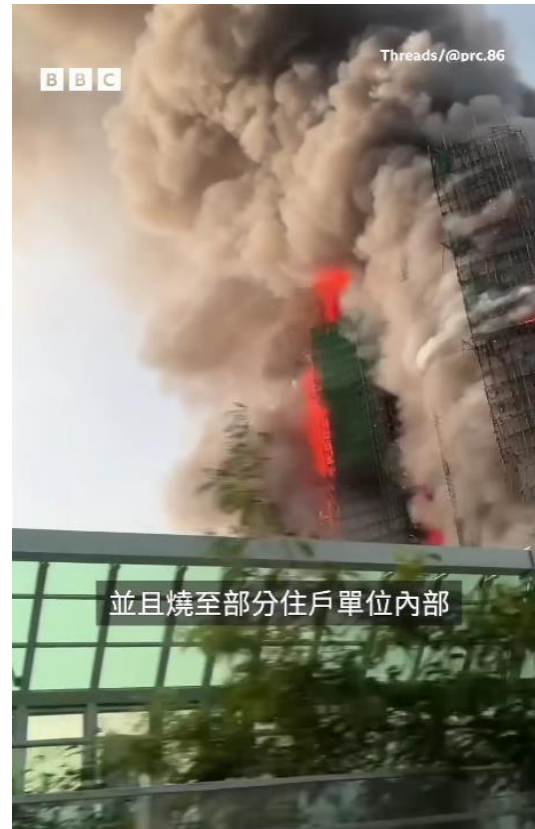
Photo 5-10 (b):  
Fire Spread along the South  
Re-entrant of Wang Tai House at  
1517 hours

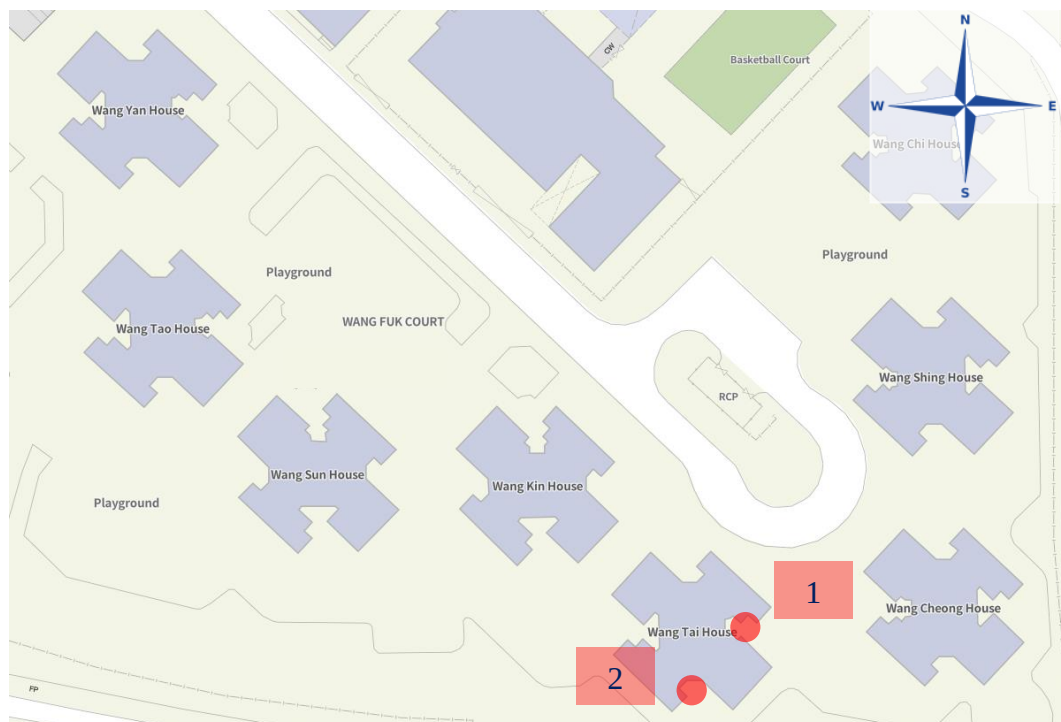
Figure 5-13: Map Indicating the  
Fire Spread along Re-entrants at Wang Tai House

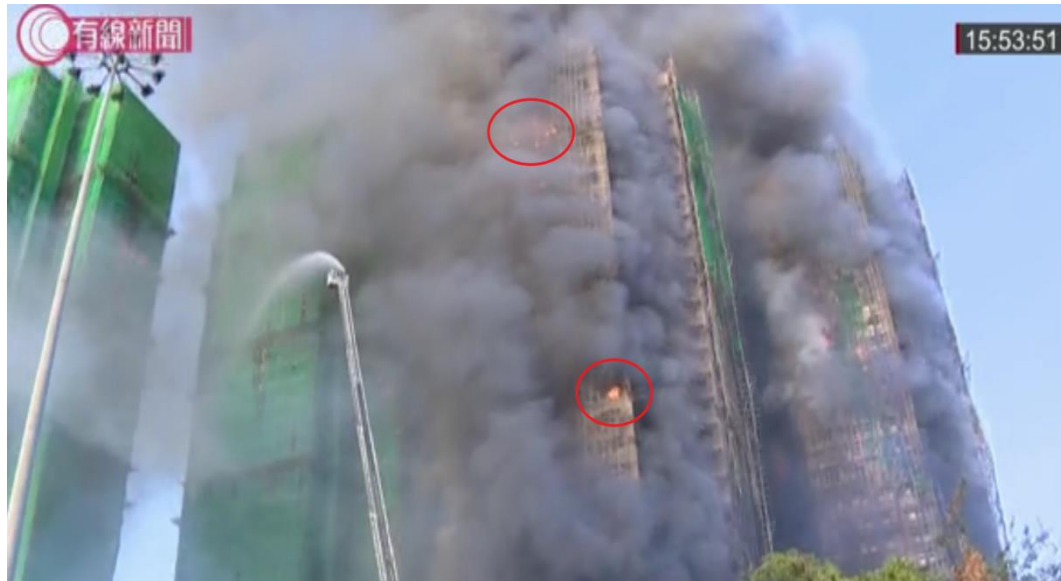
- 5.2.3.7 According to available materials, it was captured in the Cable TV footage that flames, originating from the ignited units, were observed issuing from the upper and mid-levels of the **south-west façade** of Wang Tai House at approximately 1553 hours (as shown in **Photo 5-11**).

*Photo 5-11: Flames from Ignited Units on the  
South-west Façade of Wang Tai House*

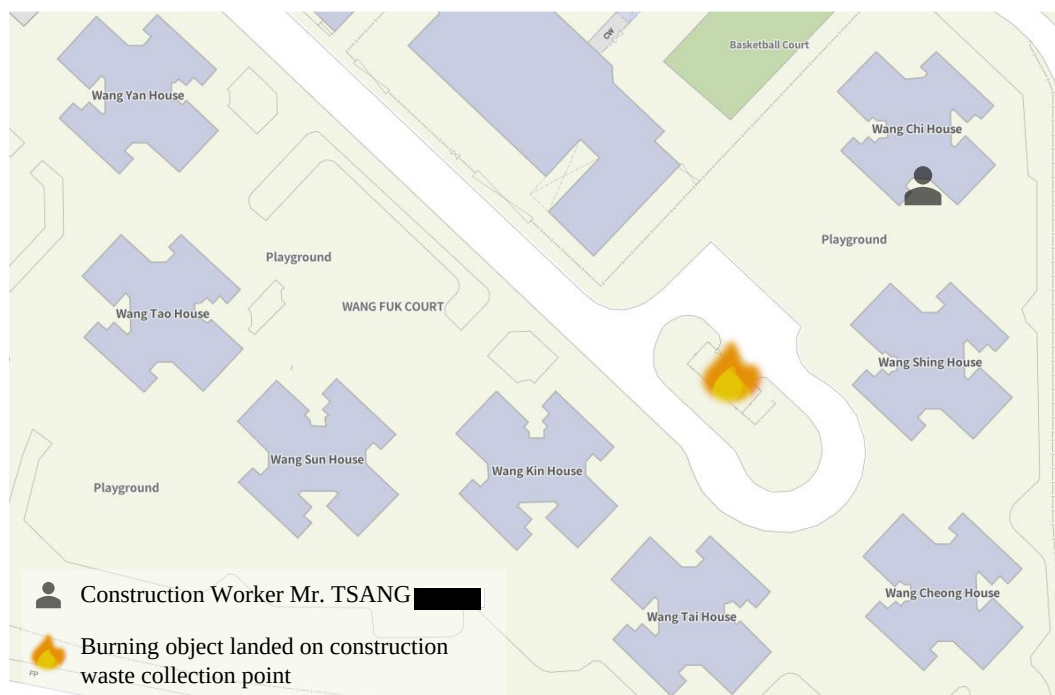
5.2.4.2 In addition to the buildings of Wang Fuk Court, Mr. TSANG [REDACTED]<sup>41</sup>, a construction worker outside Flat 16 [REDACTED] of Wang Chi House, observed at an estimated time of 1500 hours a black, burning object with apparent weight falling from either Wang Cheong House or Wang Shing House. This burning object landed on the construction waste collection point of Wang Fuk Court, igniting the materials (as shown in **Figure 5-14**). This observation highlights the significant role of embers in contributing to the spread of the fire. The embers carried by wind or falling debris, acted as ignition sources, could spark secondary fires in different areas and accelerating the overall fire spread across multiple locations in the housing estate.

***Figure 5-14: Fire Spread to the Construction Waste Collection Point***

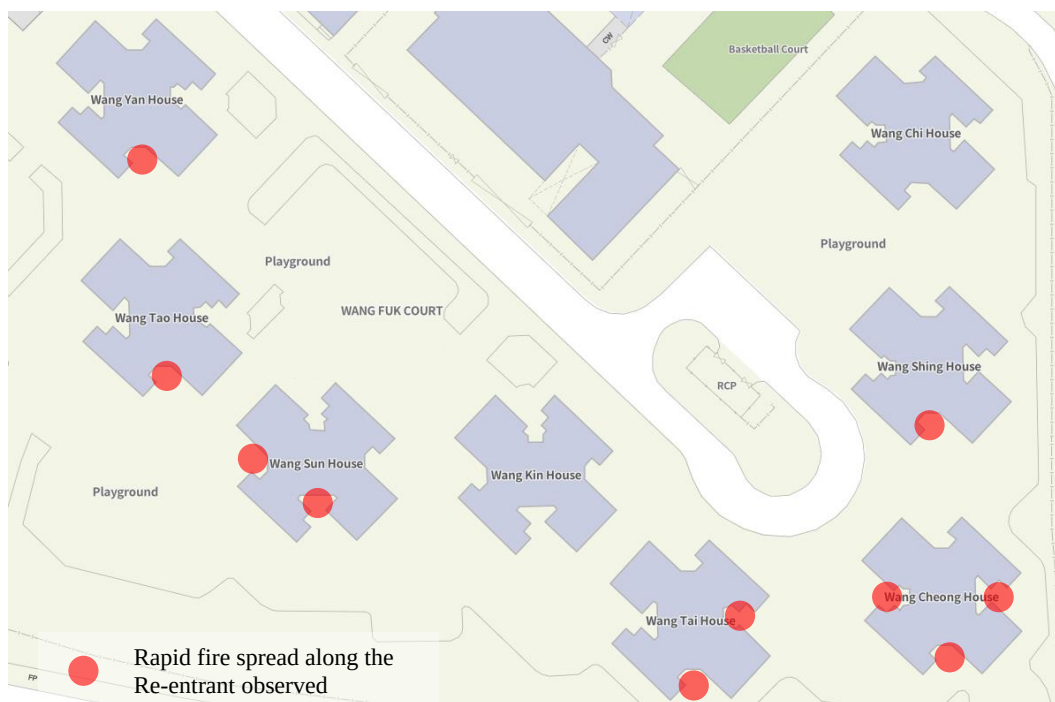
5.2.4.3 Another notable phenomenon observed during the fire was the rapid fire development within the re-entrants of Wang Cheong House, Wang Tai House, Wang Shing House, Wang Tao House, Wang Sun House, and Wang Yan House, as shown in **Figure 5-15**. This facilitated the rapid vertical spread of the fire across multiple levels. A detailed discussion would be provided in section 6.2.1.

***Figure 5-15: Rapid Fire Spread along the Re-entrants***
