# Interim Investigation Report No.5 Alarm Fire at Wang Fuk Court on 26 November 2025

Inter-Departmental Fire Investigation Task Force

February 2026

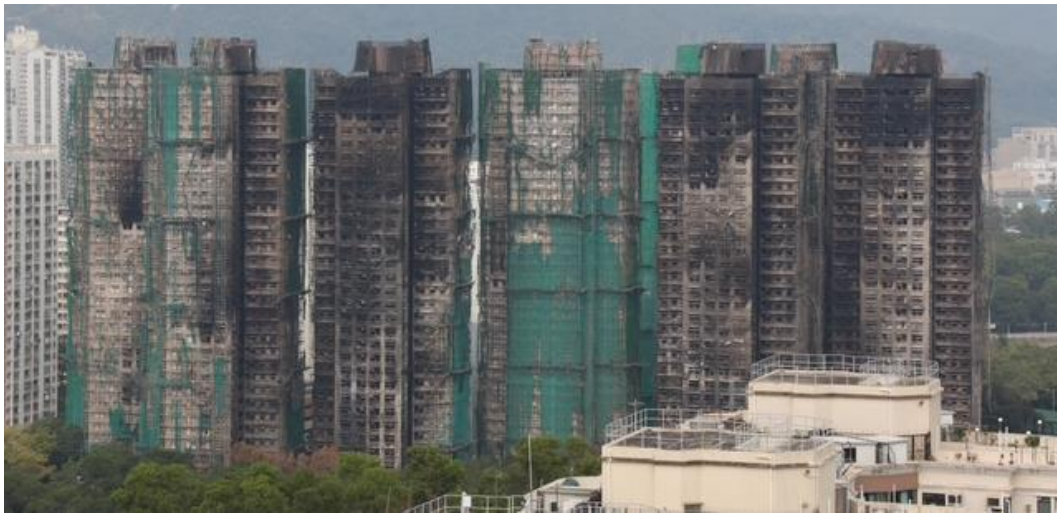
- 5.3.1 Across the seven affected buildings, a total of 1,736 flats were assessed, of which the interior of 924 flats sustained varying degrees of fire damage, while the interior of the other 812 flats remained relatively unaffected despite the exterior of the buildings have been damaged by the high temperature with prolonged exposure to fire. The post fire conditions of the exterior of Wang Fuk Court are shown in **Photo 5-12**.

Photo 5-12: Post Fire Condition of Wang Fuk Court

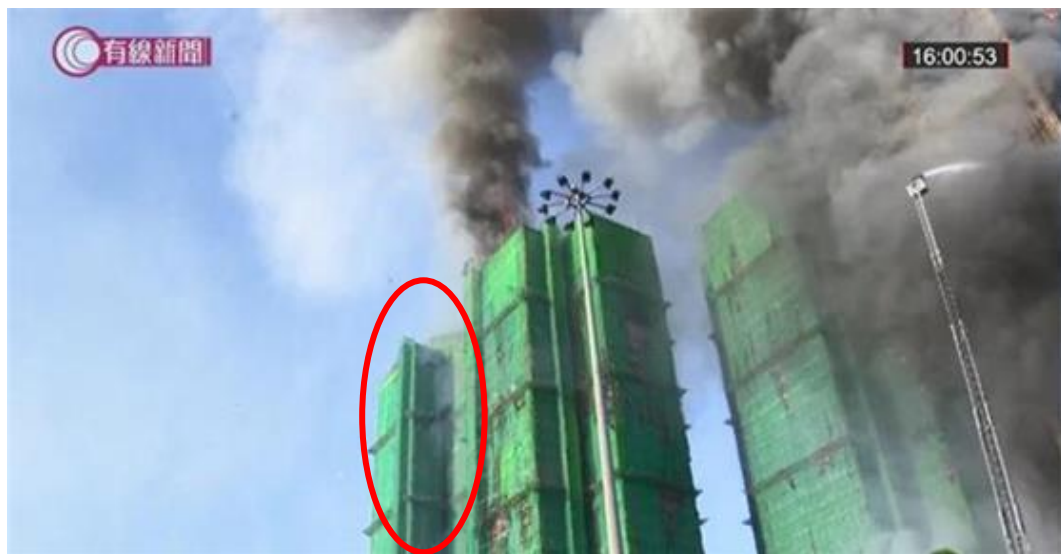
- 6.2.1.10 Similar rapid vertical fire spread within the re-entrant was observed in other buildings.
- 6.2.1.11 Cable TV footages provided a clear view of the fire spreading through the re-entrant of Wang Tao House, showing that the rapid vertical fire spread was likely caused by the ignition of pyrolyzed gases, generated from the pyrolysis of combustible materials (such as bamboo scaffolding, safety nets, wooden planks, toe-boards and polystyrene window covers), which had accumulated within the re-entrant (as shown in **Photos 6-7 (a) to (e)**).

Photo 6-7 (a): The Re-entrant of Wang Tao House  
Remained Unaffected in 1600 hours

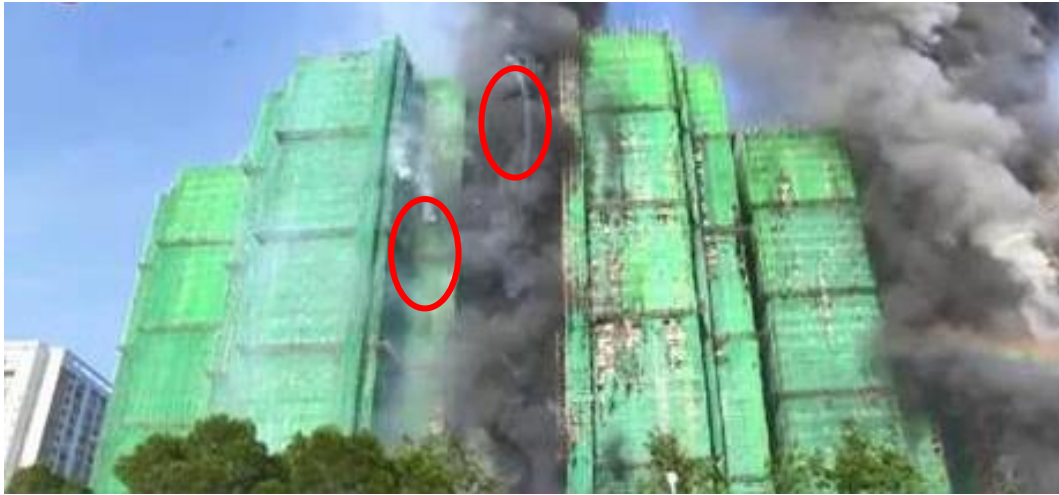
Photo 6-7 (b): Flying Embers Spreading from  
Wang Sun House to Wang Tao House

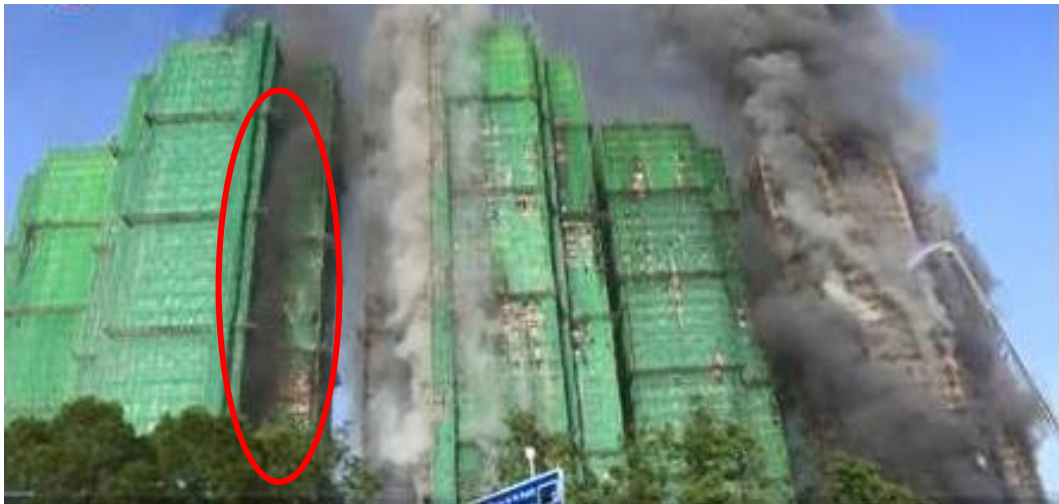
Photo 6-7 (c): Suspected Pyrolyzed Gases from  
Combustibles Accumulated in the Re-entrant

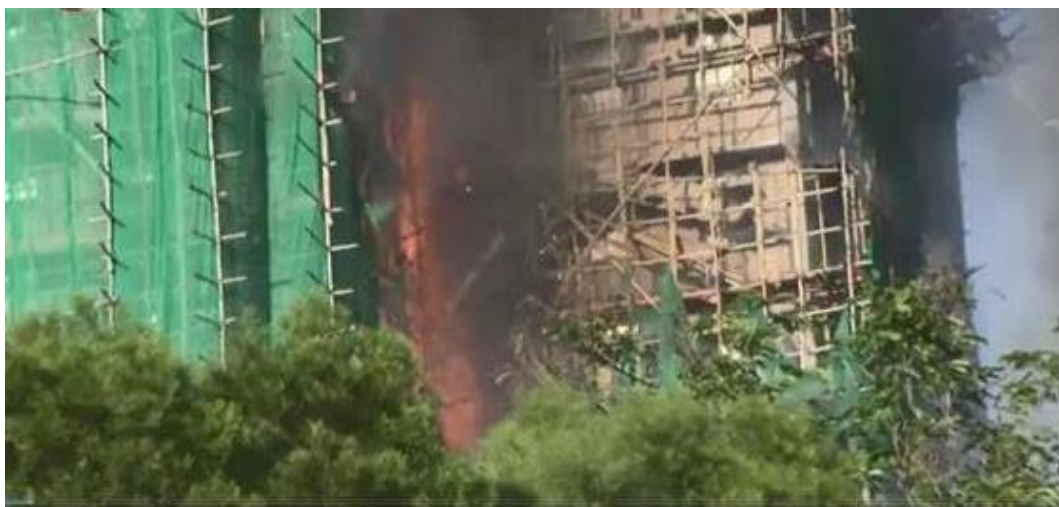
Photo 6-7 (d): Flaming Fire Observed in the  
Lower Portion of Wang Tao House

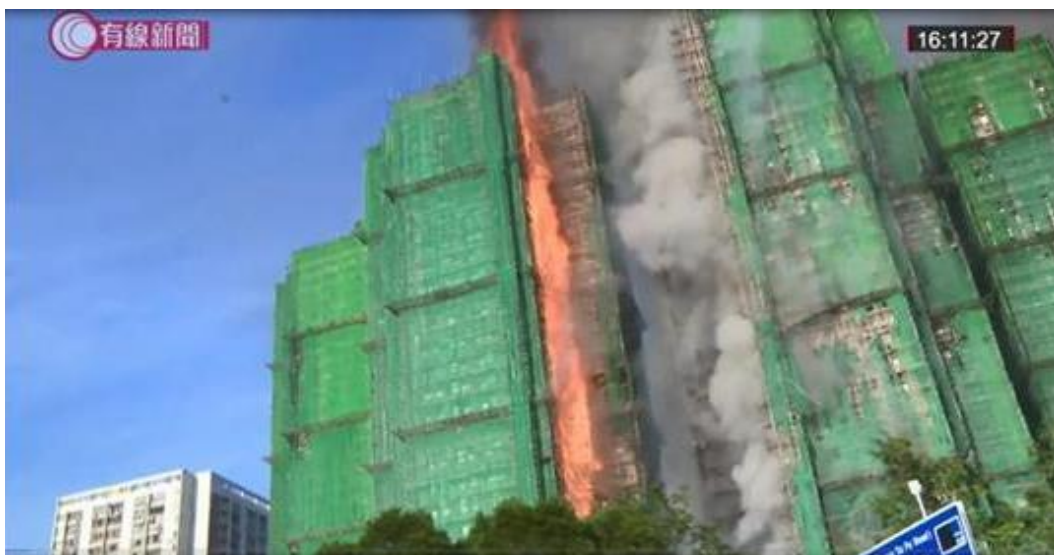
*Photo 6-7 (e): Fire Spread Vertically throughout Wang Tao House*

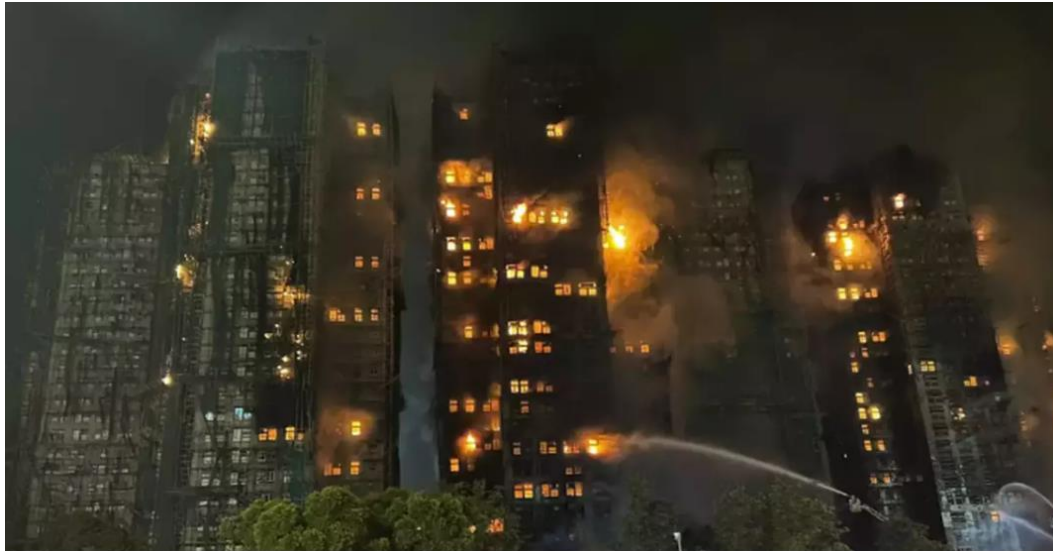
- 6.2.2.3 The enclosed nature of the domestic units further intensified the fire. As more items ignited, the temperature within the units rose, causing additional materials therein to reach their respective ignition temperatures. This chain reaction accelerated the fire development, enabling it to engulf the entire unit (as shown in **Photo 6-8**).

*Photo 6-8: Multiple Units on Fire at Wang Fuk Court*

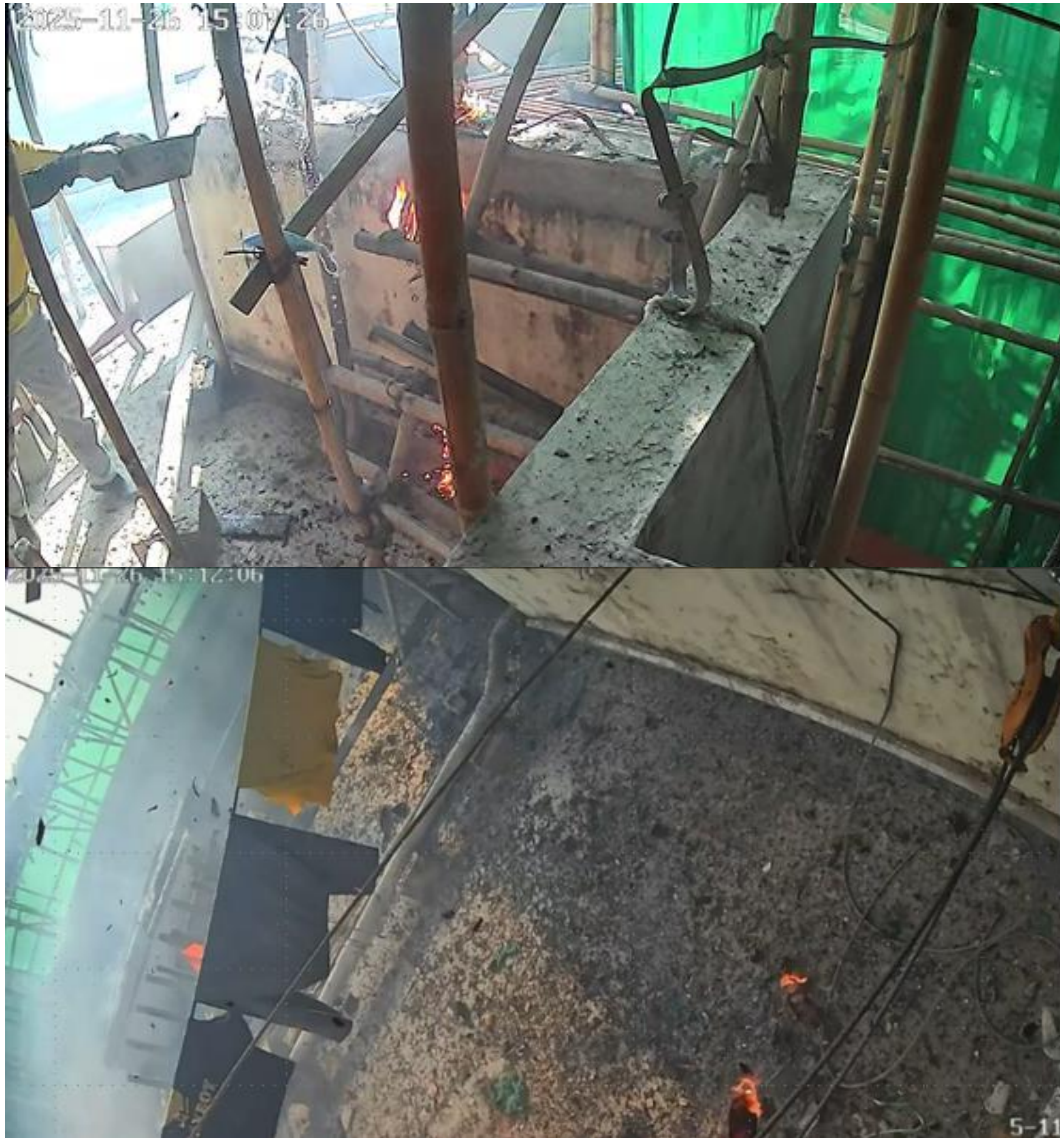
- 6.2.3.1 Witness accounts and CCTV footage (as shown in **Photos 6-9 (a) & (b)**) revealed that **winds carried embers**—small, burning fragments of combustibles—to nearby structures, where they ignited safety nets, construction debris, and other combustible materials. These embers posed a significant risk as they could travel long distances, land on exposed surfaces, and ignite new fires far from the original source.

Photos 6-9 (a) & (b): Flying Embers Suspected Spreading from Wang Cheong House to Wang Tai House at about 1506 and 1511 hours<sup>57</sup>

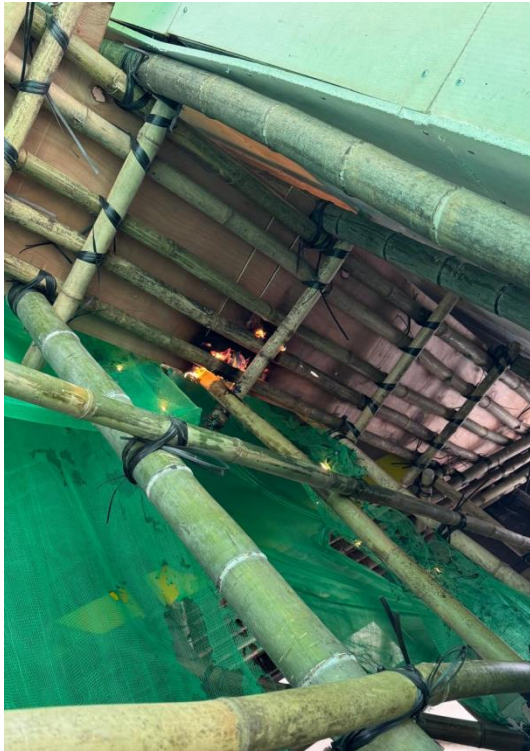
6.3.4.1 In Test 1, the fire spread to other materials on the scaffolding, including nylon strips, wooden planks and toe-boards, via the ignited the non-FR safety net (as shown in **Photos 6-14 (a) & (b)**). Although the fire source had burnt out, **localized ignition of the non-FR safety net persisted for over an hour**, with slow fire propagation continuing to **ignite other combustible materials on the scaffolding**. In Test 2, the **FR safety net either did not ignite or self-extinguished**. (as shown in **Photos 6-14 (c) & (d)**).

Photo 6-14 (a):  
Fire Spread to Wooden Plank in Test 1

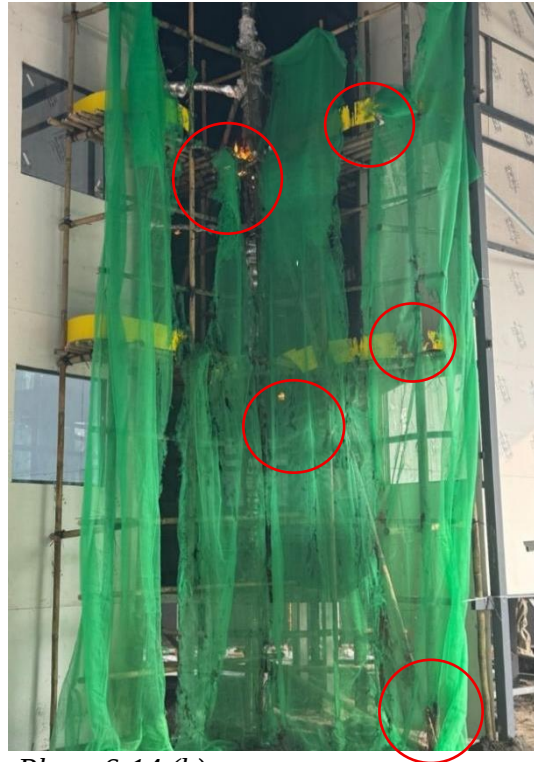
Photo 6-14 (b):  
Fire Spread along Non-FR Safety Net

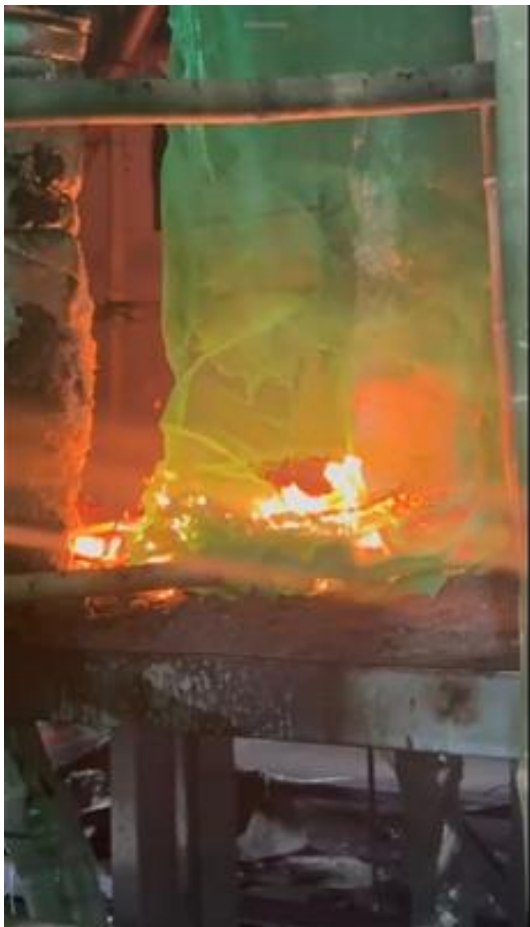
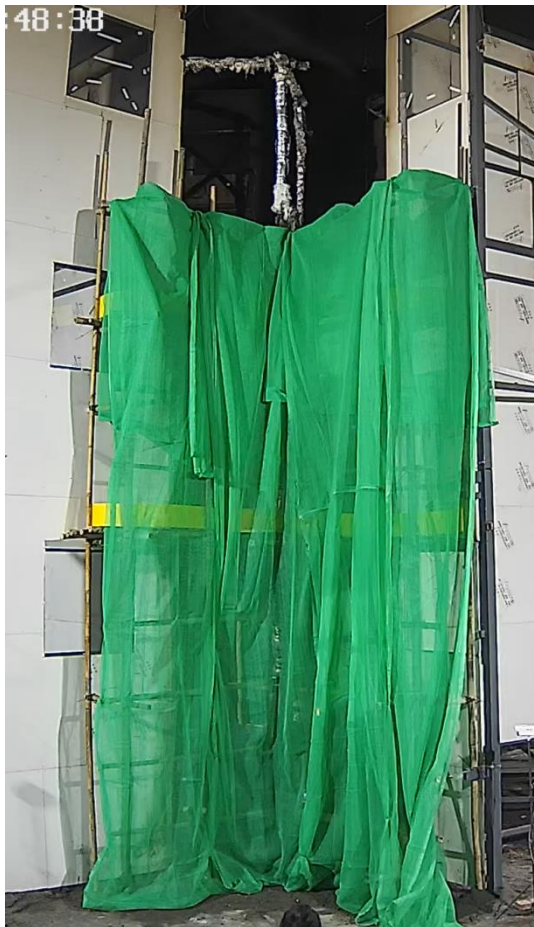
The results indicate that FR safety nets significantly reduce the risk of ignition and fire propagation compared to non-FR safety nets under small fire conditions.

Photo 6-14 (c) & (d): No Spread of Fire along FR Safety Net Observed

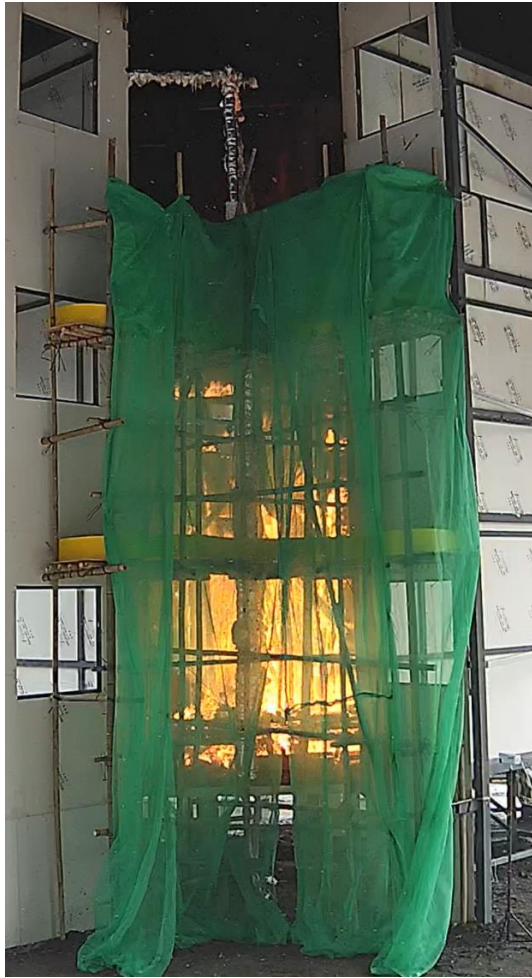
- 6.3.4.3 In both Tests 3 and 4, relatively large fire source were used and most of the combustible materials within the re-entrant, including bamboo scaffolding, safety nets, toe-boards and wooden planks, were burnt by the end of the tests (as shown in **Photos 6-15 (a) & (b)**).

Photo 6-15 (a):  
Full Developed Fire in Test 3  
(Non-FR Safety Net)

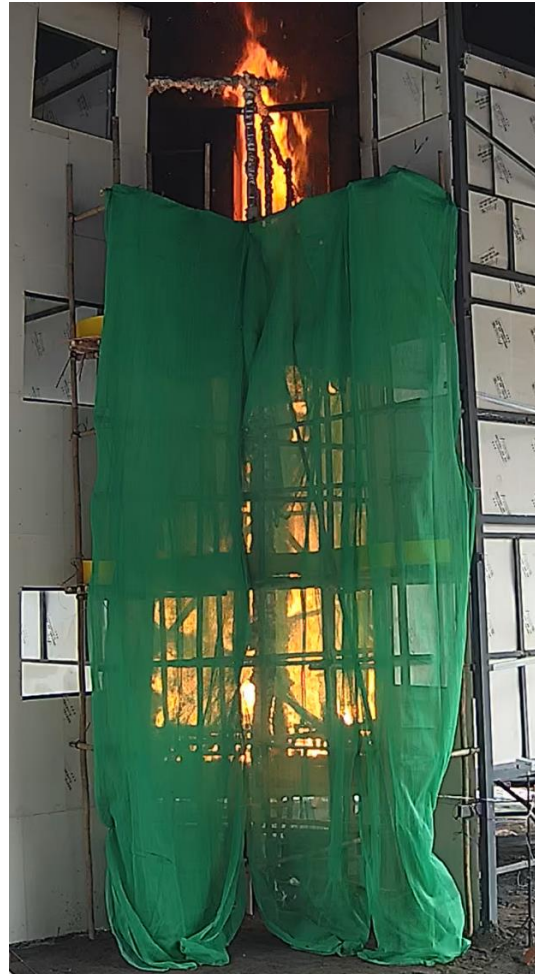
Photo 6-15 (b):  
Full Developed Fire in Test 4  
(FR Safety Net)

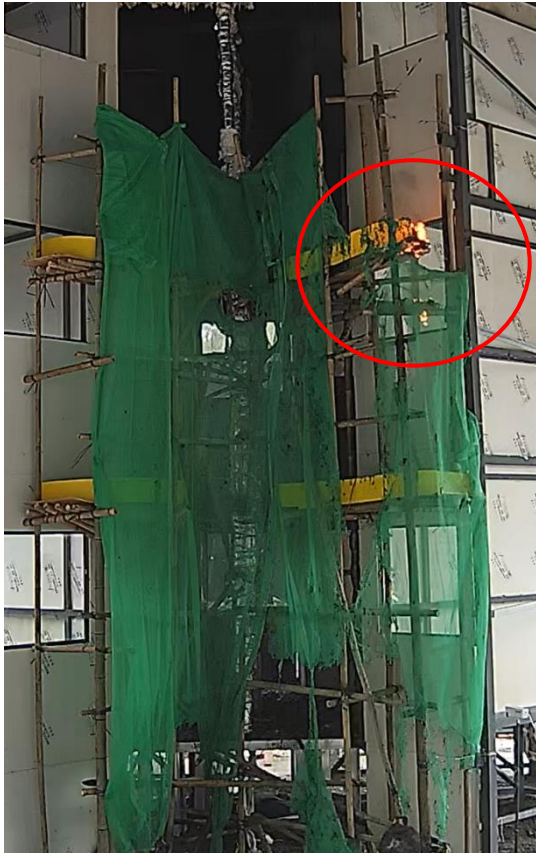
- 6.3.4.5 It is noteworthy that in Test 3, after the fire in the re-entrant area entered the decay stage, localized ignition of the non-FR safety net persisted. Slow propagation of small fire continued, eventually resulting in secondary ignitions at various locations on the scaffolding, occurring between 50 and 120 minutes after the re-entrant fire entered the decay stage (as shown in **Photo 6-16(a)**). Further details can be found in the timeline analysis in **Appendix A-27 Annex C.**

- 6.3.4.7 Key Observation (3):  
Secondary ignition can occur at a distance from the initial fire origin, even after the initial fire has burnt out, as non-FR safety nets sustained ignition and allowed fire to spread. However, such spread was not observed in tests conducted with FR safety nets, as the fire would generally self-extinguish once the external heat source was removed.

Photo 6-16 (a):  
Secondary Ignition Occurred  
in Test 3

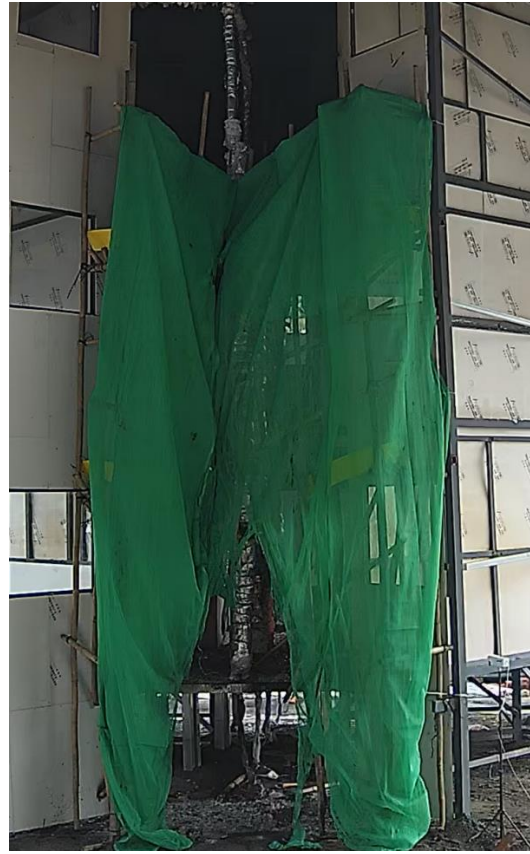
- 6.3.4.6 The observation as mentioned in paragraph 6.3.4.5 was not noted in Test 4. Even though the FR safety net was ignited by embers or flaming construction materials, the fire self-extinguished once the external fire source diminished (as shown in **Photo 6-16(b)**).

Photo 6-16 (b):  
No Secondary Ignition Occurred  
in Test 4

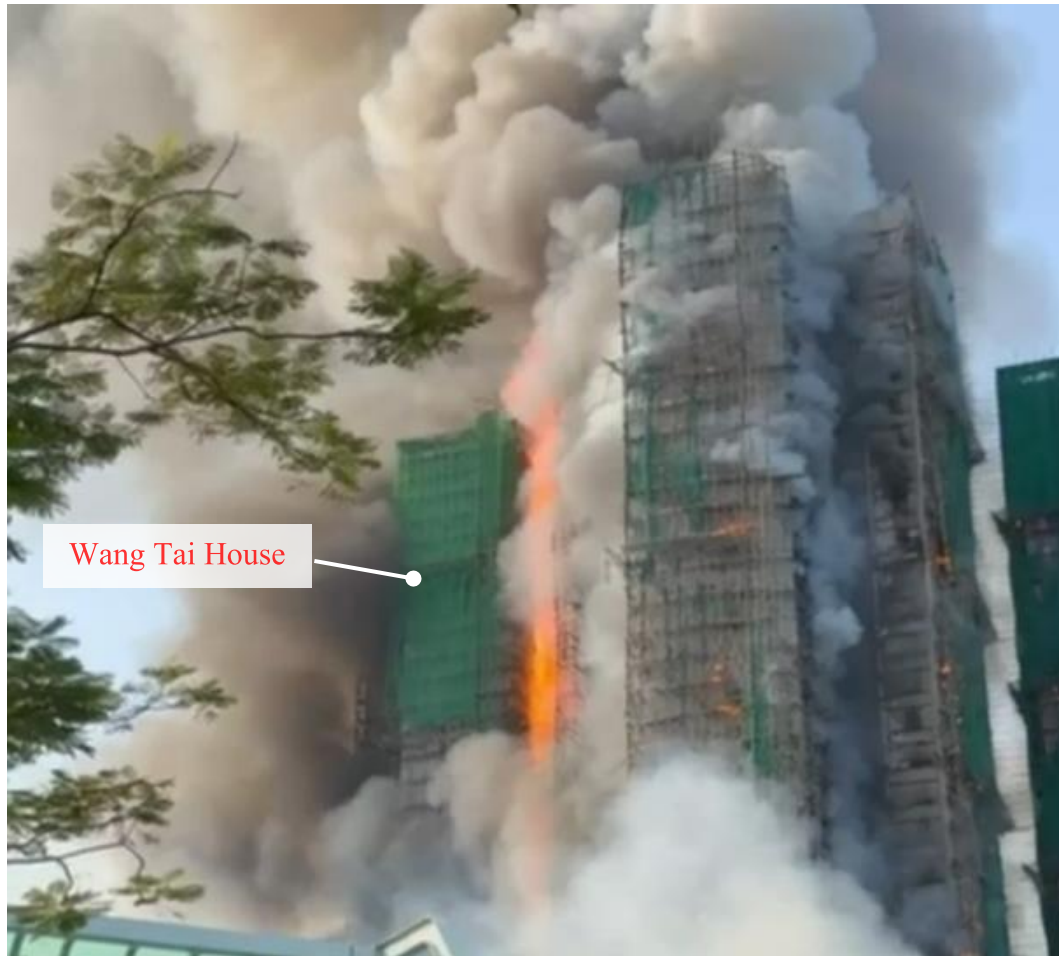
7.2.3.1 Details of the fire development of Wang Tai House can be referenced in section 5.2.3. Briefly, the fire spread to Wang Tai House via flying embers, though not on a large scale, was observed around 1500 hours. The situation deteriorated quickly, and at about 1516 hours, video footage captured vertical fire spread along the re-entrant on the east side of Wang Tai House (as stated in paragraph 5.2.3.5 and shown in **Photo 7-4**).

*Photo 7-4: Rapid Vertical Fire Spread along  
the East Re-entrant of Wang Tai House at 1516 hours*

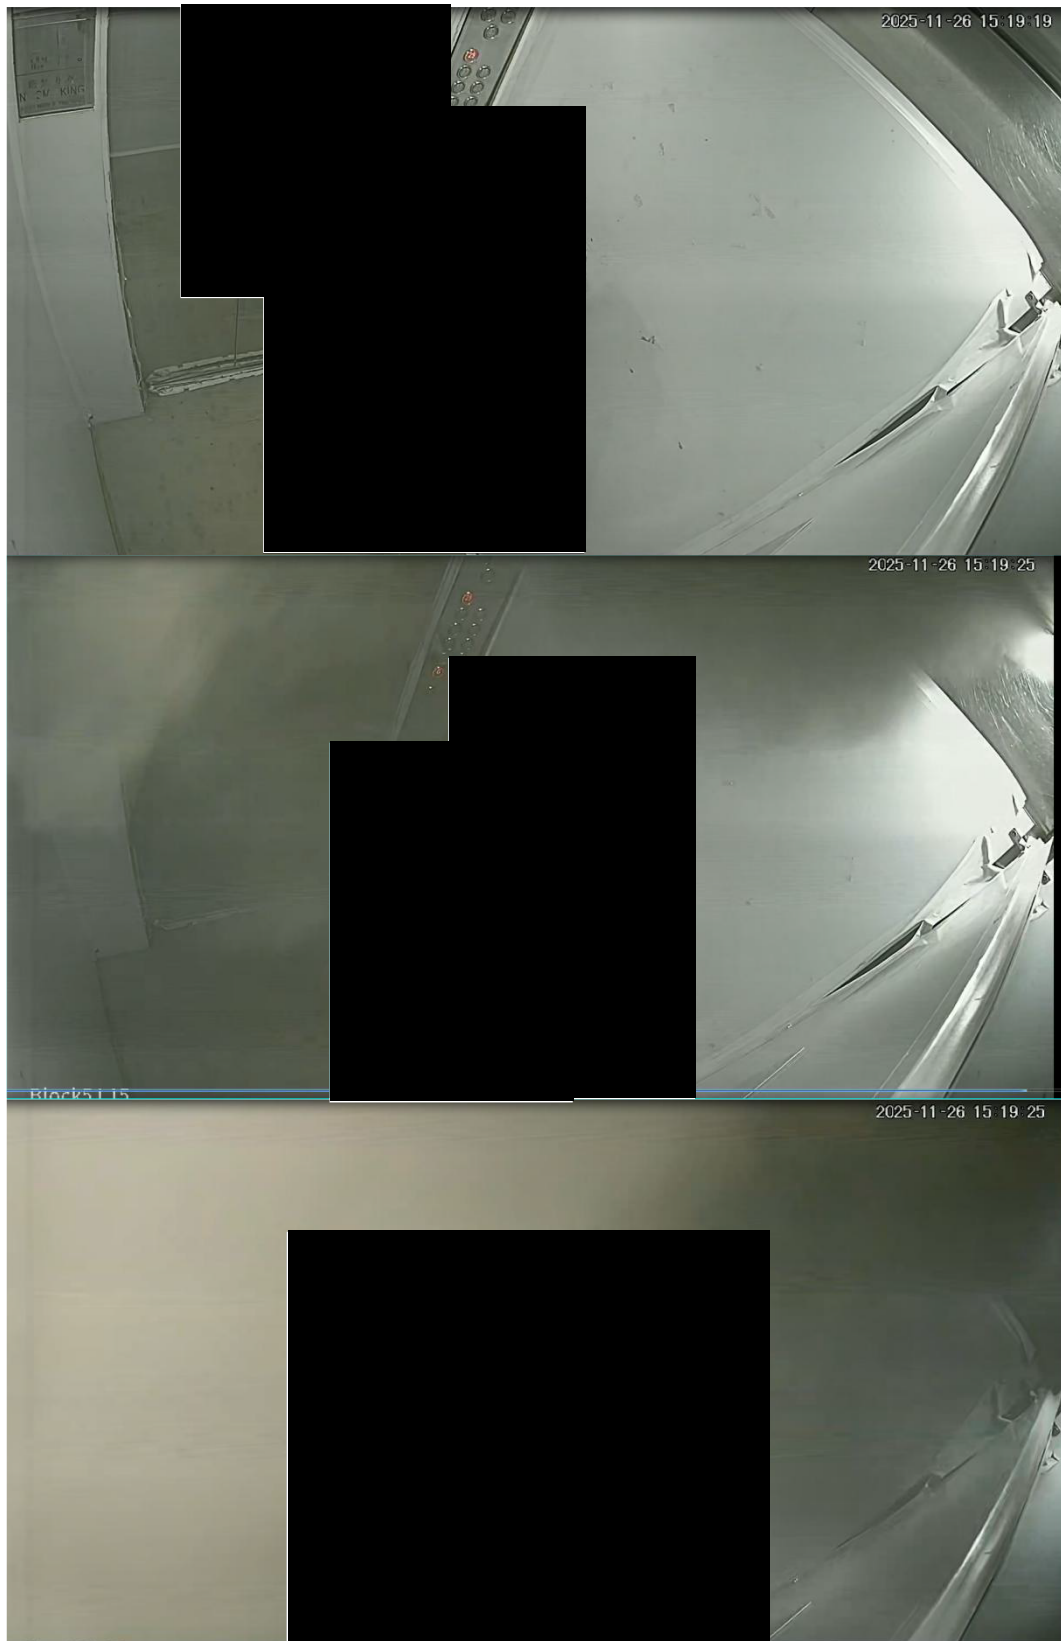
- 7.2.3.2 CCTV footage and online video sources were thoroughly reviewed to analyze the internal conditions of Wang Tai House during the fire, which provided insights into the sequence of events and the rapid deterioration of conditions inside the building.
- 7.2.3.3 CCTV footage showed [REDACTED] entering lift L14 of Wang Tai House on the 31/F at about 1520 hours<sup>67</sup> (as shown in **Photo 7-5**). Another video from an online source showed [REDACTED] encountered heavy and dense smoke entering through the upper openable part of the window in the lift lobby (as shown in **Photos 7-6 (a) & (b)**).
- 7.2.3.4 CCTV footage showed [REDACTED] inside lift L15 of Wang Tai House at about 1521 hours<sup>68</sup>. When the lift doors opened on 23/F, heavy and dense black smoke entered the lift (as shown in **Photos 7-7 (a) to (c)**).

Photos 7-7 (a) to (c): CCTV Screenshots  
Showing Internal Condition of Lift L15 on 23/F

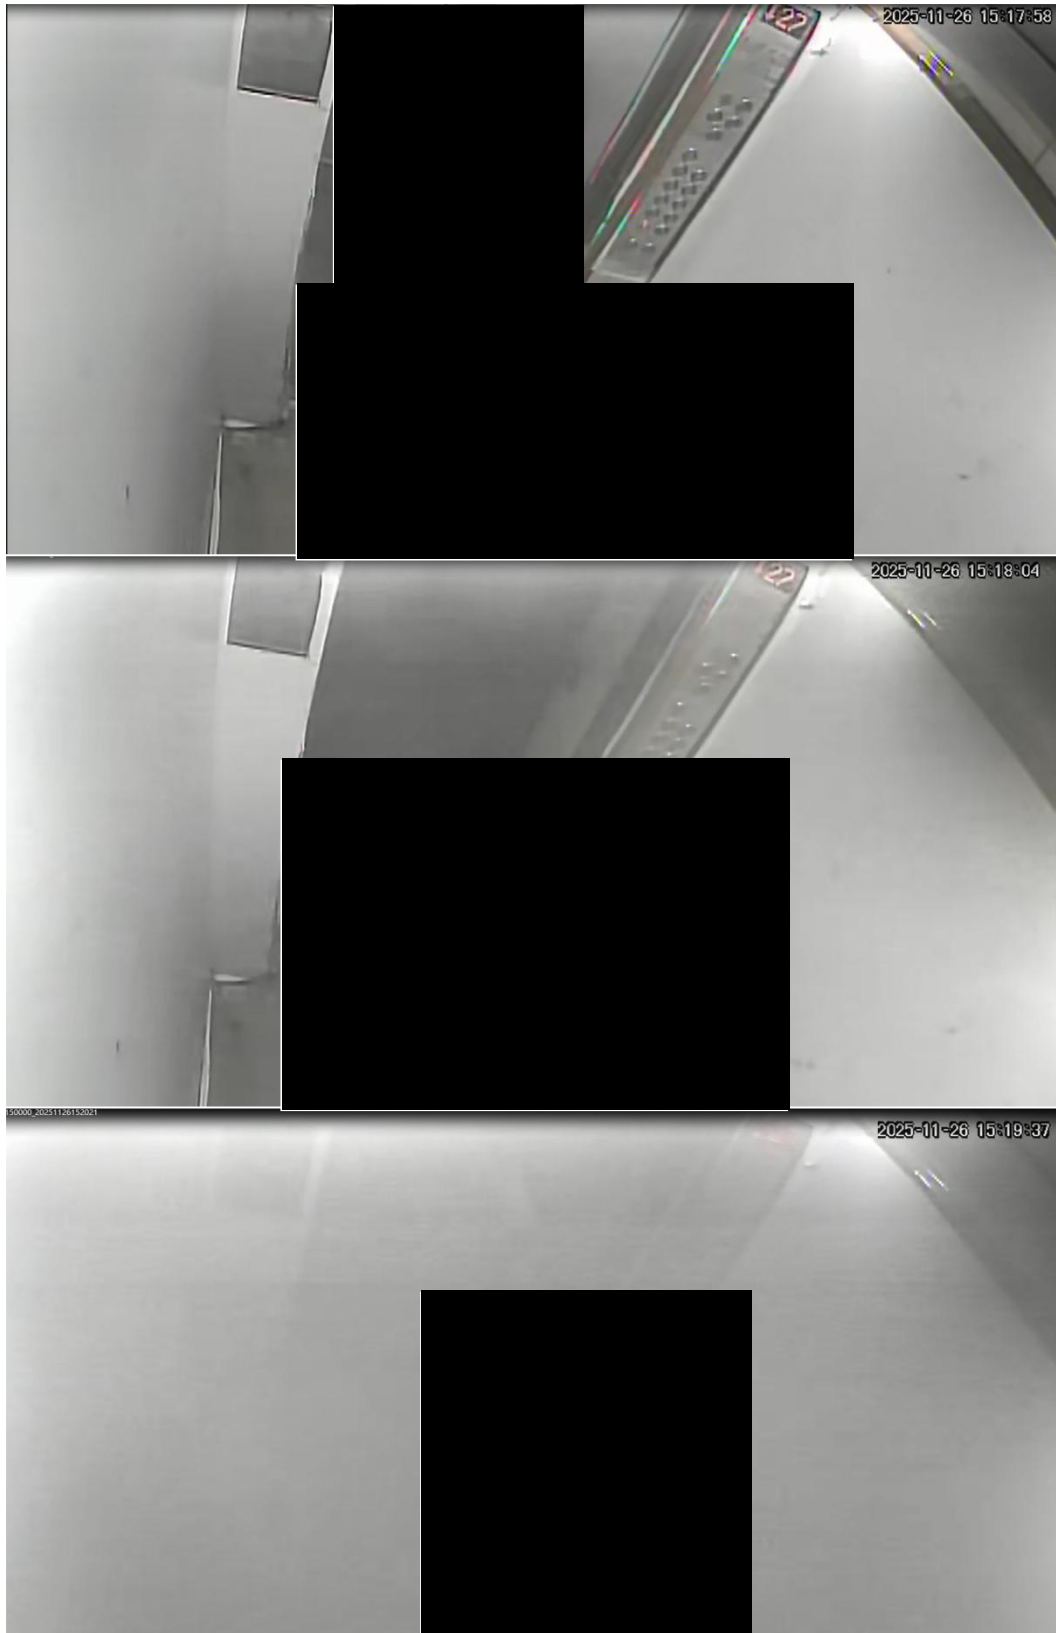
- 7.2.3.5 Another CCTV footage showed [REDACTED] inside lift L13 of Wang Tai House at about 1521 hours<sup>69</sup>. When the lift doors opened on 24/F, heavy and dense black smoke poured intensely into the lift (as shown in **Photos 7-8 (a) to (c)**) This coincided with Fn HO's dispatch of the Mayday message, highlighting the severely deteriorating conditions at Wang Tai House.

Photos 7-8 (a) to (c): CCTV Screenshots  
Showing Internal Condition of Lift L13 on 24/F

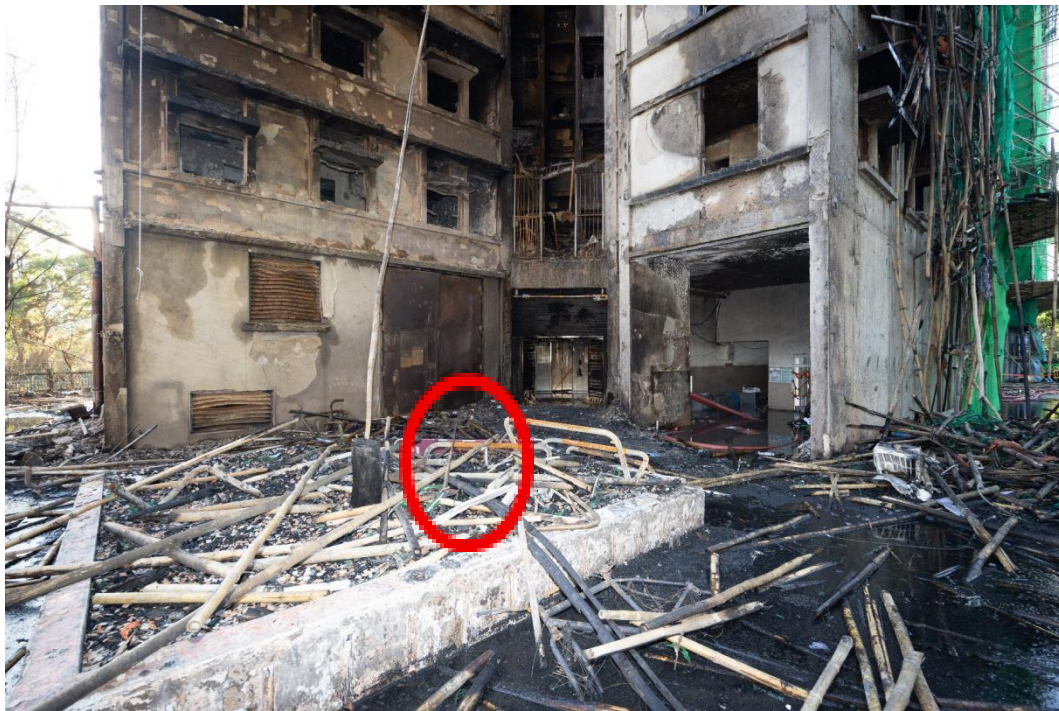
- 7.2.4.6 At approximately 1555 hours, Fn HO was found by PStnO WONG Man-hin and SFn [REDACTED] CHEUK Kam-wing of TP/MP. At the material time, Fn HO was found unconscious and lying on top of the burning scaffolding outside Wang Tai House (as shown in **Photo 7-9**).

Photo 7-9: Photo Showing the Location where Fn HO was Discovered

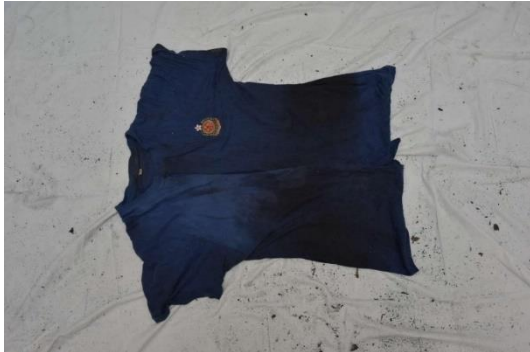
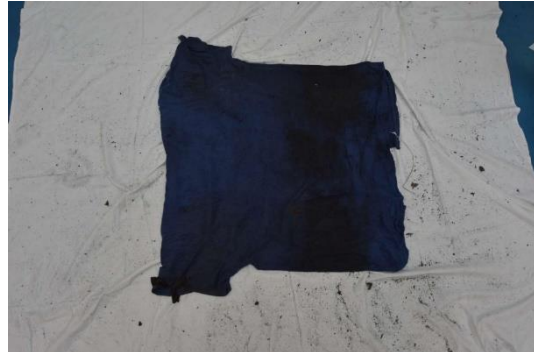
7.2.6.4 The post-fire visual inspection revealed that Fn HO might have been in prolonged contact with hot or burning objects, resulting in severe fire damage to his Station T-shirt, No. 3 trousers, PBI Matrix tunic and trousers anti-flash hood and his helmet (as shown in **Photos 7-11 to 7-16**).

Photo 7-11 (a):  
Station T-shirt (Front)

Photo 7-11 (b):  
Station T-shirt (back)

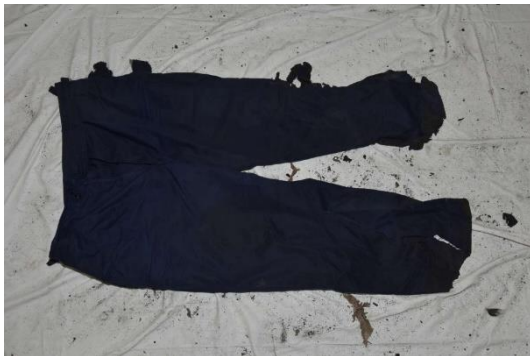
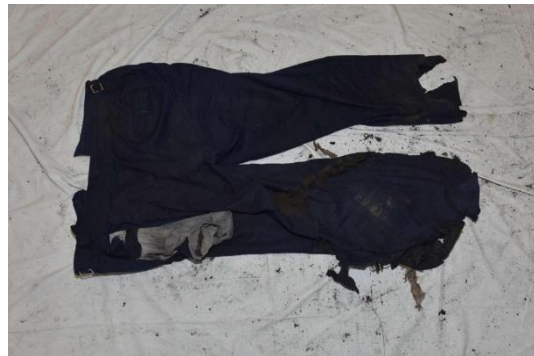
Photo 7-12 (a):  
No. 3 Trousers (front)

Photo 7-12 (b):  
No. 3 Trousers (back)

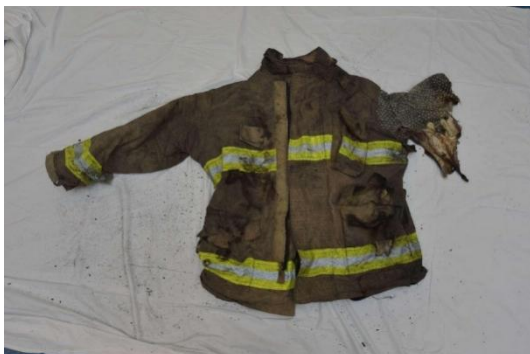
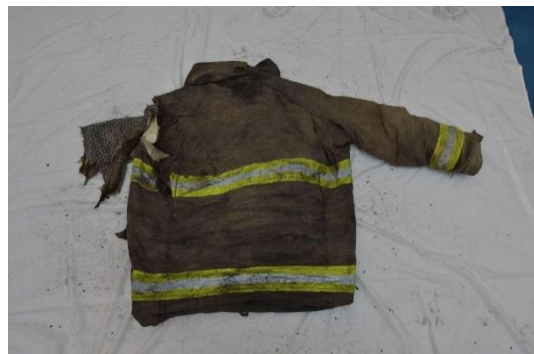
Photo 7-13 (a):  
PBI Matrix Tunic (front)<sup>73</sup>

Photo 7-13 (b):  
PBI Matrix Tunic (back)

<sup>73</sup> In accordance with EN 469:2020, PBI Matrix tunic and trousers shall withstand 1,093°C for up to 8 seconds.

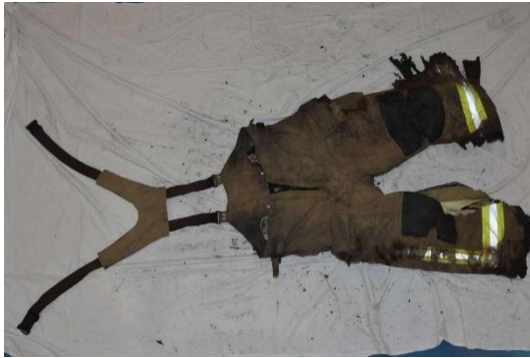
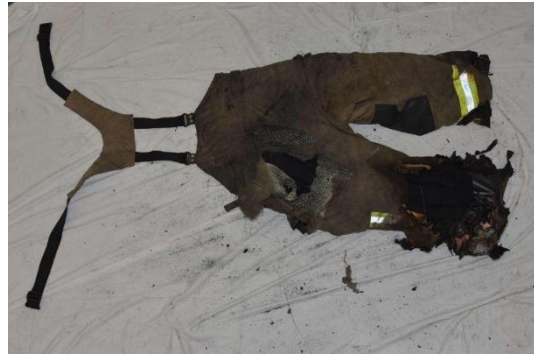
Photo 7-14 (a):  
PBI Matrix Trousers (front)

Photo 7-14 (b):  
PBI Matrix Trousers (back)

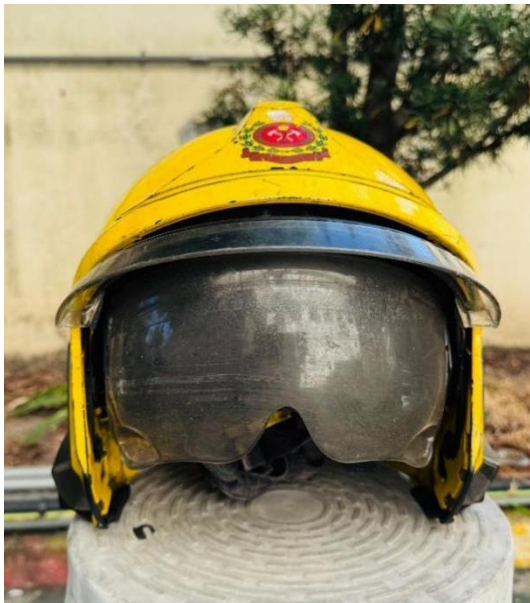
Photo 7-16 (a): The Helmet<sup>75</sup>

<sup>75</sup> In accordance with EN 443:2008, helmets shall be resistant to flame combustion at 900 – 1,000°C for up to 10 seconds; resistant to radiant heat for up to 480 seconds, impact resistance against 5 kg weight and penetration resistance against 1 kg sharp object impact.

- 7.2.6.5 No unusual damage was observed on Fn HO's anti-flash hood and helmet, apart from a crack in the visor, which might have been caused by contact with a sharp or hard object either prior to or during the fire.
- 7.2.6.6 The post-fire visual inspection revealed that Fn HO's rubber boots might have also been in prolonged contact with hot or burning objects, resulting in severe fire damage. As the boots are designed to provide protection against fire in accordance with EN 15090:2012<sup>76</sup>, it is believed that the intense heat or flames exceeded the boots' protective capacity over an extended period (as shown in **Photos 7-17 (a) & (b)**).

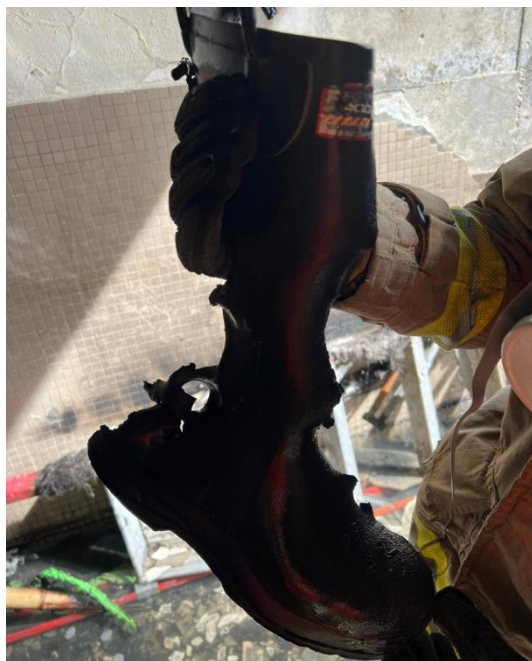
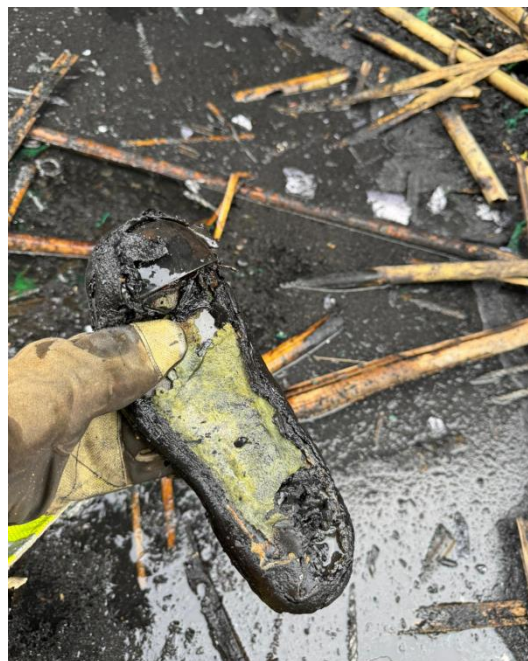
Photo 7-17 (a):  
The Rubber Boot (right-foot)

Photo 7-17 (b):  
The sole of the Boot (left-foot)

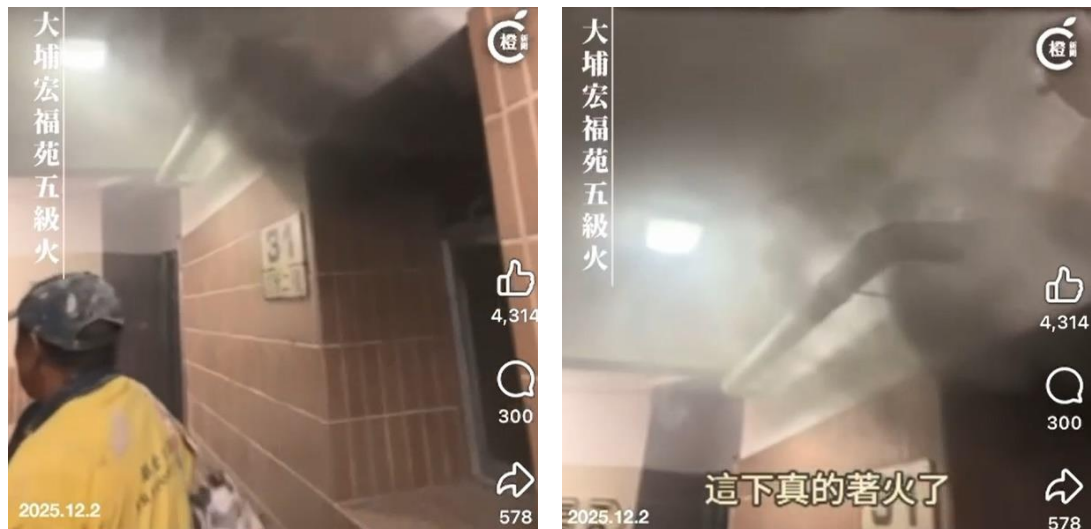
8.5.1.1 During the fire, the upper openable<sup>85</sup> parts of the windows in the lift lobbies on some floors were left open. This allowed smoke from burning combustible materials on the external scaffolding to enter the lift lobbies and corridors, which in turn hinder evacuation (as shown in **Photos 8-1 (a) & (b)**). Even while residents still had a theoretical opportunity to leave, the corridors and lobbies through which they had to pass were rapidly filling with smoke, reducing visibility, increasing heat and stress and slowing movement. In this situation, the residents were likely too panicked to close the windows, although doing so might have helped relieve the situation.

<sup>85</sup> As explained in paragraph 4.3.2, the upper part of the windows at the lift lobbies as well as in the staircases of the eight blocks of Wang Fuk Court were openable, while the lower part of the windows was fixed light. Such design was compliant with the prevailing standard at the time of construction of Wang Fuk Court (i.e. Clause 23 of CoP on MOE 1976)

Photos 8-1 (a) & (b): Video from Online Source Showing Smoke Entering Lift Lobby through the Upper Openable Part of Window of Wang Tai House

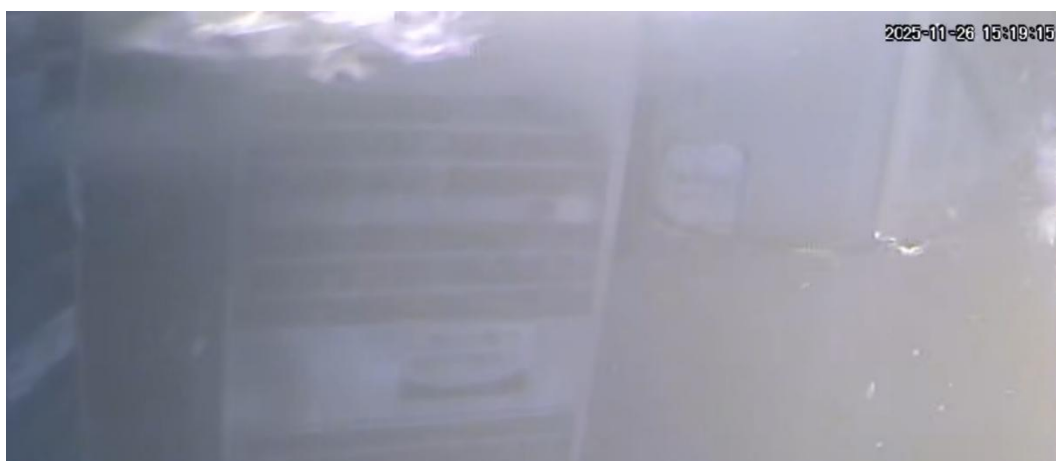
- 8.6.1 Flaming bamboo scaffolding and other construction materials detached from the upper levels during the fire led to a large amount of burning debris being accumulated on the ground level, resulting in flaming obstructions that blocked building entrances. As a result, both escape for evacuees and access for firefighting personnel were obstructed, thus delaying escape, rescue efforts and fire suppression (as shown in **Photo 8-3**). For some occupants, even after they had managed to fight their way down through smoke-affected corridors and staircases, their final exit from the building was still blocked by walls of flame and burning debris. In addition, smoke entering the building from the G/F further hindered escape and hampered the rescue operations of firefighting personnel (as shown in **Photo 8-4**).

*Photo 8-4: Flame was Observed at the Entrance of Wang Tai House at about 1521 hours<sup>87</sup>*
