# **Independent Committee in relation to the fire at Wang Fuk Court in Tai Po**

## **Experts' Presentation**

**(Fire Engineering Experts for the Independent Committee)**

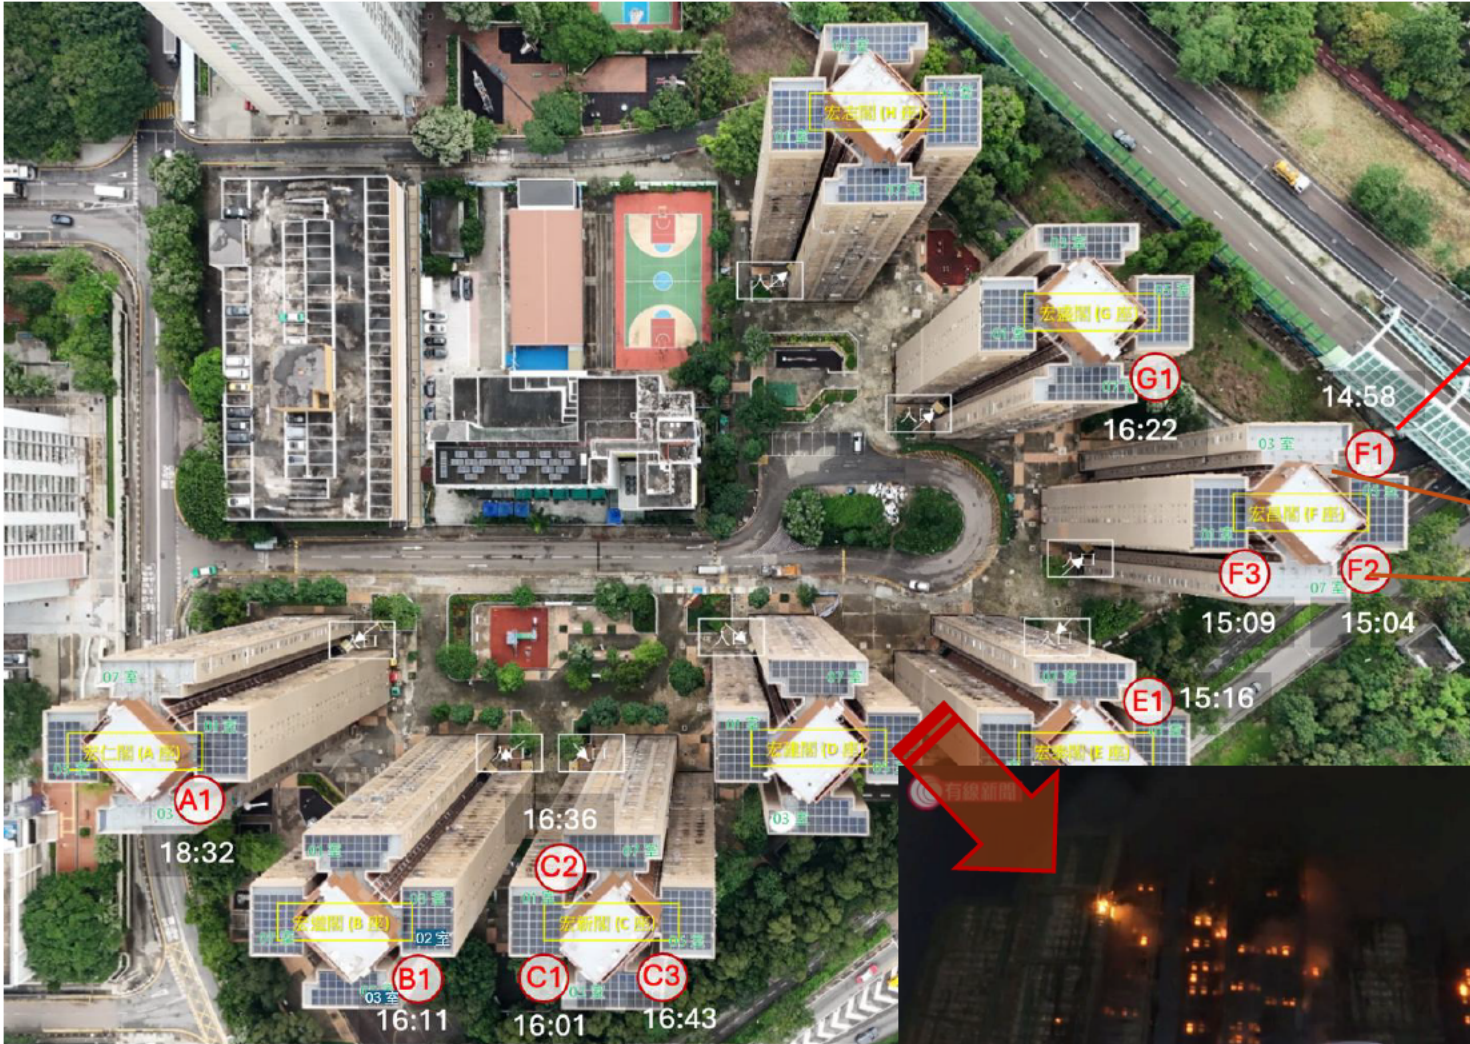
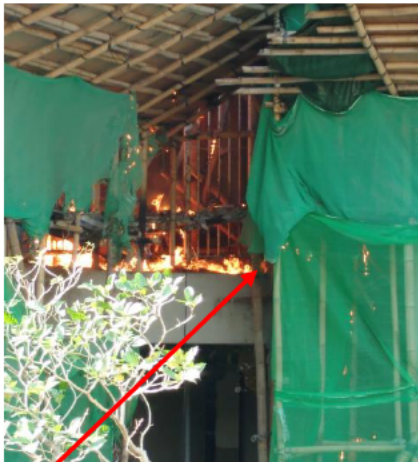
Initiation of fire at Flat roof of Re-entrant of Block F  
14:50 | 26 Nov 2025

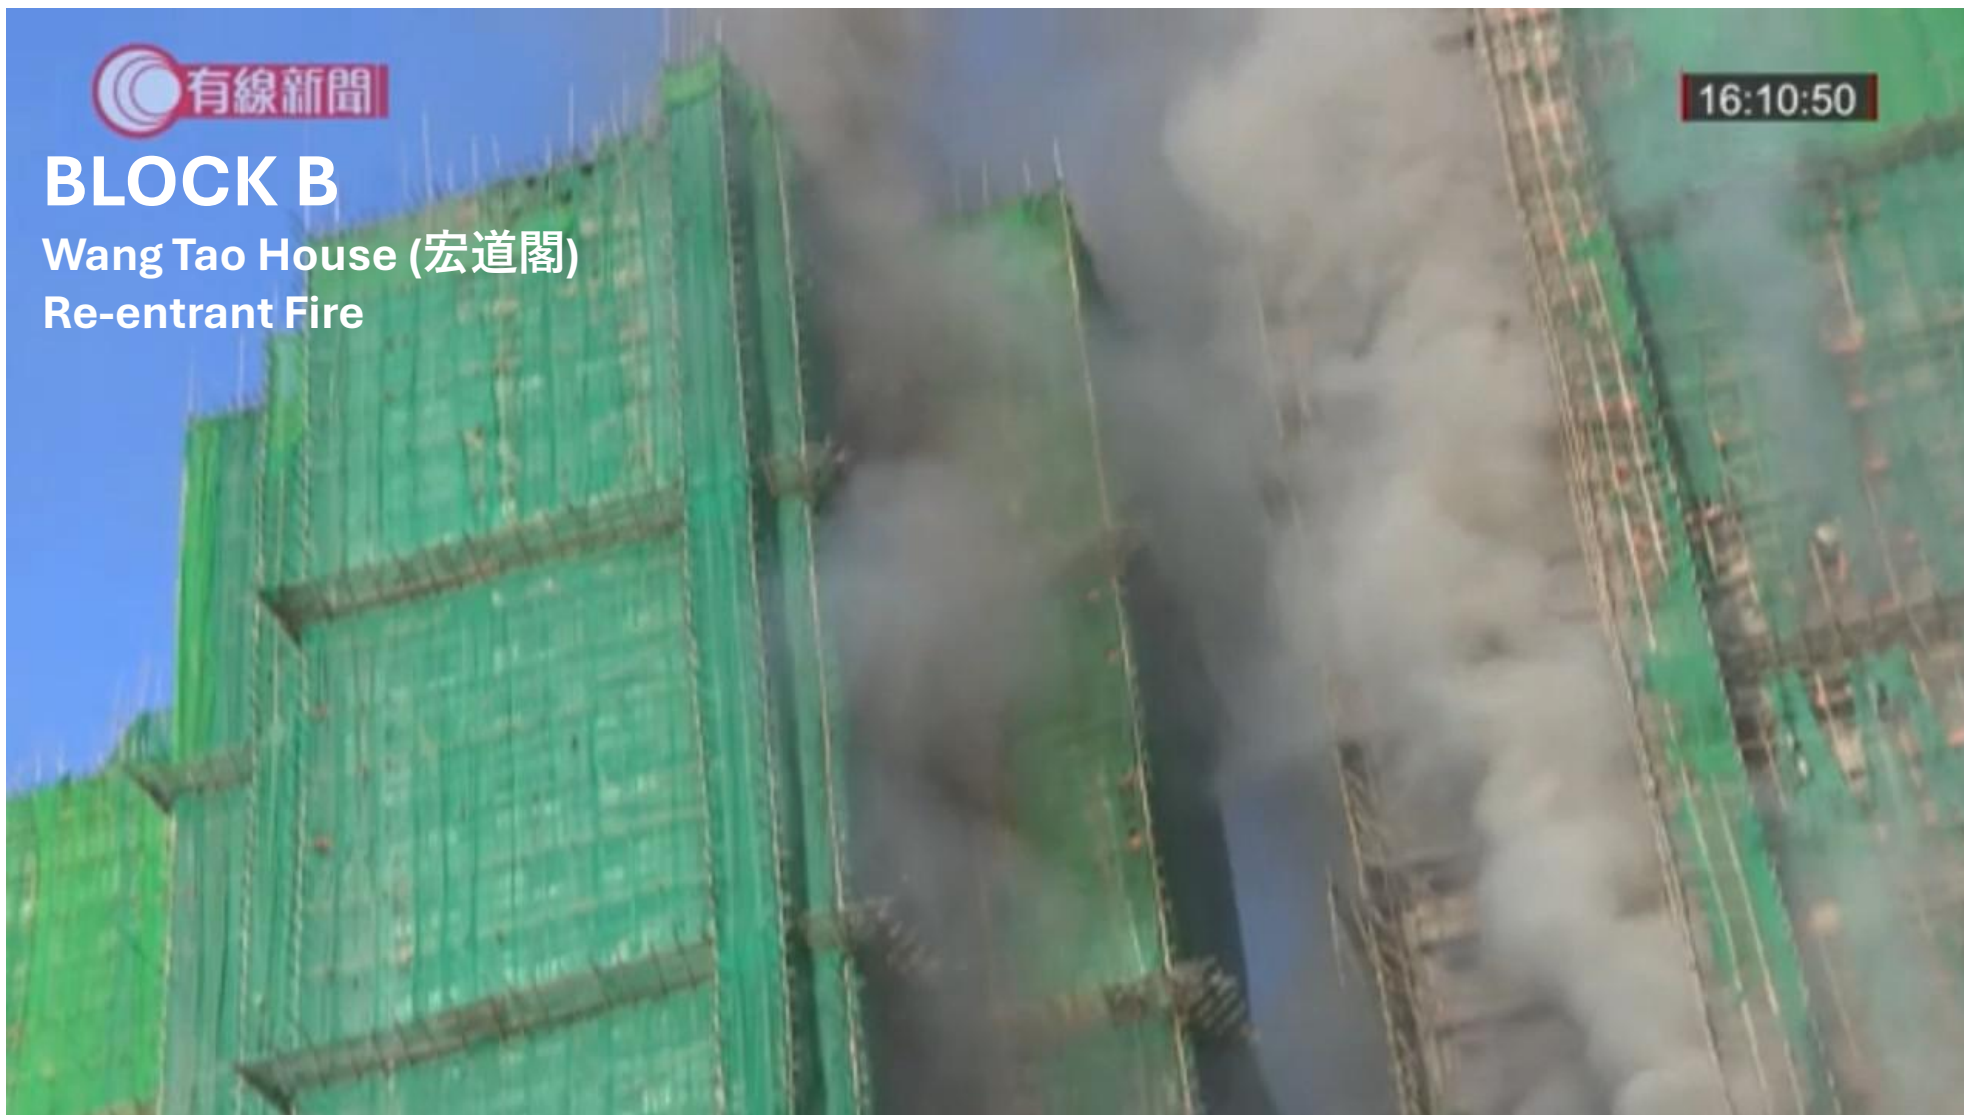
## Re-entrant Fires

(Block B re-entrant fire captured by Cable News as example)

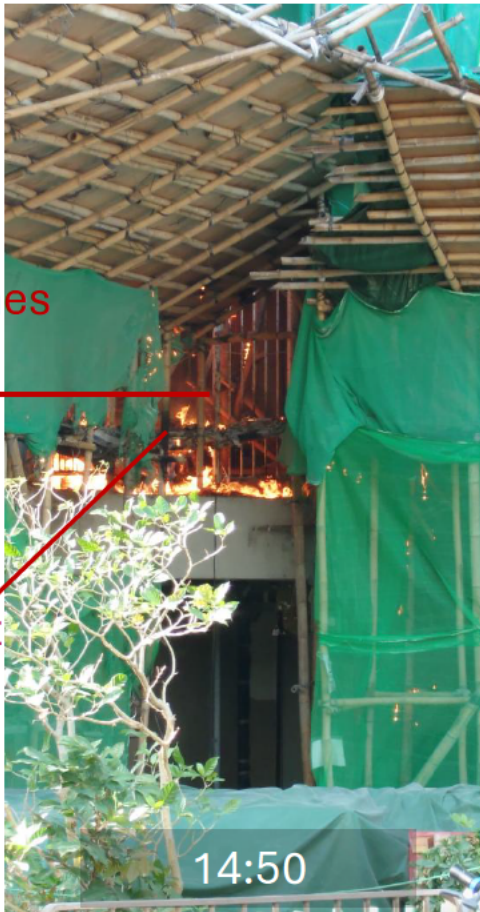
A large localised fire  
above flat roof

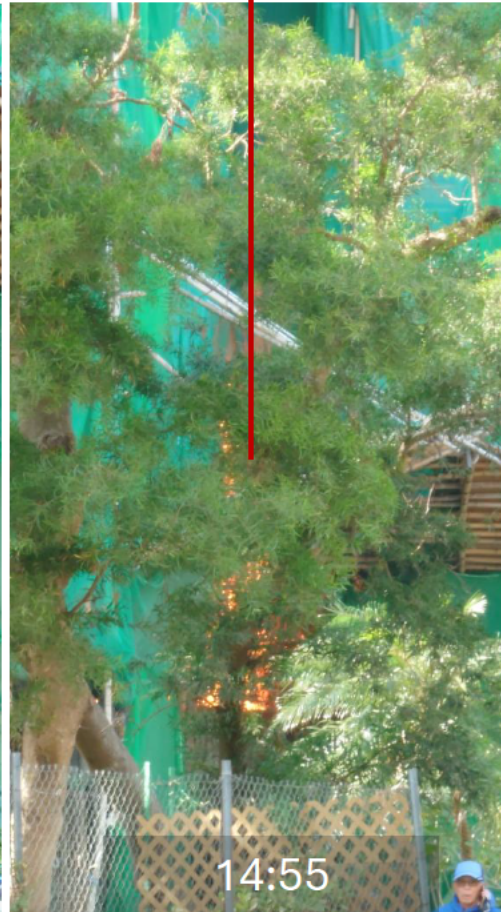
1<sup>st</sup> fast-spreading re-entrant  
fire of Block F

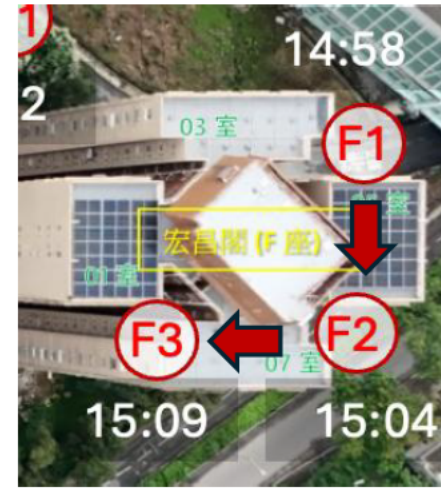
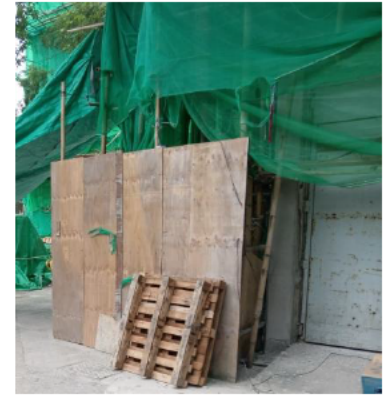
- Very short period between each two re-entrant fires
- Likely due to ground fire spread
- Burning of collapsed scaffolding materials together with combustible construction materials on the ground

**Ground combustibles**

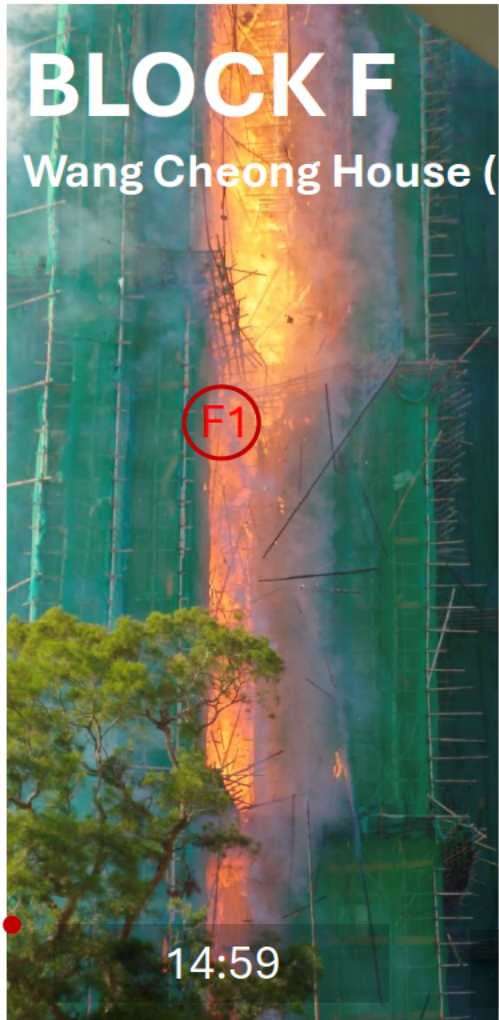
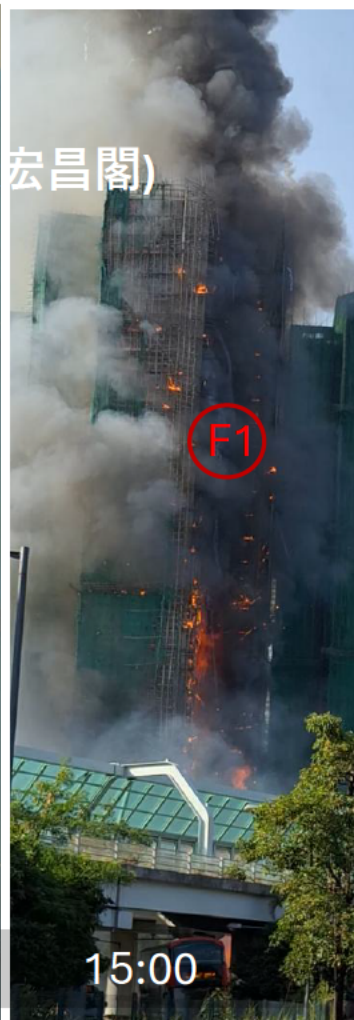
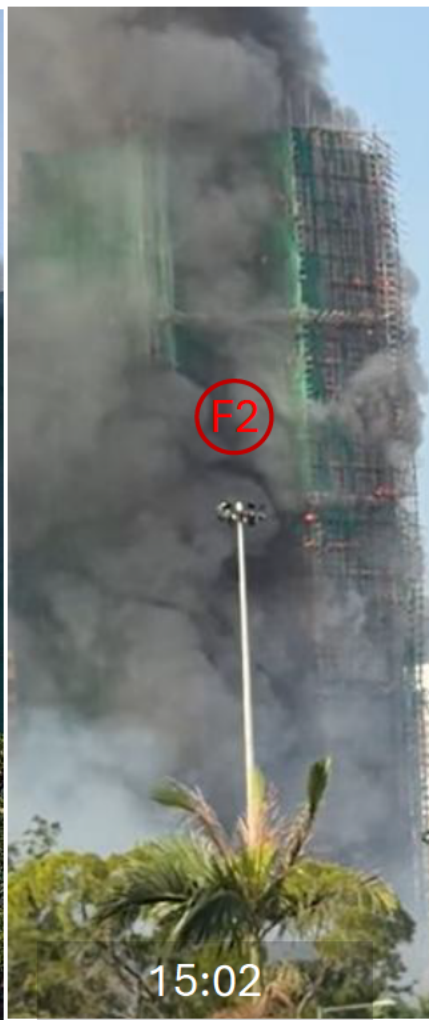
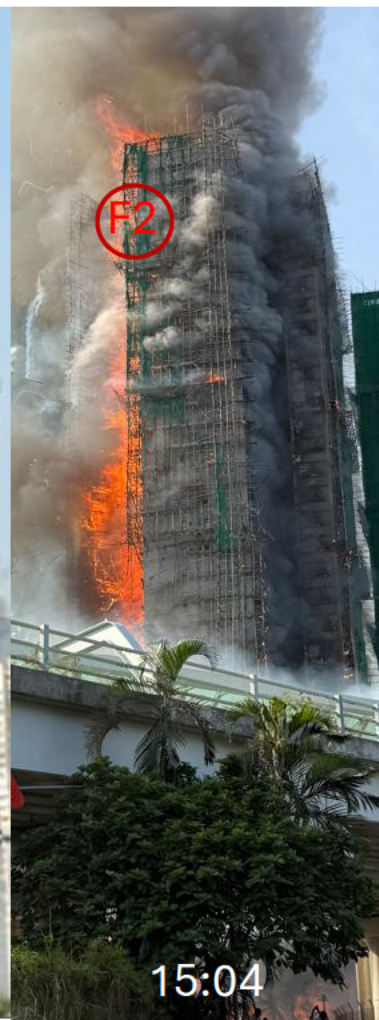
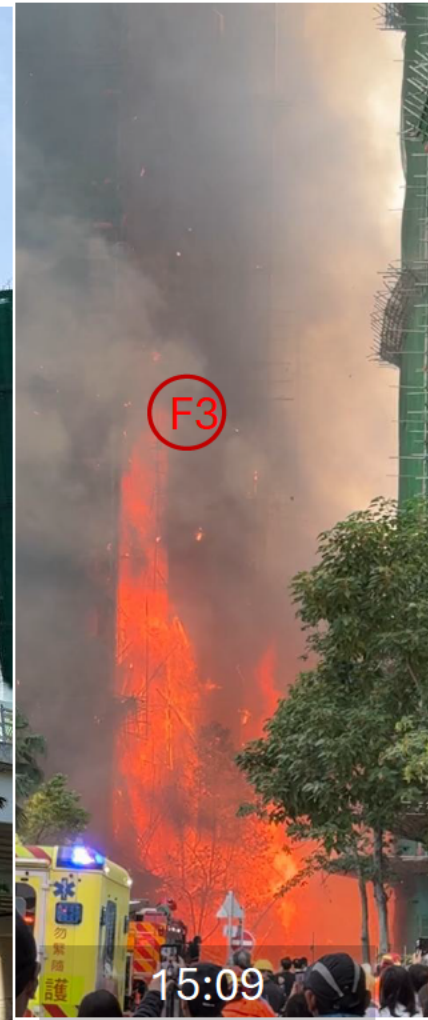
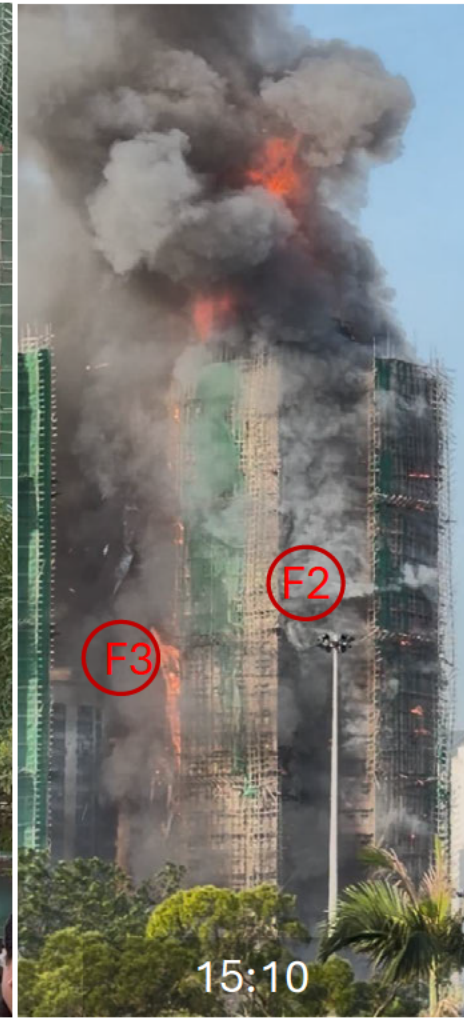
# During Re-entrant Fires | Re-entrant fires of Block F

Re-entrant fire of F1

Re-entrant fire of F2

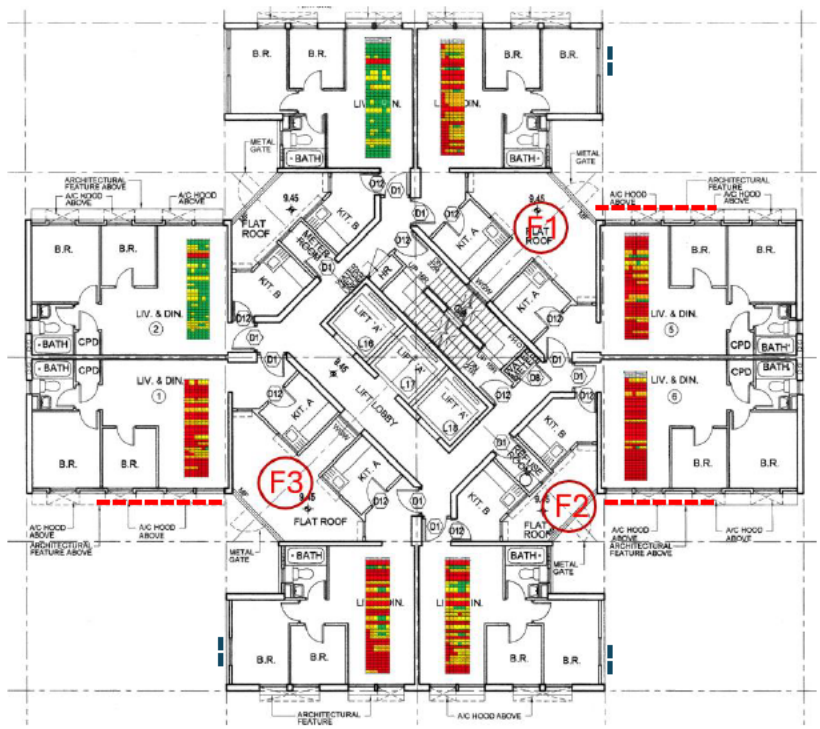
Room Unit Fire Damage Map

Room Damage closely linked to re-entrant fires | Different levels of damage in each re-entrant fire

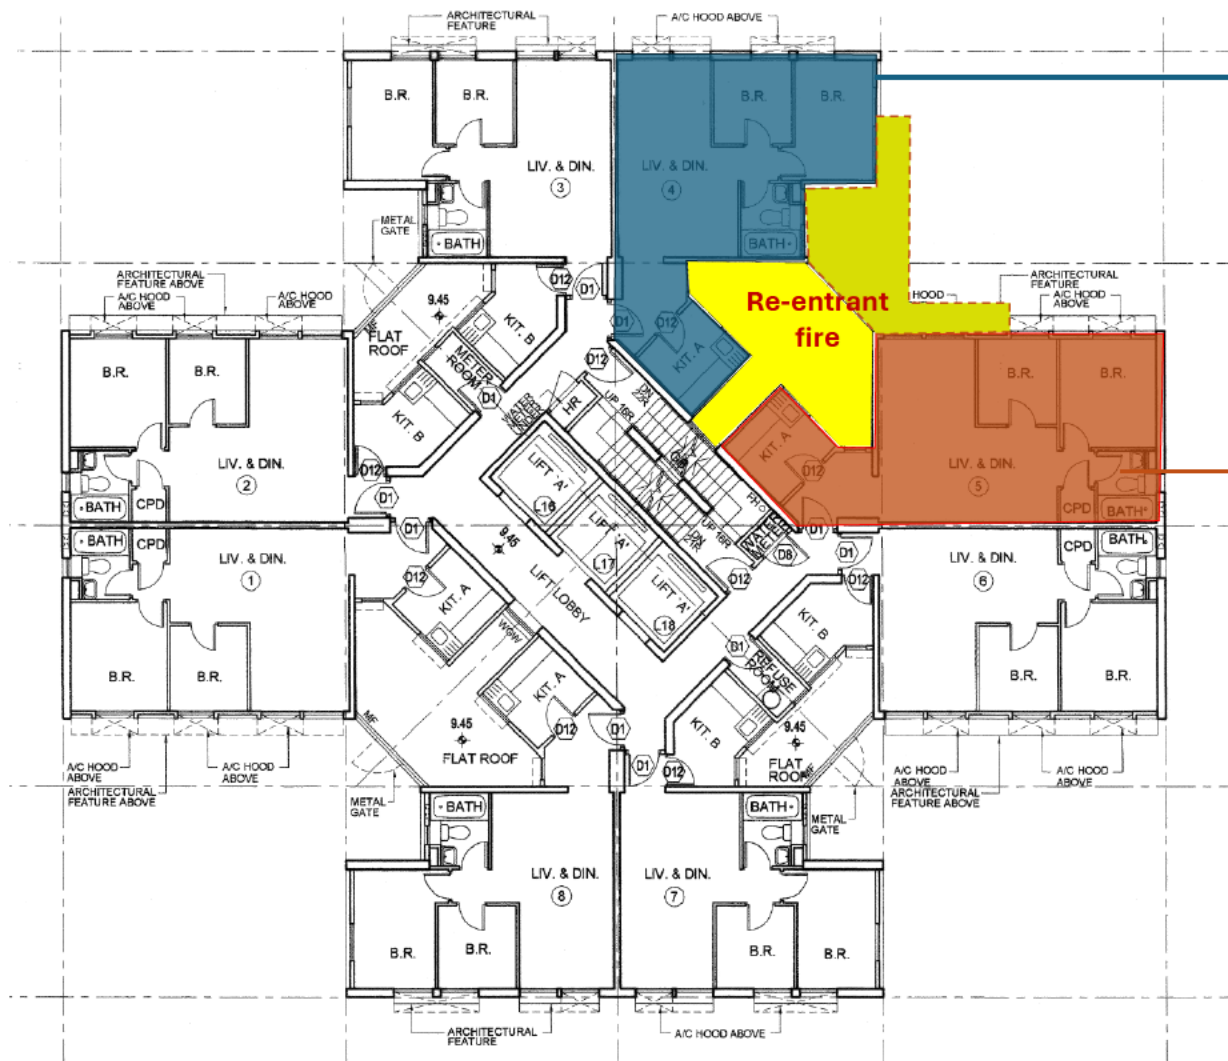
## Window-Fire Damage Mapping

- **Main bedroom side windows** exposed to extended re-entrant fire
- Possible Fire starting locations: kitchens, corridors near gates, bathrooms, main bedrooms

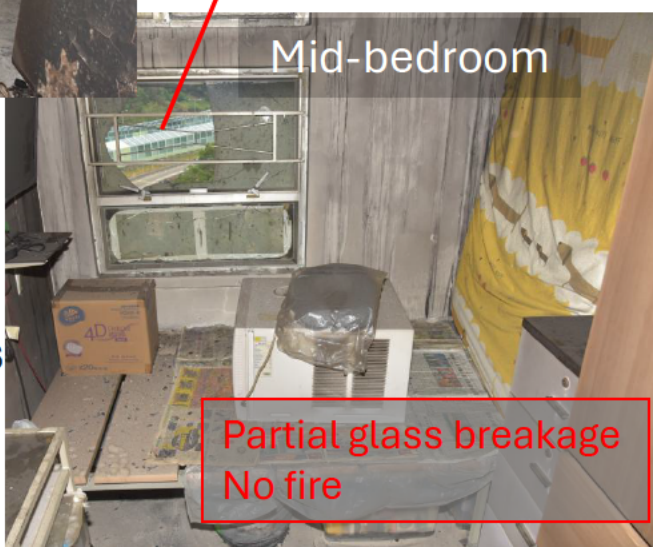
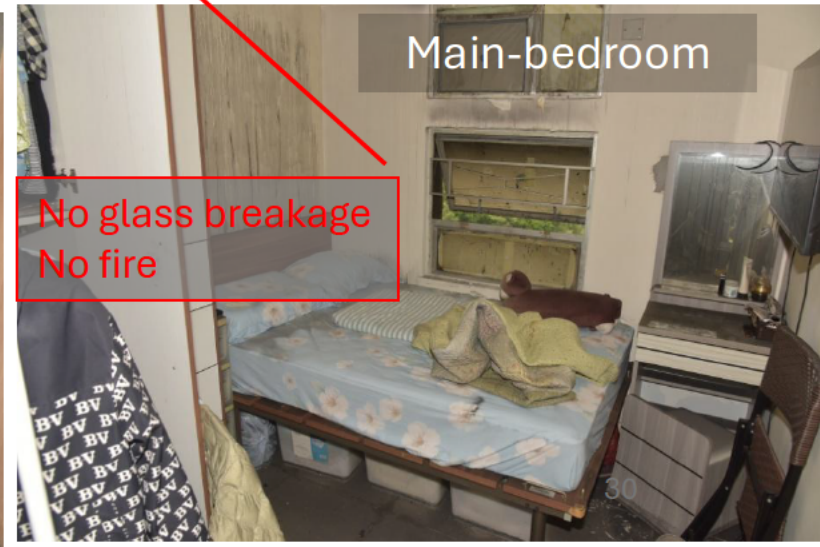
Ignition  
after living  
room glass  
breakage

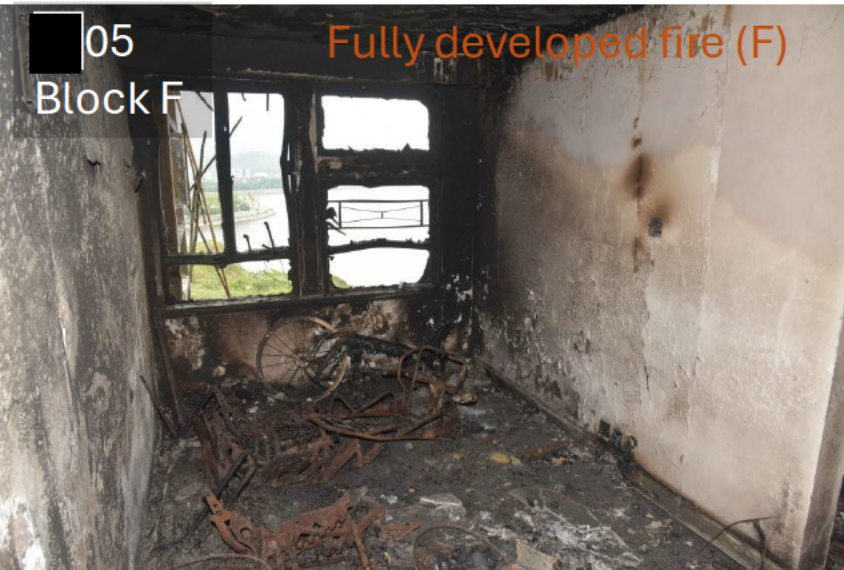
## Room 05 (Type A)

- Fully-developed fire in whole room unit
- Sufficient fuel to sustain fire development after glass breakage

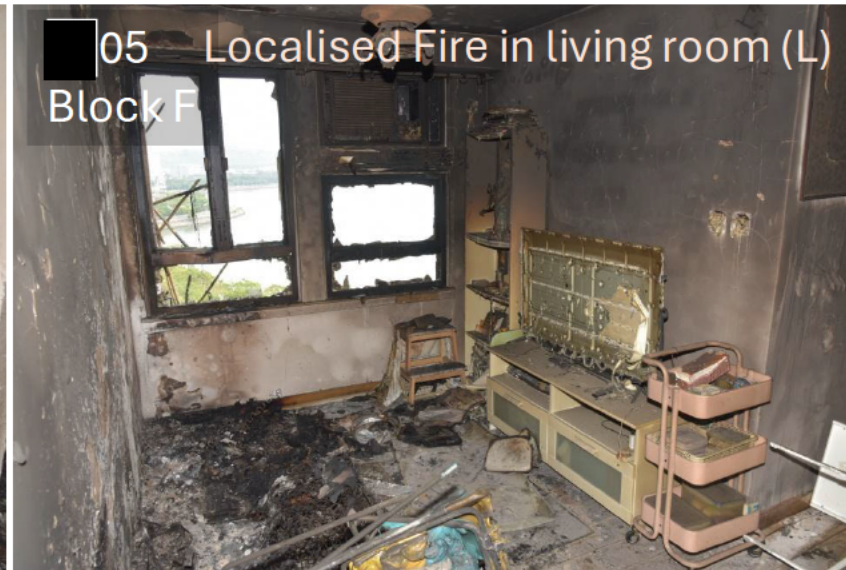
## Room 05 (Type A)

- Localised fire in living room
- Limited fuel ignited after glass breakage
- Early glass fallout (“active opening” )

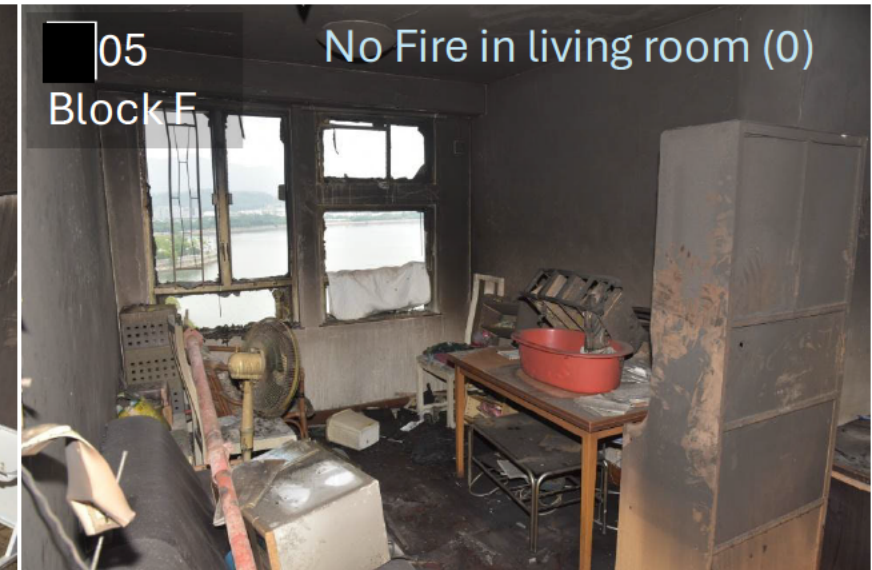
## Room 05 (Type A)

- No fire in living room
- Full glass breakage, excluding internal fire, ejecting flames from lower floor
- Glass fallout only due to re-entrant fire

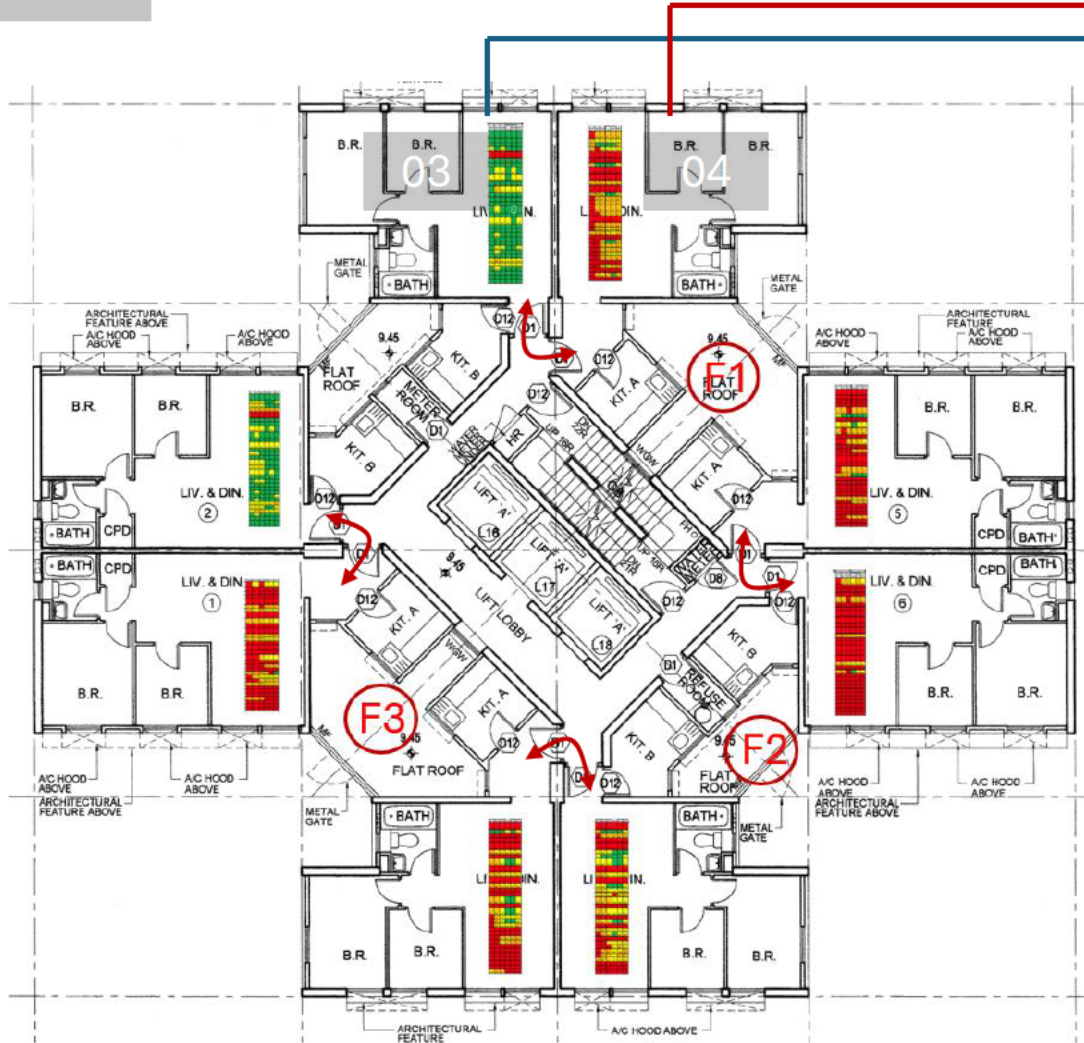
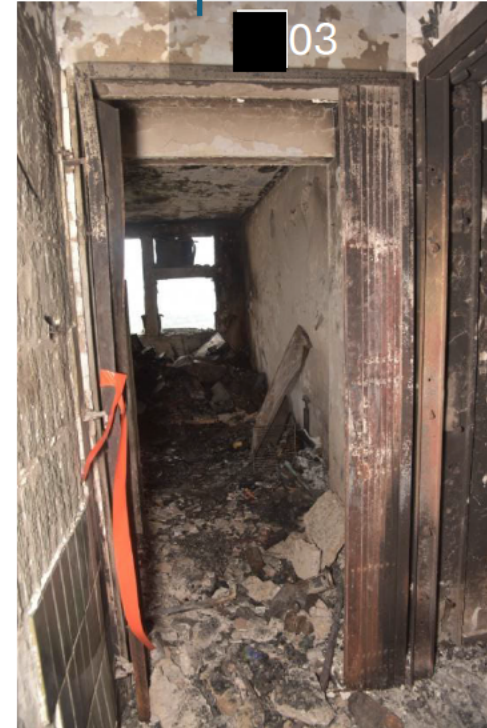
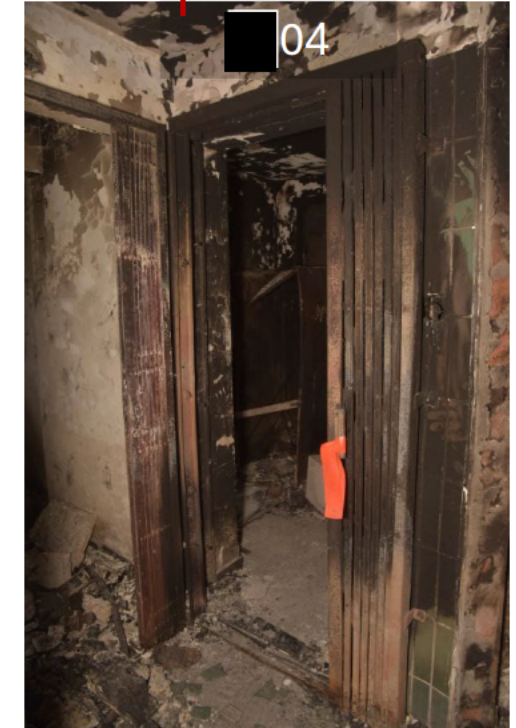
Fully-developed Room fire spread to adjacent room unit through neighboring front doors

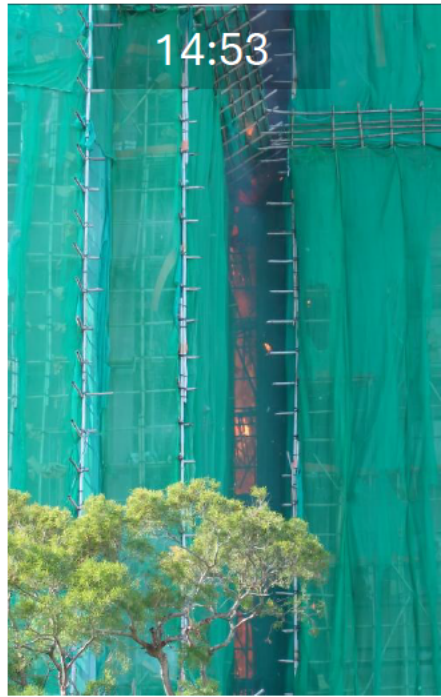
- Flames at building façade are likely the burning of safety net
- The burning of safety net was caused by unknown fire source at the flat roof area of F1
- The burning of safety net of other buildings could be caused by flying ember, flaming debris

A large localised fire  
To trigger re-entrant  
fire

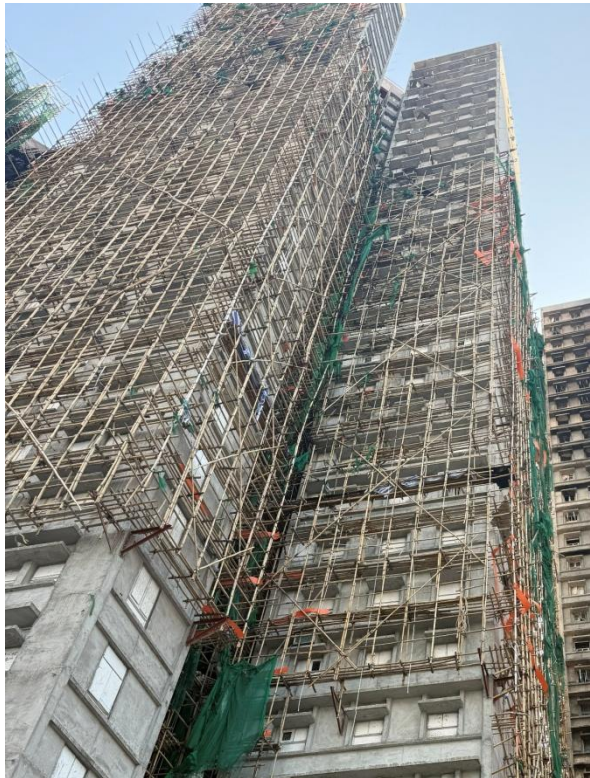
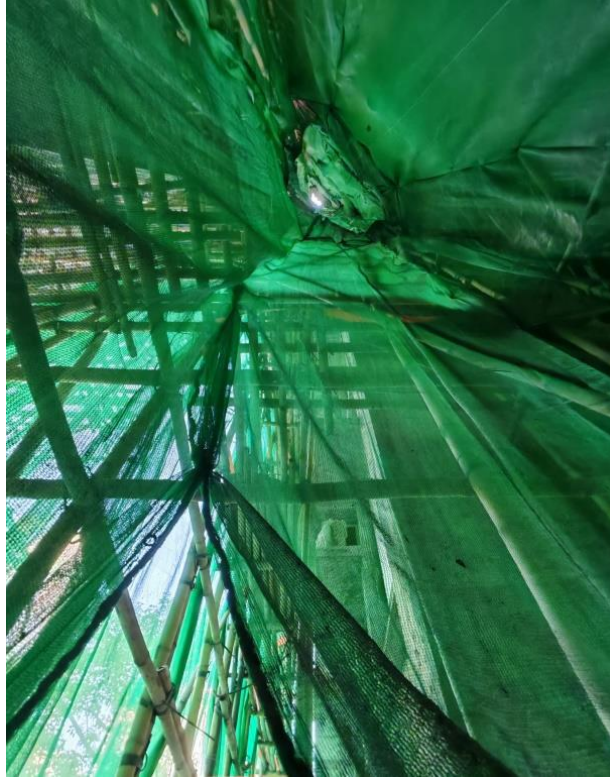
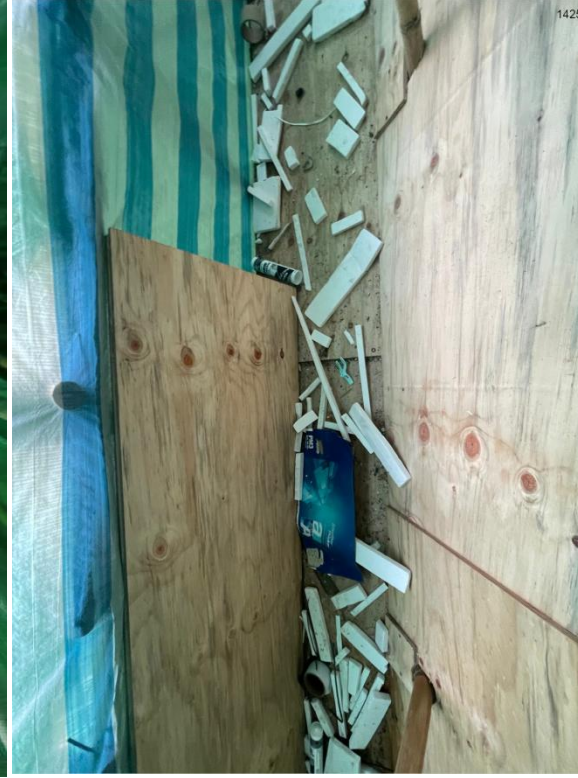
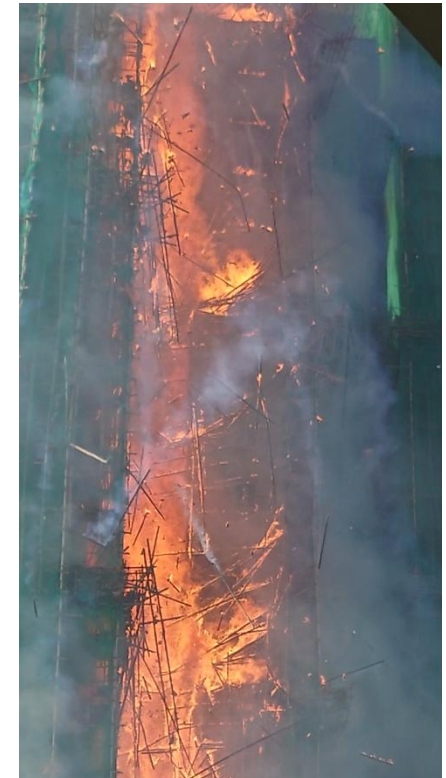
- A sufficiently large localised fire leading to pyrolysis of wood and bamboo
- Large amount of pyrolysis gas released from the heated items intensified the fire (demonstrated in Test E1)
- The intensified fire further prompted the release of pyrolysis gas
- In such intensive re-entrant fires, all combustible items contributed to fire development

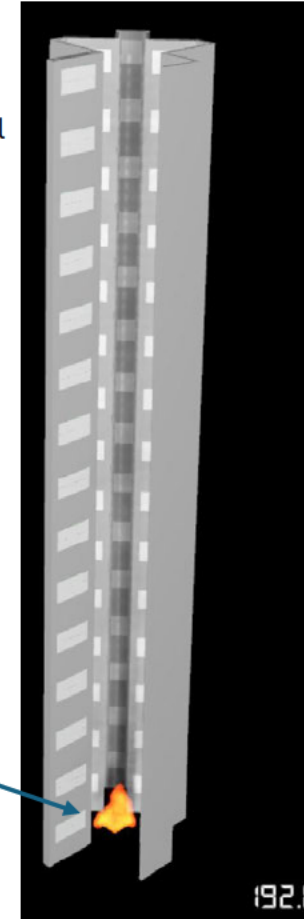
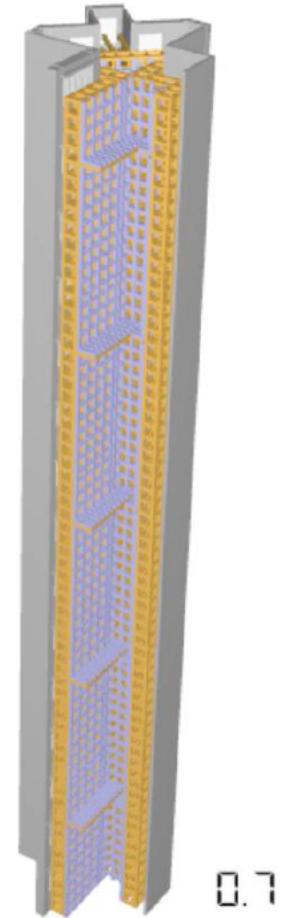
**Case 4 Model**

Localised fire  
to initiate re-  
entrant fire  
(HRR:4140kW)

Note: CFD fire simulations have many limitations in reproducing such large-scale fires (e.g., the falling behaviour of scaffolding during burning)

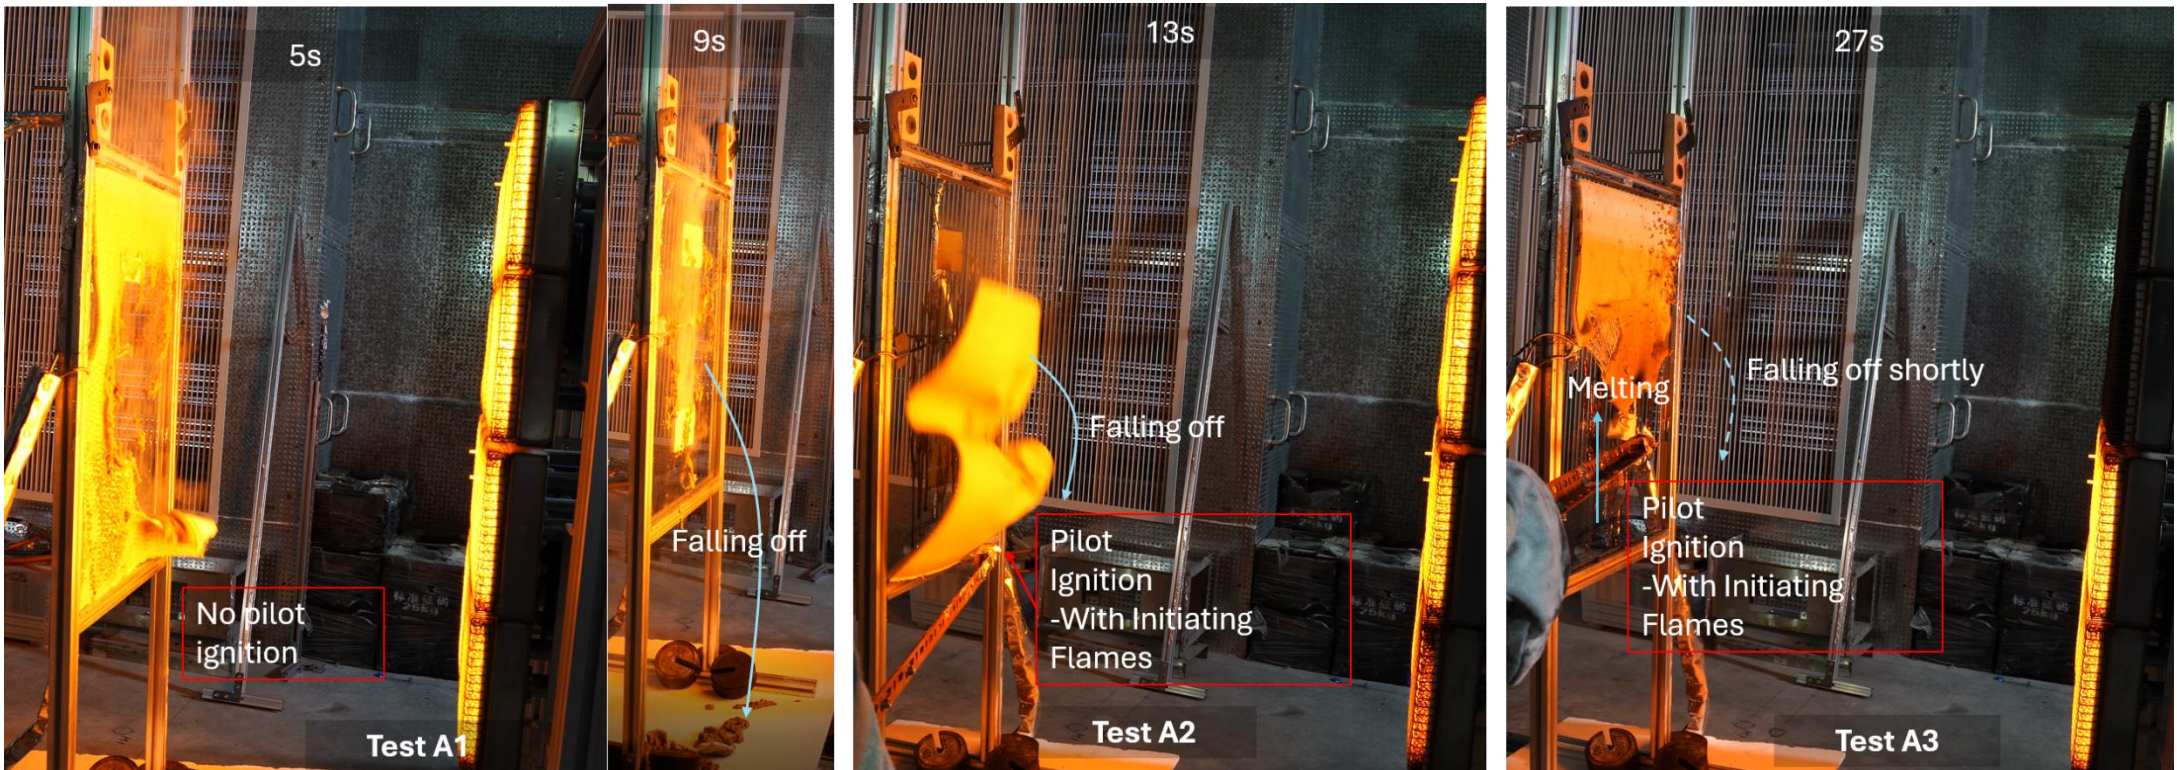
- The effect of Polystyrene foam boards pasted on glass panels is tested
- Under the heating of radiant panel to approximate fire heating, foam boards quickly melted and shrank

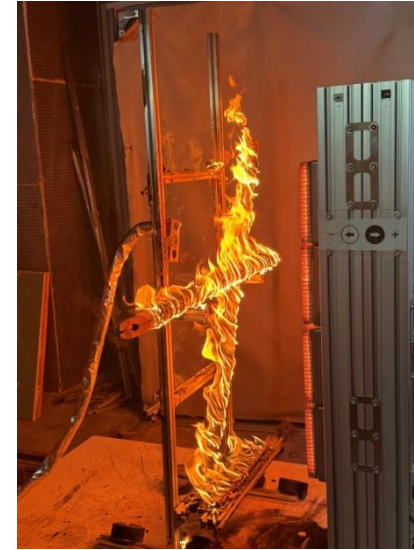
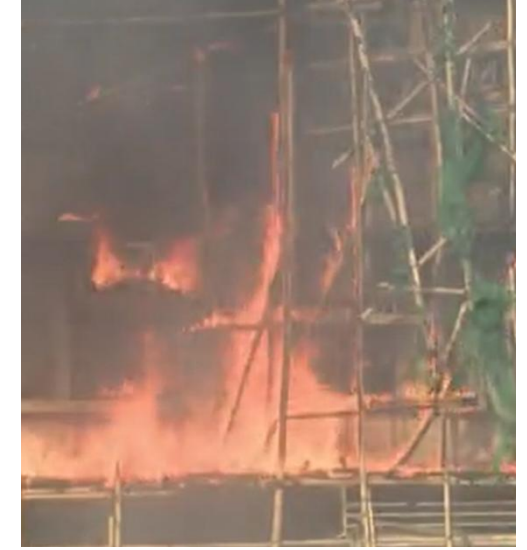
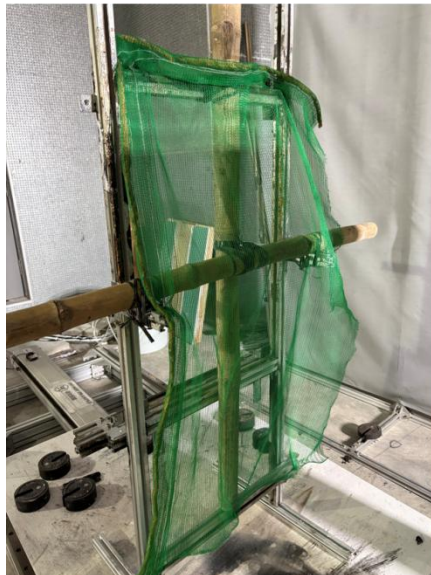
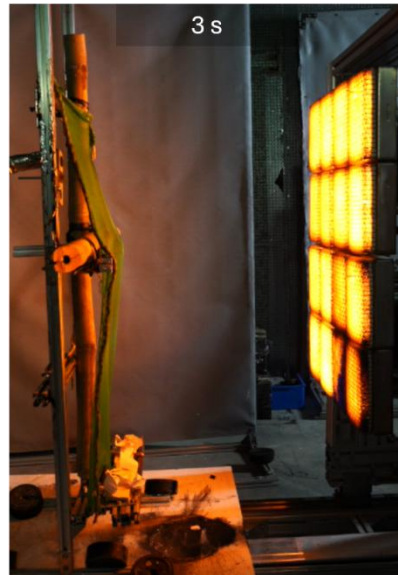
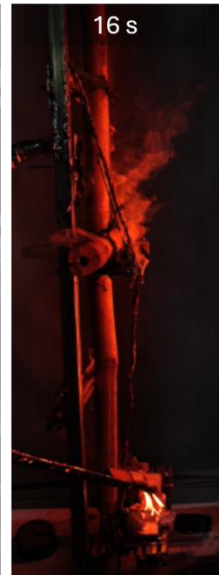
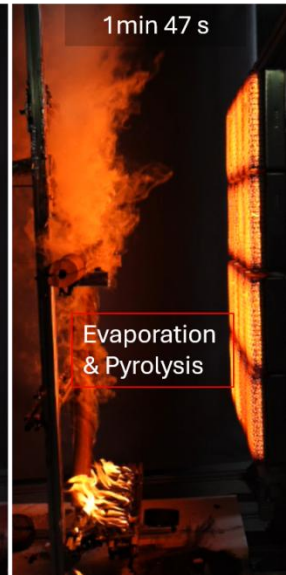
- Possibly triggered by ejecting flames from room units
- Burning of remaining scaffolding fire at façade
- Bamboo, wood boards, non-FR safety net, and polystyrene foam boards are likely to contribute in the subsequent fire spread

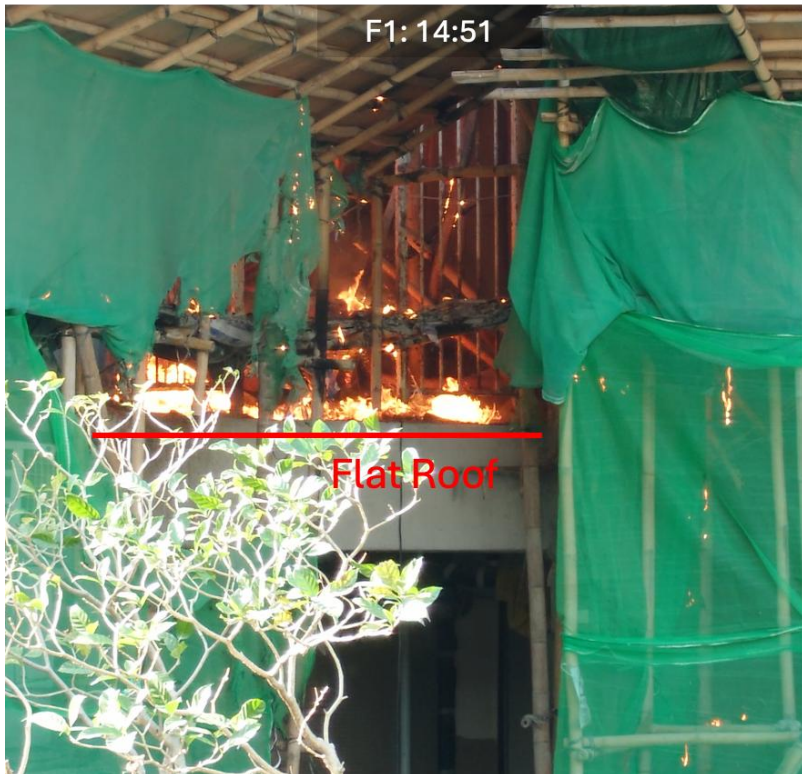
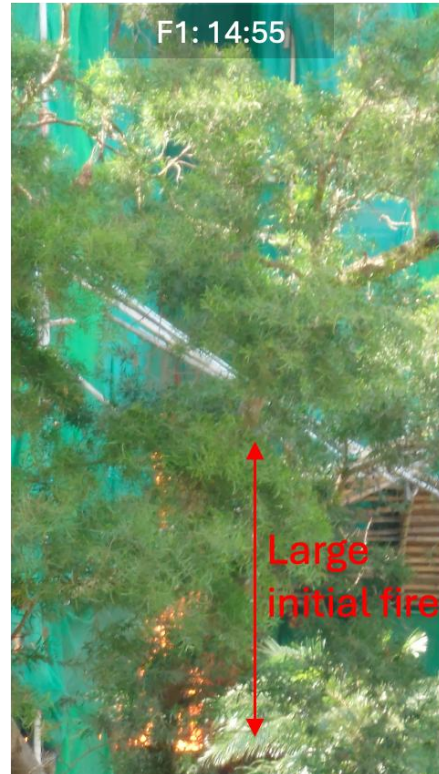
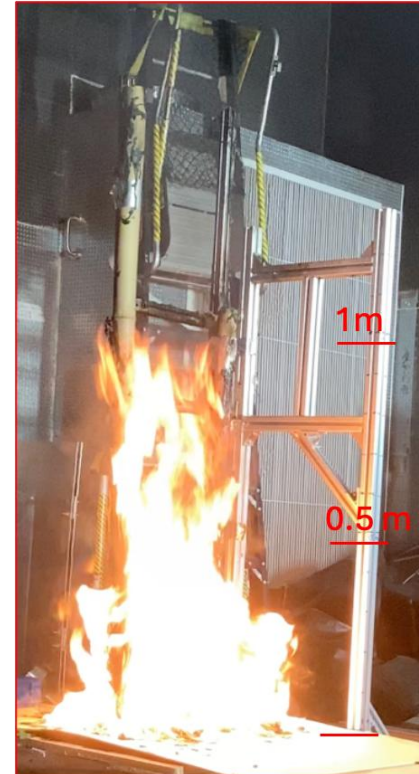
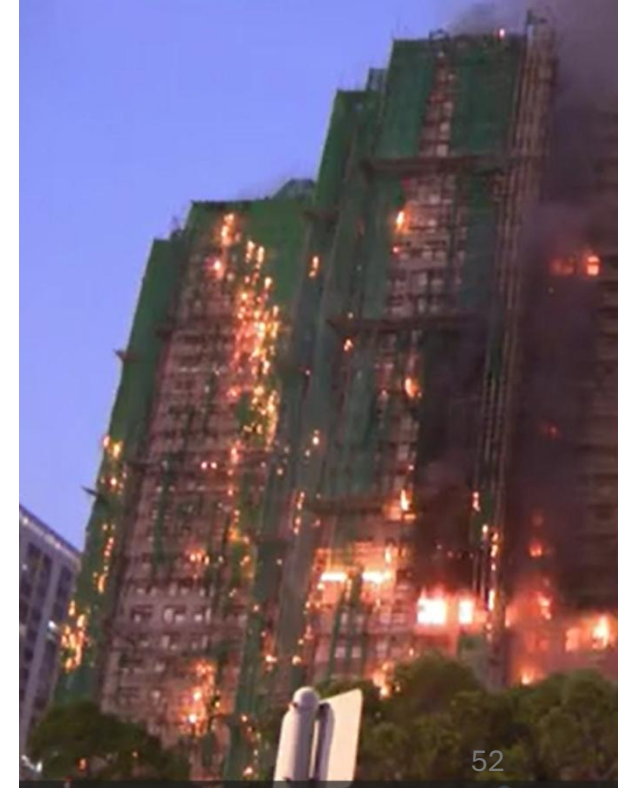
- Each re-entrant of the buildings has a flat roof above the ground floor
- The flat roof facilitated the accumulation of dripping flames and joint burning of itmes
- The existence of flat roof facilitated the key localised fire initiating re-entrant fire
- Noted other source of localised fire (e.g., random fires from room units) may lead to re-entrant fire
