# **Independent Committee in relation to the fire at Wang Fuk Court in Tai Po**

## **Experts' Presentation**

**(Fire Engineering Experts for the Independent Committee)**

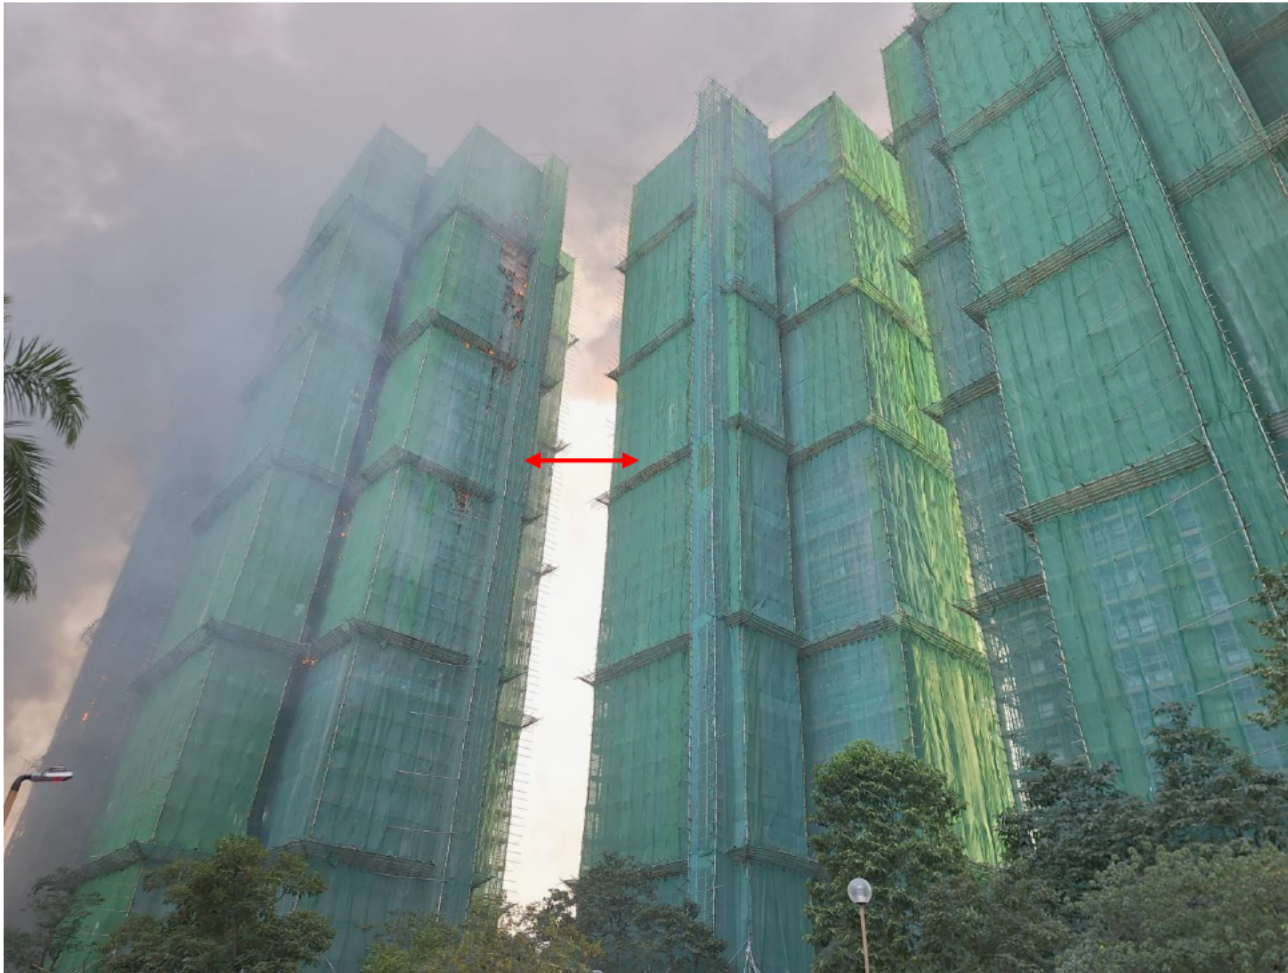
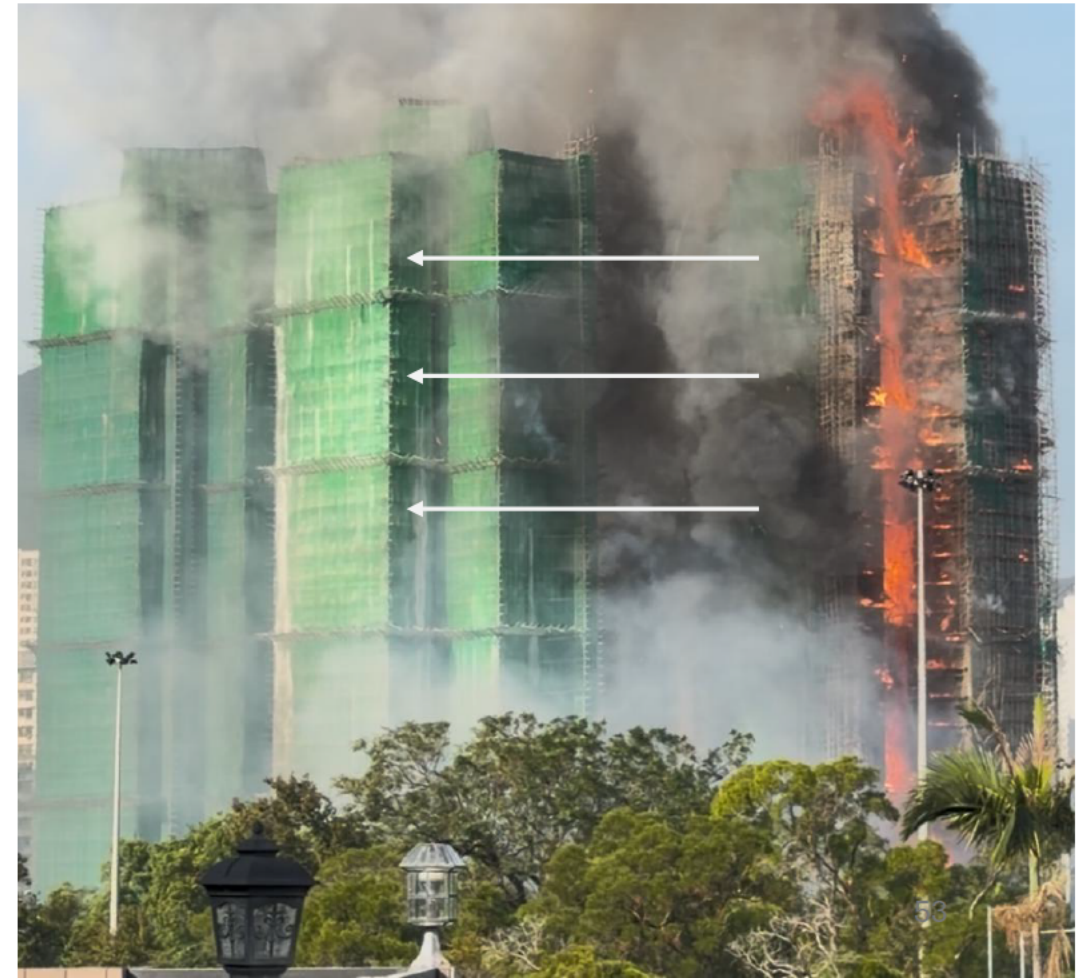
- Short distances between buildings
- High-momentum air flow in re-entrant fire and Wind effect

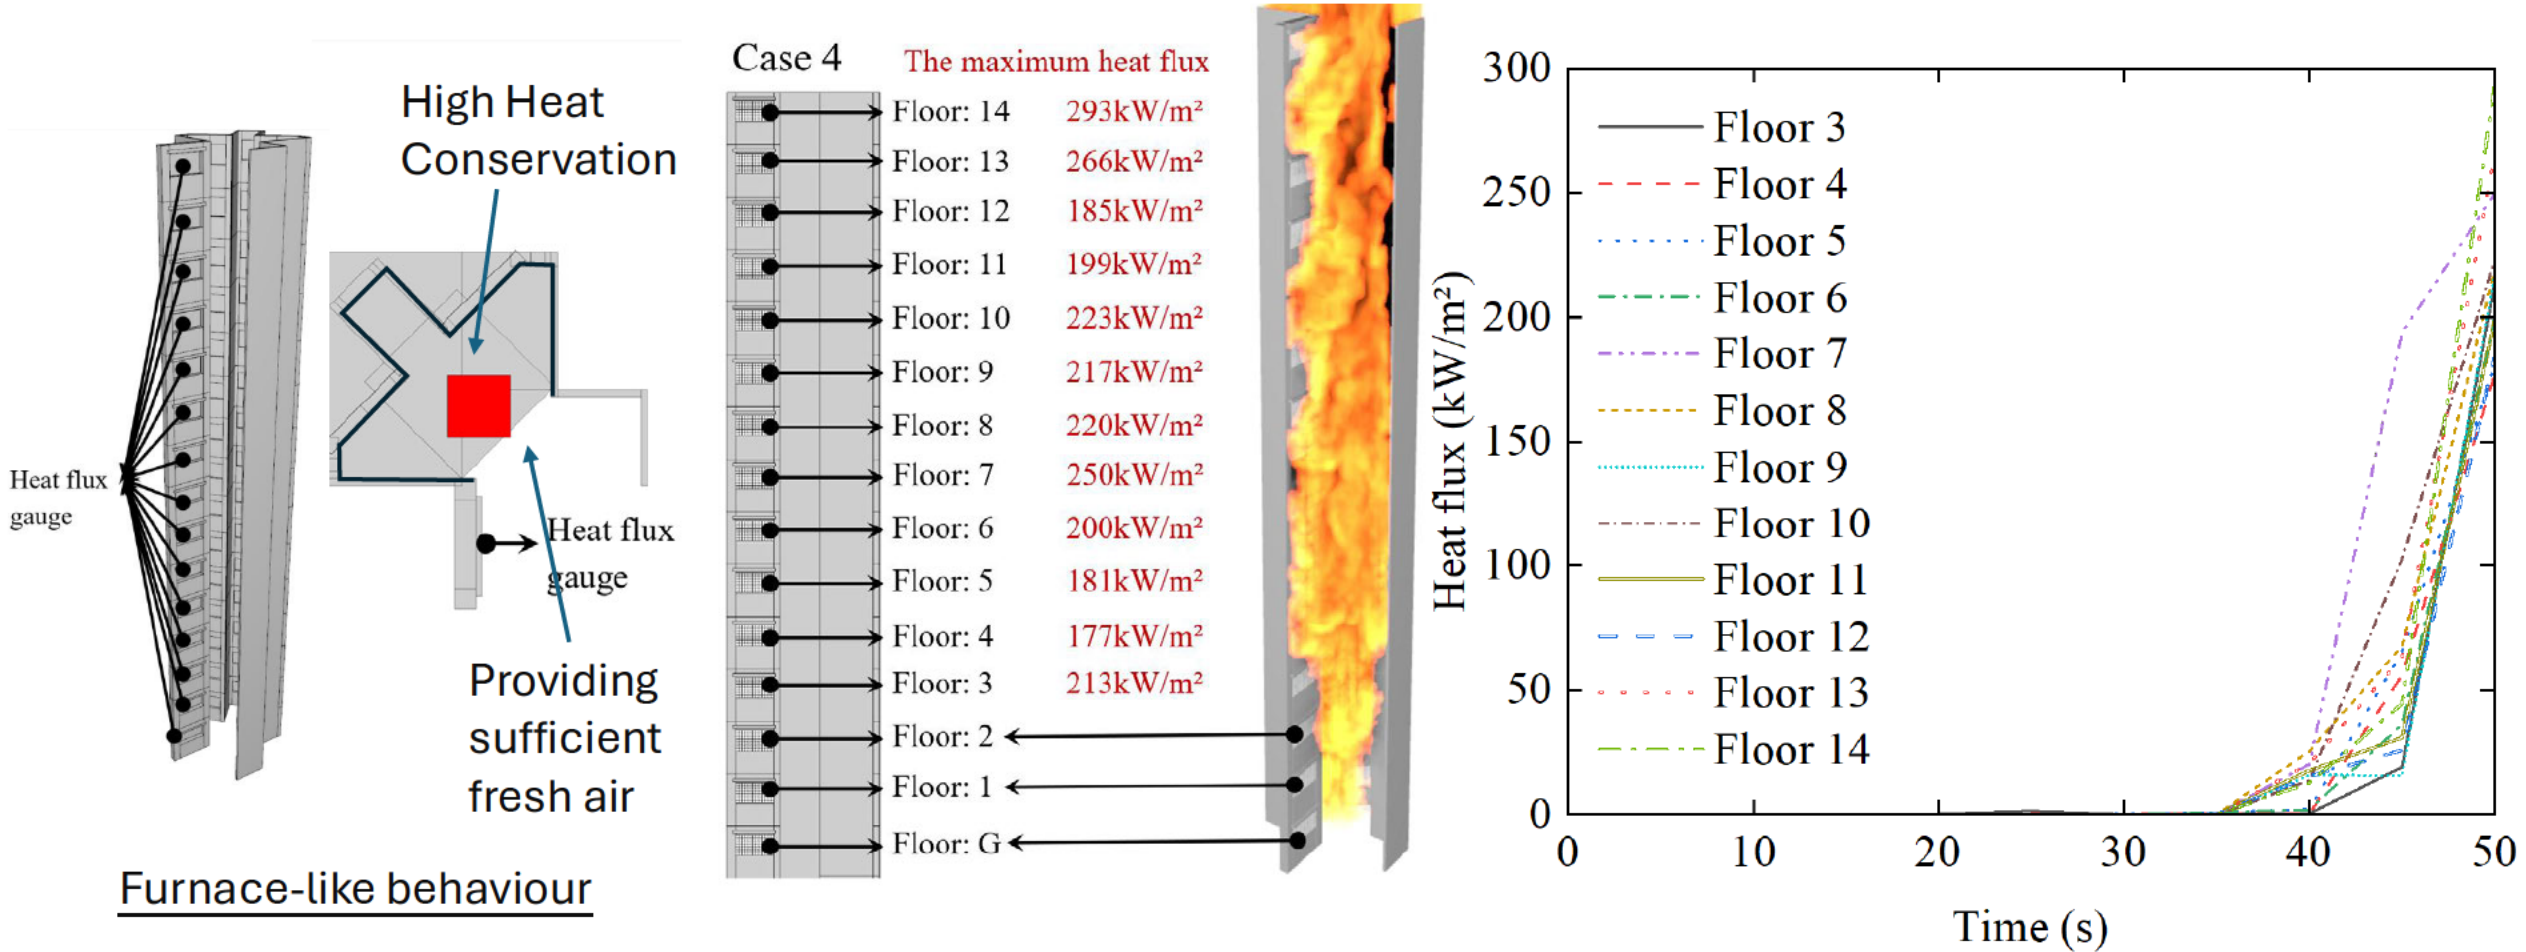
- High gauge heat fluxes in re-entrant region simulated

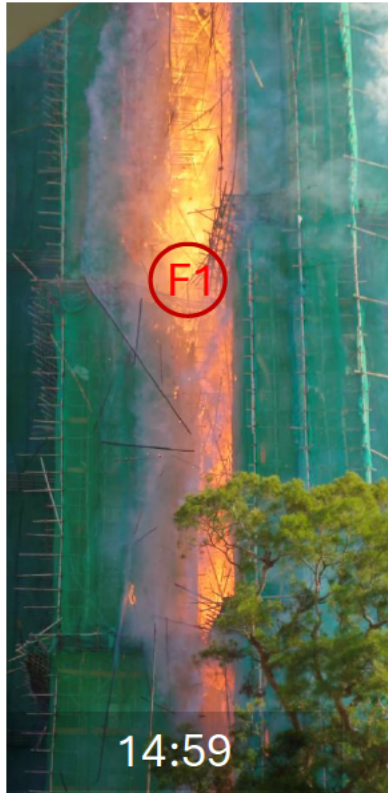
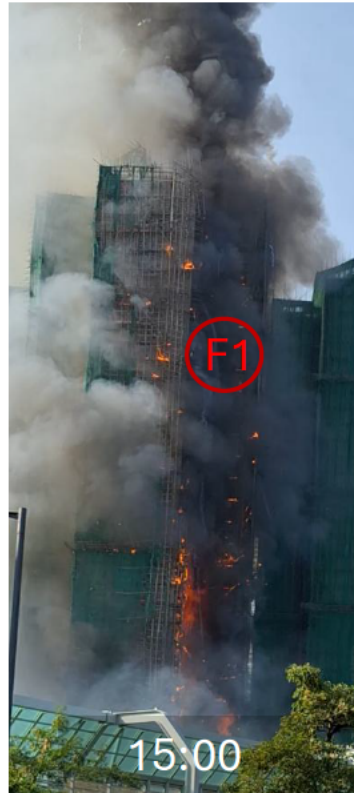
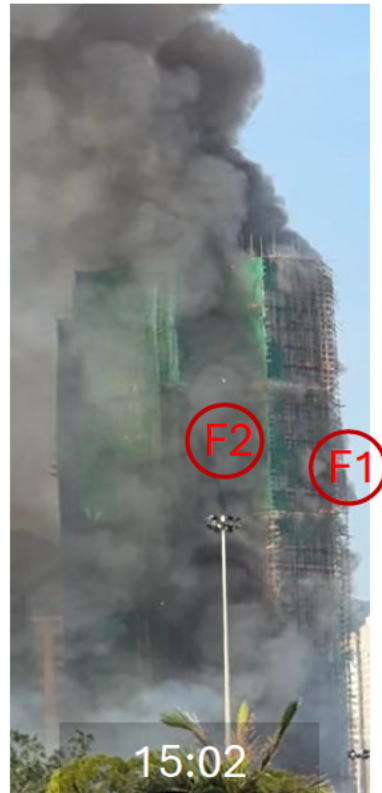
Rapid smoke accumulation:

- 1) ineffective burning of re-entrant scaffolding materials
- 2) Ignition of room items

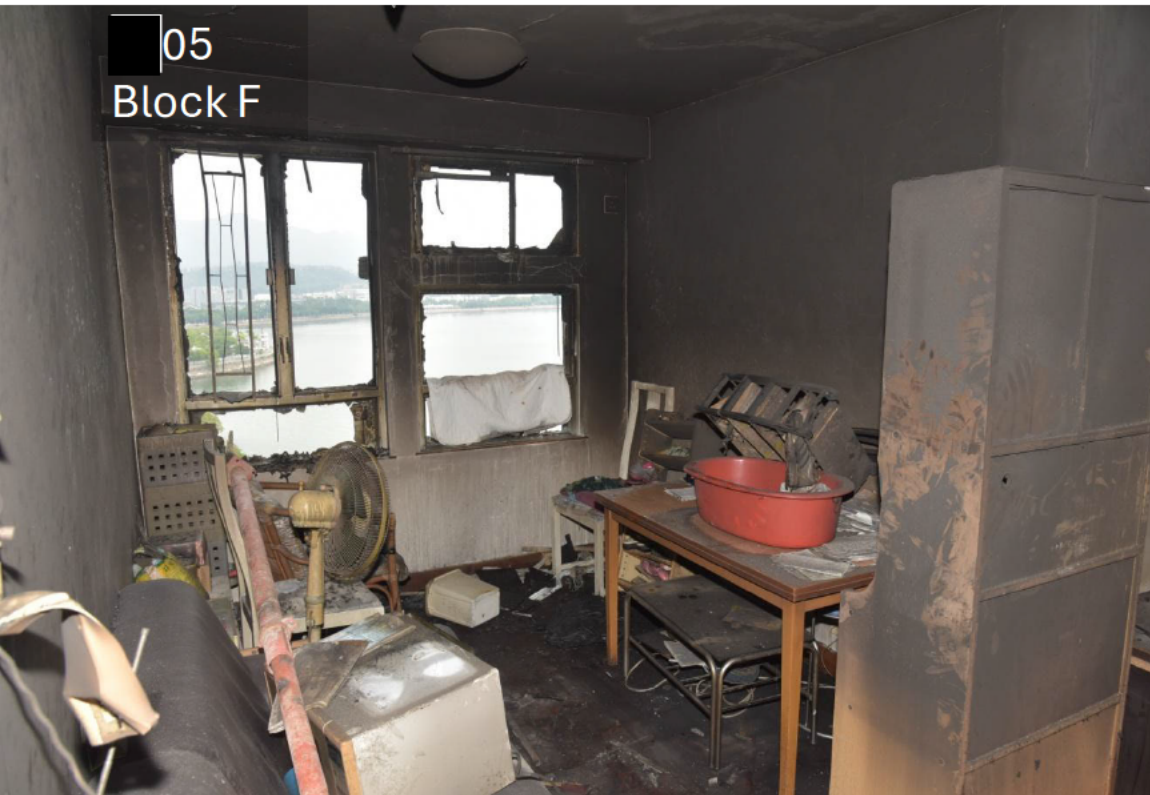
05  
Block F

# Smoke spread through window openings in Block F Unit ■ 05

Living room

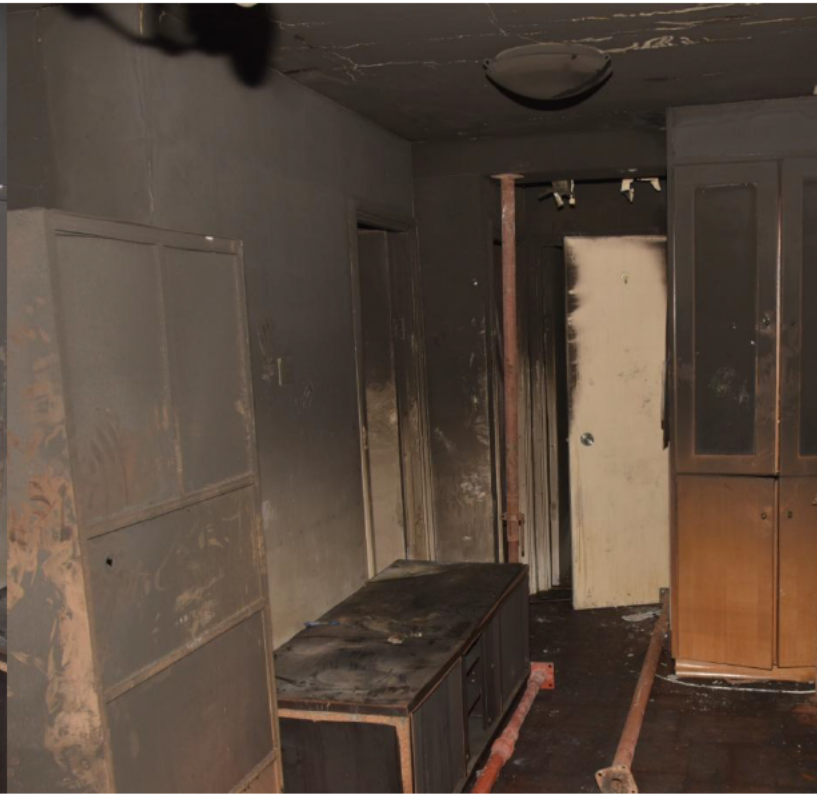
Room corridor

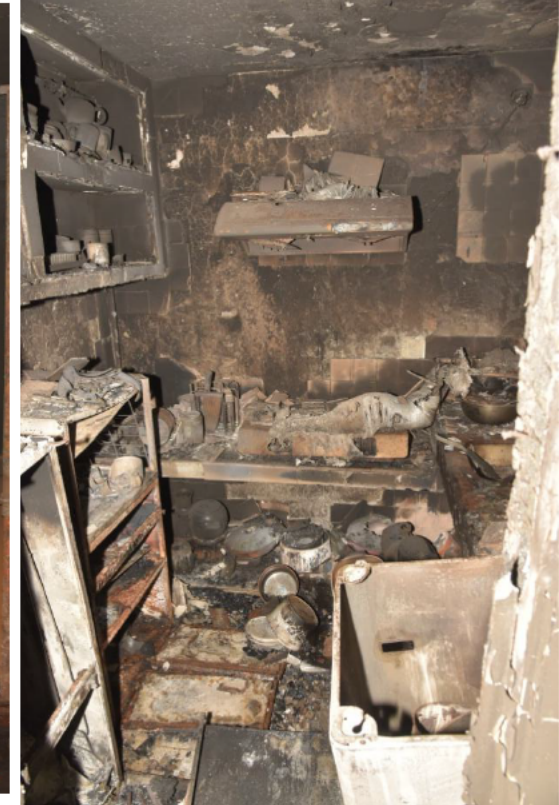
Kitchen

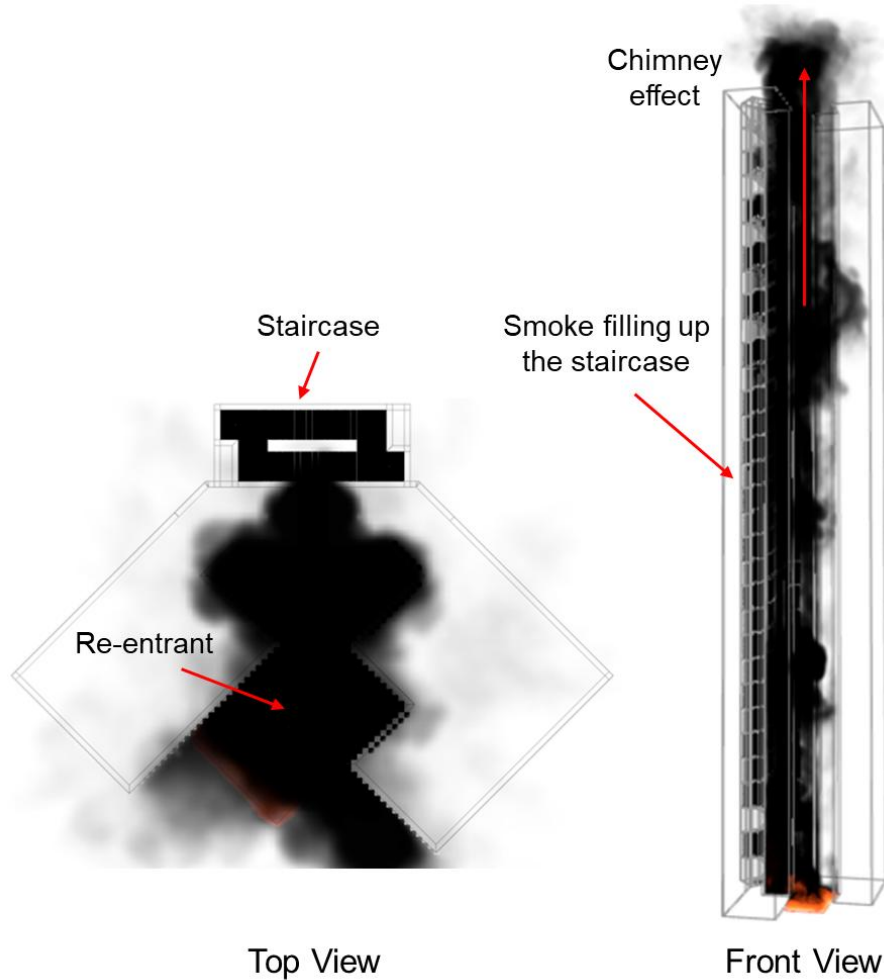
- Video footage showed fire spread from the bottom to the top within 10 seconds.
- The upper part of WGWs is left open for ventilation.
- Some WGWs were replaced by wooden doors. The wooden doors have gaps or left open or burnt through during the fire.
- The CFD simulation results indicate a very rapid vertical spread of fire gases in the re-entrant, with smoke entering the staircases and lift hall on all floors.

Figure 4.8. Simulation results of smoke spread from the re-entrant into the staircase

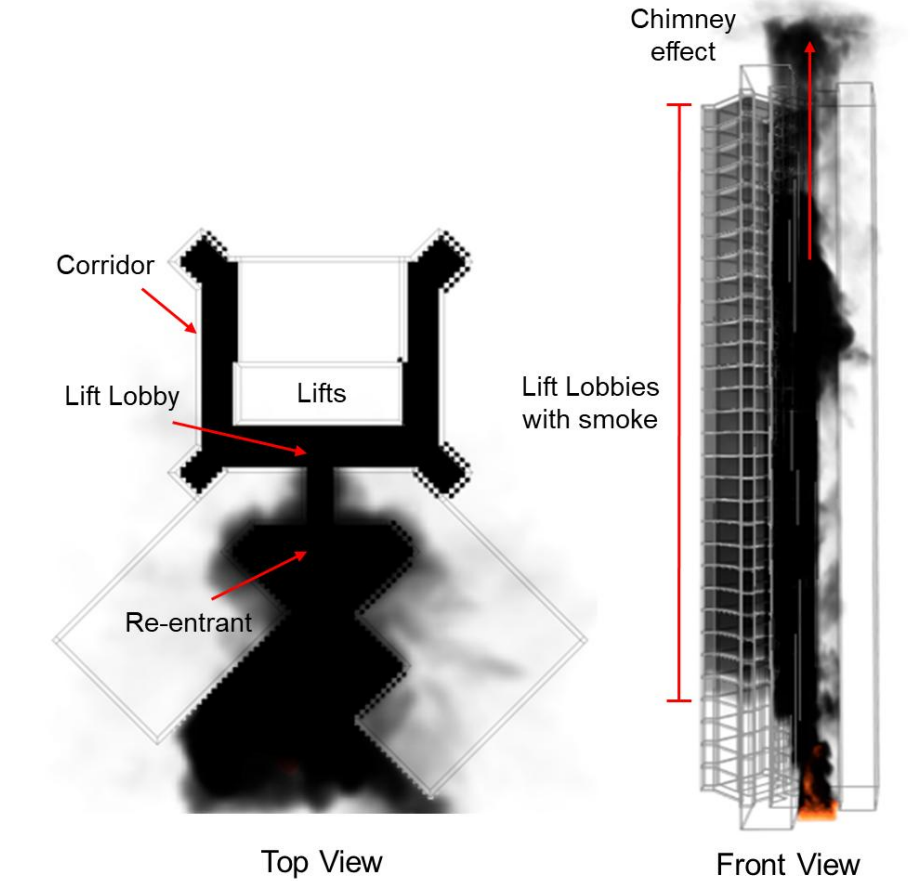
Figure 4.9. Simulation results of smoke spread from the re-entrant into lift halls.

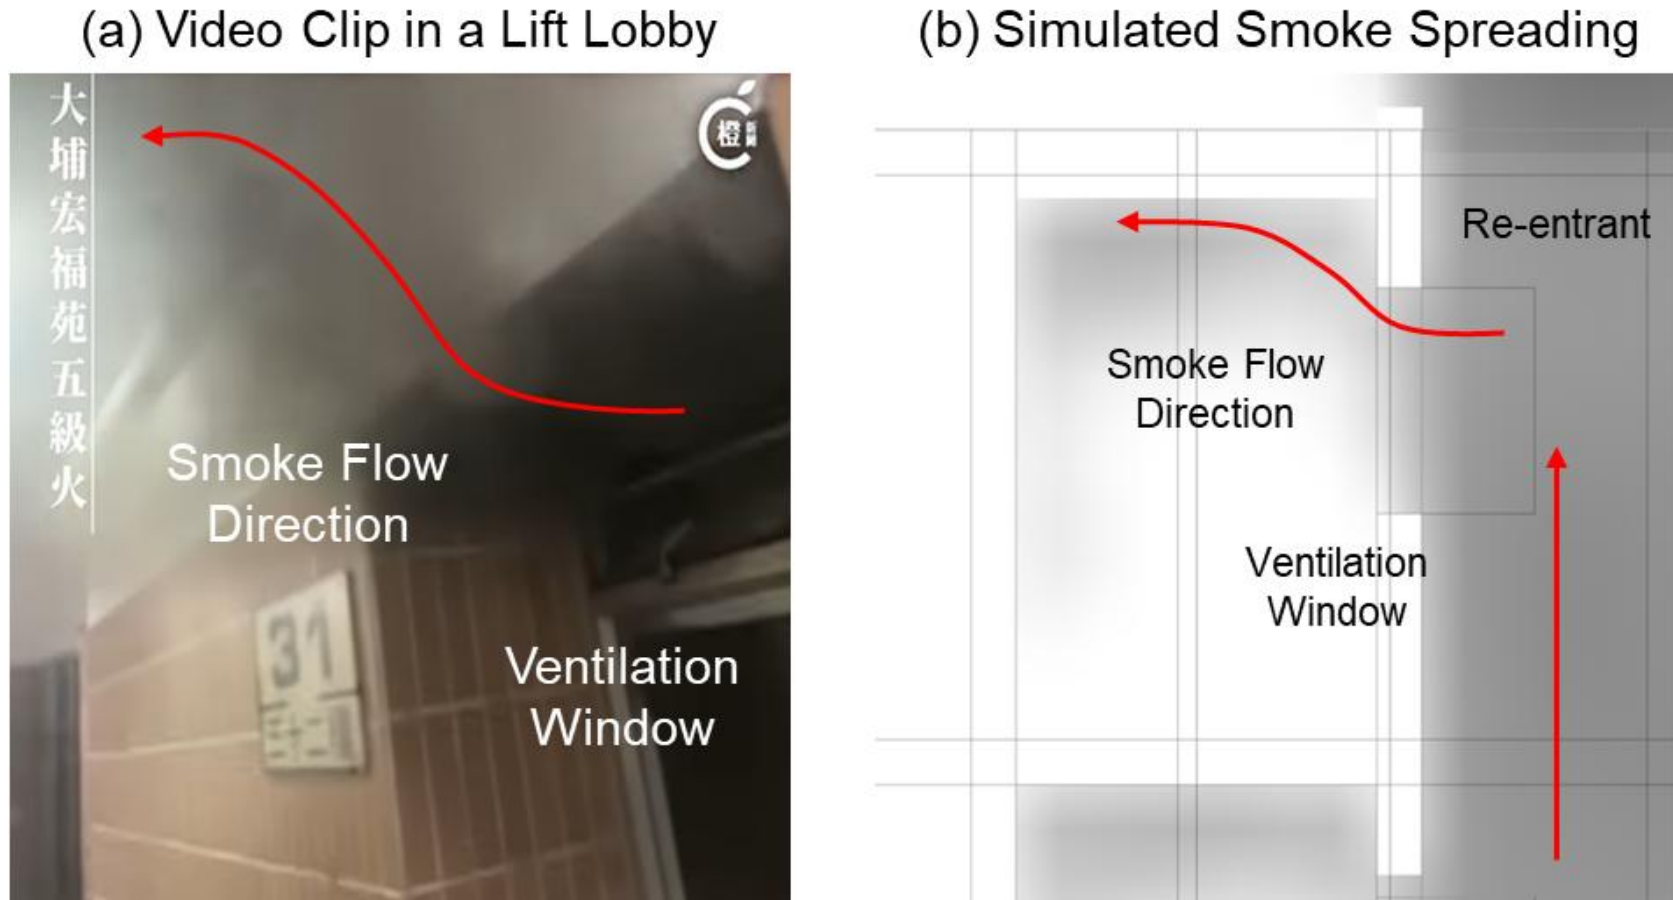
**Figure 4.10. Smoke spreading conditions in the lift lobby: (a) video, and (b) simulation result**

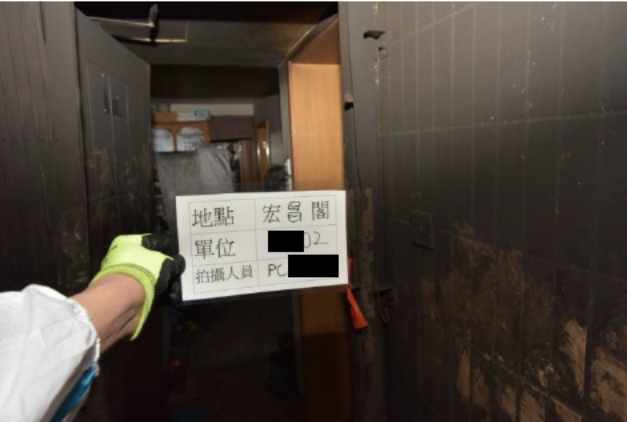
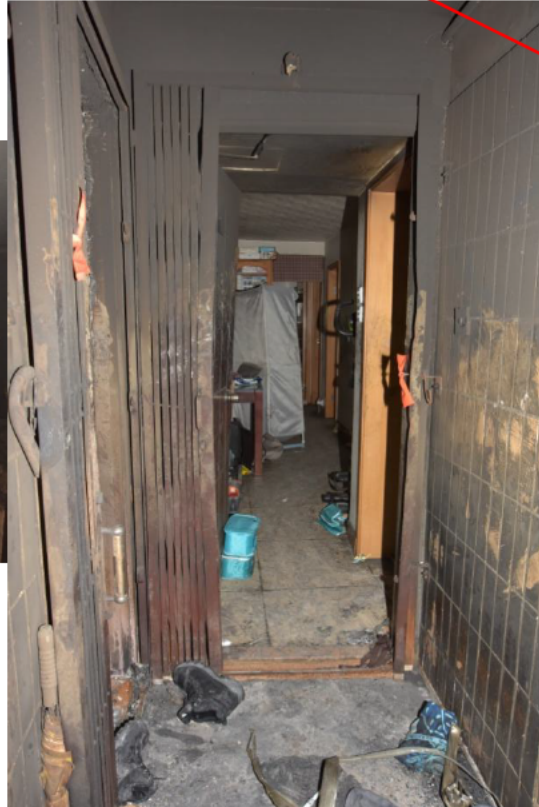
Entrance Door

Hot smoke penetrated into Unit 02 through the door gaps while other units on the same floor were burning for an extended period.

Heavy soot deposition and char on the entrance door leaf and on the ceiling of Unit 02 close to the entrance door

- 15:10 – 15:30 Fire in Unit ■01 was developing to flashover.
- 15:30 – 16:00 The entrance door of Unit ■01 broke through.  
Hot smoke and flames from Unit ■01 would have impinged directly on the entrance door of Unit ■02; then smoke leaked into Unit ■02 through door gaps and overcame 4 victims in Unit ■02.

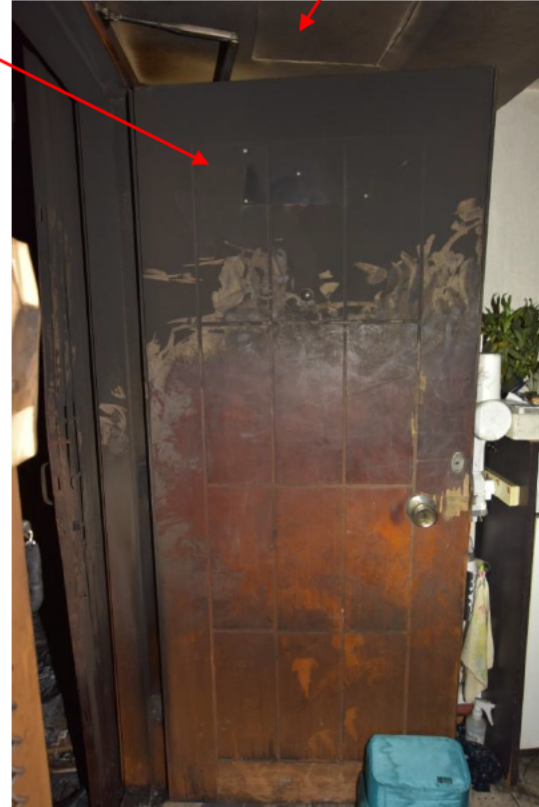
Entrance door leaf
