**Independent Committee in relation to the  
Fire at Wang Fuk Court in Tai Po**

**4<sup>th</sup> Witness Statement of YIU Men-yeung**

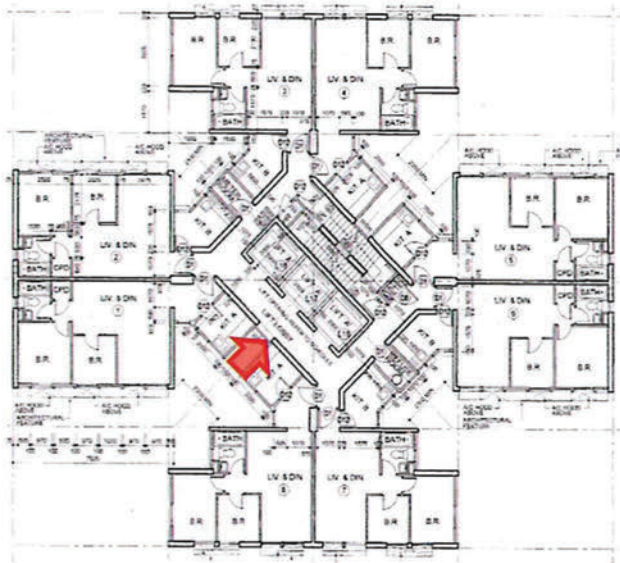
Figure 1 (a):  
Location of Lift Lobby Window

26. The west re-entrant of Wang Cheong House was connected to the lift lobbies via windows on each floor, as shown in Photos 1(a) and 1(b), with the upper part of the windows being openable. The rapid fire spread along the west re-entrant was observed at 1511 hours. Intense smoke and heat generated by the rapid fire spread would have penetrated into the lift lobbies through the openable section of the windows, significantly hindering evacuation efforts.

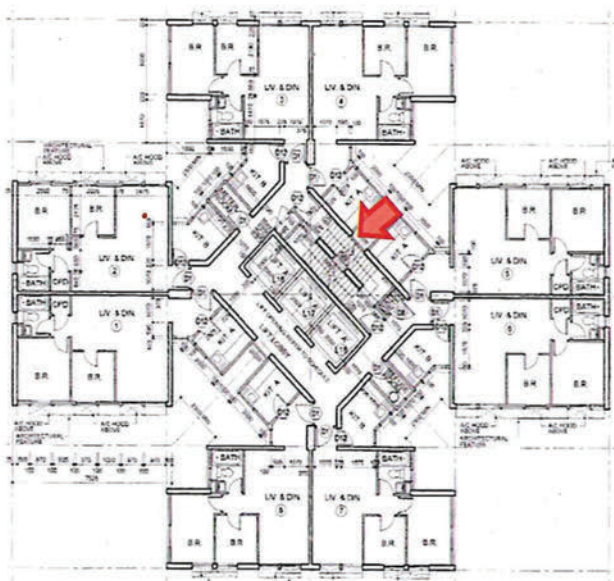
Figure 1(b):  
Location of Staircase Window

Remarks: For all blocks of Wang Fuk Court, all the existing staircase windows, of which the upper part was openable, were proposed to be replaced with fire-rated windows as part of the renovation works of Wang Fuk Court.

14. It was only revealed after the fire that some windows at the staircases were replaced with movable boards, most of which were believed to be wooden and the rest of them were made of other materials, to provide convenient access for workers to the scaffold.

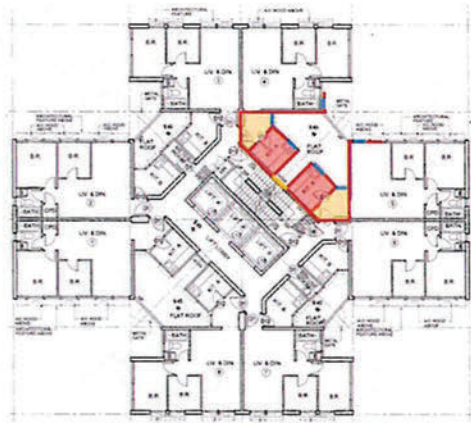
Figure 3(a): Replicated Portion of Wang Cheong House

16. At the Sichuan University of Science and Engineering, a three-storey full scale model simulating the flat roof outside Flats 104 and 105 of Wang Cheong House was constructed to conduct a series of full-scale fire tests. The tests replicated the condition of Wang Fuk Court at the material time, with, amongst others, wired glass windows and movable wooden boards installed in the

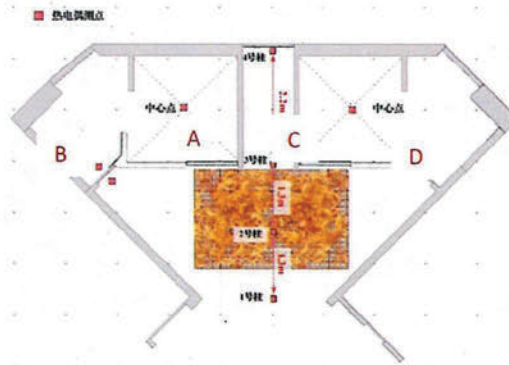
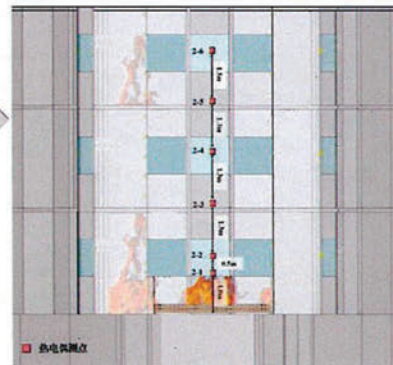
Figure 3(c): Temperature Measurement Points outside the Wooden Boards and Windows

18. As observed during the trial test, the fire spread rapidly and severely along the re-entrant. The temperature on 1/F, 2/F and 3/F rose to 60°C after 30m 34s (1834s), 27m 13s (1633s), and 27m 4s (1624s) respectively.<sup>2</sup> The wooden board on 2/F was ignited by the intense fire in the re-entrant, which in turn spread through the opening on 2/F into the staircase void, with the peak temperature recorded immediately outside the wooden board reaching approximately 1,000°C eventually. This extreme heat, combined with the vigorous fire spread, likely caused conditions in the lift lobbies, corridors and staircases connecting to the re-entrant to deteriorate rapidly in the actual fire incident, thereby severely impeding evacuation efforts during the fire at Wang Fuk Court. Therefore, it is reasonable to assume that the lift lobbies, corridors and staircases at Wang Fuk Court became untenable as the rapid fire spread along the re-entrant was observed.
