**Independent Committee in relation to the
Fire at Wang Fuk Court in Tai Po**

Witness Statement of TANG Wing-wah

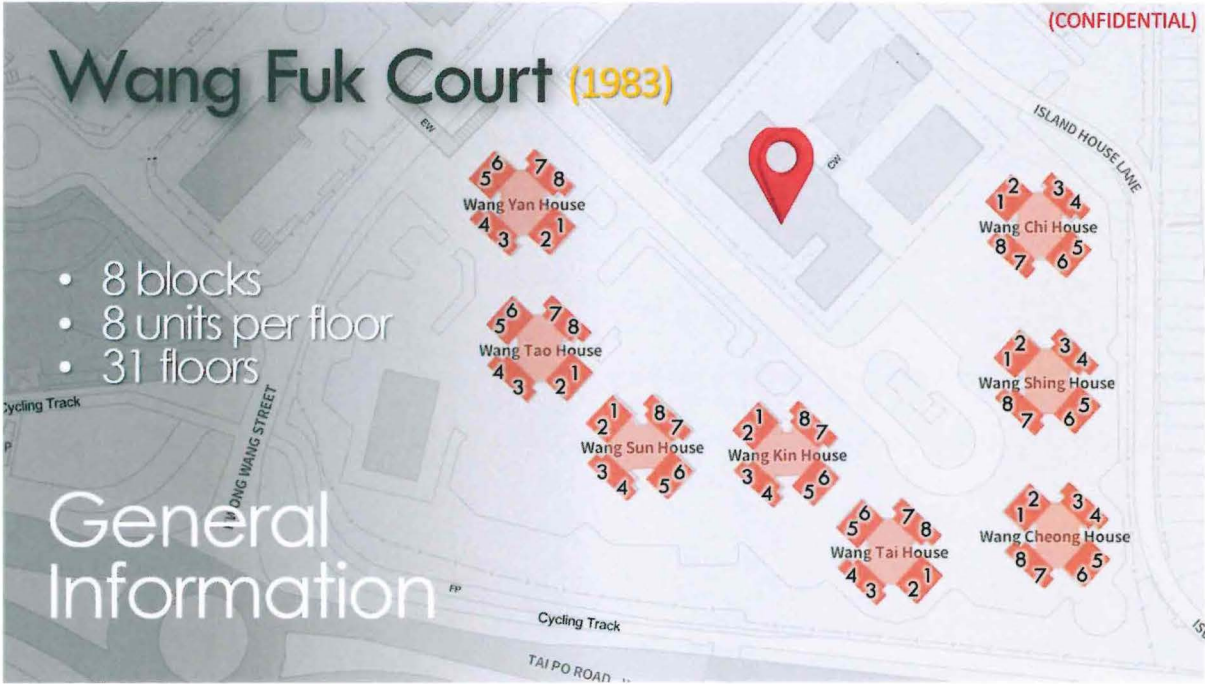
General Layout of Wang Fuk Court

7. Completed in 1983, the Wang Fuk Court is a Home Ownership Scheme estate consisting of eight residential blocks, namely (i) Wang Yan House (Block A), (ii) Wang Tao House (Block B), (iii) Wang Sun House (Block C), (iv) Wang Kin House (Block D), (v) Wang Tai House (Block E), (vi) Wang Cheong House (Block F), (vii) Wang Shing House (Block G), and (viii) Wang Chi House (Block H). Each block consists of 31 floors. Each floor consists of 8 units numbered 1 to 8, connected by a “U-shaped” corridor with the lift lobby at the centre. Opposite to the lift lobby, there are two sets of criss-crossing staircases commonly called “scissor stairs” to provide a continuous means of escape. Both staircases can be accessed from the 31st floor down to the ground floor, but only one of them leads to the rooftop. A general layout of Wang Fuk Court and a sample floorplan taken of Wang Cheong House are shown below for reference.
